Expertise

Protocol number: 41588416
Order No. / Reference: 25196984
Inspection date: 11 Sept 2025

Manufacturer: Ford	Model: Transit Custom 340 L1H1 LKW VA Autm. Trend
VIN: WF0YXXTTGYLR14557

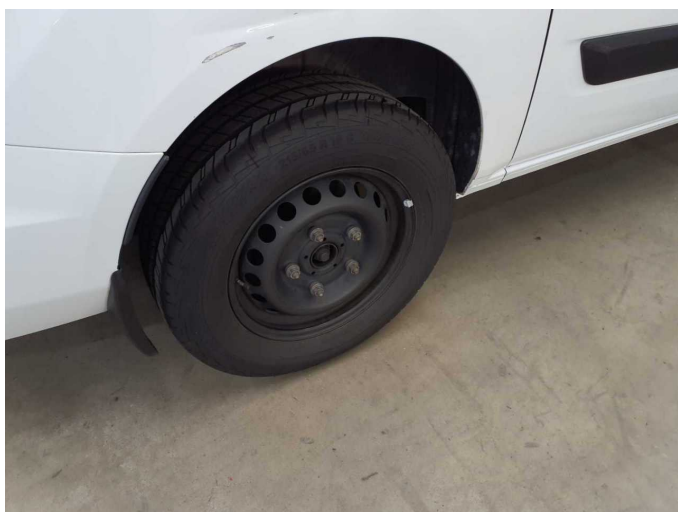
Damage 1: Wheel / tyres: Wheel cover - rear right side - Missing - Replace

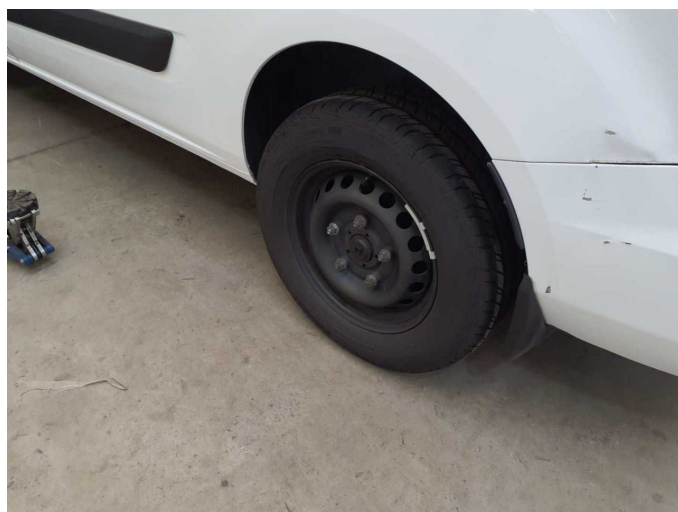
Damage 2: Wheel / tyres: Wheel cover - rear left side - Missing - Replace

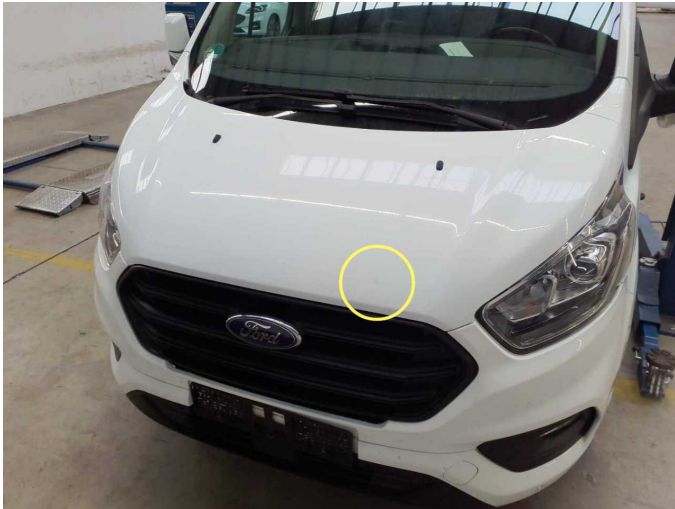
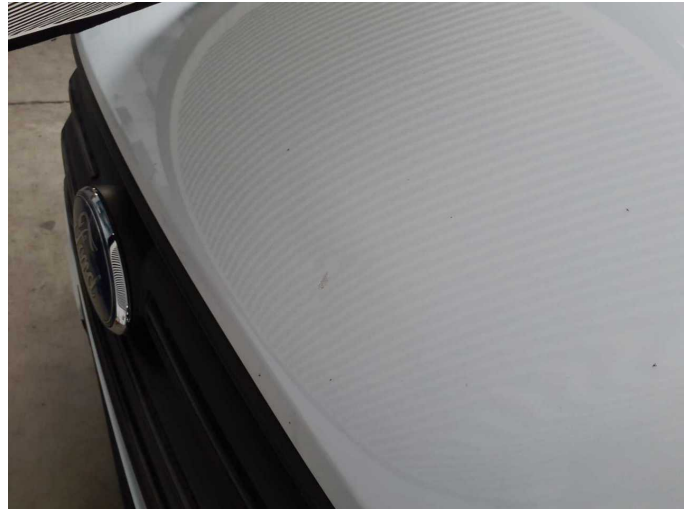
Damage 3: Bonnet: Bonnet - dent(s) - Smooth repair work

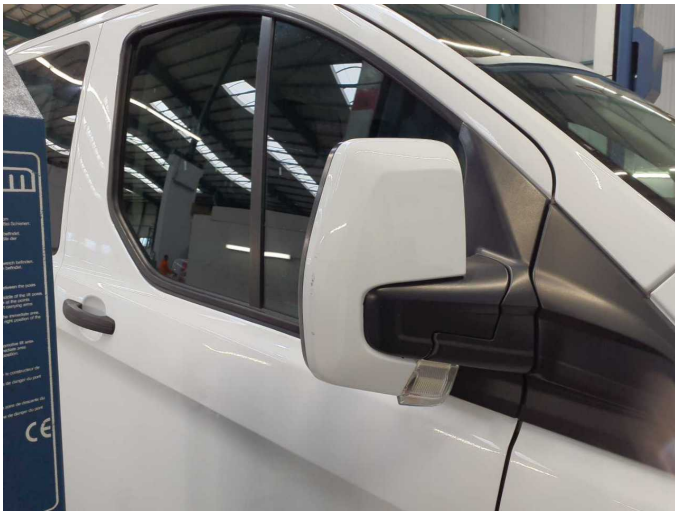
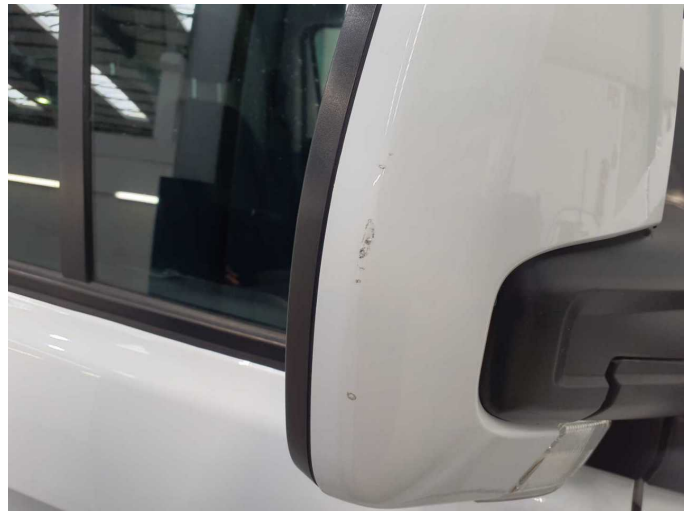
Damage 4: Wing mirror - right side: Cap - Scratch(es) - Paint

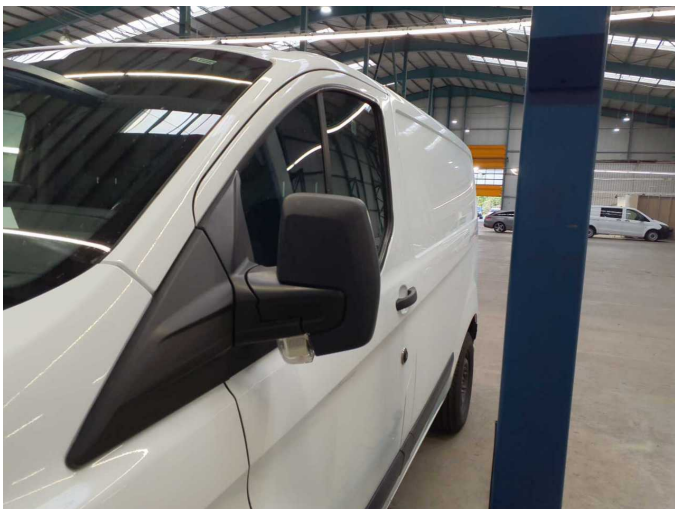
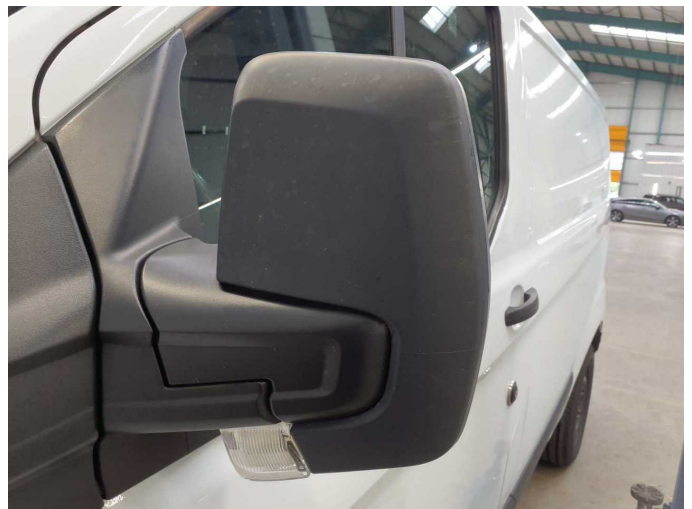
Damage 5: Wing mirror - left side: Cap (Unlackiert) - Does not meet the leasing specifications - Paint

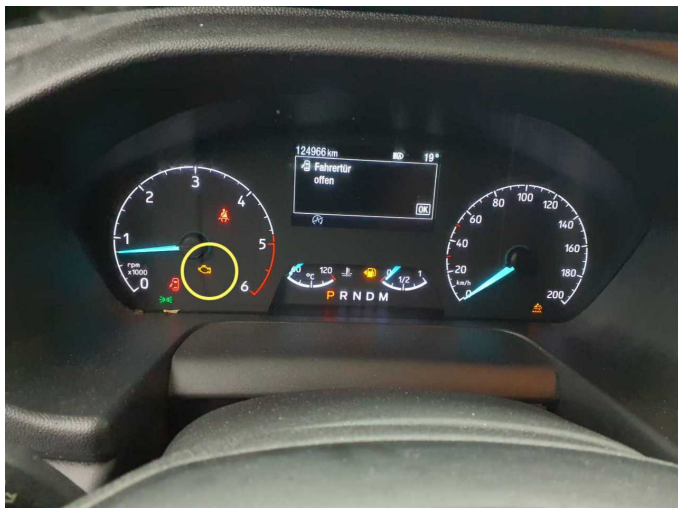
Damage 6: Instrument panel: Indicator light (Motorkontrollleuchte - Mehrkosten können entstehen) - on - Perform diagnosis

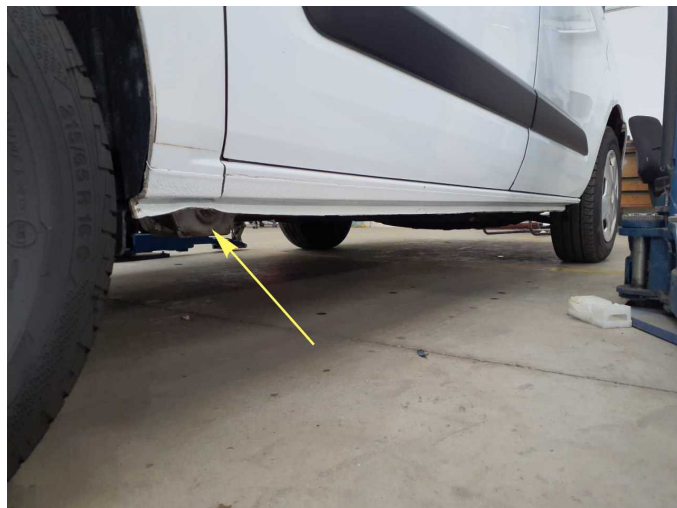
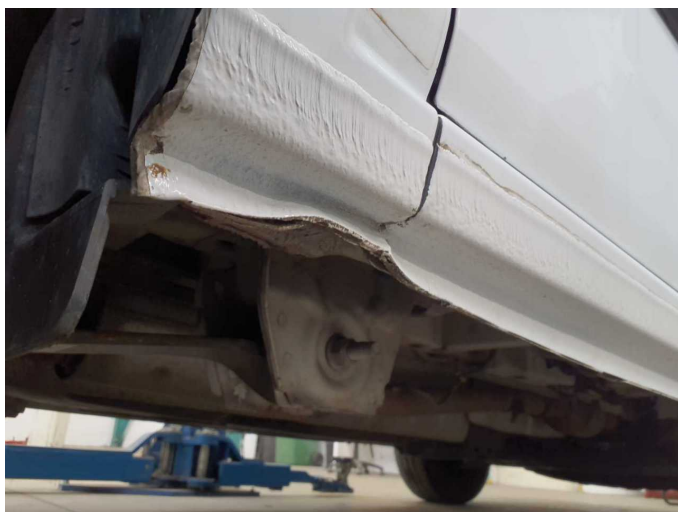
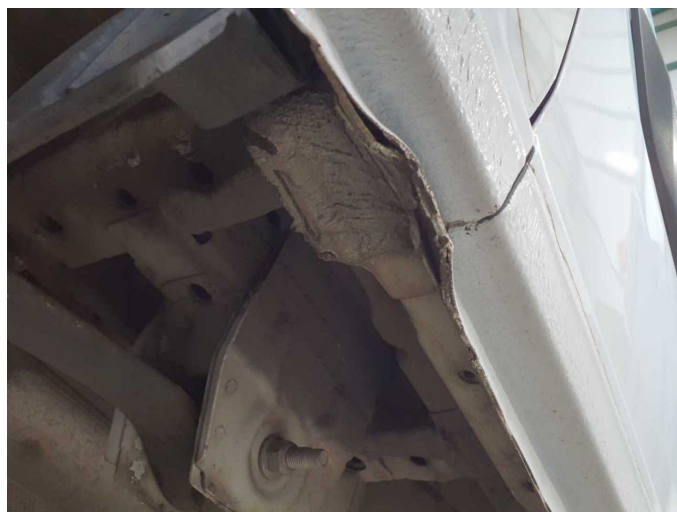
Damage 7: Sill - right side: Sill - Damaged - Repair and paint

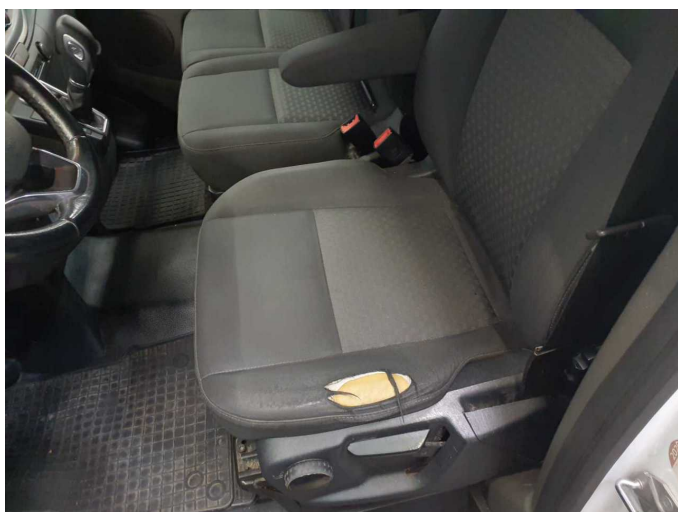
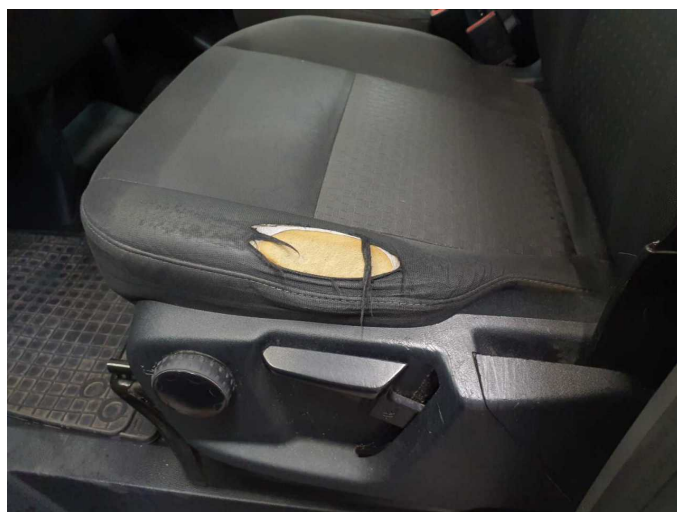
Damage 8: Seat - front: Seat cover - left side - Damaged - Replace

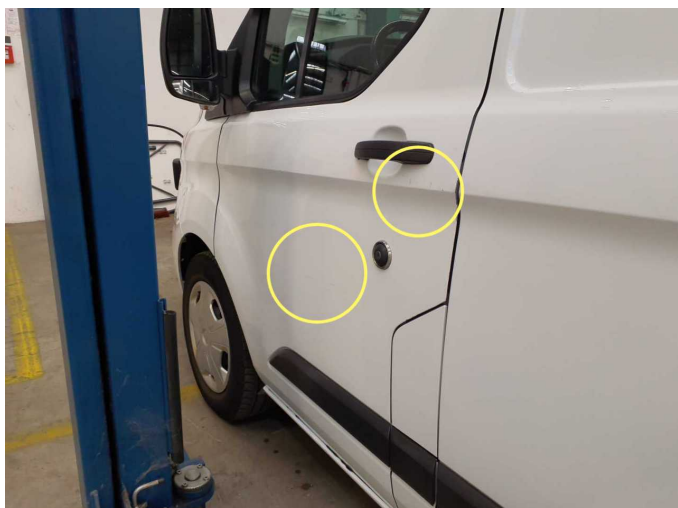
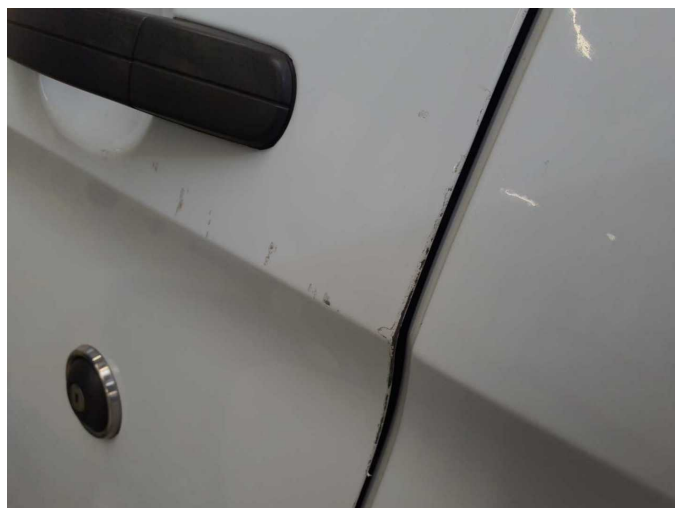
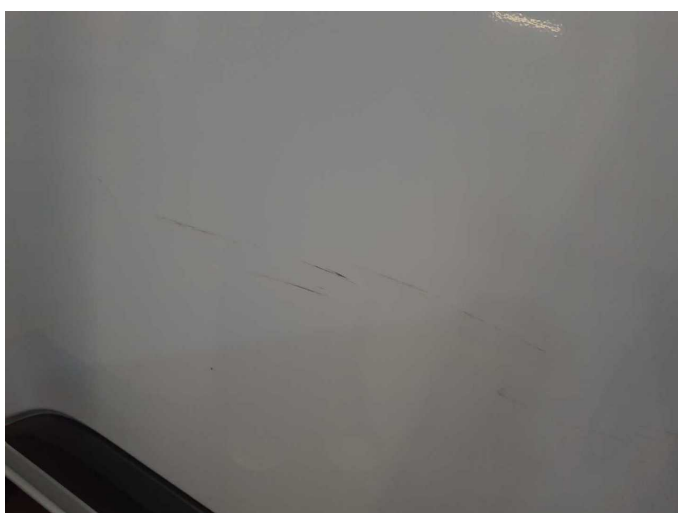
Damage 9: Door - front left side: Door - Scratch(es) - Paint

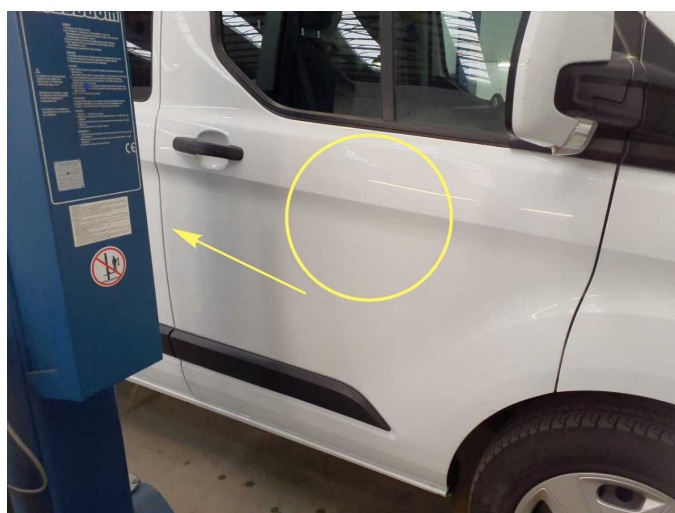
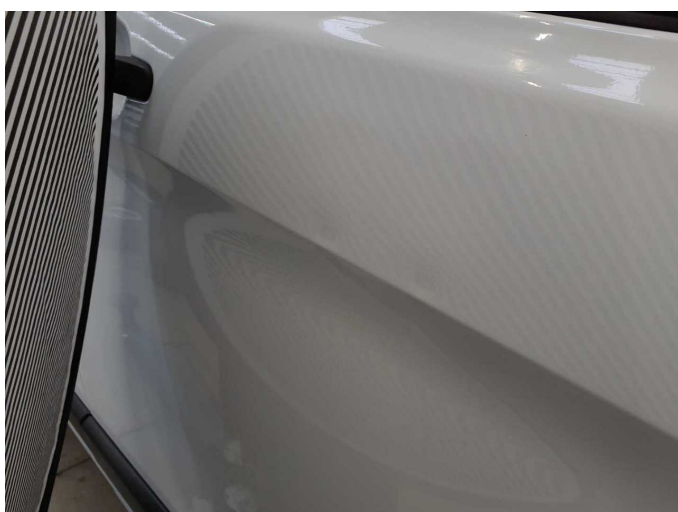
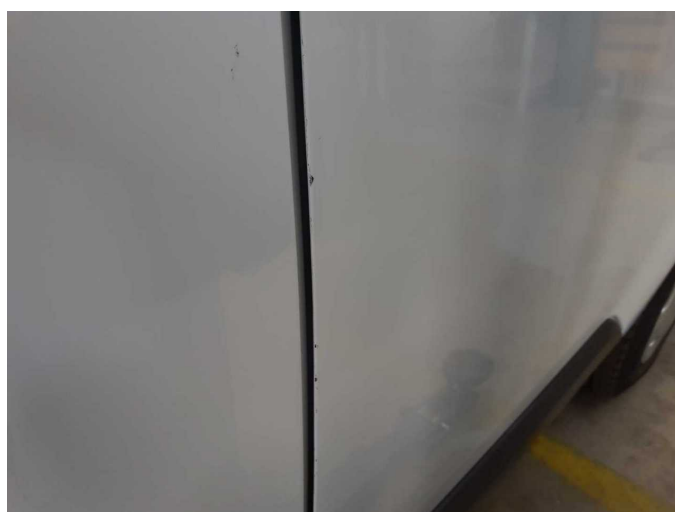
Damage 10: Door - front right side: Door edge - Dent / paintcoat damage - Repair and paint
