Expertise

Protocol number: 41642732
Order No. / Reference: 25252059
Inspection date: 19 Sept 2025

Manufacturer: Ford

Model: Transit Custom 280 L1H1 LKW VA Trend

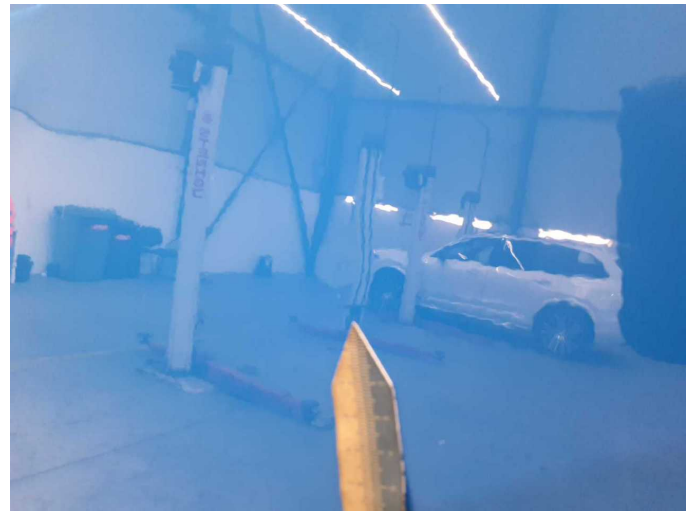
No.	Component group	Description
1	Side panel - rear left side	Side panel - Dent / paintcoat damage - Smart repair

Damage 1: Side panel - rear left side: Side panel - Dent / paintcoat damage - Smart repair

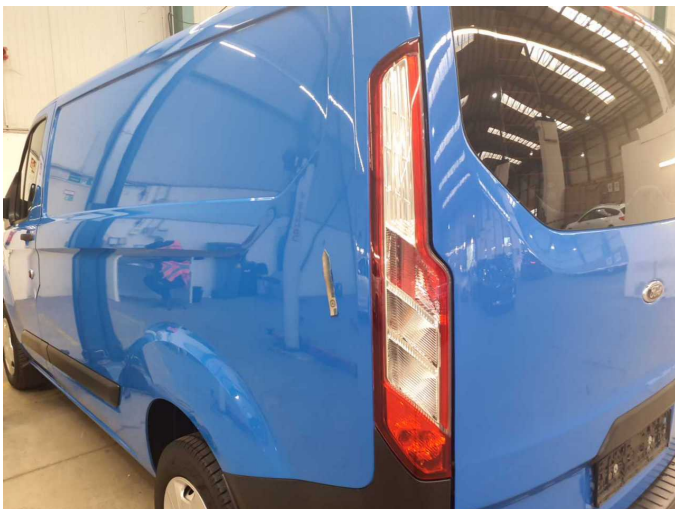
Damage 1: Side panel - rear left side: Side panel - Dent / paintcoat damage - Smart repair

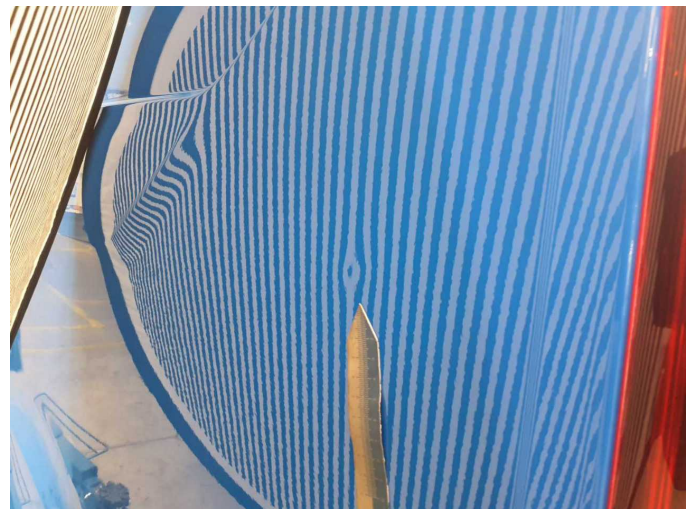
Damage 1: Side panel - rear left side: Side panel - Dent / paintcoat damage - Smart repair

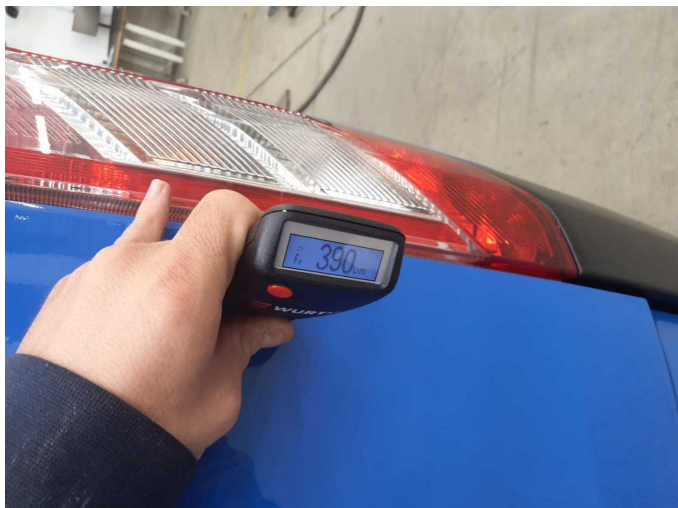
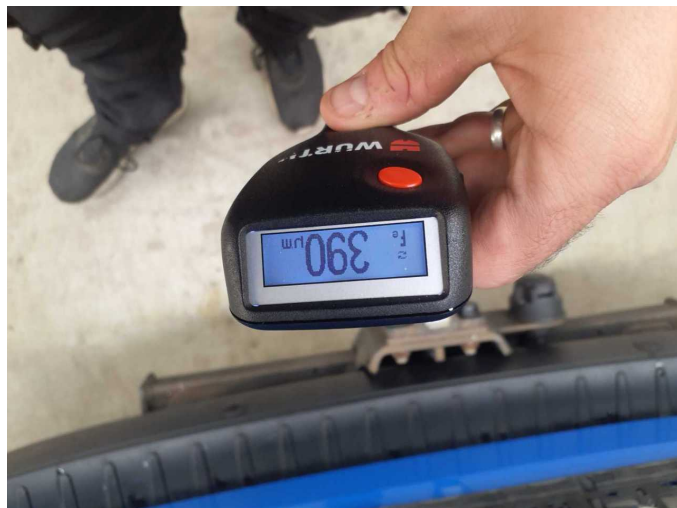
No.	Repainting
1	Boot lid / rear door, Professionally carried out, Invoice of repair done Non-existent
2	Side panel - rear right side, Professionally carried out, Invoice of repair done Non-existent
3	Door - rear right side, Professionally carried out, Invoice of repair done Non-existent
4	Door - front right side, Professionally carried out, Invoice of repair done Non-existent

Boot lid / rear door	390 µm	Side panel - rear right side	198 µm
Door - rear right side	189 µm	Door - front right side	186 µm

Repainting 1: Boot lid / rear door

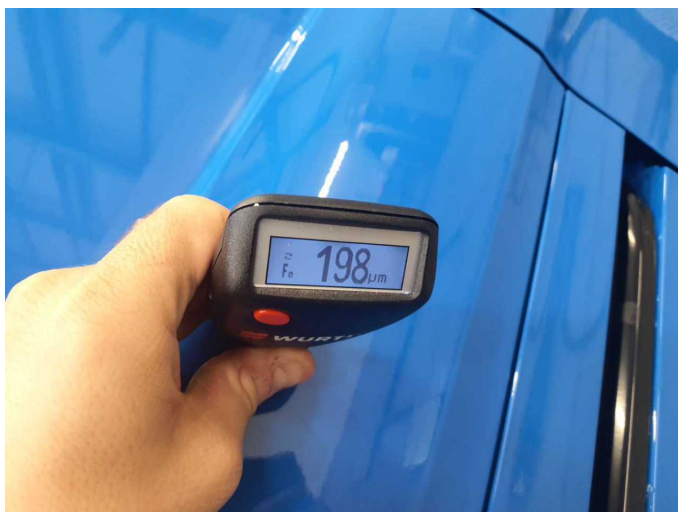
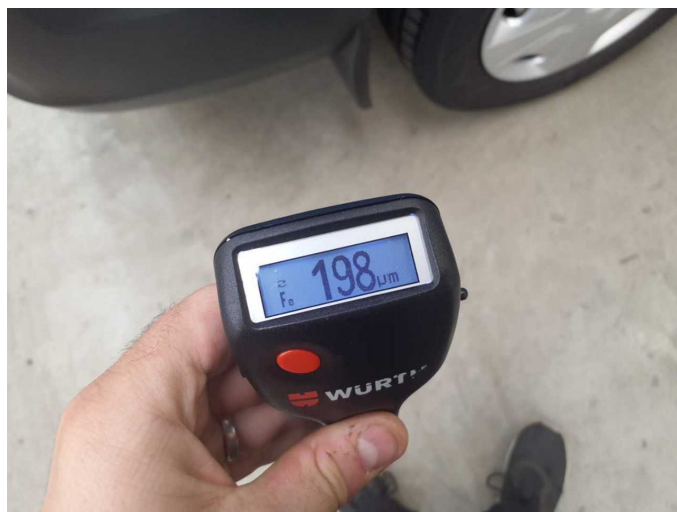
Repainting 2: Side panel - rear right side

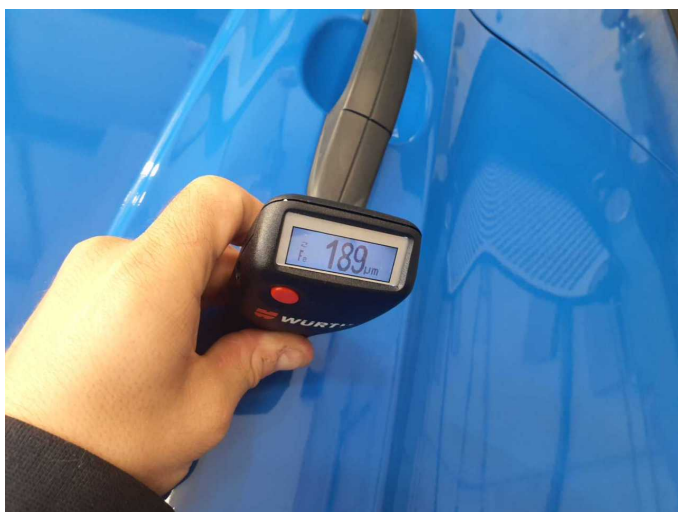
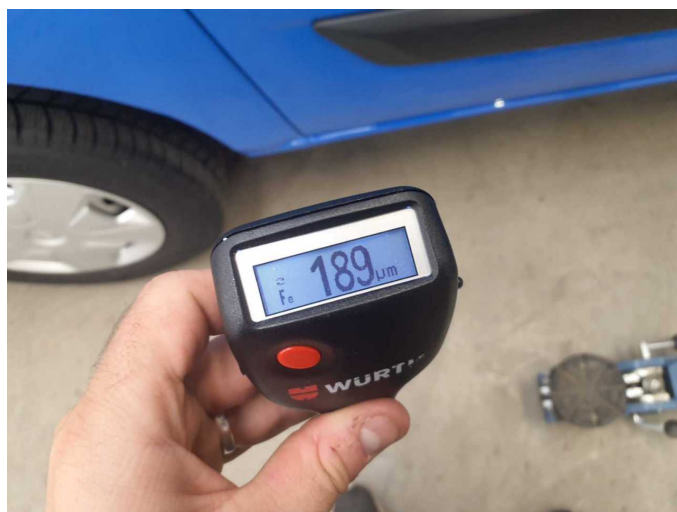
Repainting 3: Door - rear right side

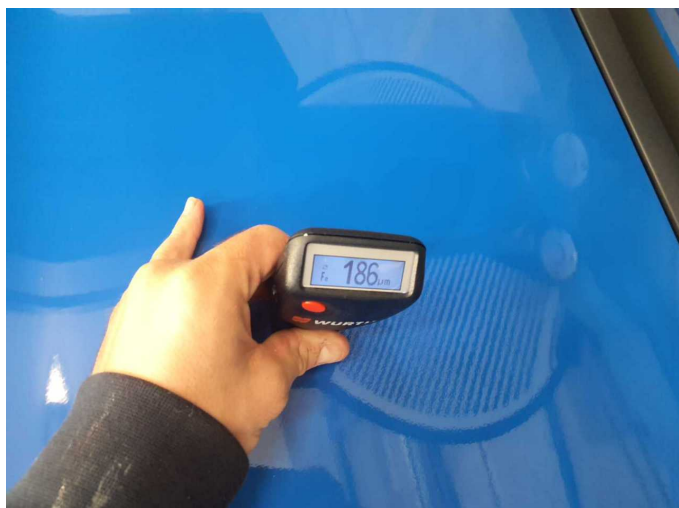
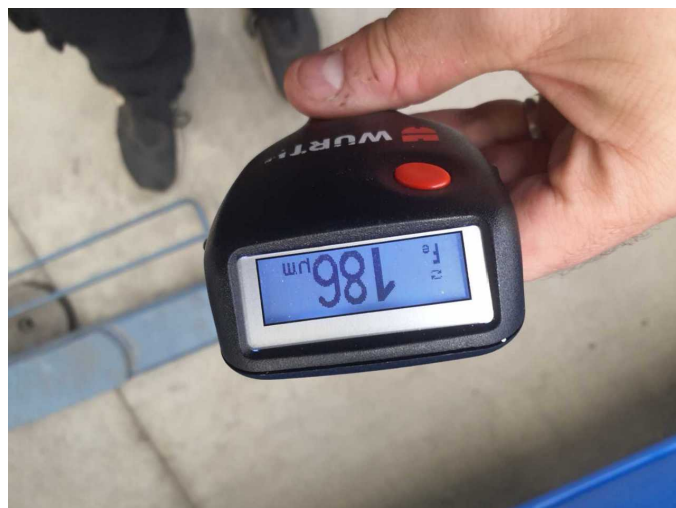
Repainting 4: Door - front right side
