## status report

#### Ford Transit Custom Kasten 300 L2 Trend

| Vehicle identification number | <b>WF0YXTTGYMA23429</b> | mileage read: | <b>65005 km</b> |

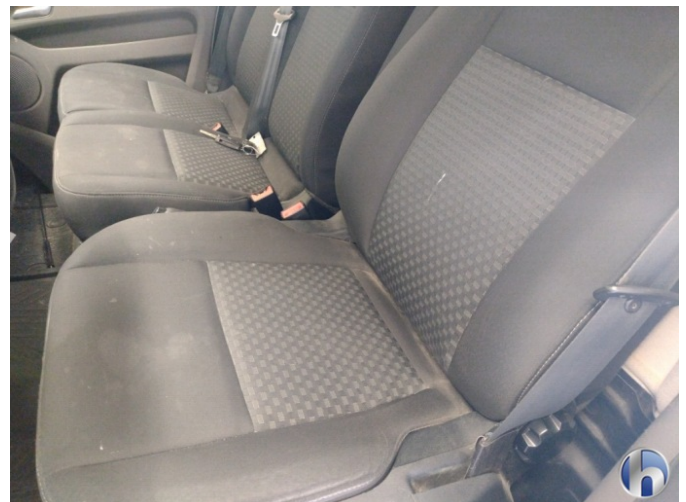
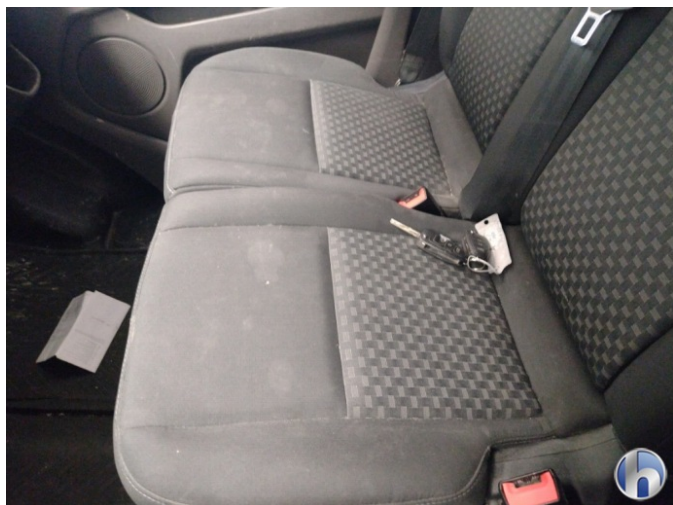
| component | Damage | Rep kind |
|---|---|---|
| 1. Sitzreihe Vorne | Dirty | |

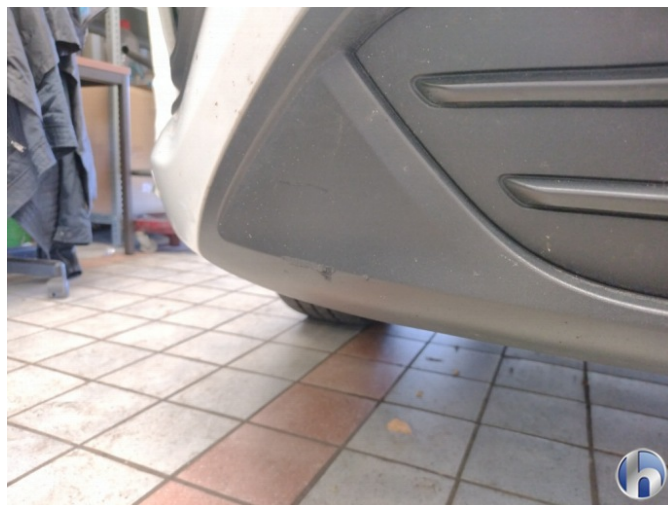
| component | Damage | Rep kind |
|---|---|---|
| 3. spoiler | Damaged | Replace |

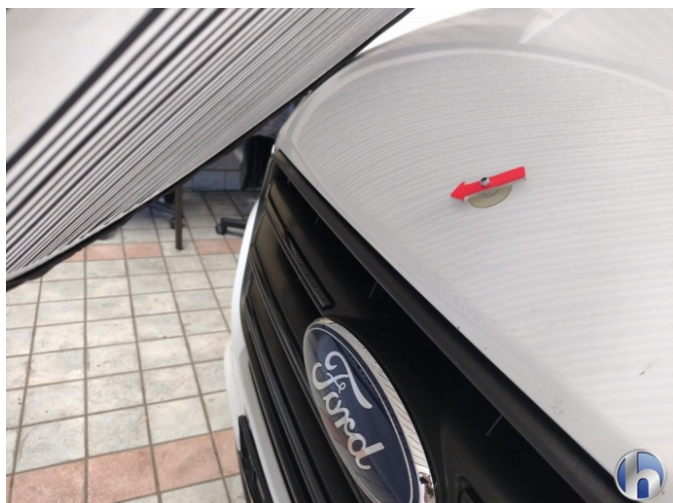
| component | Damage | Rep kind |
|---|---|---|
| 4. hood | Delle | Smart repair |

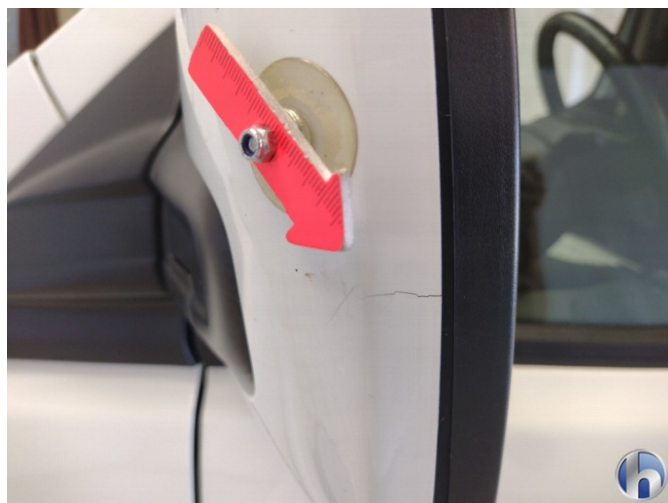
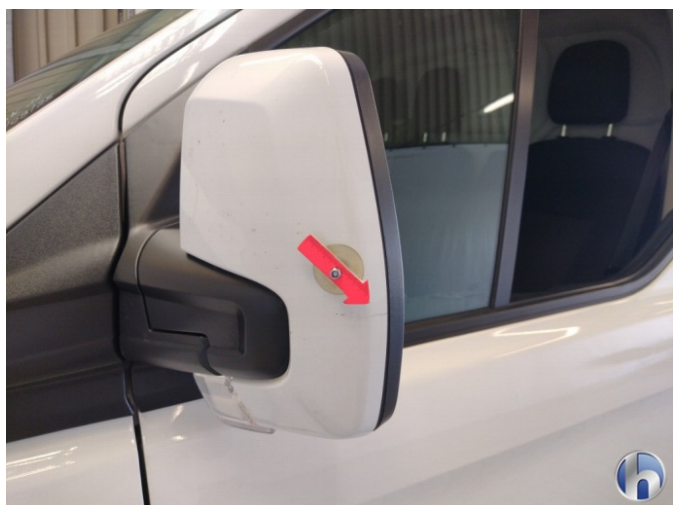
| component | Damage | Rep kind |
|---|---|---|
| 5. | Breakage | Replace |

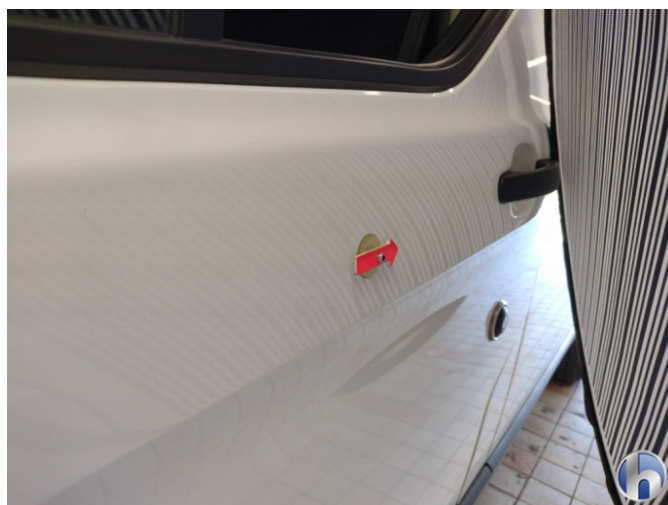
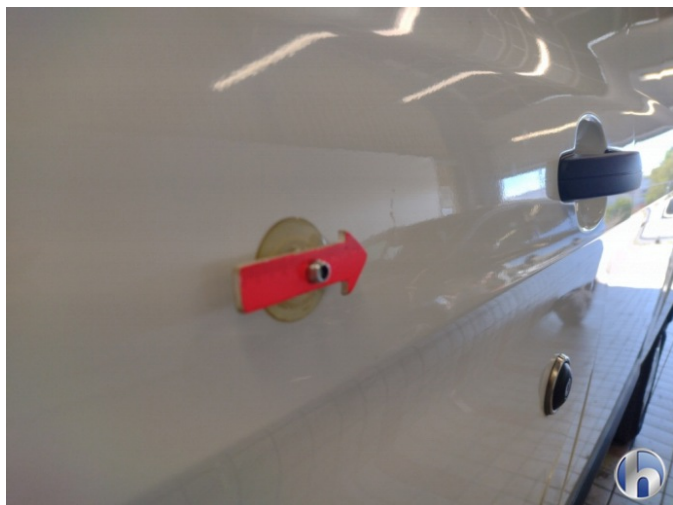
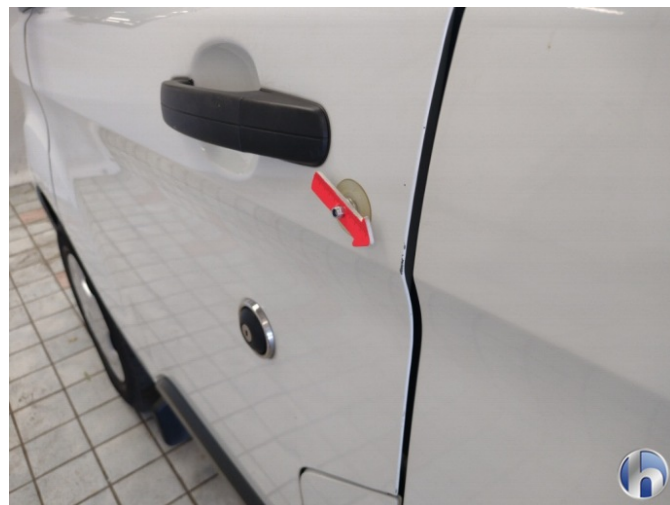
| component | Damage | Rep kind |
|---|---|---|
| 6. Front door - left | Damaged | Refurbish and paint |

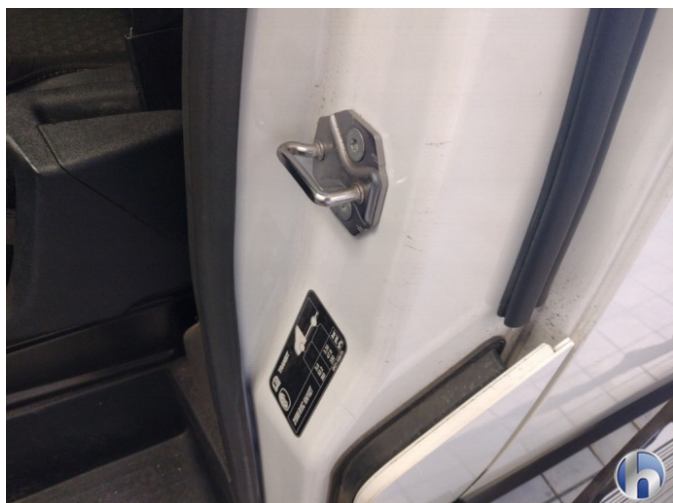
| component | Damage | Rep kind |
|---|---|---|
| 7. Türeinstieg Vorne - Links | Scratch(es) | Paint |

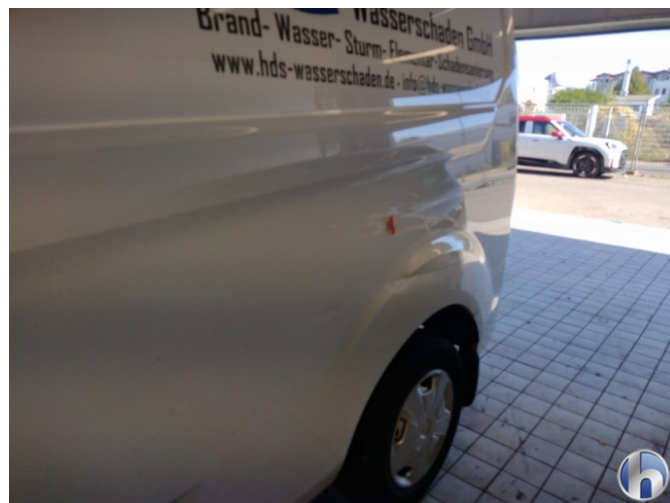
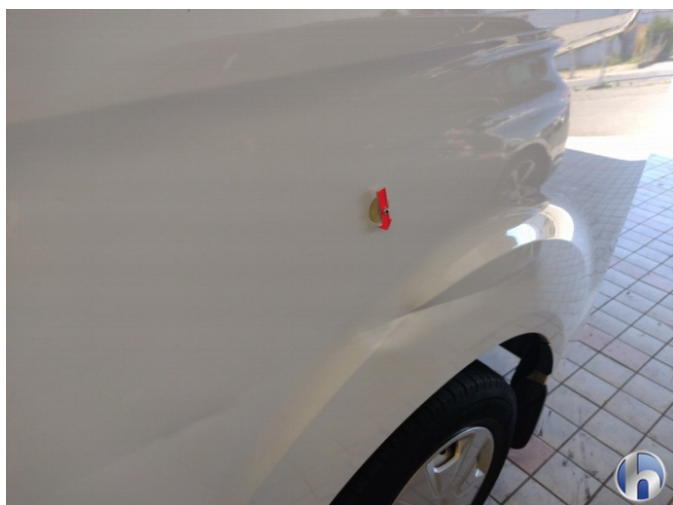
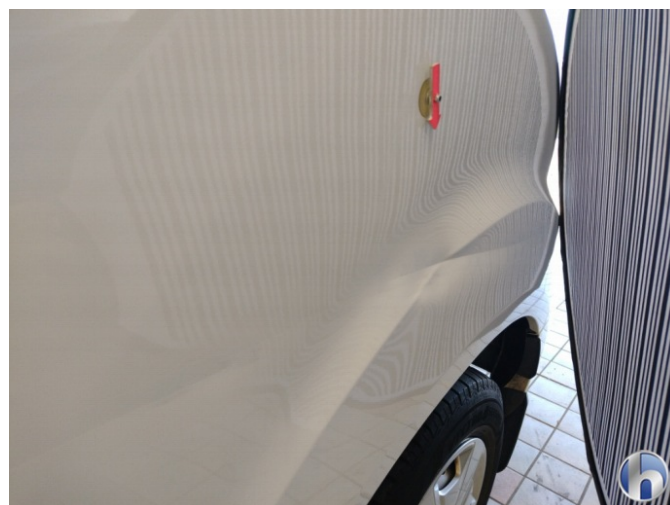
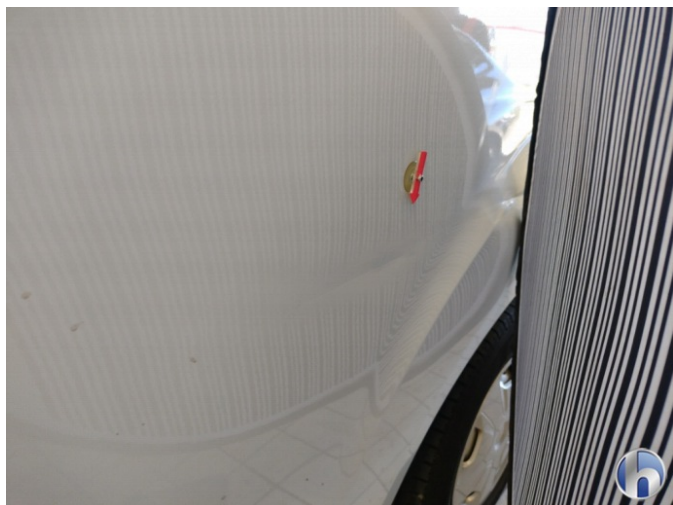
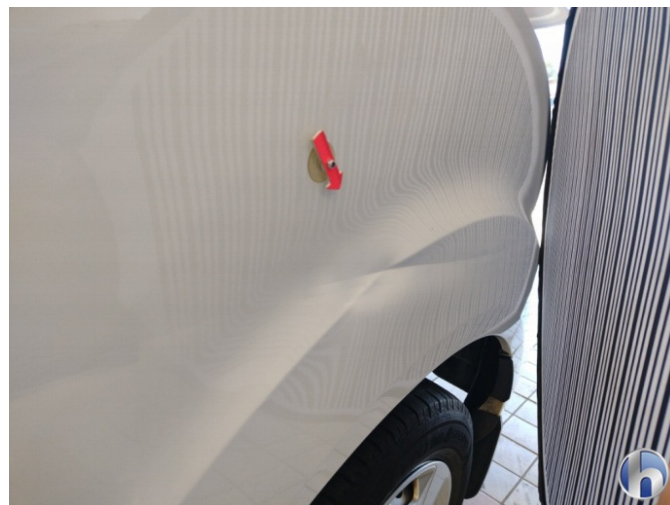
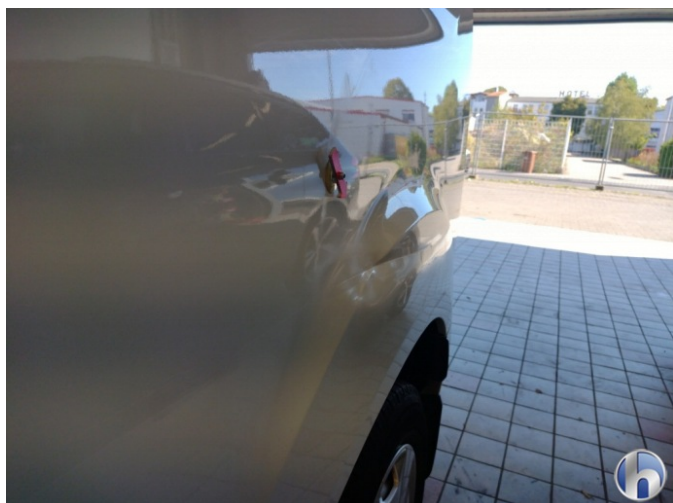
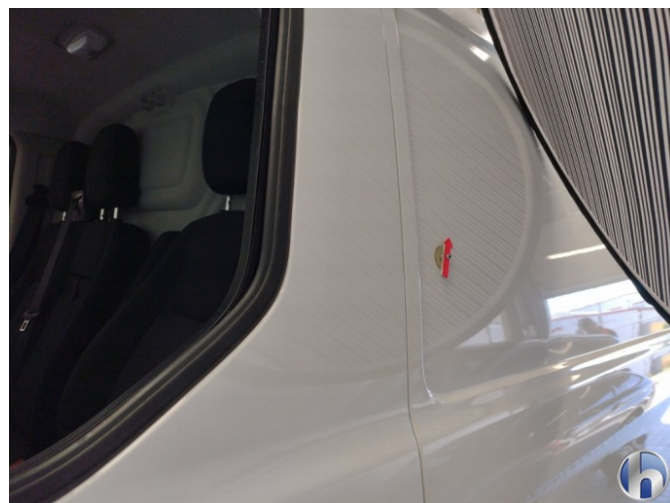
| component | Damage | Rep kind |
|---|---|---|
| 8. Sidewall - Rear - Left | Deformed | Refurbish and paint |

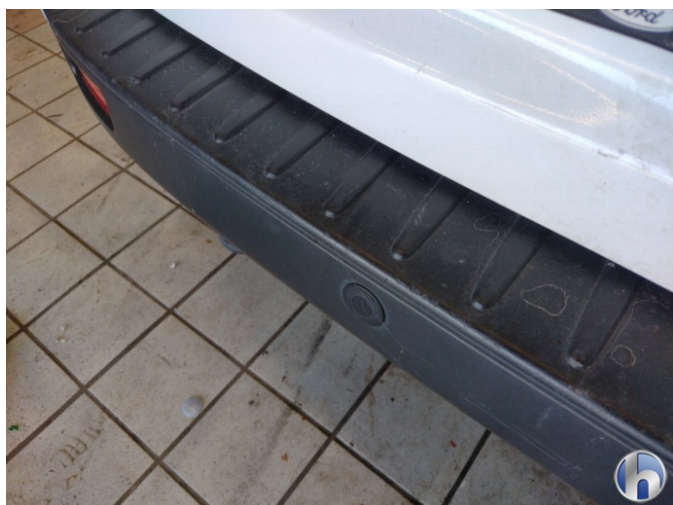
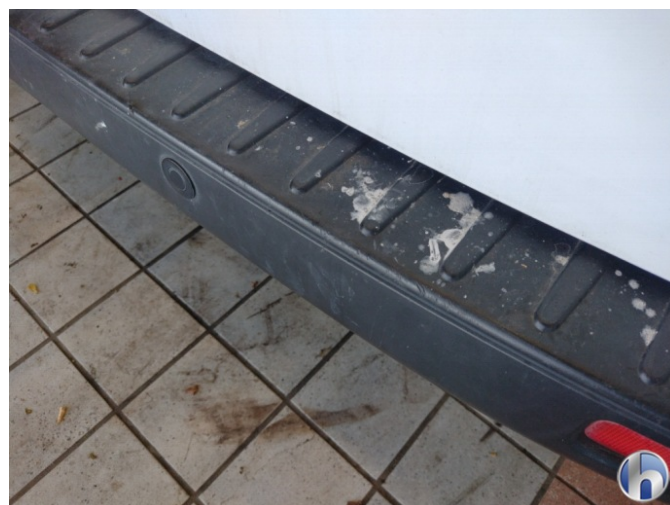
| component | Damage | Rep kind |
|---|---|---|
| 9. Rear bumper | Wear and tear | acceptable |

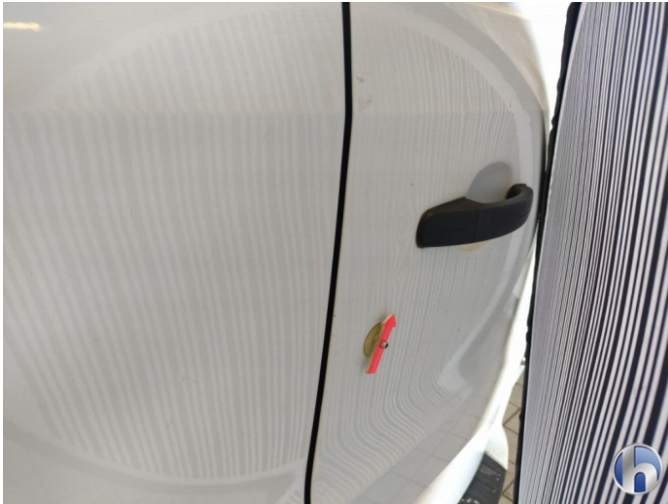
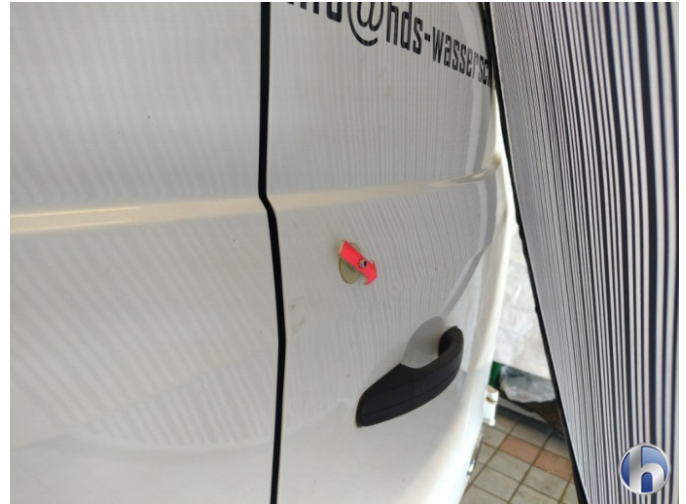
| component | Damage | Rep kind |
|---|---|---|
| 10. Tailgate right | Damaged | Refurbish and paint |

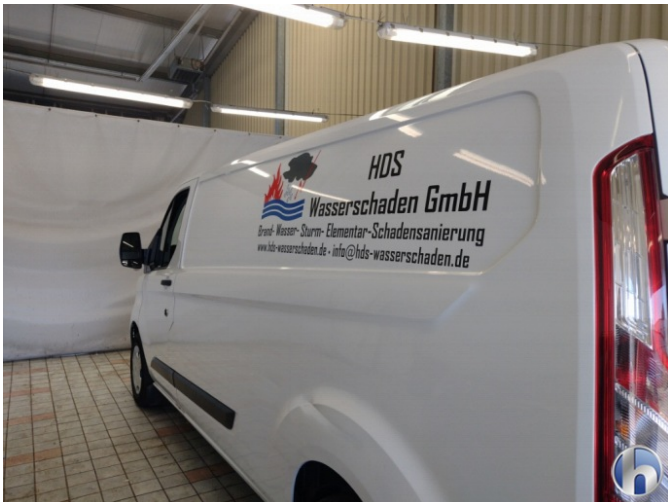
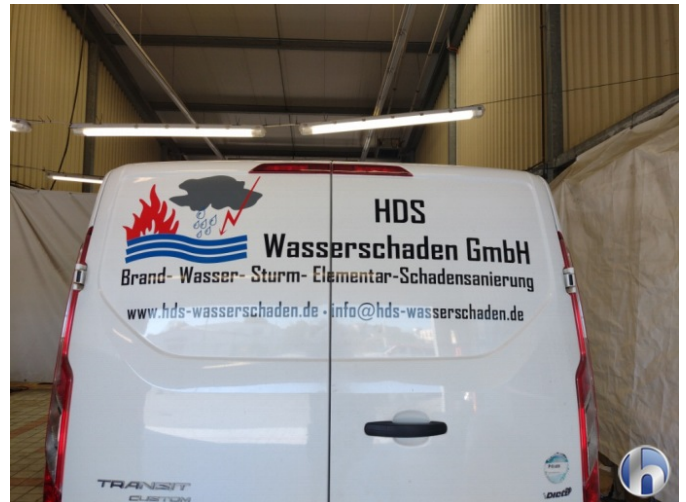
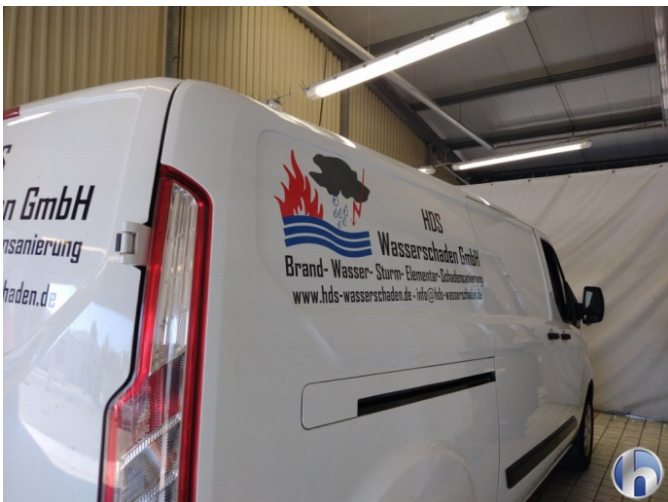
| Performed testing technology | |
|---|---|
| <b>reference:</b> | *Fahrzeug Teilweise Beklebt darunter liegende Schäden können nicht ausgeschlossen werden<br>Nutzfahrzeug typische Gebrauchsspuren und Beschädigungen. |

| component | Damage | Rep kind |
|---|---|---|
| 11. Fahrzeug Beklebt | Sticker | |

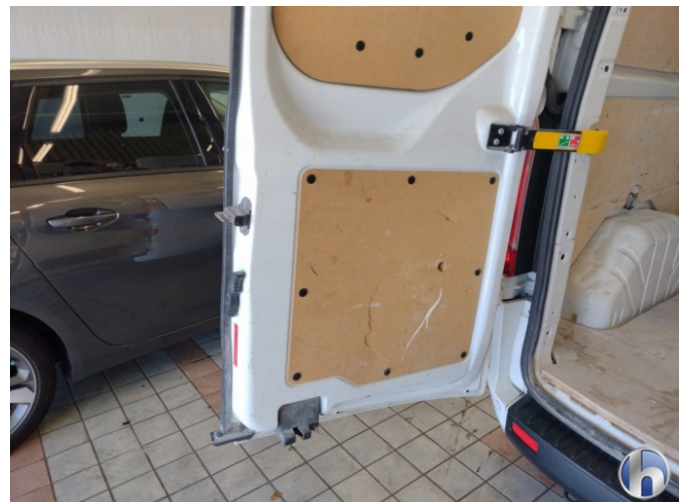
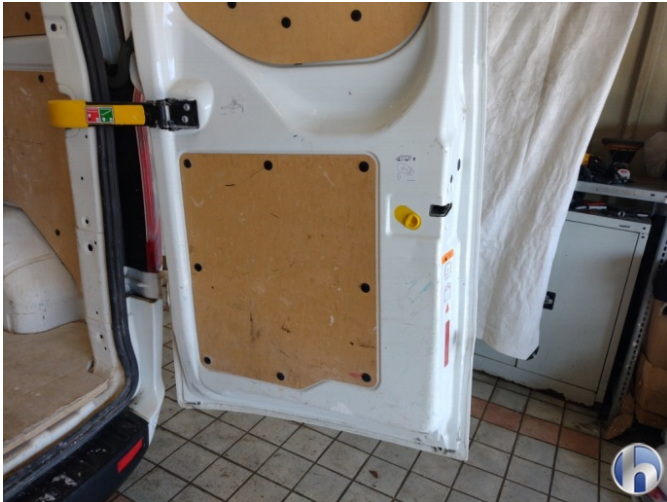
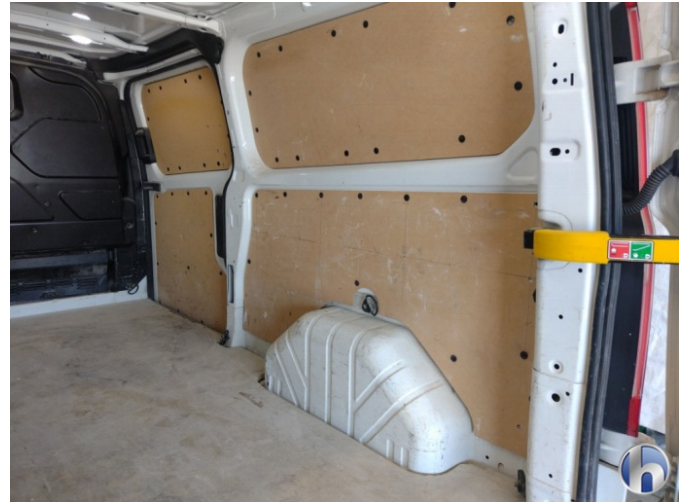
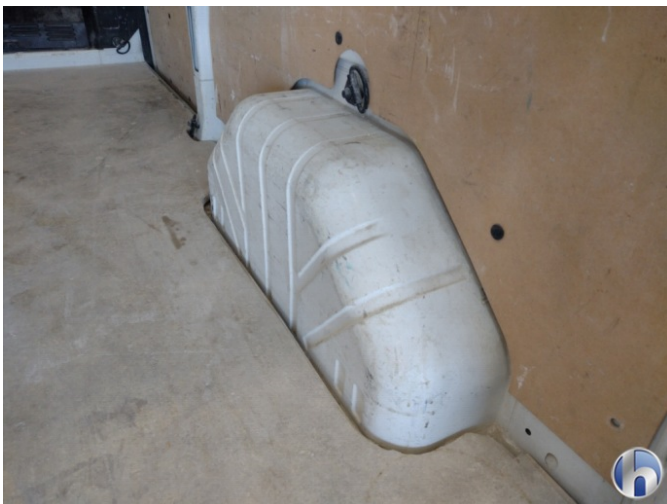
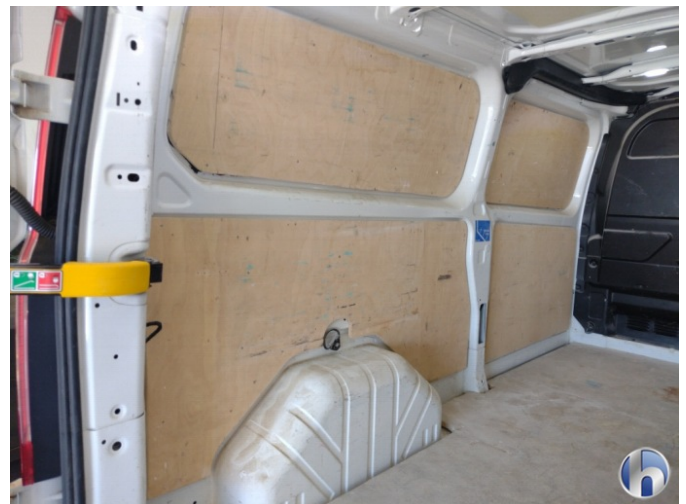
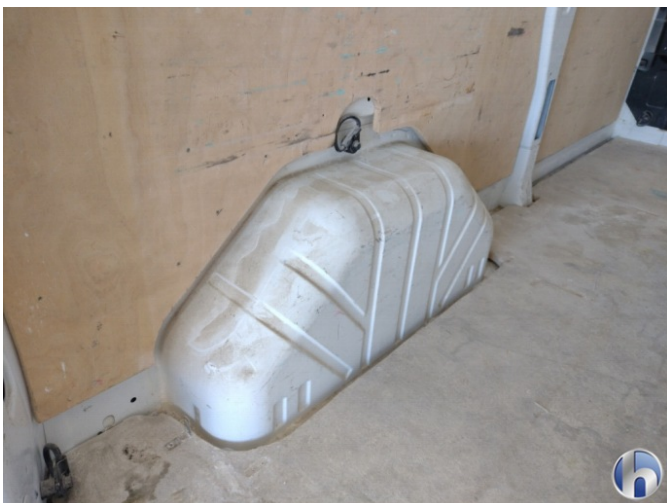
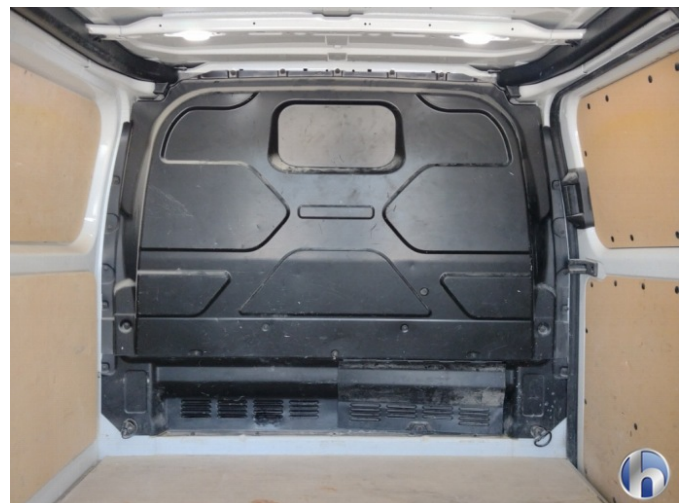
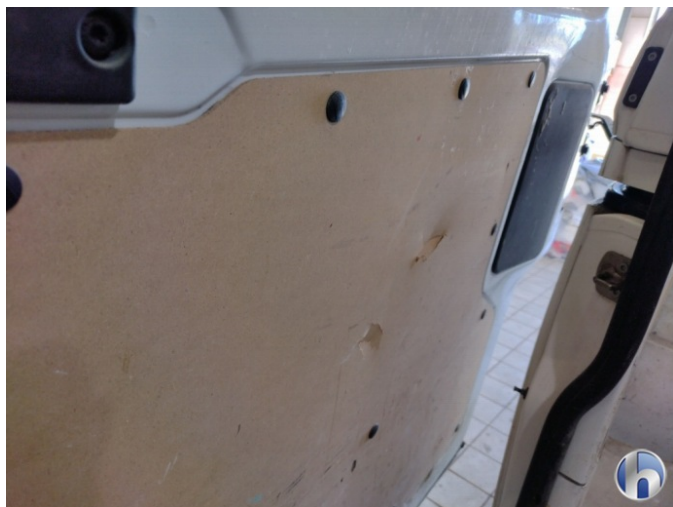
| component | Damage | Rep kind |
|---|---|---|
| 12. Laderaum und Verkleidungen Diverse<br>Kratzer, Dellen, Verformungen,<br>Beschädigungen | Damaged | Replace |

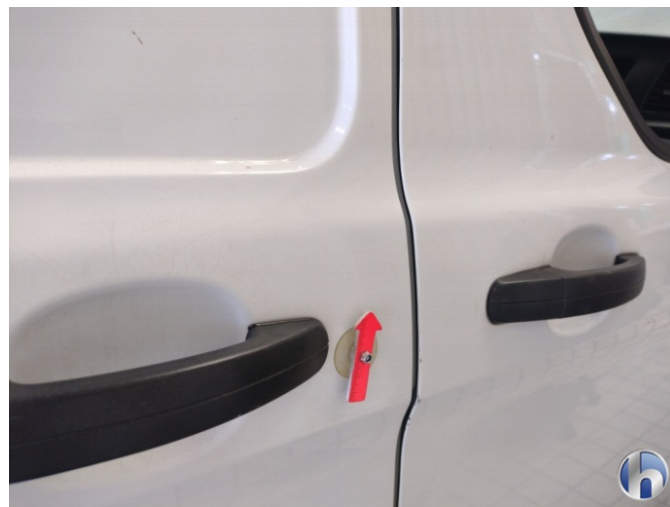
| component | Damage | Rep kind |
|---|---|---|
| 13. Door Rear - right | Scratch(es) | |

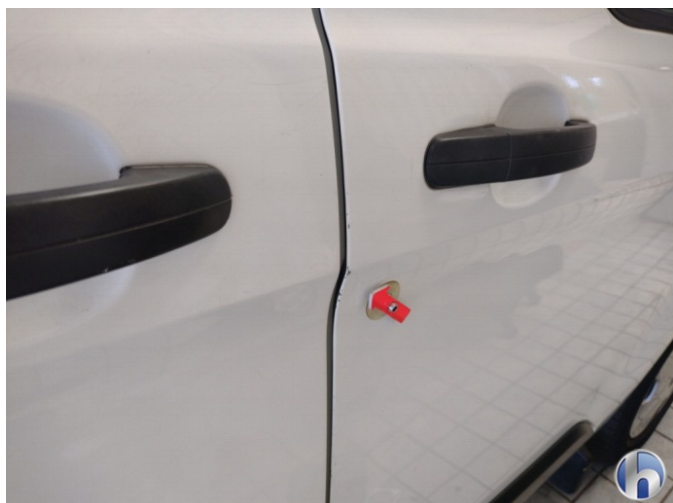
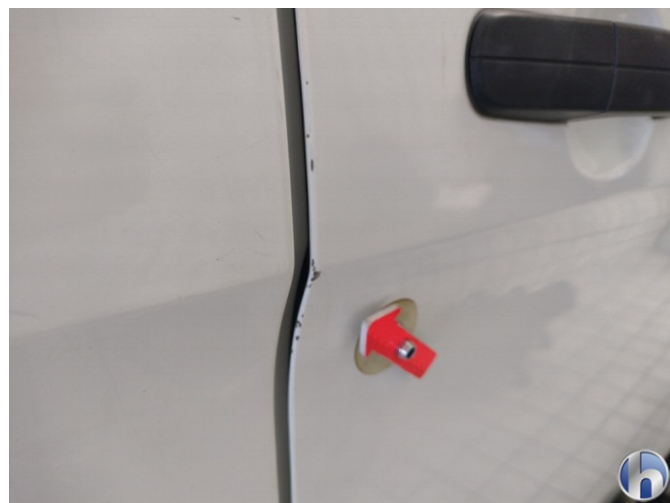
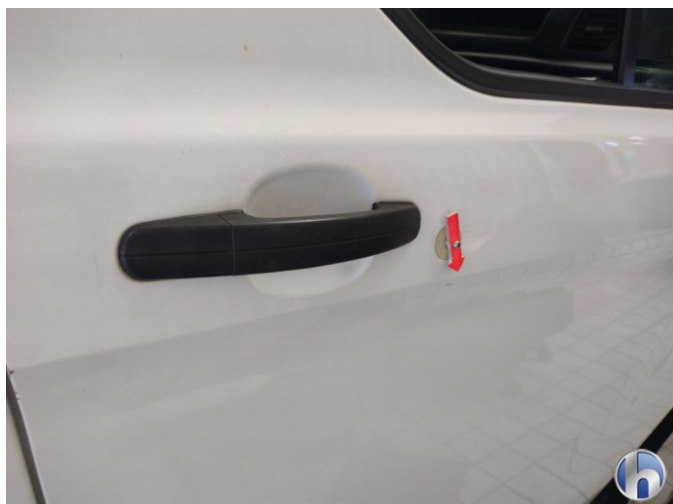
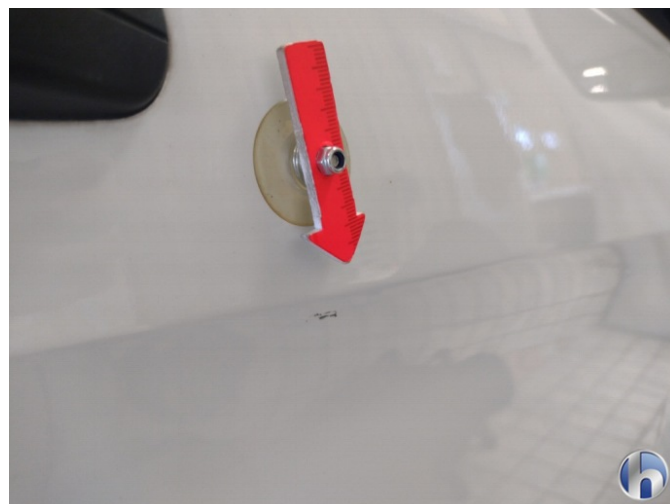
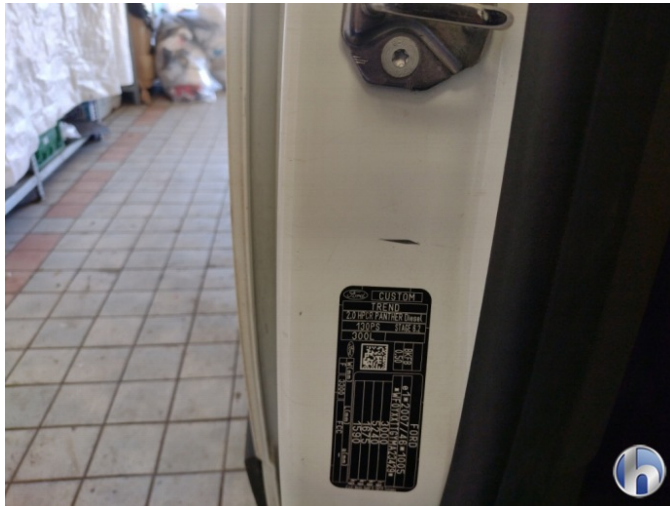
| component | Damage | Rep kind |
|---|---|---|
| 14. Front door - right | Scratch(es) | Paint |

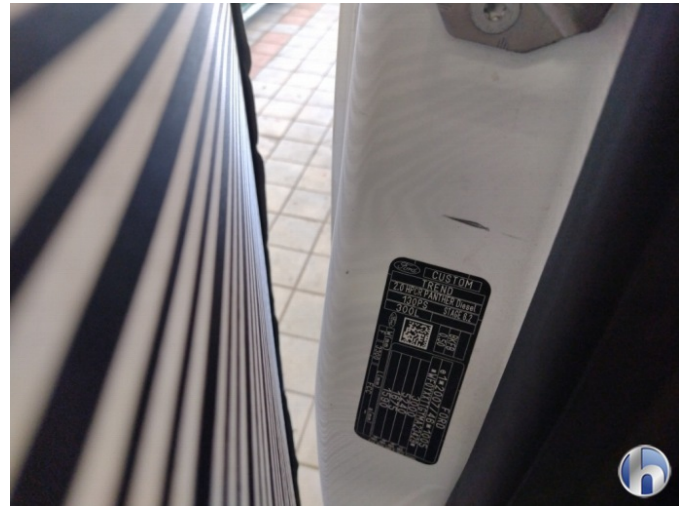
| component | Damage | Rep kind |
|---|---|---|
| 15. Türeinstieg Vorne - Rechts | Damaged | Refurbish and paint |

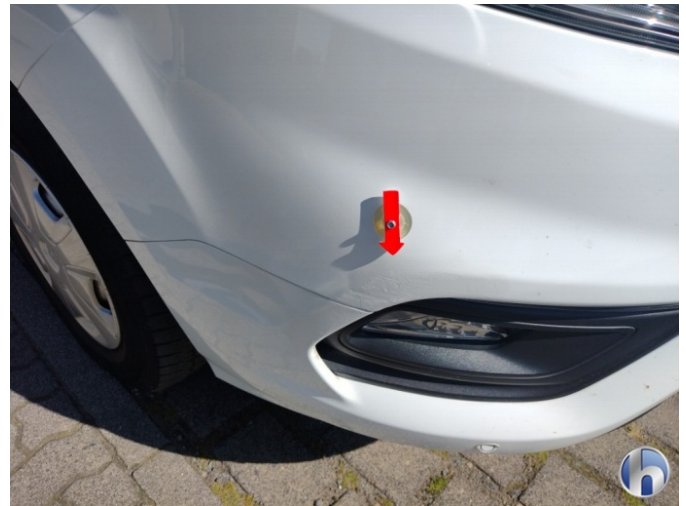
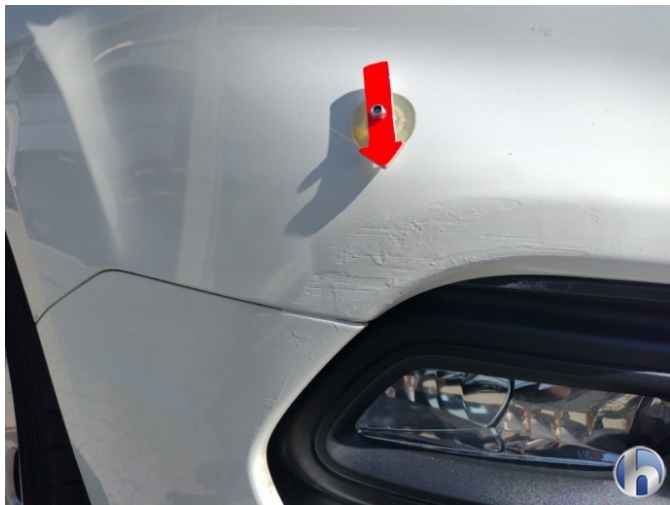
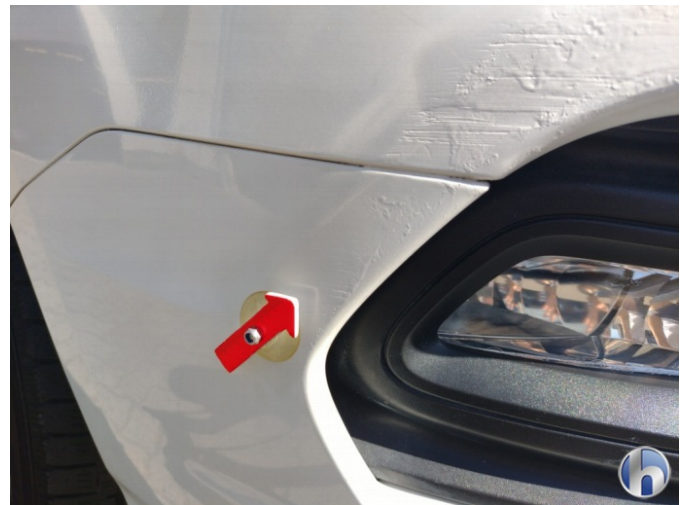
| component | Damage | Rep kind |
|---|---|---|
| 17. Front bumper | Damaged | Replace |
