Expertise

Protocol number: 41610583
Order No. / Reference: 25138863
Inspection date: 18 Sept 2025

Manufacturer: Ford

Model: Transit Custom 320 L1H1 LKW VA Trend

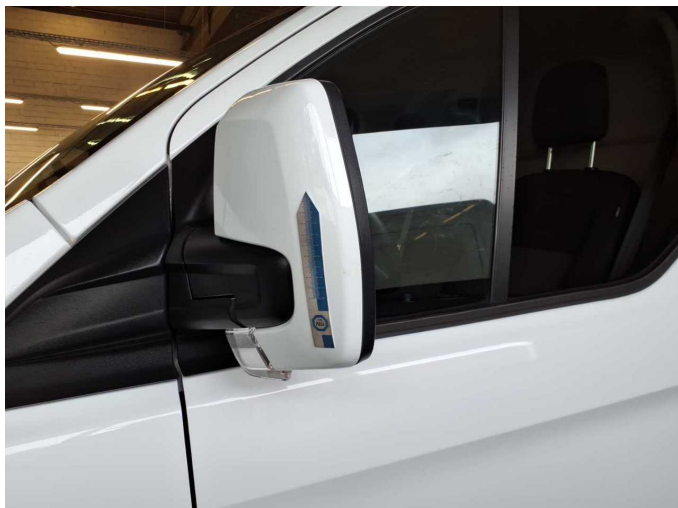
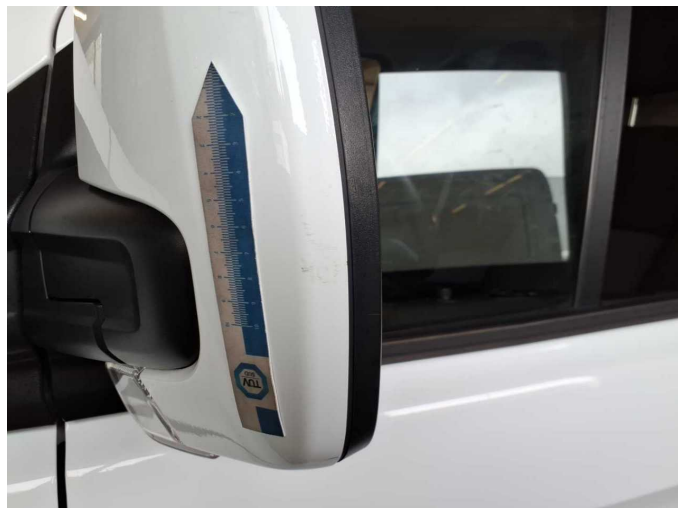
Damage 4: Wing mirror - left side: Cap - Scratch(es) - Smart repair

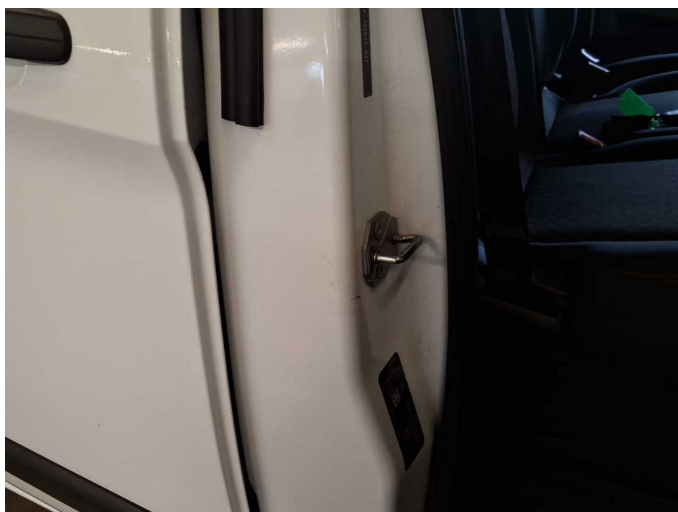
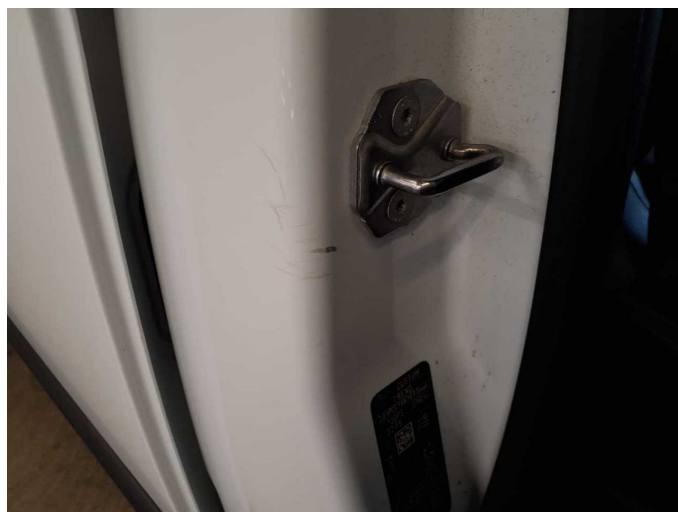
Damage 5: Body: B-pillar - right side - Scratch(es) - Smart repair

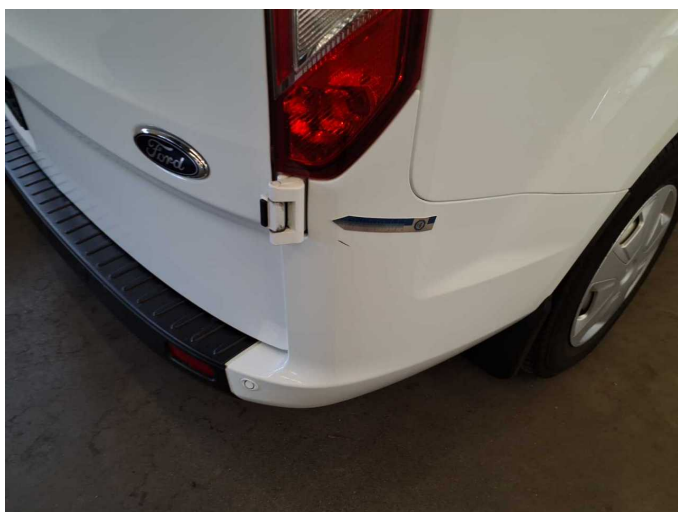
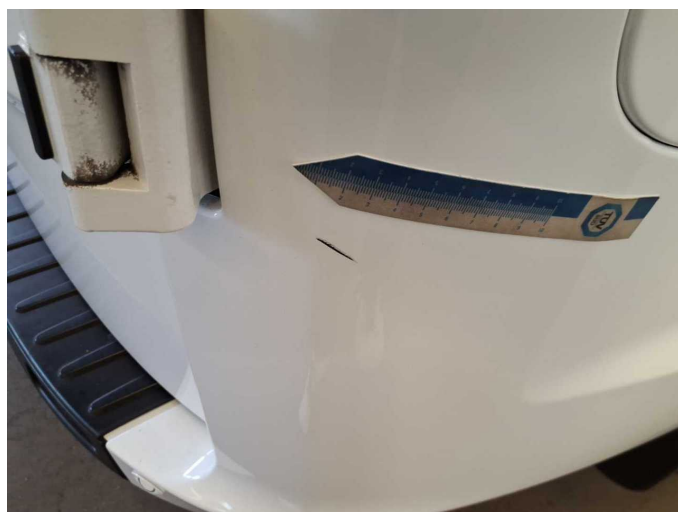
Damage 6: Rear bumper: Bumper - rear right side - Scratch(es) - Smart repair

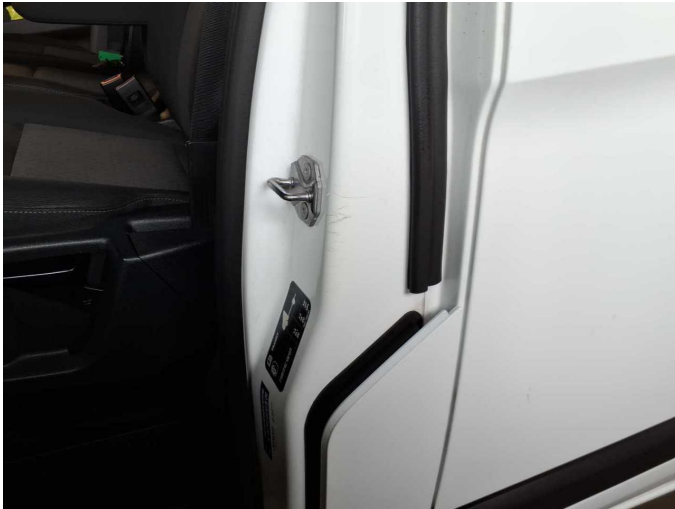
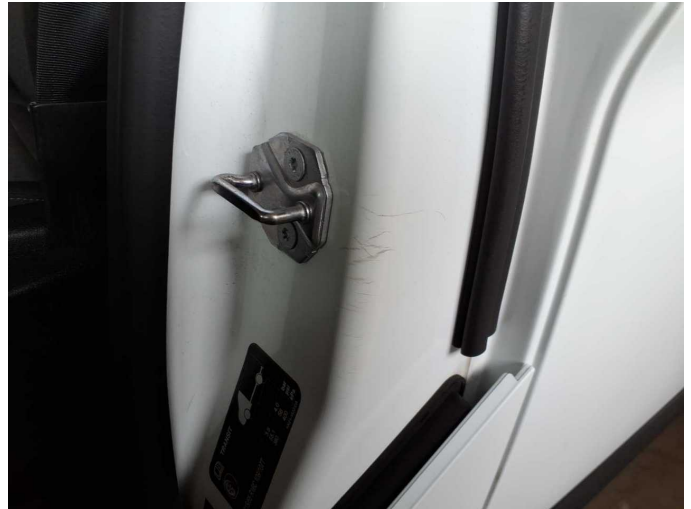
Damage 7: Body: B-pillar - left side - Scratch(es) - Smart repair

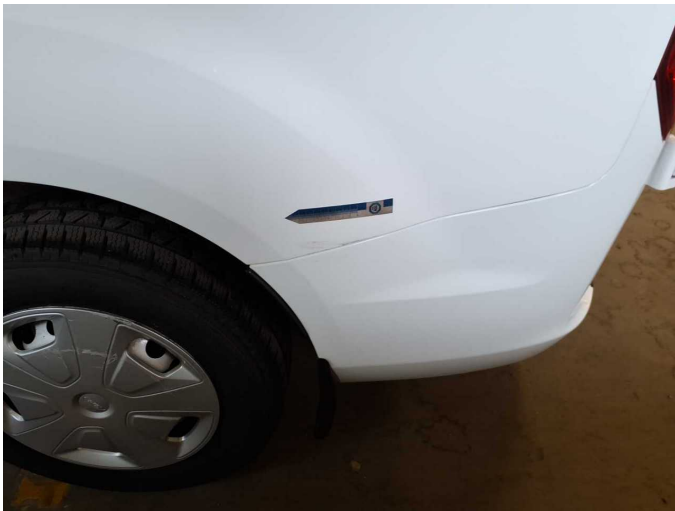
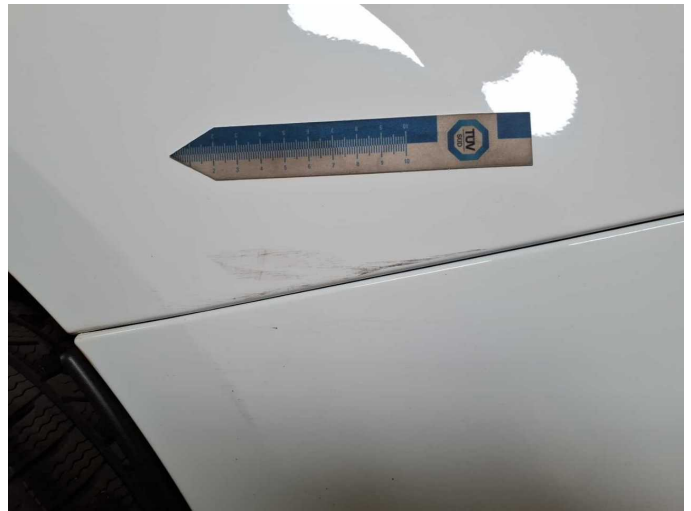
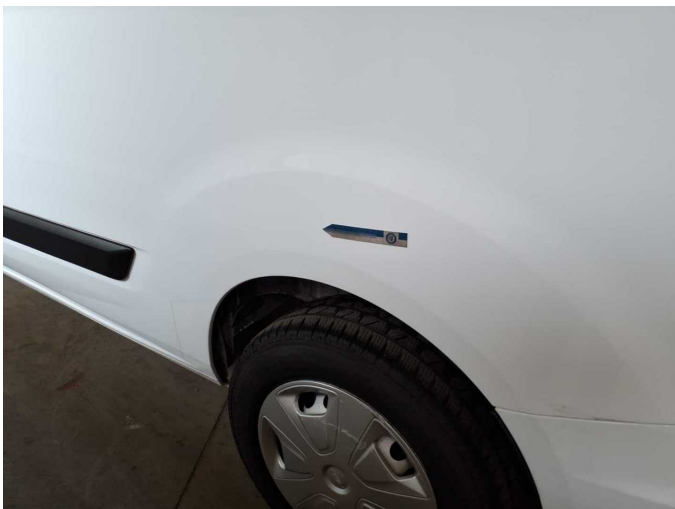
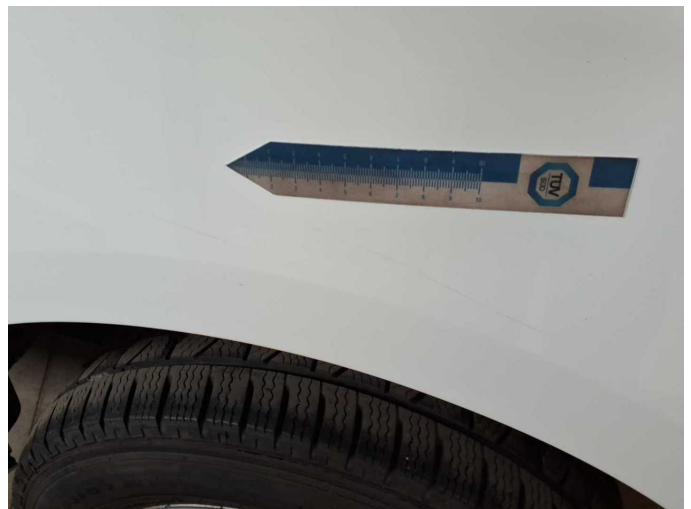
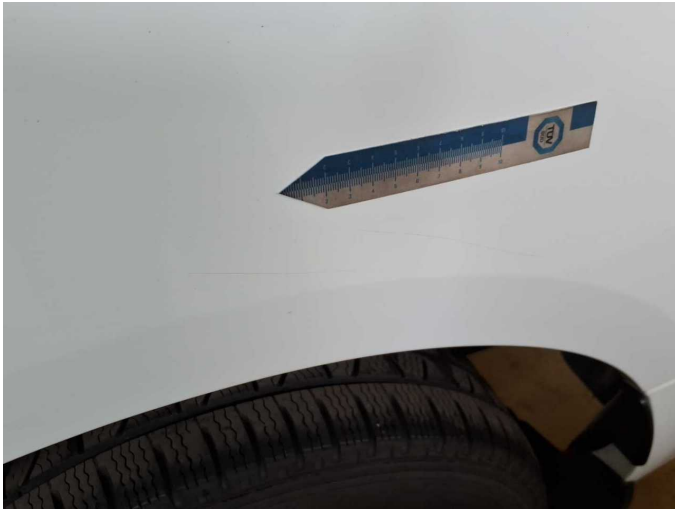
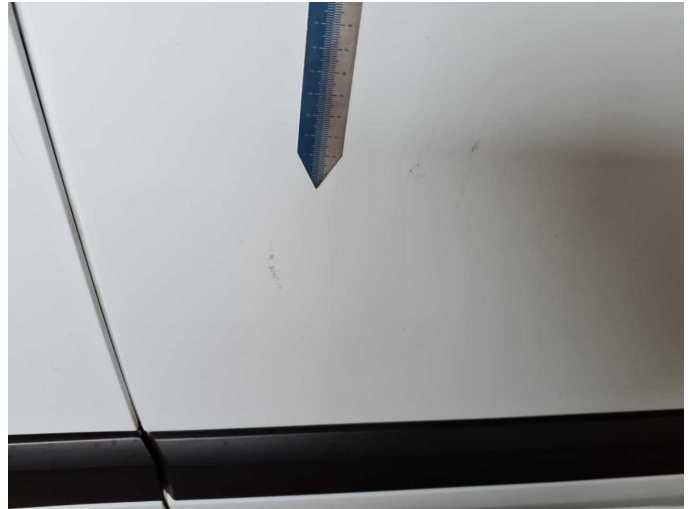
Damage 8: Side panel - rear left side: Side panel - Scratch(es) - Smart repair

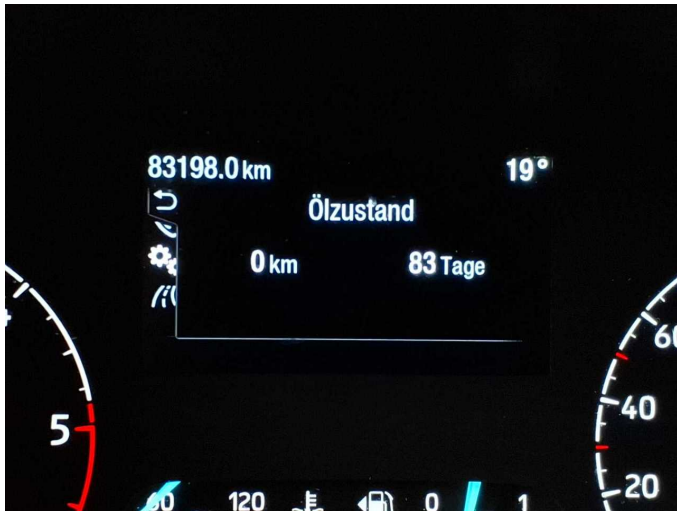
Damage 9: Misc.: Inspection / maintenance - Due - Perform

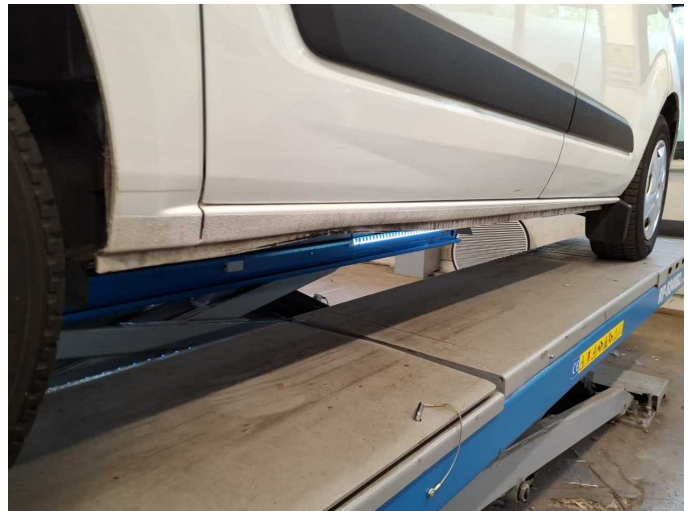
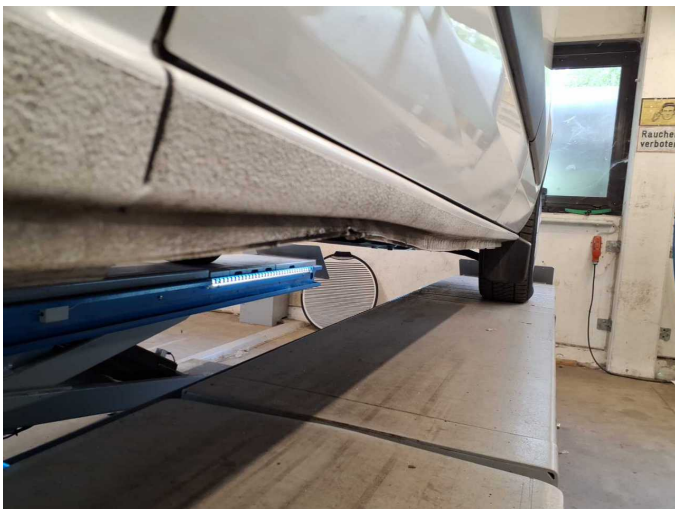
Damage 11: Sill - right side: Sill - Deformed - Repair and paint

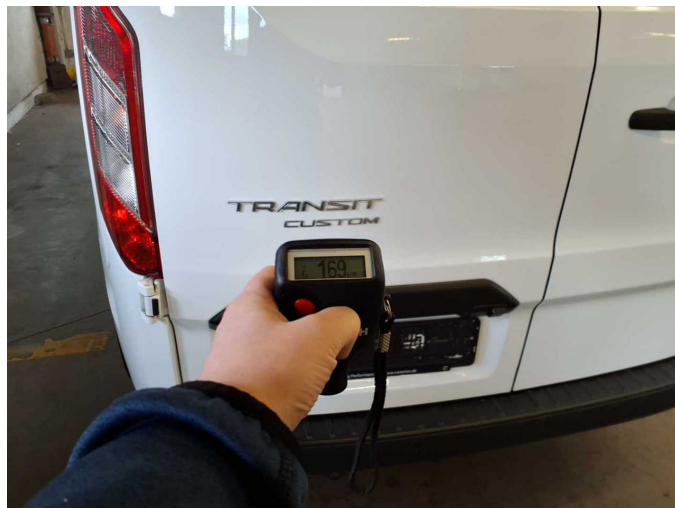
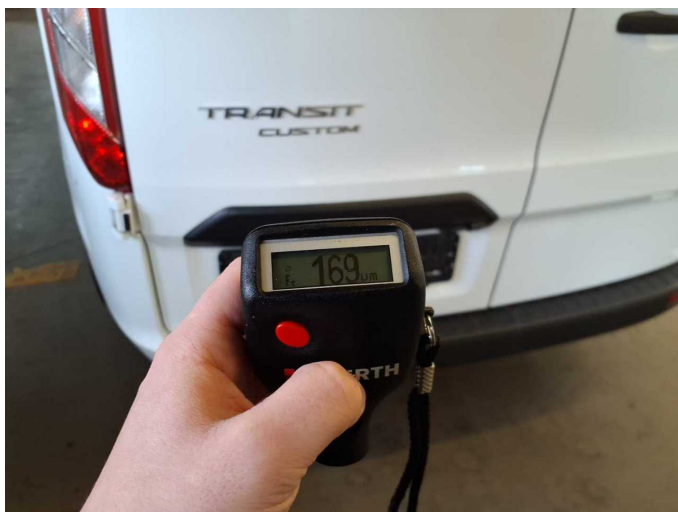
No.	Repainting
1	Boot lid / rear door, Professionally carried out, Invoice of repair done Non-existent

Boot lid / rear door	169 µm
----------------------	--------

Repainting 1: Boot lid / rear door
