Expertise

Protocol number: 41589270  
Order No. / Reference: 25233162  
Inspection date: 18 Sept 2025

Manufacturer: Ford	Model: Transit Custom 280 L1H1 LKW VA Autm. Trend
VIN: WF0YXXTTGYME68875

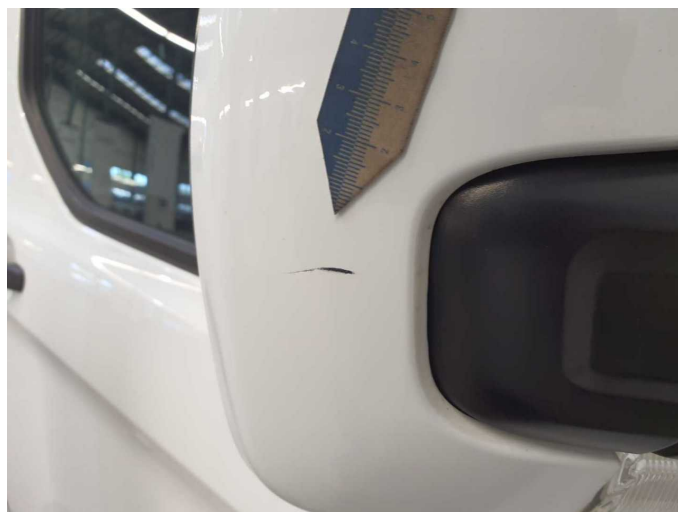
No.	Component group	Description
1	Wing mirror - right side	Cap - Scratch(es) - Smart repair
2	Door - front left side	Door - Dent / paintcoat damage - Smart repair

Damage 1: Wing mirror - right side: Cap - Scratch(es) - Smart repair

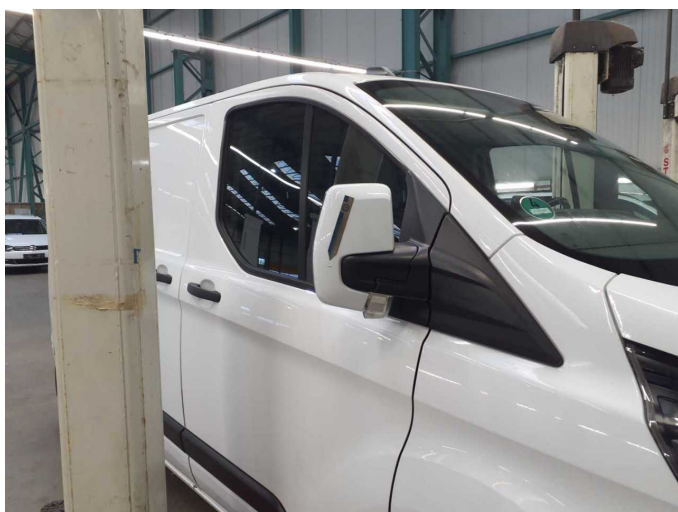
Damage 1: Wing mirror - right side: Cap - Scratch(es) - Smart repair

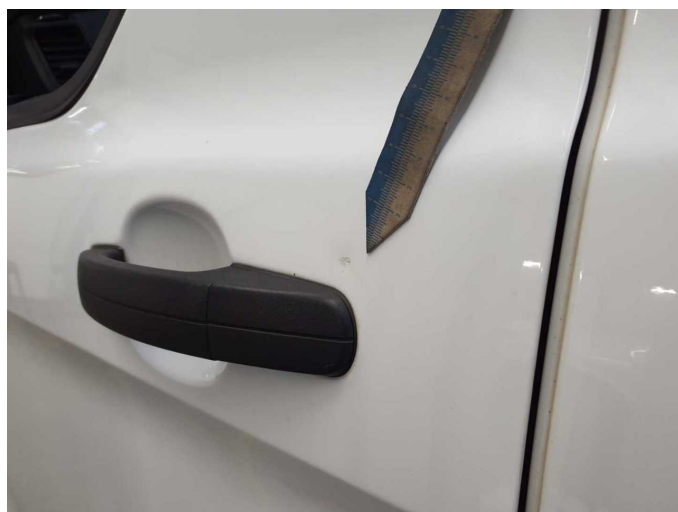
Damage 2: Door - front left side: Door - Dent / paintcoat damage - Smart repair

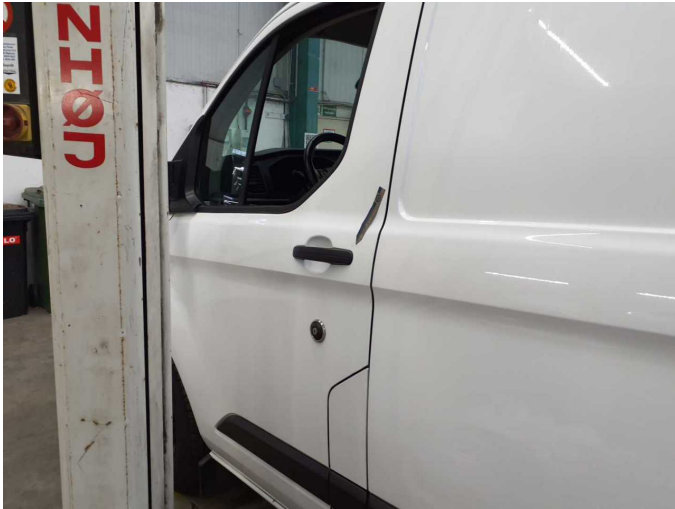
**Damage 2:** Door - front left side: Door - Dent / paintcoat damage - Smart repair

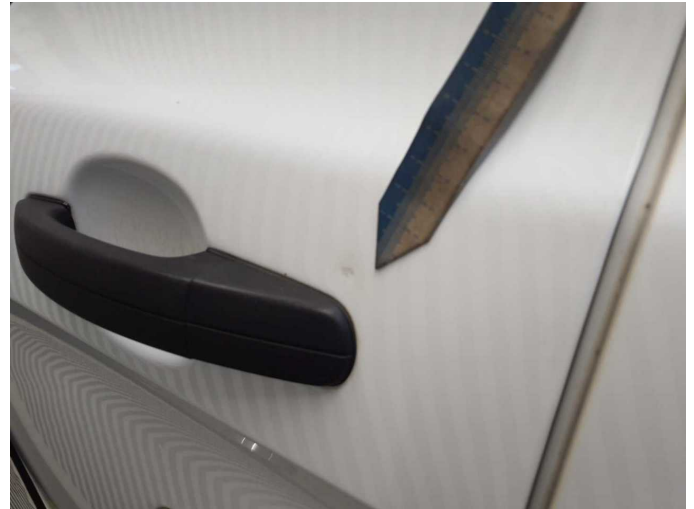
**Damage 2:** Door - front left side: Door - Dent / paintcoat damage - Smart repair

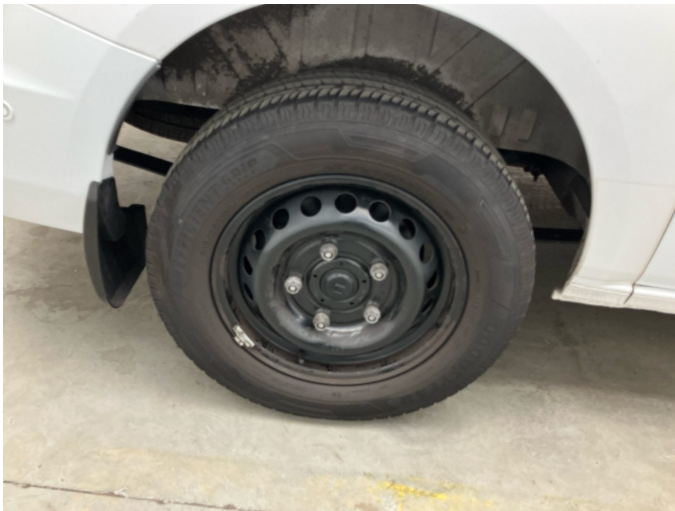
2nd wheel set - Wheel cover set - complete

**Missing part 1:** 2nd wheel set: Wheel cover set - complete - Missing - Replace
