Expertise

Protocol number: 41719553
Order number / reference: 25287871
Inspection date: 26 Sept 2025

Manufacturer: Ford

Model: Transit Custom 320 L1H1 LKW VA MH Trend

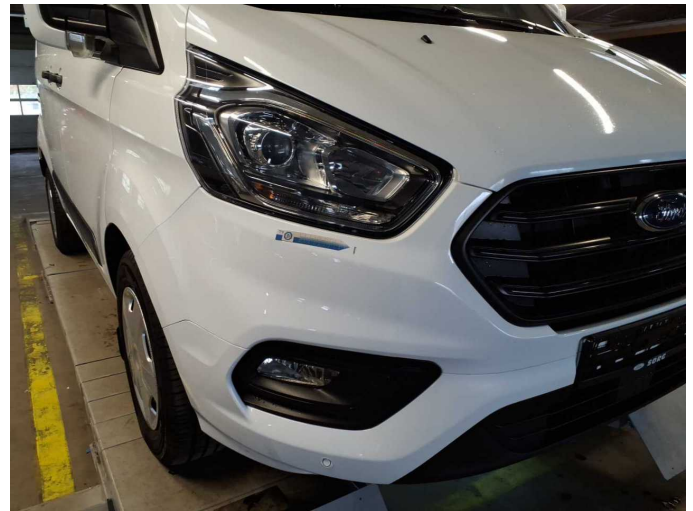
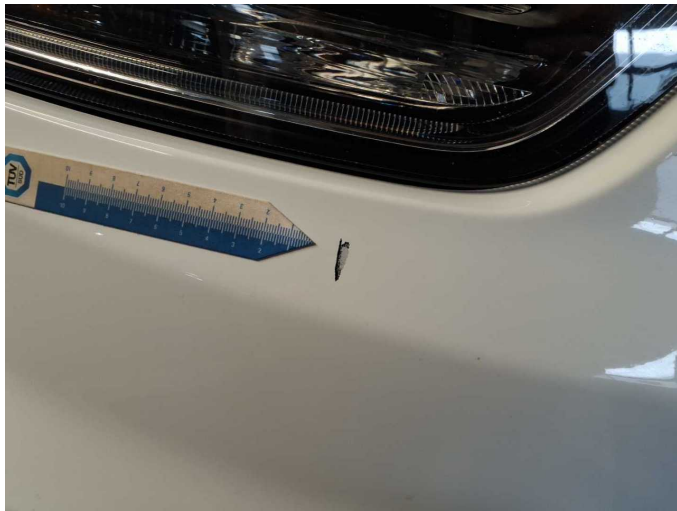
Damage 2: Front bumper: Front bumper - Scratch(es) - Smart repair

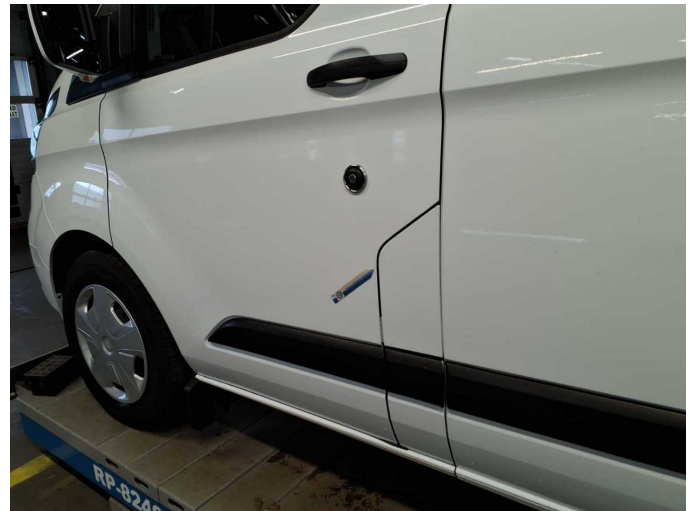
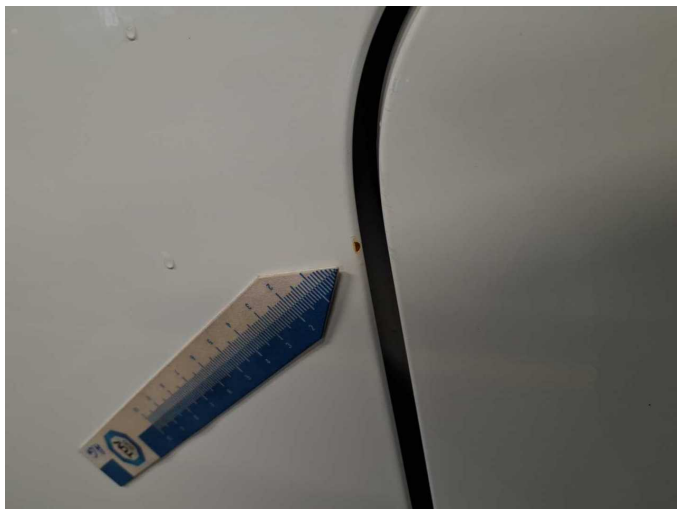
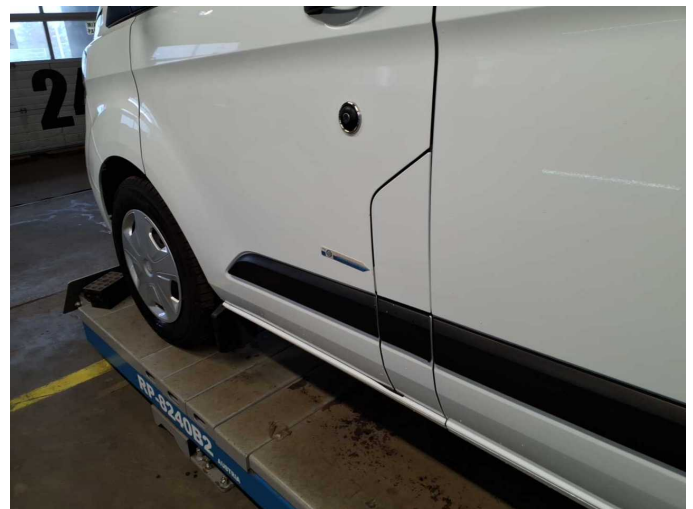
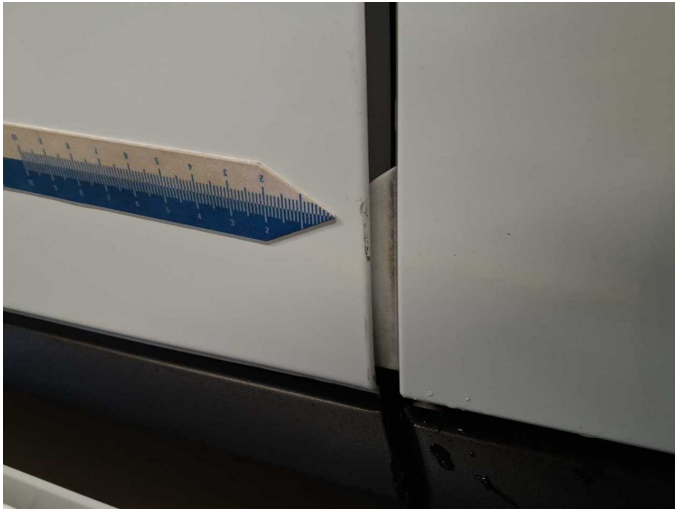
Damage 3: Door - front left side: Door edge (Kratzer) - Stone chips - Smart repair

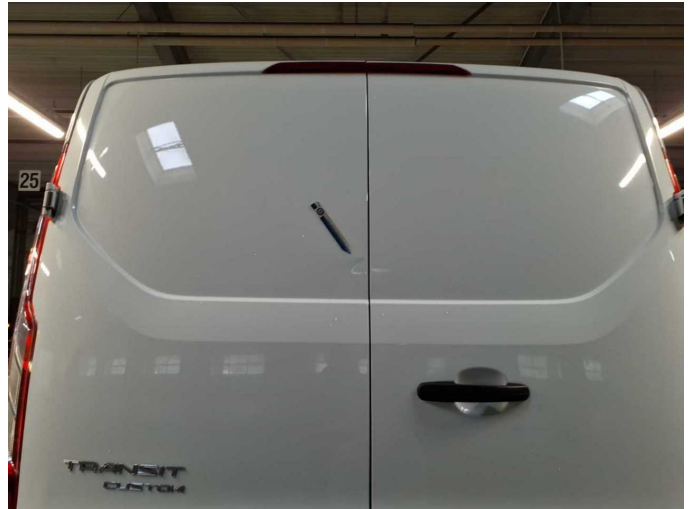
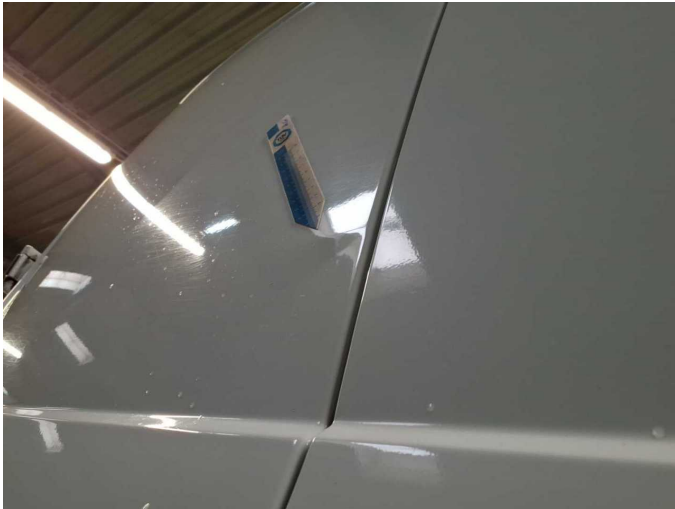
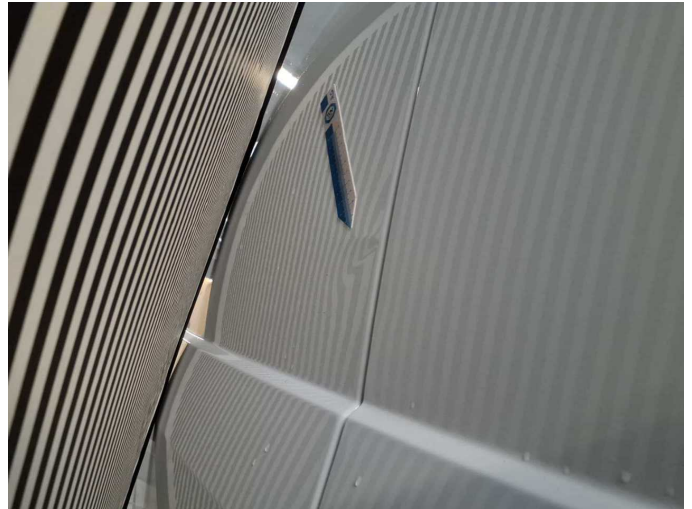
Damage 4: Boot lid / rear door: Rear door - left side - Deformed - Loss in value
