Expertise

Protocol number: 41666611
Order No. / Reference: 25229552
Inspection date: 24 Sept 2025

Manufacturer: Ford

Model: Transit Custom 320 L1H1 LKW VA Trend

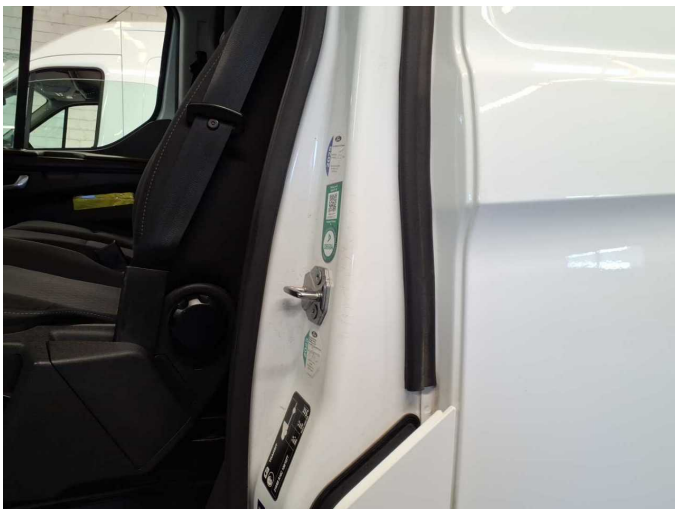
No.	Component group	Description
1	Body	B-pillar - left side - Scratch(es) - Smart repair
2	Door - rear right side	Door edge - Scratch(es) - Smart repair
3	Body	Body (Ausbleichungen) - Glued / labelled - De-glue / neutralise

Damage 1: Body: B-pillar - left side - Scratch(es) - Smart repair

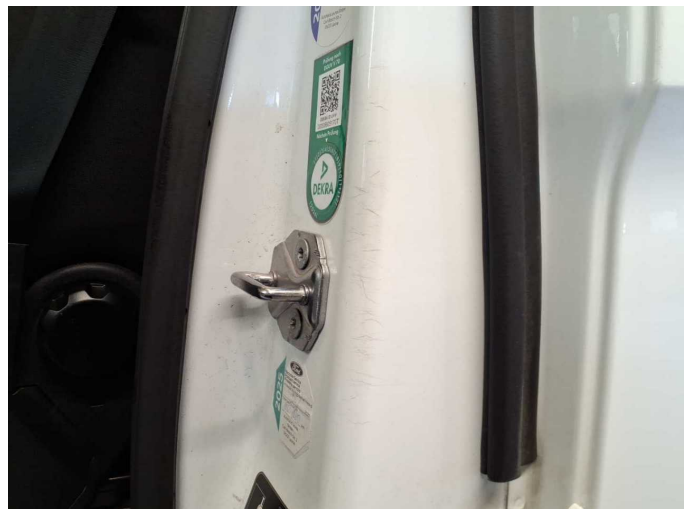
Damage 1: Body: B-pillar - left side - Scratch(es) - Smart repair

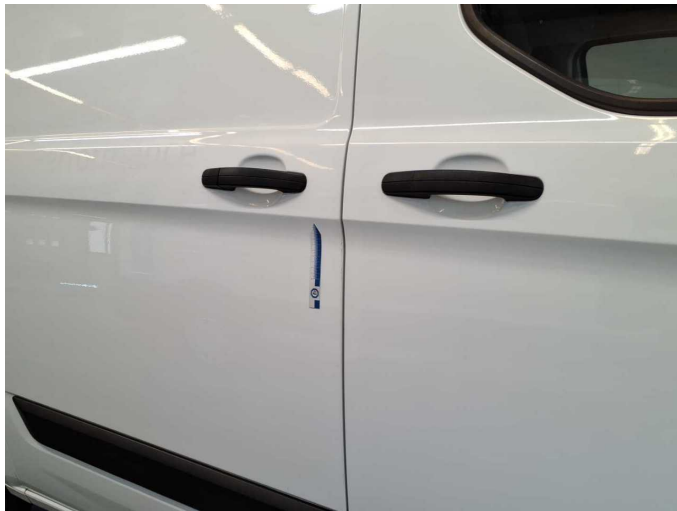
Damage 2: Door - rear right side: Door edge - Scratch(es) - Smart repair

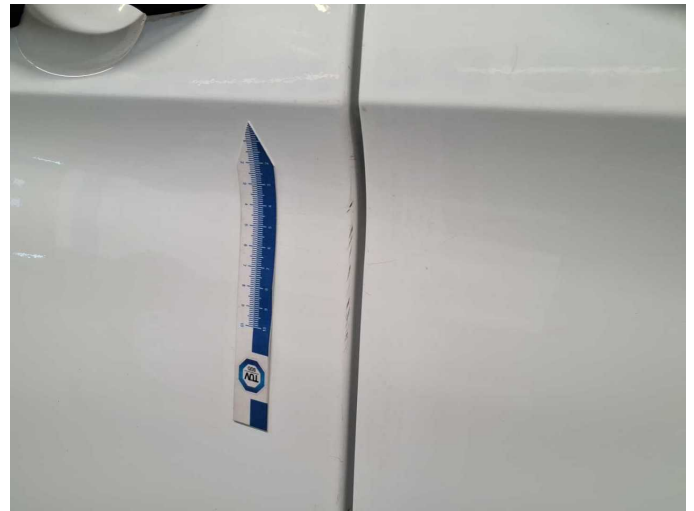
Damage 2: Door - rear right side: Door edge - Scratch(es) - Smart repair

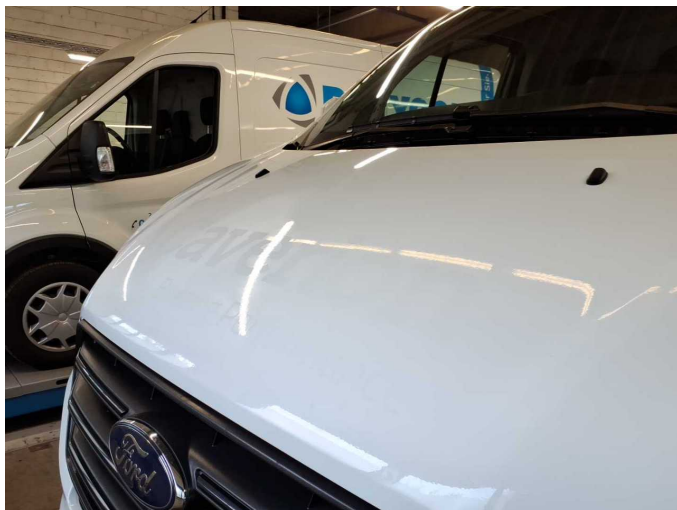
Damage 3: Body: Body (Ausbleichungen) - Glued / labelled - De-glue / neutralise

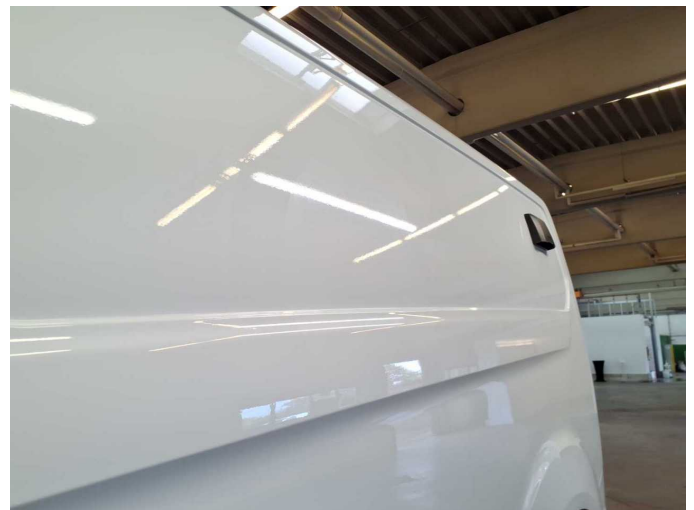
Damage 3: Body: Body (Ausbleichungen) - Glued / labelled - De-glue / neutralise

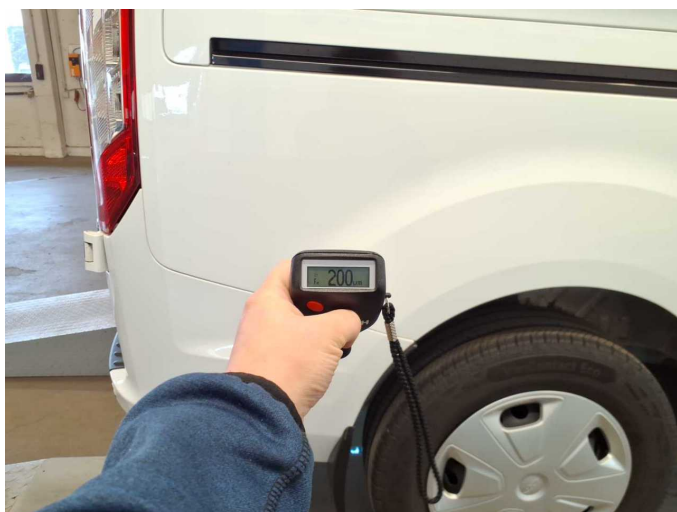
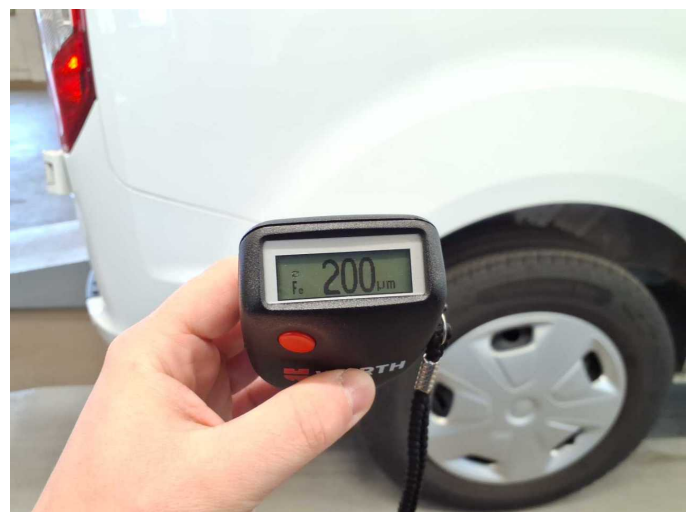
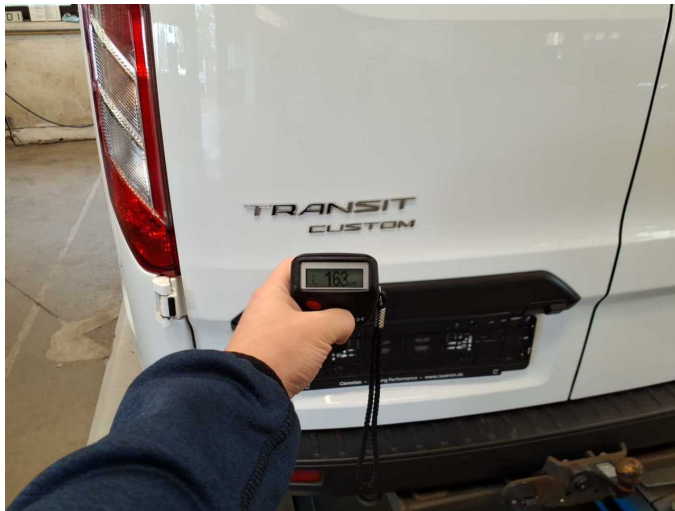
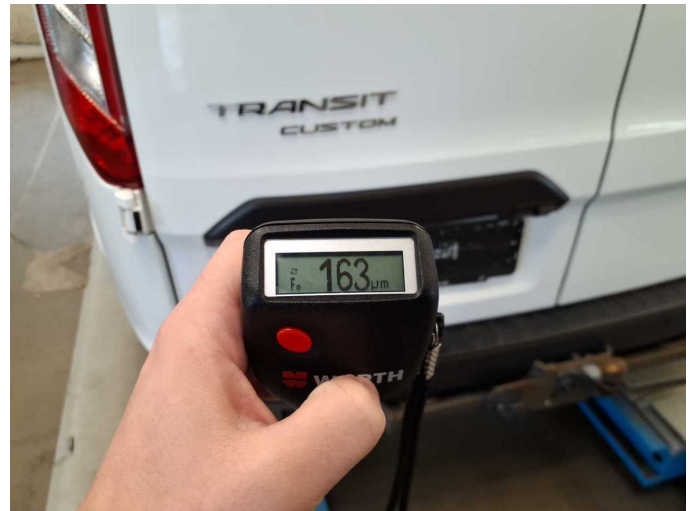
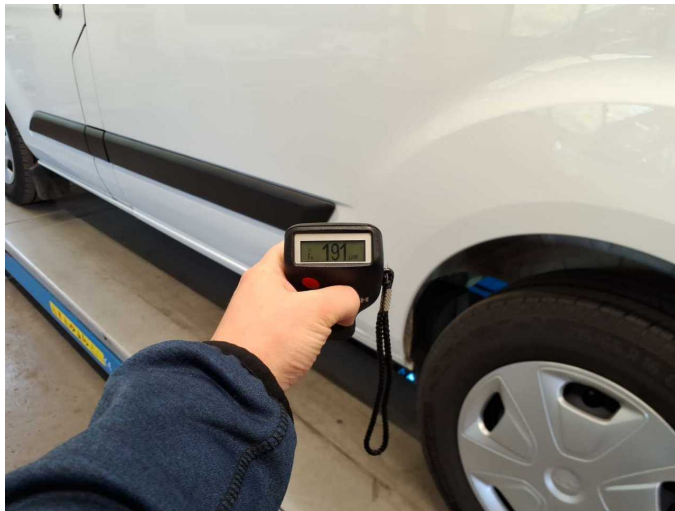
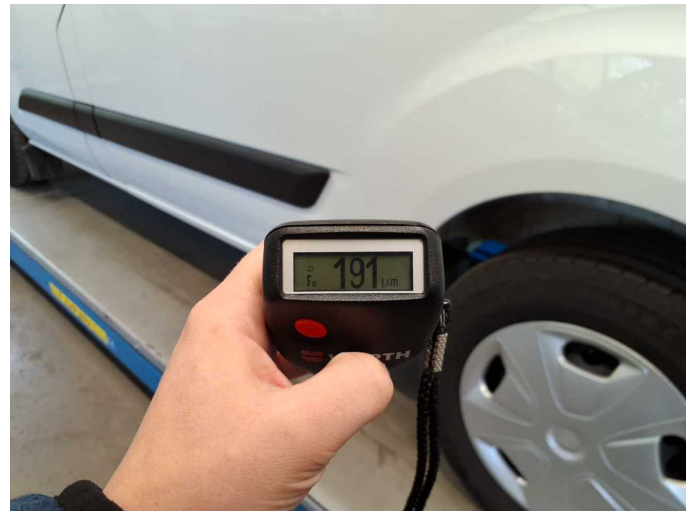
No.	Previous damage	Extent of damage (Net)
1	Rear, Side - left, Side right, Professionally repaired, Invoice of repair done	Non-existent

No.	Repainting
1	Boot lid / rear door, Side panel - rear left side, Side panel - rear right side, Professionally carried out, Invoice of repair done

Boot lid / rear door	163 µm	Side panel - rear left side	191 µm
Side panel - rear right side	200 µm

Repainting 1: Boot lid / rear door, Side panel - rear left side, Side panel - rear right side
