Expertise

Protocol number: 41678697
Order No. / Reference: 25228393
Inspection date: 24 Sept 2025

Manufacturer: Ford	Model: Transit Custom 300 L2H1 LKW VA Trend
VIN: WF0YXXTTGYNA83678

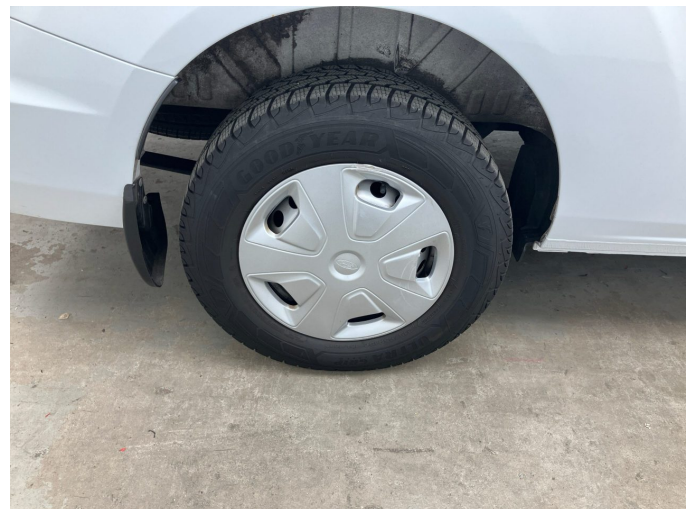
Figure 12: Mounted tyres

- Winterradsatz ist kein Bestandteil des Auslieferumfangs.
- Für den montierten Radsatz wurde kein Nachweiß erbracht.

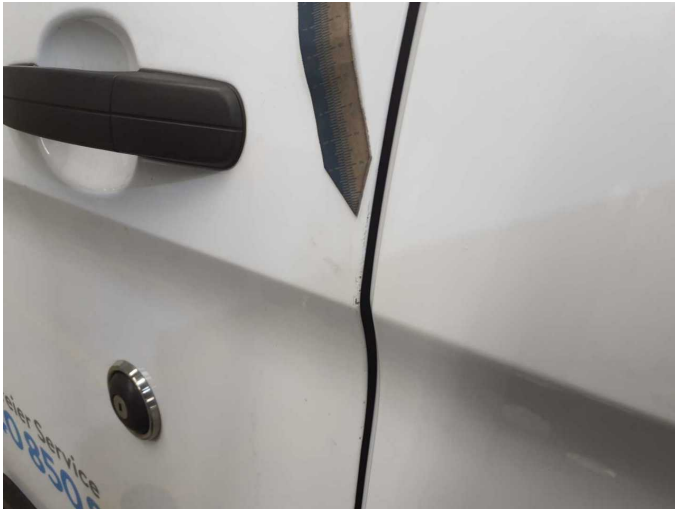
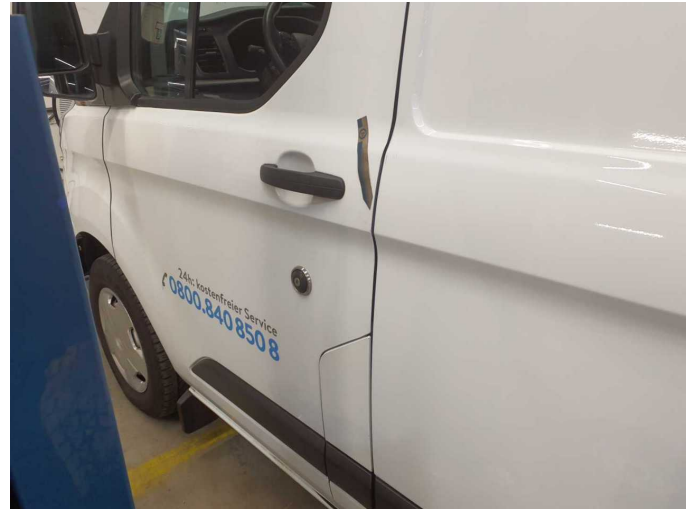
Damage 2: Door - front left side: Door edge - Scratch(es) - Smart repair

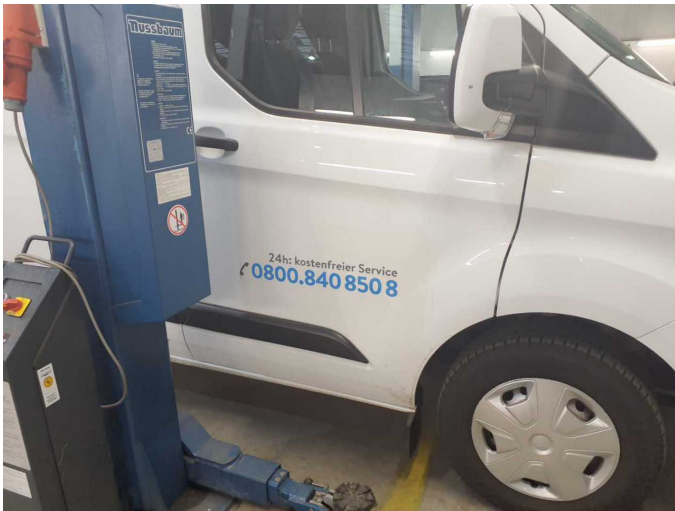
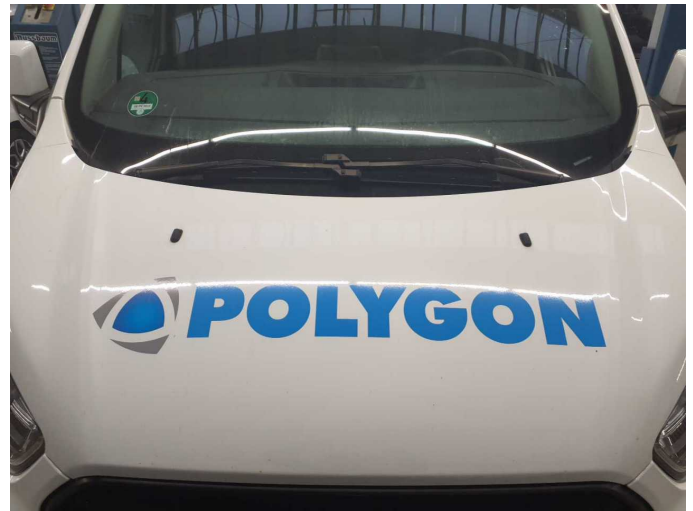
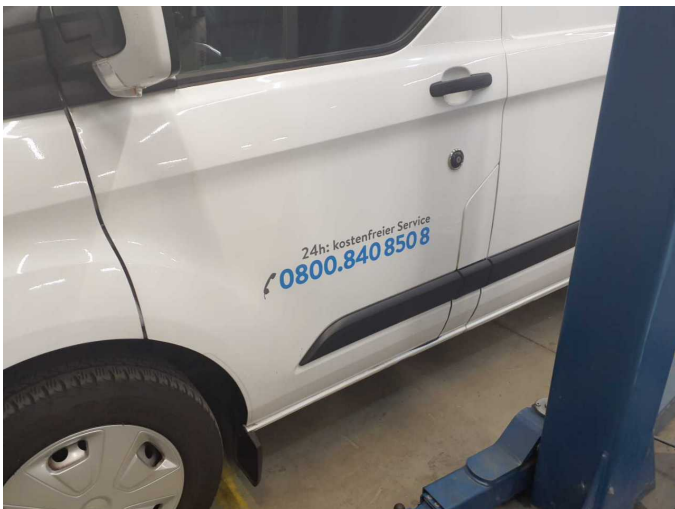
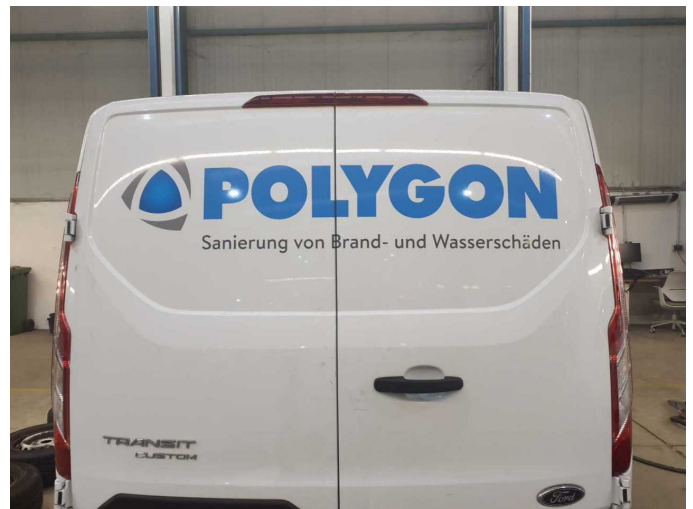
Damage 3: Body: Body - Glued / labelled - De-glue / neutralise

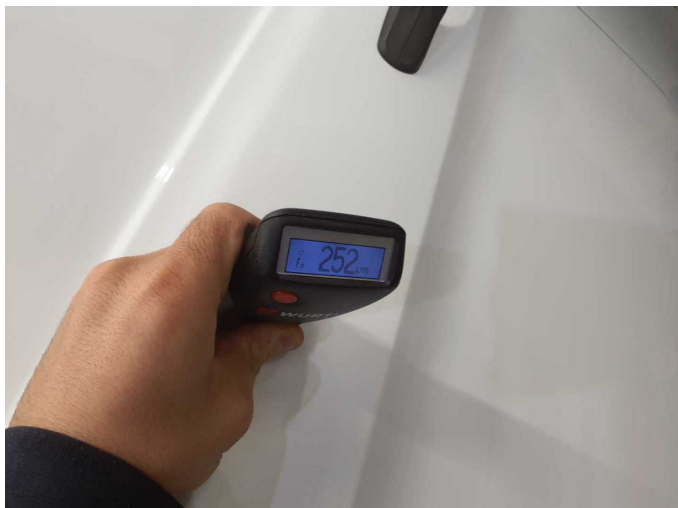
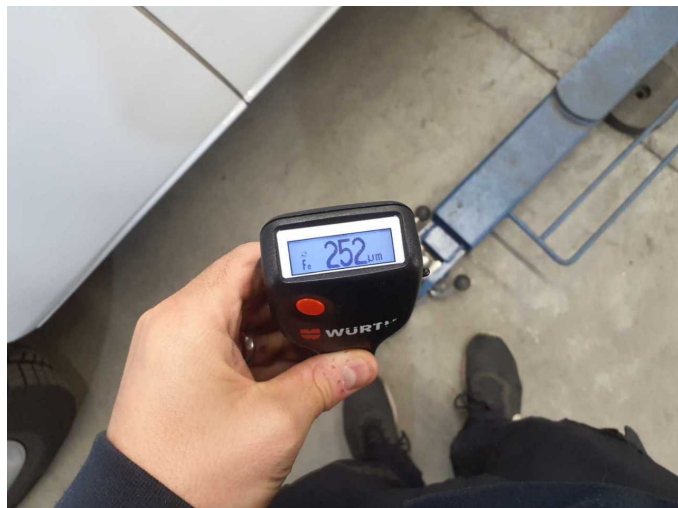
1 Door - rear right side, Professionally carried out, Invoice of repair done Non-existent

Door - rear right side 252 µm |

Repainting 1: Door - rear right side
