Expertise

Protocol number: 41631286
Order No. / Reference: 25196447
Inspection date: 19 Sept 2025

Manufacturer: Ford	Model: Transit Custom 300 L2H1 LKW VA Trend
VIN: WF0YXXTTGYNG28326

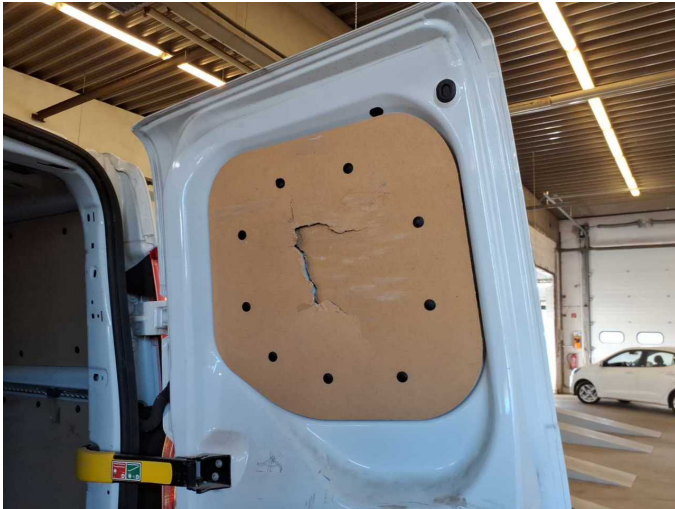
No.	Component group	Description
1	Misc.	Main inspection - No evidence - No deduction
2	Wheel / tyres	Wheel cover - front right side - Missing - Replace
3	Trim / covers	Boot lid - interior trim (Rechts oben) - Broken / torn - Replace
4	Trim / covers	Boot lid - interior trim (Links) - Broken / torn - Replace
5	Rear bumper	Bumper - rear left side - Scratch(es) - Smart repair
6	Body	B-pillar - left side - Scratch(es) - Smart repair
7	Body	Body - Glued / labelled - De-glue / neutralise
8	Seat - front	Seat cover - left side - Broken / torn - Replace
9	Boot lid / rear door	Boot lid (Links) - Scratch(es) - Paint
10	Boot lid / rear door	Boot lid (Rechts) - Scratch(es) - Paint

Damage 3: Trim / covers: Boot lid - interior trim (Rechts oben) - Broken / torn - Replace

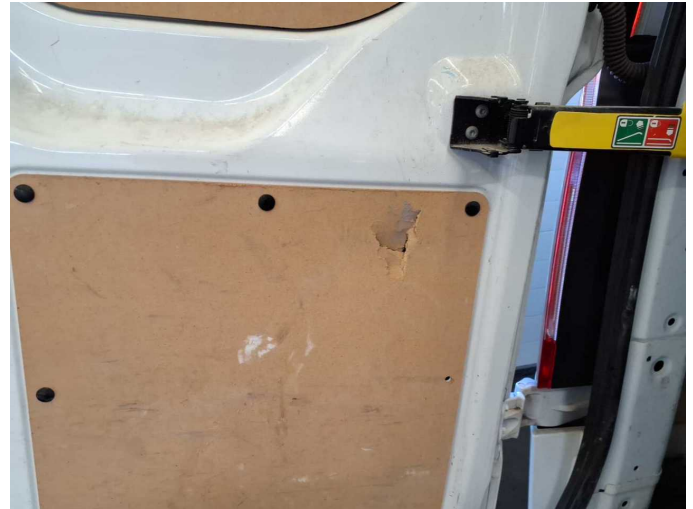
Damage 4: Trim / covers: Boot lid - interior trim (Links) - Broken / torn - Replace

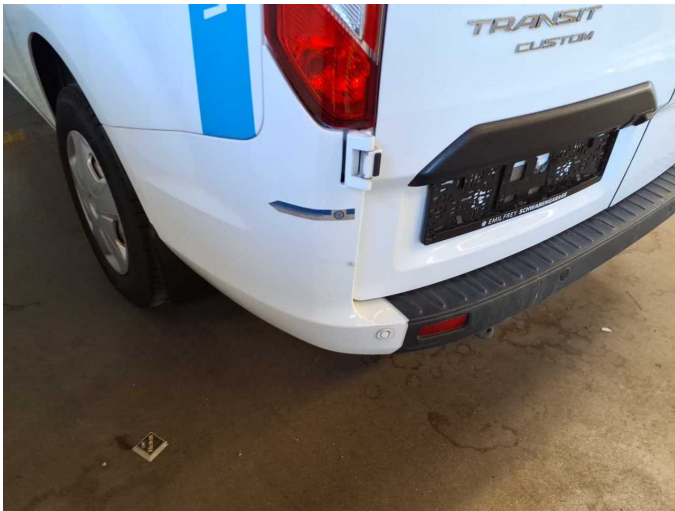
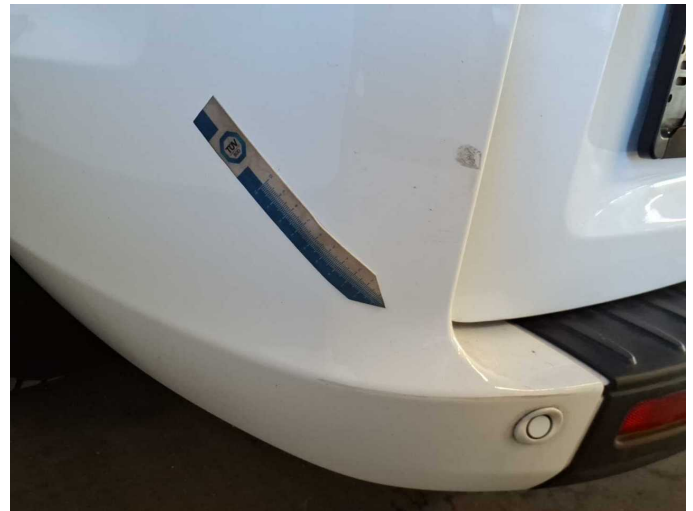
Damage 5: Rear bumper: Bumper - rear left side - Scratch(es) - Smart repair

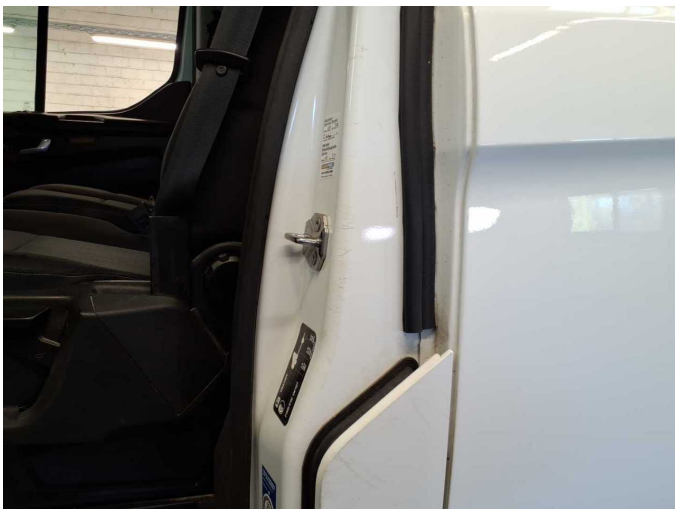
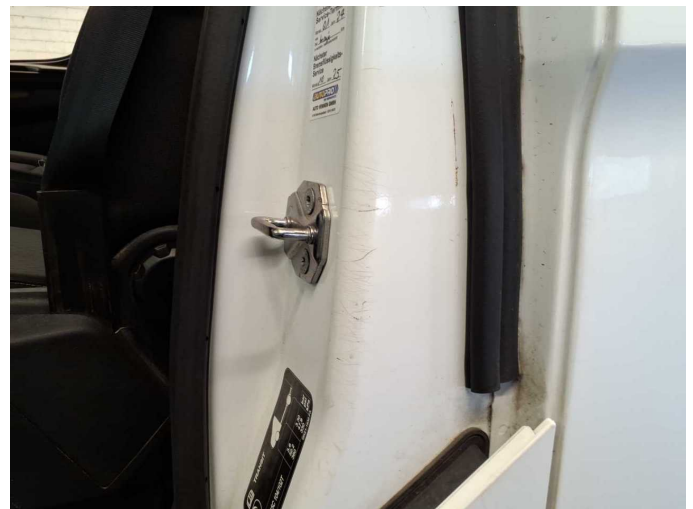
Damage 6: Body: B-pillar - left side - Scratch(es) - Smart repair

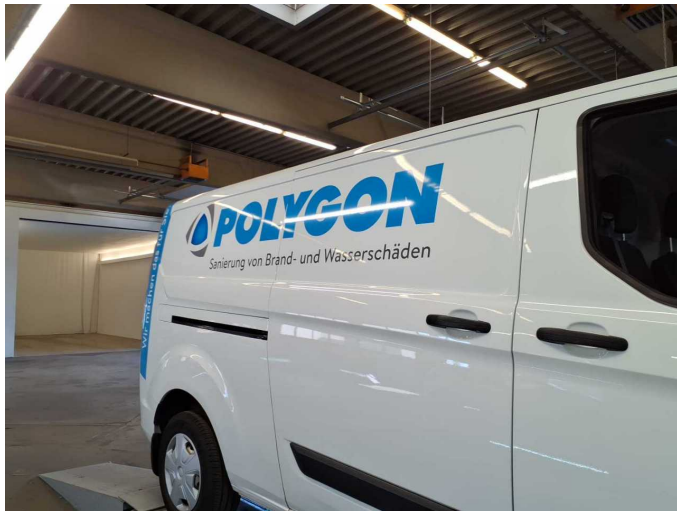
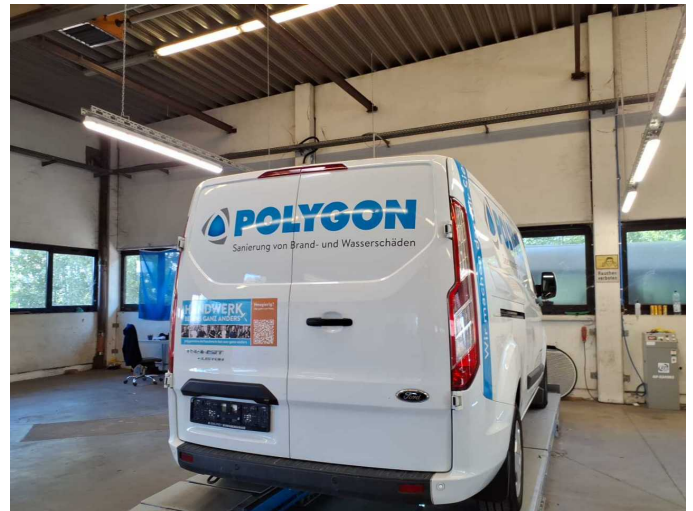
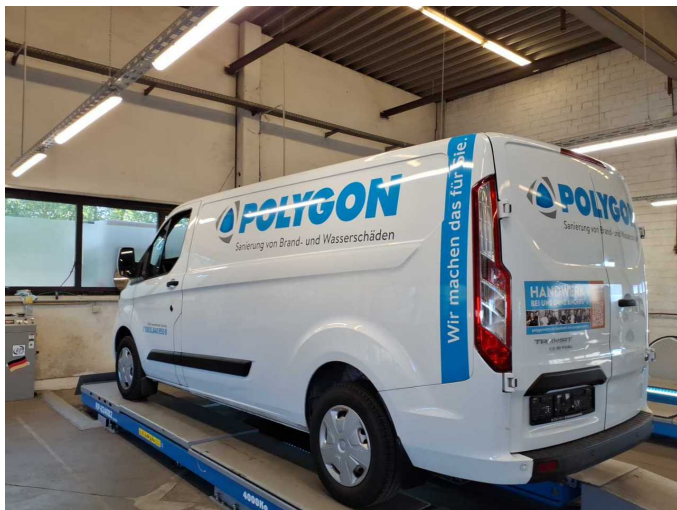
Damage 7: Body: Body - Glued / labelled - De-glue / neutralise

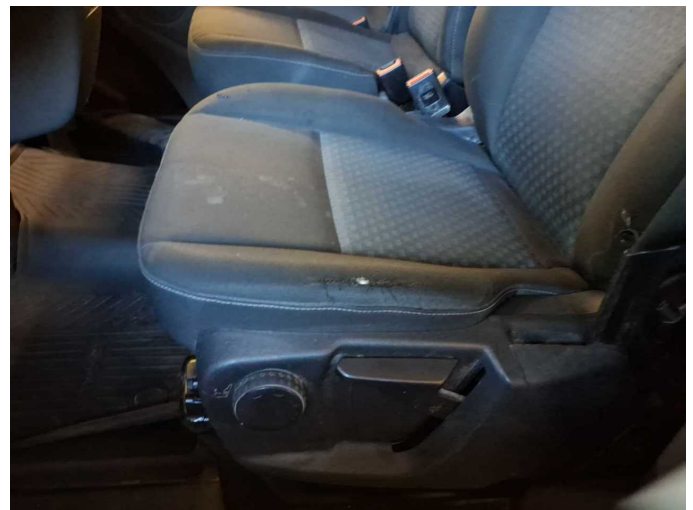
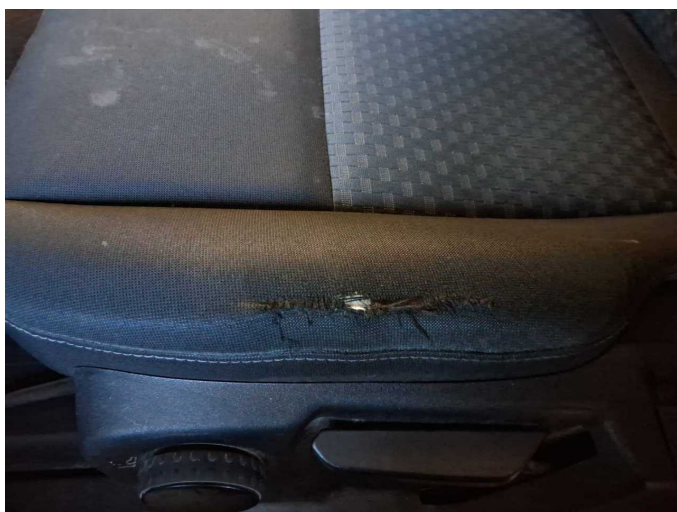
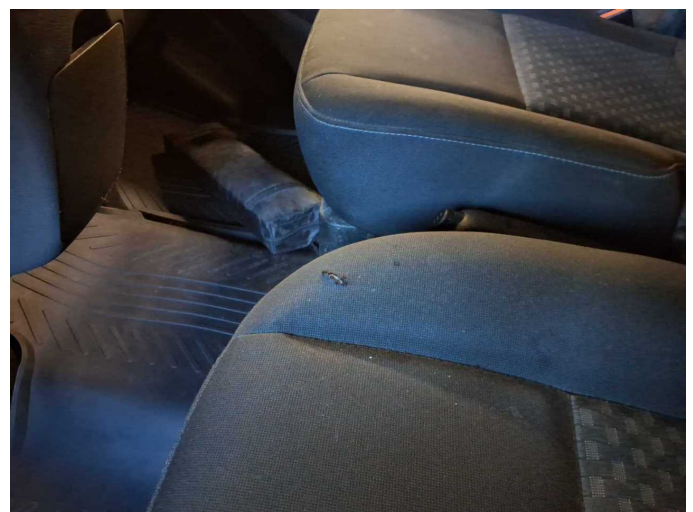
Damage 8: Seat - front: Seat cover - left side - Broken / torn - Replace

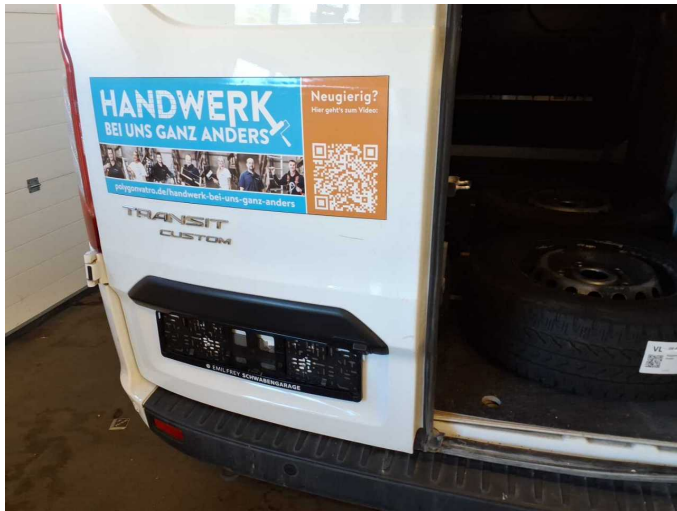
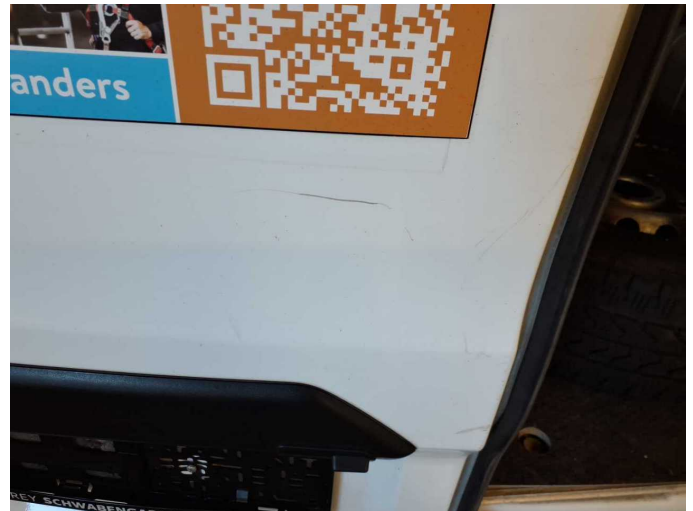
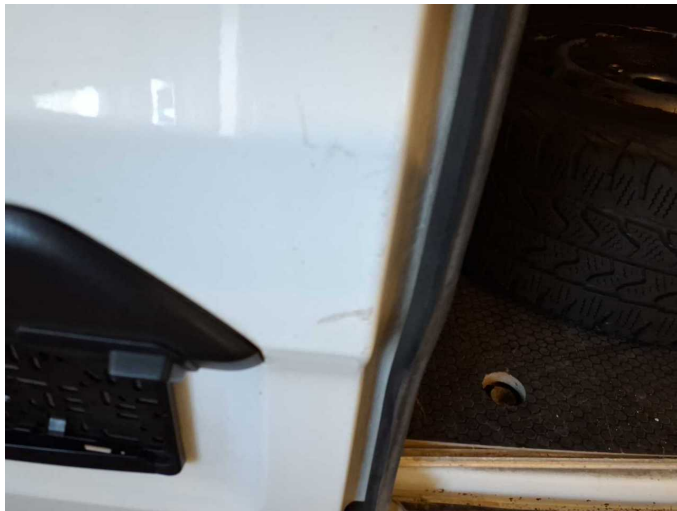
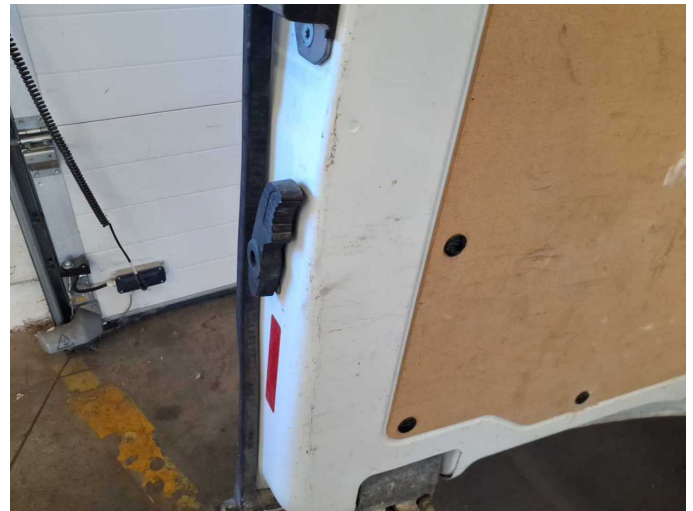
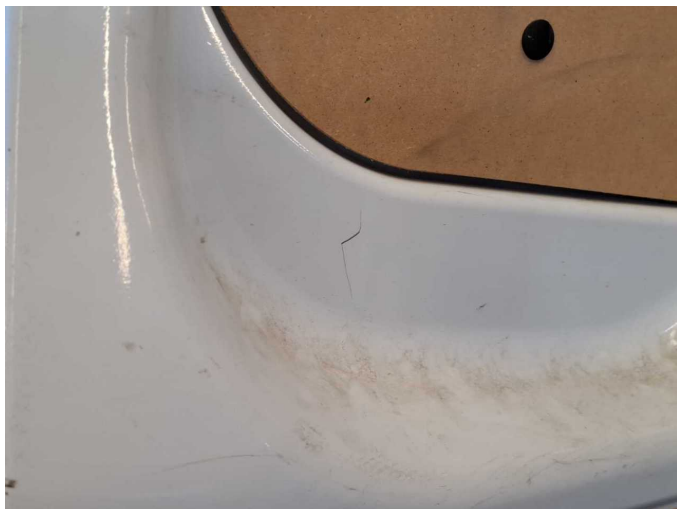
Damage 9: Boot lid / rear door: Boot lid (Links) - Scratch(es) - Paint

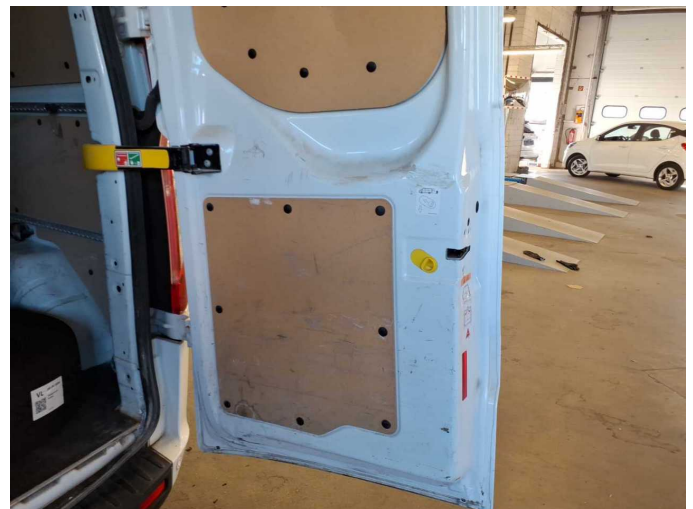
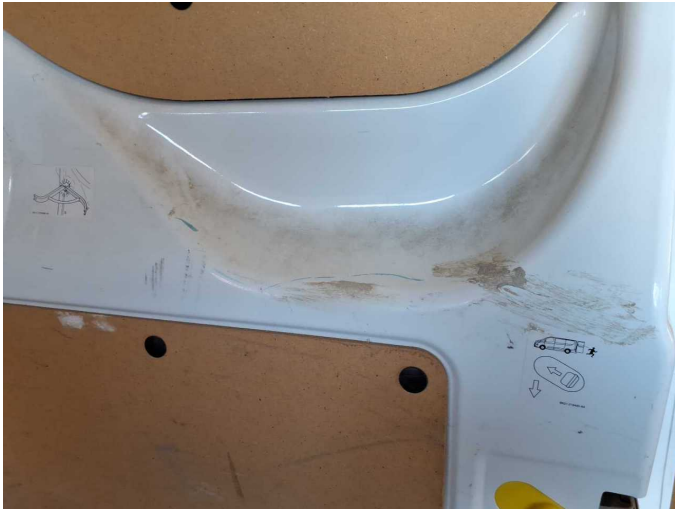
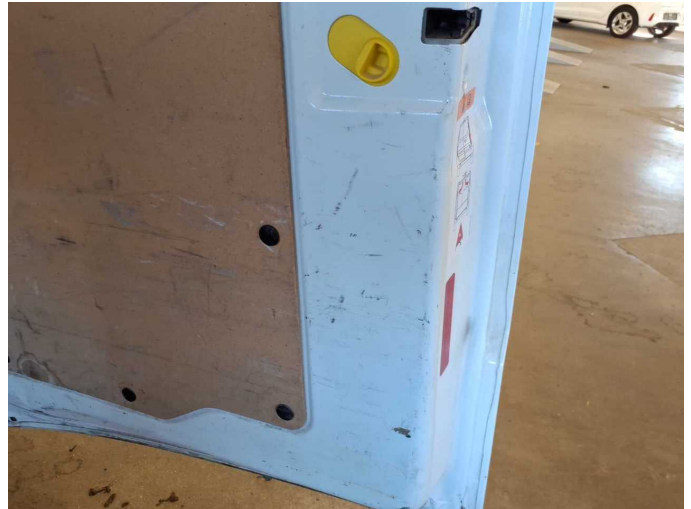
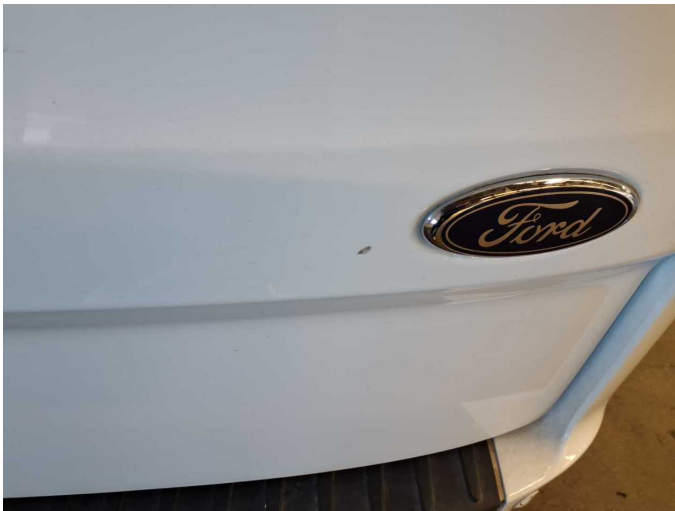
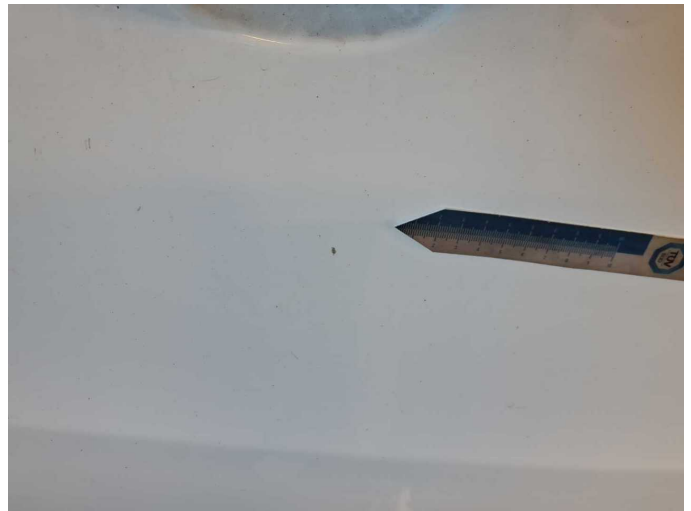
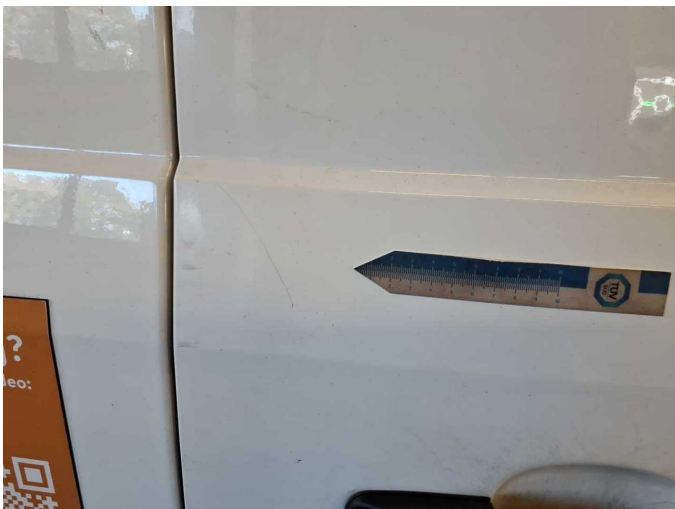
Damage 10: Boot lid / rear door: Boot lid (Rechts) - Scratch(es) - Paint

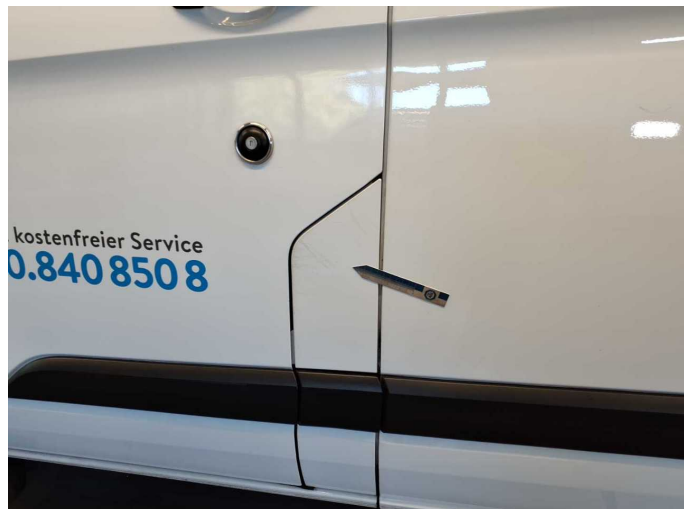
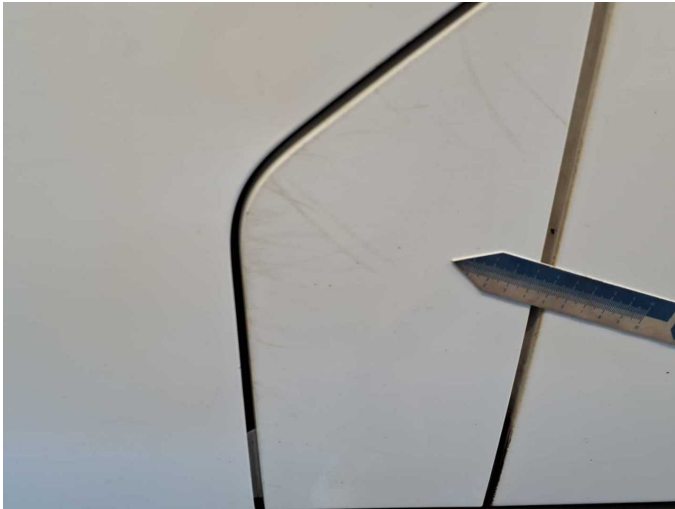
No.	Component group	Description
1	Body	Body - Scratch(es) - No deduction
2	Front bumper	Front bumper - Scratch(es) - No deduction
3	Bonnet	Bonnet - Stone chips - No deduction
4	Rear bumper	Rear bumper (unpainted) - Scratch(es) - No deduction
5	Fuel system	Tank flap - Scratch(es) - Conditioning

Wear and tear 5: Fuel system: Tank flap - Scratch(es) - Conditioning

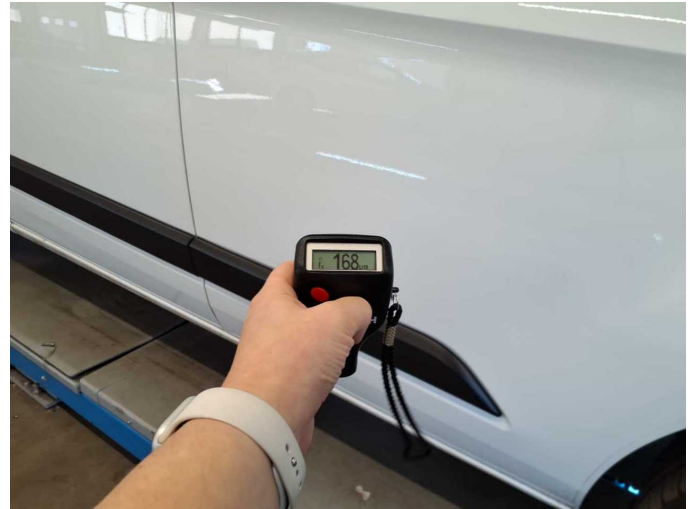
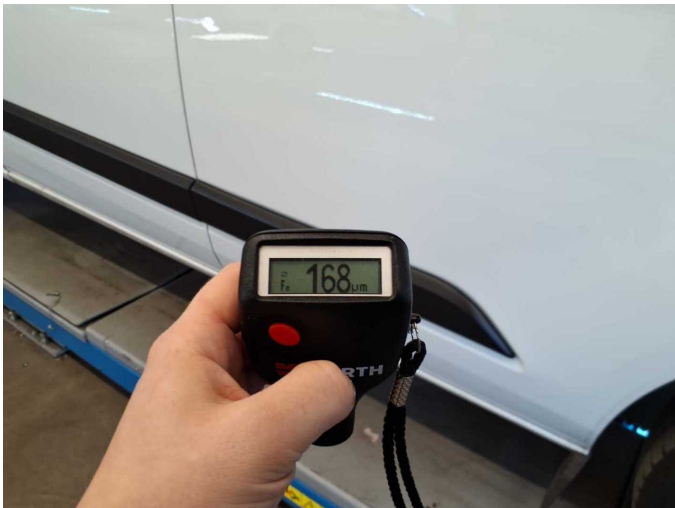
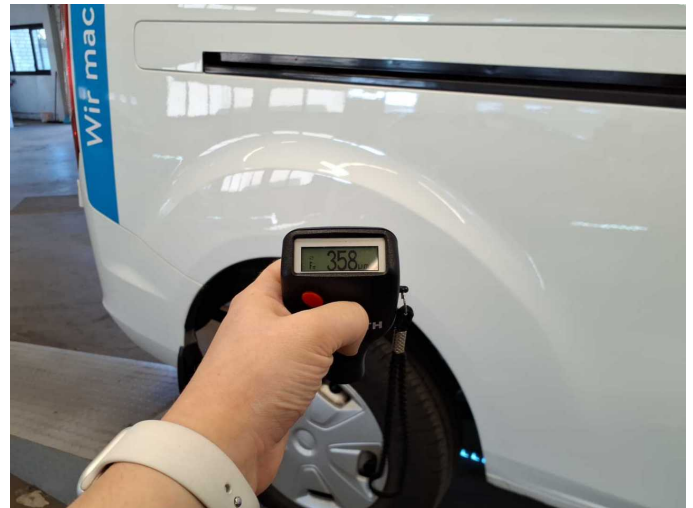
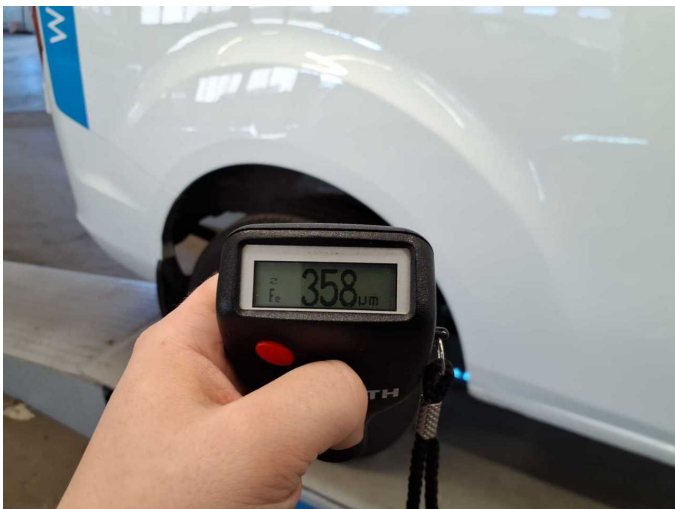
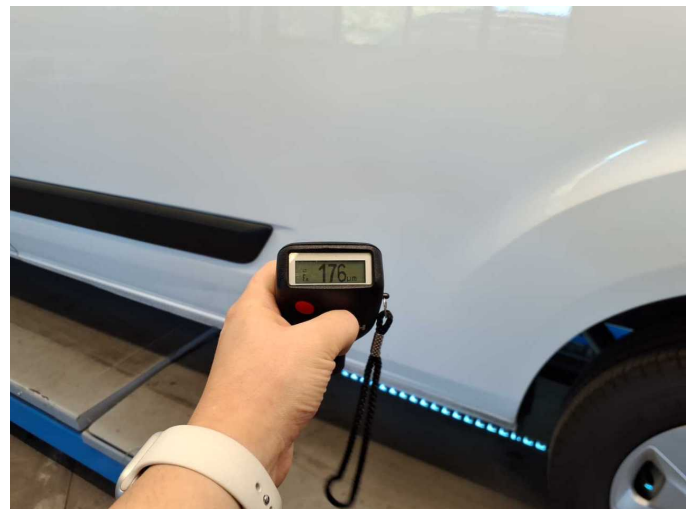
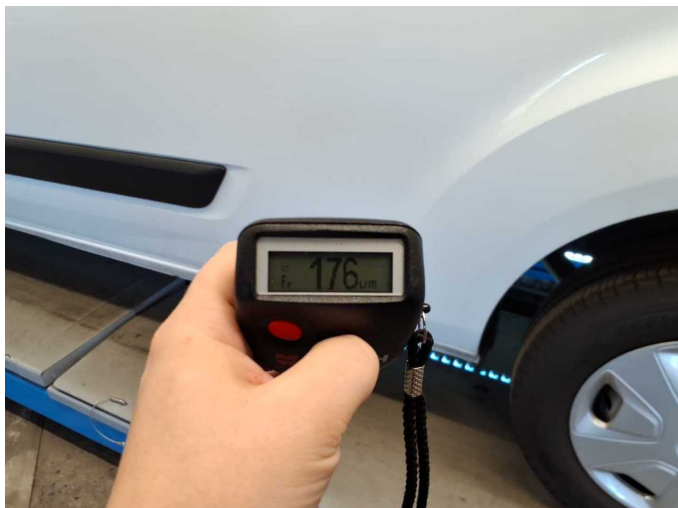
1 Side panel - rear left side, Side panel - rear right side, Door - front right side, Professionally carried out, Invoice of repair done Non-existent

Side panel - rear left side	176 µm	Side panel - rear right side	358 µm
Door - front right side	168 µm

Repainting 1: Side panel - rear left side, Side panel - rear right side, Door - front right side

Repainting 1: Side panel - rear left side, Side panel - rear right side,
Door - front right side
