Expertise

Protocol number: 41826539
Order number / reference: 25273746
Inspection date: 6 Oct 2025

Manufacturer: Ford

Model: Transit Custom 320 L1H1 LKW VA Trend

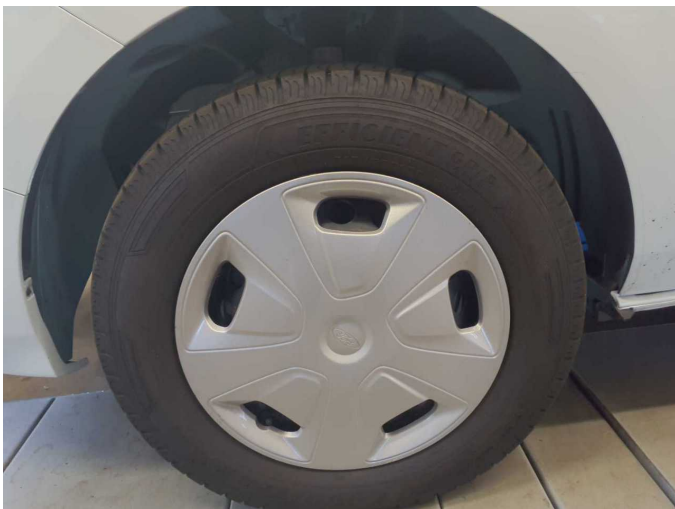
Figure 11: Mounted tyres

#	Tyre size	Type of tyre	Manufacturer	Tread depth
1)	215/65 R16 107T	Summer tyres on Steel rim with wheel cover	Goodyear	8mm / 8mm
2)	215/65 R16 107T	Summer tyres on Steel rim with wheel cover	Goodyear	6mm / 6mm

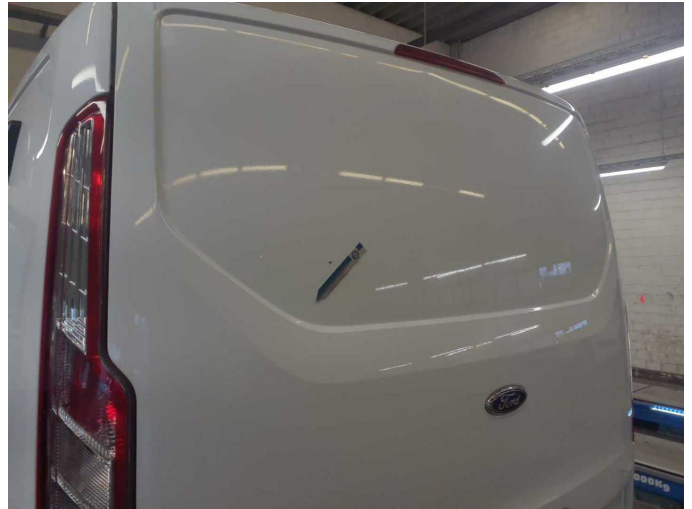
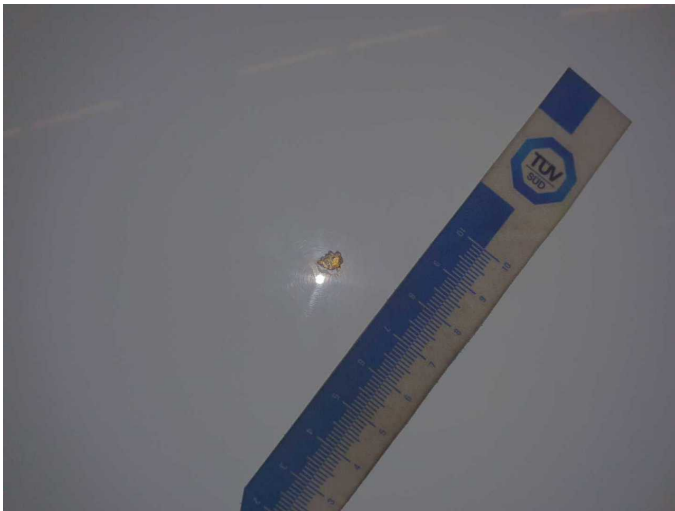
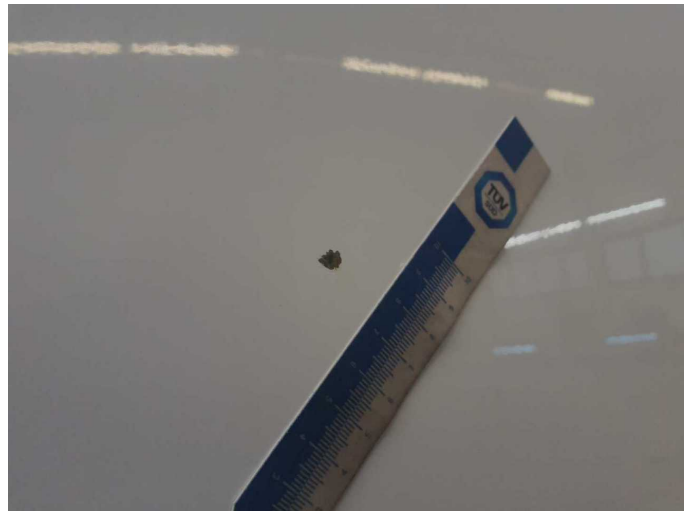
No.	Component group	Description
1	Misc.	Main inspection - No evidence - No deduction
2	Boot lid / rear door	Boot lid (+Kratzer) - Corrosion - Repair and paint

Damage 2: Boot lid / rear door: Boot lid (+Kratzer) - Corrosion - Repair and paint
