Expertise

Protocol number: 41186590
Order No. / Reference: 25066747
Inspection date: 22 Aug 2025

Manufacturer: Ford

Model: Transit Custom 280 L1H1 LKW VA Trend

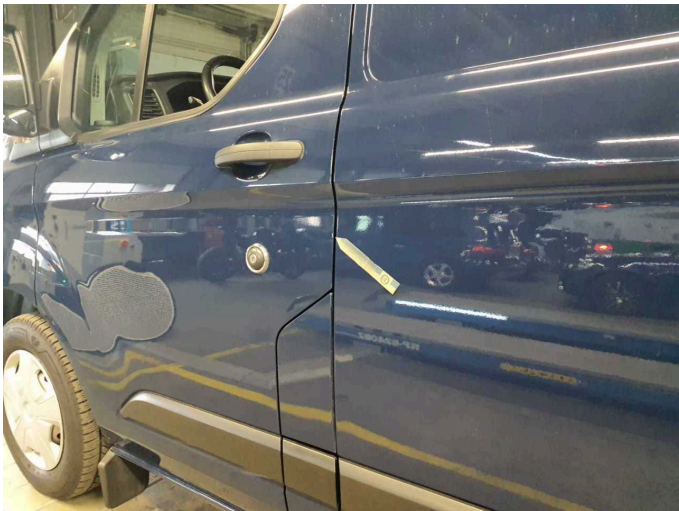
Damage 1: Door - front left side: Door edge - Scratch(es) - Smart repair

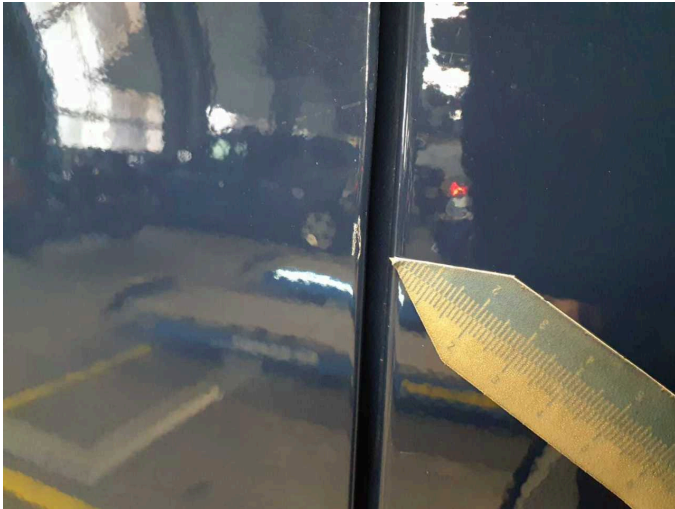
No.	Component group	Description
1	Door - front left side	Door edge - Scratch(es) - Smart repair
2	Sliding door, right	Sliding door - dent(s) - Smooth repair work
3	Side panel - rear left side	Side panel - Scratch(es) - Smart repair
4	Door - front right side	Door - Scratched - Paint

Damage 1: Door - front left side: Door edge - Scratch(es) - Smart repair

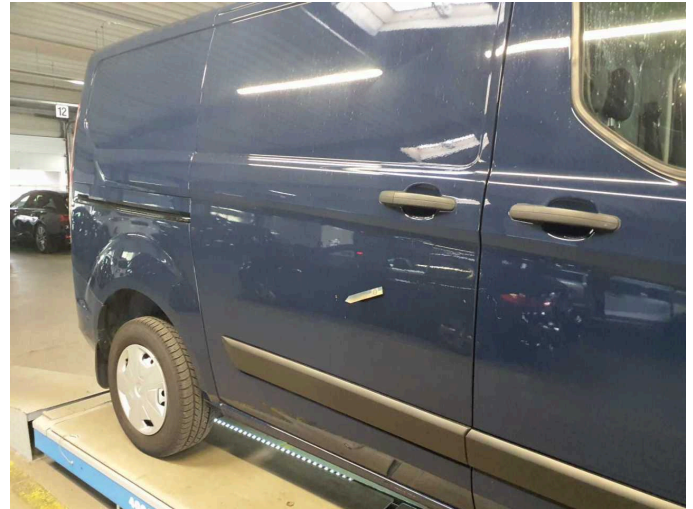
Damage 2: Sliding door, right: Sliding door - dent(s) - Smooth repair work

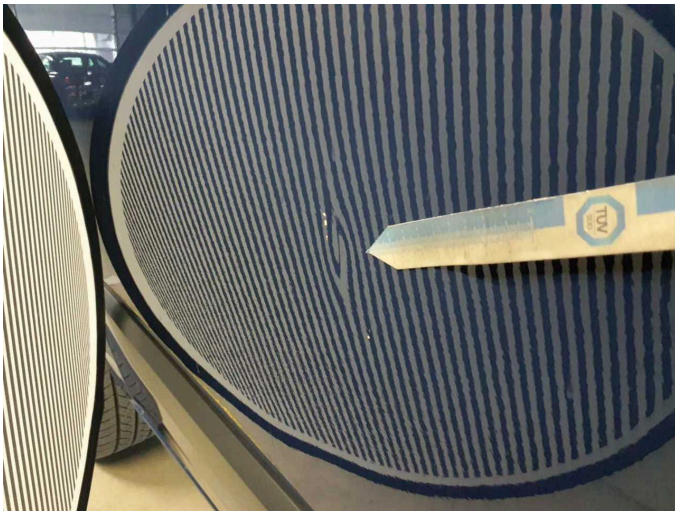
Damage 2: Sliding door, right: Sliding door - dent(s) - Smooth repair work

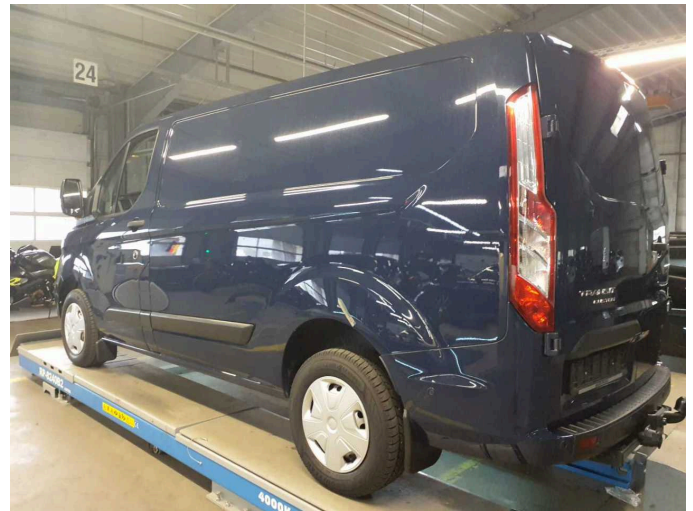
Damage 3: Side panel - rear left side: Side panel - Scratch(es) - Smart repair

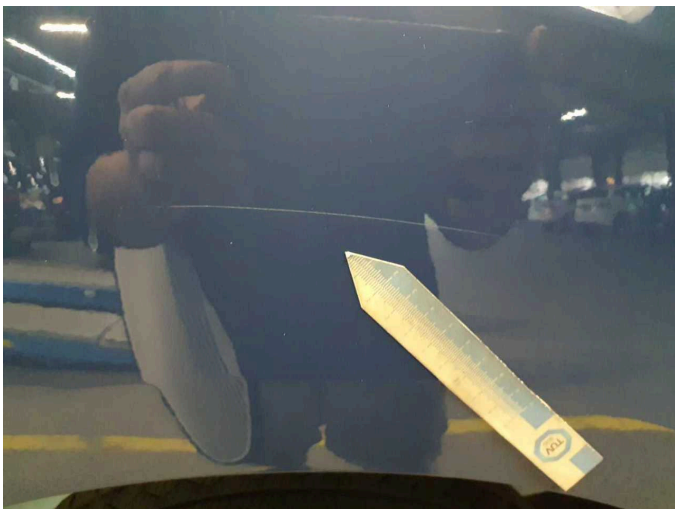
Damage 3: Side panel - rear left side: Side panel - Scratch(es) - Smart repair

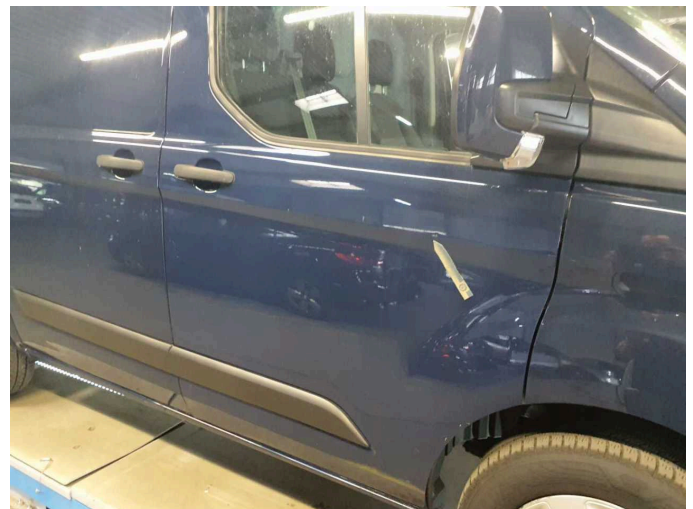
Damage 4: Door - front right side: Door - Scratched - Paint

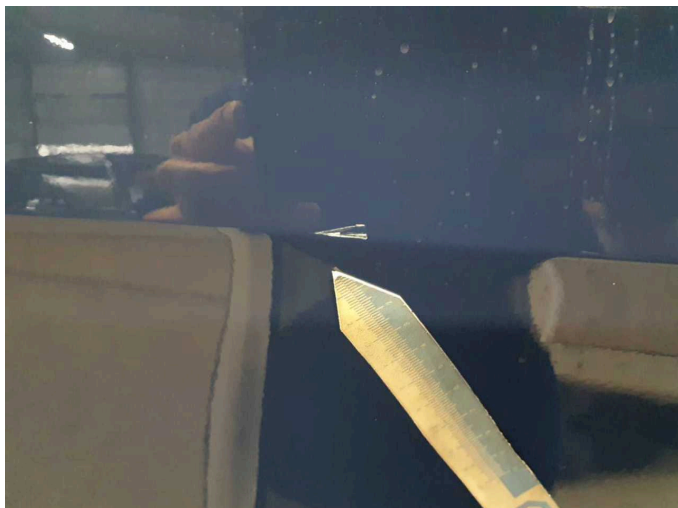
Damage 4: Door - front right side: Door - Scratched - Paint

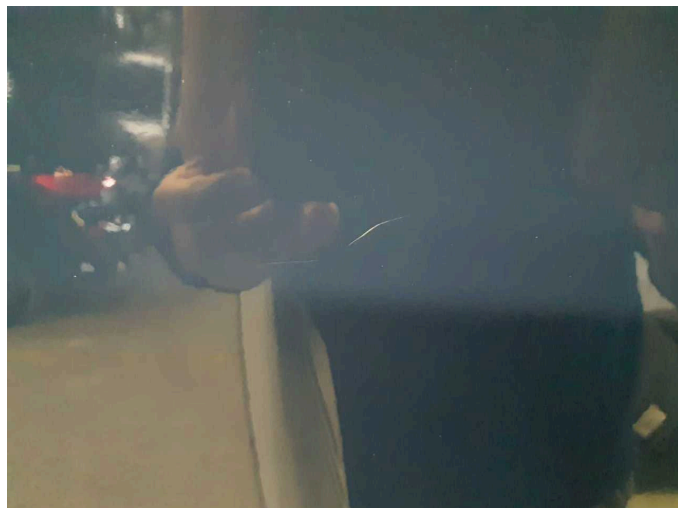
Damage 4: Door - front right side: Door - Scratched - Paint

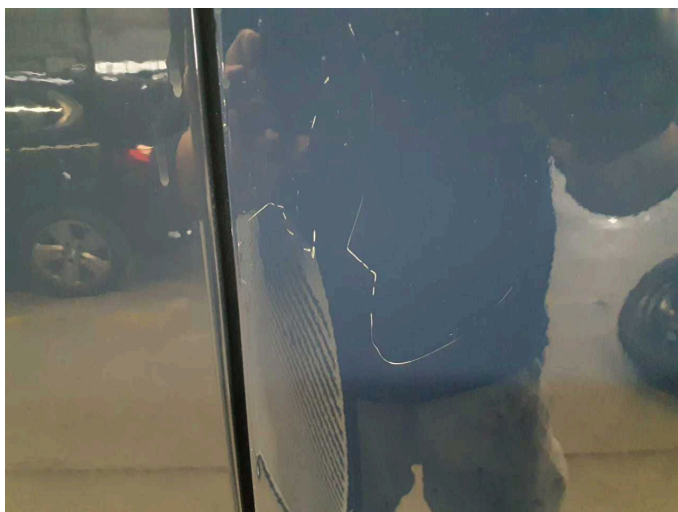
Damage 4: Door - front right side: Door - Scratched - Paint
