Expertise

Protocol number: 41574972
Order No. / Reference: 25201889
Inspection date: 16 Sept 2025

Manufacturer: Ford

Model: Transit Custom 280 L1H1 LKW VA Trend

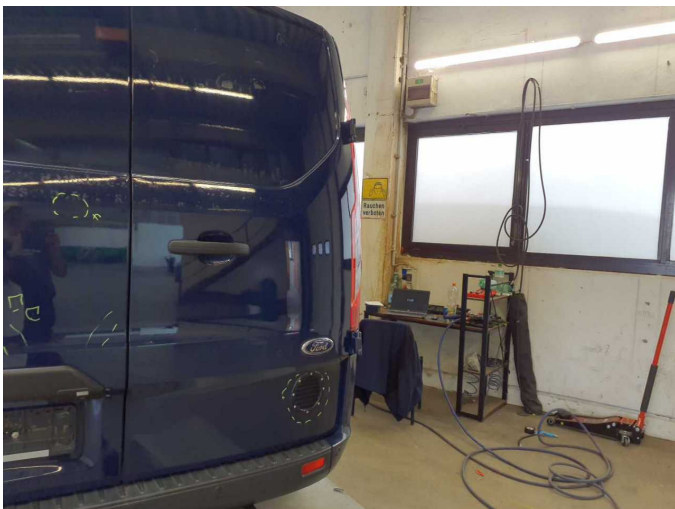
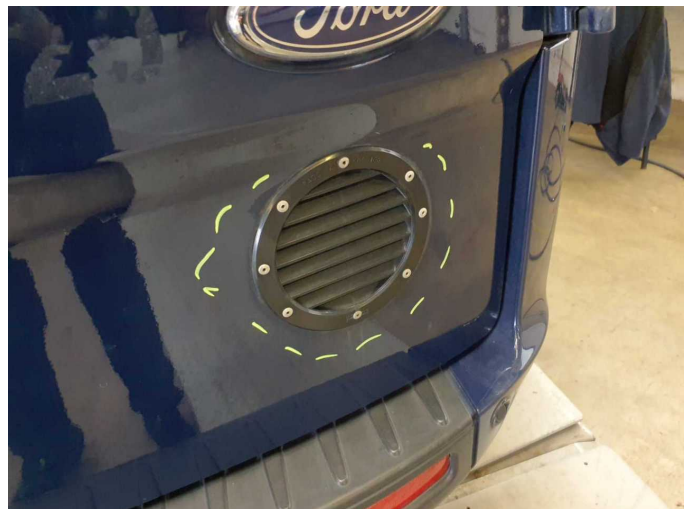
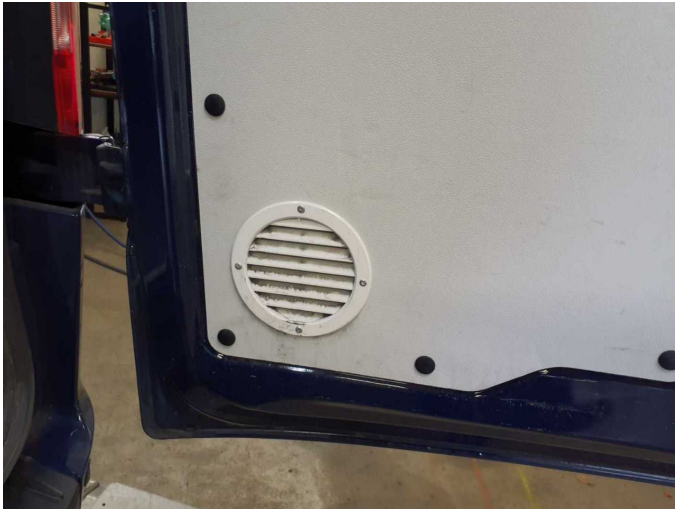
Damage 1: Boot lid / rear door: Rear door - right side (Laderaum Belüftung) - No evidence - No deduction

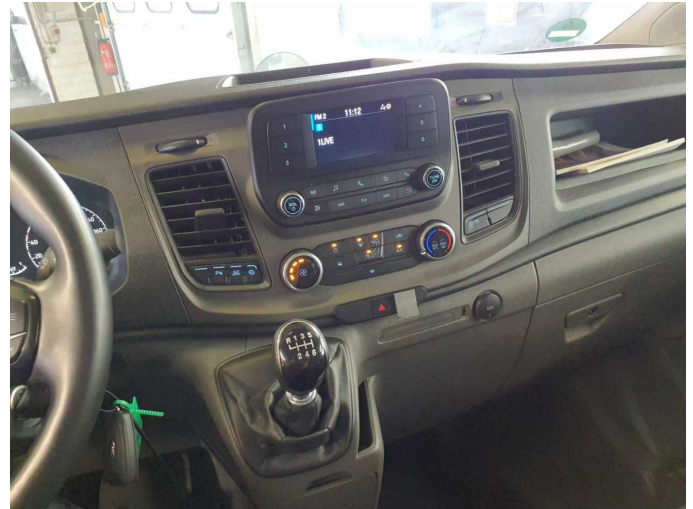
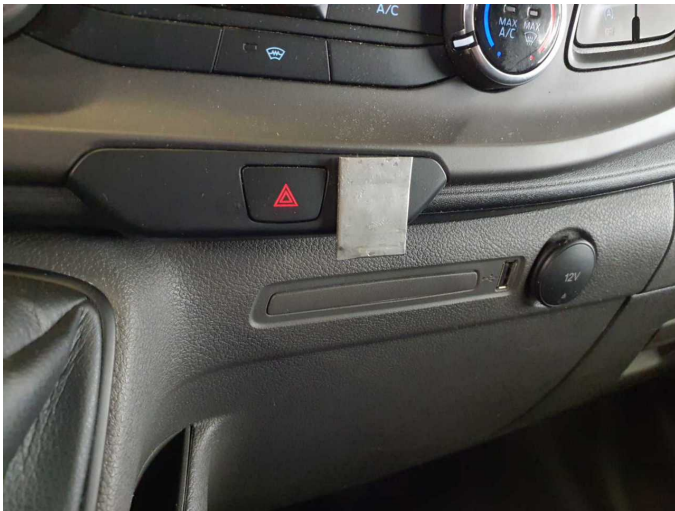
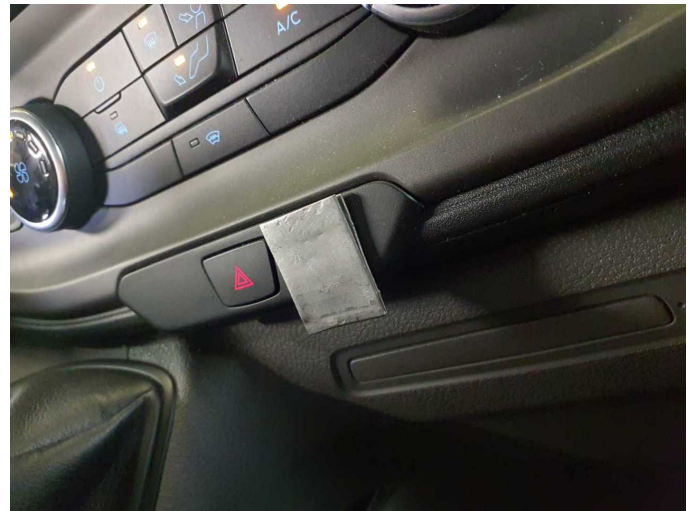
Damage 2: Instrument panel: Centre console - front - Glued / labelled - De-glue / neutralise

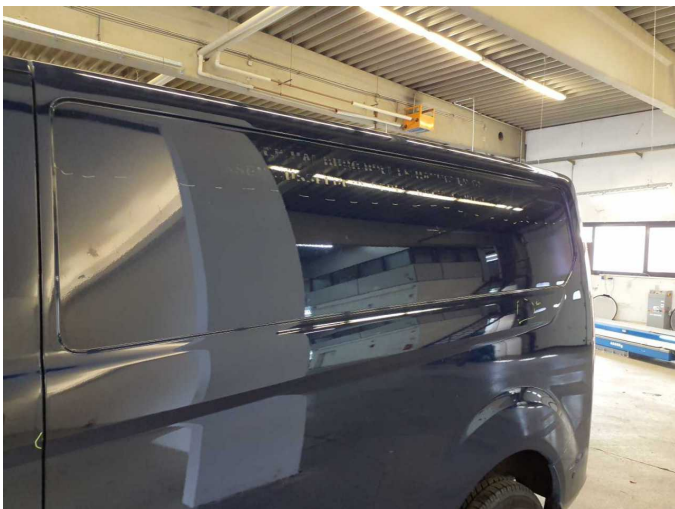
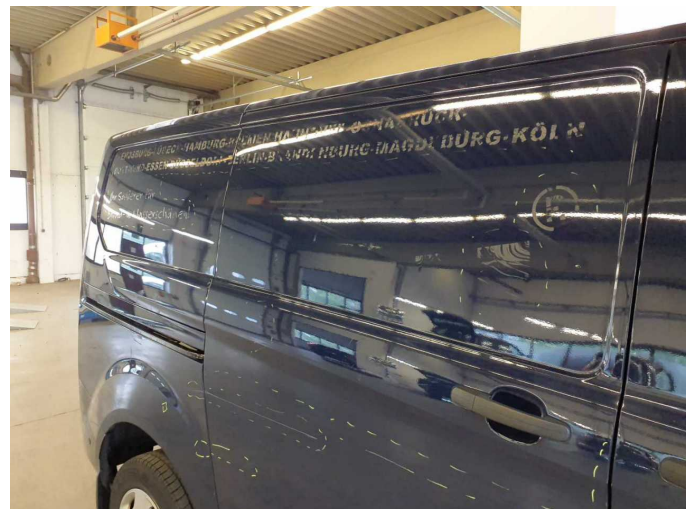
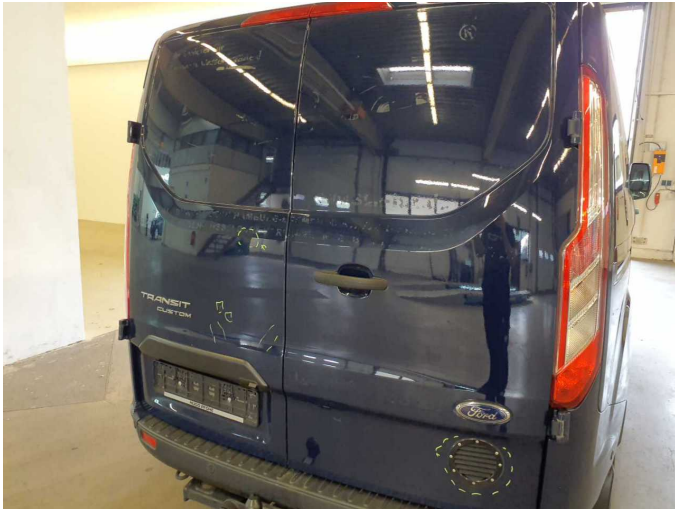
Damage 3: Body: Body (Klebereste) - Glued / labelled - De-glue / neutralise

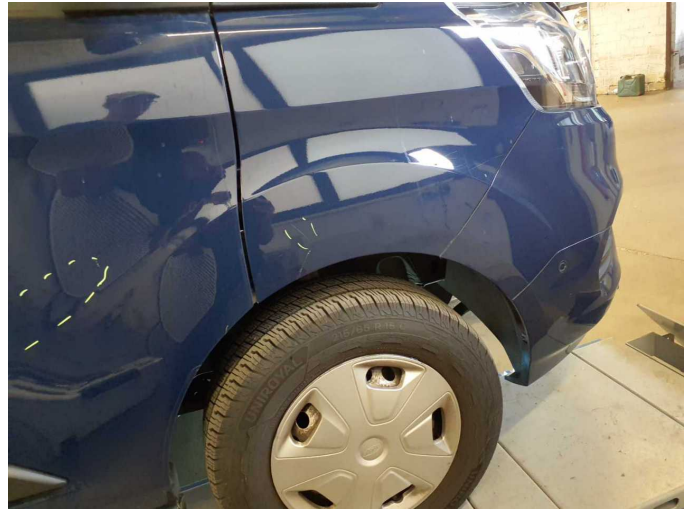
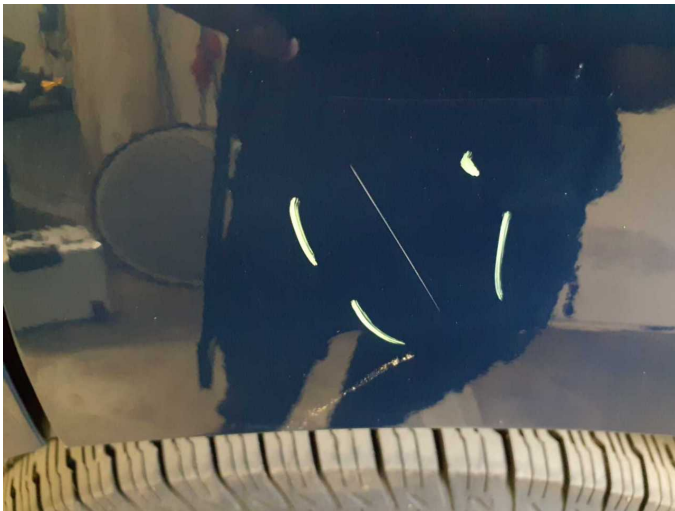
Damage 4: Mudguard - right side: Wheel arch - Scratched - Smart repair

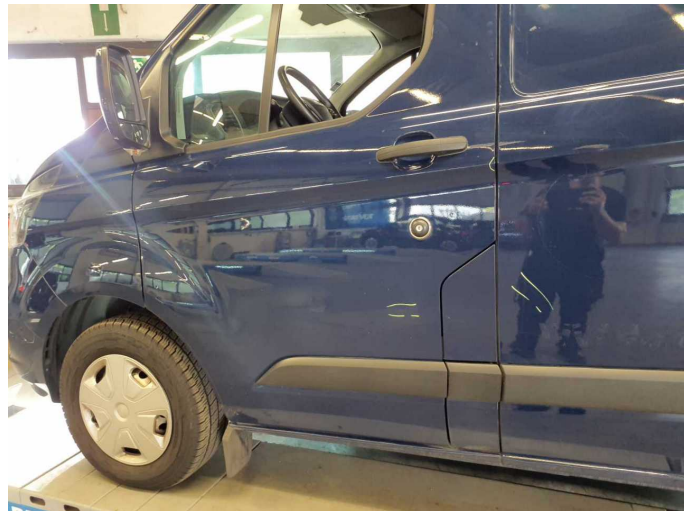
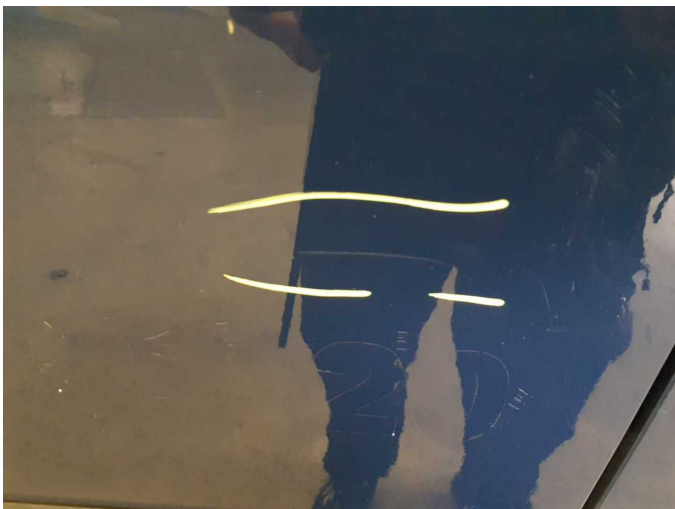
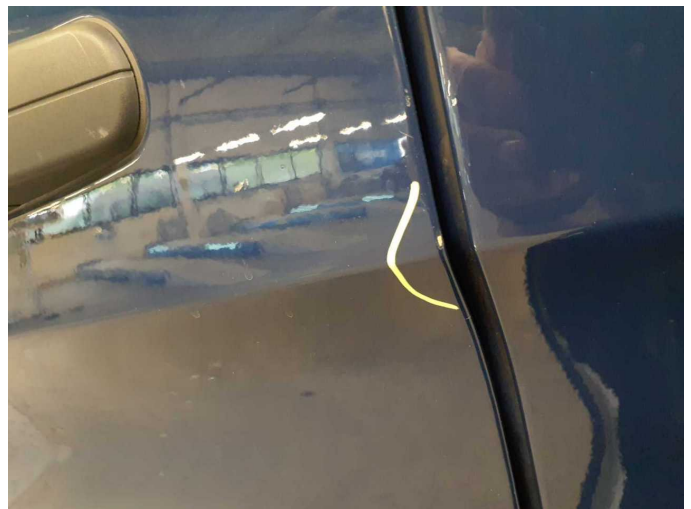
Damage 5: Door - front left side: Door - Scratched - Paint

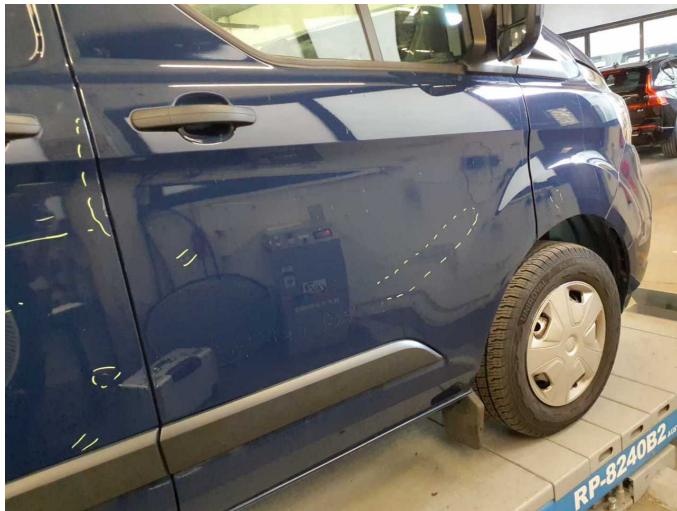
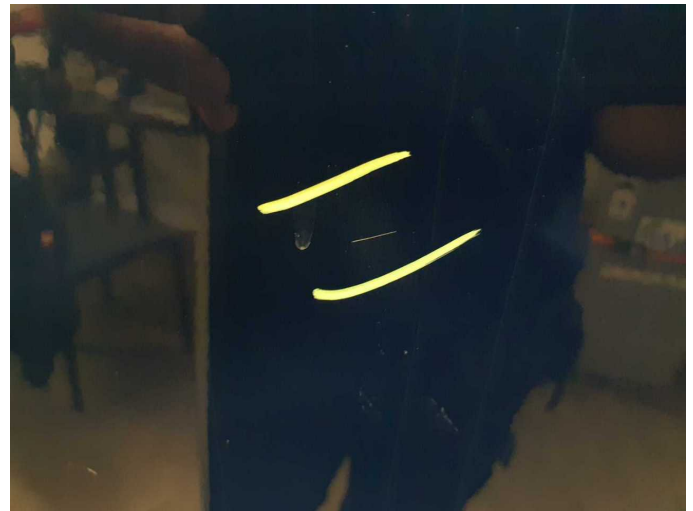
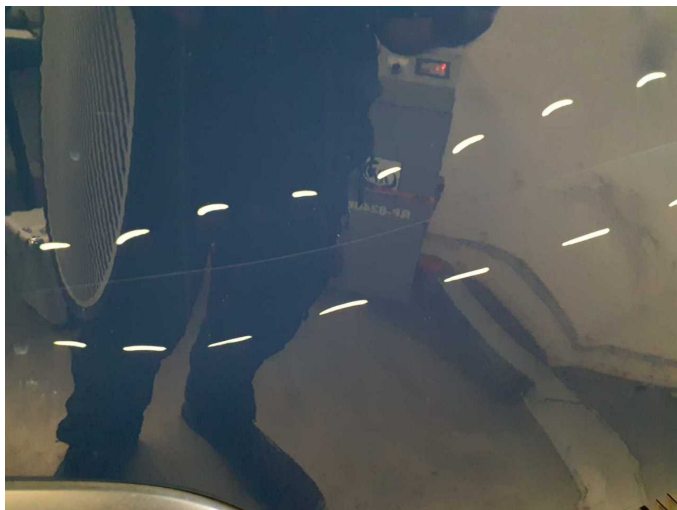
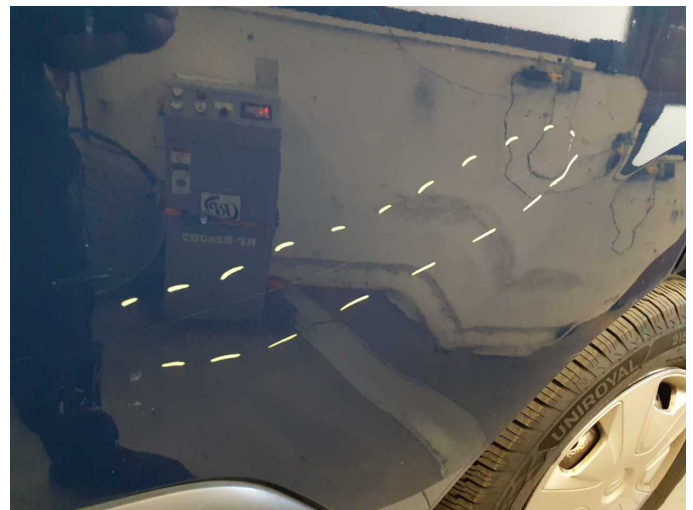
Damage 6: Door - front right side: Door - Scratched - Paint

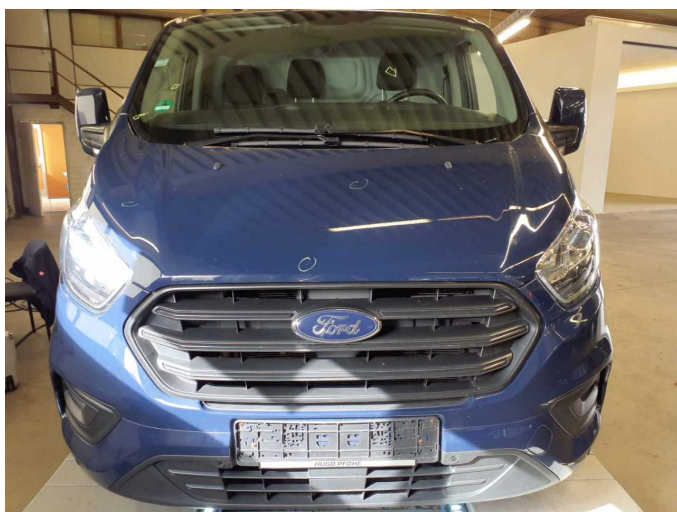
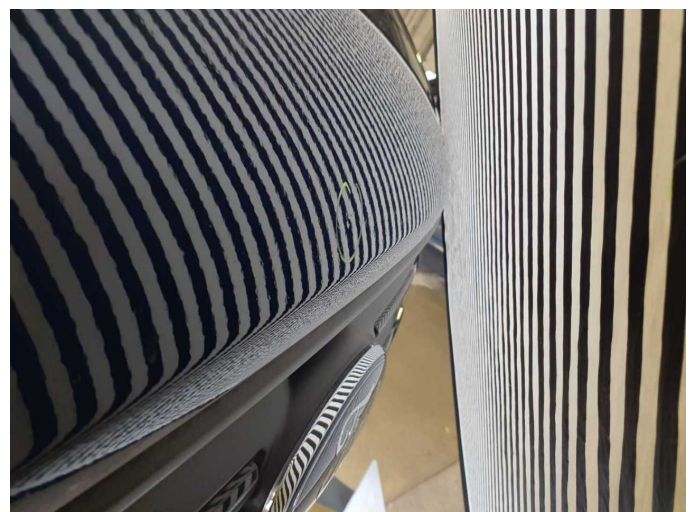
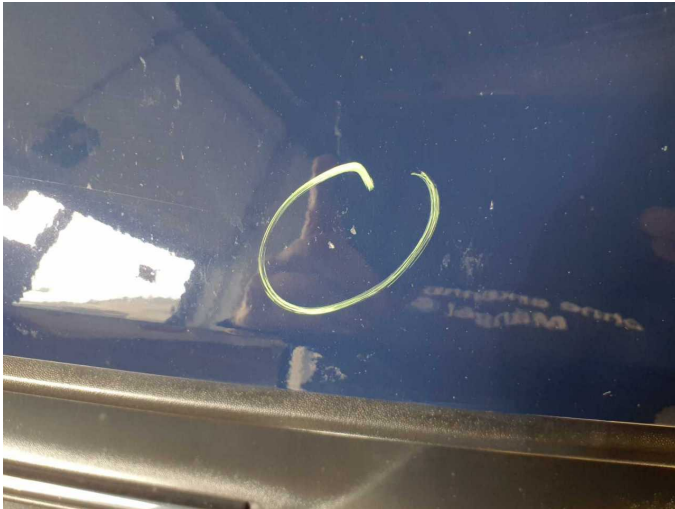
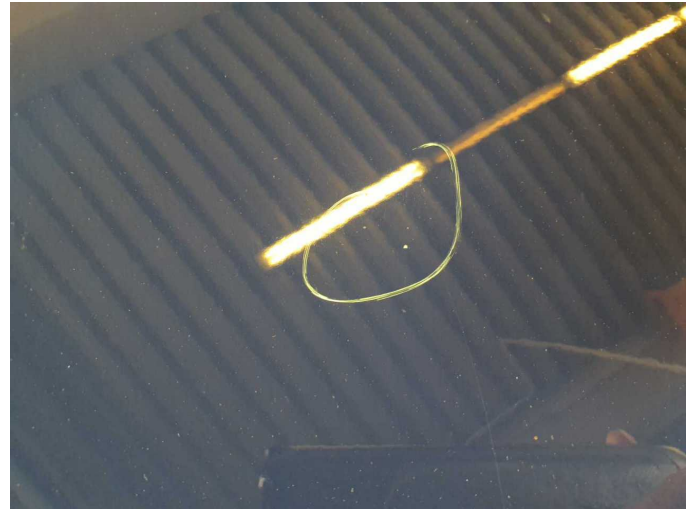
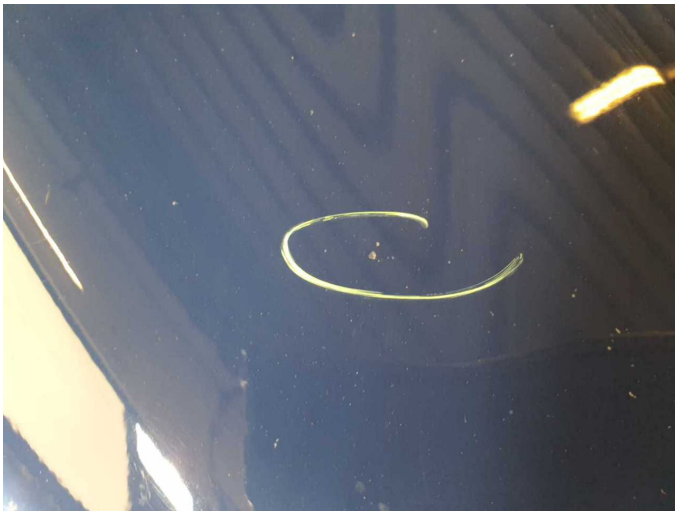
Damage 7: Bonnet: Bonnet - Dent / paintcoat damage - Repair and paint

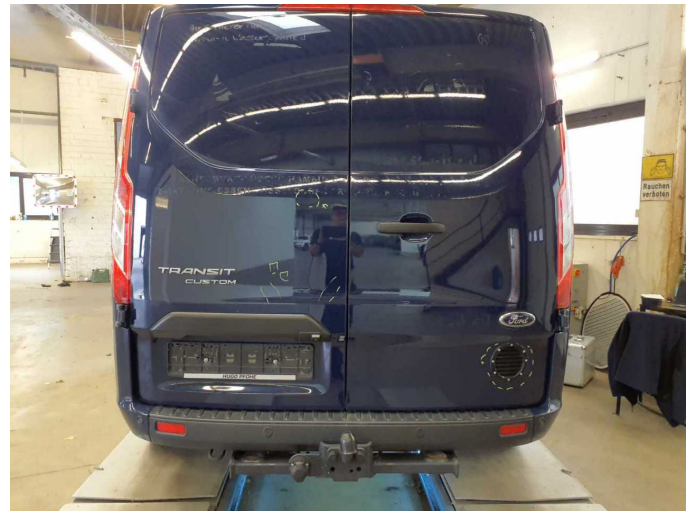
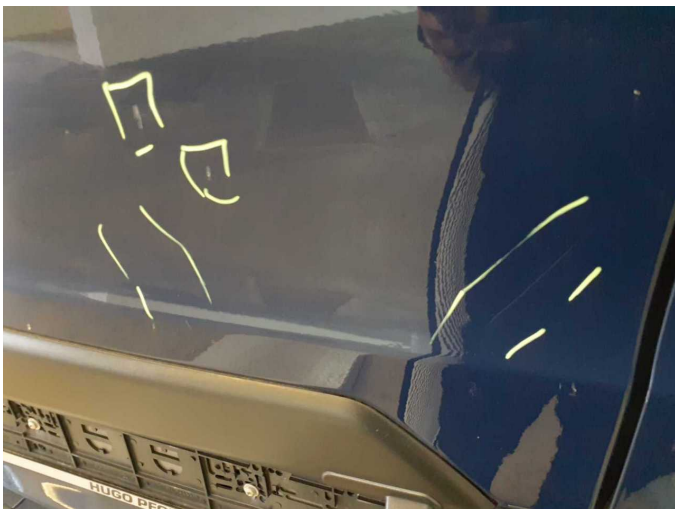
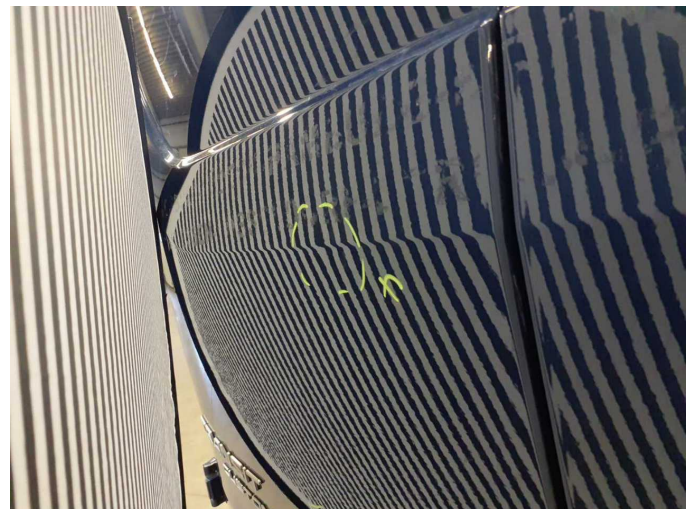
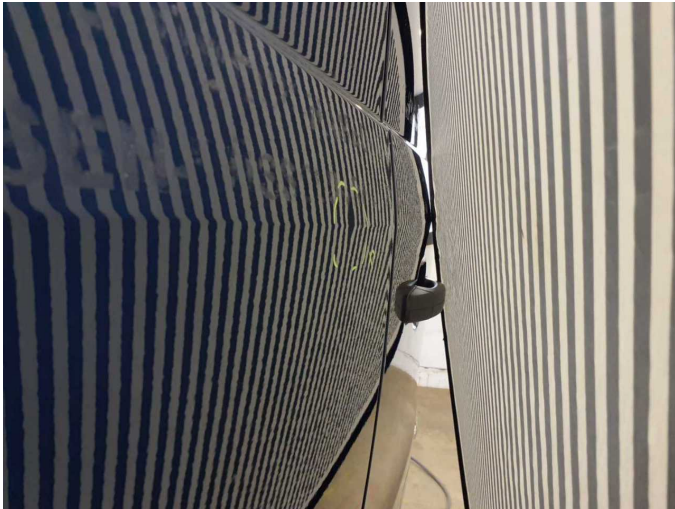
Damage 8: Boot lid / rear door: Rear door - left side - Dent / paintcoat damage - Repair and paint

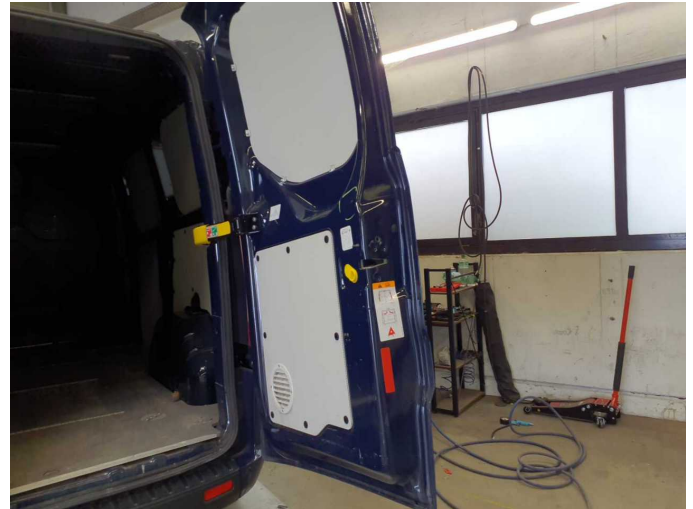
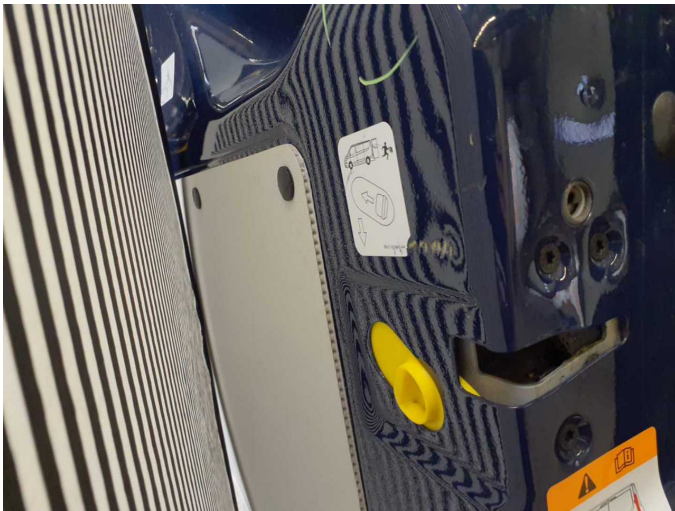
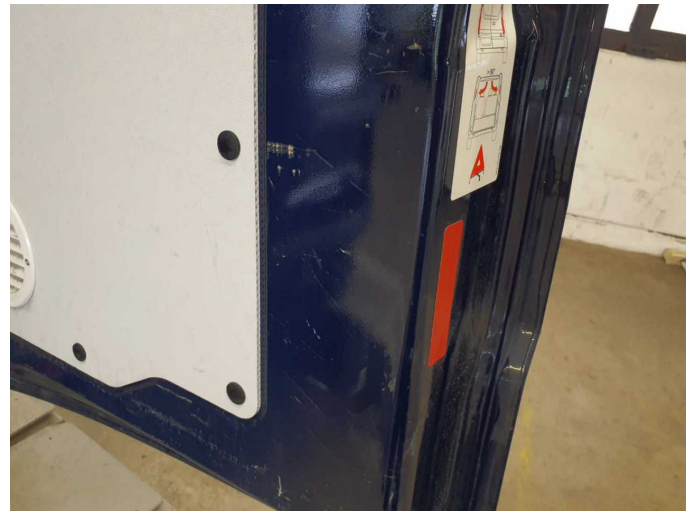
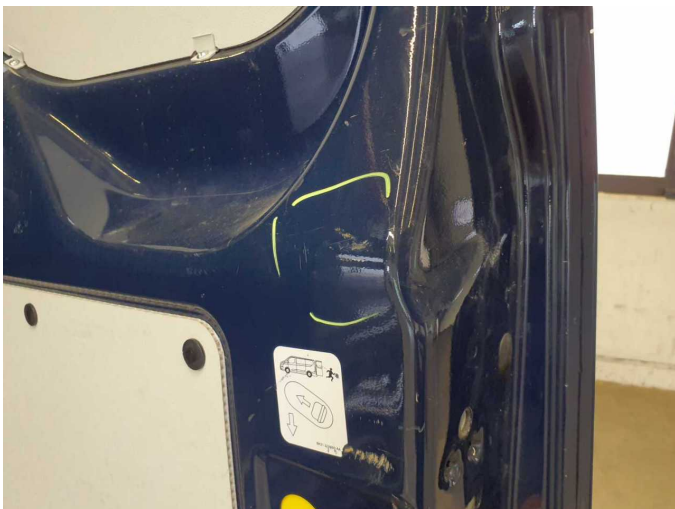
Damage 9: Boot lid / rear door: Rear door - right side - Dent / paintcoat damage - Repair and paint

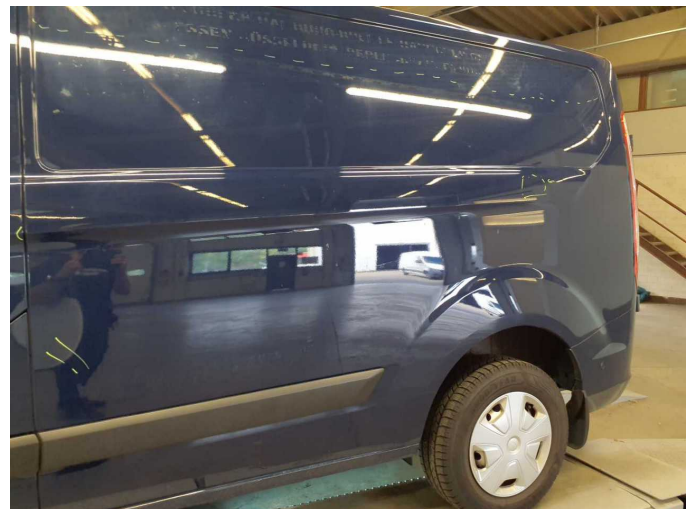
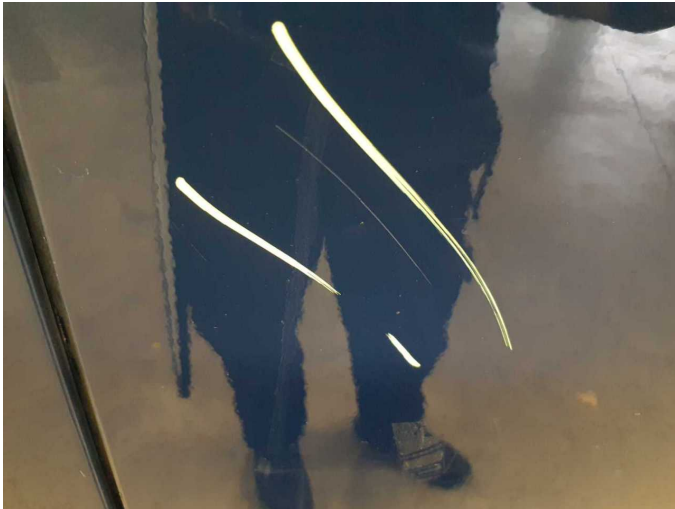
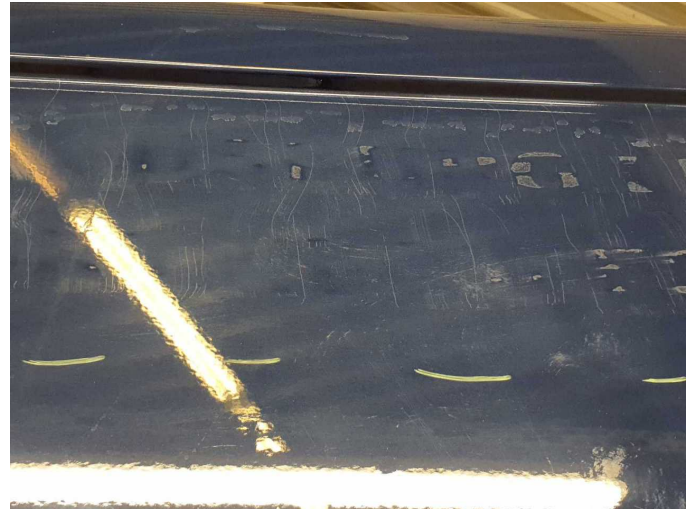
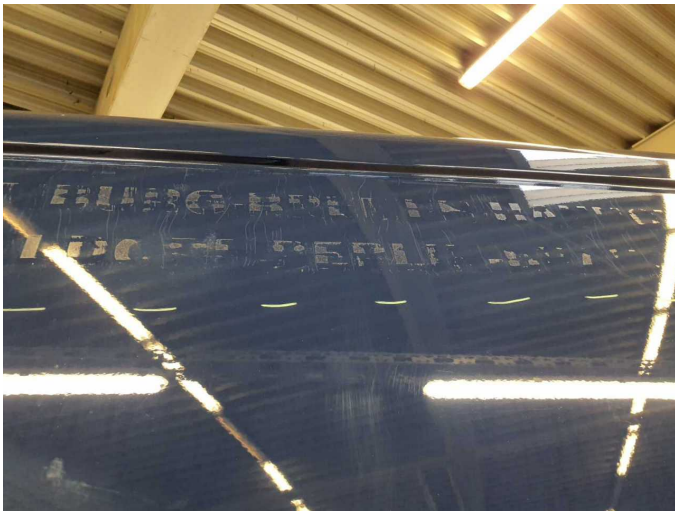
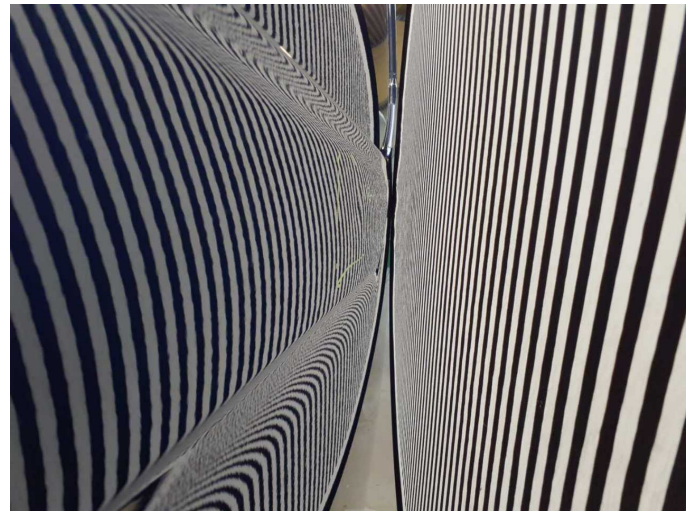
Damage 10: Side panel - rear left side: Side panel - Dent / paintcoat damage - Repair and paint

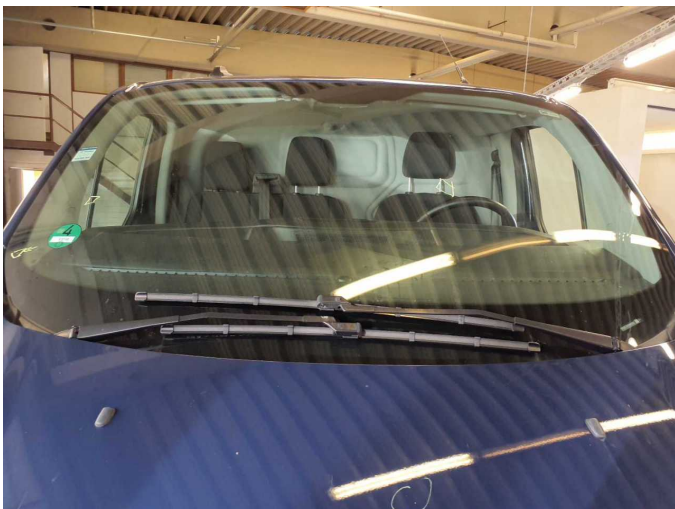
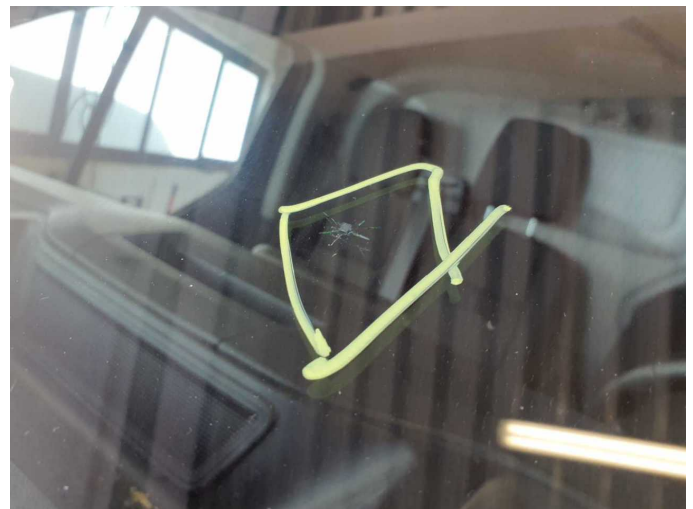
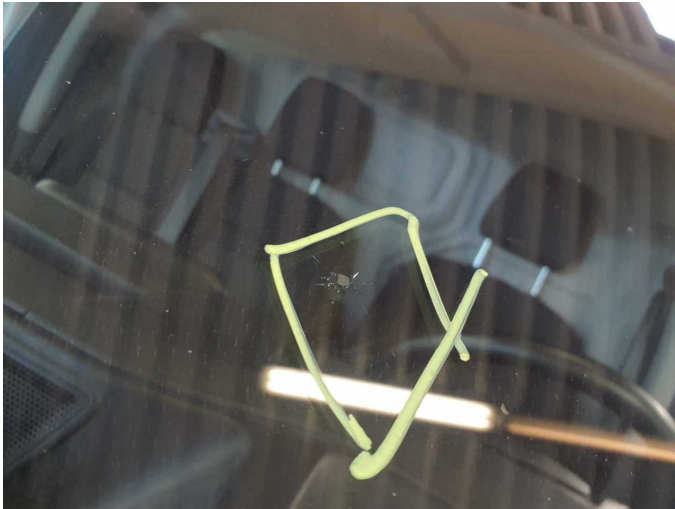
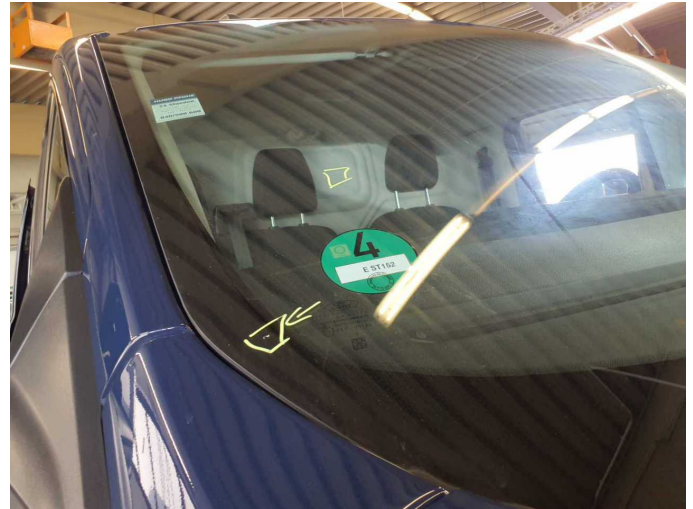
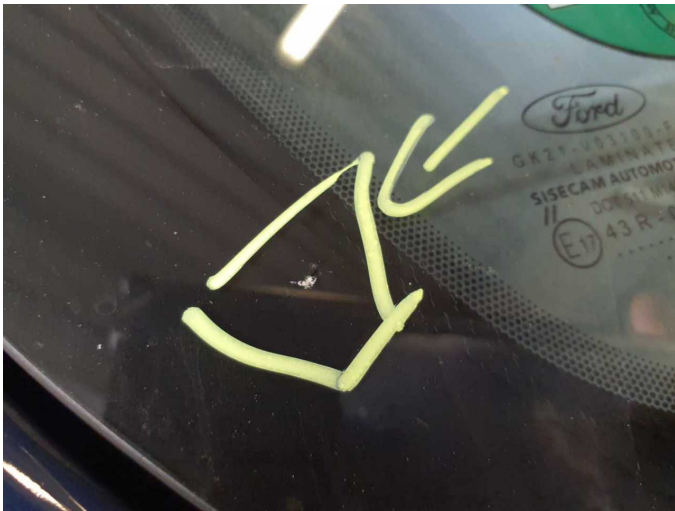
Damage 11: Vehicle glazing: Windscreen (Sichtbereich Rissbildung) - Stone chips - repair according to calculation

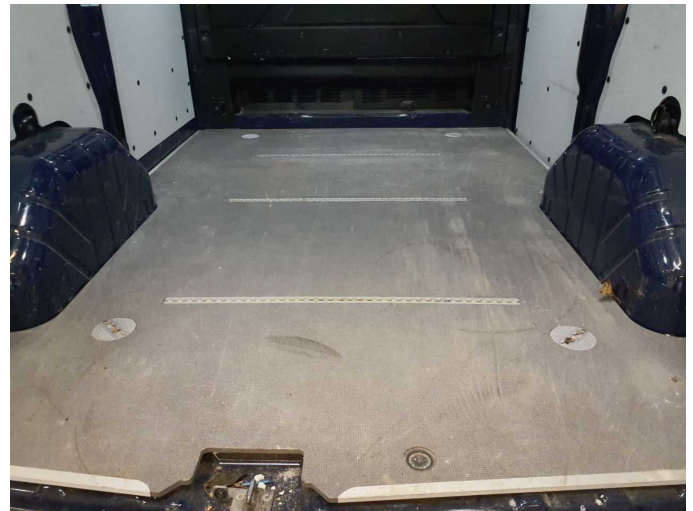
Wear and tear 1: Interior: Cargo area floor - Scratched - No deduction

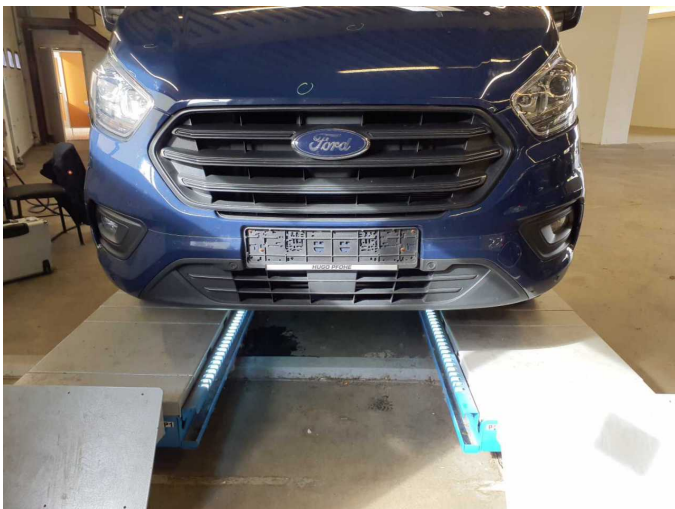
Wear and tear 2: Front bumper: Front bumper - Stone chips - No deduction

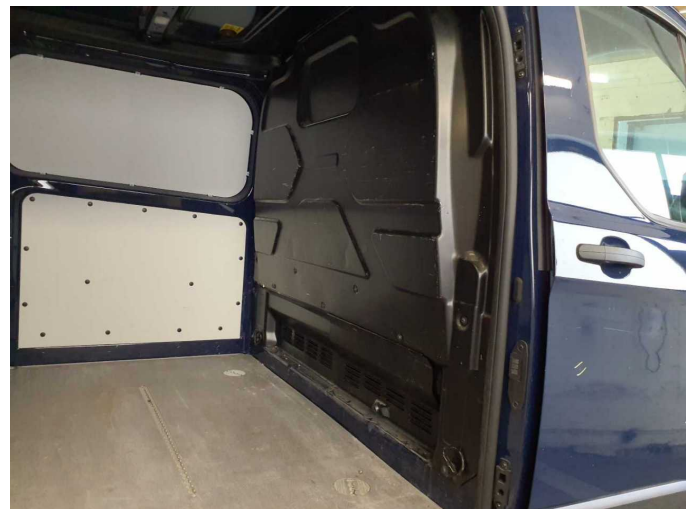
Wear and tear 3: Body: Partition wall - Dent / paintcoat damage - No deduction

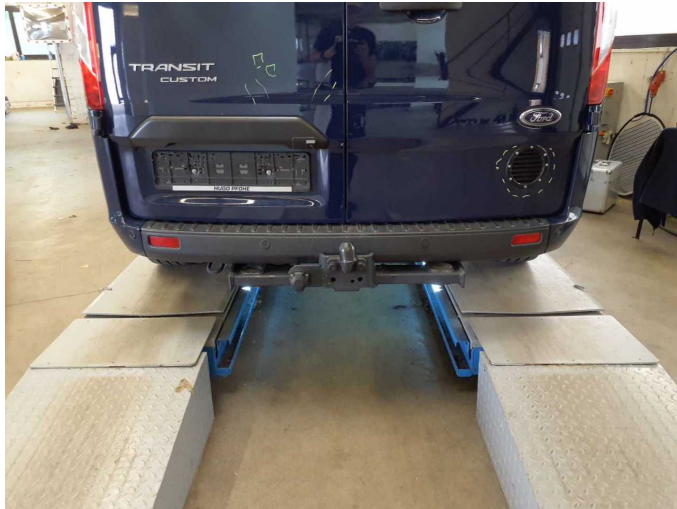
Wear and tear 4: Rear bumper: Rear bumper - Scratched - No deduction

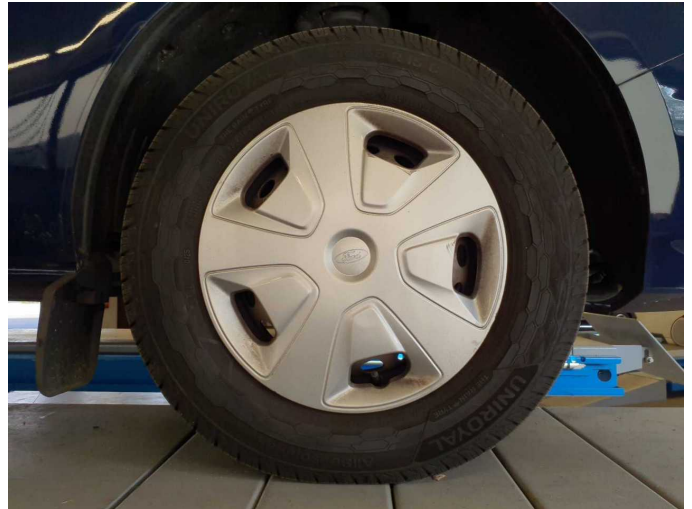
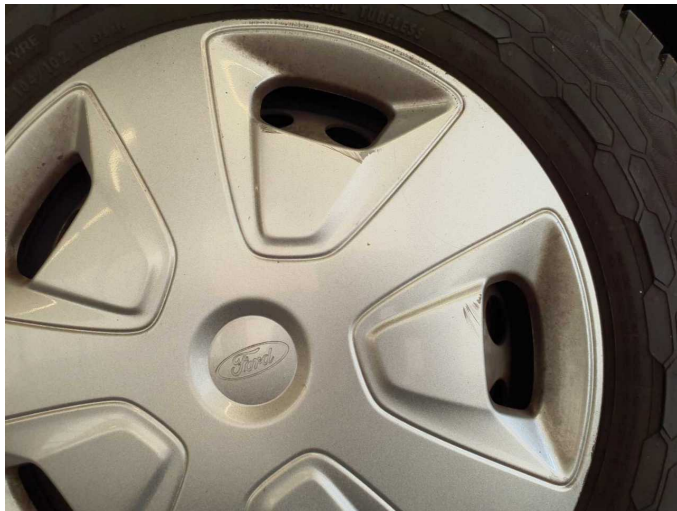
Wear and tear 5: Wheel / tyres: Wheel cover - front right side - Scratched - No deduction

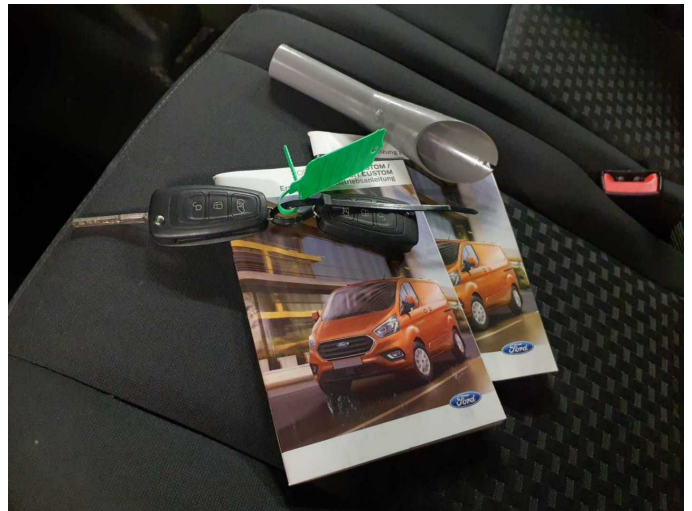
Missing part 1: Documents: Service book - Missing - Replace
