Expertise

Protocol number: 41634804
Order No. / Reference: 25238617
Inspection date: 22 Sept 2025

Model: Transit Custom 280 L1H1 LKW VA Trend

VIN: WF0ZXXTTGZLR04757

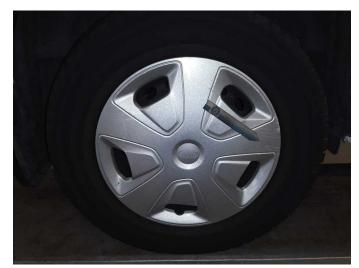
Damage 1: Wheel / tyres: Wheel cover - front right side - Scratched - Replace

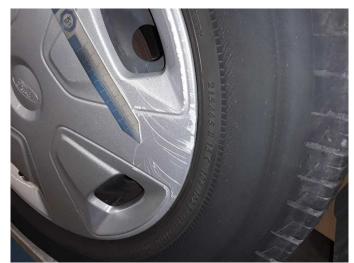
Damage 2: Wheel / tyres: Wheel cover - rear right side - Scratched - Replace

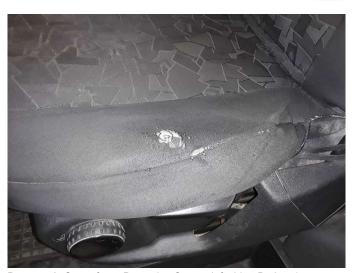
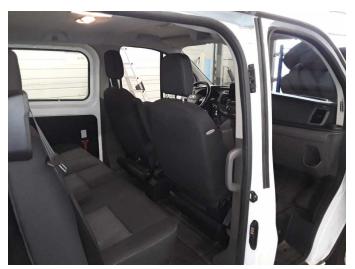
Damage 3: Seat - front: Protective Cover - left side - Broken / torn - Replace

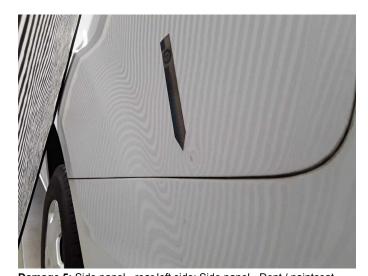
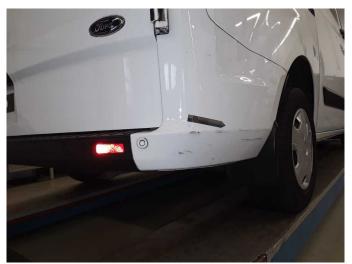
Damage 5: Side panel - rear left side: Side panel - Dent / paintcoat damage - Smart repair

$\begin{tabular}{ll} \textbf{Damage 5:} Side panel - rear left side: Side panel - Dent / paintcoat damage - Smart repair \end{tabular}$

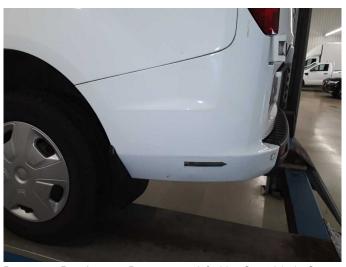
Damage 6: Rear bumper: Bumper - rear right side - Scratch(es) - Smart repair

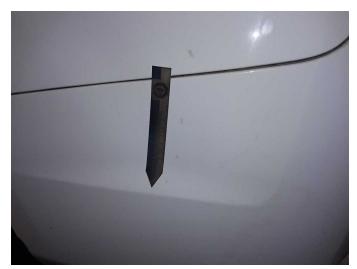
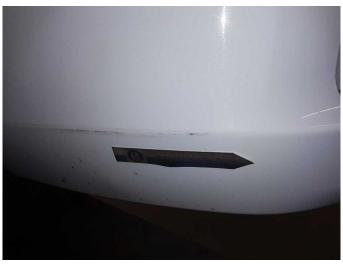
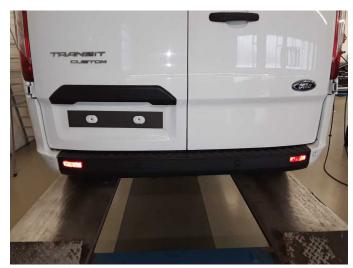
Damage 7: Rear bumper: Bumper - rear left side - Scratch(es) - Smart repair

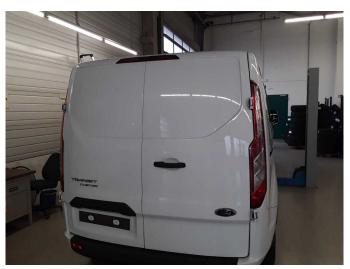
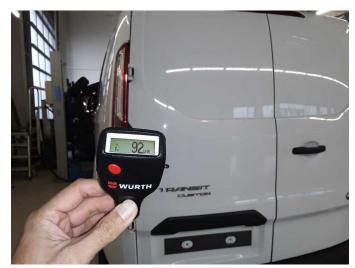
Boot lid / rear door: 1,510 µm

Boot lid / rear door: 1,510 μm

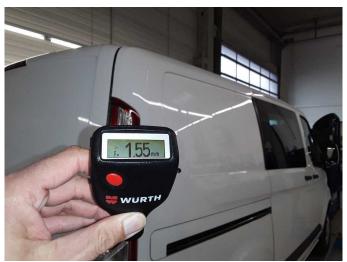
Side panel - rear left side: 785 µm

Side panel - rear left side: $785~\mu m$

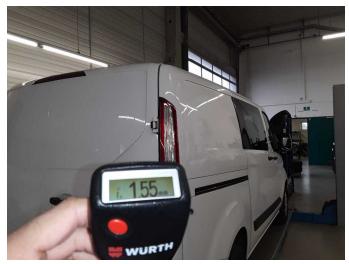
Side panel - rear right side: 1,550 μm
