## status report

**customer:** Bank 11, Neuss  
**contract number:**  
**reference:**

#### Smart fortwo cabrio Basis 52 kW

| Vehicle identification number | <b>WME4534421K133139</b> | mileage read: | <b>57570 km</b> |

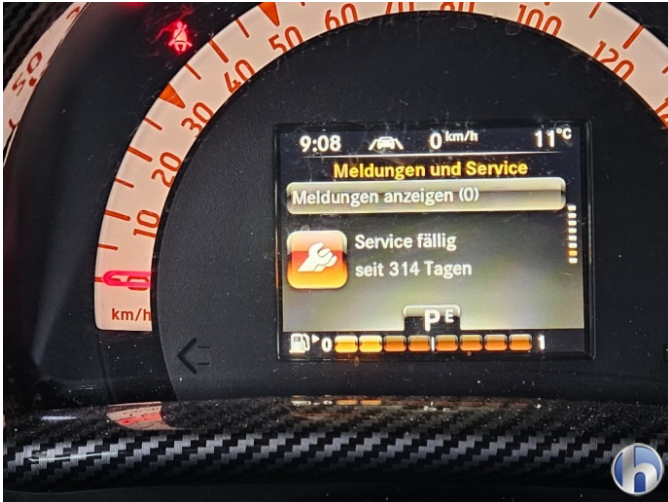
| component | Damage | Rep kind |
|---|---|---|
| 1. maintenance | Missing | Replace |

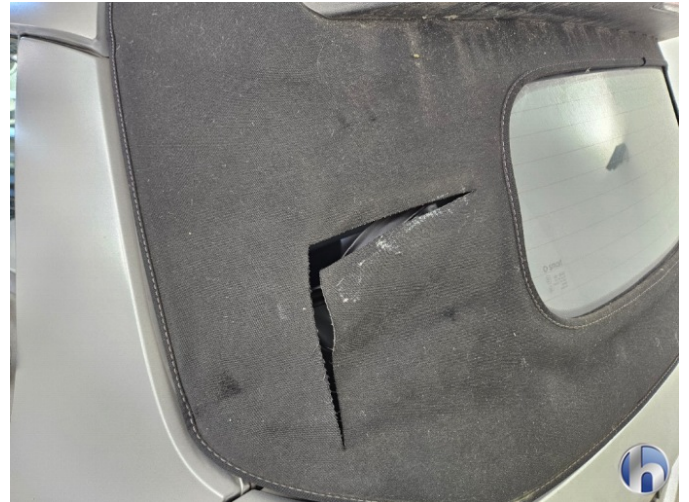
| component | Damage | Rep kind |
|---|---|---|
| 5. | Damaged | Replace |

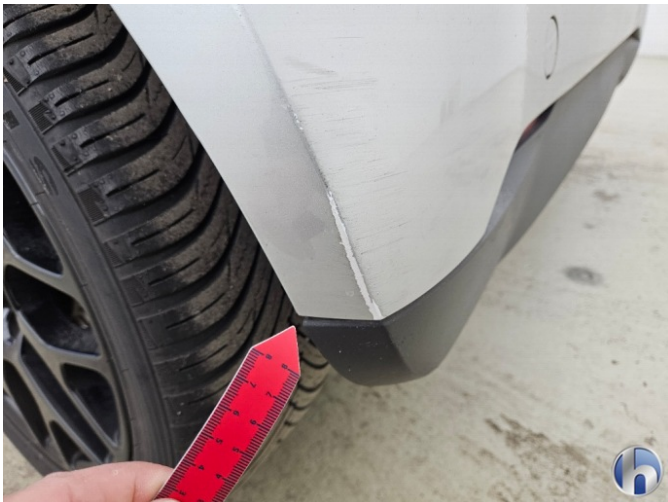
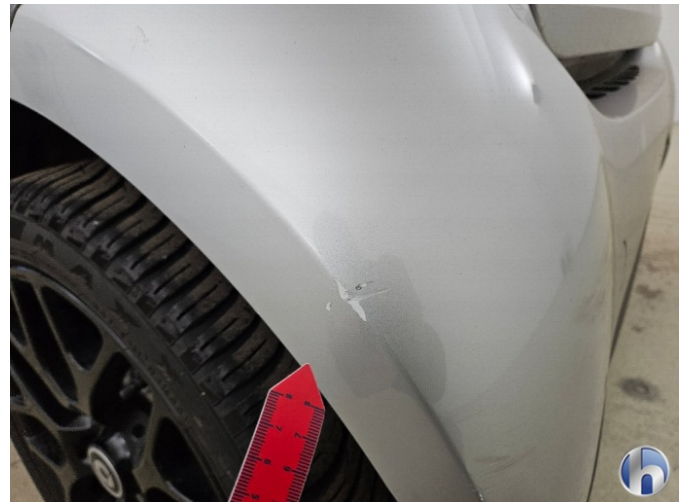
| component | Damage | Rep kind |
|---|---|---|
| 6. Rear bumper | Scrape | Paint |

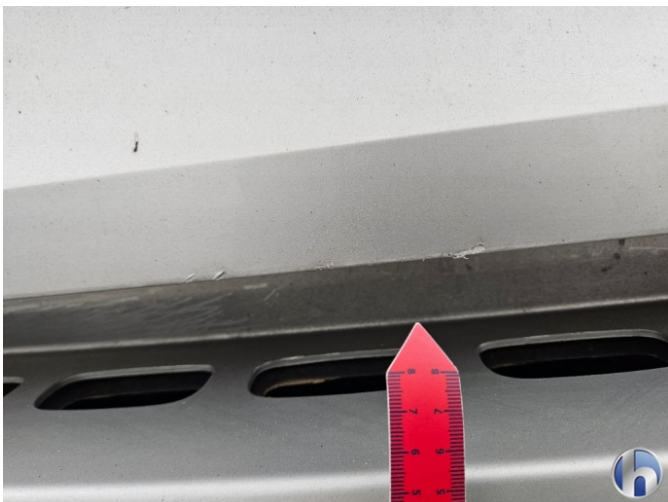
| component | Damage | Rep kind |
|---|---|---|
| 7. tailgate | Scratch(es) | Smart repair |

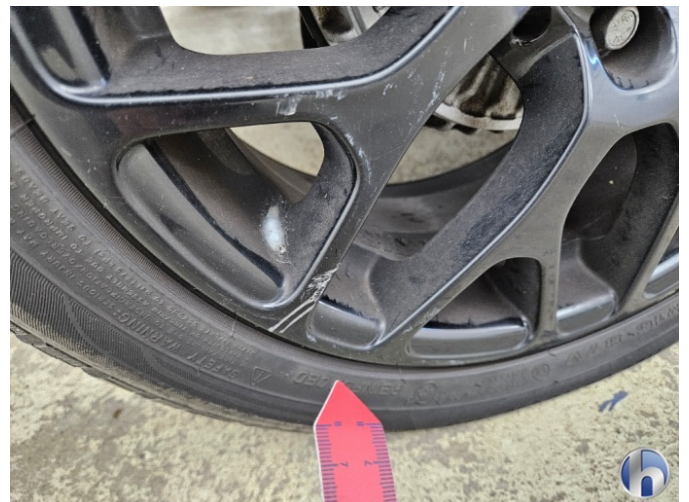
| component | Damage | Rep kind |
|---|---|---|
| 8. | Scratch(es) | Smart repair |

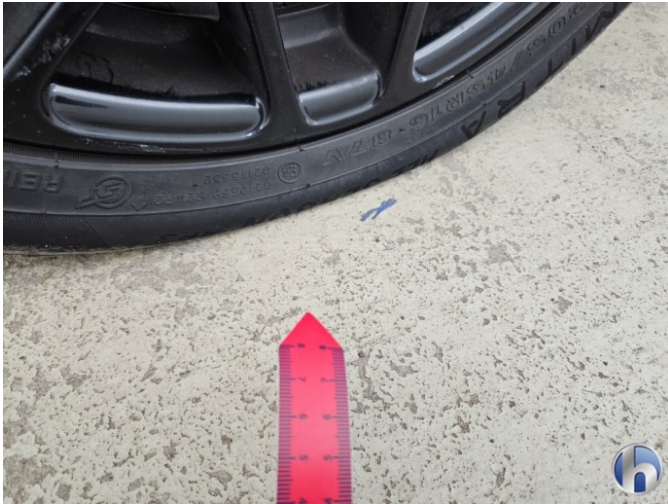
| Performed testing technology | |
|---|---|
| <b>reference:</b> | *Fzg. nur bedingt fahrbereit, Reifen h.r. Druckverlust |

| component | Damage | Rep kind |
|---|---|---|
| 9. tire rear - right | Not okay | Carry out a fault diagnosis |

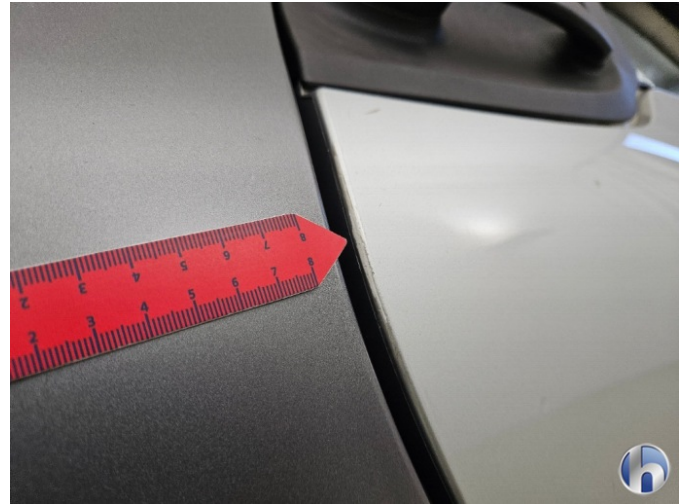
| component | Damage | Rep kind |
|---|---|---|
| 10. Front door - right | Delle | Smart repair |

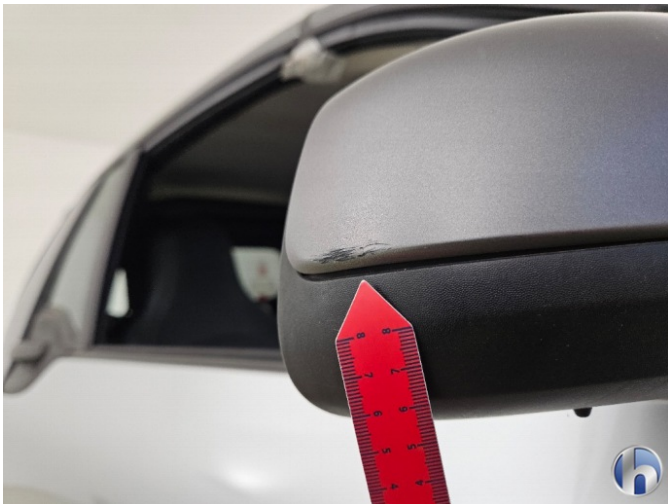
| component | Damage | Rep kind |
|---|---|---|
| 11. | Scratch(es) | Smart repair |

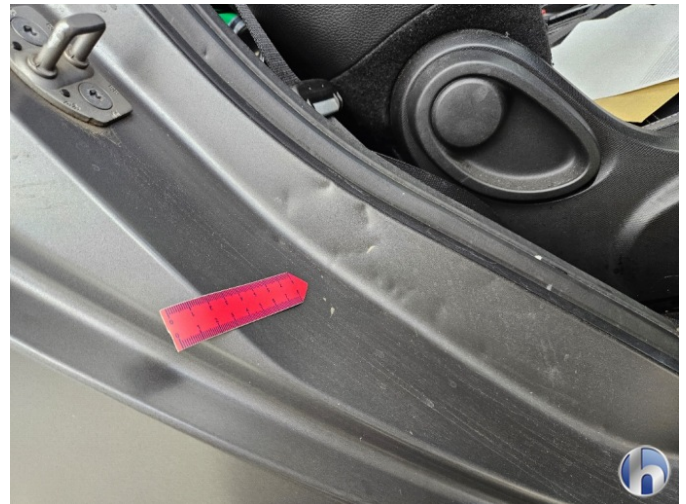
| component | Damage | Rep kind |
|---|---|---|
| 12. Türeinstieg Vorne - Rechts | Damaged | Refurbish and paint |

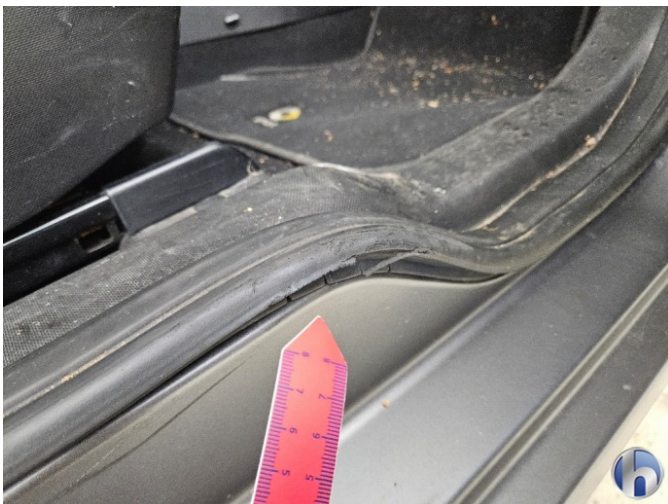
| component | Damage | Rep kind |
|---|---|---|
| 13. Door Seal Front - right | Damaged | Replace |

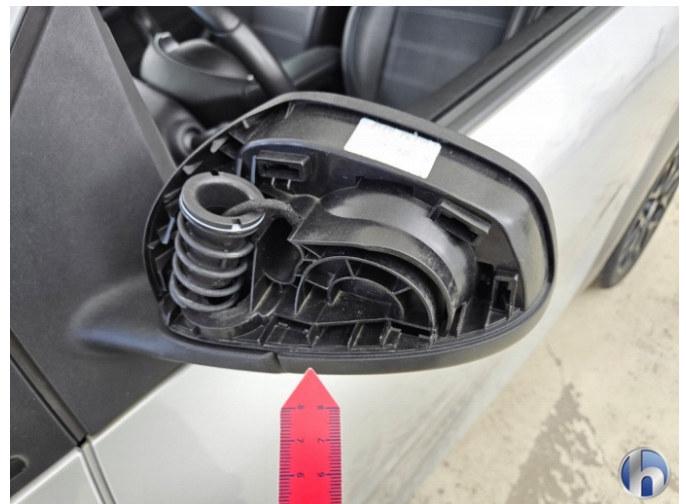
| component | Damage | Rep kind |
|---|---|---|
| 14. | Missing | Replace |

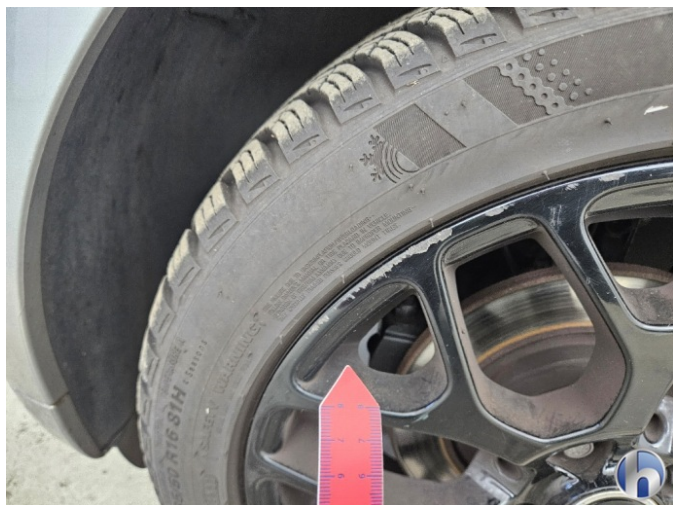
| component | Damage | Rep kind |
|---|---|---|
| 15. | Scratch(es) | Paint |

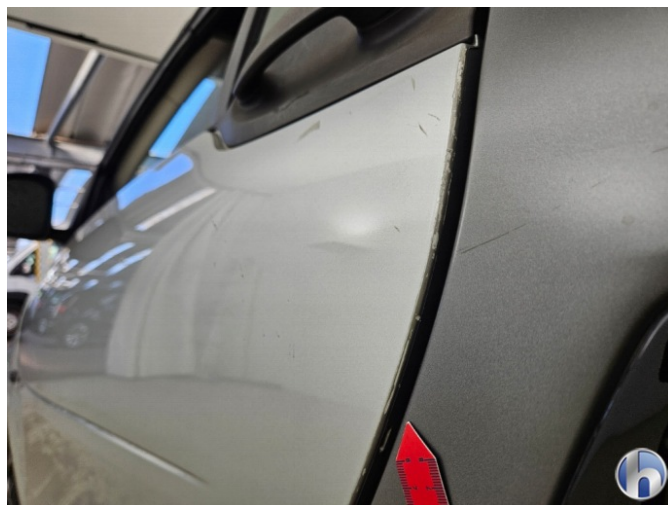
| component | Damage | Rep kind |
|---|---|---|
| 16. Front door - left | Delle | Smart repair |

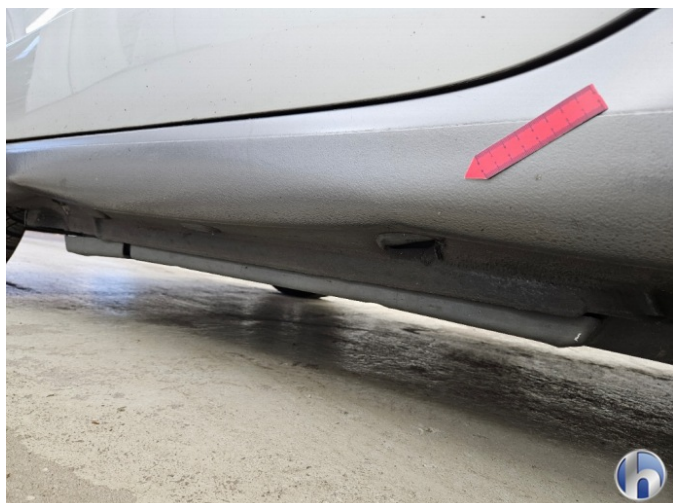
| component | Damage | Rep kind |
|---|---|---|
| 17. side skirt - left | Deformed (slightly) | Refurbish and paint |

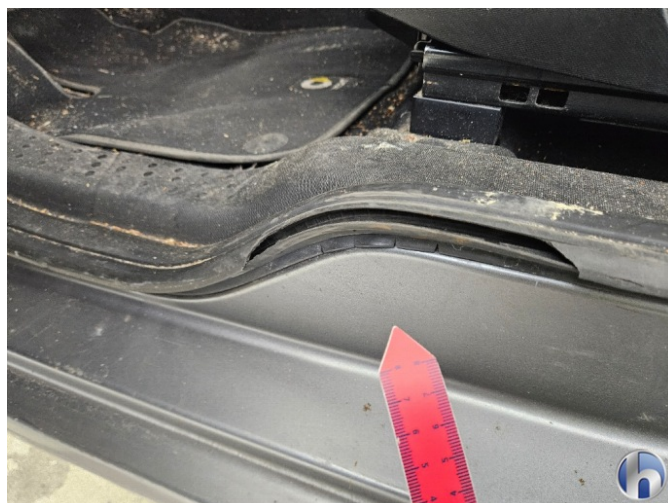
| component | Damage | Rep kind |
|---|---|---|
| 18. Front door seal - left | Damaged | Replace |

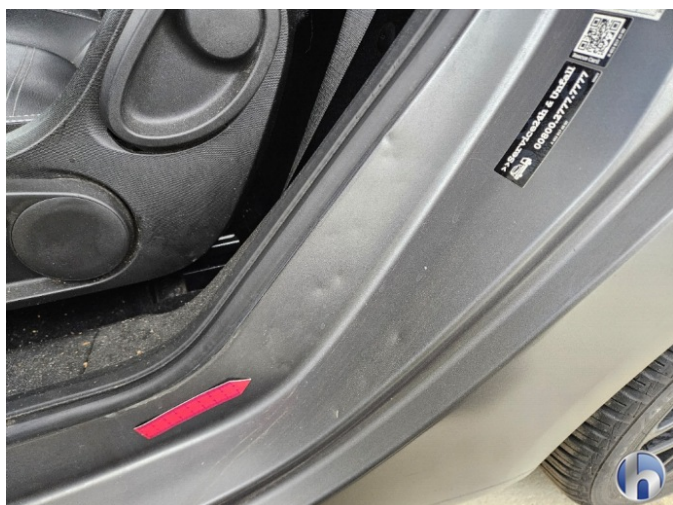
| component | Damage | Rep kind |
|---|---|---|
| 19. Türeinstieg Vorne - Links | Deformed (slightly) | Refurbish and paint |

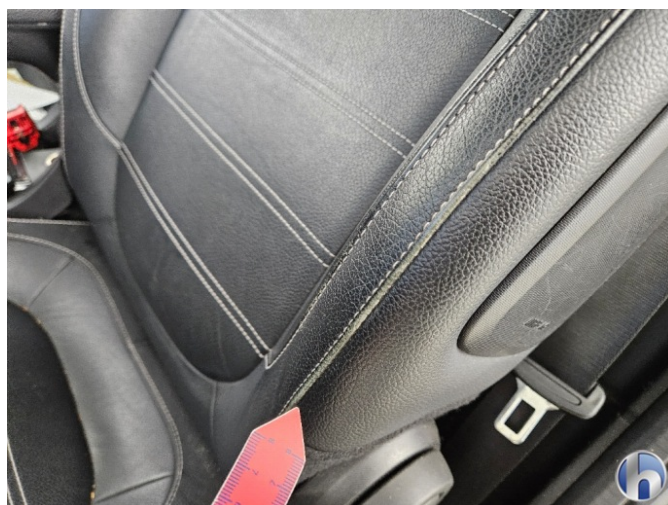
| component | Damage | Rep kind |
|---|---|---|
| 20. | Wear and tear | acceptable |

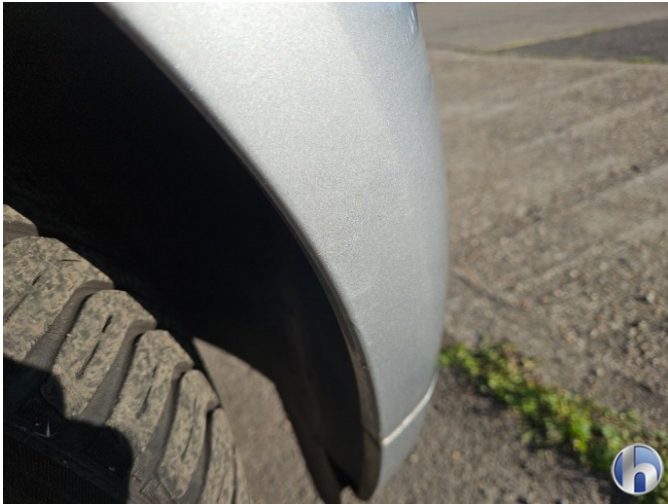
| component | Damage | Rep kind |
|---|---|---|
| 21. Front bumper | Wear and tear | acceptable |

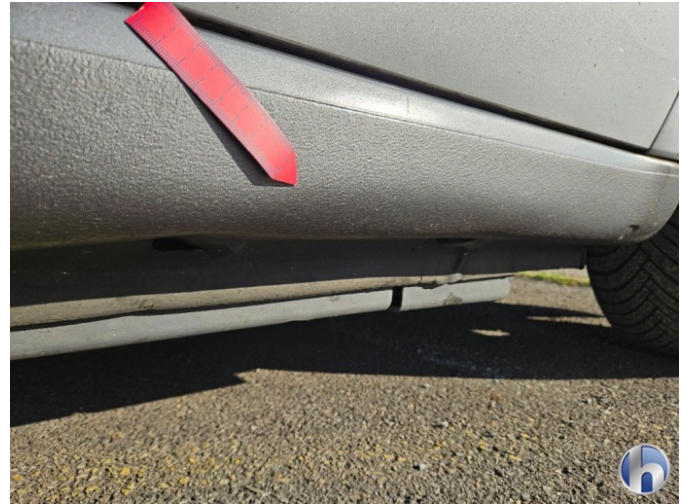
| component | Damage | Rep kind |
|---|---|---|
| 22. side skirt - right | Deformed (slightly) | Refurbish and paint |
