OPEL Cascada Benzina  
Cascada 1.6 t sidi Cosmo s&s

VIN NO WOLWT3D95GG074610  
Registration Number FC409SR

Inspection Report Summary

| Customer | BCA Lodi | Report Number | P20250926102711 |

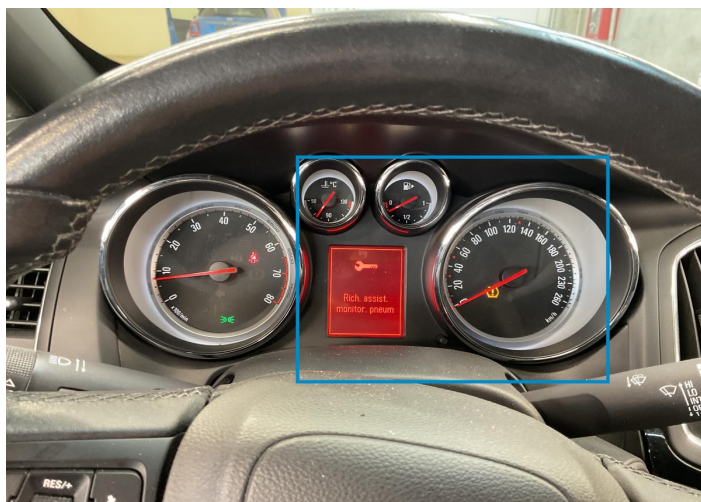
1. Dashboard / Front  
Interior / Warning Light ON -

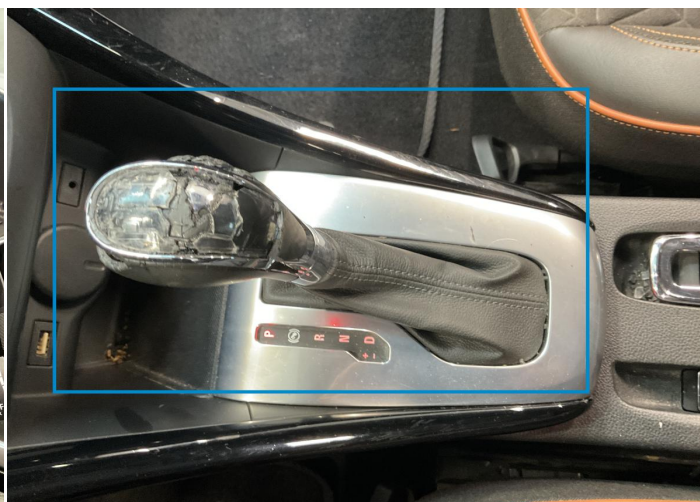
2. Gear Knob  
Interior / Broken -

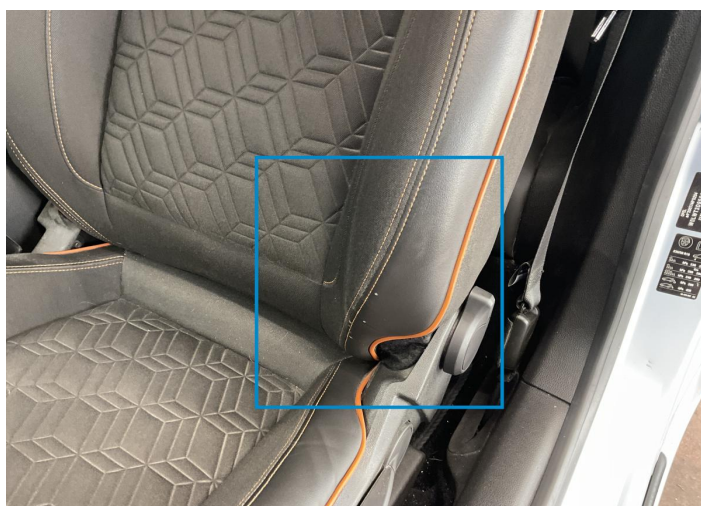
3. Seat / Front Left  
Interior / Worn - out -

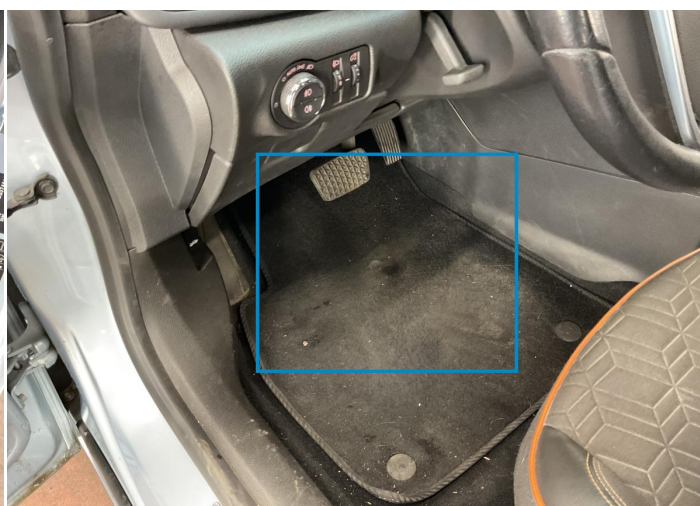
4. Floor Carpet  
Interior / Ripped -

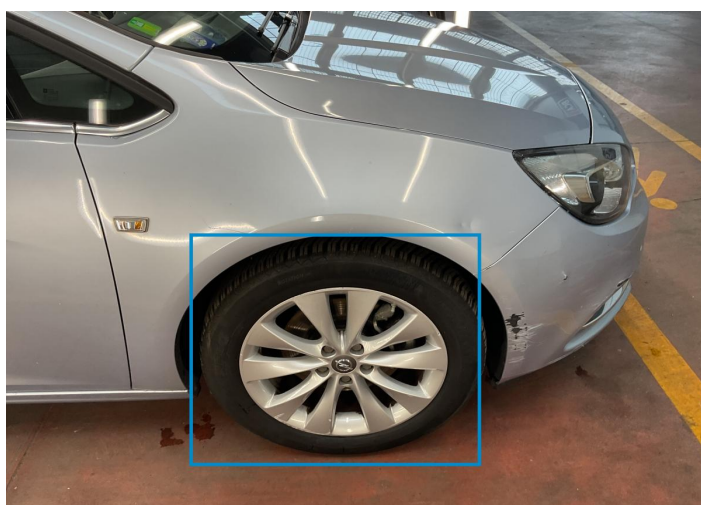
5. Rim / Front Right  
Out of Bodywork / Scratch -

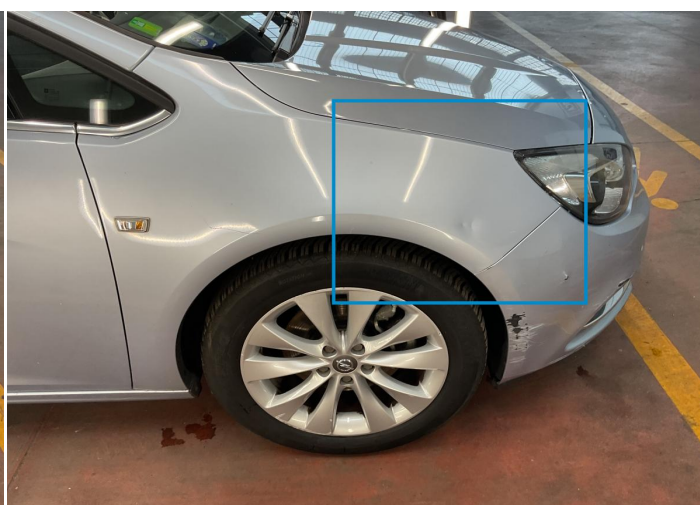
6. Fender / Front Right  
Bodywork / Dent -

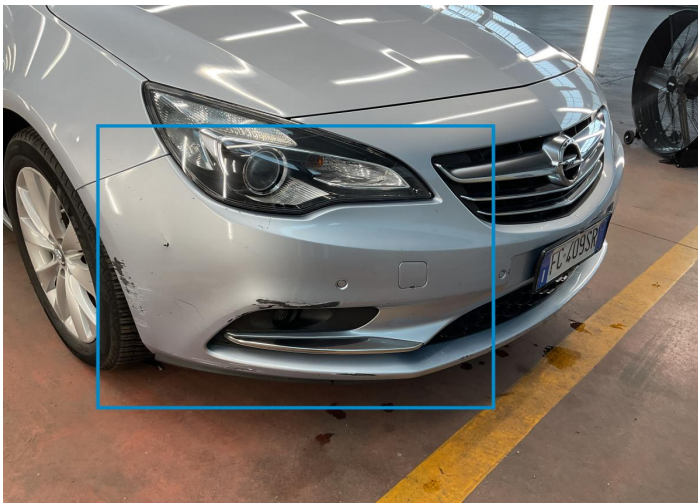
7. Bumper / Front  
Bodywork / Dent -

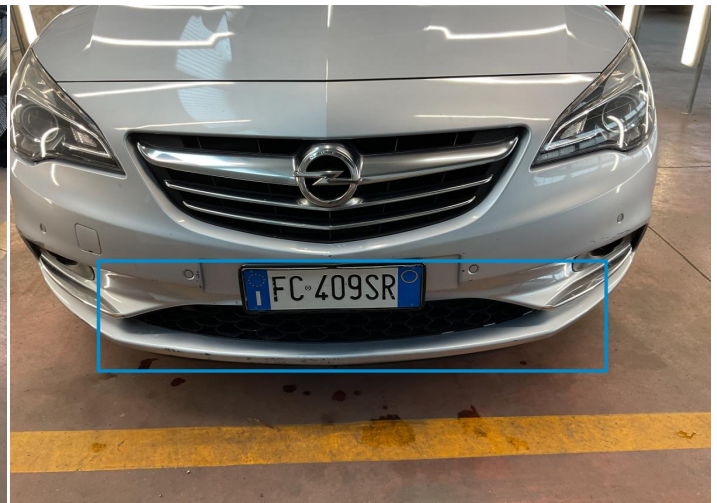
8. Shield Grid / Front Center  
Bodywork / Breakage -

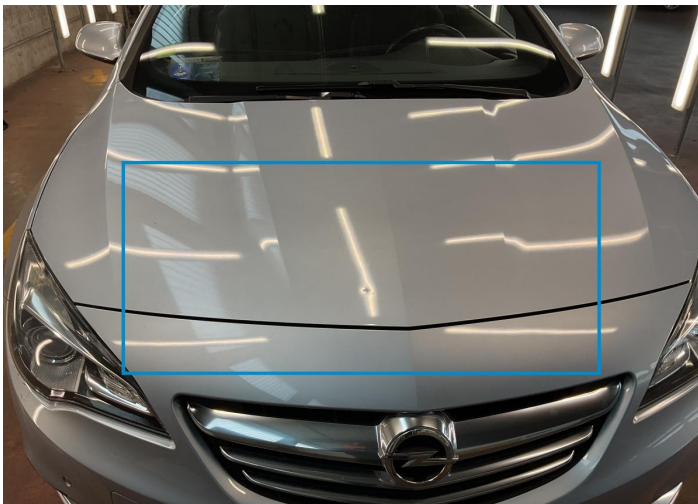
9. Hood  
Bodywork / Dent -

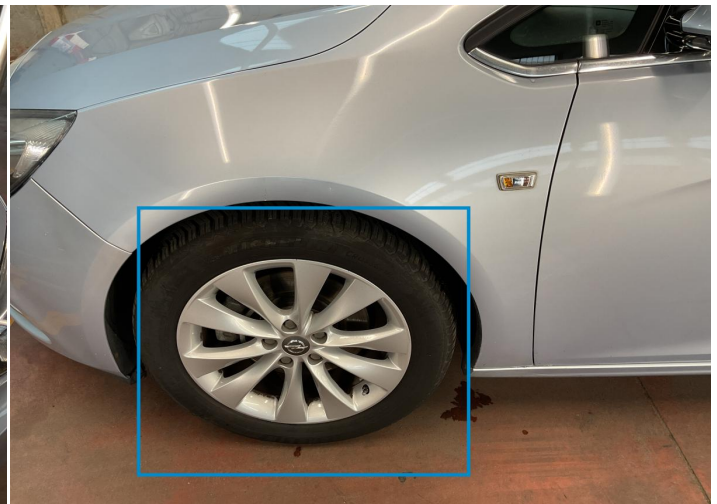
10. Rim / Front Left  
Out of Bodywork / Scratch -

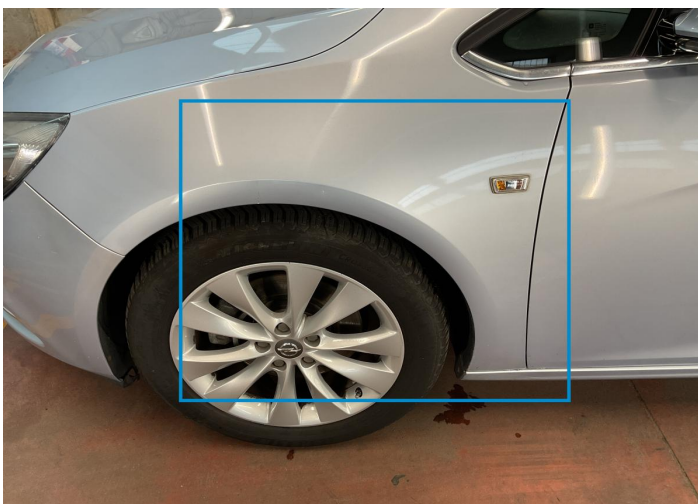
11. Fender / Front Left  
Paint / Scratch / Line -

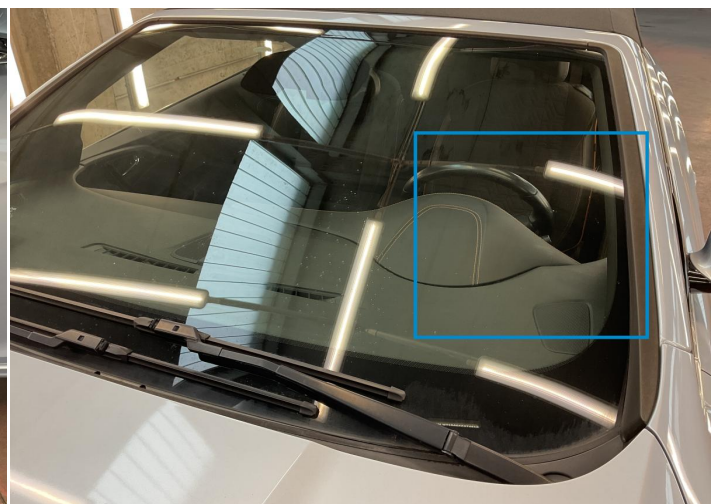
12. Windshield / Front  
Glass Break -

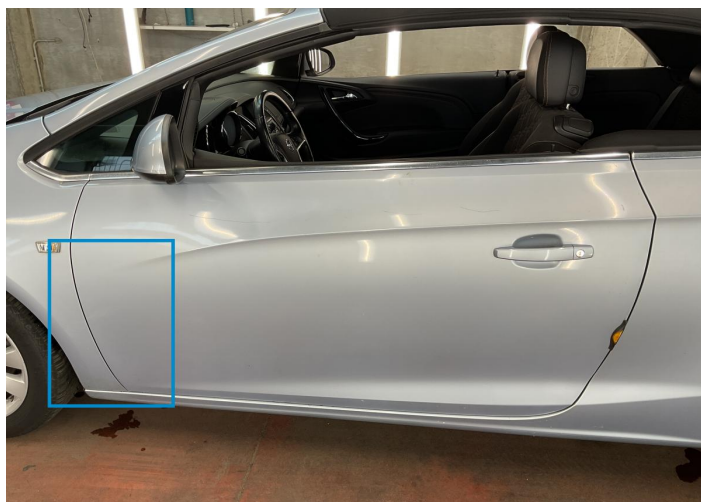
| 13 | Door / Front Left | Bodywork / Dent |

13. Door / Front Left  
Bodywork / Dent -

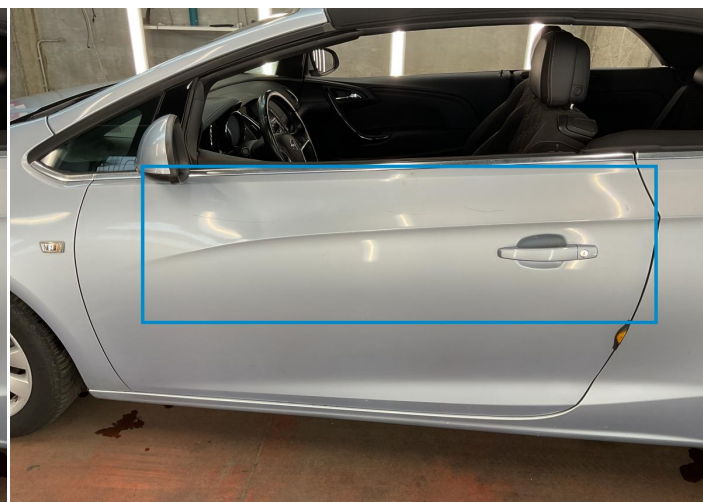
| 14 | Door / Front Left | Paint / Scratch / Line |

14. Door / Front Left  
Paint / Scratch / Line -

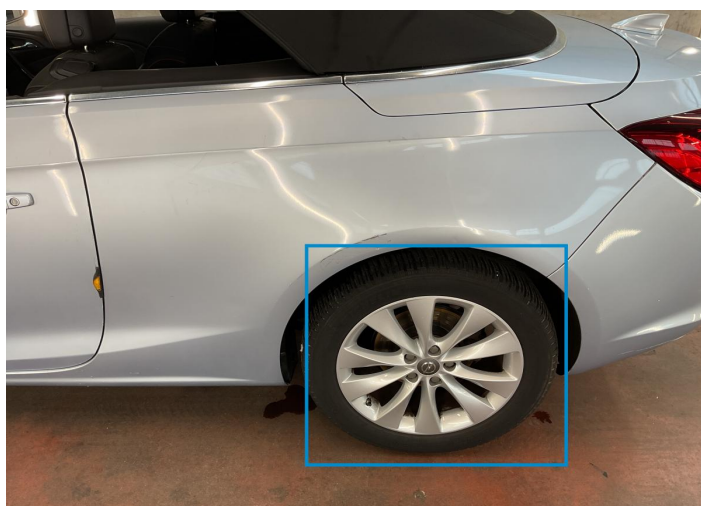
| 15 | Rim / Back Left | Out of Bodywork / Scratch |

15. Rim / Back Left  
Out of Bodywork / Scratch -

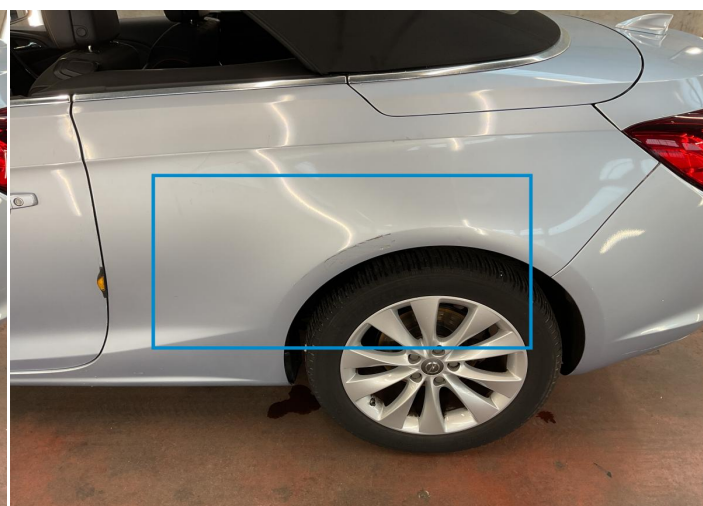
| 16 | Fender / Back Left | Bodywork / Dent |

16. Fender / Back Left  
Bodywork / Dent -

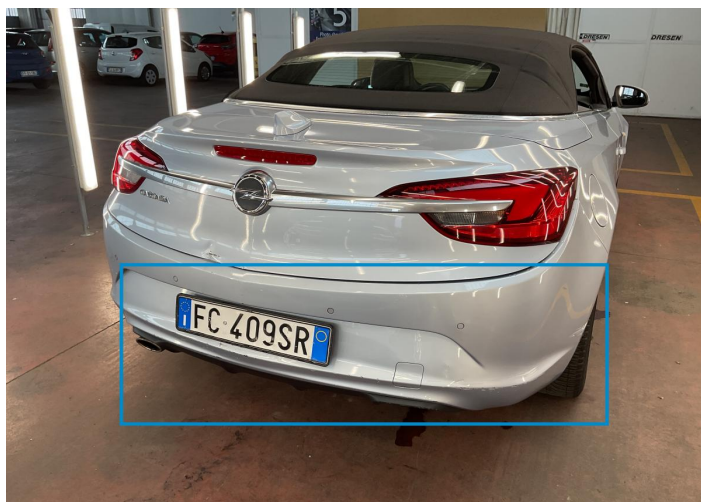
| 17 | Bumper / Back | Bodywork / Breakage |

17. Bumper / Back  
Bodywork / Breakage -

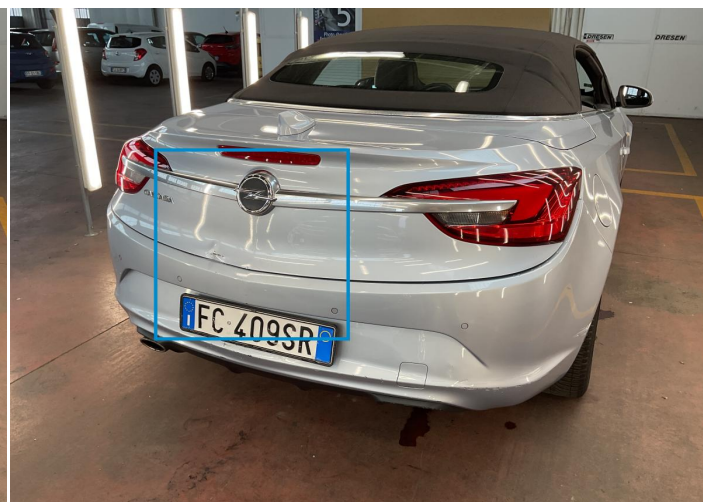
| 18 | Tailgate | Bodywork / Dent |

18. Tailgate  
Bodywork / Dent -

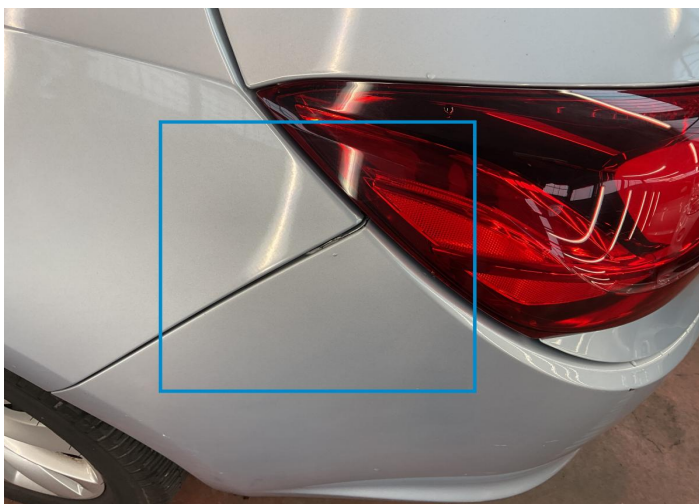
| 19 | Bumper / Back | Bodywork / Breakage |

19. Bumper / Back  
Bodywork / Breakage -

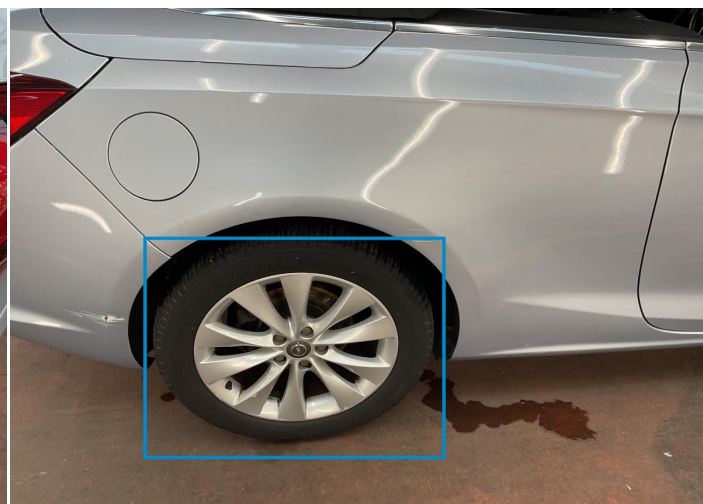
| 20 | Rim Brake pads | Out of Bodywork / Scratch |

20. Rim Brake pads  
Out of Bodywork / Scratch -

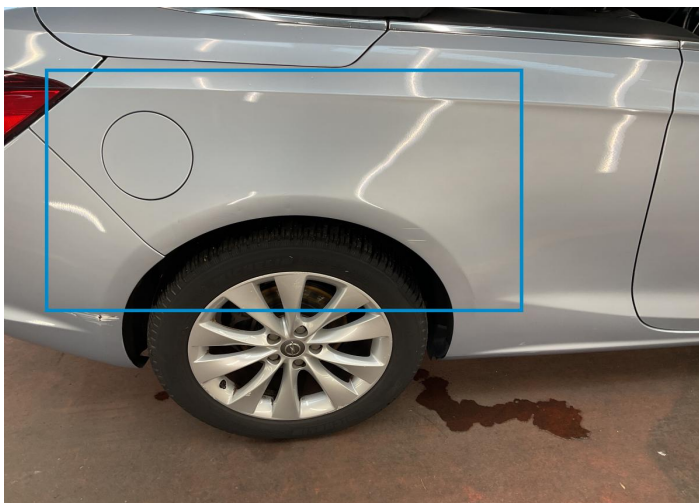
| 21 | Fender / Back Right | Bodywork / Dent |

21. Fender / Back Right  
Bodywork / Dent -

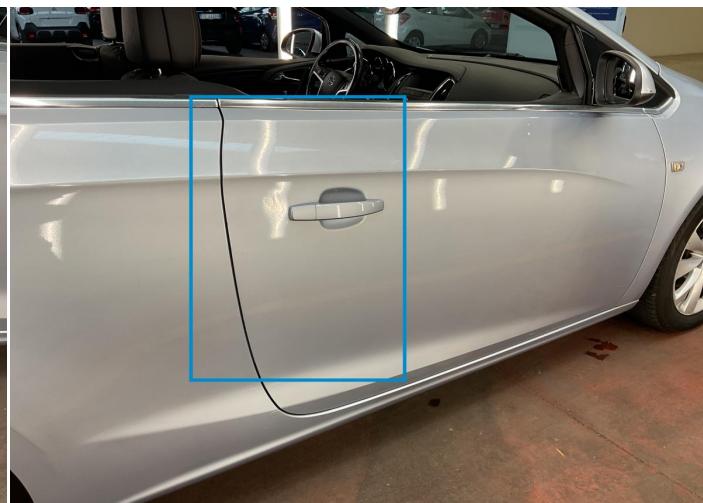
| 22 | Door / Front Right | Bodywork / Dent |

22. Door / Front Right  
Bodywork / Dent -

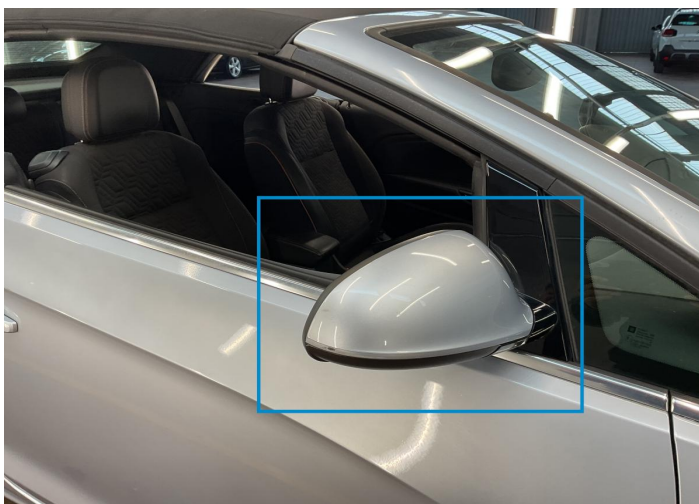
| 23 | Mirror Shell / Front Right | Paint / Scratch / Line |

23. Mirror Shell / Front Right  
Paint / Scratch / Line -

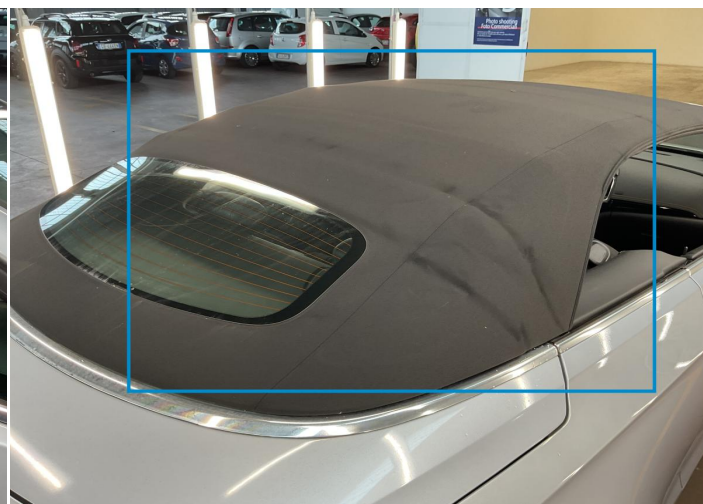
| 24 | Convertible Roof | Paint / Scratch / Line |

24. Convertible Roof  
Paint / Scratch / Line -
