# VOLKSWAGEN CRAFTER FOURGON

## CRAFTER VAN 30 L2H2 2.0 TDI 136 FAP

VIN NO WV1ZZZ2EZF6037231  
Registration Number DV607VM

#### Inspection Report Summary

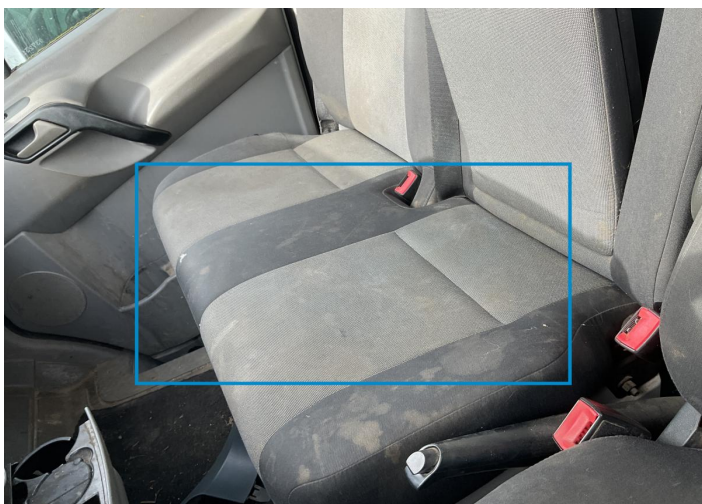
| Component | | Damage | Comments |
|---|---|---|---|
| 1 | Seat / Front Right | Interior / Dirty | |

1. Seat / Front Right  
Interior / Dirty -

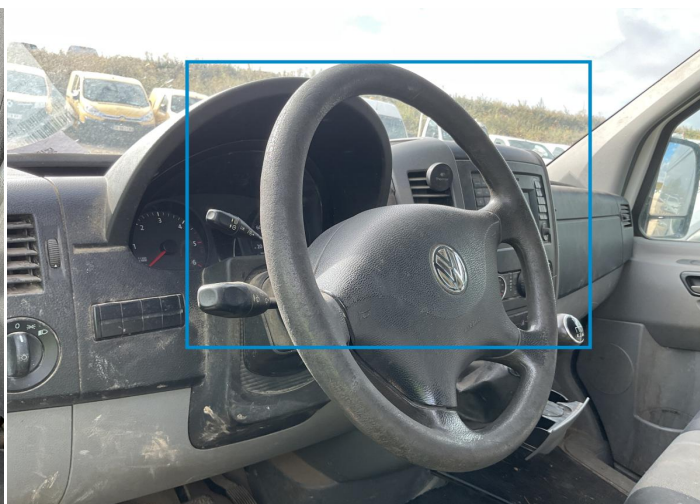
| Component | | Damage | Comments |
|---|---|---|---|
| 2 | Steering Wheel / Front | Interior / Scratched | |

2. Steering Wheel / Front  
Interior / Scratched -

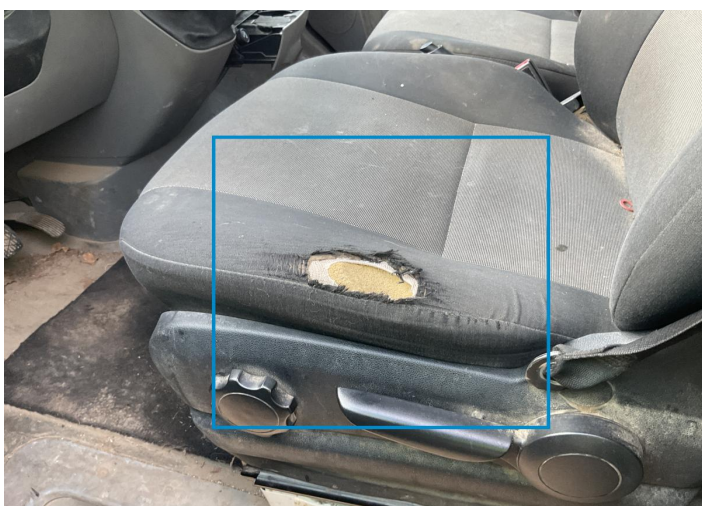
| Component | | Damage | Comments |
|---|---|---|---|
| 3 | Seat / Front Left | Interior / Ripped | |

3. Seat / Front Left  
Interior / Ripped -

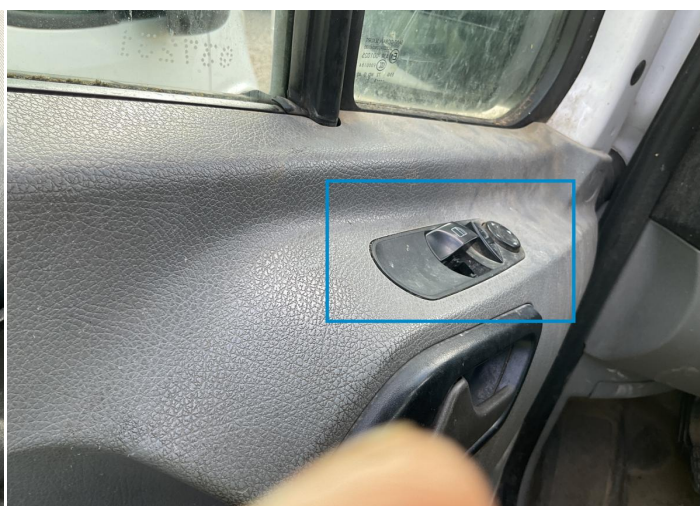
| Component | | Damage | Comments |
|---|---|---|---|
| 4 | Window Switch / Front Left | Interior / Broken | |

4. Window Switch / Front Left  
Interior / Broken -

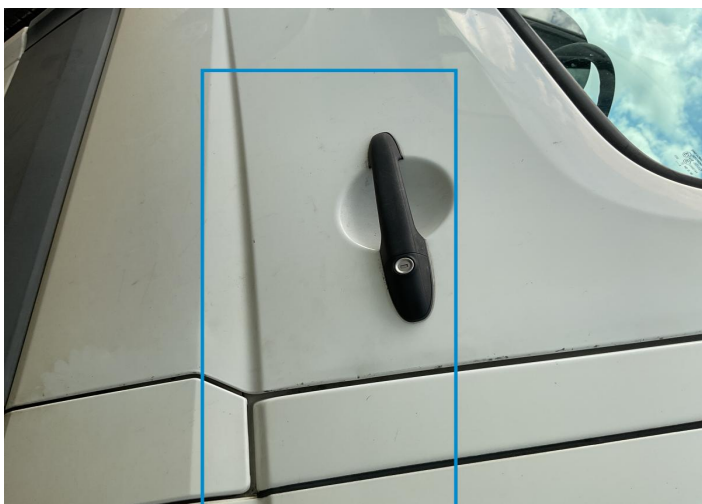
| Component | | Damage | Comments |
|---|---|---|---|
| 5 | Door / Front Left | Paint / Scratch / Line | |

5. Door / Front Left  
Paint / Scratch / Line -

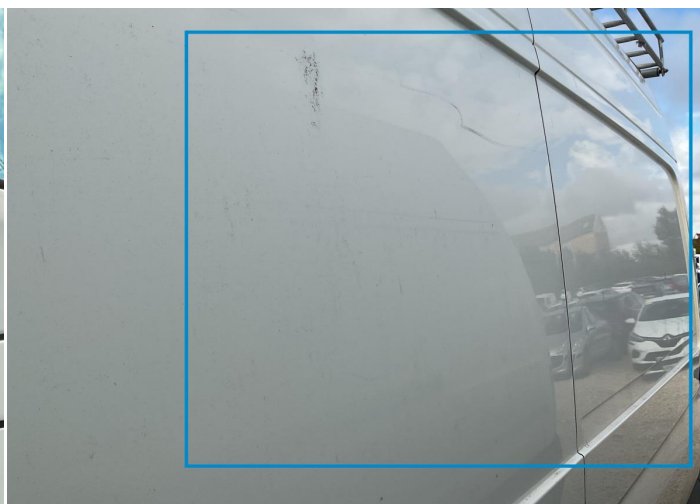
| Component | | Damage | Comments |
|---|---|---|---|
| 6 | Side Panel / Back Left | Paint / Scratch / Line | |

6. Side Panel / Back Left  
Paint / Scratch / Line -

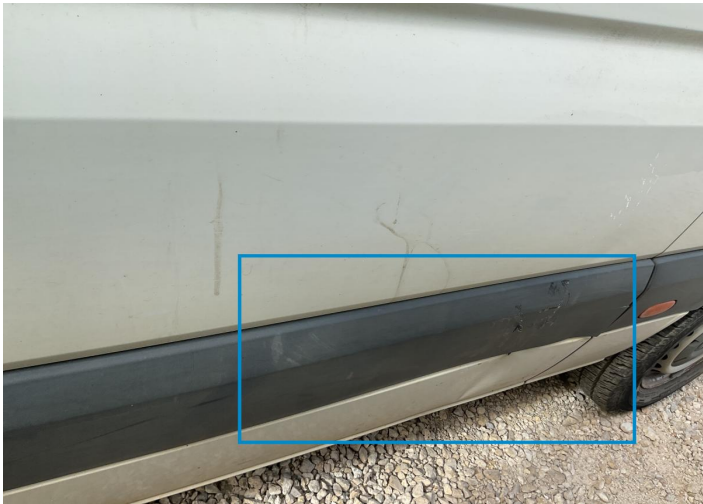
| Component | | Damage | Comments |
|---|---|---|---|
| 7 | Wing Stick / Back Left | Paint / Scratch / Line | |

7. Wing Stick / Back Left  
Paint / Scratch / Line -

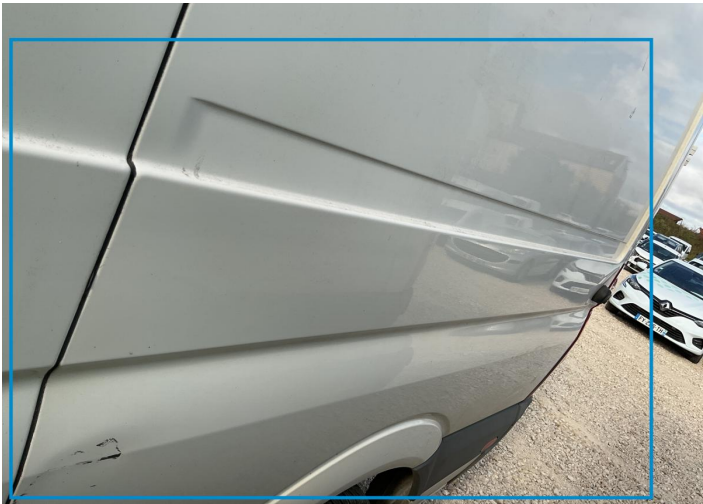
| Component | | Damage | Comments |
|---|---|---|---|
| 8 | Side Panel / Back Left | Paint / Scratch / Line | |

8. Side Panel / Back Left  
Paint / Scratch / Line -

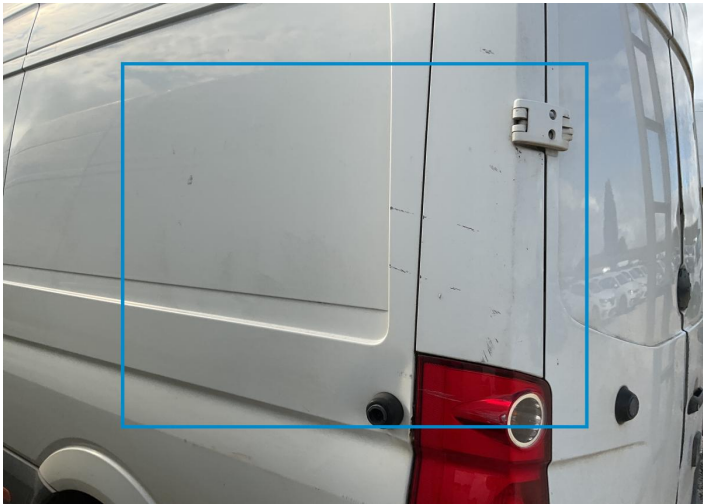
| Component | | Damage | Comments |
|---|---|---|---|
| 9 | Side Panel / Back Left | Paint / Scratch / Line | |

9. Side Panel / Back Left  
Paint / Scratch / Line -

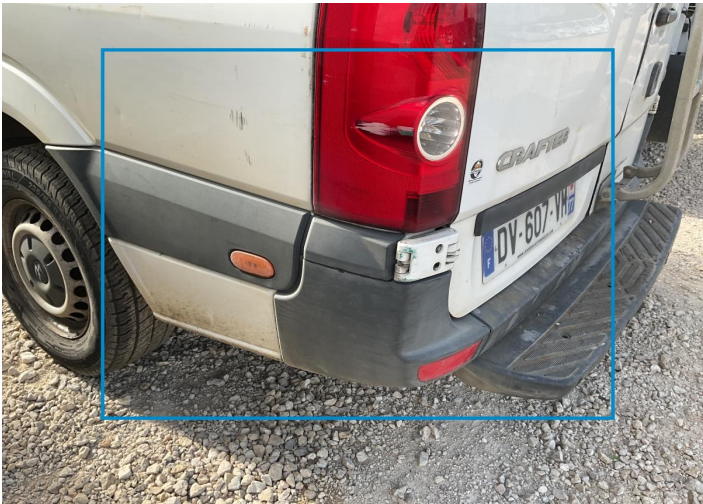
| Component | | Damage | Comments |
|---|---|---|---|
| 10 | Bumper / Back | Paint / Scratch / Line | |

10. Bumper / Back  
Paint / Scratch / Line -

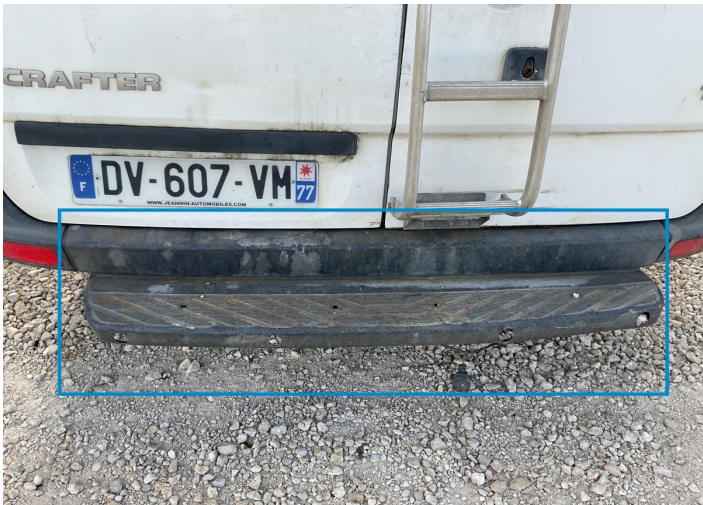
| Component | | Damage | Comments |
|---|---|---|---|
| 11 | Bumper / Back | Paint / Scratch / Line | |

11. Bumper / Back  
Paint / Scratch / Line -

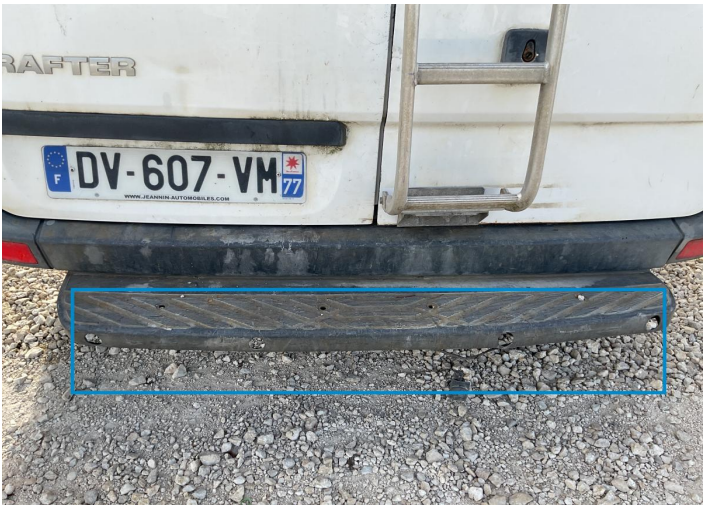
| Component | | Damage | Comments |
|---|---|---|---|
| 12 | Outside Sensor / Back | Bodywork / Breakage / Hole | |

12. Outside Sensor / Back  
Bodywork / Breakage / Hole -

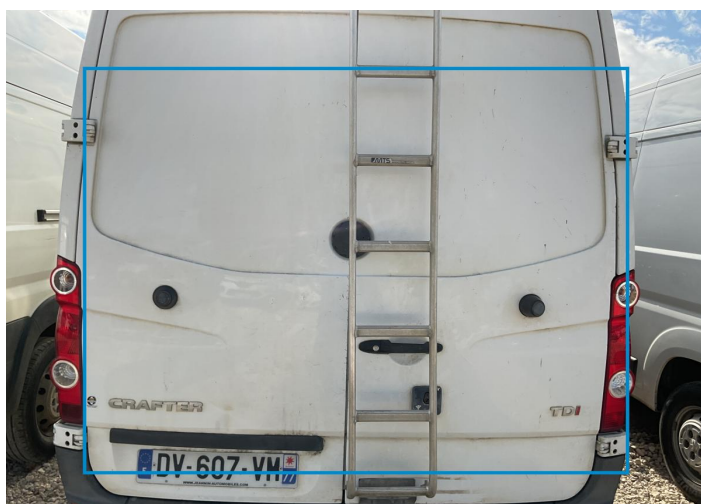
| Component | | Damage | Comments |
|---|---|---|---|
| 13 | Tailgate | Paint / Scratch / Line | |

13. Tailgate  
Paint / Scratch / Line -

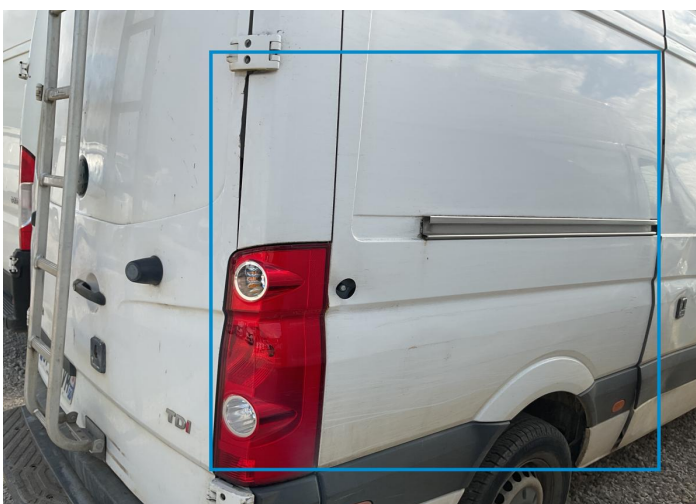
| 14 | Side Panel / Back Right | Paint / Scratch / Line |

14. Side Panel / Back Right  
Paint / Scratch / Line -

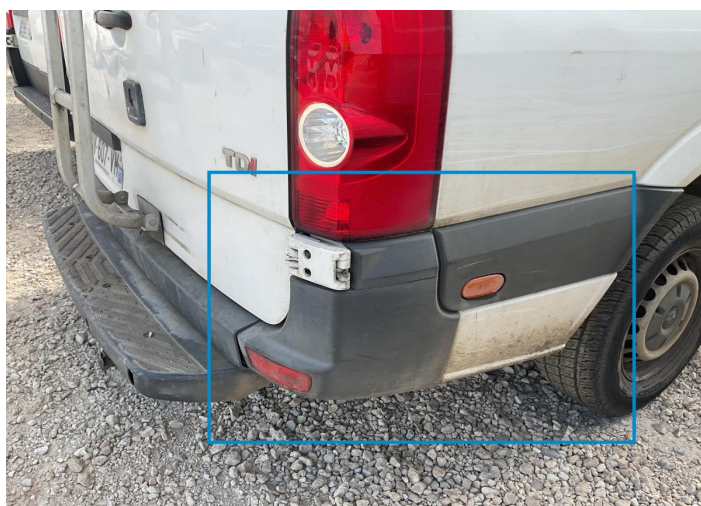
| 15 | Bumper / Back | Paint / Scratch / Line |

15. Bumper / Back  
Paint / Scratch / Line -

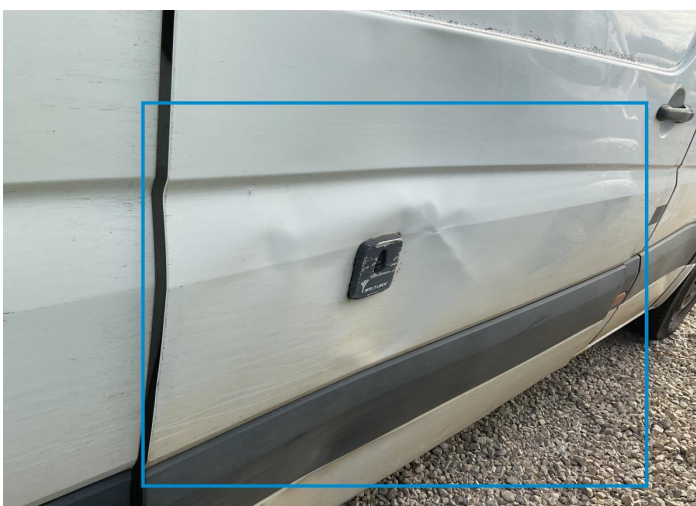
| 16 | Door / Back Right | Bodywork / Dent / Dent |

16. Door / Back Right  
Bodywork / Dent / Dent -

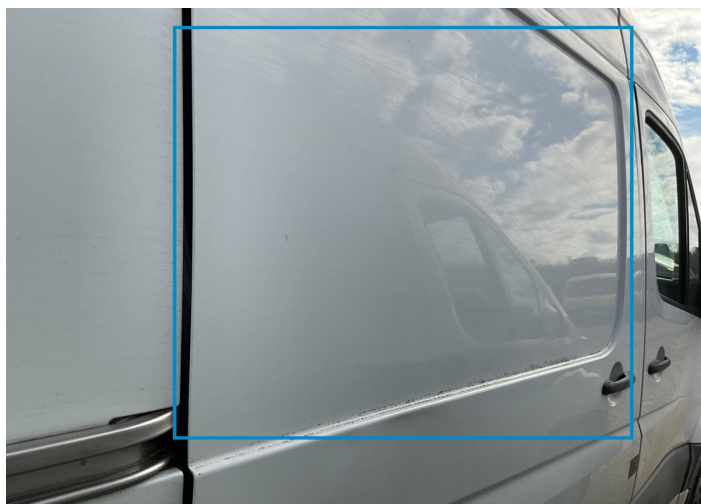
| 17 | Door / Back Right | Paint / Scratch / Line |

17. Door / Back Right  
Paint / Scratch / Line -

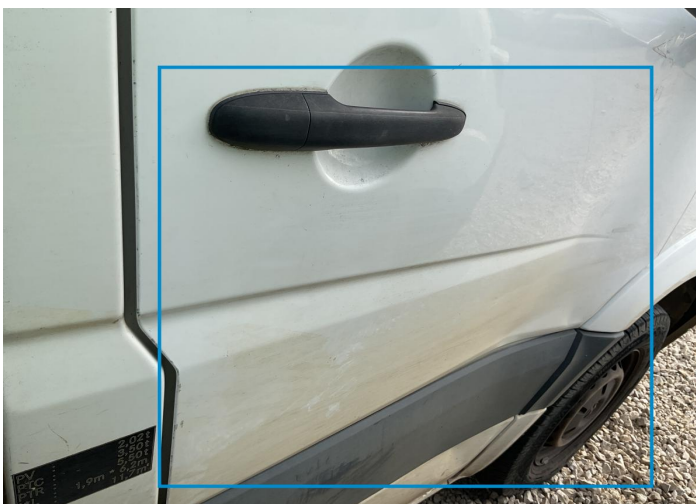
| 18 | Door / Front Right | Bodywork / Dent / Dent |

18. Door / Front Right  
Bodywork / Dent / Dent -

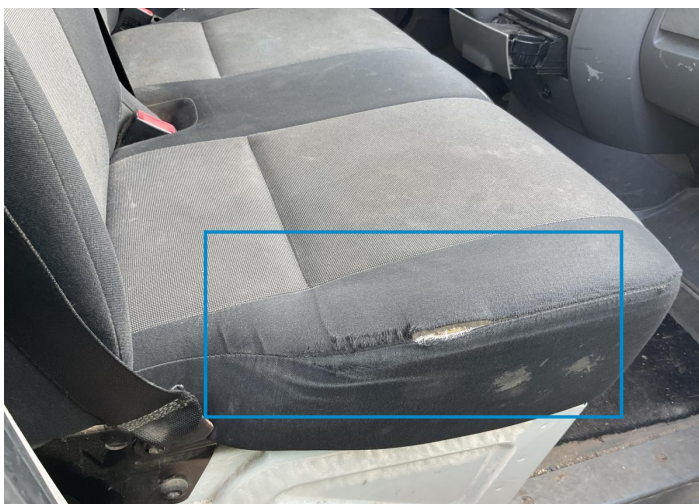
| 19 | Seat / Front Right | Interior / Ripped |

19. Seat / Front Right  
Interior / Ripped -

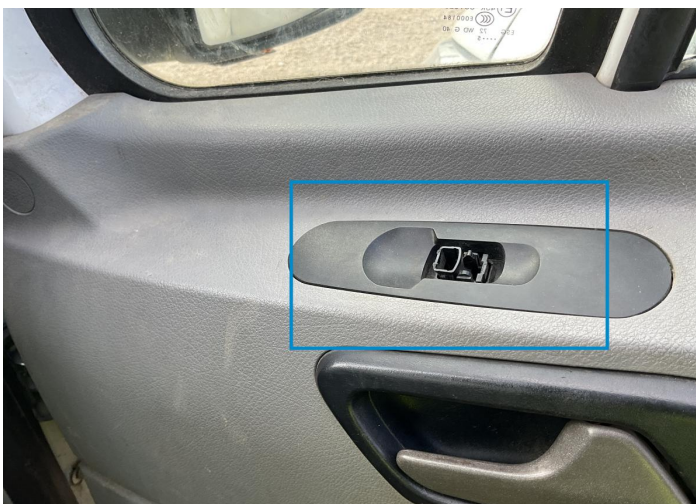
| 20 | Window Switch / Front Right | Interior / Broken |

20. Window Switch / Front Right  
Interior / Broken -

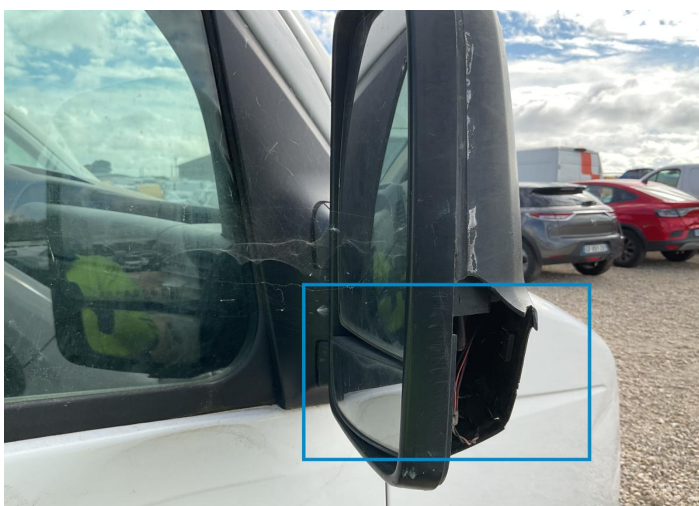
| 21 | Mirror / Front Right | Bodywork / Breakage / Hole |

21. Mirror / Front Right  
Bodywork / Breakage / Hole -

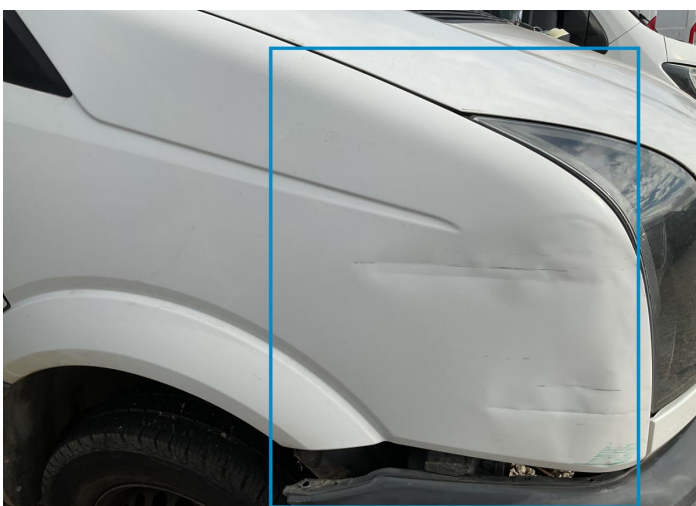
| 22 | Fender / Front Right | Bodywork / Dent / Dent |

22. Fender / Front Right  
Bodywork / Dent / Dent -

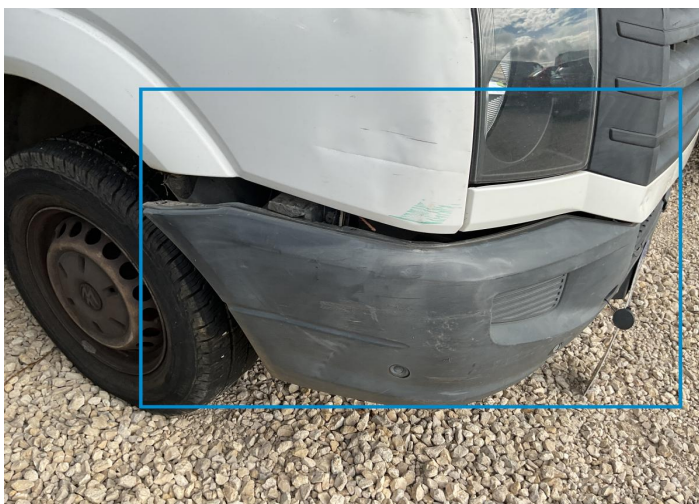
| 23 | Bumper / Front | Bodywork / Breakage / Hole |

23. Bumper / Front  
Bodywork / Breakage / Hole -

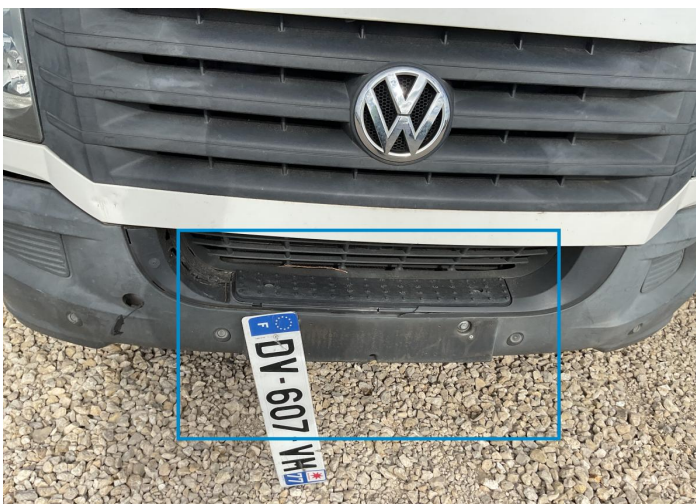
| 24 | License Plate / Front | Out of Bodywork / Breakage |

24. License Plate / Front  
Out of Bodywork / Breakage -

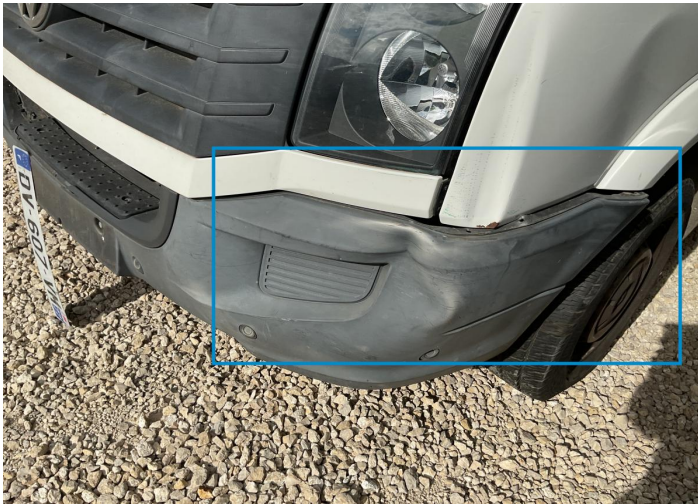
| 25 | Bumper / Front | Bodywork / Breakage / Hole |

25. Bumper / Front  
Bodywork / Breakage / Hole -

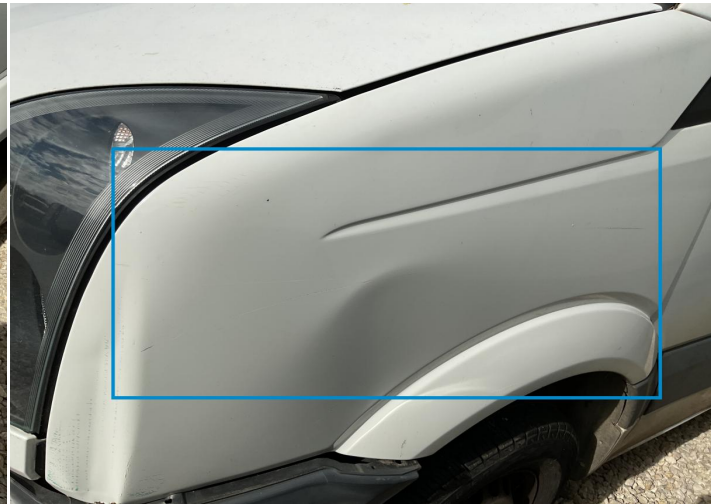
| 26 | Fender / Front Left | Paint / Scratch / Line |

26. Fender / Front Left  
Paint / Scratch / Line -

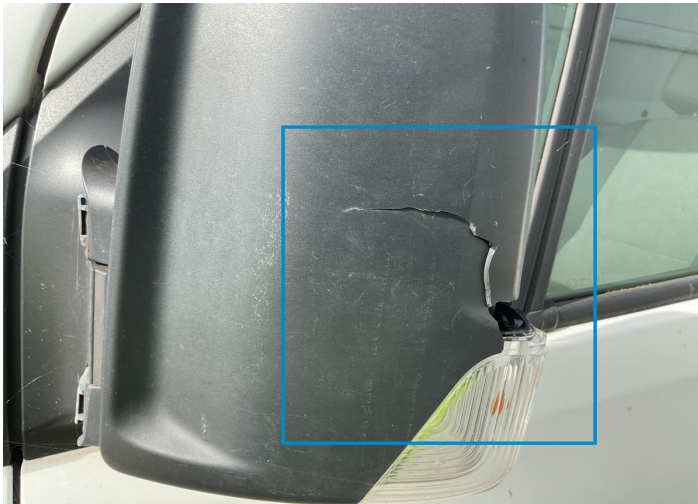
| 27 | Mirror / Front Left | Bodywork / Breakage / Hole |

27. Mirror / Front Left  
Bodywork / Breakage / Hole -
