## Volkswagen Caddy: VBB23D

| Vinnumber: | <b>WV1ZZZ2KZKX125297</b> | Versionname: | <b>Caddy Maxi 1.4 TGI Ecofuel 81kW</b> |

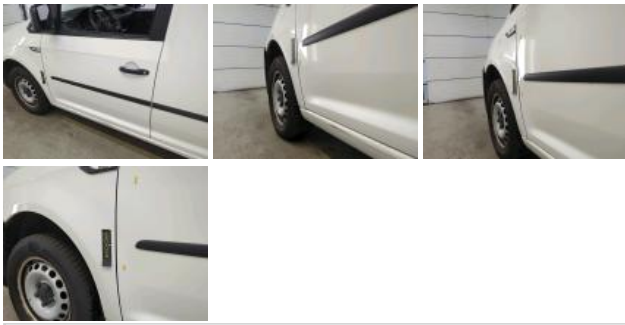
## Door FL, Dent(s), Repair and paint (complete)

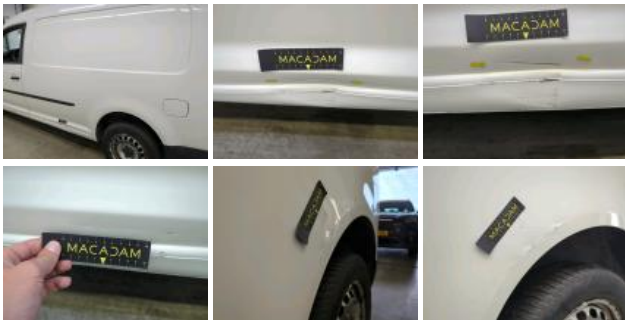
Wing RL, Dent(s) and scratch(es), Repair and paint (complete)

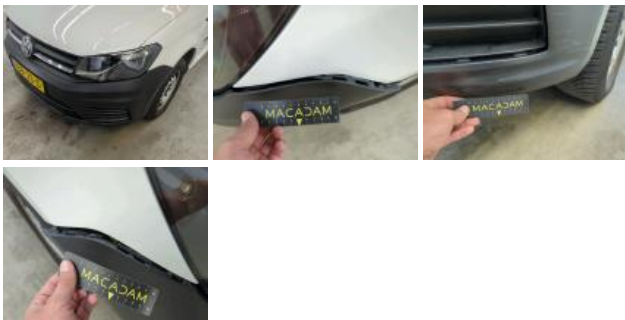
Bumper F, Broken, Replace
