Expertise

Protocol number: 41625729  
Order No. / Reference: 25193210  
Inspection date: 19 Sept 2025

Manufacturer: Volkswagen

Model: Caddy 2.0 TDI DSG EcoProfi

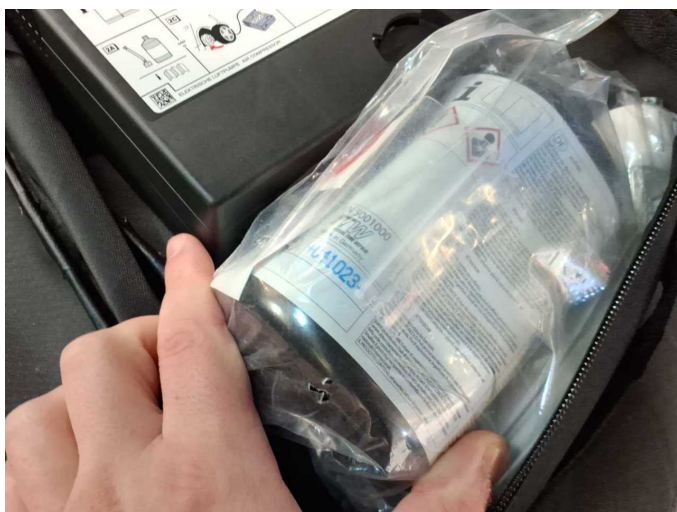
Damage 1: Equipment: Tirefit filler - Expired - Replace

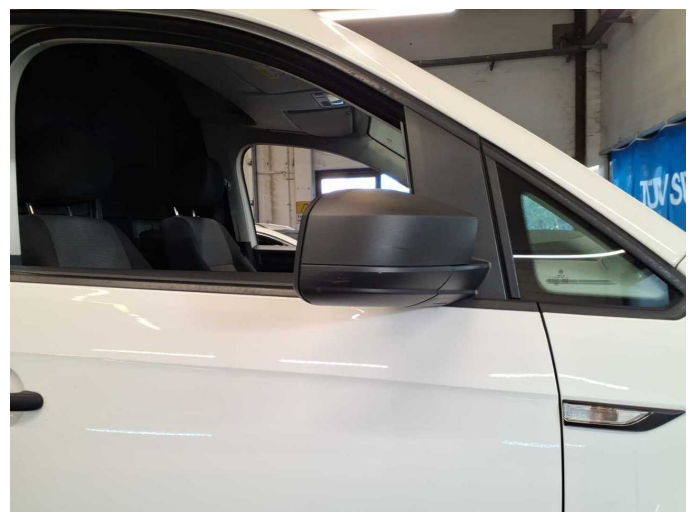
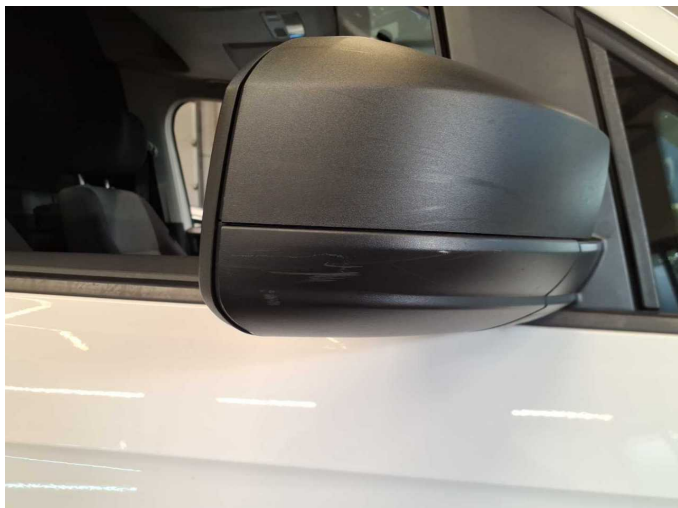
Damage 2: Wing mirror - right side: Cap - Scratch(es) - Smart repair

**Damage 2:** Wing mirror - right side: Cap - Scratch(es) - Smart repair

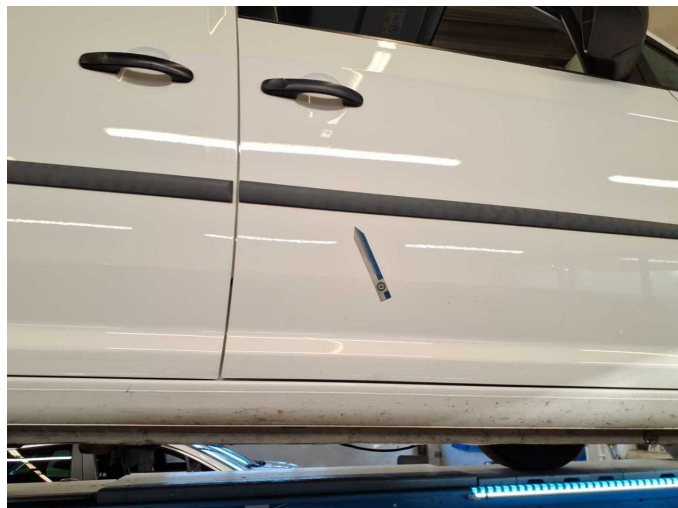
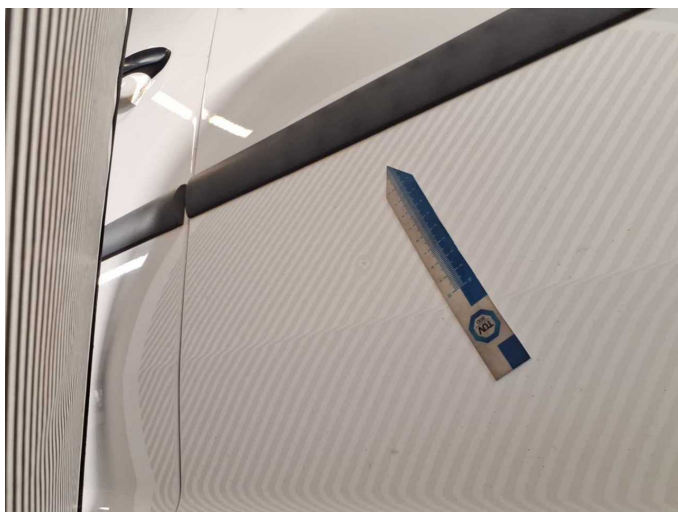
**Damage 3:** Door - front right side: Door - dent(s) - Smooth repair work

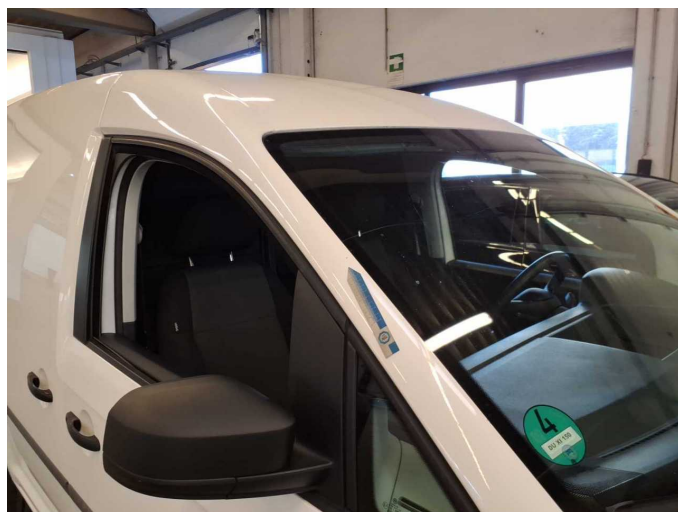
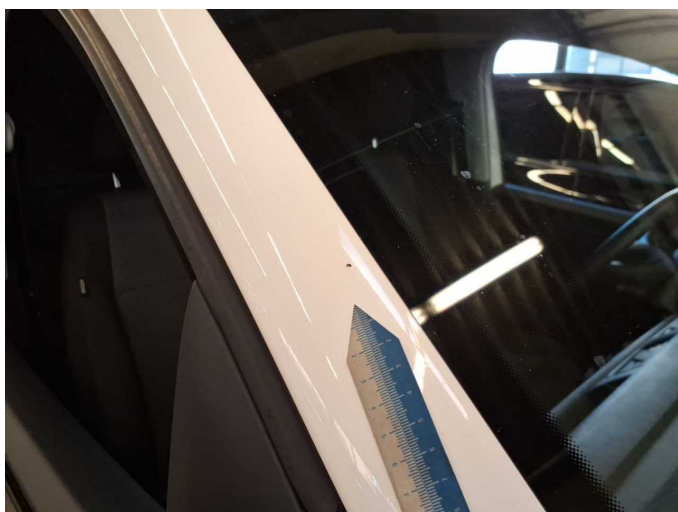
**Damage 4:** Roof: Roof rail - right side - Stone chips - Smart repair

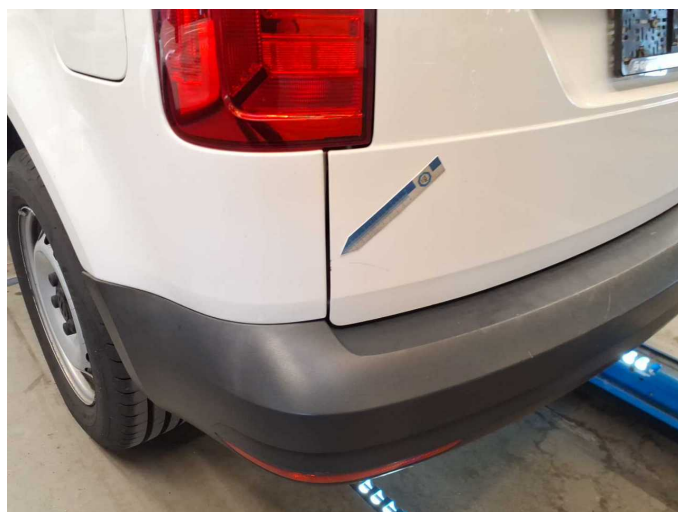
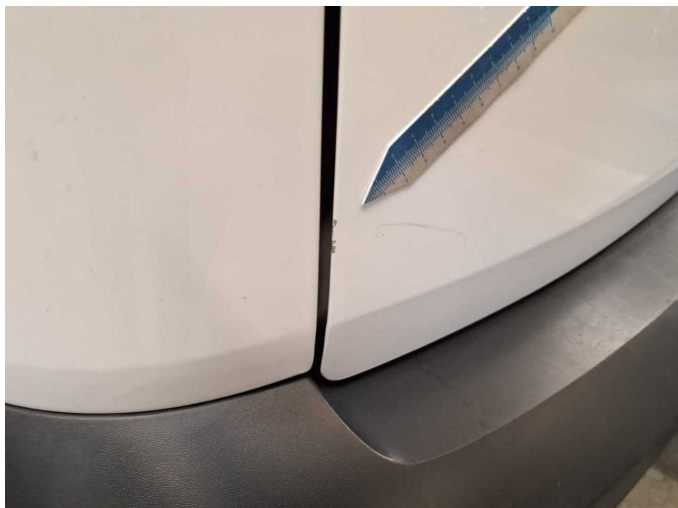
**Damage 5:** Boot lid / rear door: Boot lid - Scratch(es) - Smart repair

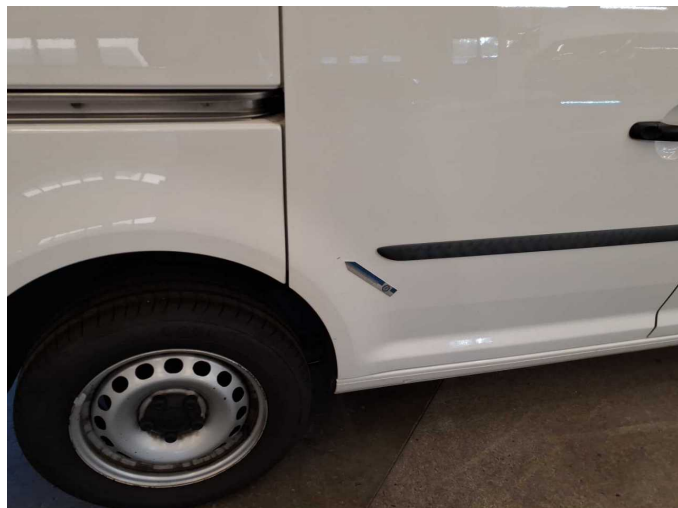
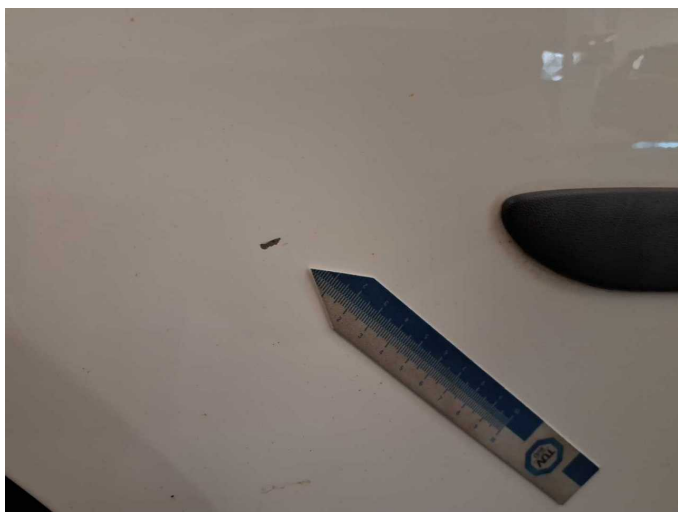
**Damage 6:** Door - rear right side: Door (Abplatzter) - Paint defect - Smart repair

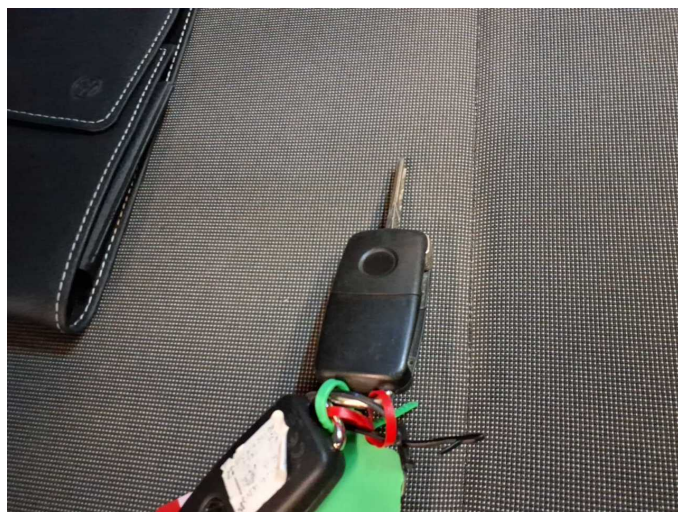
**Damage 7:** Equipment: Vehicle key - Damaged - Replace

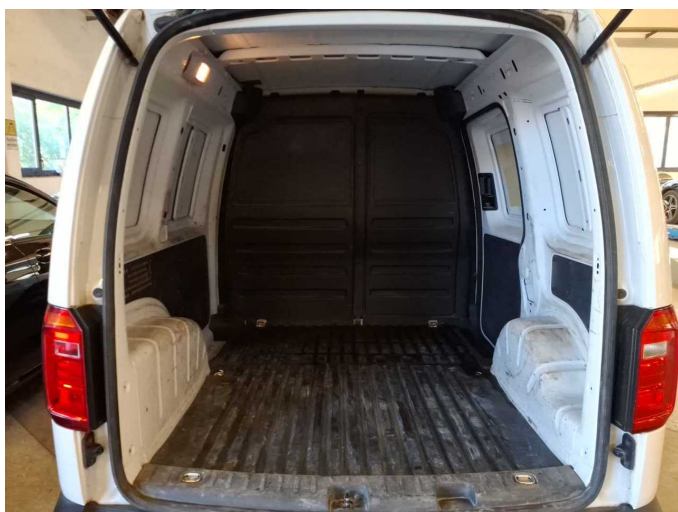
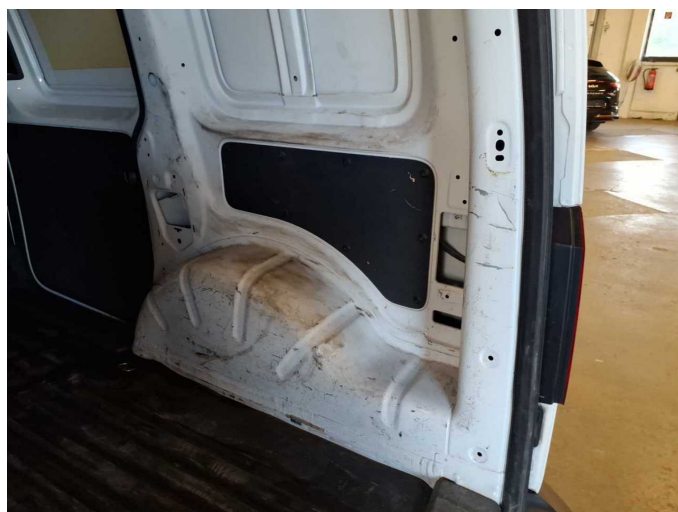
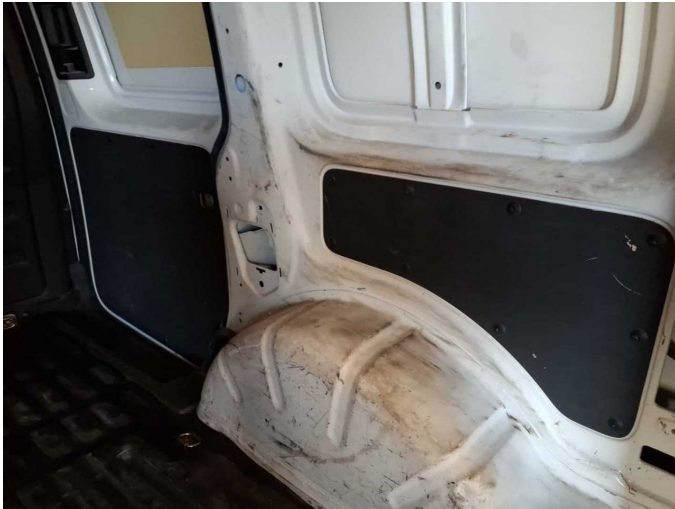
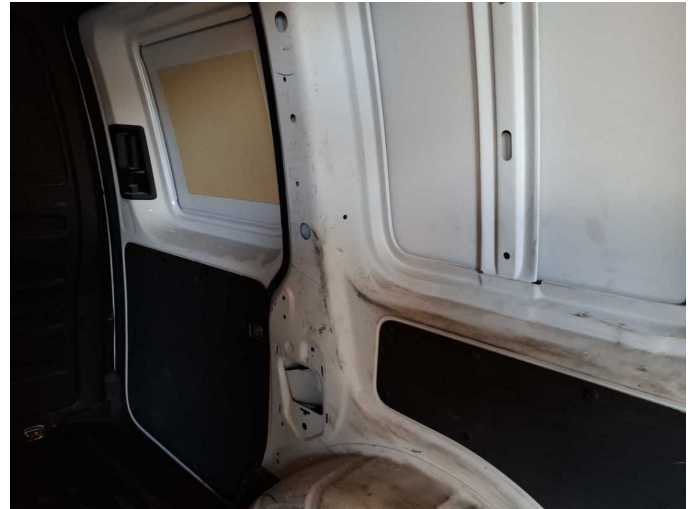
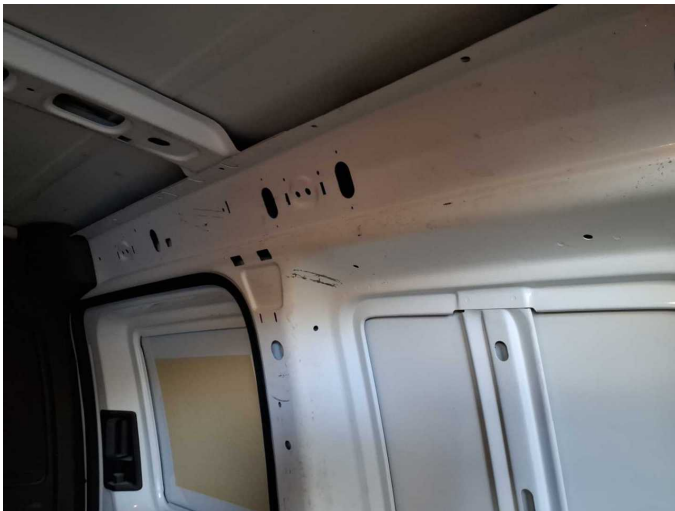
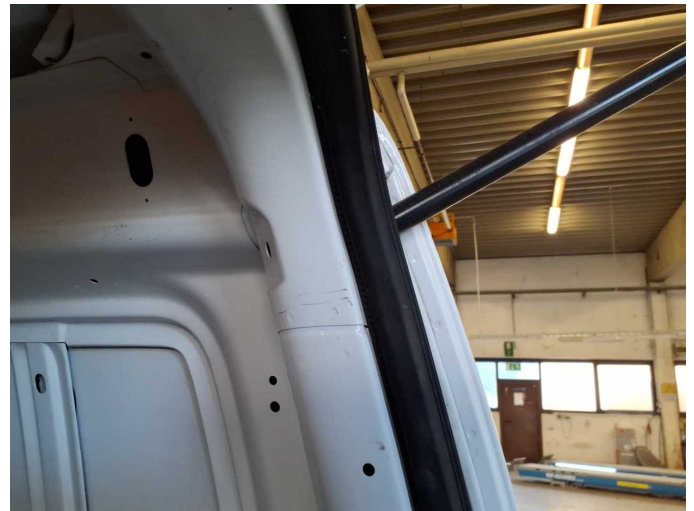
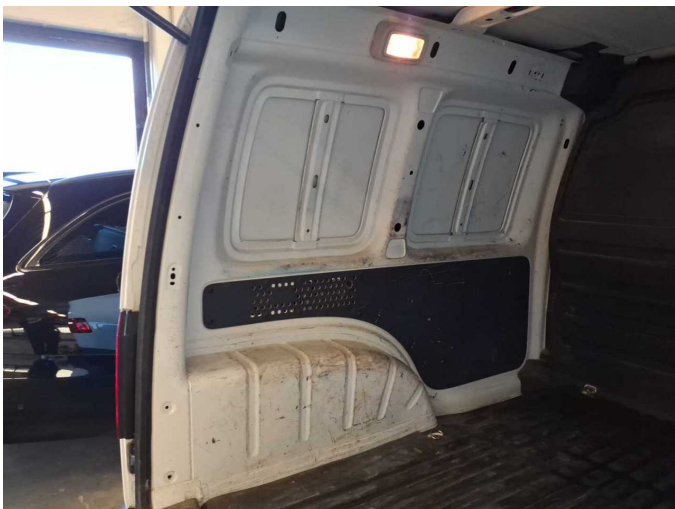
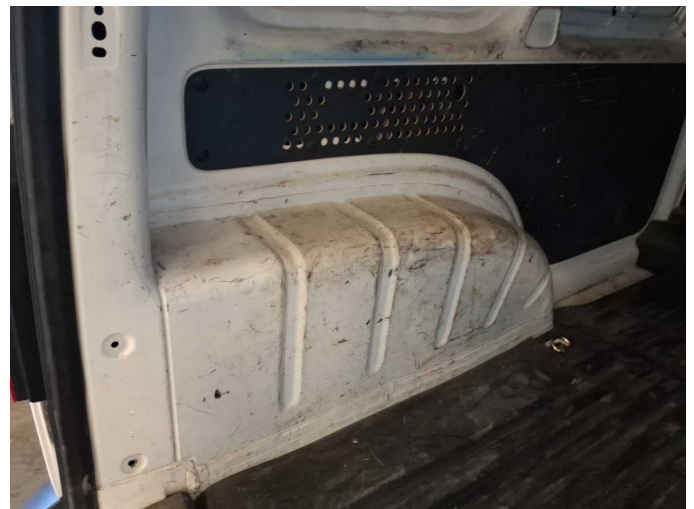
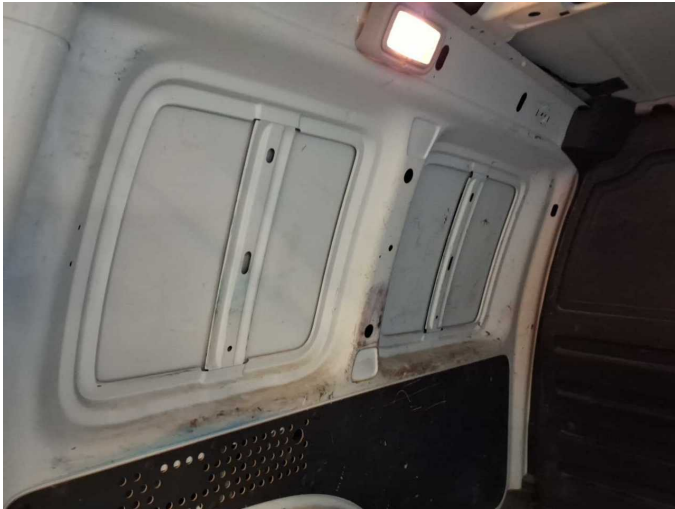
**Damage 8:** Trim / covers: Boot lining (Laderaum) - Scratch(es) - Loss in value

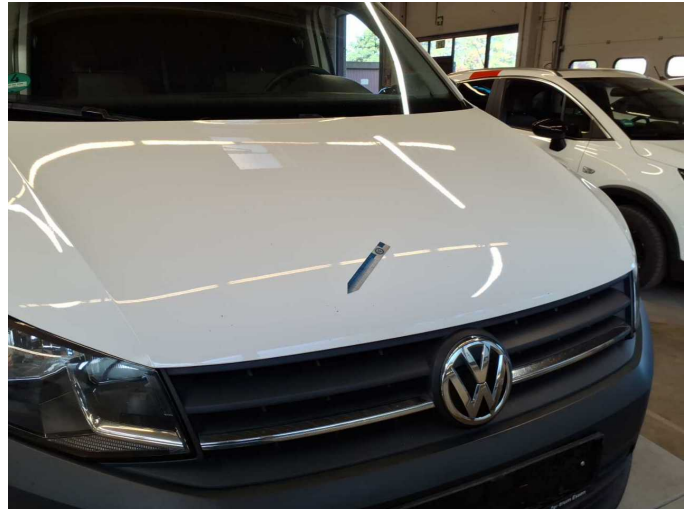
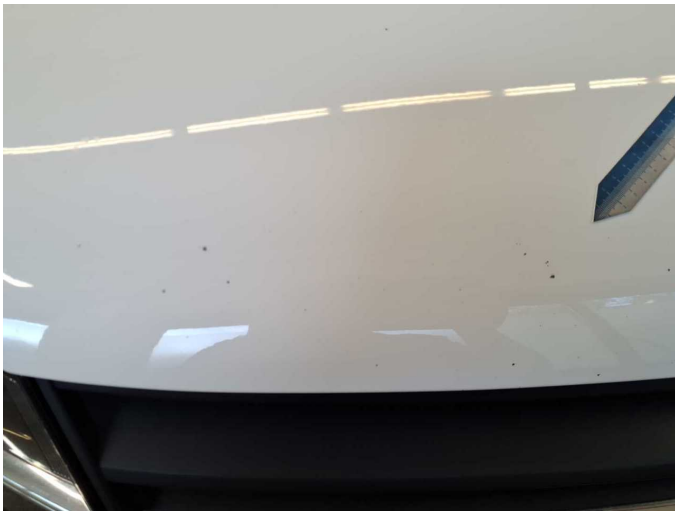
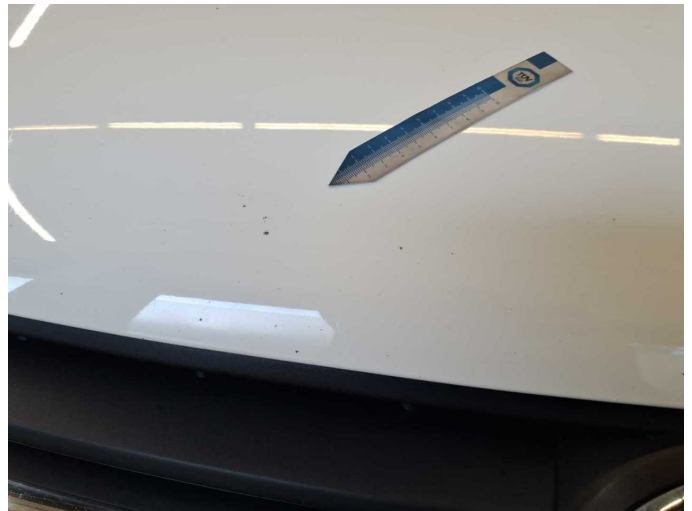
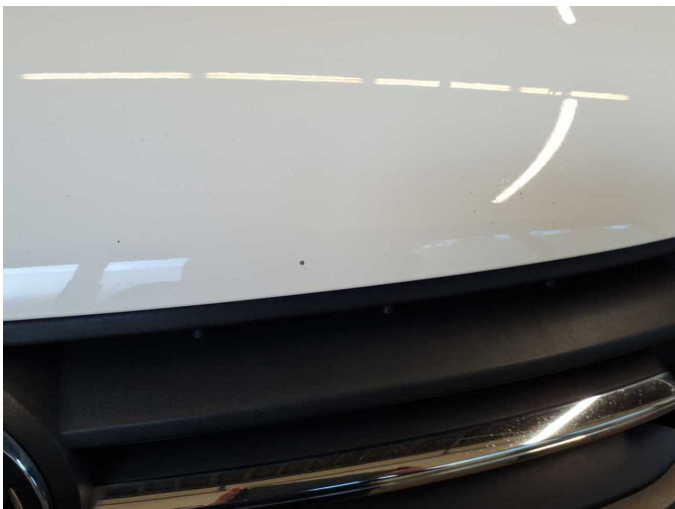
**Damage 9:** Bonnet: Bonnet - Stone chips - Paint
