Expertise

Protocol number: 41634455  
Order No. / Reference: 25254742  
Inspection date: 19 Sept 2025

| Manufacturer: Volkswagen | Model: Caddy 2.0 TDI Maxi EcoProfi |
| VIN: WV1ZZZ2KZLX117237 | |

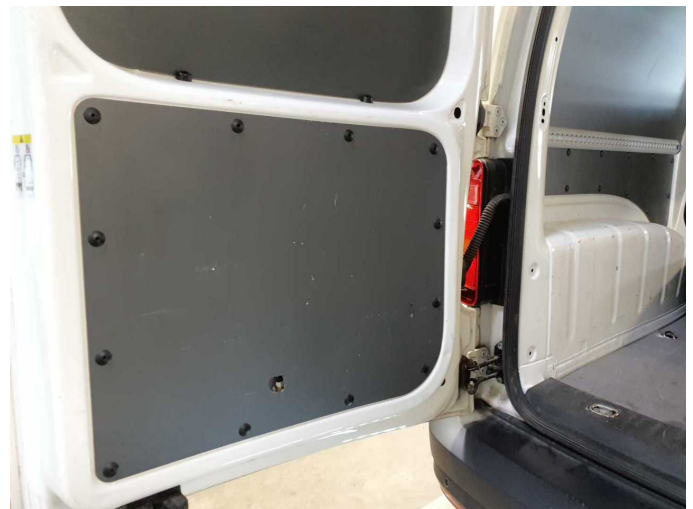
| No. | Component group | Description |
|---|---|---|
| 2 | Boot lid / rear door | Rear door - left side (Verkleidung) - Broken / torn - Replace |

**Damage 2:** Boot lid / rear door: Rear door - left side (Verkleidung) - Broken / torn - Replace

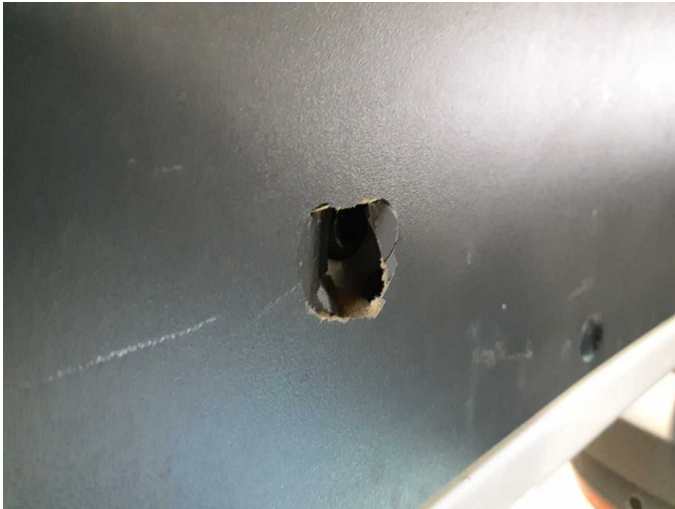
**Damage 2:** Boot lid / rear door: Rear door - left side (Verkleidung) - Broken / torn - Replace

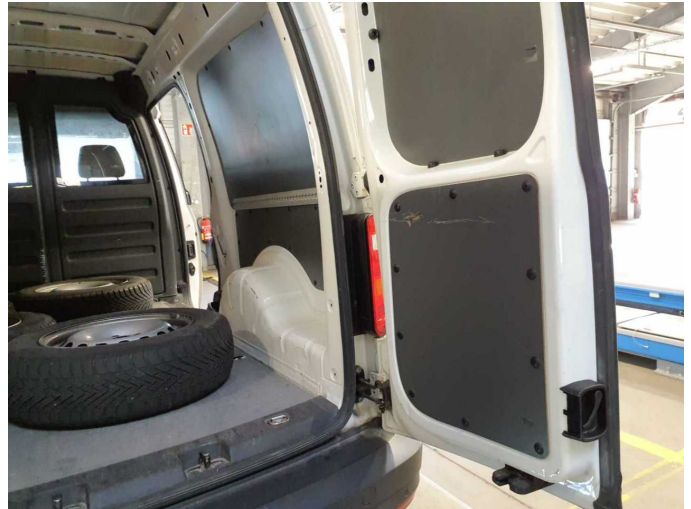
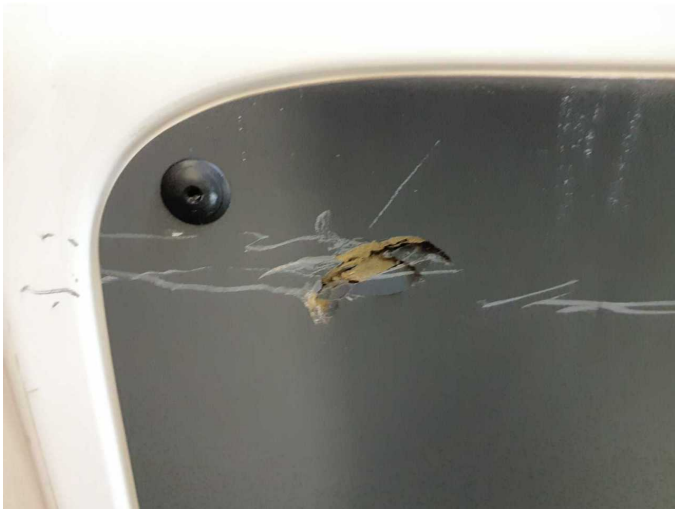
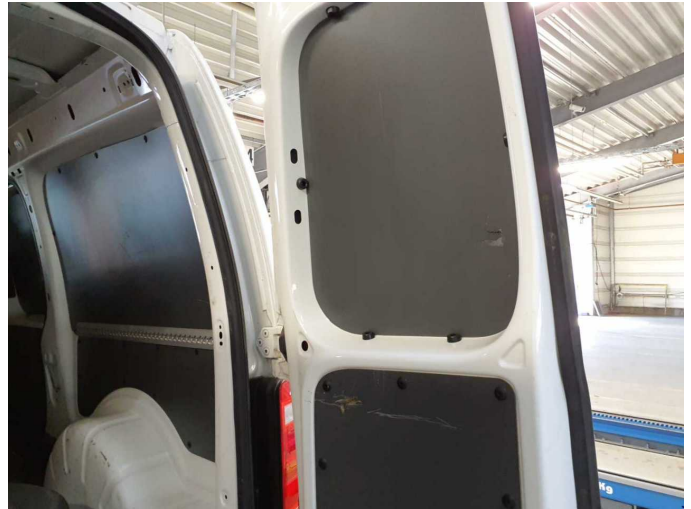
| No. | Component group | Description |
|---|---|---|
| 3 | Boot lid / rear door | Rear door - right side (Verkleidung) - Broken / torn - Replace |

**Damage 3:** Boot lid / rear door: Rear door - right side (Verkleidung) - Broken / torn - Replace

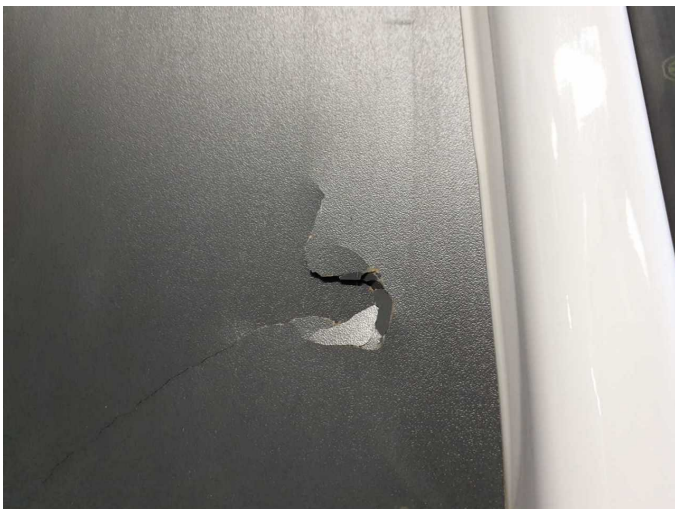
**Damage 3:** Boot lid / rear door: Rear door - right side (Verkleidung) - Broken / torn - Replace

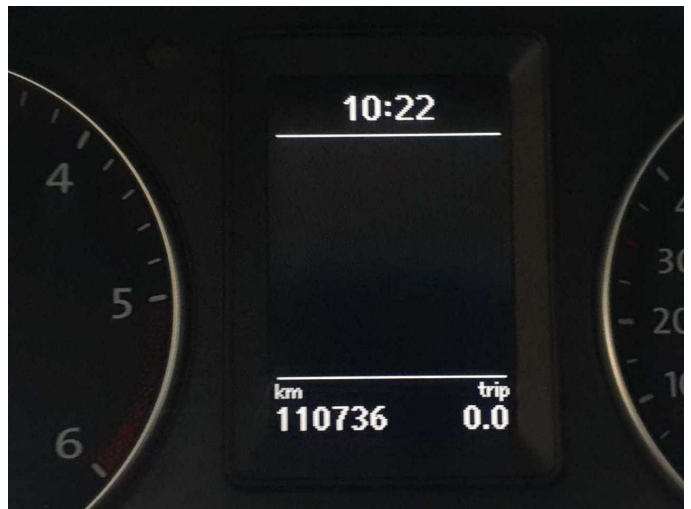
| No. | Component group | Description |
|---|---|---|
| 4 | Misc. | Inspection / maintenance (digitaler Nachweis / unplausibel) - Missing - Perform diagnosis |

**Damage 4:** Misc.: Inspection / maintenance (digitaler Nachweis / unplausibel) - Missing - Perform diagnosis

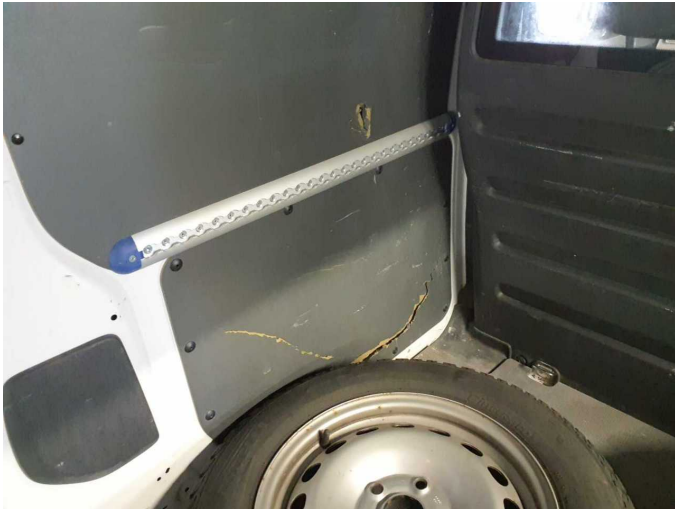
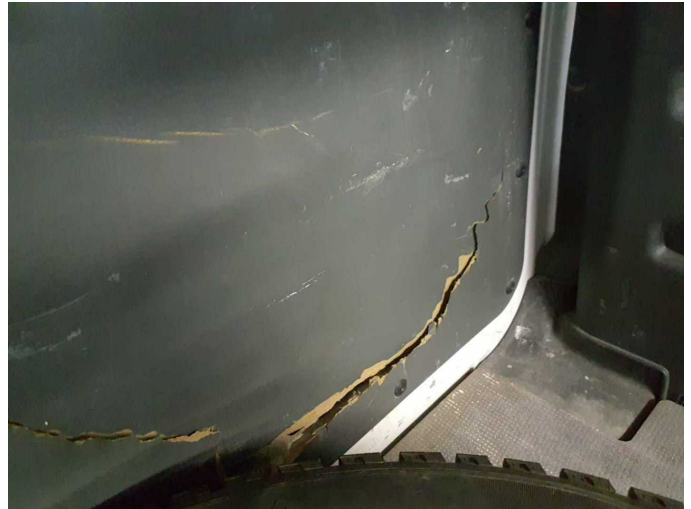
| No. | Component group | Description |
|---|---|---|
| 5 | Trim / covers | Cargo area - lining -left side - Broken / torn - Replace |

**Damage 5:** Trim / covers: Cargo area - lining -left side - Broken / torn - Replace

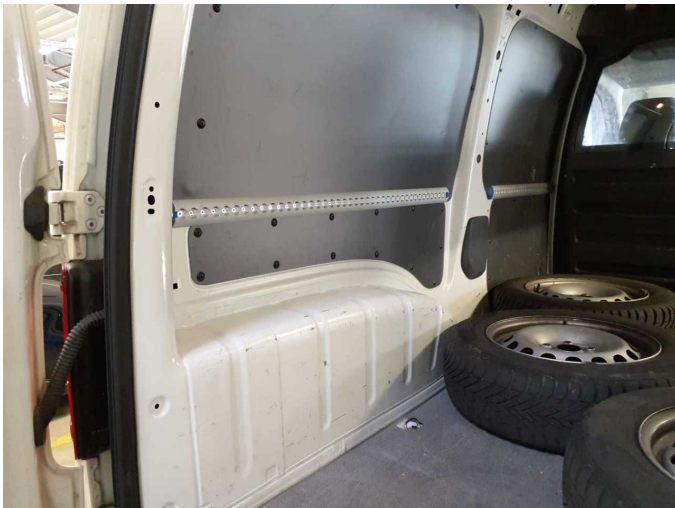
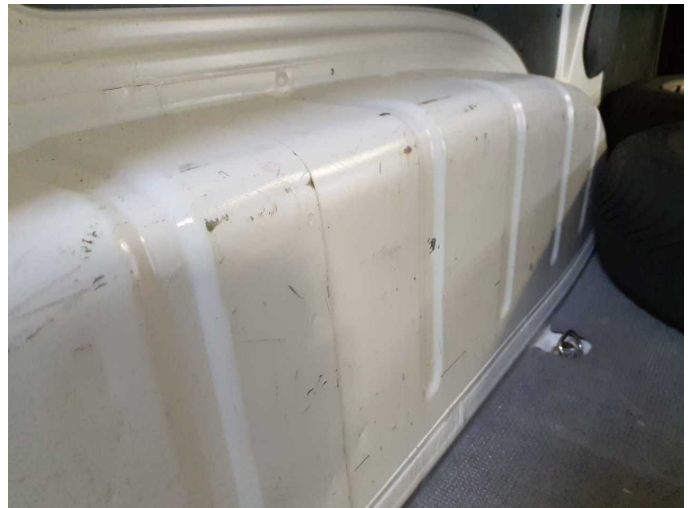
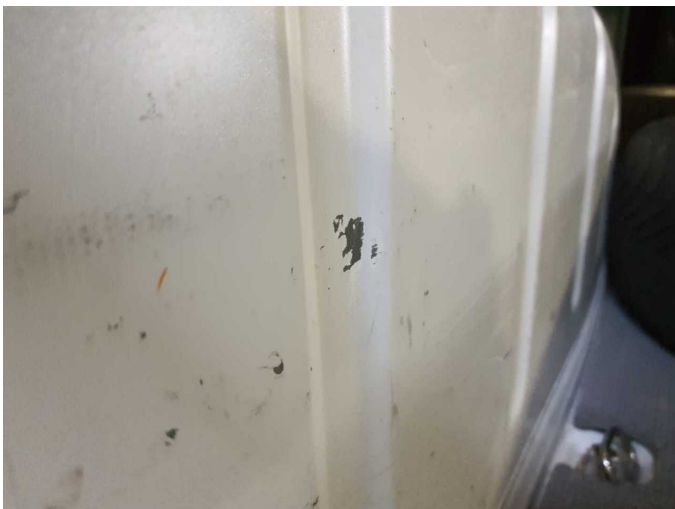
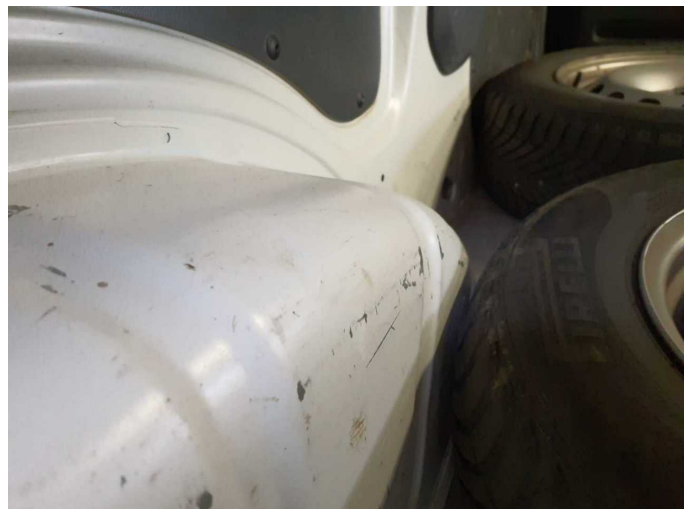
| No. | Component group | Description |
|---|---|---|
| 6 | Interior | Interior (SEITENTEIL H I L) - Scratched - Smart repair |

**Damage 6:** Interior: Interior (SEITENTEIL H I L) - Scratched - Smart repair

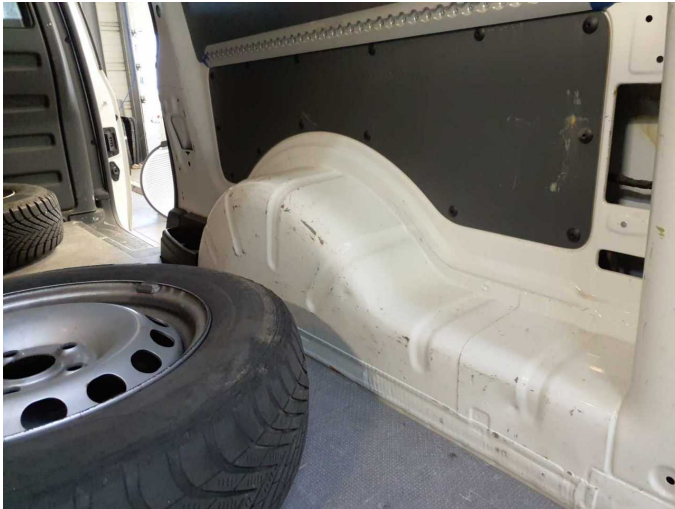
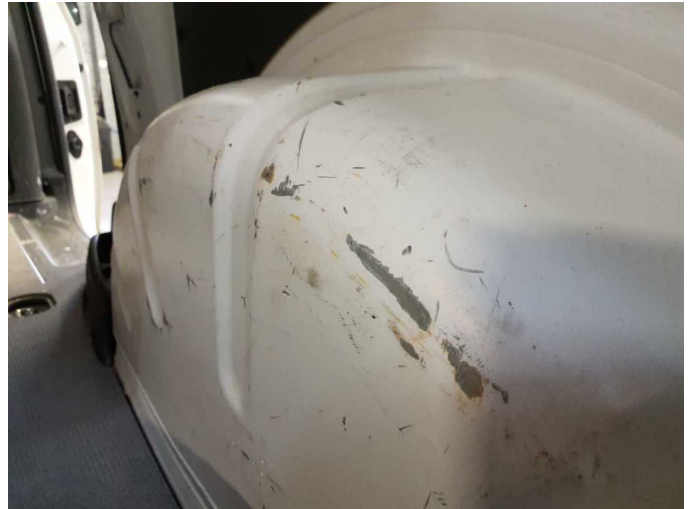
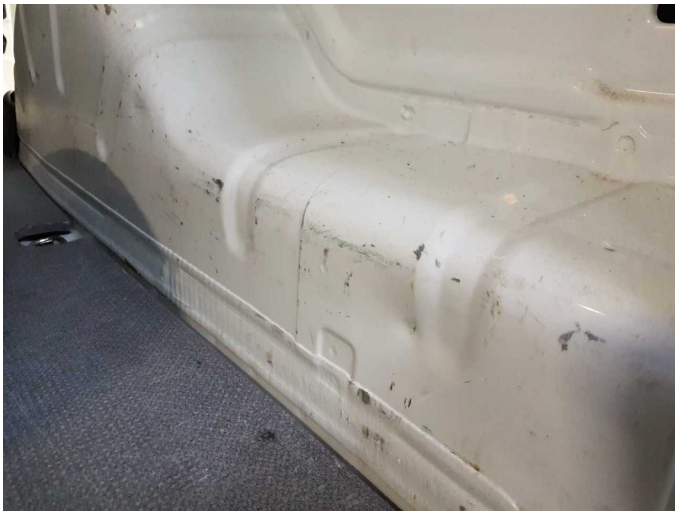
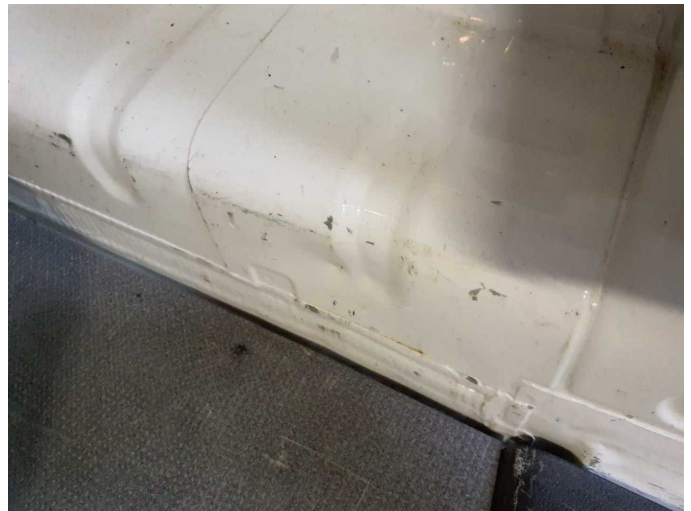
| No. | Component group | Description |
|---|---|---|
| 7 | Interior | Interior (SEITENTEIL H I R) - Scratched - Smart repair |

**Damage 7:** Interior: Interior (SEITENTEIL H I R) - Scratched - Smart repair

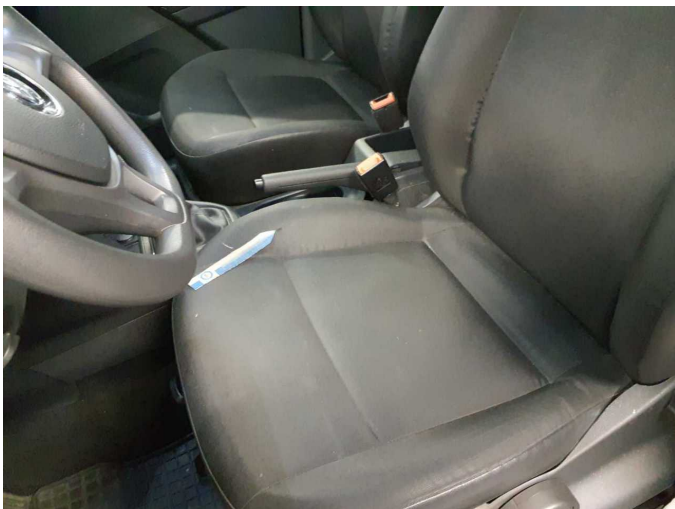
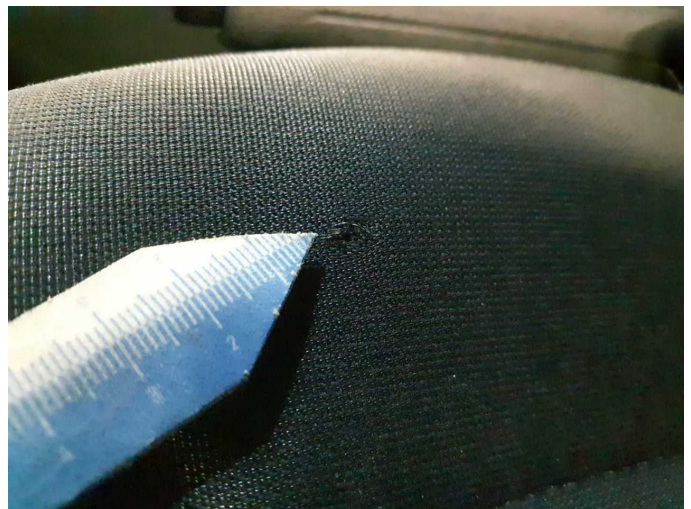
| No. | Component group | Description |
|---|---|---|
| 8 | Seat - front | Seat cover - left side - Holes - Smart repair |

**Damage 8:** Seat - front: Seat cover - left side - Holes - Smart repair

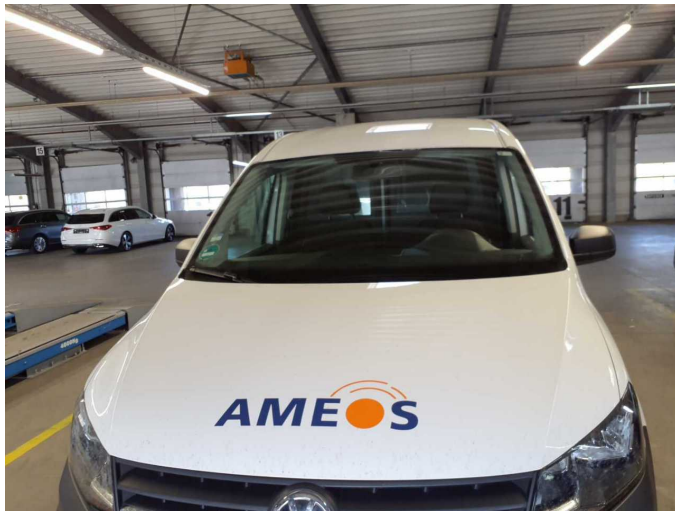
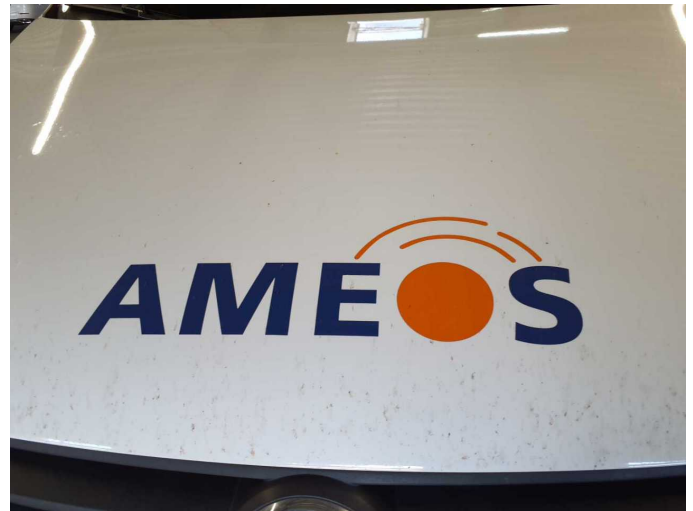
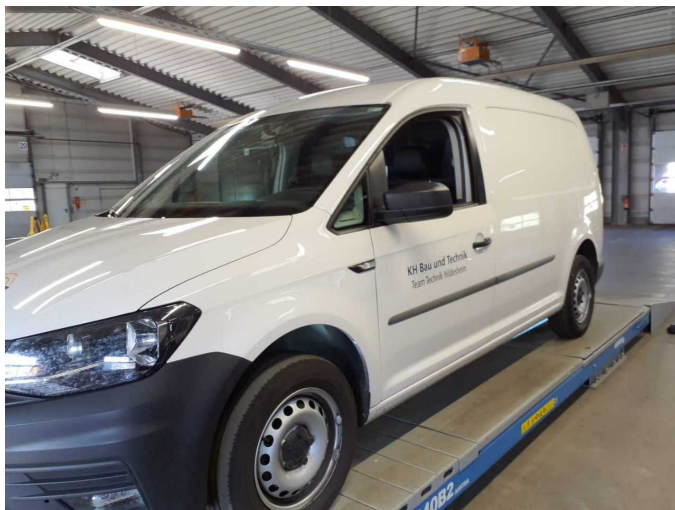
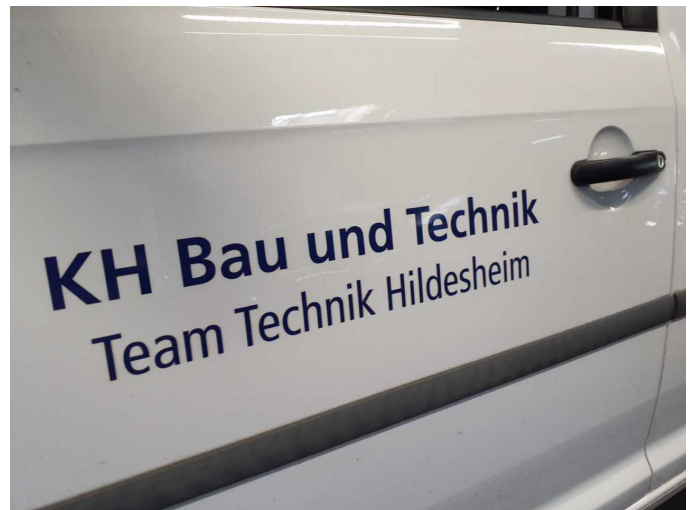
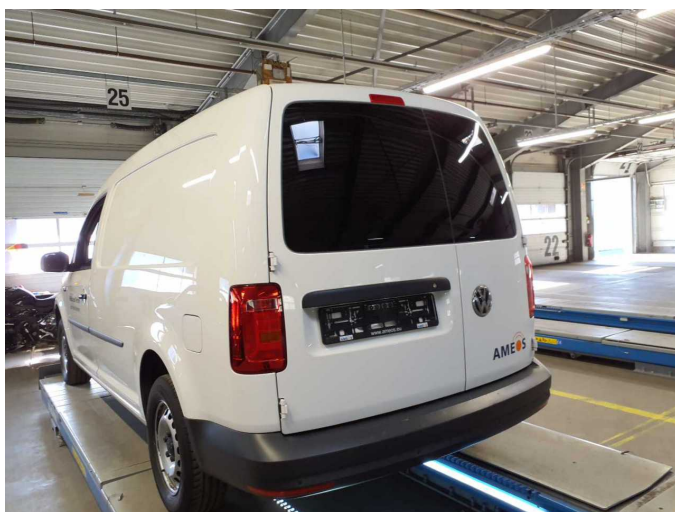
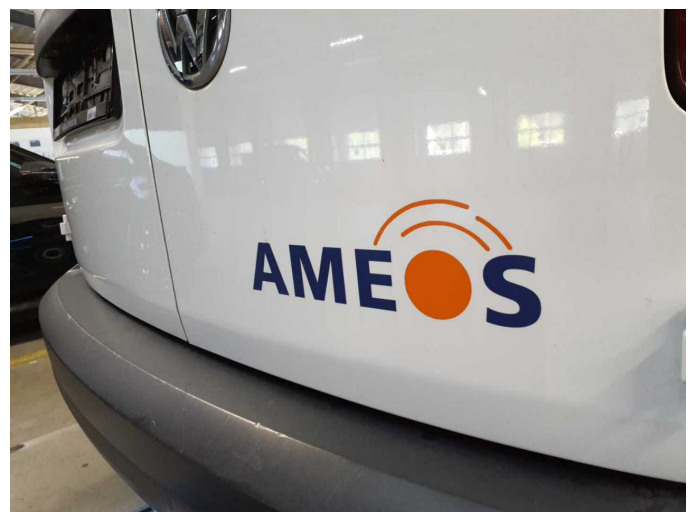
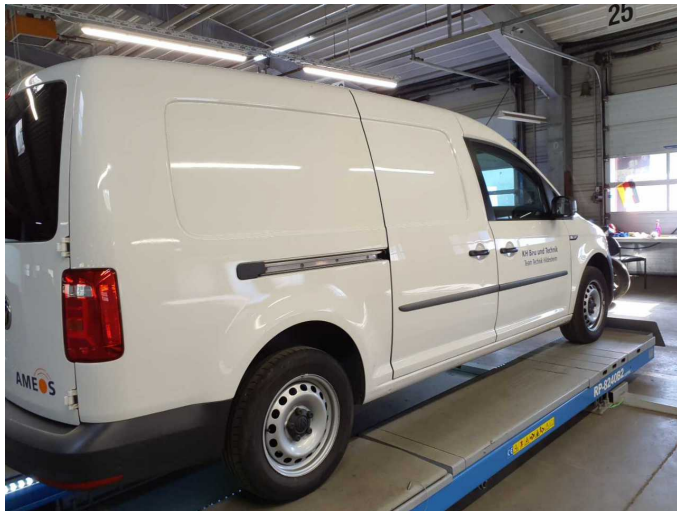
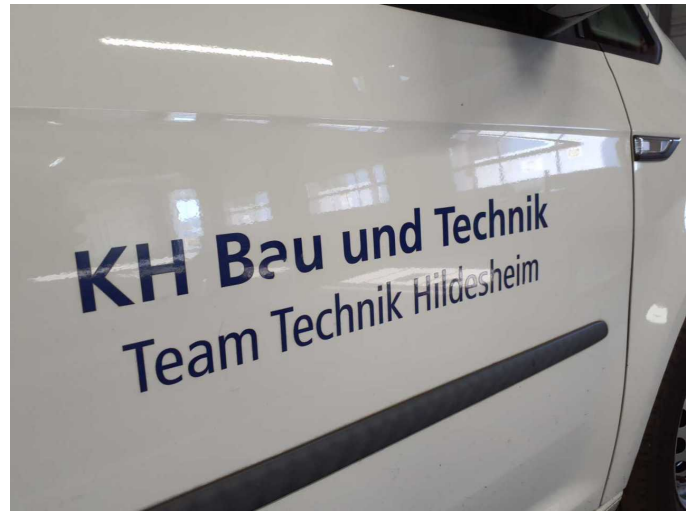
| No. | Component group | Description |
|---|---|---|
| 9 | Body | Body - Glued / labelled - De-glue / neutralise |

Damage 9: Body: Body - Glued / labelled - De-glue / neutralise

**Damage 9:** Body: Body - Glued / labelled - De-glue / neutralise

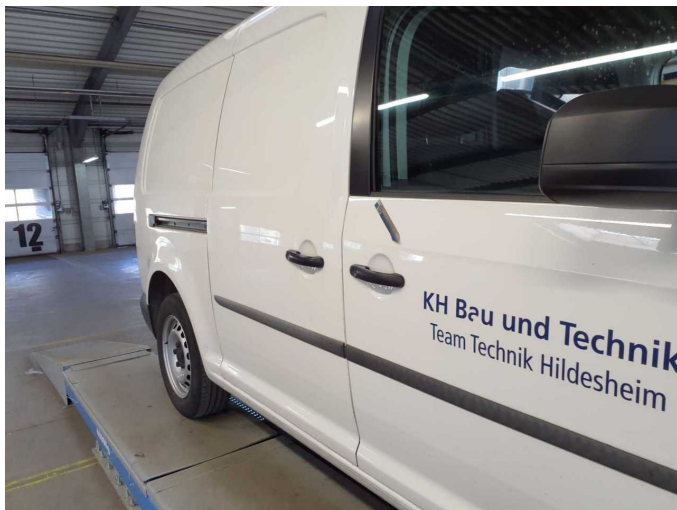
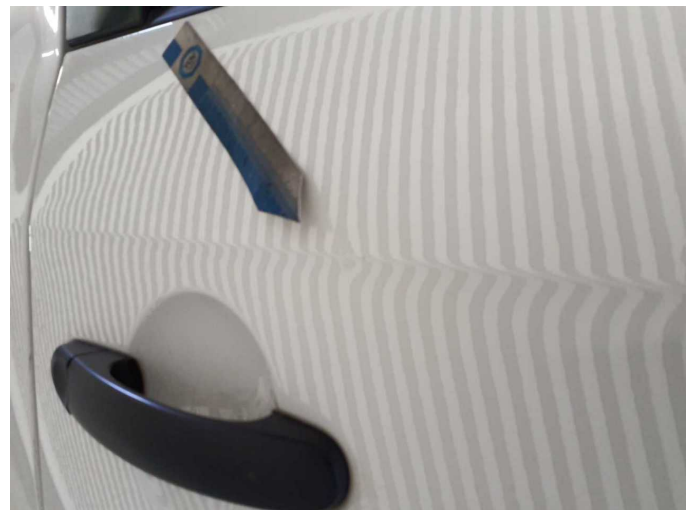
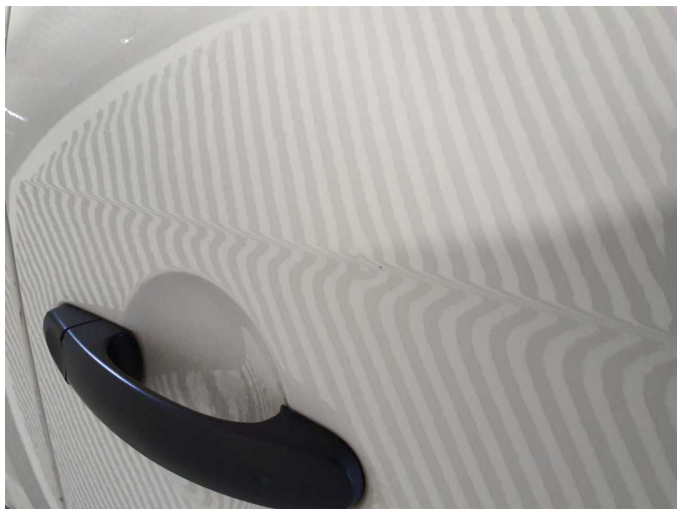
| No. | Component group | Description |
|---|---|---|
| 10 | Door - front right side | Door - dent(s) - Smooth repair work |

**Damage 10:** Door - front right side: Door - dent(s) - Smooth repair work

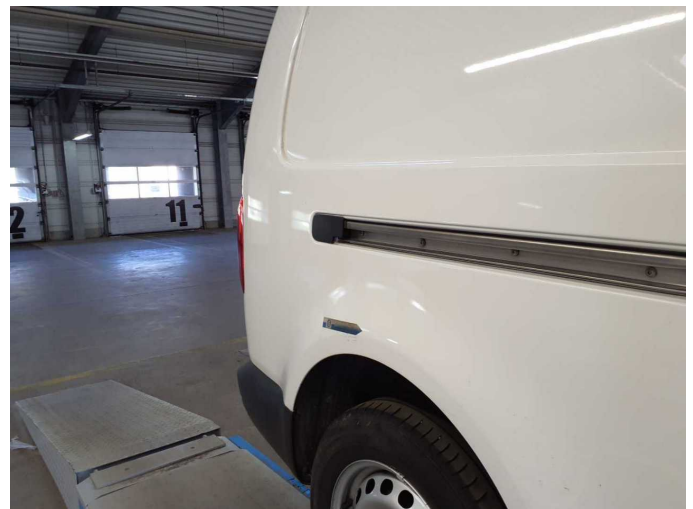
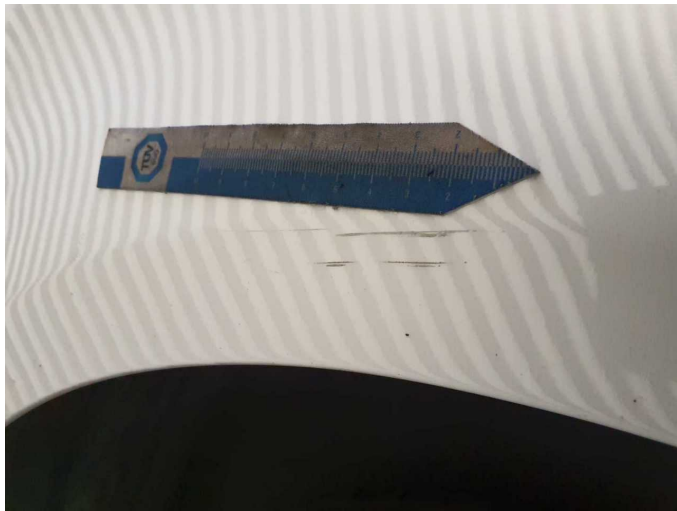
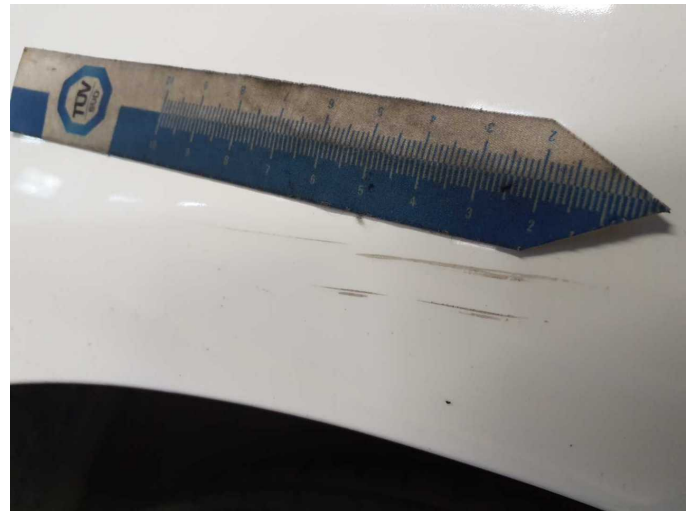
| No. | Component group | Description |
|---|---|---|
| 11 | Side panel - rear right side | Side panel - Scratched - Smart repair |

**Damage 11:** Side panel - rear right side: Side panel - Scratched - Smart repair

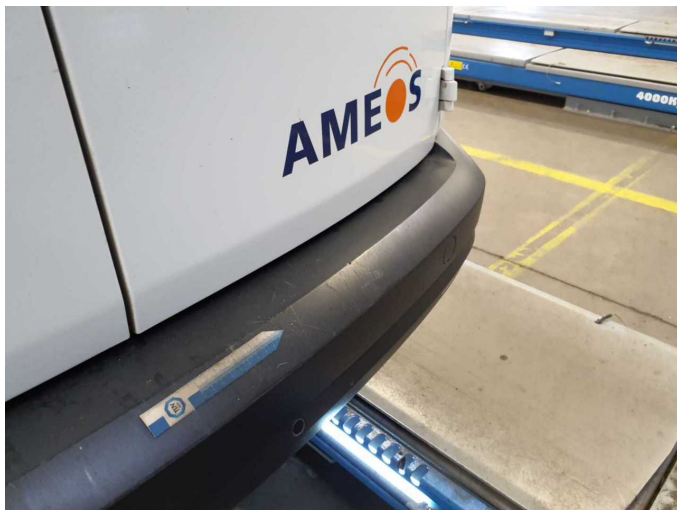
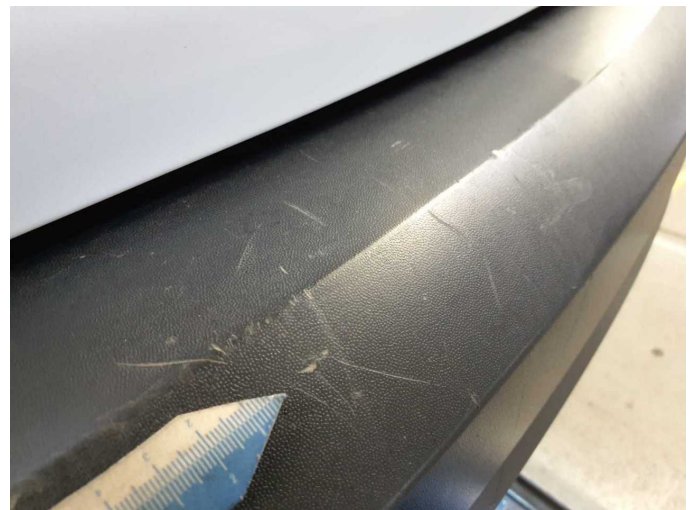
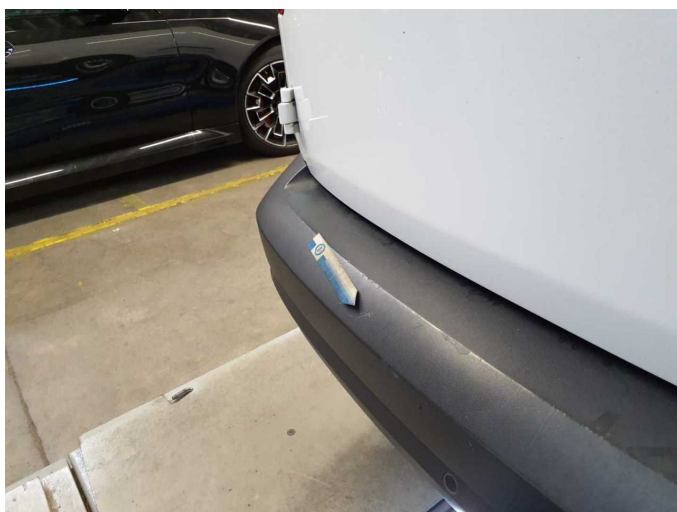
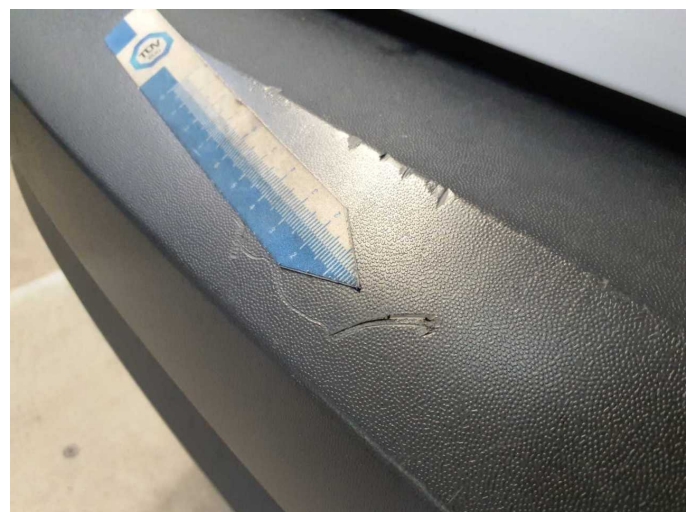
| No. | Component group | Description |
|---|---|---|
| 12 | Rear bumper | Rear bumper - Scratched - Loss in value |

**Damage 12:** Rear bumper: Rear bumper - Scratched - Loss in value

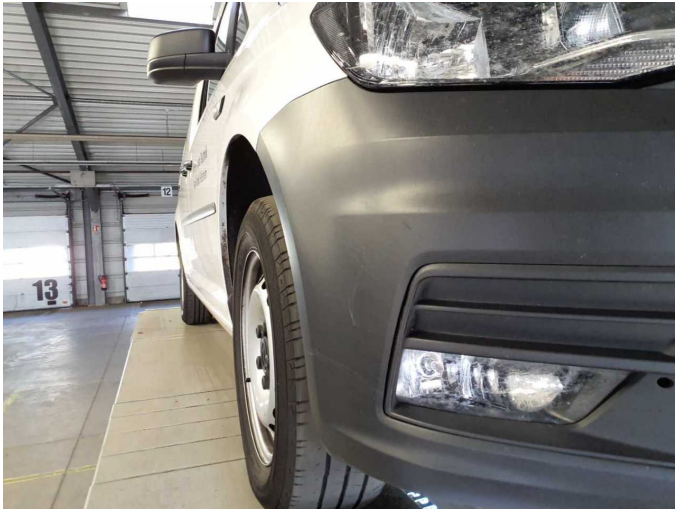
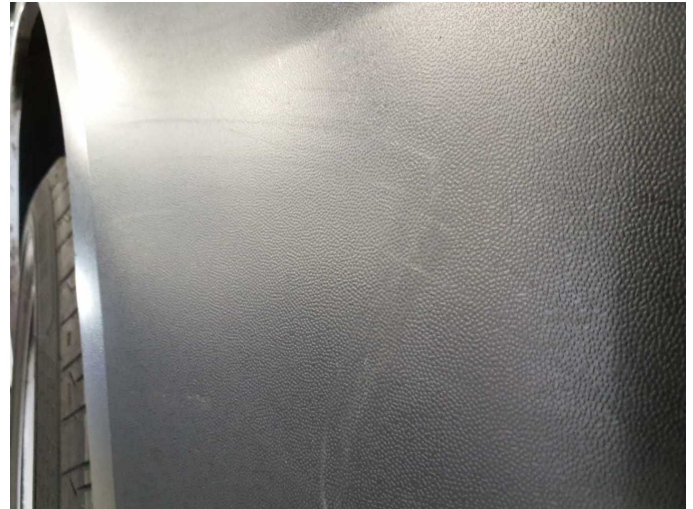
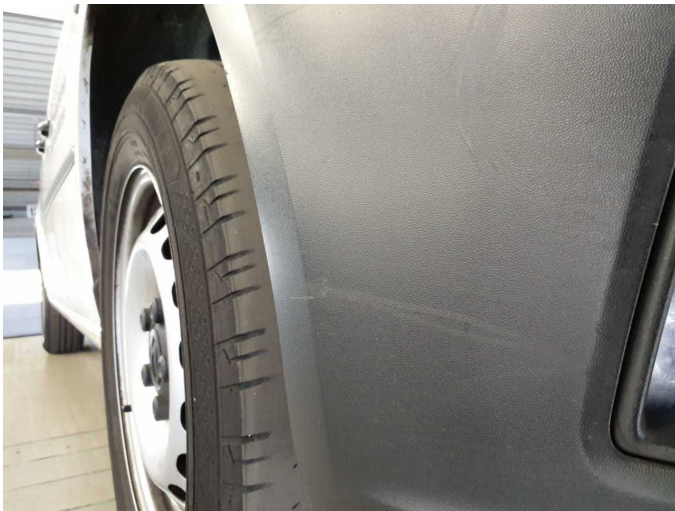
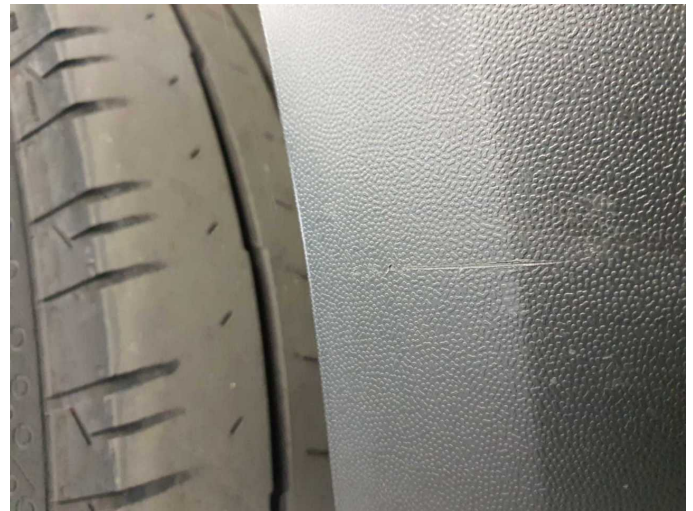
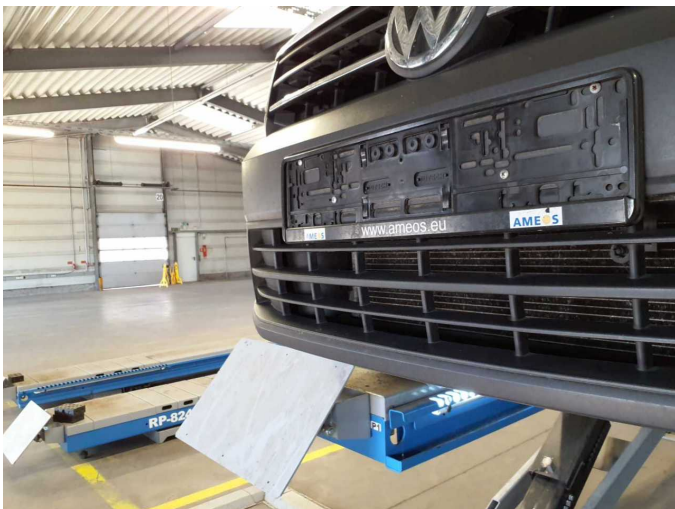
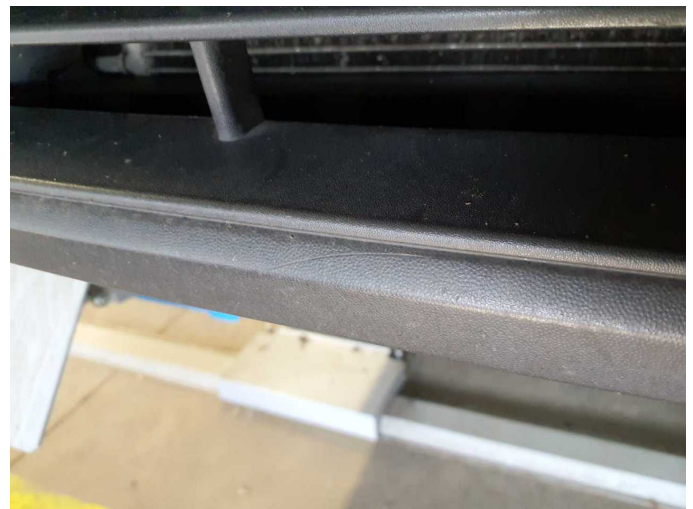
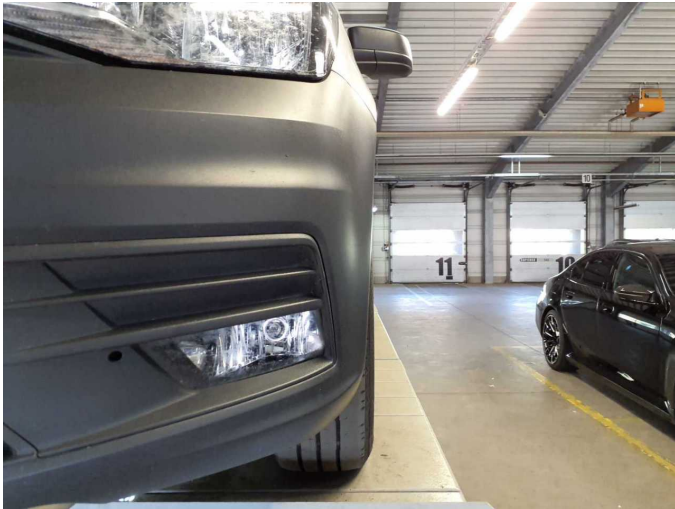
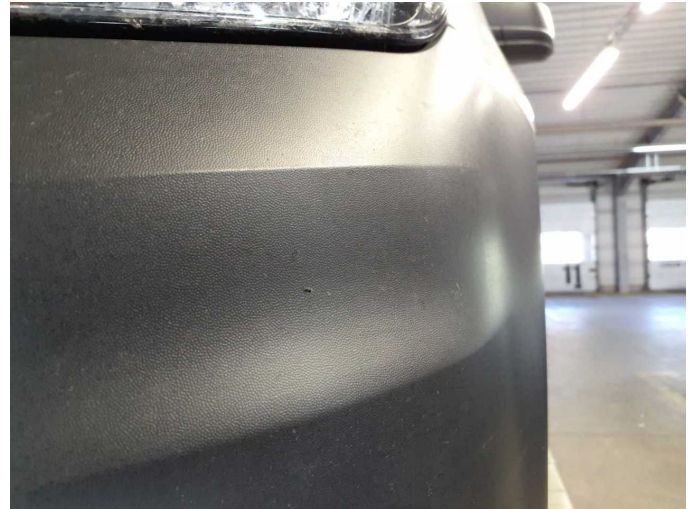
| No. | Component group | Description |
|---|---|---|
| 13 | Front bumper | Front bumper - Scratched - Smart repair |

**Damage 13:** Front bumper: Front bumper - Scratched - Smart repair

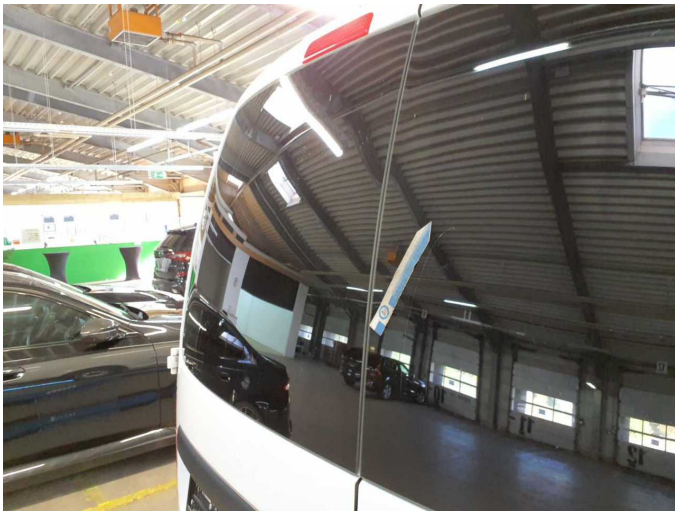
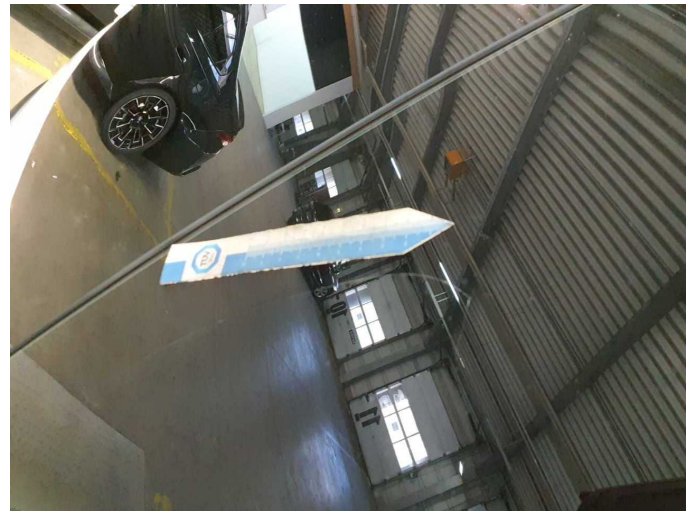
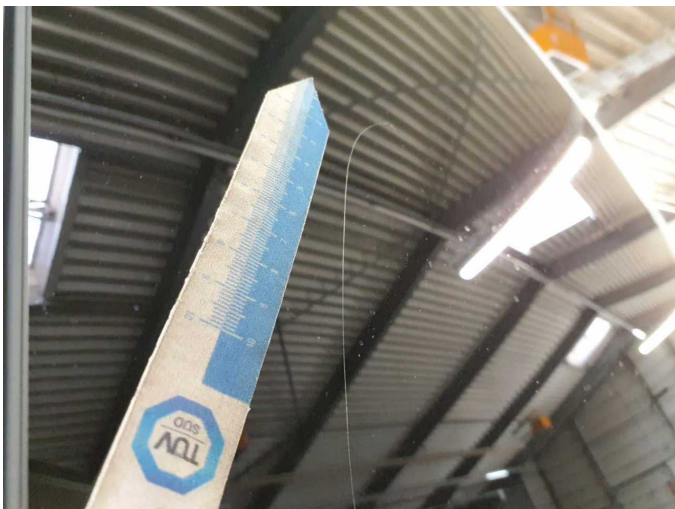
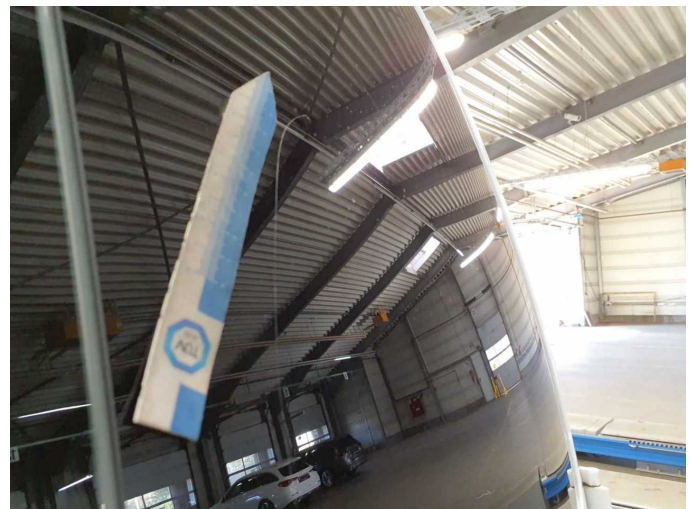
| No. | Component group | Description |
|---|---|---|
| 14 | Vehicle glazing | Rear window - right side - Scratched - Loss in value |

**Damage 14:** Vehicle glazing: Rear window - right side - Scratched - Loss in value

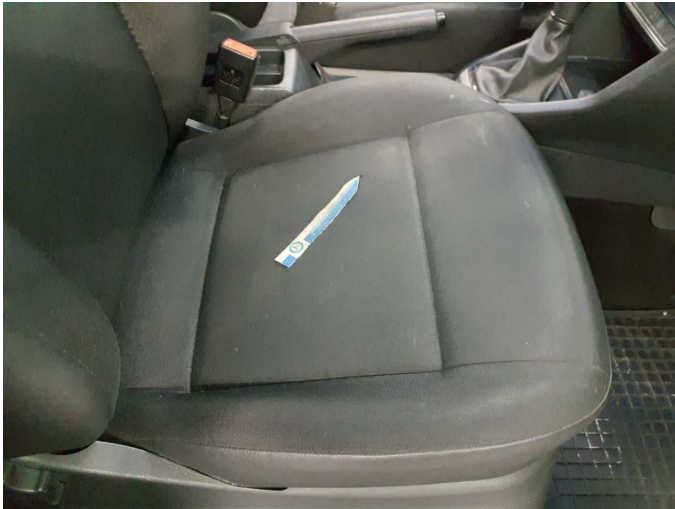
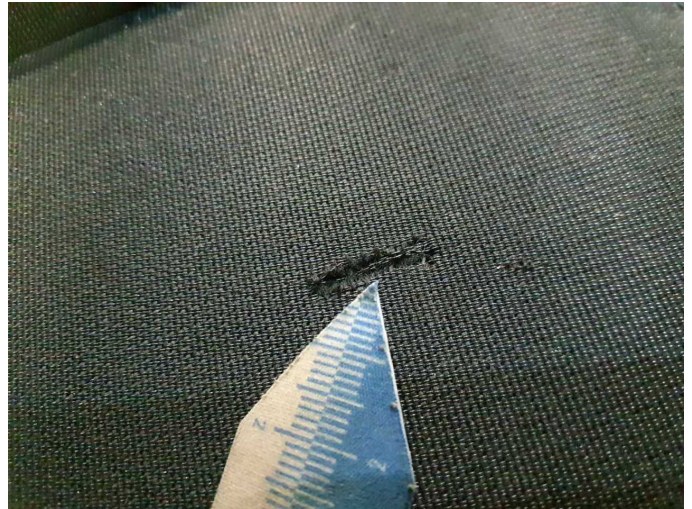
| No. | Component group | Description |
|---|---|---|
| 15 | Seat - front | Seat cover - right side - Holes - Replace |

**Damage 15:** Seat - front: Seat cover - right side - Holes - Replace

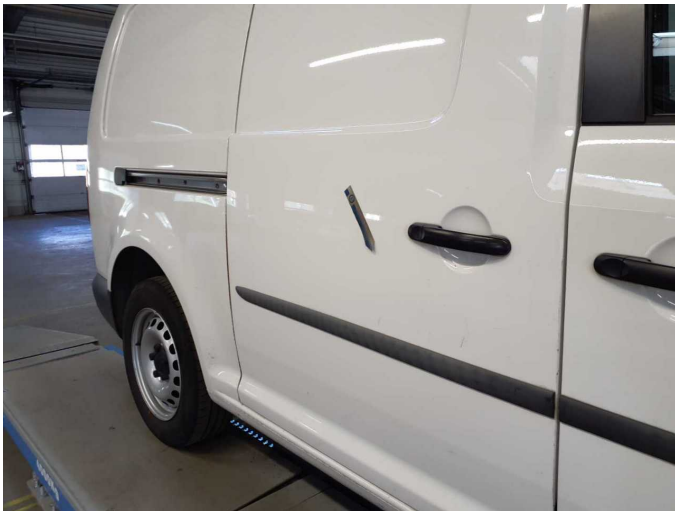
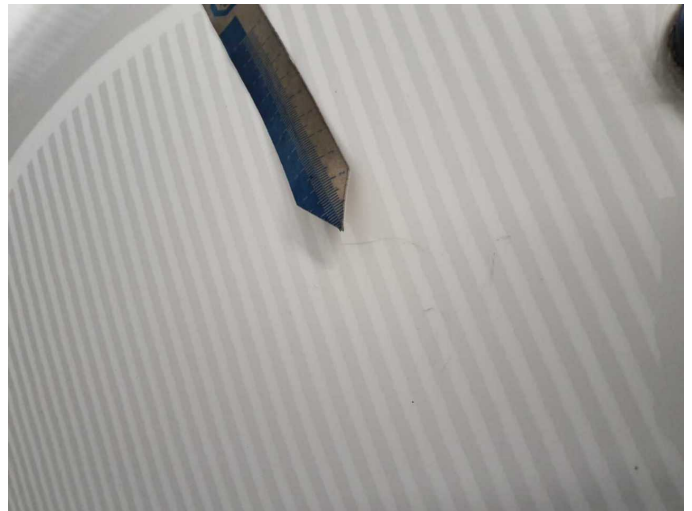
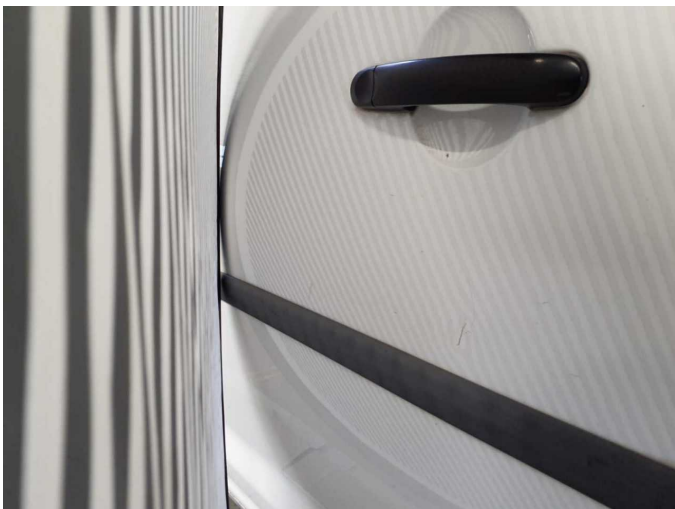
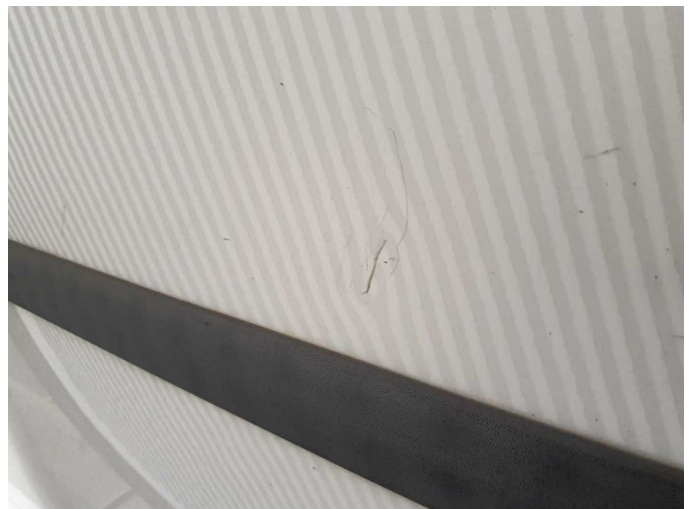
| No. | Component group | Description |
|---|---|---|
| 16 | Sliding door, right | Sliding door (Kratzer) - Dent / paintcoat damage - Repair and paint |

**Damage 16:** Sliding door, right: Sliding door (Kratzer) - Dent / paintcoat damage - Repair and paint

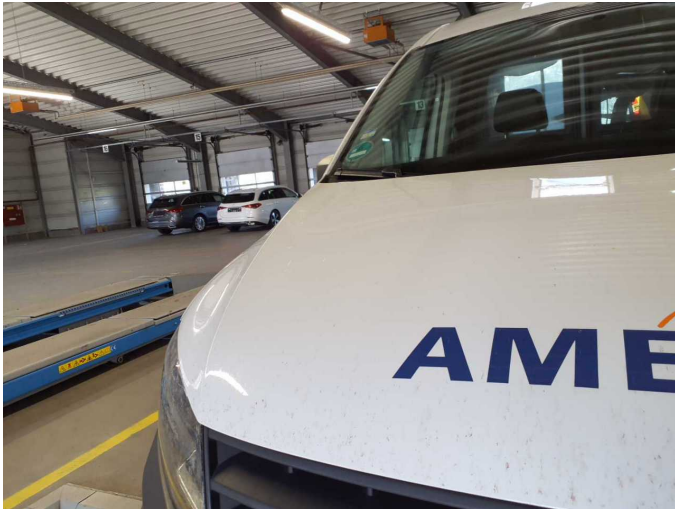
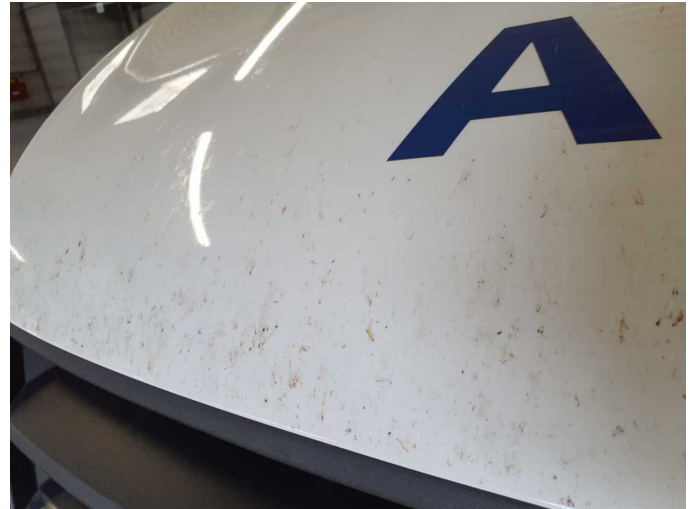
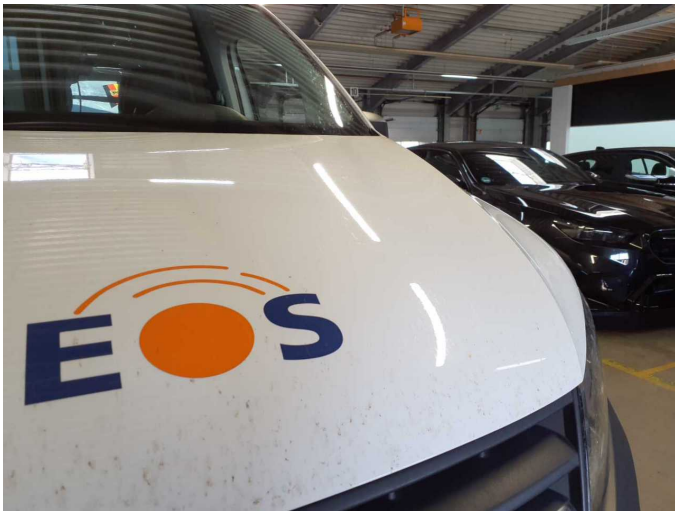
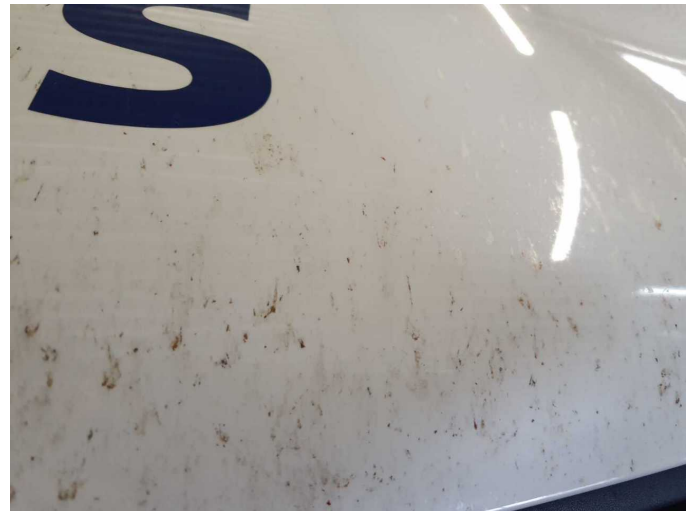
| No. | Component group | Description |
|---|---|---|
| 7 | Bonnet | Bonnet - Stone chips - No deduction |

**Wear and tear 7: Bonnet: Bonnet - Stone chips - No deduction**

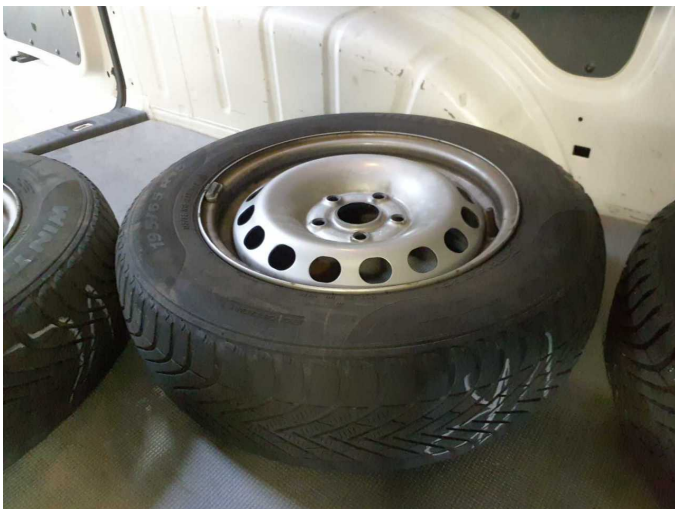
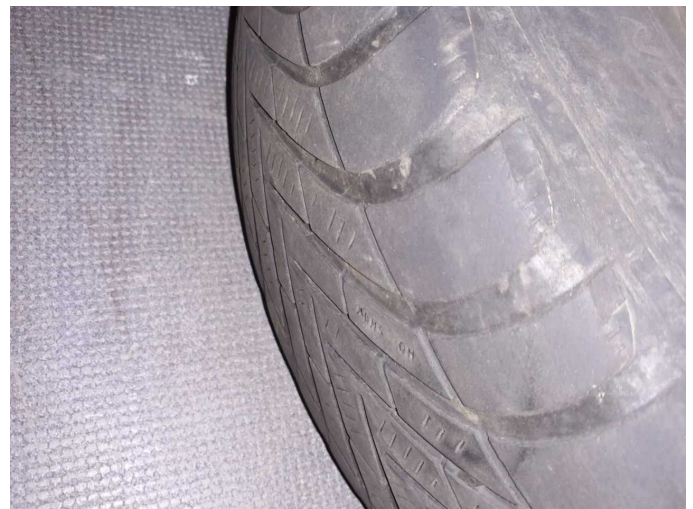
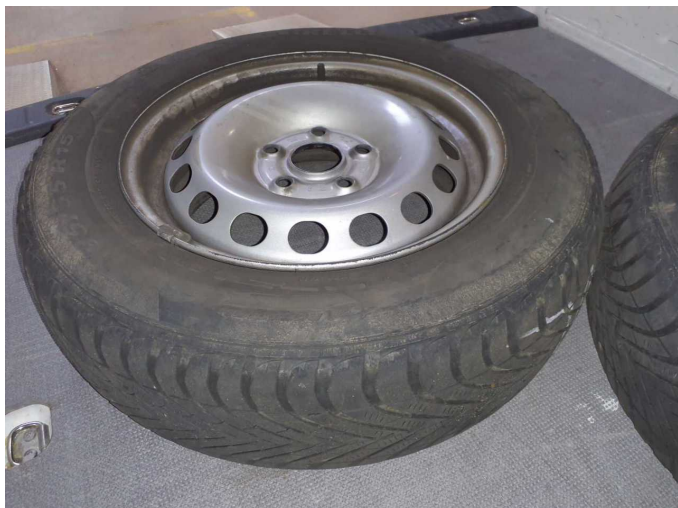
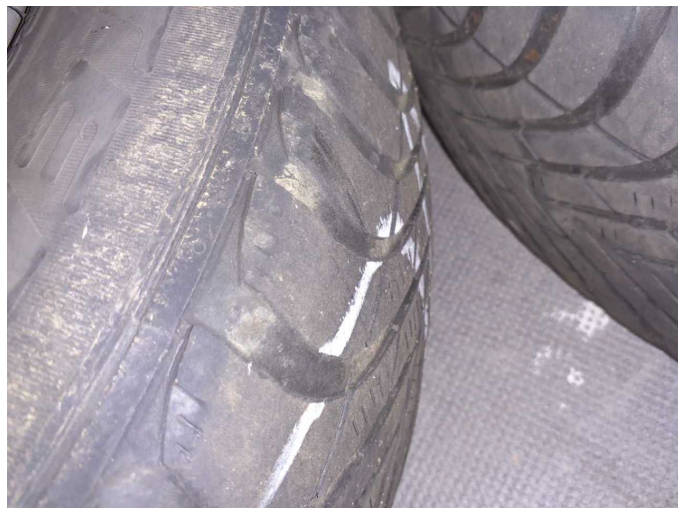
| No. | Component group | Description |
|---|---|---|
| 14 | 2nd wheel set | 2 tyres - Expired - No deduction |

**Wear and tear 14: 2nd wheel set: 2 tyres - Expired - No deduction**

**Wear and tear 14:** 2nd wheel set: 2 tyres - Expired - No deduction
