Expertise

Protocol number: 41634455  
Order No. / Reference: 25254742  
Inspection date: 19 Sept 2025

| Manufacturer: Volkswagen | Model: Caddy 2.0 TDI Maxi EcoProfi |
| VIN: WV1ZZZ2KZLX117237 | |

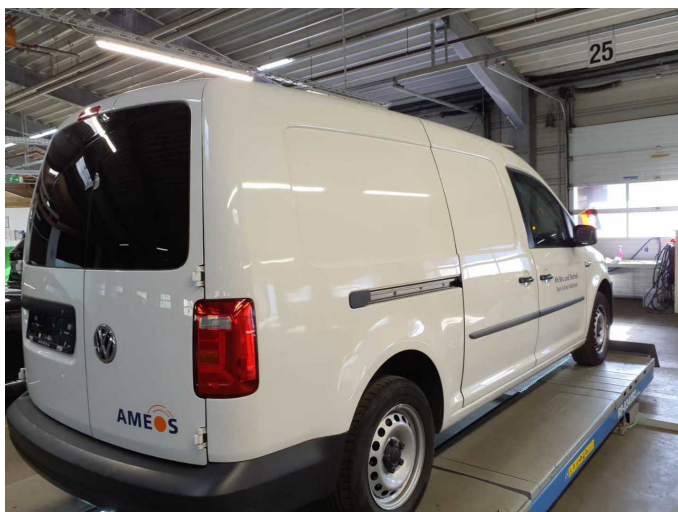
- Side panel - rear right side, Invoice of repair done Non-existent

Side panel - rear right side 256 µm |

**Repainting 1:** Side panel - rear right side
