Expertise

Protocol number: 40923598  
Order No. / Reference: 25055944  
Inspection date: 5 Aug 2025

Manufacturer: Volkswagen

Model: Transporter T6 Kurz BlueMotion

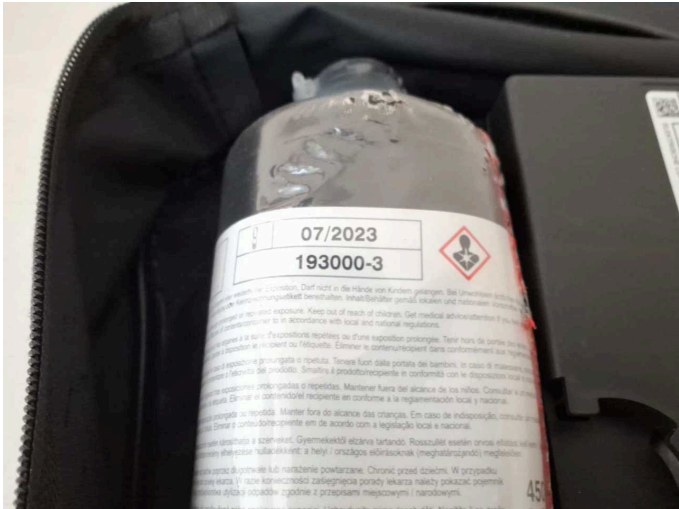
Damage 1: Equipment: Tirefit filler - Expired - Replace

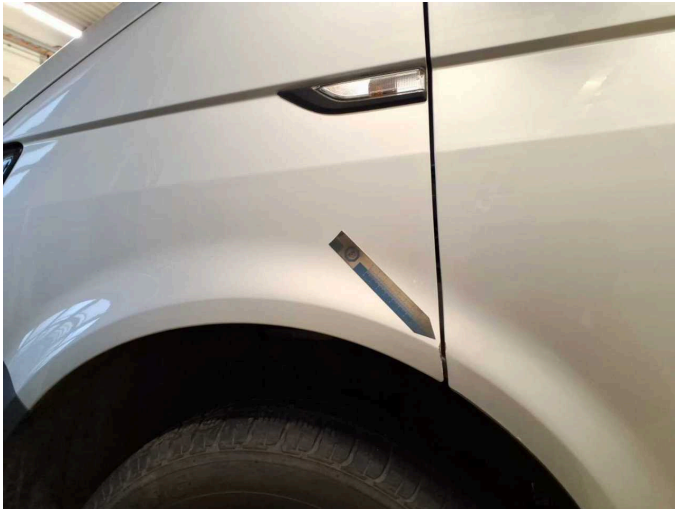
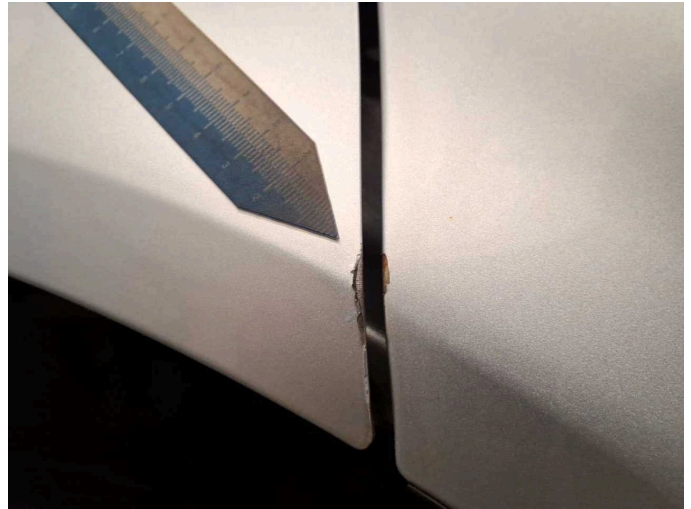
**Damage 2:** Mudguard - left side: Mudguard - left side - Scratch(es) - Smart repair

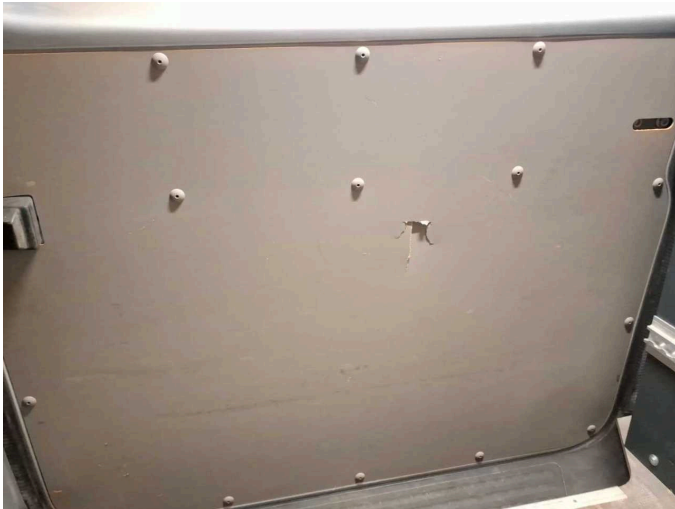
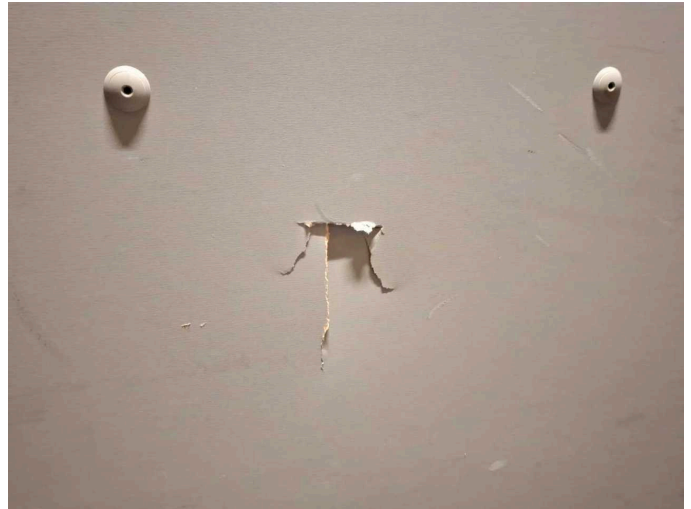
**Damage 3:** Sliding door, right: Trim - Broken / torn - Replace

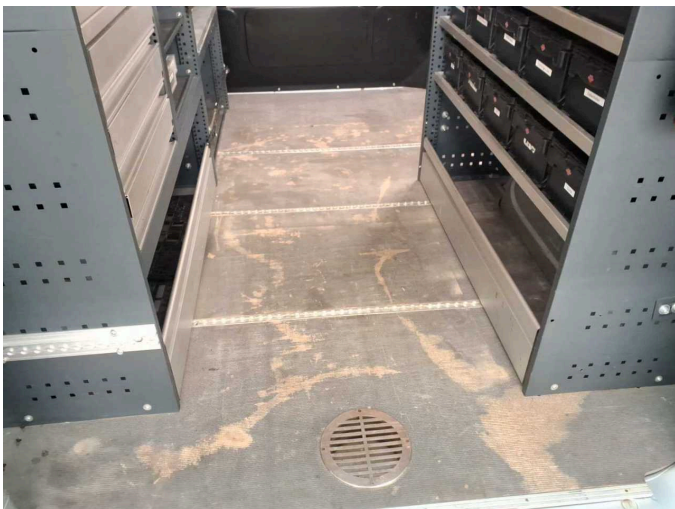
**Damage 4:** Interior: Cargo area floor - Scratched - Loss in value

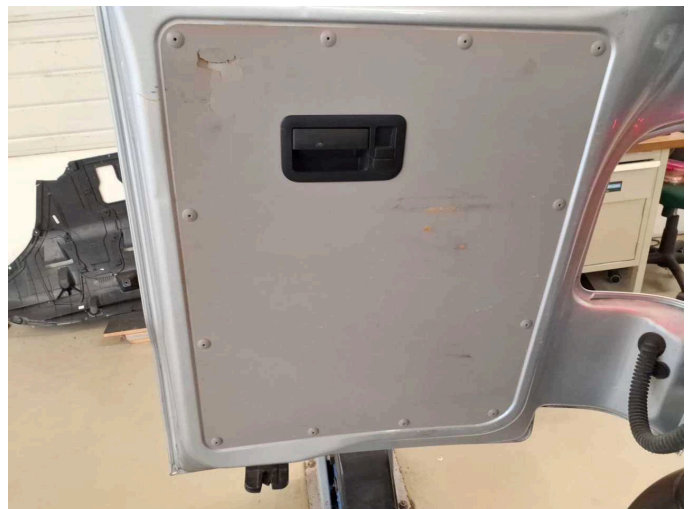
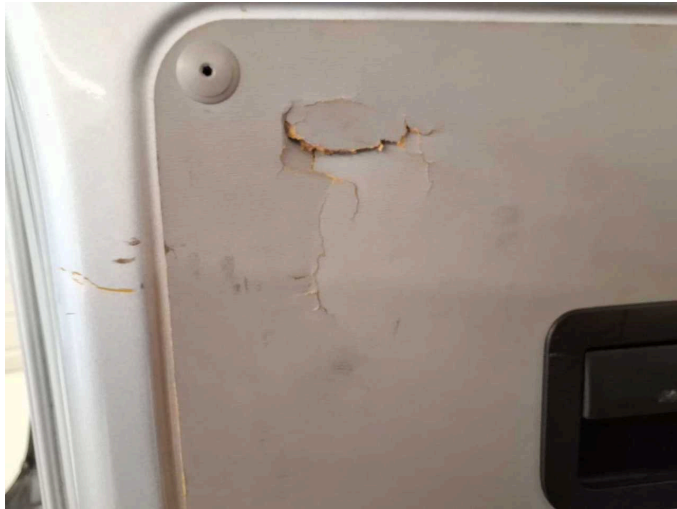
**Damage 5:** Boot lid / rear door: Trim rear door - hard fibre - lower (links) - Broken / torn - Replace

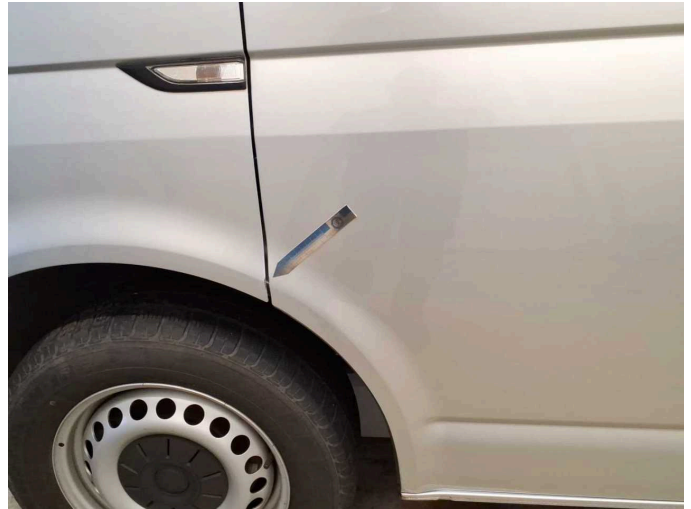
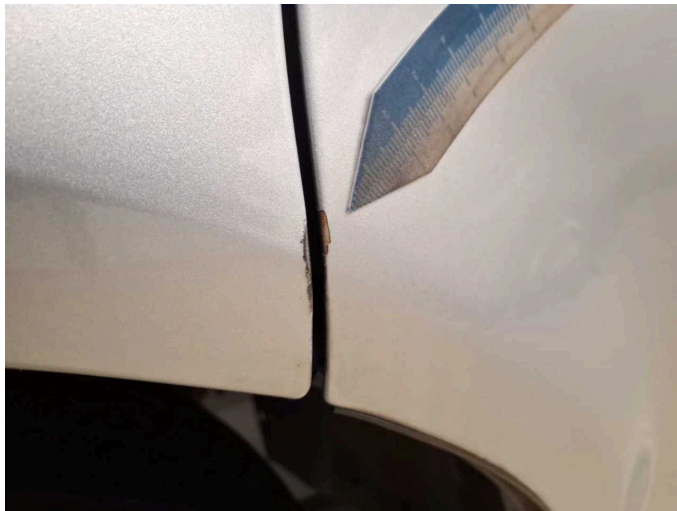
**Damage 6:** Door - front left side: Door - Corrosion - Smart repair

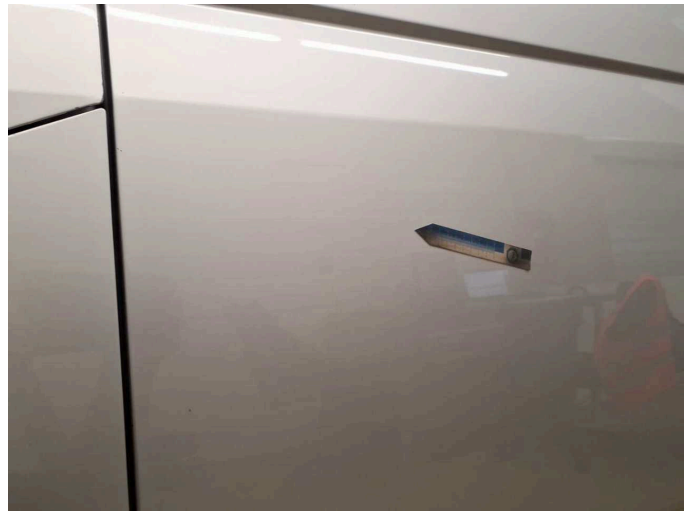
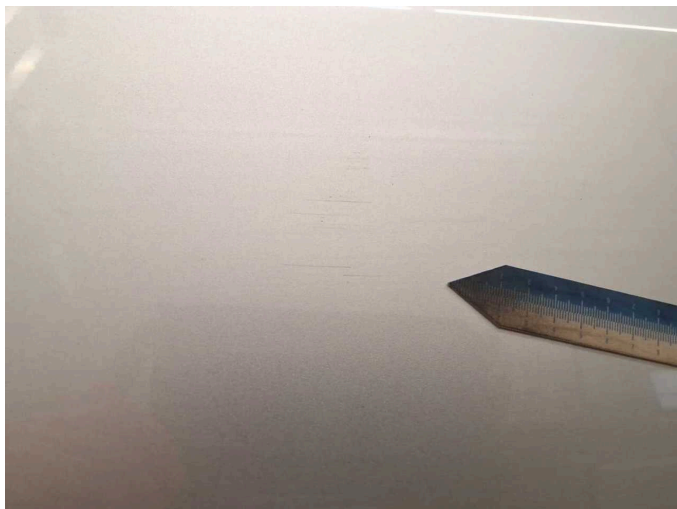
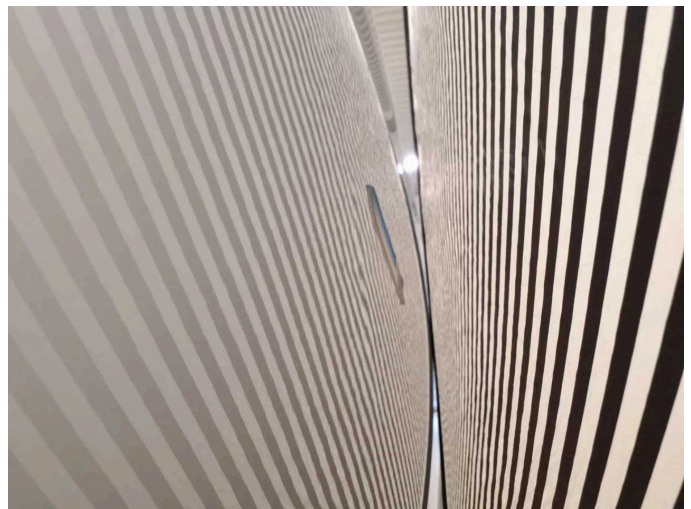
**Damage 7:** Side panel - rear left side: Side panel - Dent / paintcoat damage - Smart repair

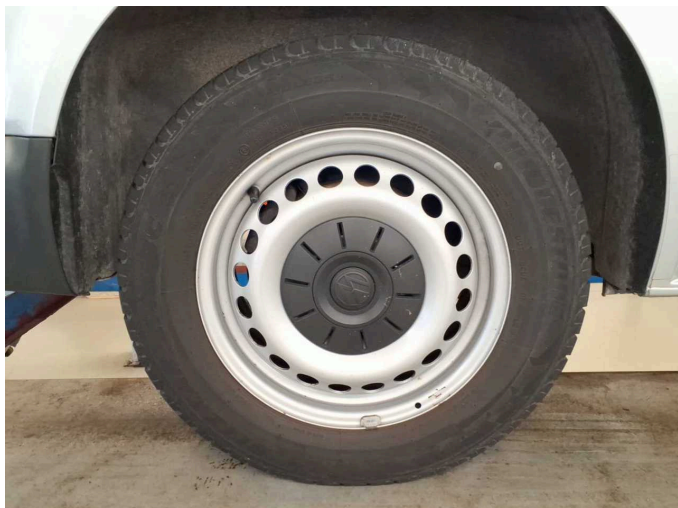
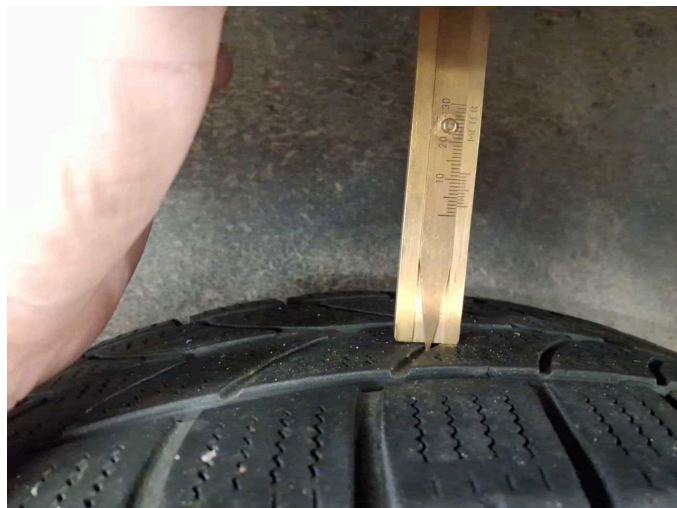
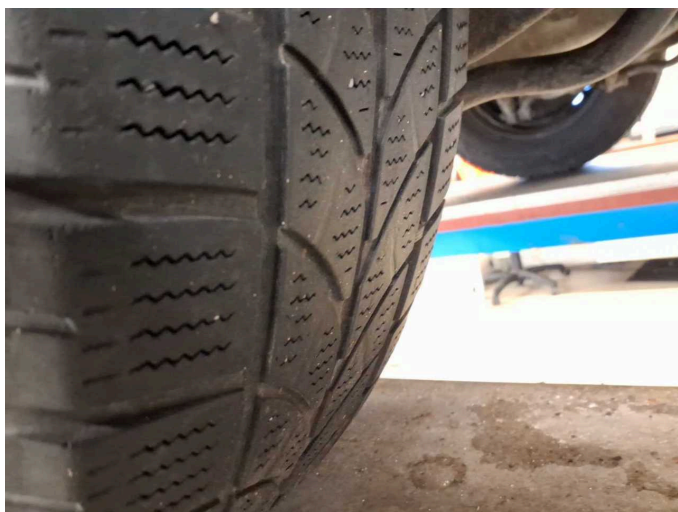
**Damage 8:** Wheel / tyres: Tyre - right - Does not meet the leasing specifications - Replace

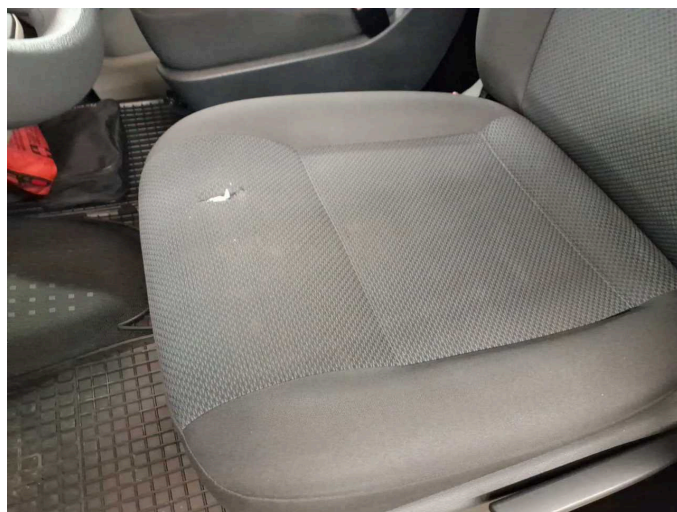
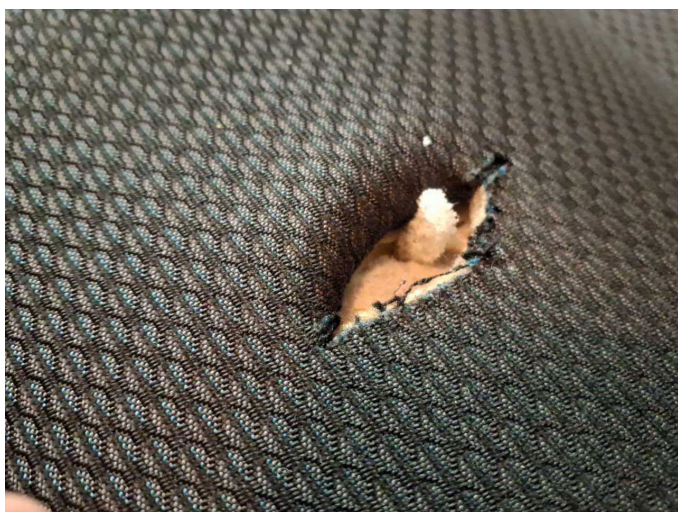
**Damage 9:** Seat - front: Seat cover - left side (inkl. Polster) - Broken / torn - Replace

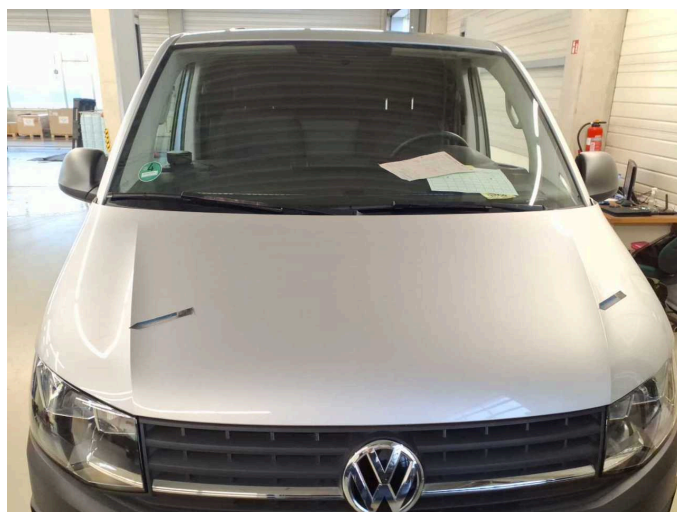
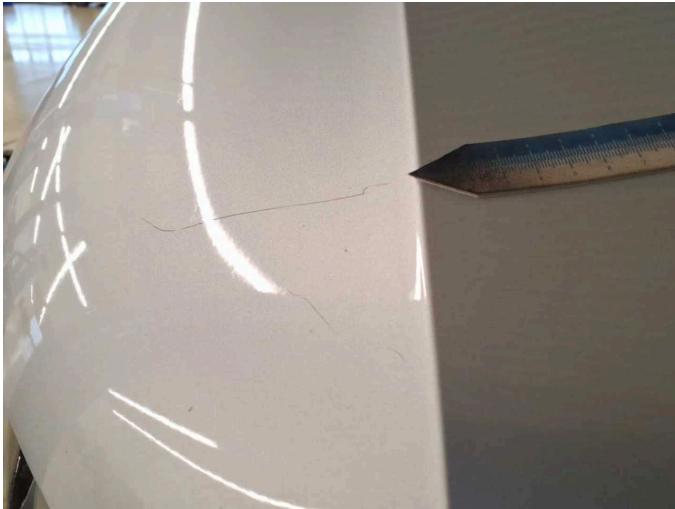
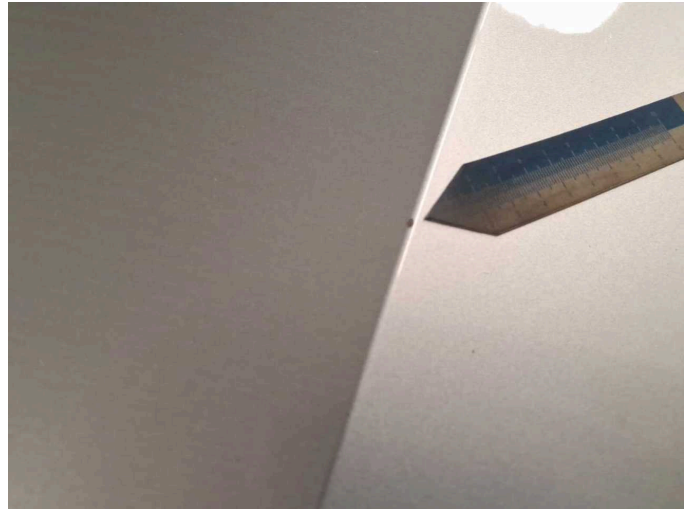
**Damage 10:** Bonnet: Bonnet - Scratch(es) - Paint

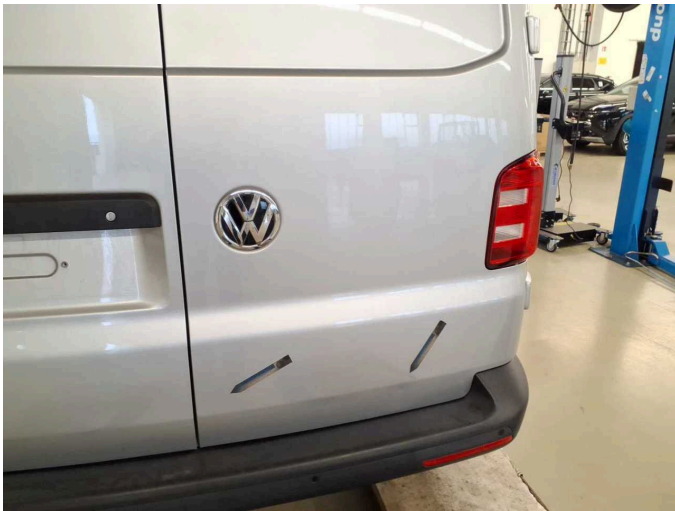
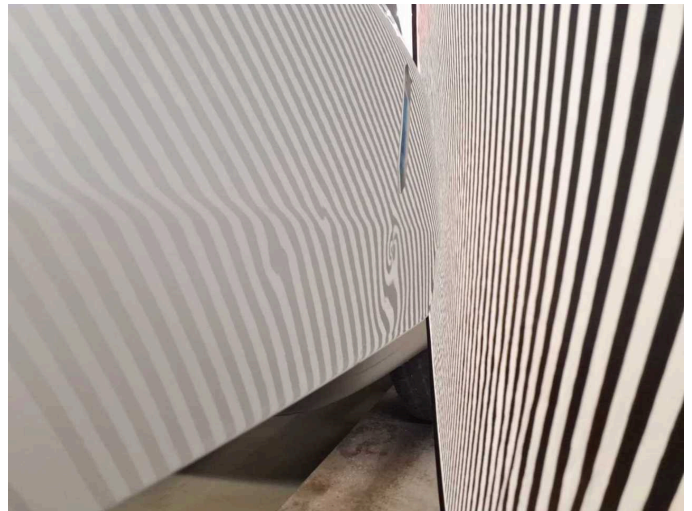
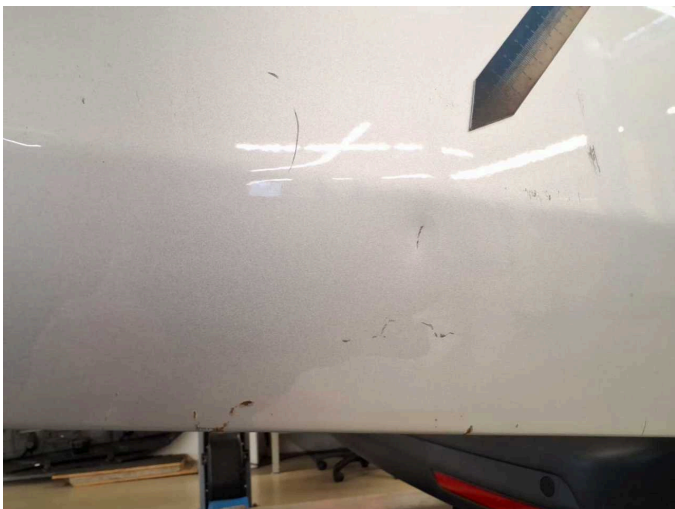
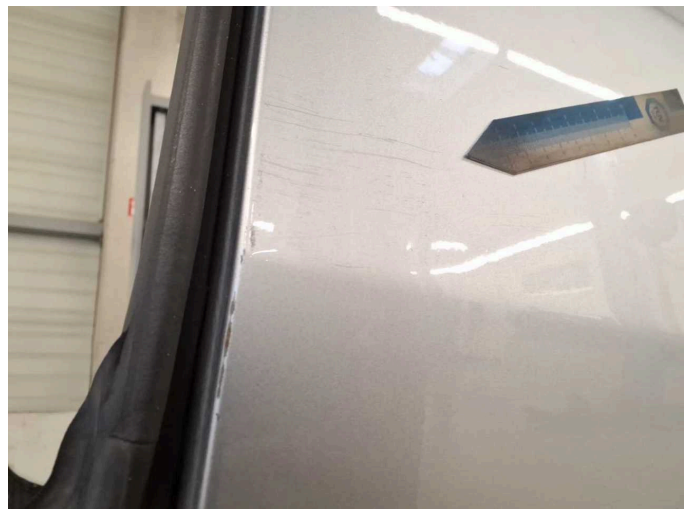
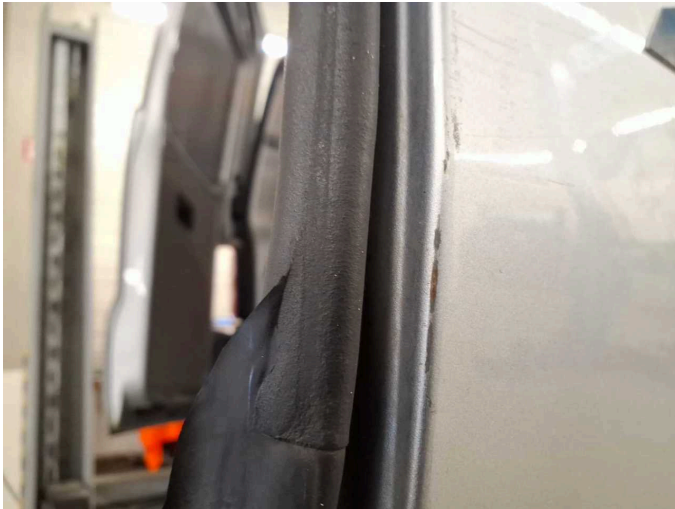
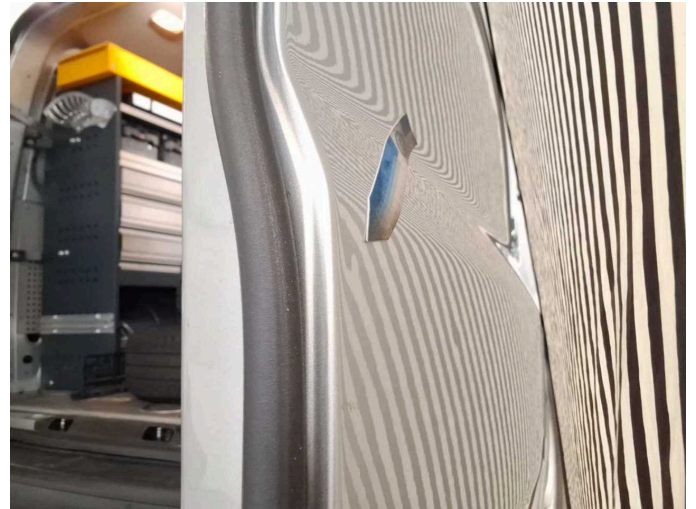
**Damage 11:** Boot lid / rear door: Rear door - right side - Dent / paintcoat damage - Repair and paint

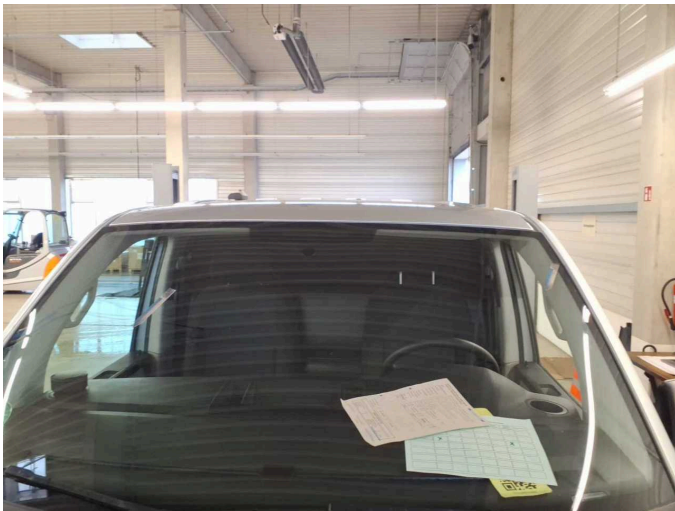
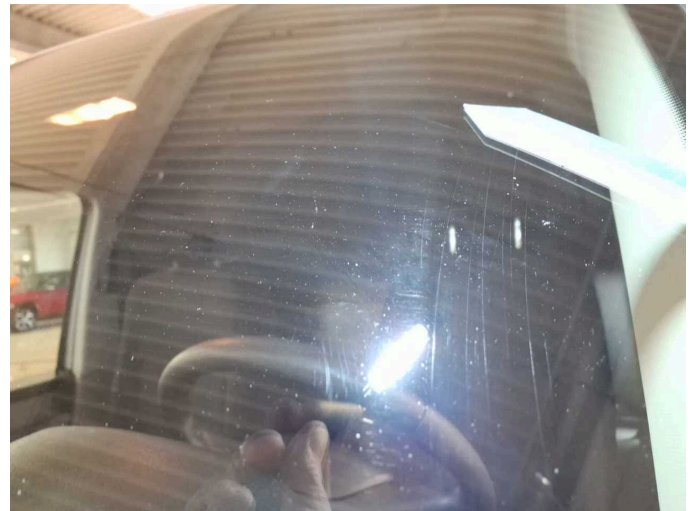
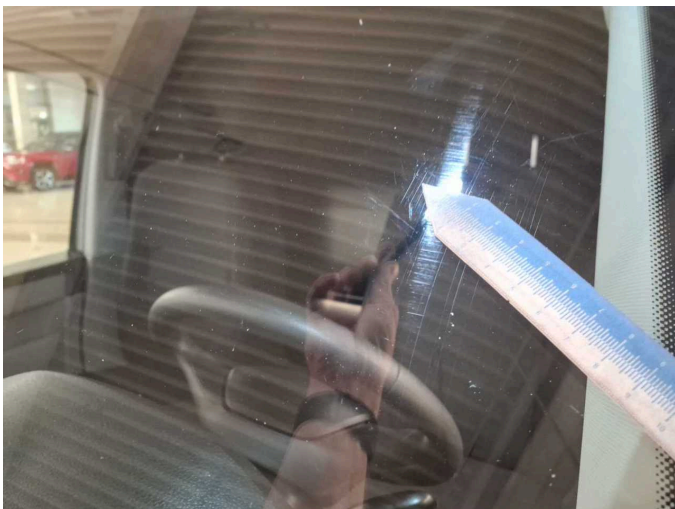
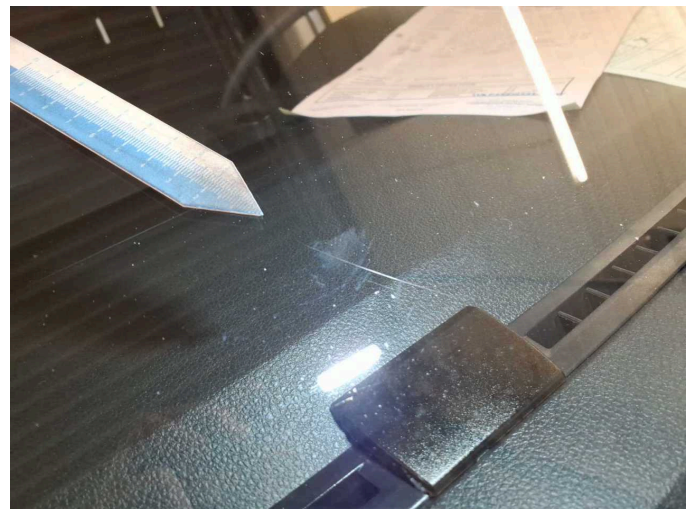
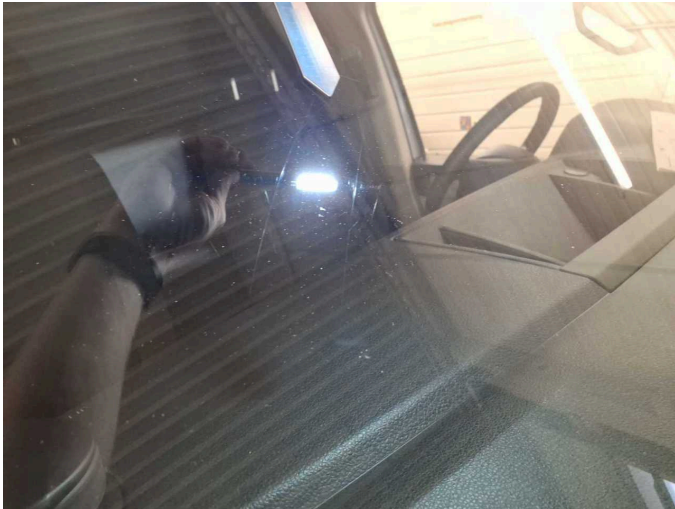
**Damage 12:** Vehicle glazing: Windscreen - Scratched - Replace

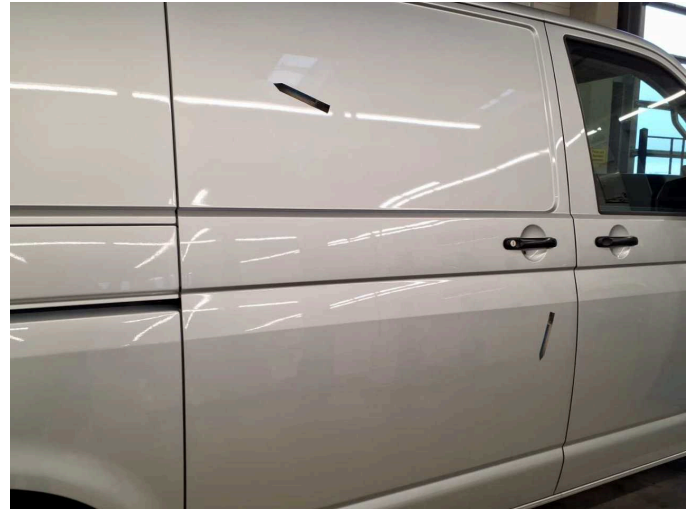
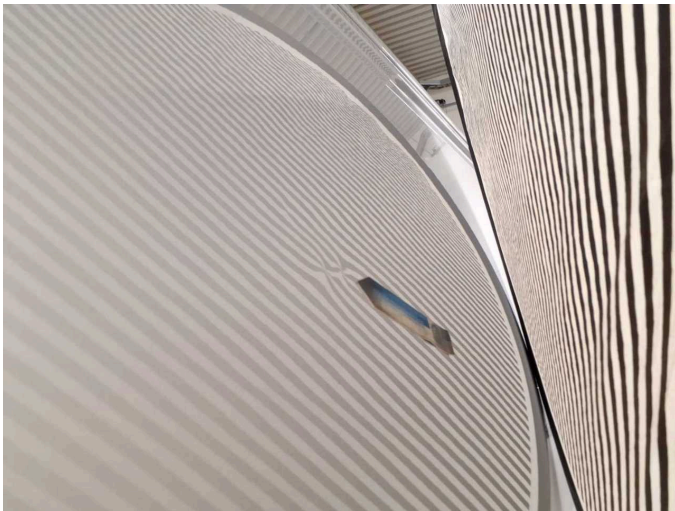
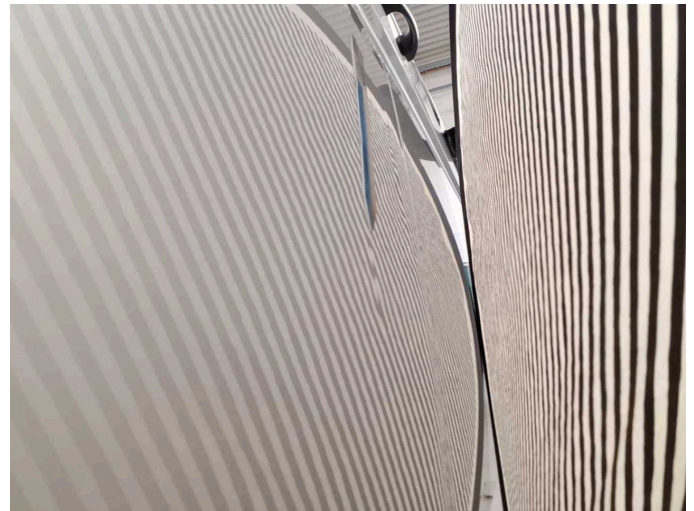
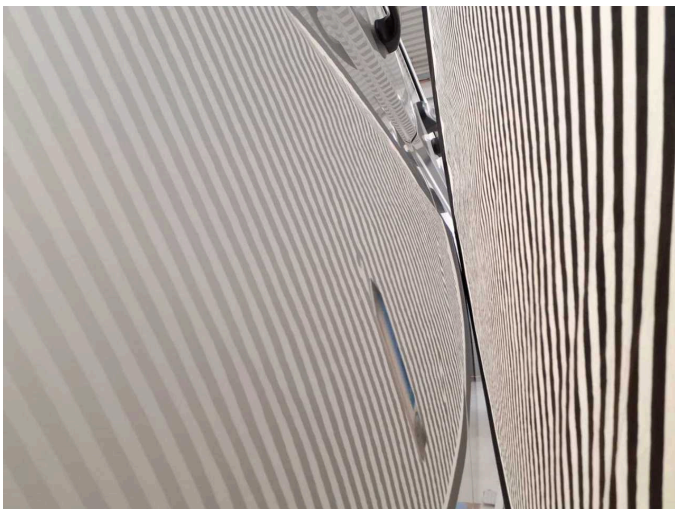
**Wear and tear 4:** Sliding door, right: Sliding door - dent(s) - No deduction

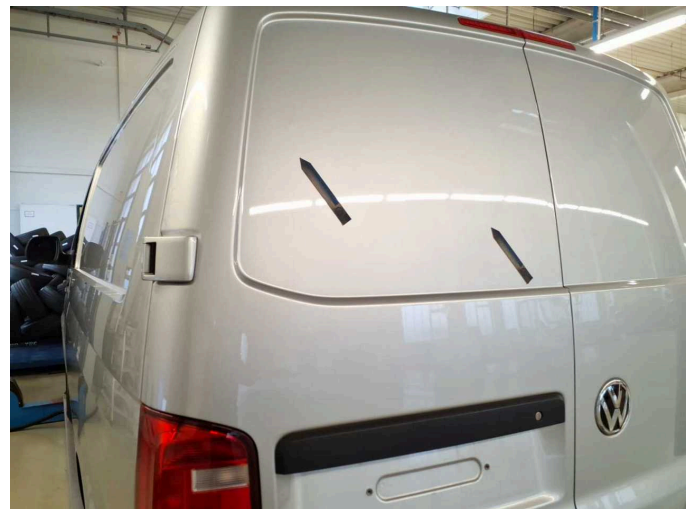
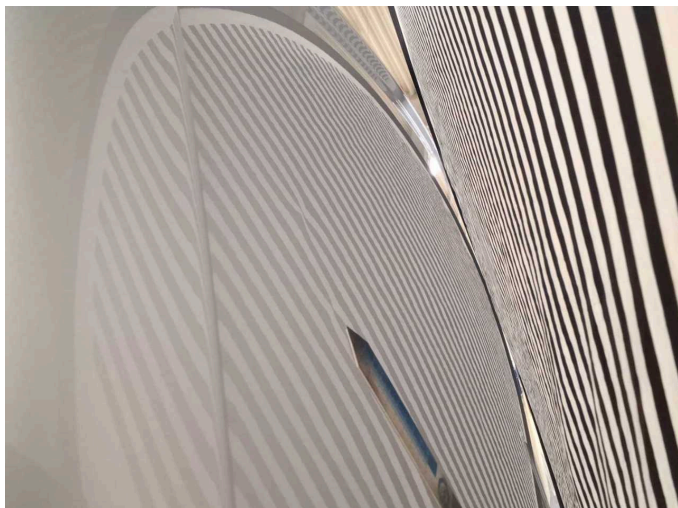
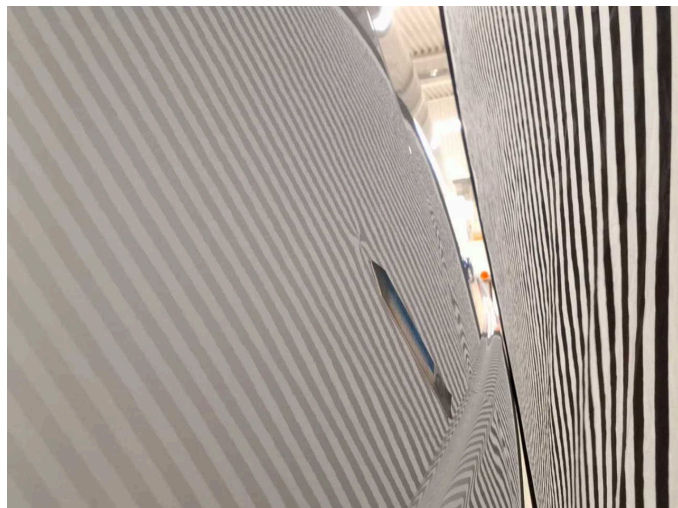
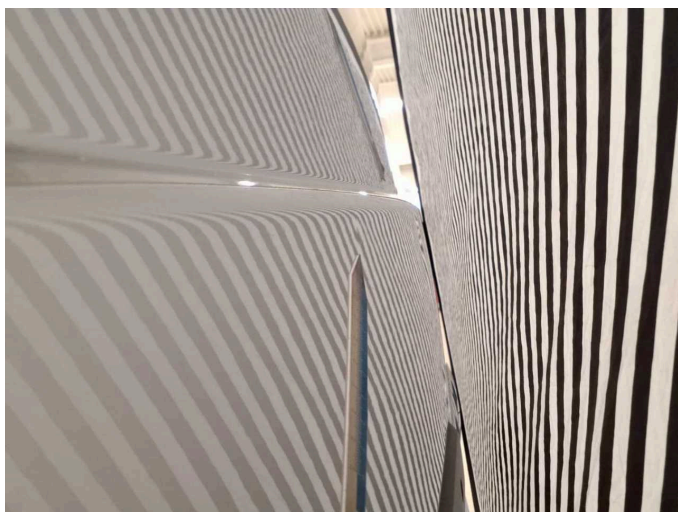
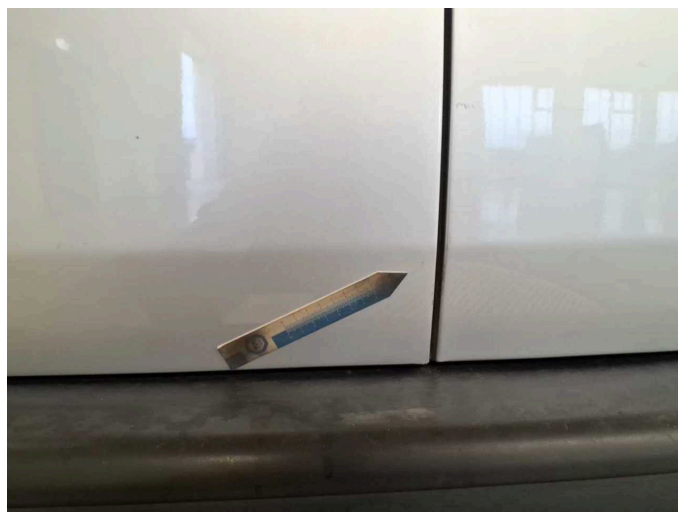
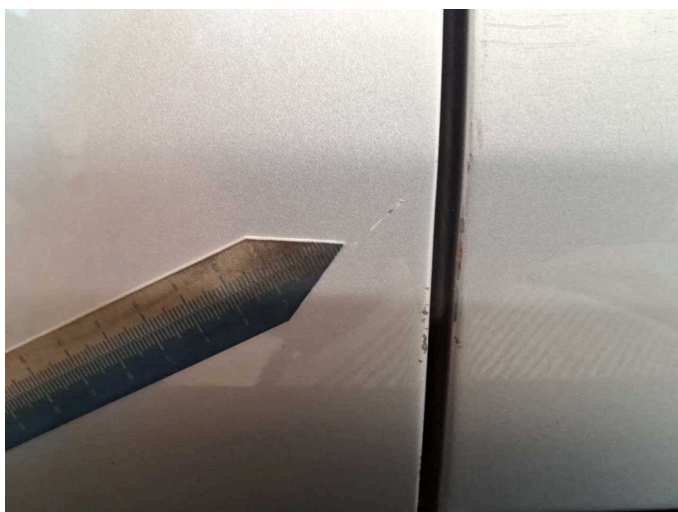
**Wear and tear 5:** Boot lid / rear door: Rear door - left side - Dent / paintcoat damage - No deduction
