Expertise

Protocol number: 41685748  
Order No. / Reference: 25226674  
Inspection date: 24 Sept 2025

Manufacturer: Volkswagen

Model: Transporter T6 Kurz BlueMotion

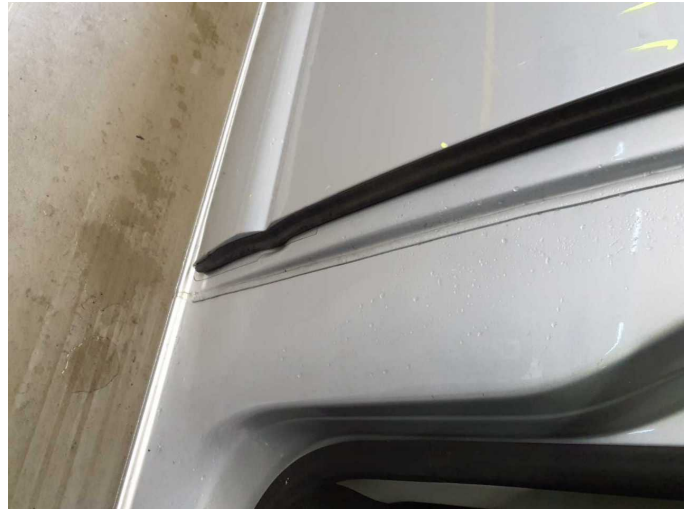
| No. | Component group | Description |
|---|---|---|
| 1 | Body | Identification plate - Missing - Replace |

**Damage 1:** Body: Identification plate - Missing - Replace

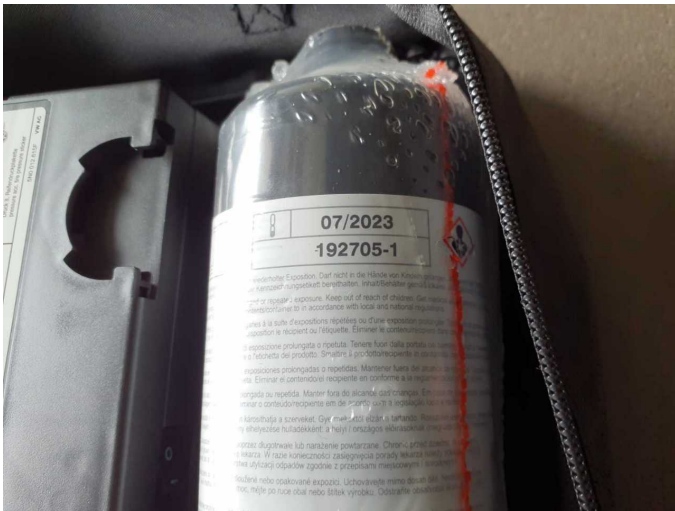
| No. | Component group | Description |
|---|---|---|
| 2 | Equipment | Tirefit filler - Expired - Replace |

**Damage 2:** Equipment: Tirefit filler - Expired - Replace

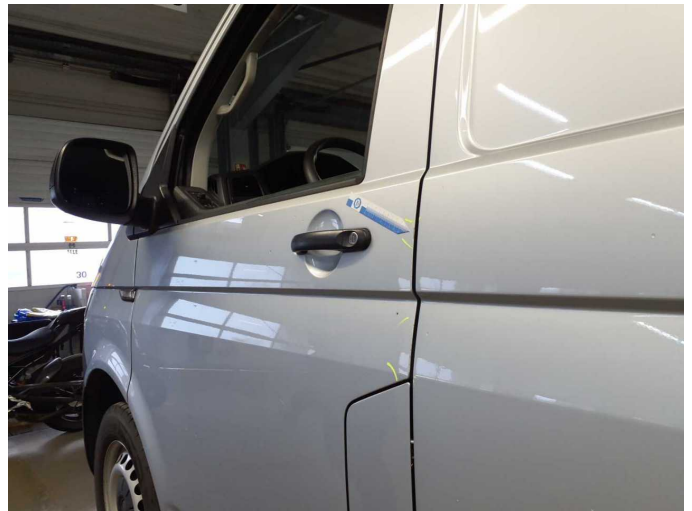
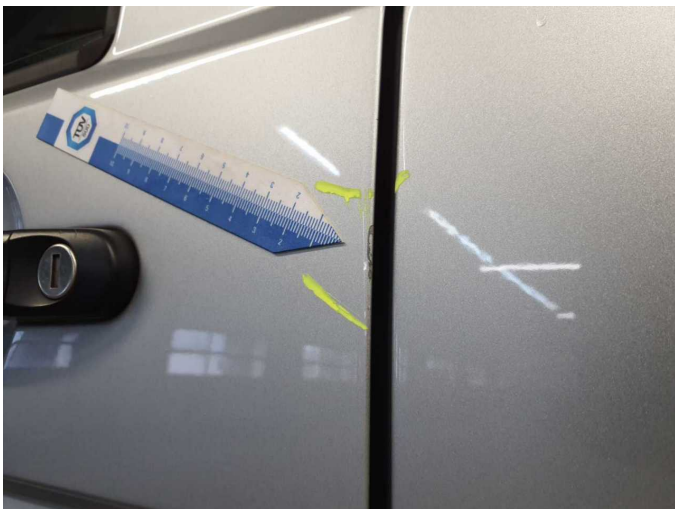
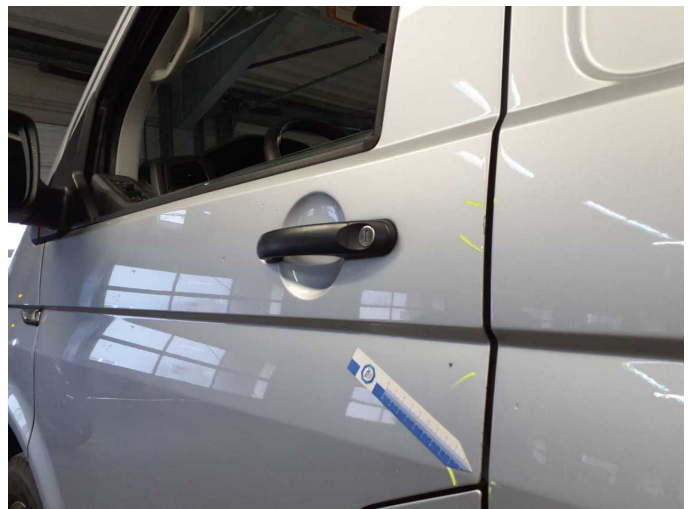
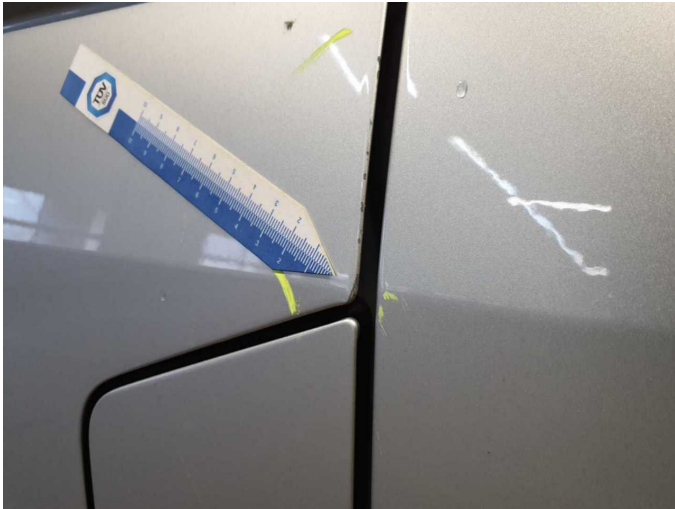
| No. | Component group | Description |
|---|---|---|
| 3 | Door - front left side | Door edge - Scratched - Smart repair |

**Damage 3:** Door - front left side: Door edge - Scratched - Smart repair

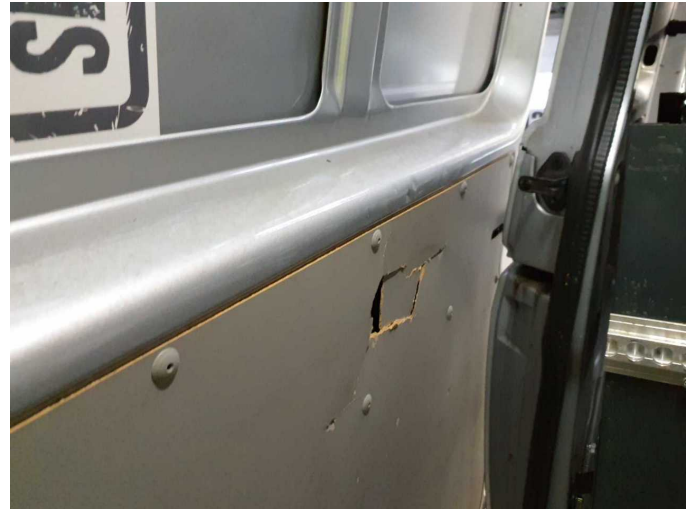
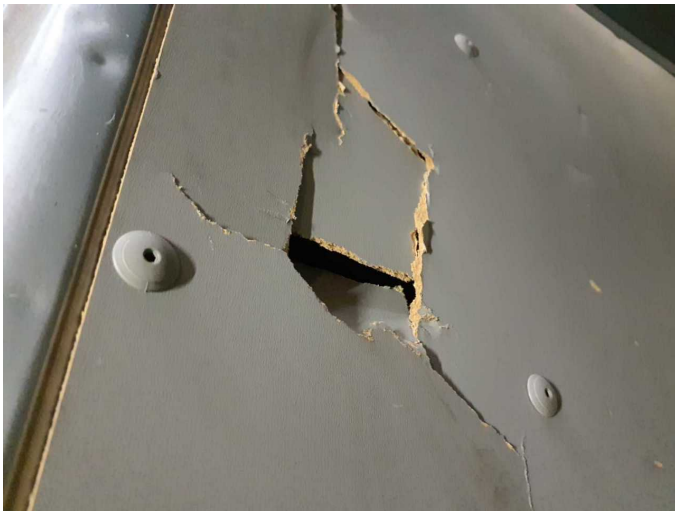
| No. | Component group | Description |
|---|---|---|
| 4 | Sliding door, right | Sliding door (Verkleidung) - Broken / torn - Replace |

**Damage 4:** Sliding door, right: Sliding door (Verkleidung) - Broken / torn - Replace

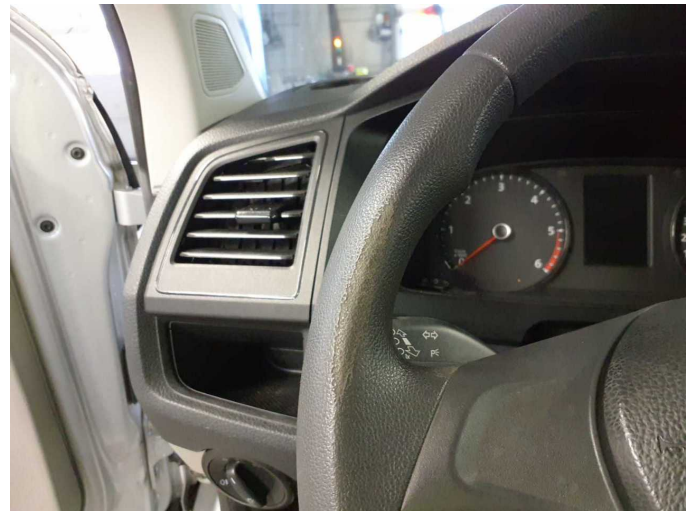
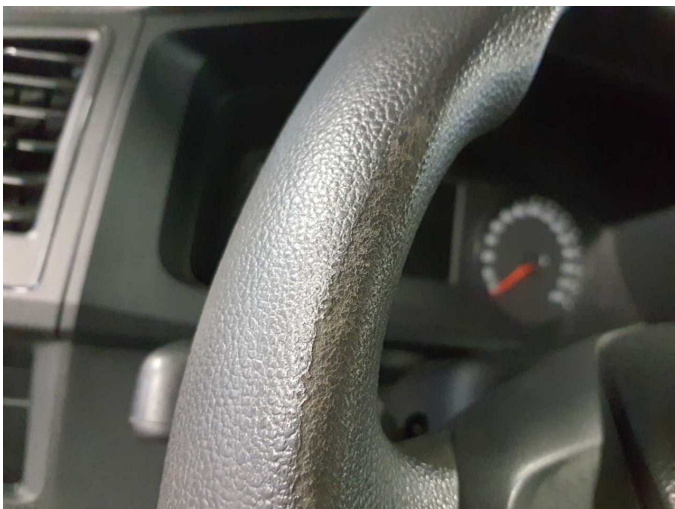
| No. | Component group | Description |
|---|---|---|
| 5 | Steering system | Steering wheel - Scratched - Smart repair |

**Damage 5:** Steering system: Steering wheel - Scratched - Smart repair

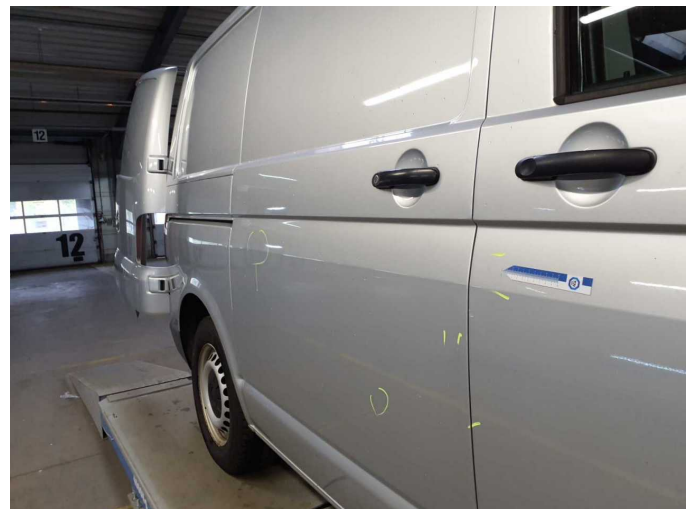
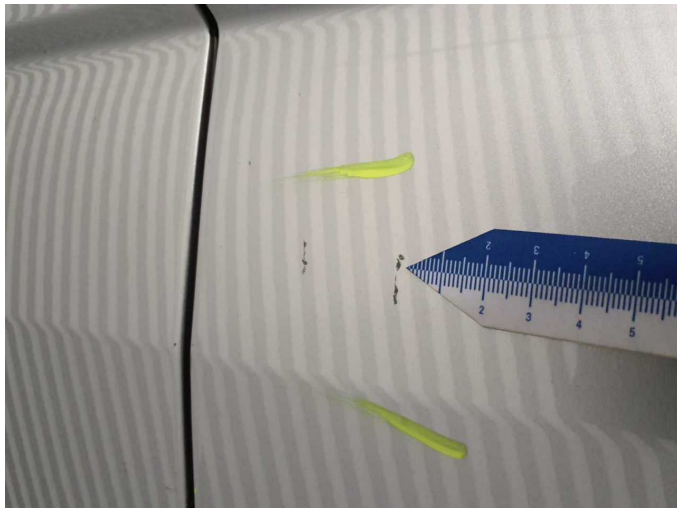
| No. | Component group | Description |
|---|---|---|
| 6 | Door - front right side | Door - Scratched - Smart repair |

**Damage 6:** Door - front right side: Door - Scratched - Smart repair

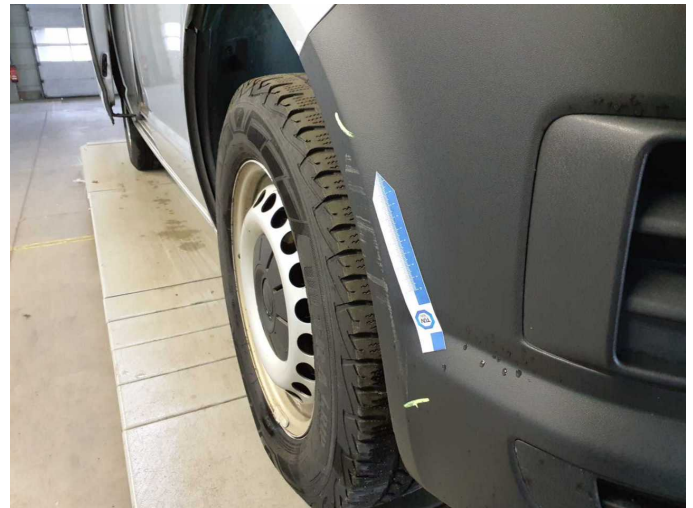
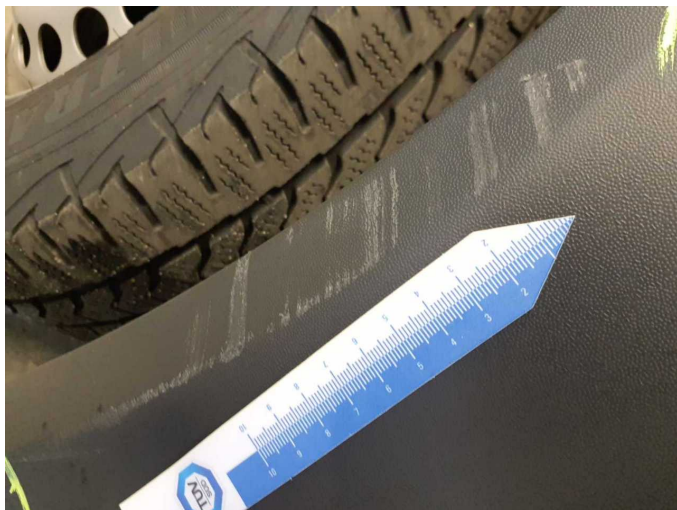
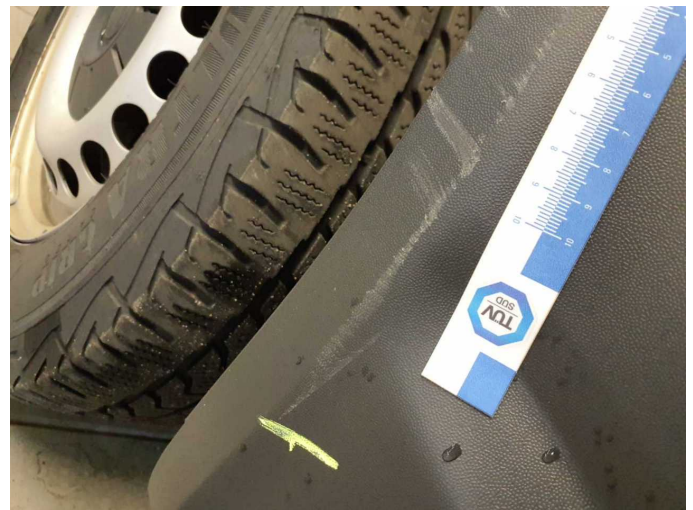
| No. | Component group | Description |
|---|---|---|
| 7 | Front bumper | Front bumper - Scratched - Smart repair |

**Damage 7:** Front bumper: Front bumper - Scratched - Smart repair

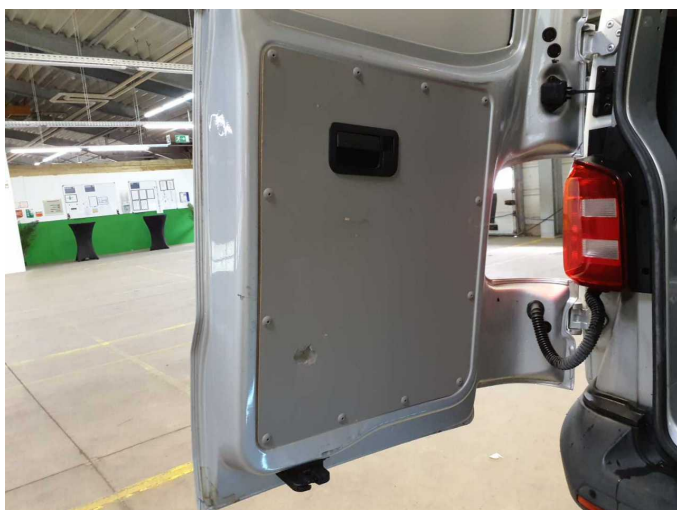
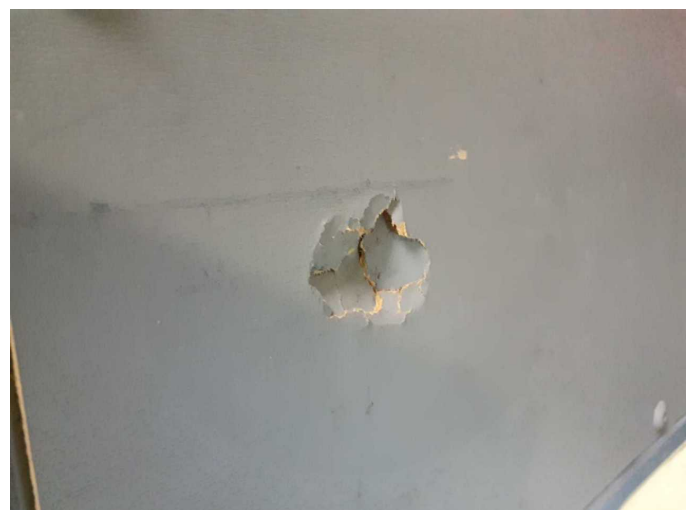
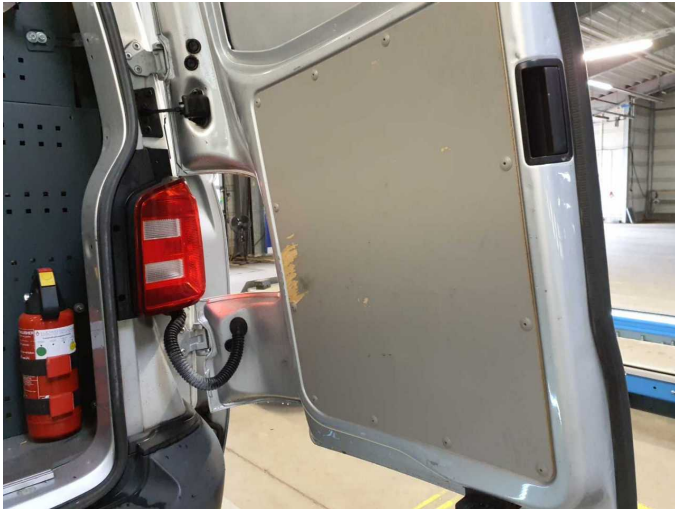
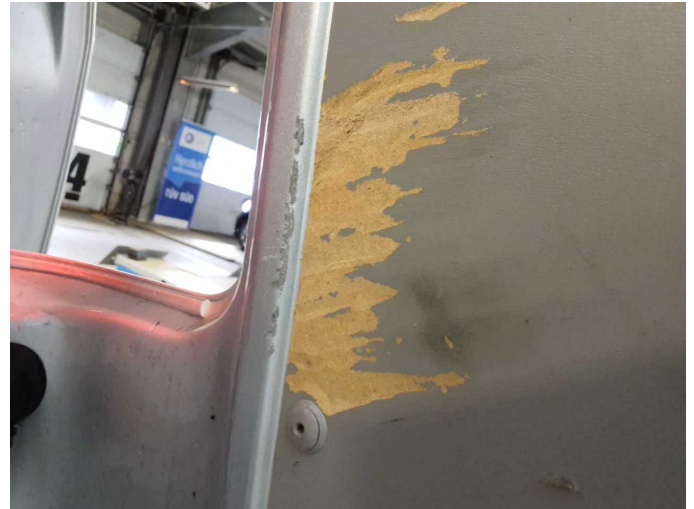
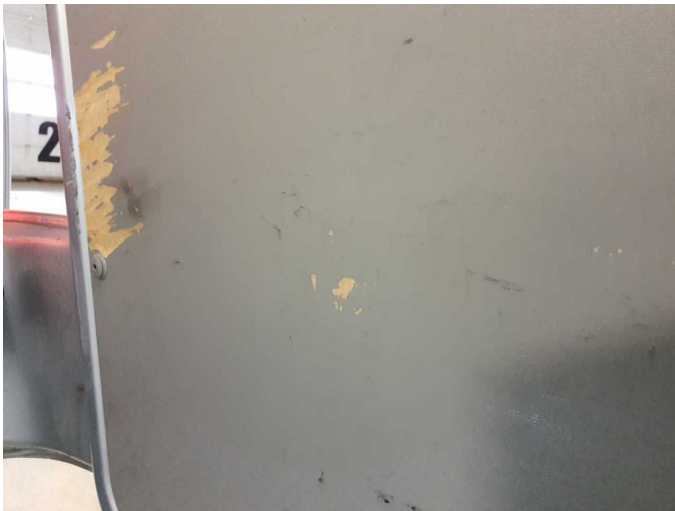
| No. | Component group | Description |
|---|---|---|
| 8 | Trim / covers | Boot lid - interior trim (Kratzer) - Broken / torn - Replace |

**Damage 8:** Trim / covers: Boot lid - interior trim (Kratzer) - Broken / torn - Replace

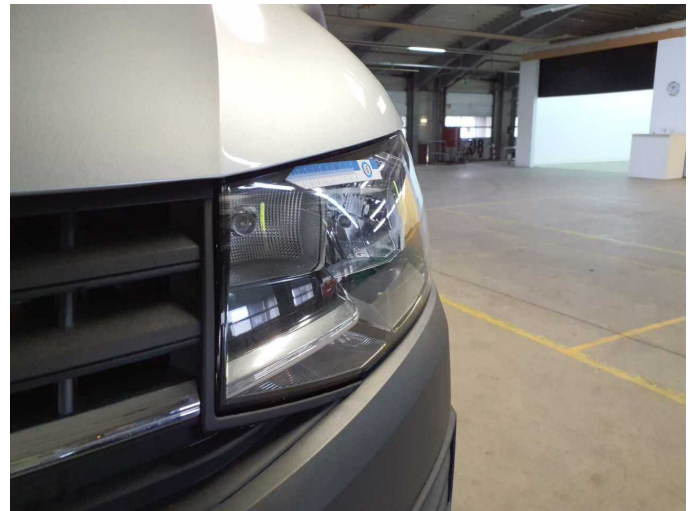
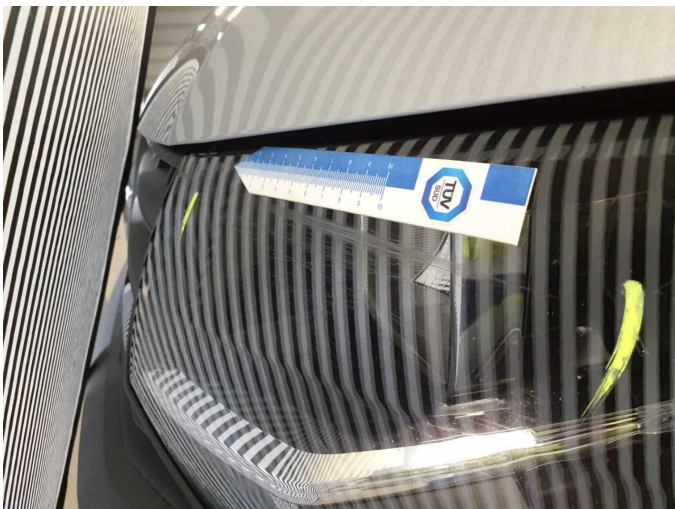
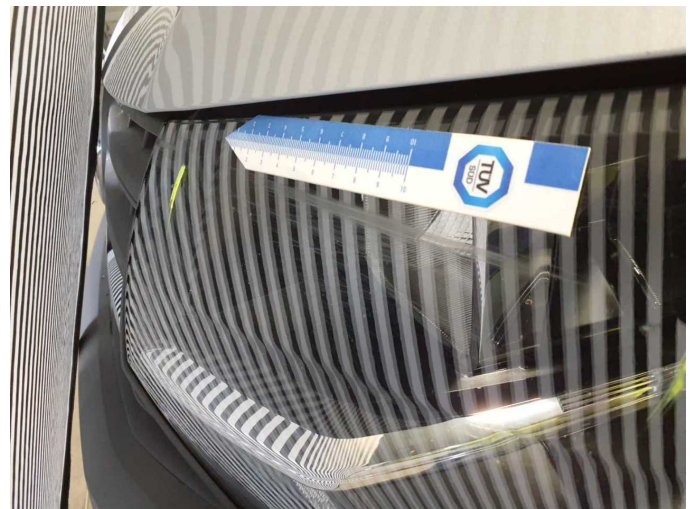
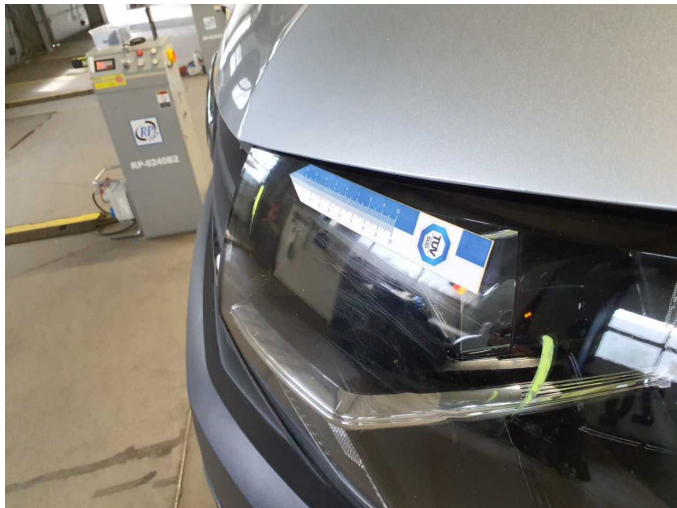
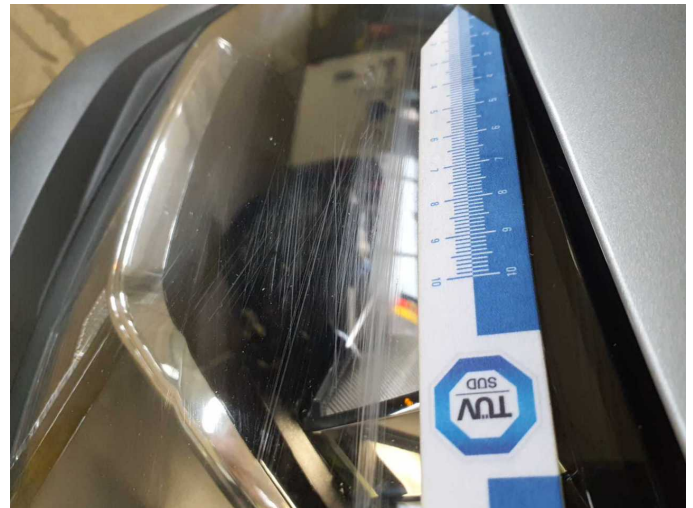
| No. | Component group | Description |
|---|---|---|
| 9 | Headlight | Headlight - left side - Scratched - Replace |

**Damage 9:** Headlight: Headlight - left side - Scratched - Replace

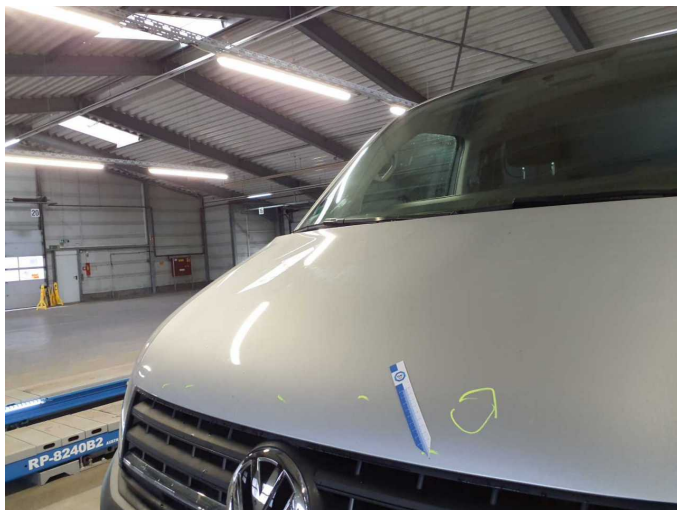
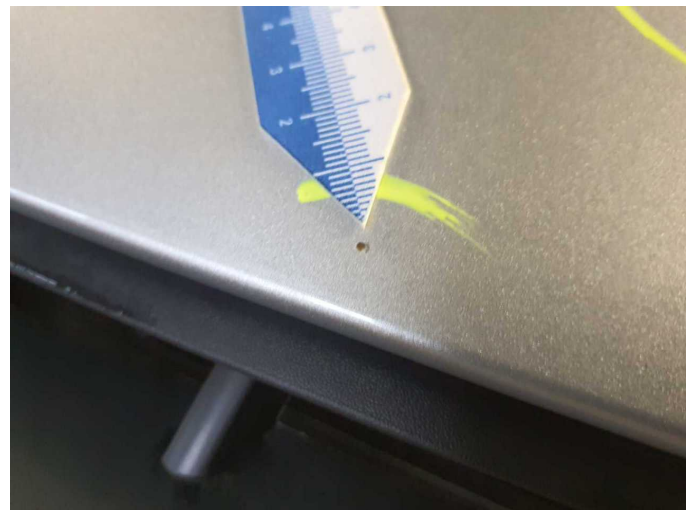
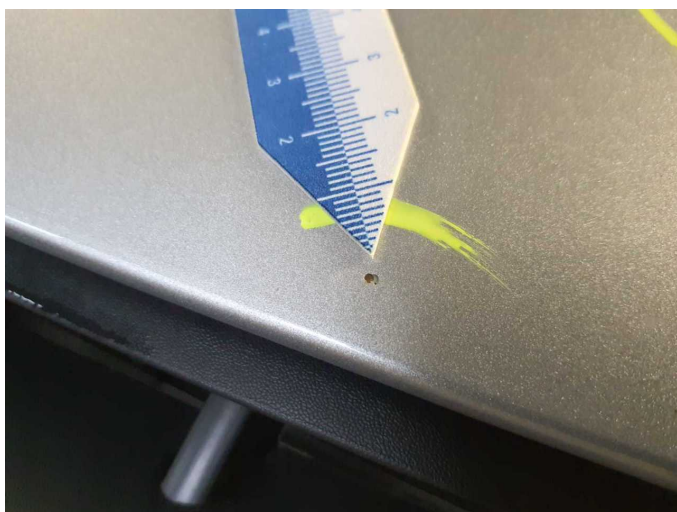
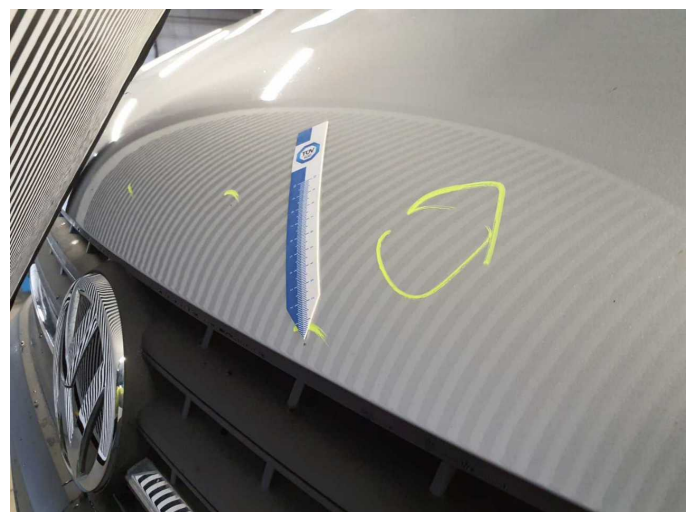
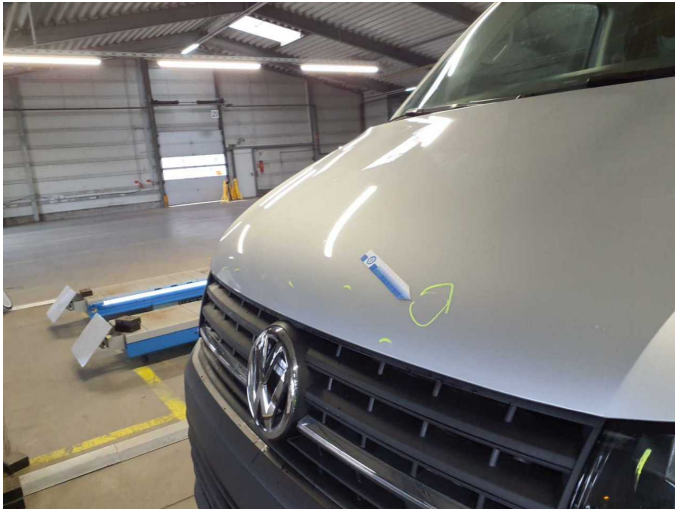
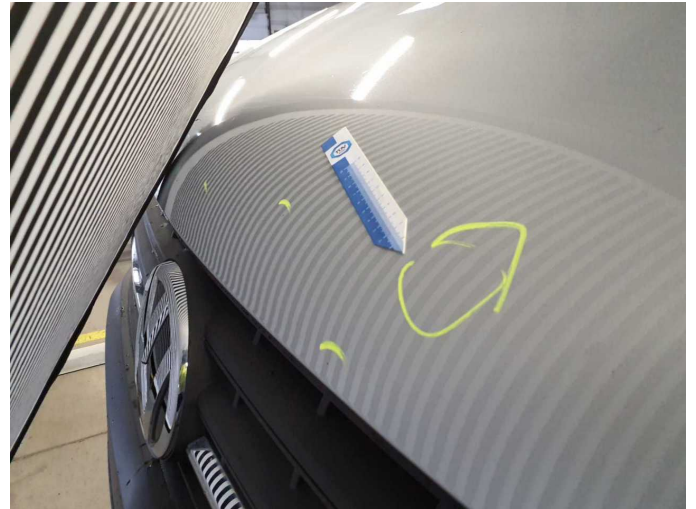
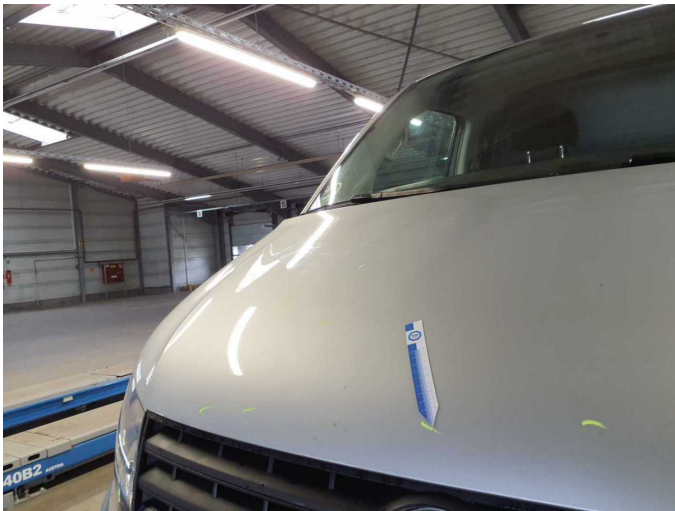
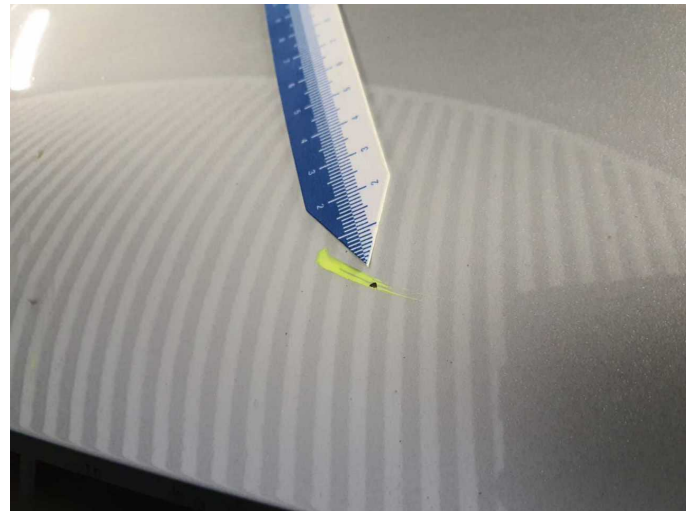
| No. | Component group | Description |
|---|---|---|
| 10 | Bonnet | Bonnet (Steinschlag) - Corrosion - Repair and paint |

**Damage 10:** Bonnet: Bonnet (Steinschlag) - Corrosion - Repair and paint

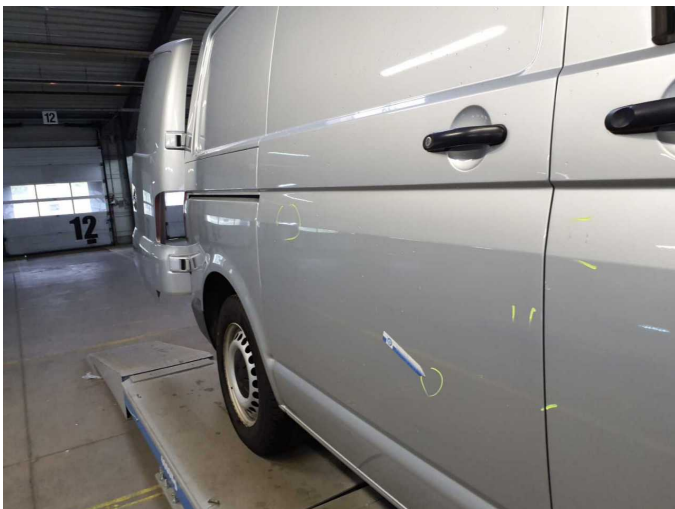
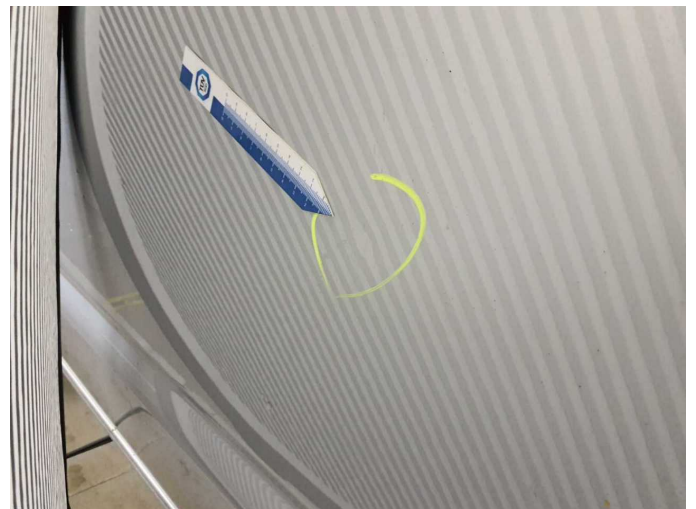
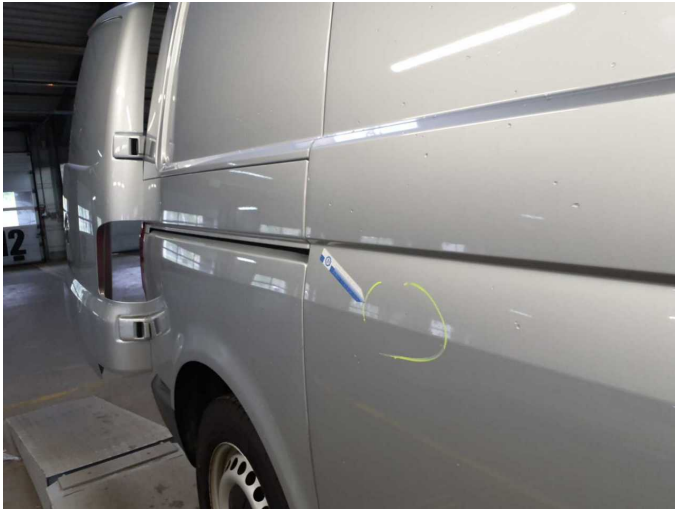
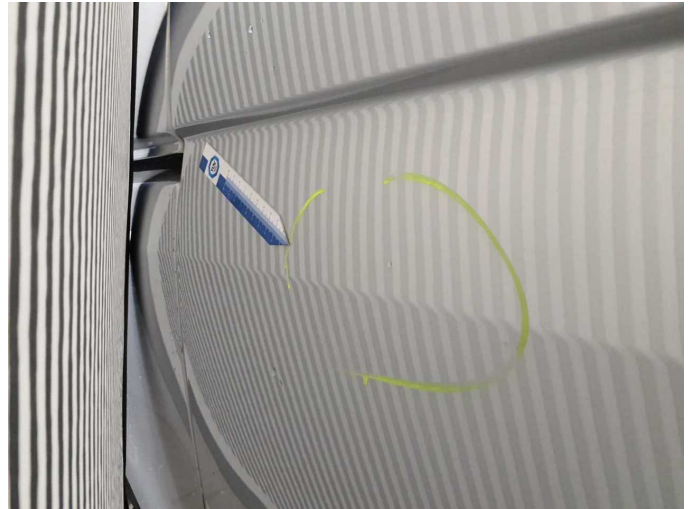
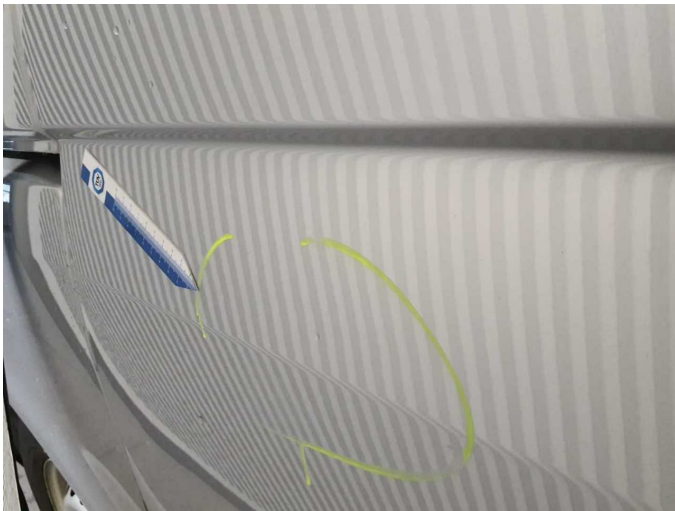
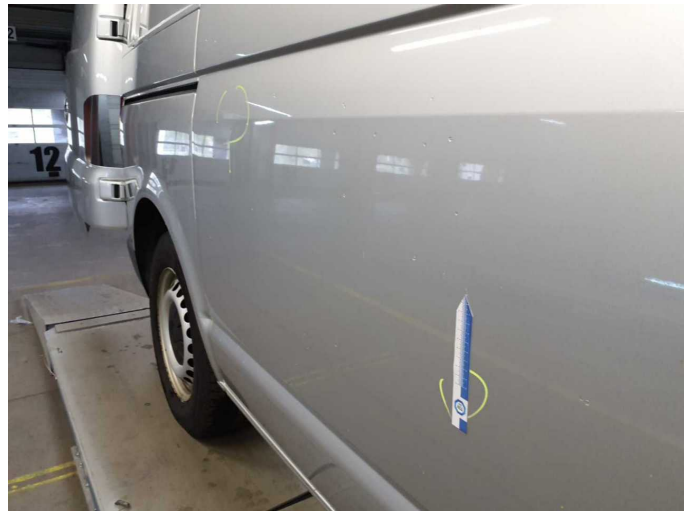
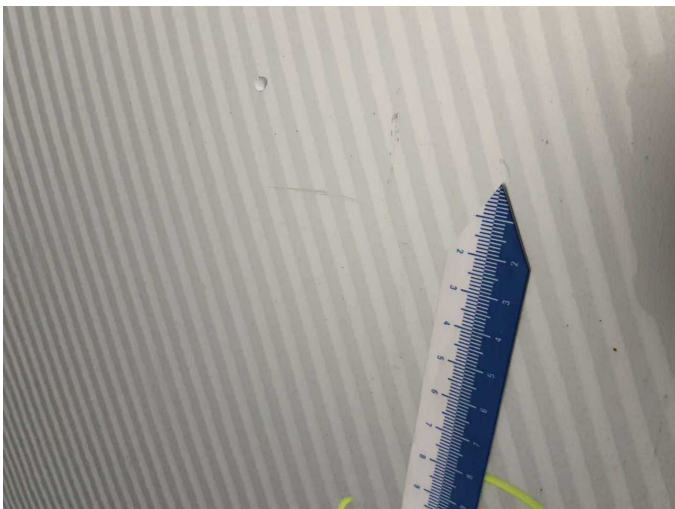
| No. | Component group | Description |
|---|---|---|
| 11 | Sliding door, right | Sliding door (Dellen) - Scratched - Repair and paint |

**Damage 11:** Sliding door, right: Sliding door (Dellen) - Scratched - Repair and paint

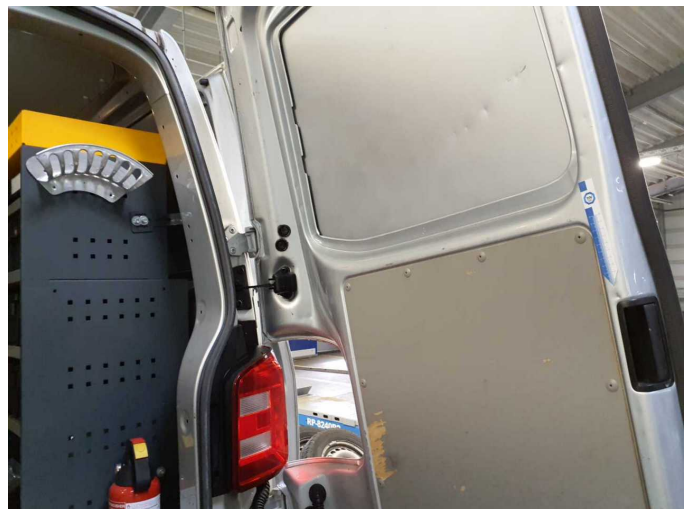
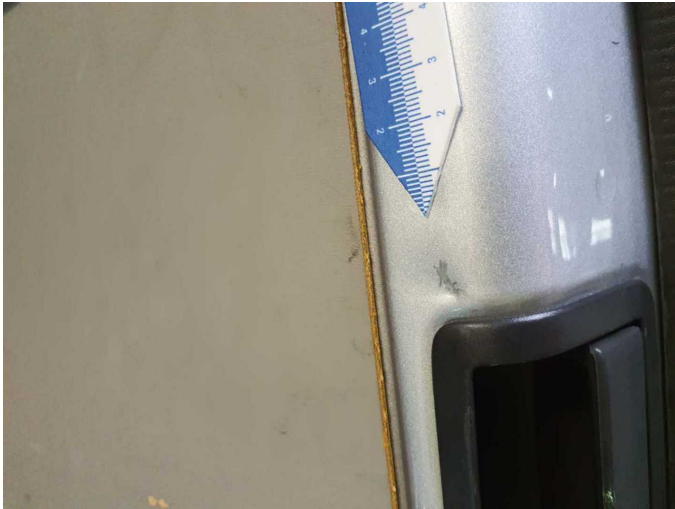
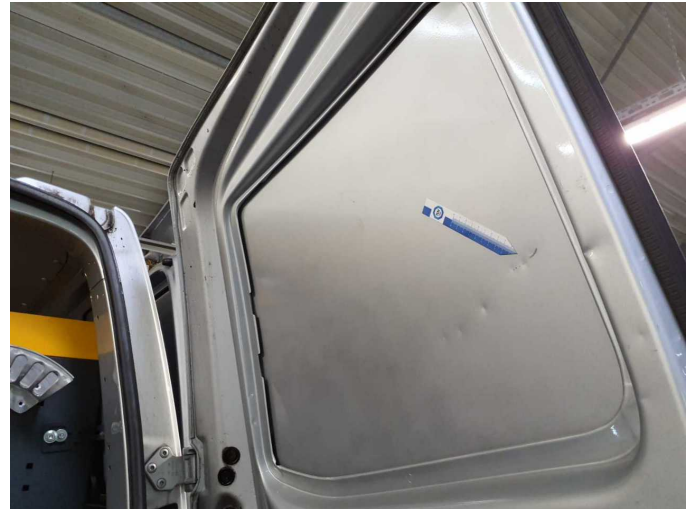
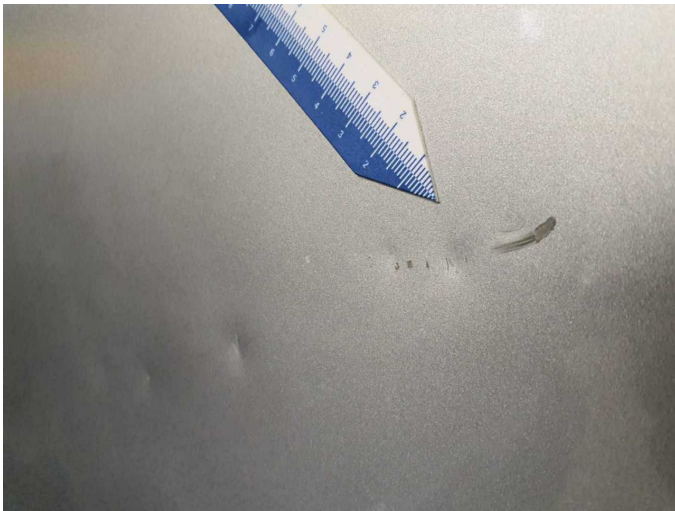
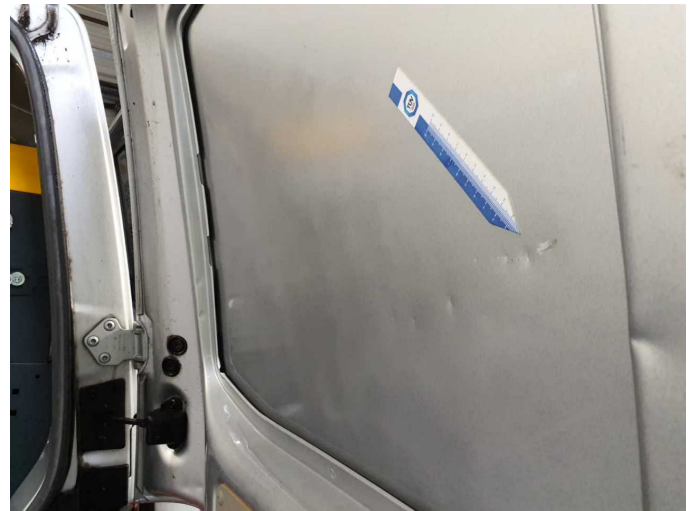
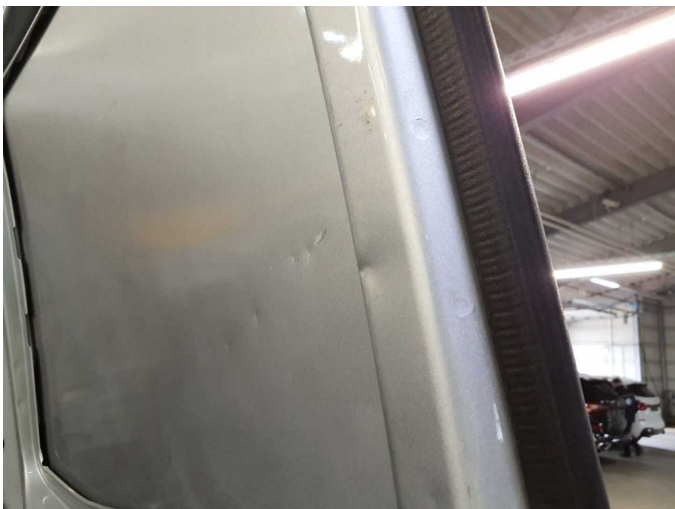
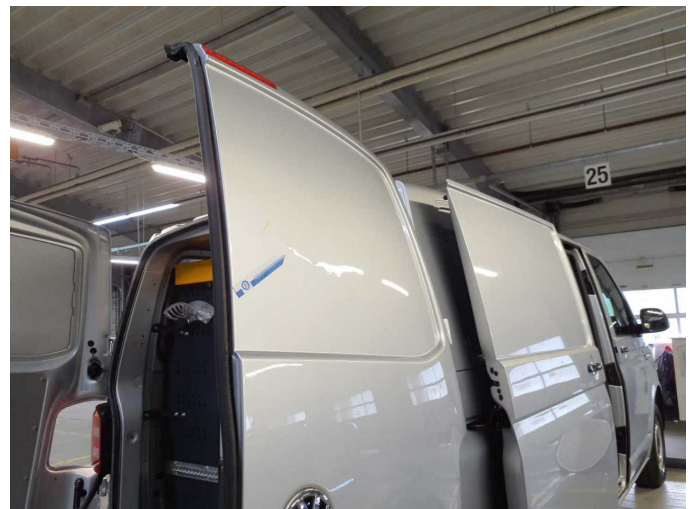
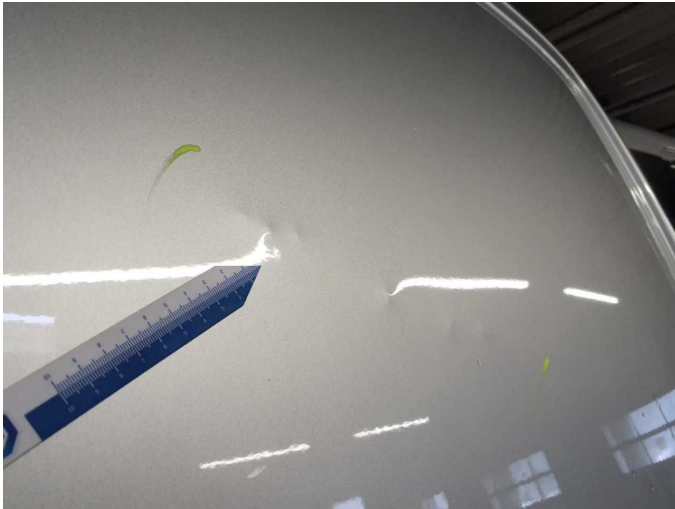
| No. | Component group | Description |
|---|---|---|
| 12 | Boot lid / rear door | Rear door - right side (Kratzer) - Deformed - Repair and paint |

**Damage 12:** Boot lid / rear door: Rear door - right side (Kratzer) - Deformed - Repair and paint

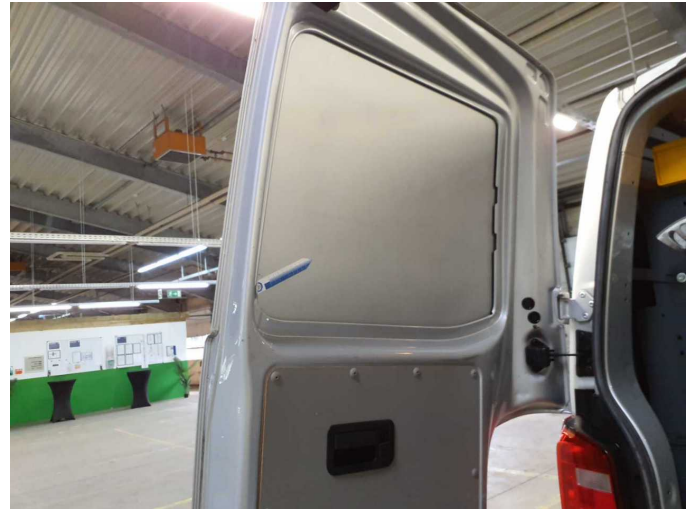
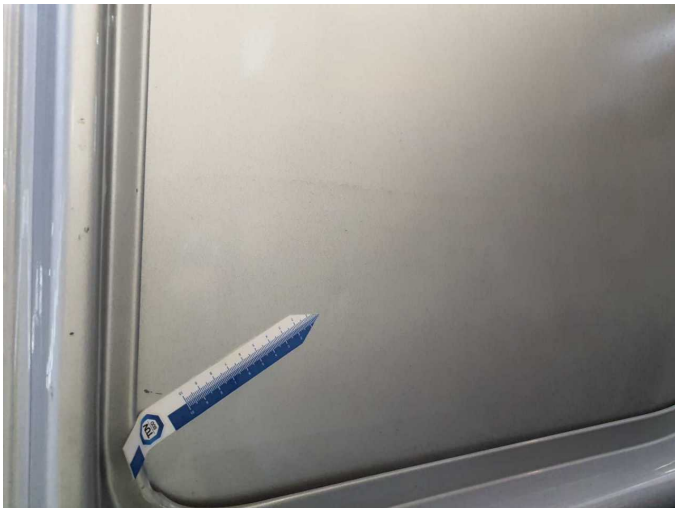
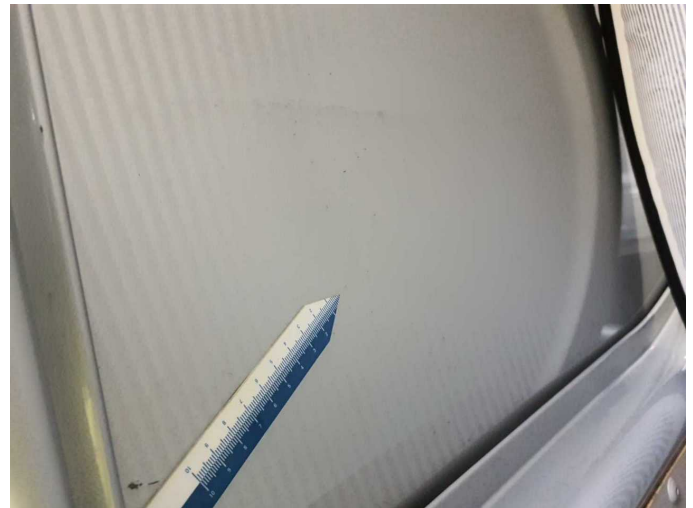
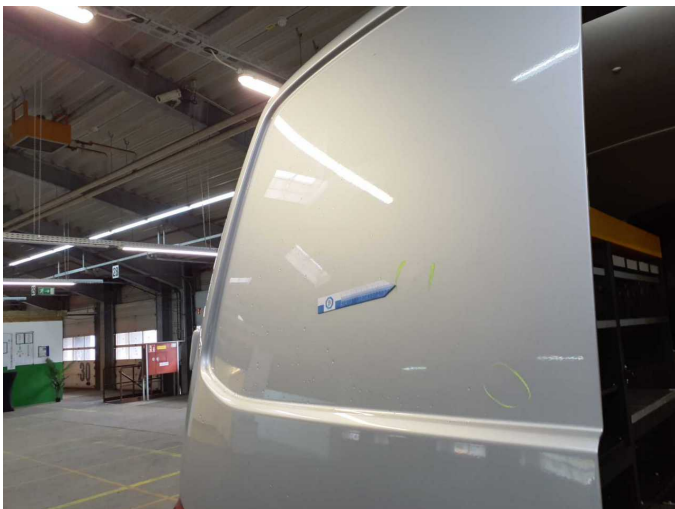
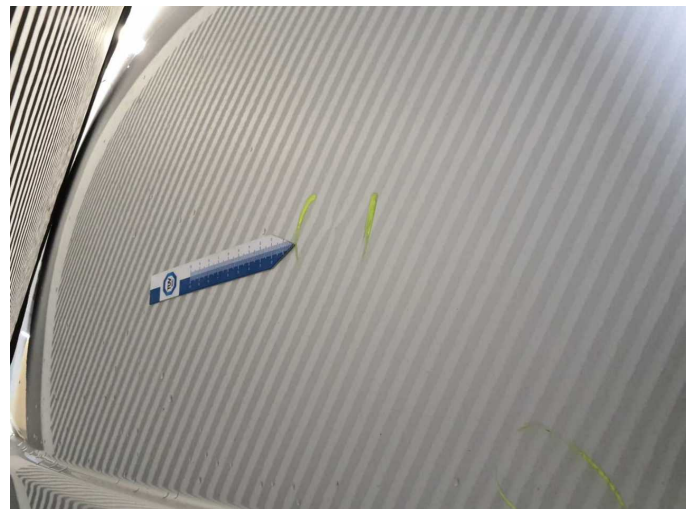
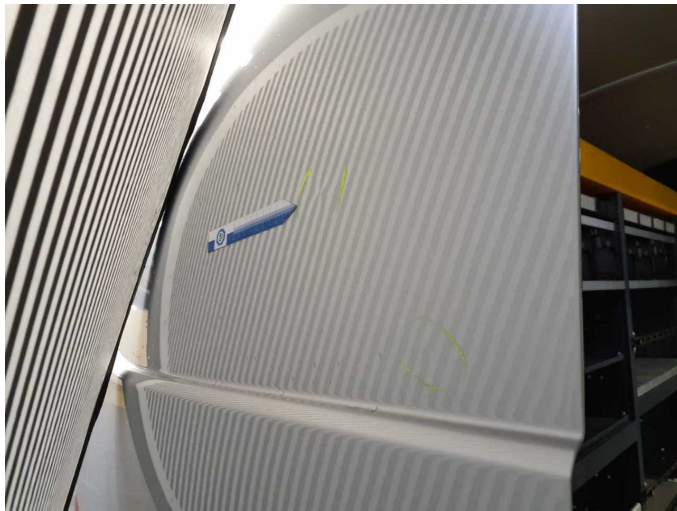
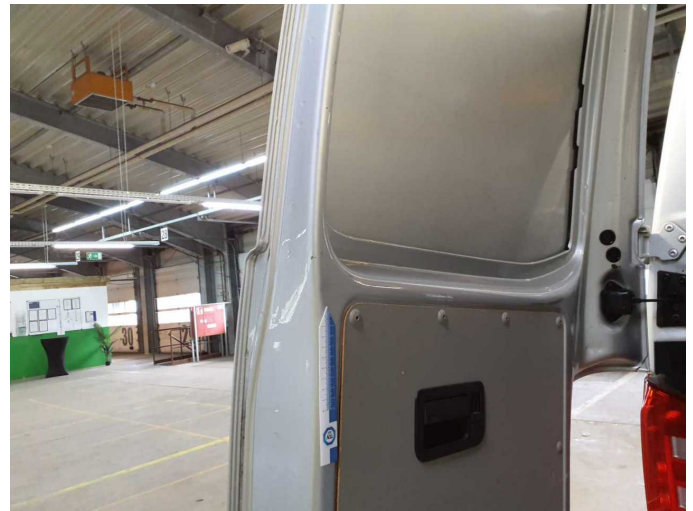
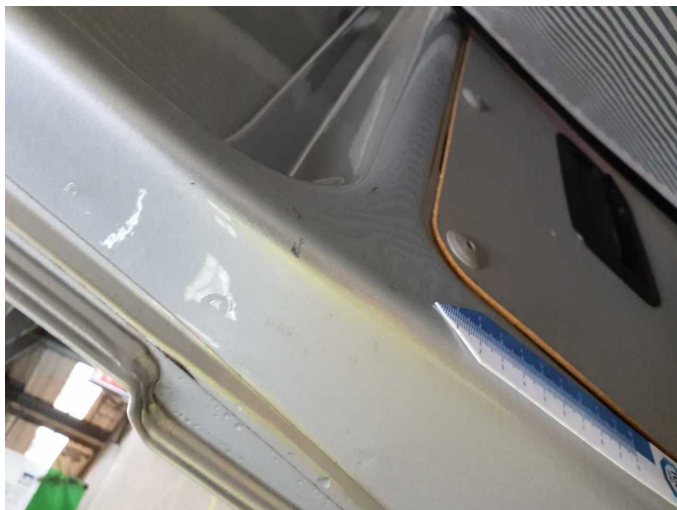
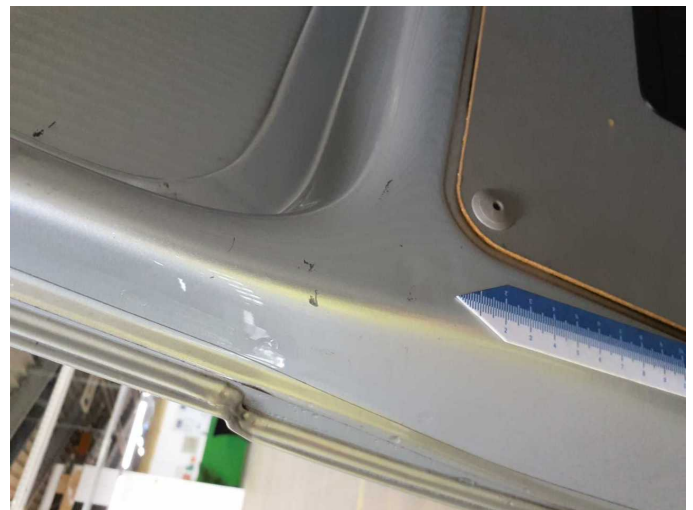
| No. | Component group | Description |
|---|---|---|
| 13 | Boot lid / rear door | Rear door - left side (Kratzer) - Dent / paintcoat damage - Repair and paint |

**Damage 13:** Boot lid / rear door: Rear door - left side (Kratzer) - Dent / paintcoat damage - Repair and paint

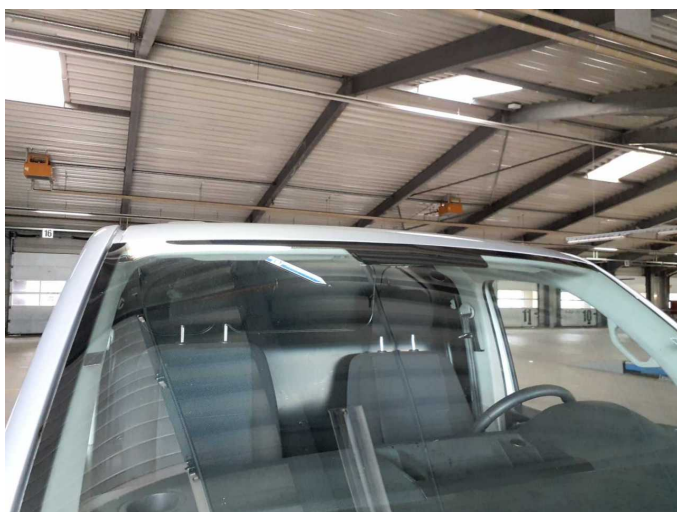
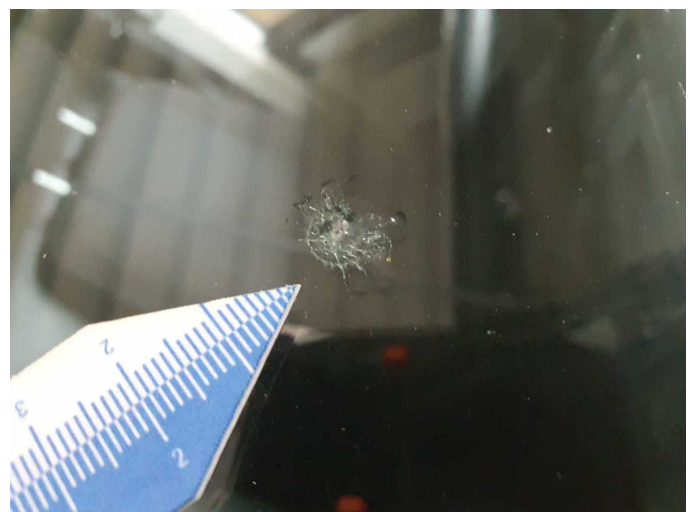
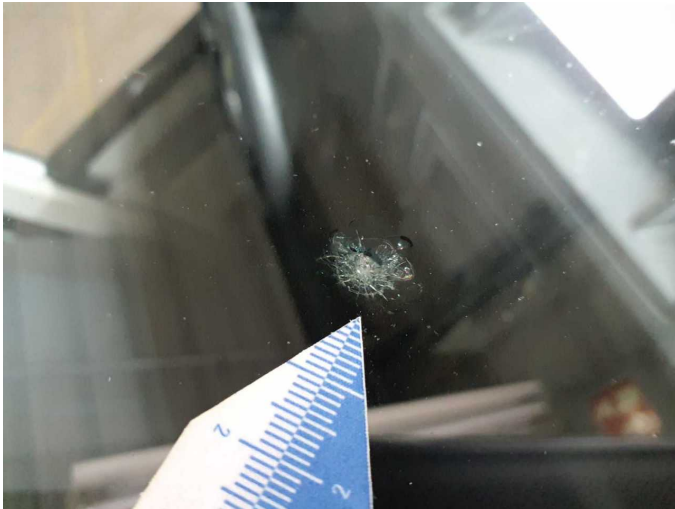
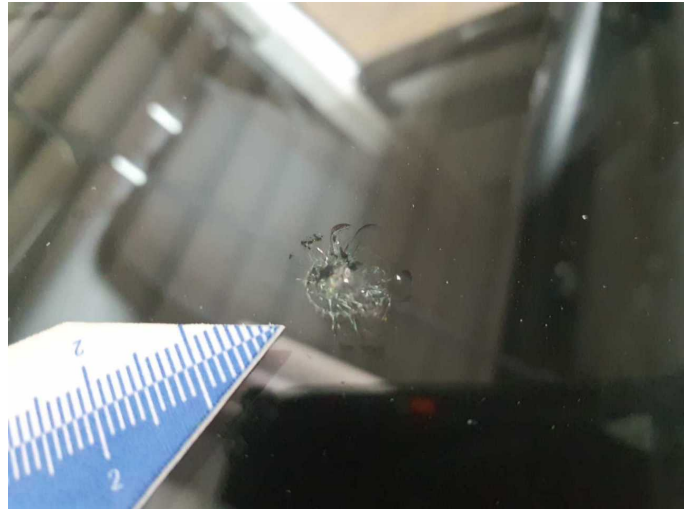
| No. | Component group | Description |
|---|---|---|
| 14 | Vehicle glazing | Windscreen (Rissbildung) - Stone chips - Replace |

**Damage 14:** Vehicle glazing: Windscreen (Rissbildung) - Stone chips - Replace
