Expertise

Protocol number: 41685748  
Order No. / Reference: 25226674  
Inspection date: 24 Sept 2025

Manufacturer: Volkswagen

Model: Transporter T6 Kurz BlueMotion

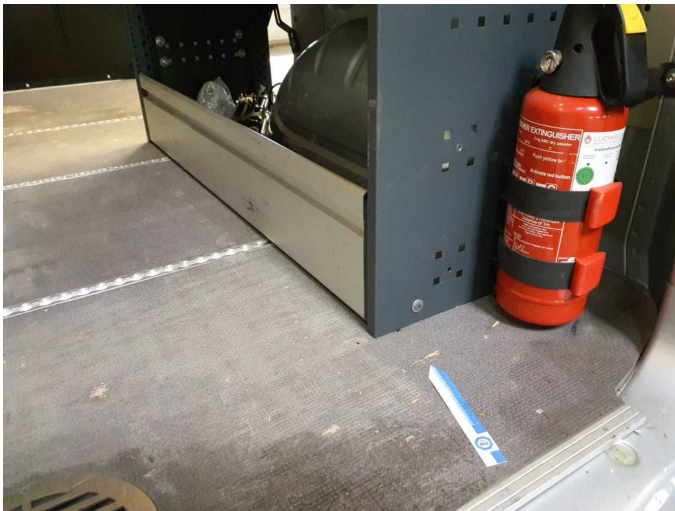
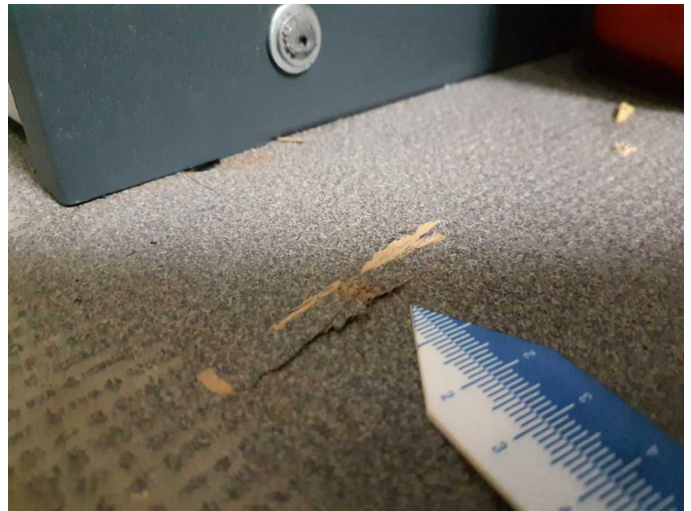
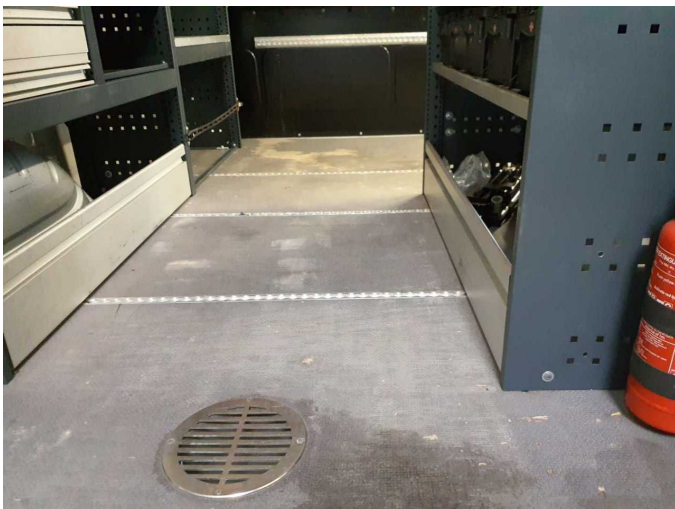
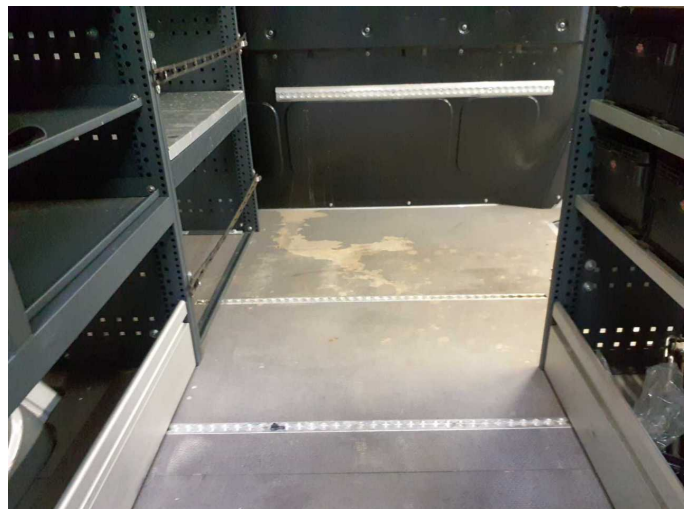
| No. | Component group | Description |
|---|---|---|
| 1 | Interior | Cargo area floor (Kratzer) - Holes - No deduction |

**Wear and tear 1:** Interior: Cargo area floor (Kratzer) - Holes - No deduction

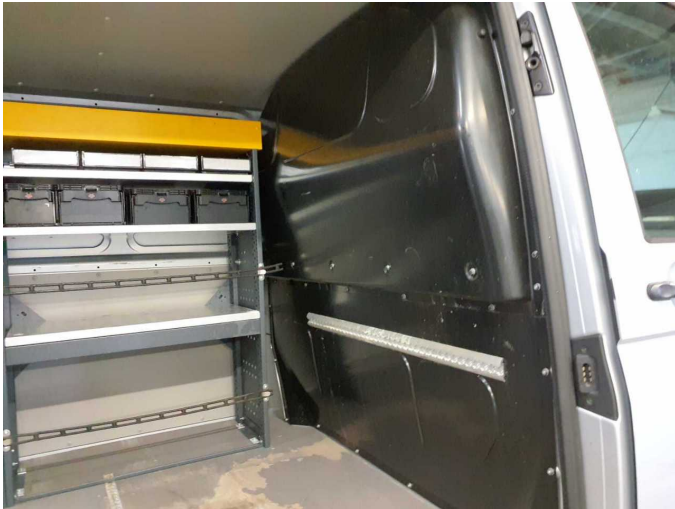
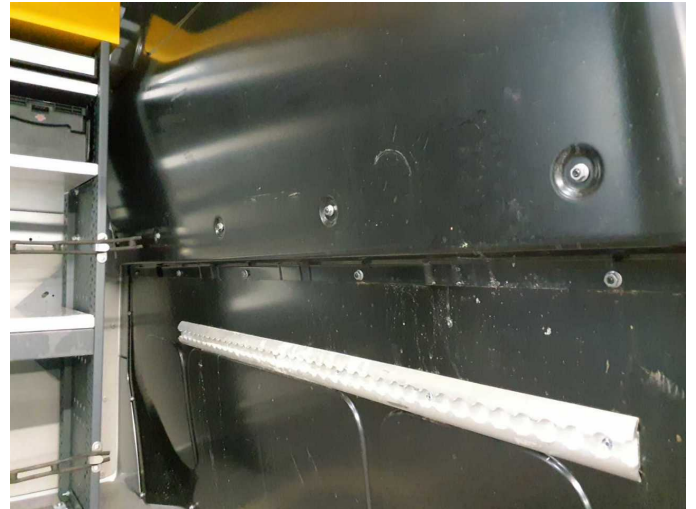
| No. | Component group | Description |
|---|---|---|
| 2 | Body | Partition wall (Dellen) - Scratched - No deduction |

**Wear and tear 2:** Body: Partition wall (Dellen) - Scratched - No deduction

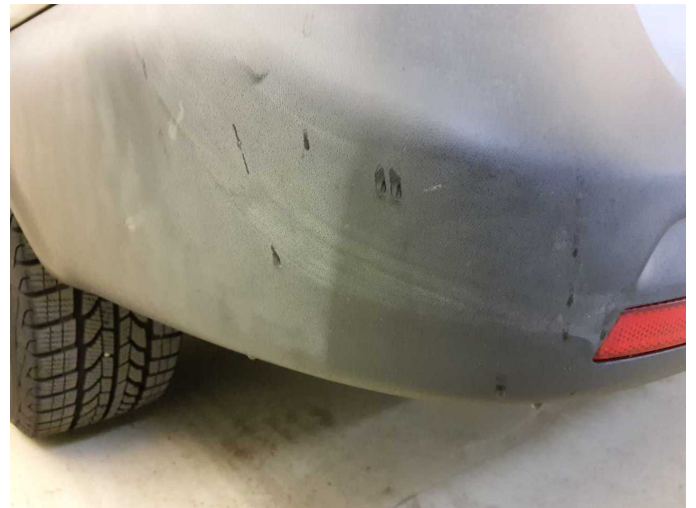
| No. | Component group | Description |
|---|---|---|
| 5 | Rear bumper | Rear bumper - Scratched - No deduction |

**Wear and tear 5:** Rear bumper: Rear bumper - Scratched - No deduction

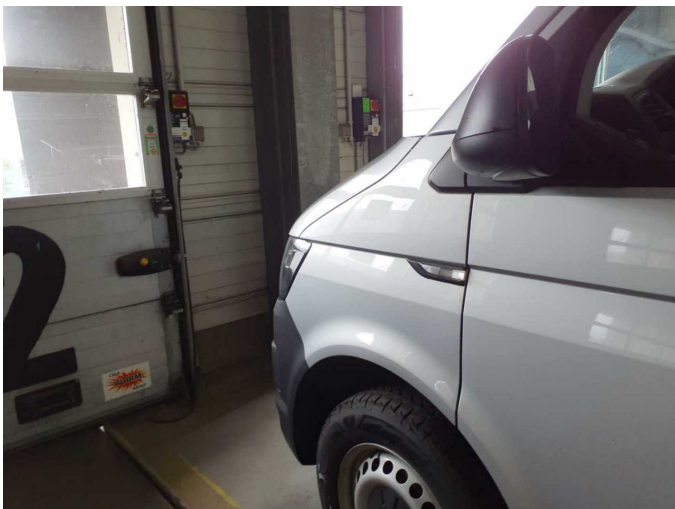
| No. | Repainting |
|---|---|
| 1 | Mudguard - left side, Professionally carried out, Invoice of repair done Non-existent |

| Mudguard - left side | 191 µm | Side panel - rear left side | 191 µm |

**Repainting 1:** Mudguard - left side
