## Volkswagen Transporter: VDL54P

| Vinnumber: | WV1ZZZ7HZKH198571 | Versionname: | Transporter 2.0 TDI 75kW L2H1 GB |

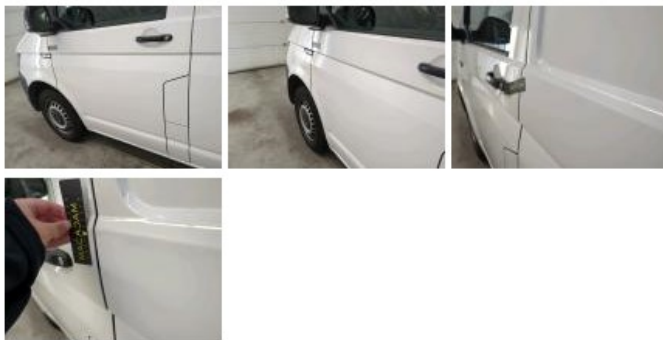
Door FL, Dent(s) and scratch(es), Repair and paint (complete)

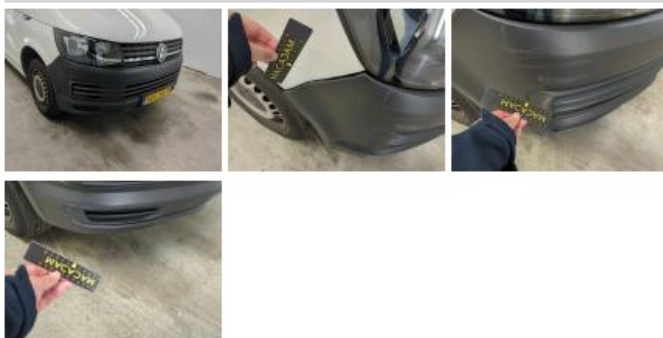
Bumper F, Scratch(es), Smart repair

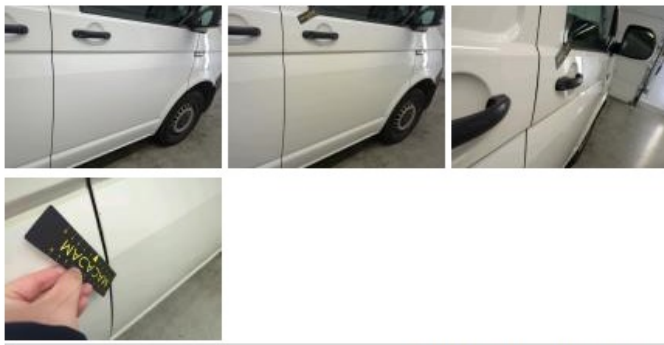
Door FR, Dent(s) and scratch(es), Repair and paint (complete)
