Expertise

Protocol number: 40614436
Order No. / Reference: 24946253
Inspection date: 16 Jul 2025

Manufacturer: Volkswagen	Model: Caddy Cargo 2.0 TDI BMT
VIN: WV1ZZZSKZNX007086

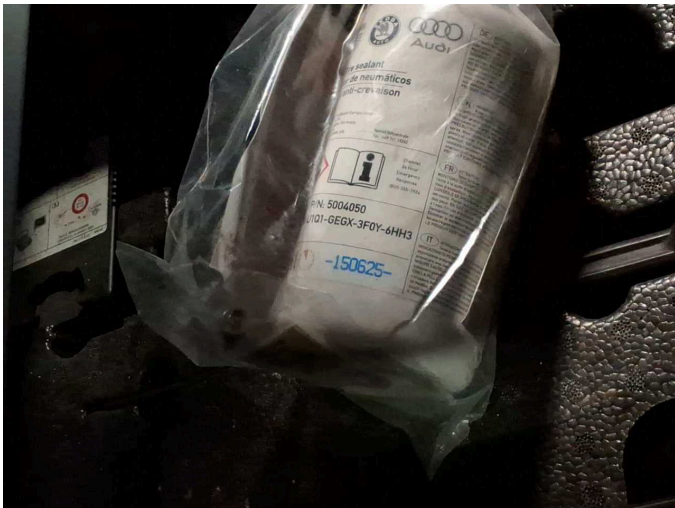
Damage 1: Equipment: Tirefit filler - Expired - Replace

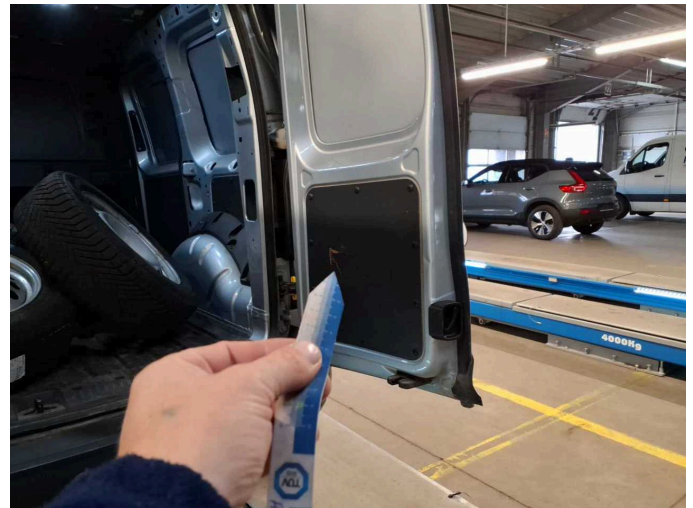
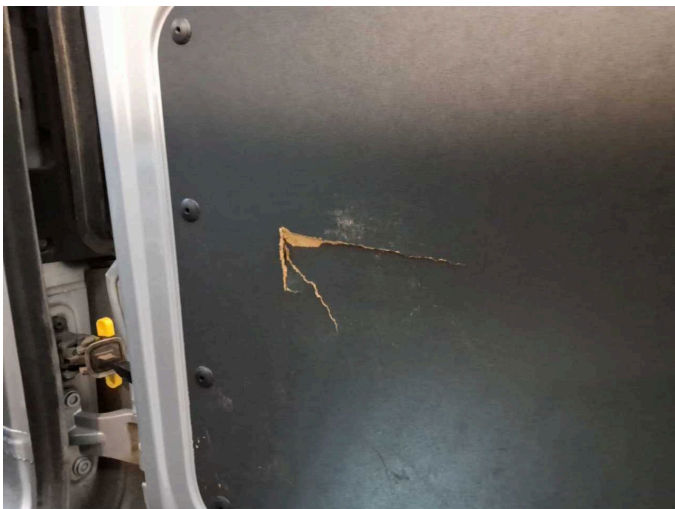
Damage 2: Boot lid / rear door: Rear door - right side (Verkleidung) - Broken / torn - Replace

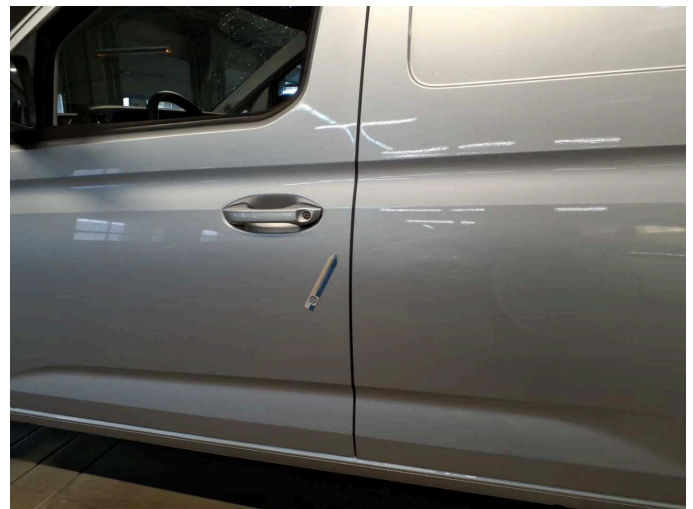
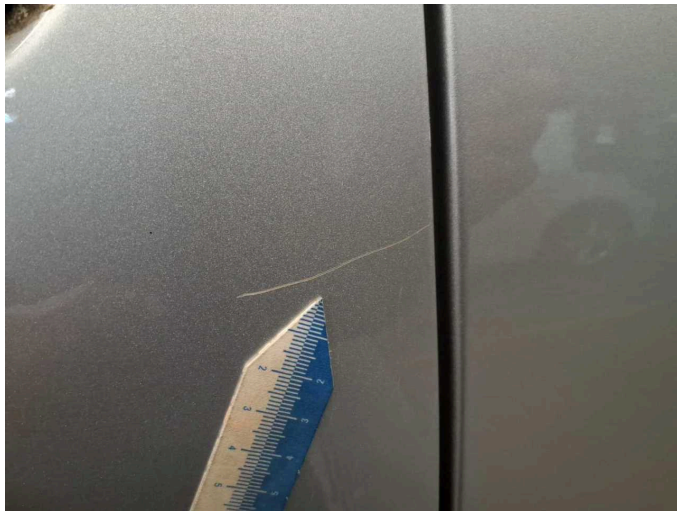
Damage 3: Door - front left side: Door - Scratch(es) - Smart repair

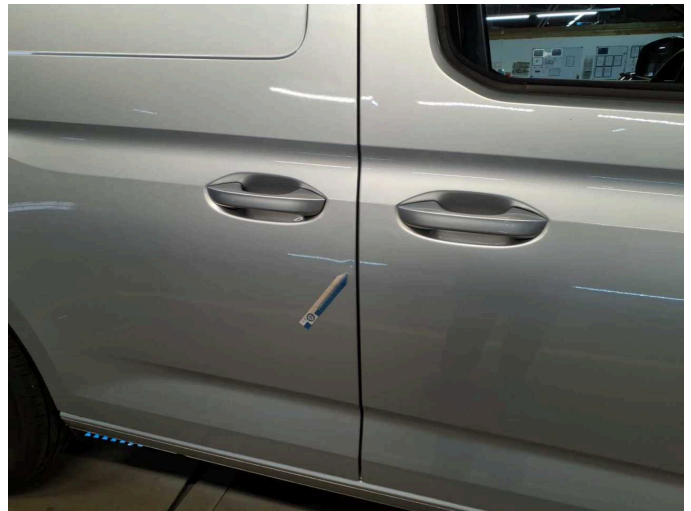
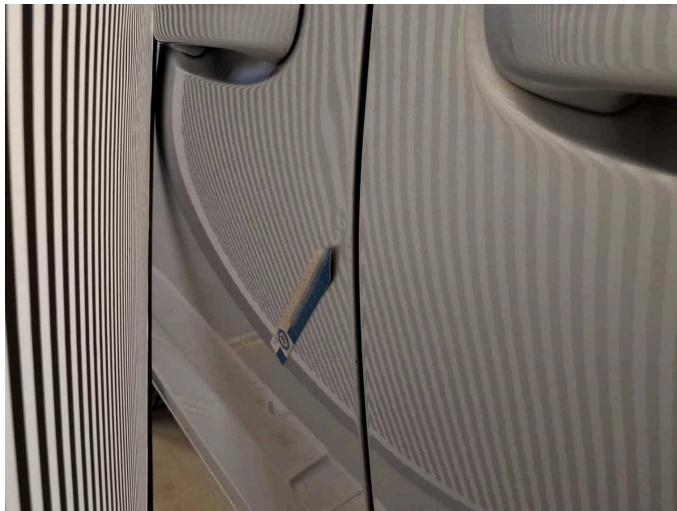
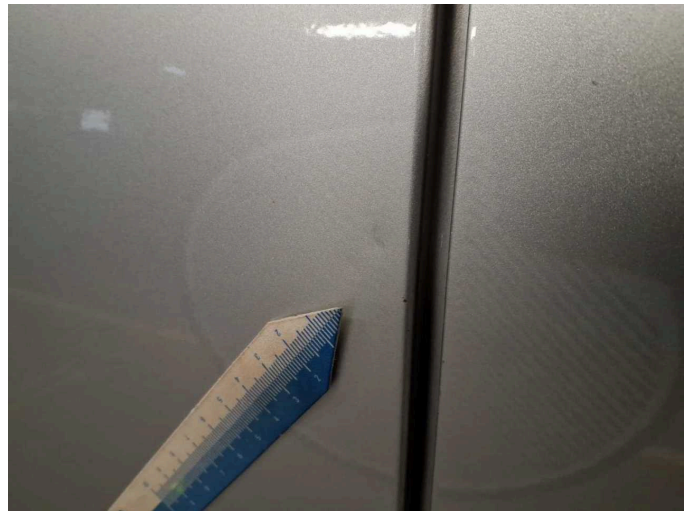
Damage 4: Sliding door, right: Sliding door - Dent / paintcoat damage - Smart repair

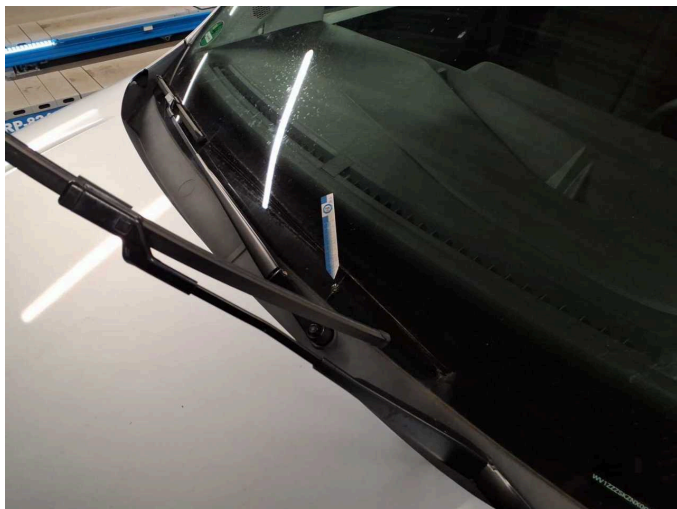
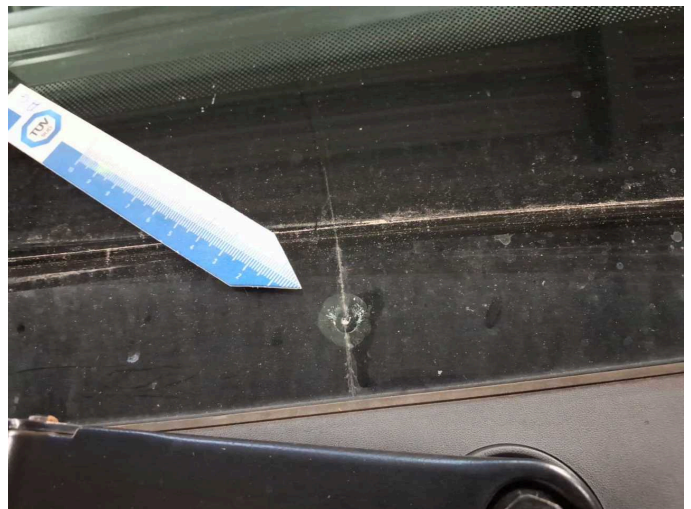
Damage 5: Vehicle glazing: Windscreen - Broken / torn - Replace
