Expertise

Protocol number: 41601740  
Order No. / Reference: 25215330  
Inspection date: 11 Sept 2025

Manufacturer: Volkswagen

Model: Caddy Cargo 2.0 TDI BMT

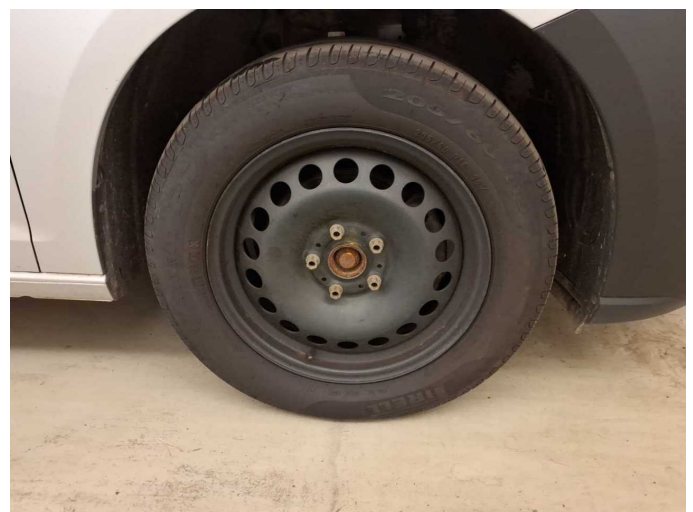
#	Tyre size	Type of tyre	Manufacturer	Tread depth
1)	205/60 R16 96V	Summer tyres on Steel	Pirelli	4mm / 4mm
2)	205/60 R16 96V	Summer tyres on Steel	Pirelli	7mm / 7mm

Figure 12: Mounted tyres

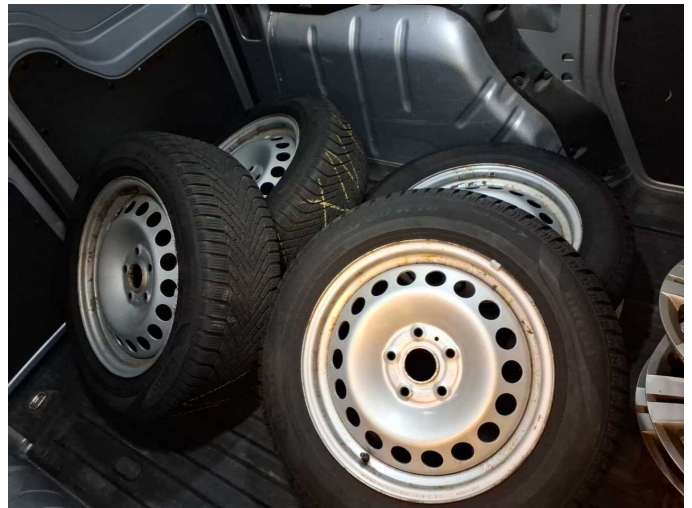
#	Tyre size	Type of tyre	Manufacturer	Tread depth
1)	205/60 R16 96H	Winter tyres on Steel	Pirelli	5mm / 5mm
2)	205/60 R16 96H	Winter tyres on Steel	Pirelli	7mm / 7mm

Figure 14: Additional tyres

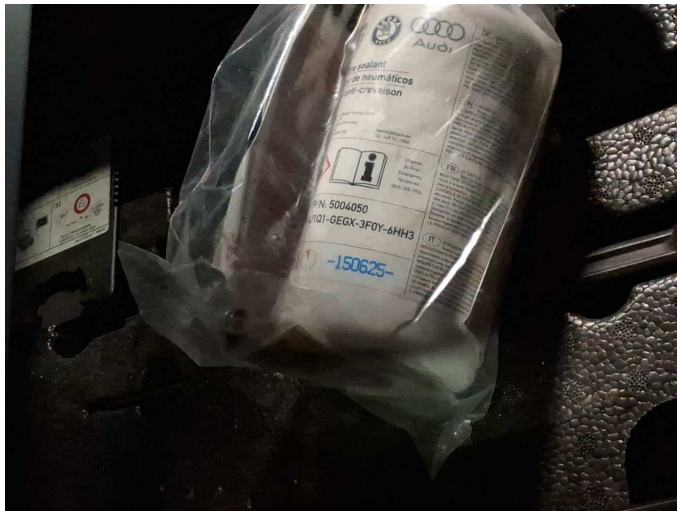
**Damage 1:** Equipment: Tirefit filler - Expired - Replace

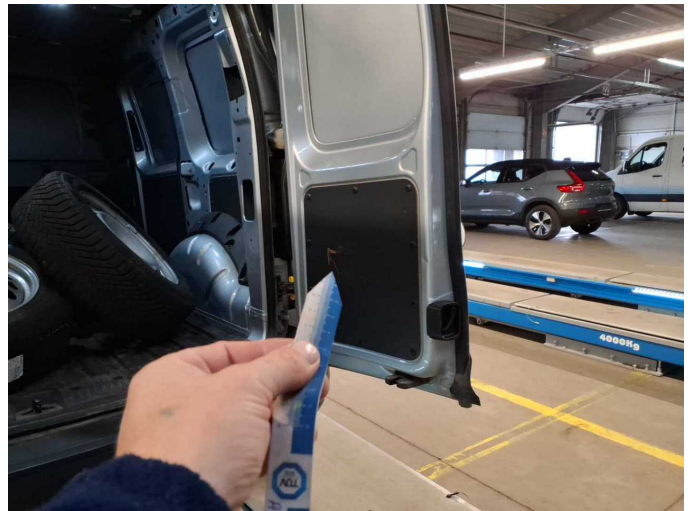
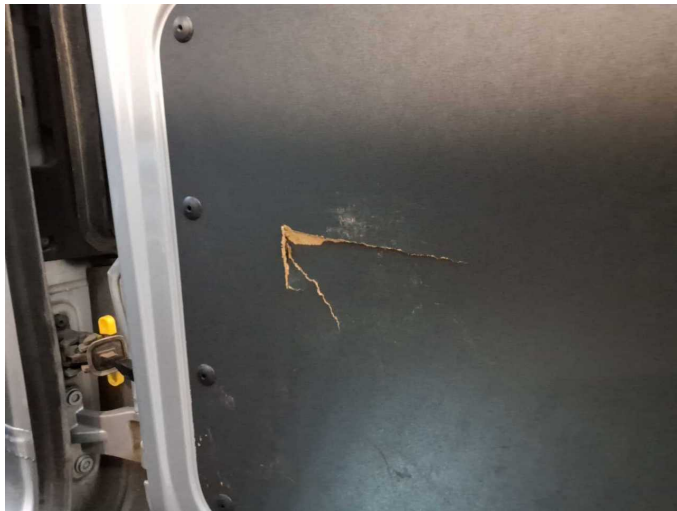
**Damage 2:** Boot lid / rear door: Rear door - right side (Verkleidung) - Broken / torn - Replace

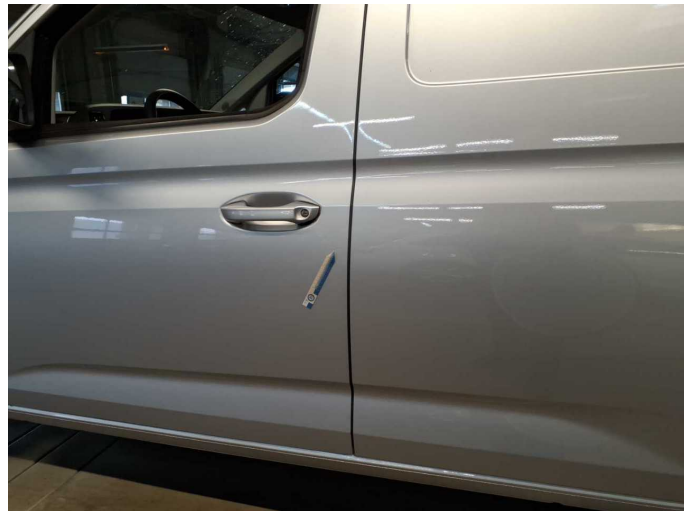
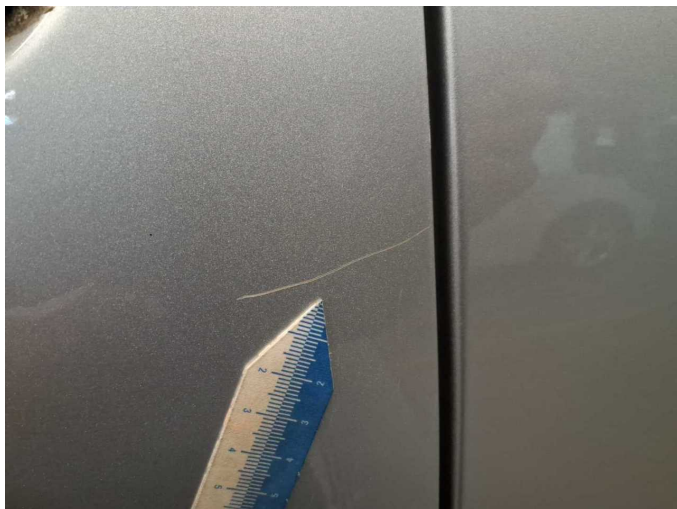
**Damage 3:** Door - front left side: Door - Scratch(es) - Smart repair

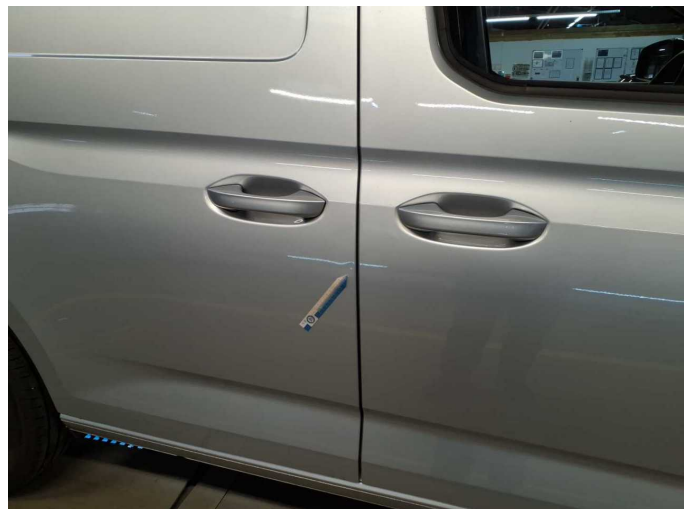
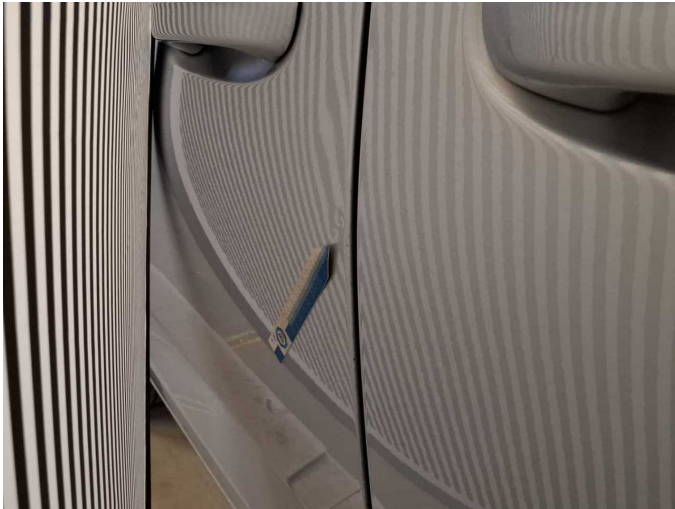
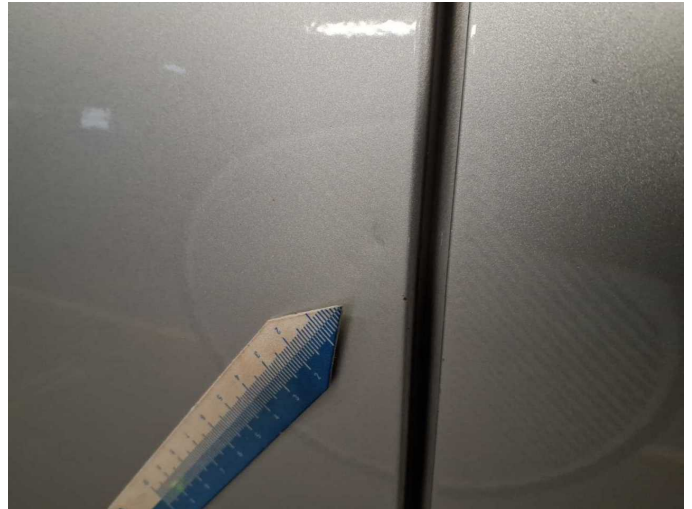
**Damage 4:** Sliding door, right: Sliding door - Dent / paintcoat damage - Smart repair

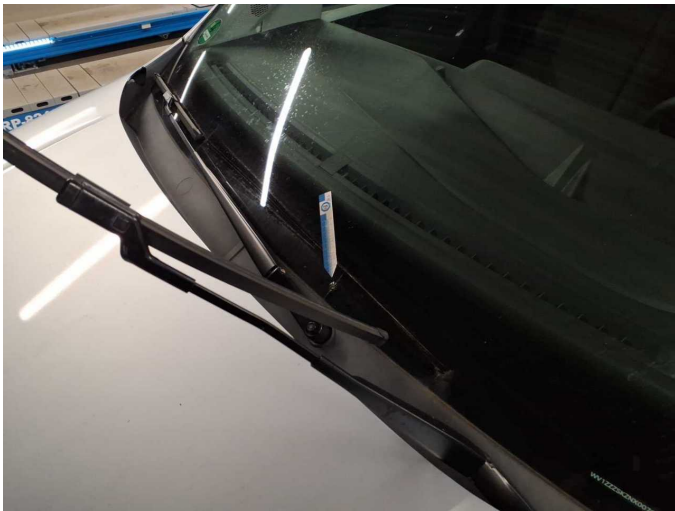
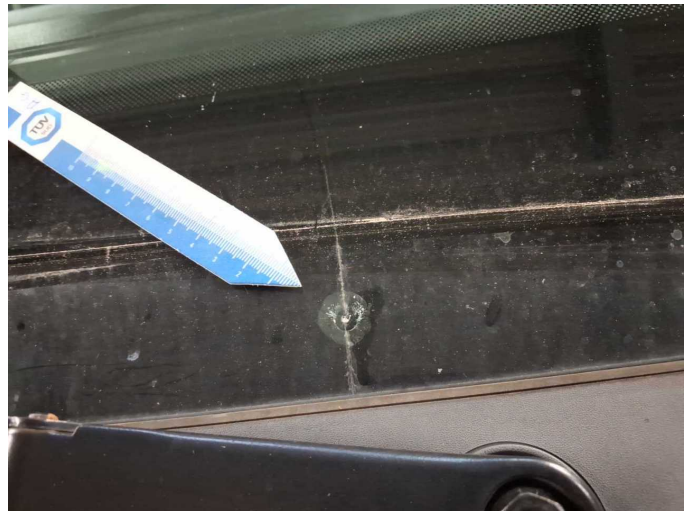
**Damage 5:** Vehicle glazing: Windscreen - Broken / torn - Replace
