## status report

#### Volkswagen Crafter Kasten Kasten 35 lang Hochdach FWD

| Vehicle identification number | <b>WV1ZZZSYZK9054523</b> | mileage read: | <b>165978 km</b> |

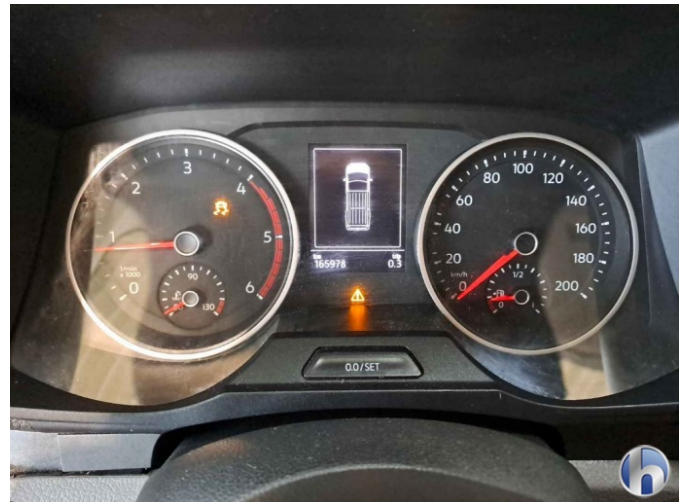
| component | Damage | Rep kind |
|---|---|---|
| 5. instrument cluster | Error message | Carry out a fault diagnosis |

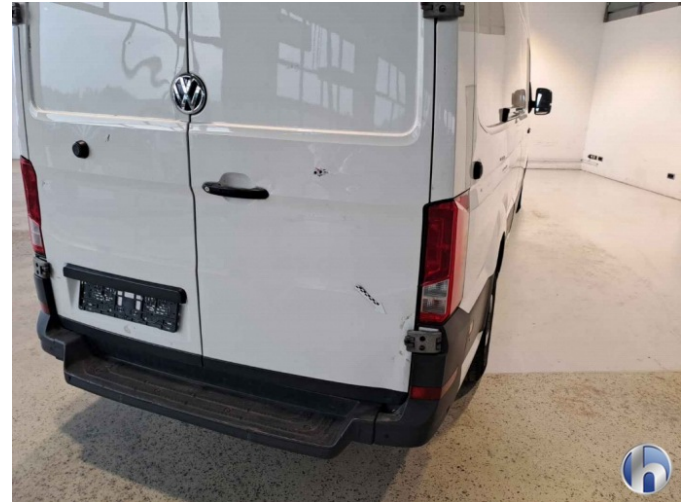
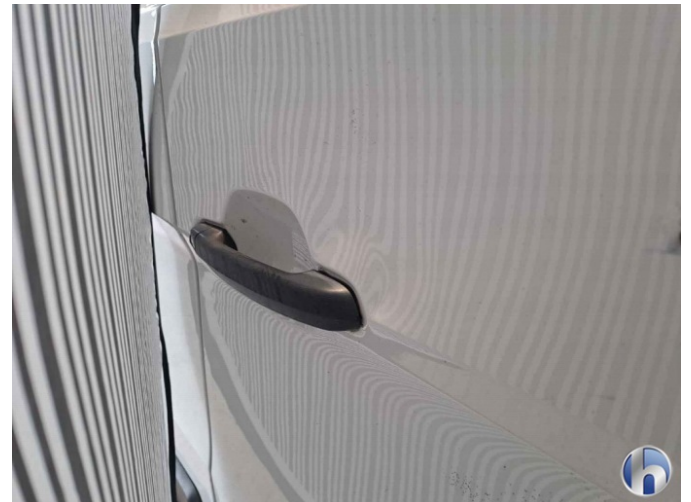
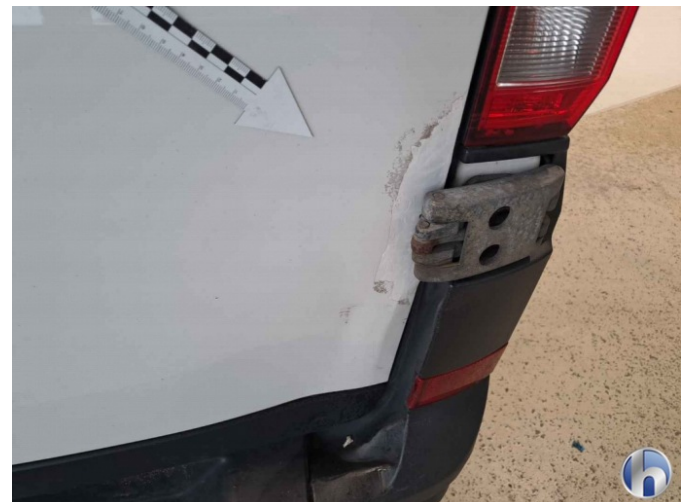
| component | Damage | Rep kind |
|---|---|---|
| 7. Tailgate right | Deformed (strongly) | Refurbish and paint |

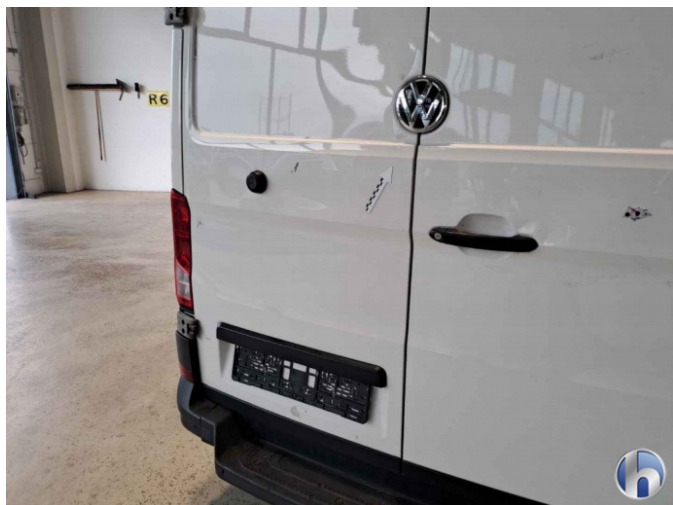
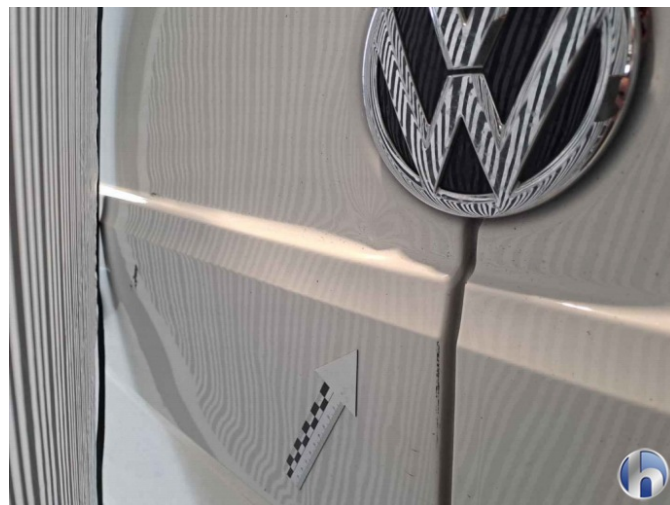
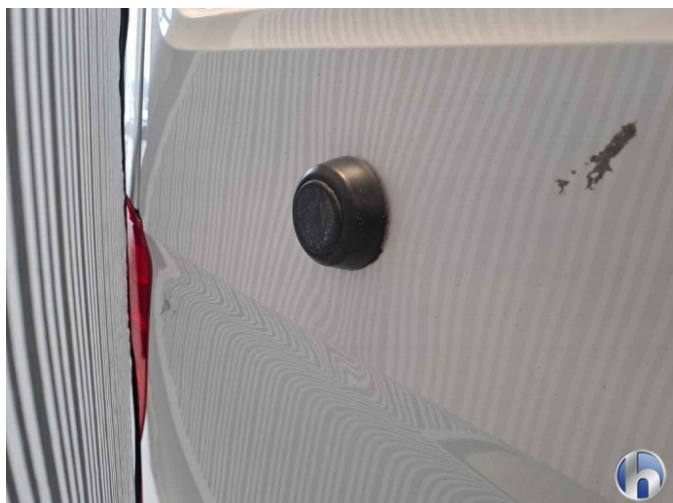
| component | Damage | Rep kind |
|---|---|---|
| 8. Tailgate left | Deformed | Refurbish and paint |

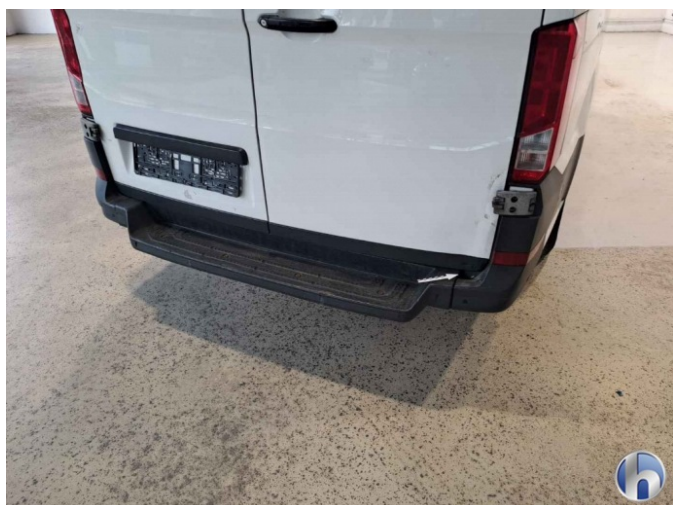
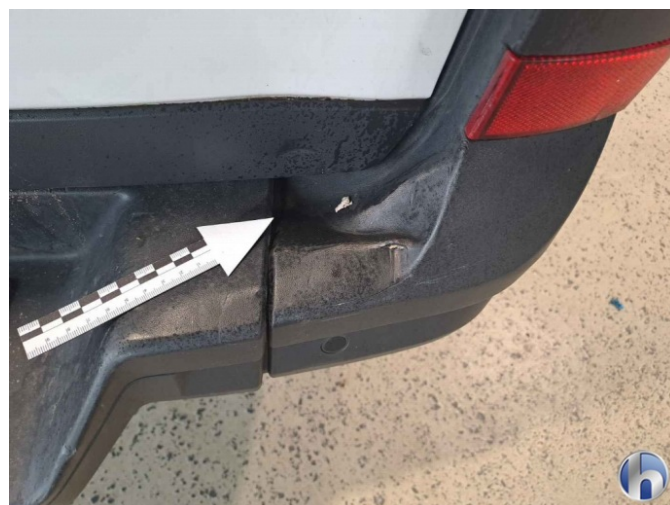
| component | Damage | Rep kind |
|---|---|---|
| 10. Rear bumper | Deformed | Replace |

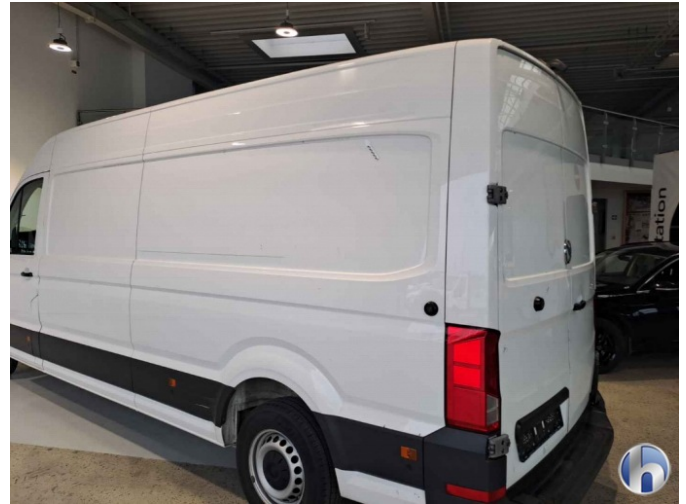
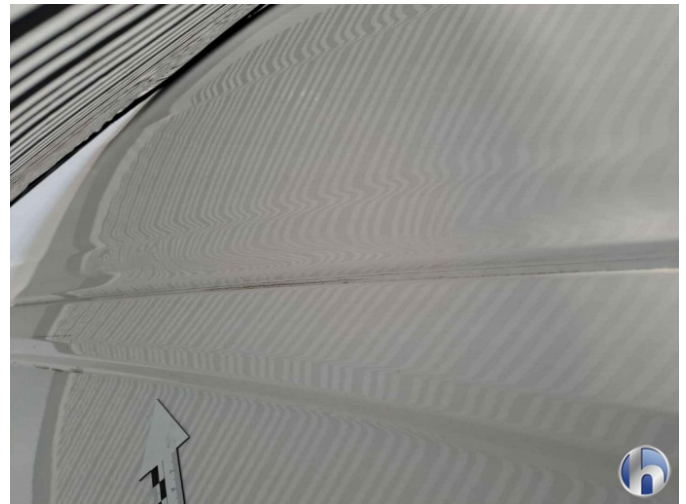
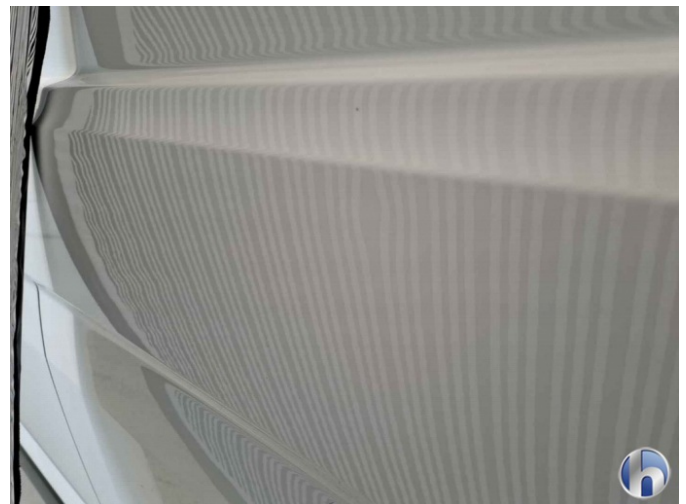
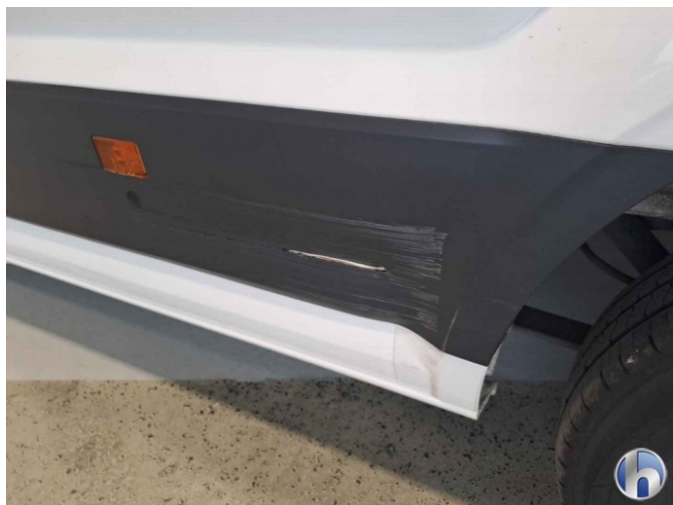
| component | Damage | Rep kind |
|---|---|---|
| 11. Sidewall - Rear - Left | Deformed | Refurbish and paint |

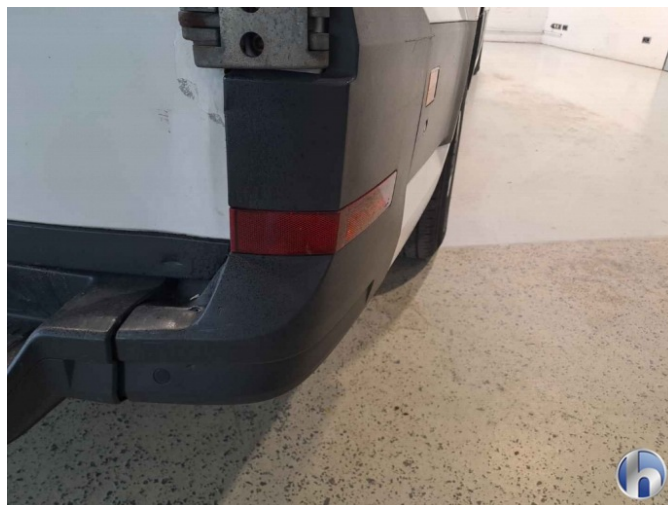
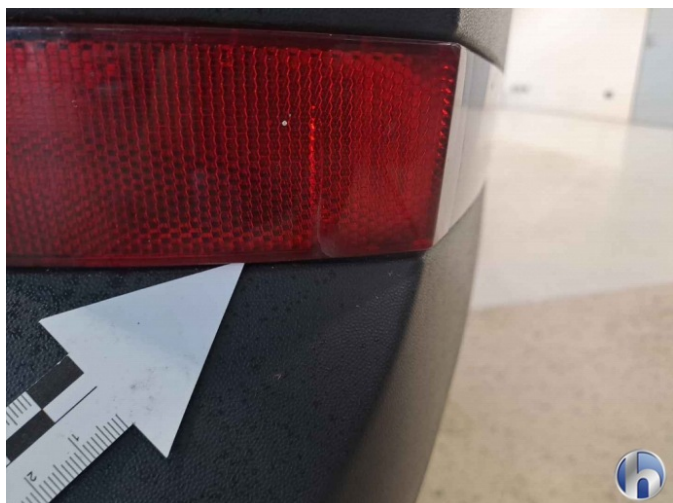
| component | Damage | Rep kind |
|---|---|---|
| 12. | Breakage | Replace |

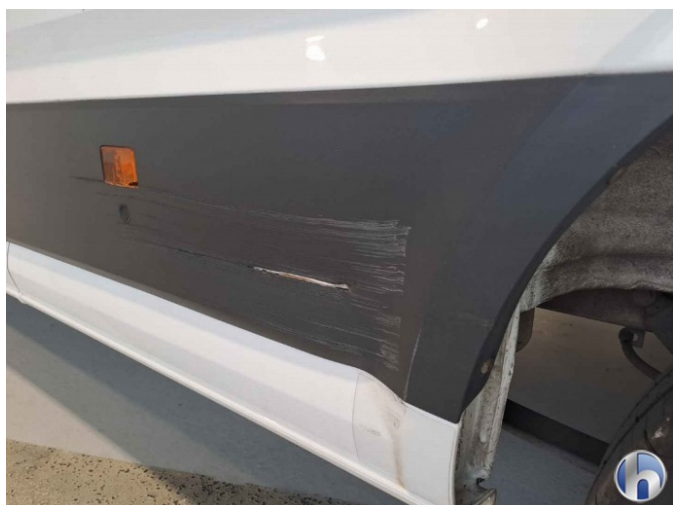
| component | Damage | Rep kind |
|---|---|---|
| 13. Beplankung links | Damaged | Replace |

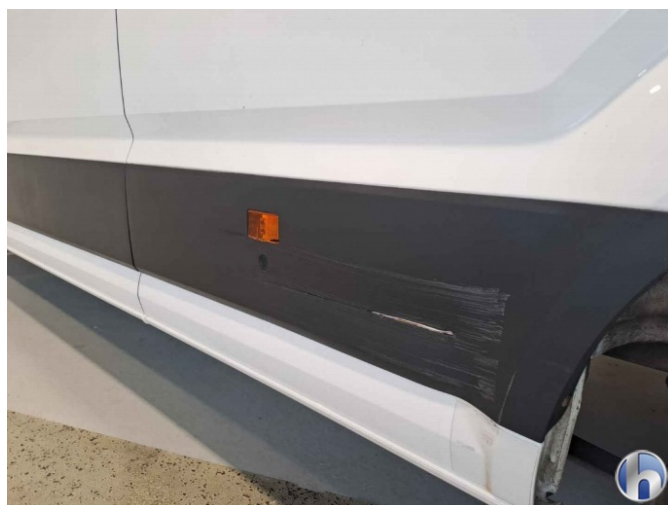
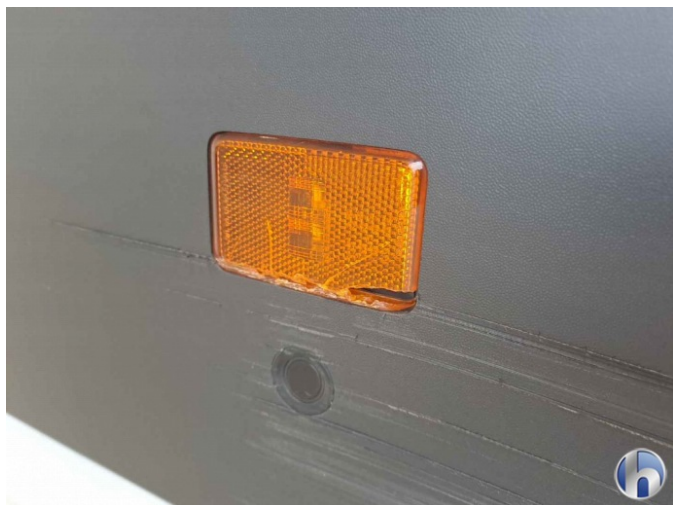
14. Seitenmarkierungsleuchte links

| component | Damage | Rep kind |
|---|---|---|
| 14. Seitenmakierungsleuchte links | Breakage | Replace |

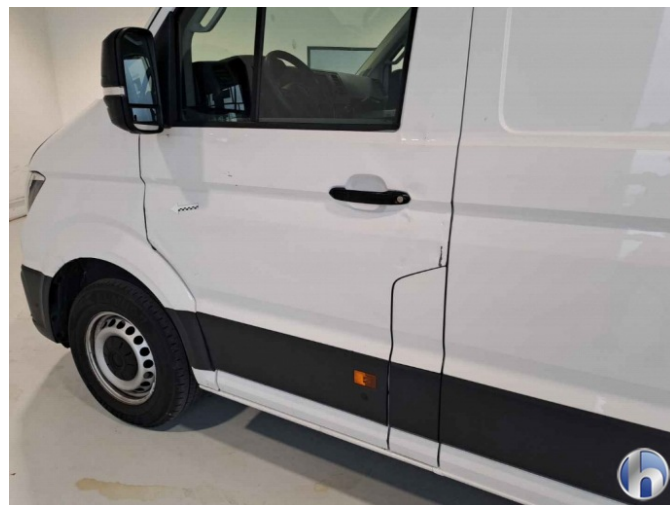
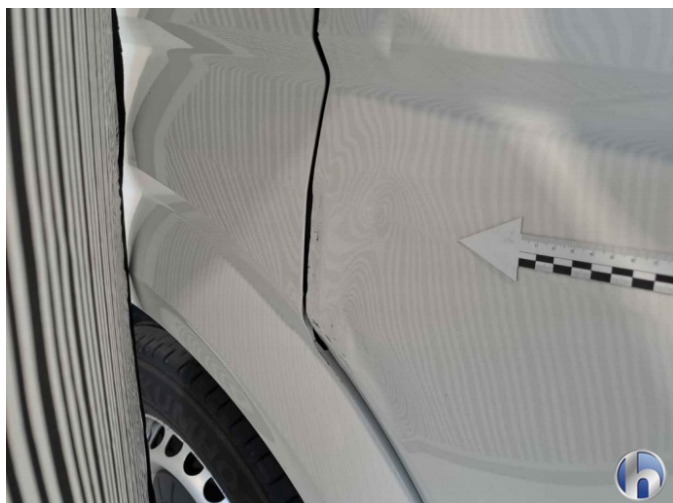
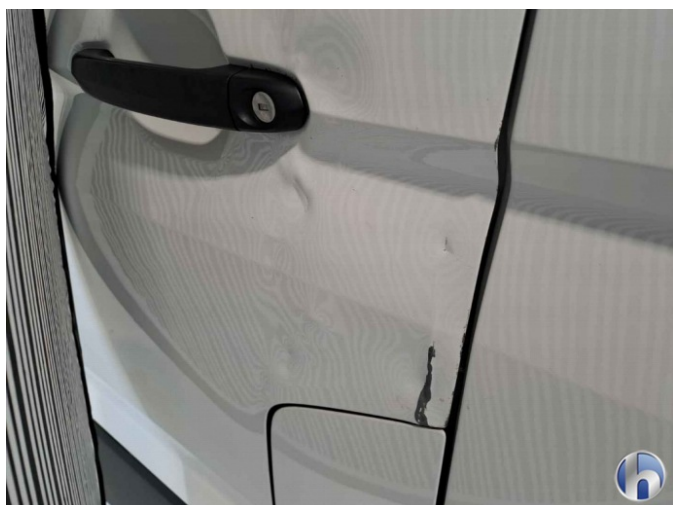
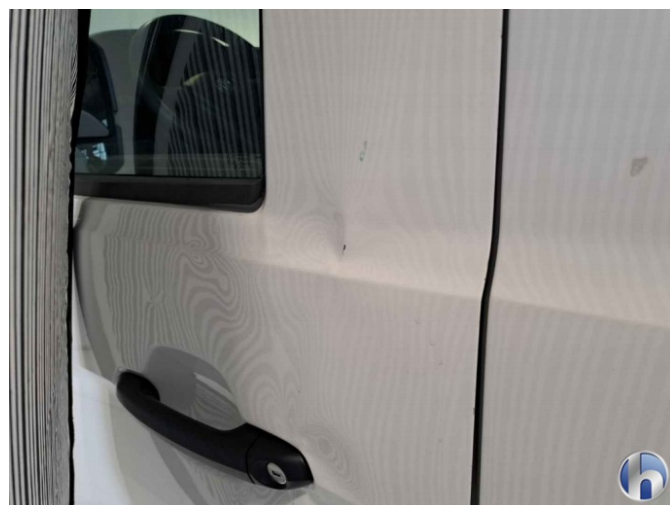
| component | Damage | Rep kind |
|---|---|---|
| 15. Front door - left | Deformed (strongly) | Replace |

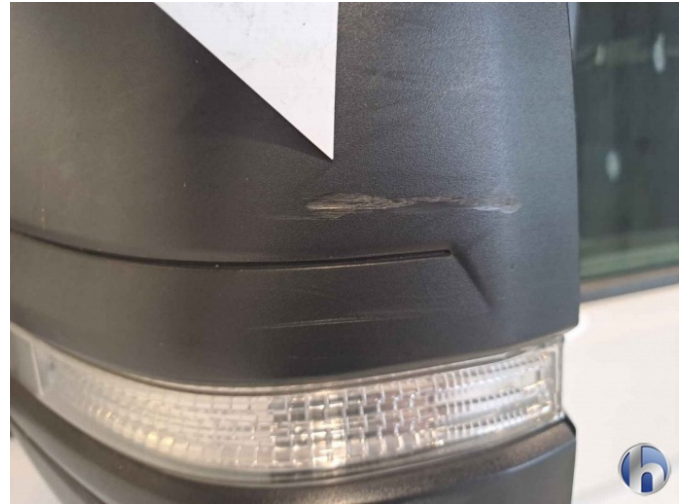
| component | Damage | Rep kind |
|---|---|---|
| 16. | Scrape | Replace |

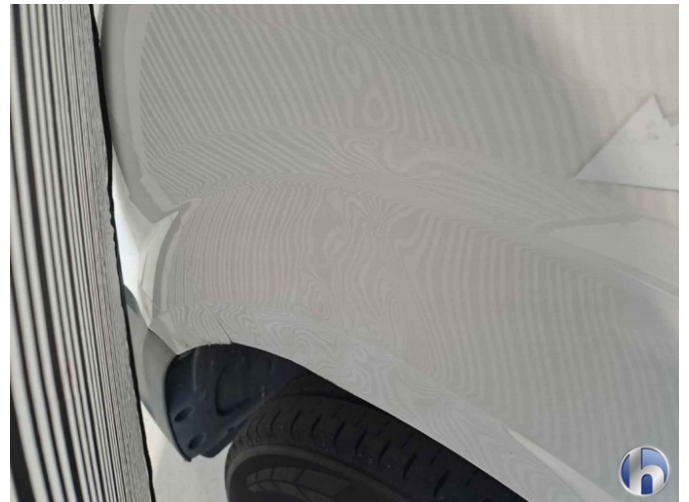
| component | Damage | Rep kind |
|---|---|---|
| 17. Front fender - left | Deformed (strongly) | Replace |

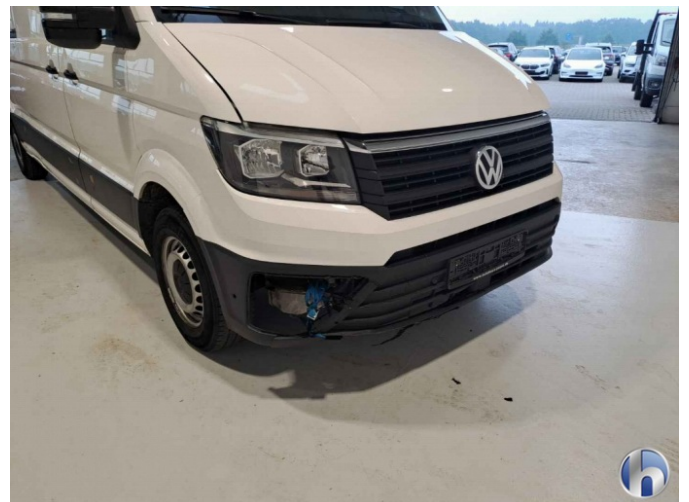
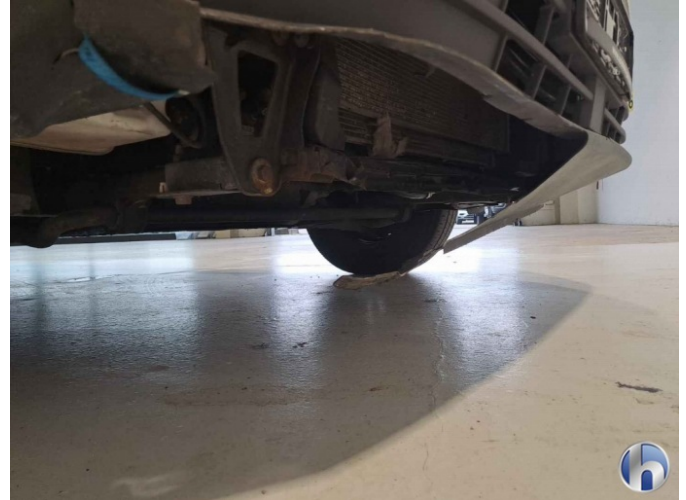
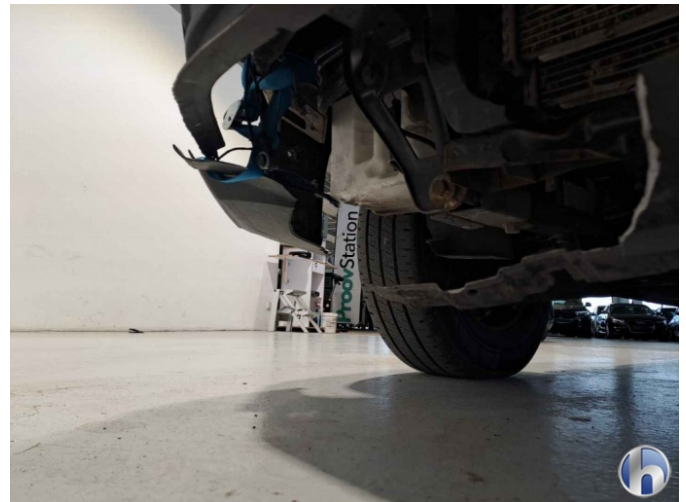
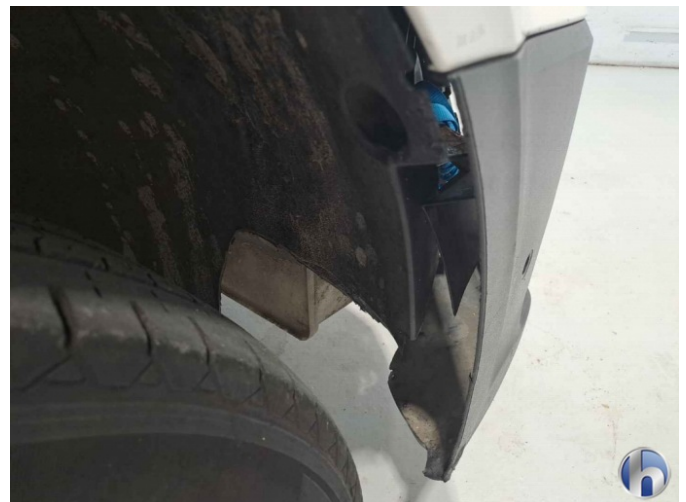
| component | Damage | Rep kind |
|---|---|---|
| 18. Front bumper | Accident damage | Replace |

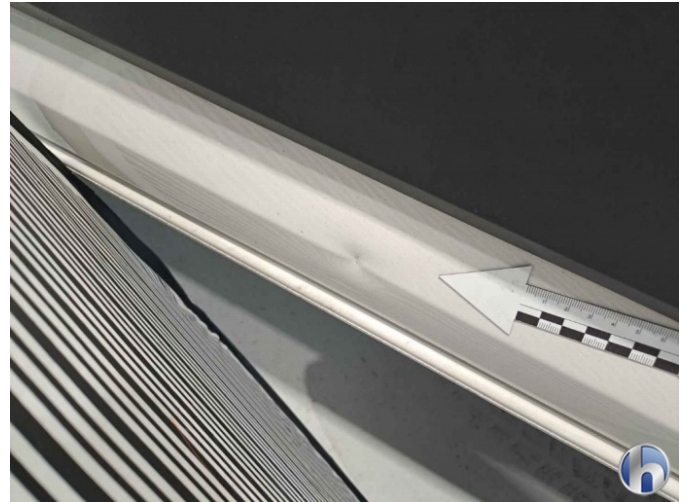
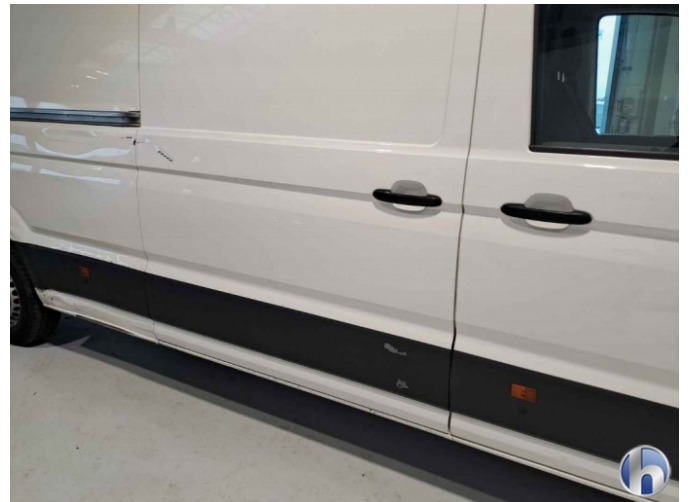
| component | Damage | Rep kind |
|---|---|---|
| 22. Front door - right | Deformed | Refurbish and paint |

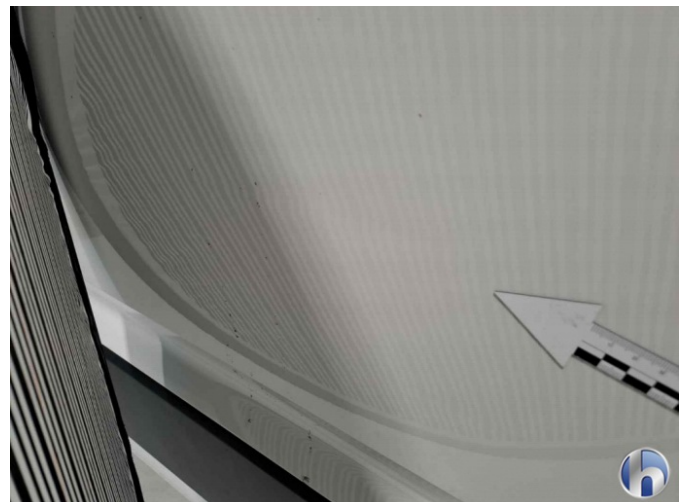
| component | Damage | Rep kind |
|---|---|---|
| 23. Sliding door - right | Deformed | Refurbish and paint |

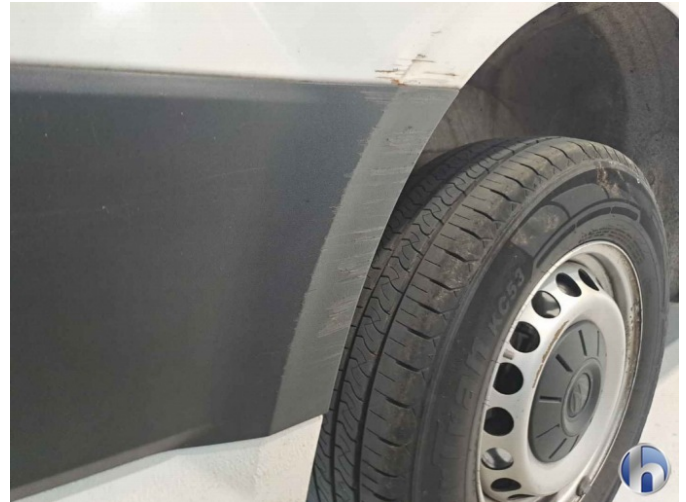
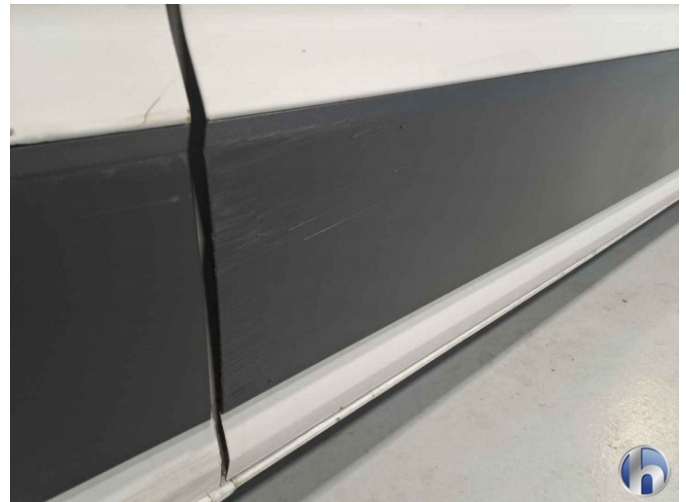
| component | Damage | Rep kind |
|---|---|---|
| 24. Beplankung rechts | Scrape | Replace |

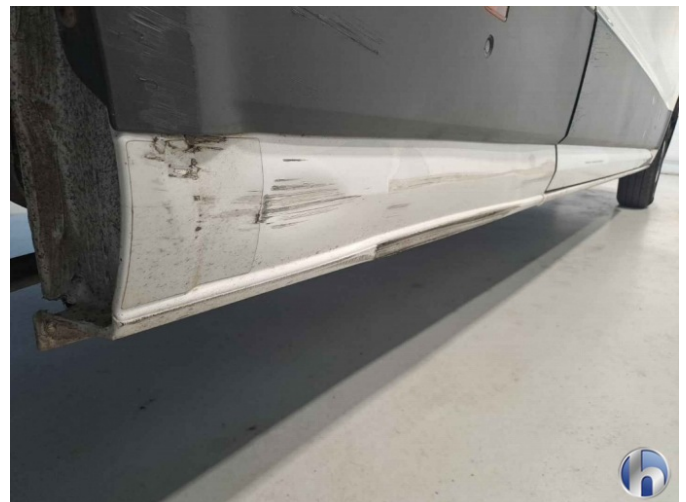
| component | Damage | Rep kind |
|---|---|---|
| 25. side skirt - right | Deformed | Refurbish and paint |

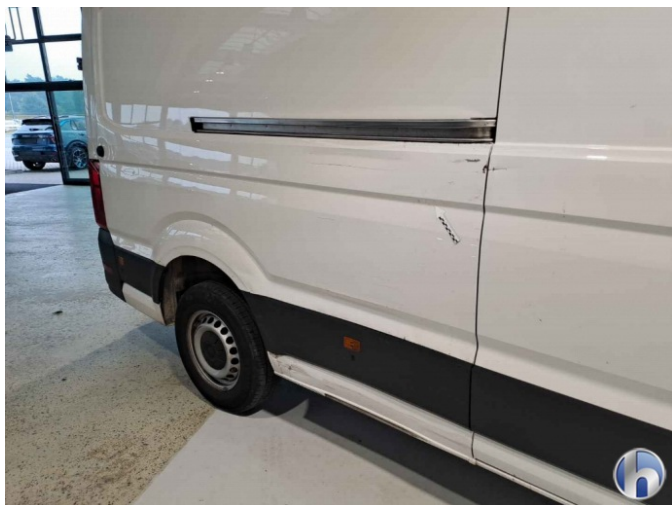
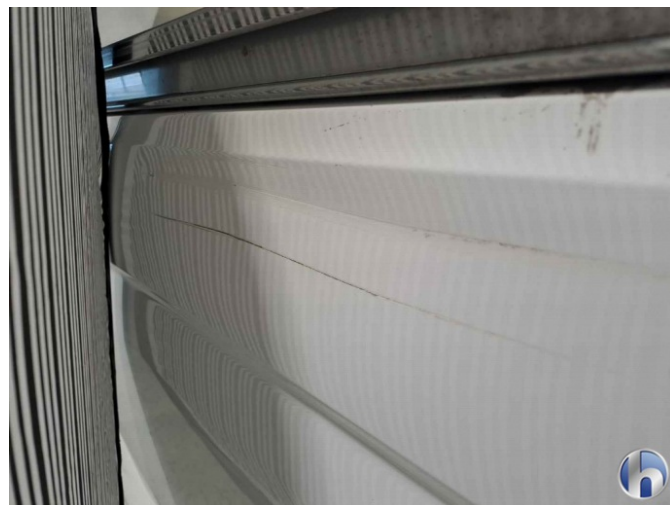
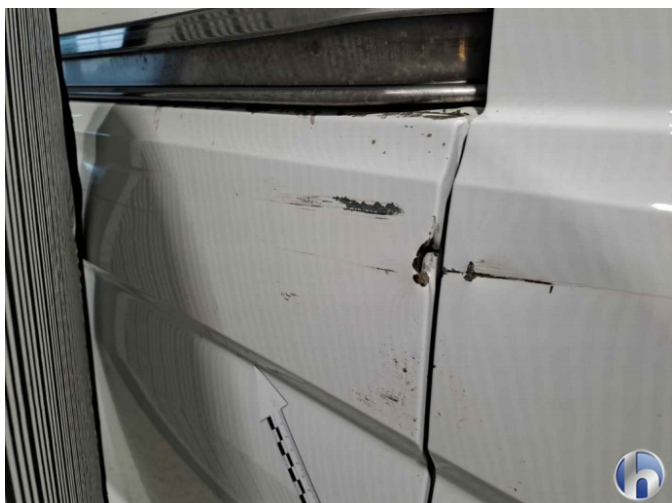
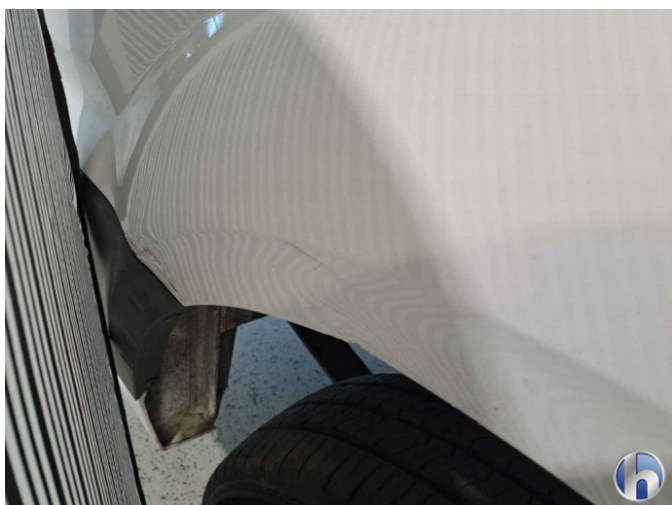
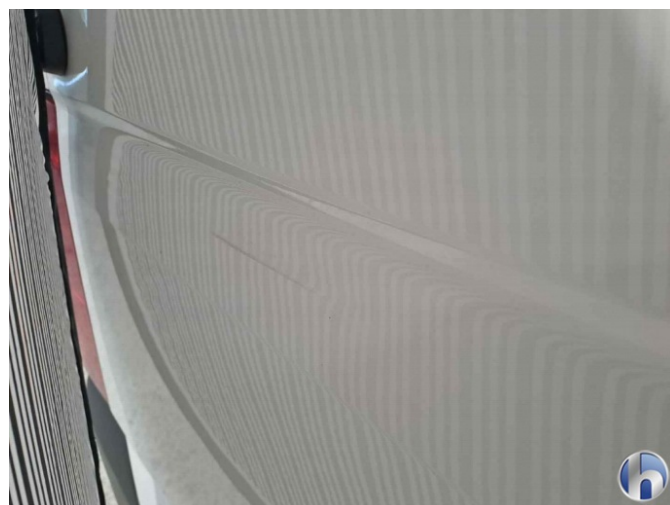
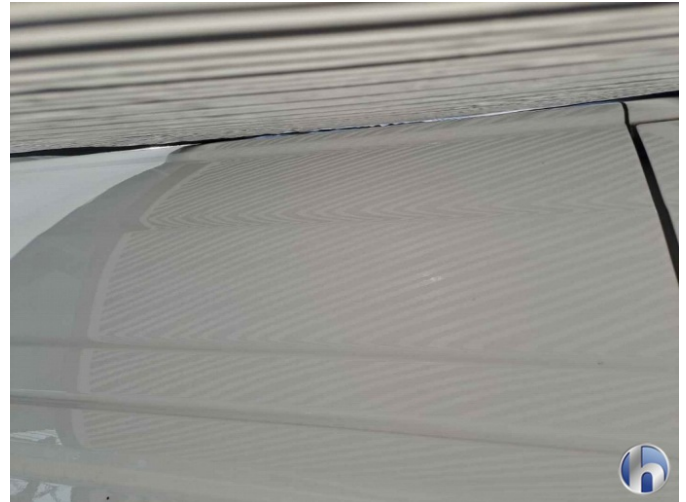
| component | Damage | Rep kind |
|---|---|---|
| 26. Sidewall - Rear - right | Deformed | Refurbish and paint |

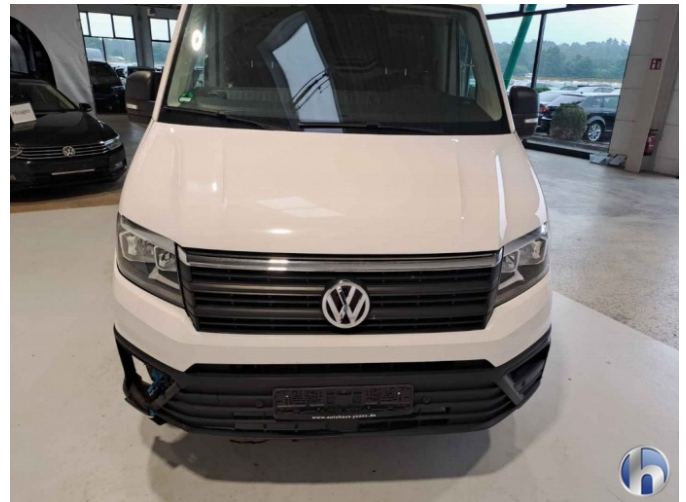
| component | Damage | Rep kind |
|---|---|---|
| 27. exterior body | Surface scratch(es) | |

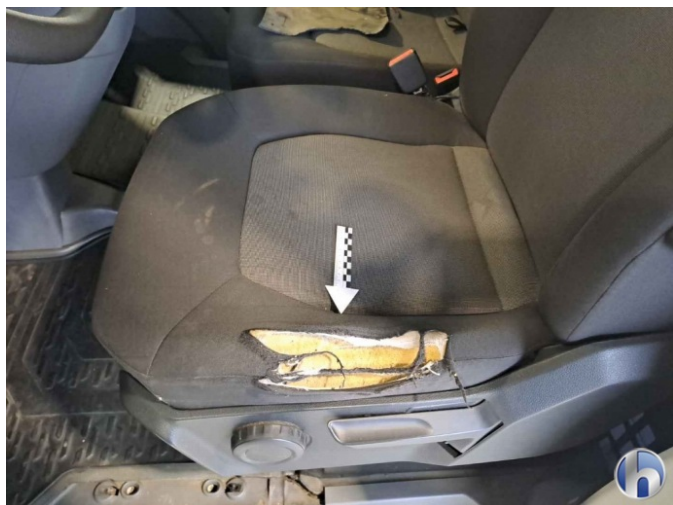
| component | Damage | Rep kind |
|---|---|---|
| 31. | Damaged | Replace |

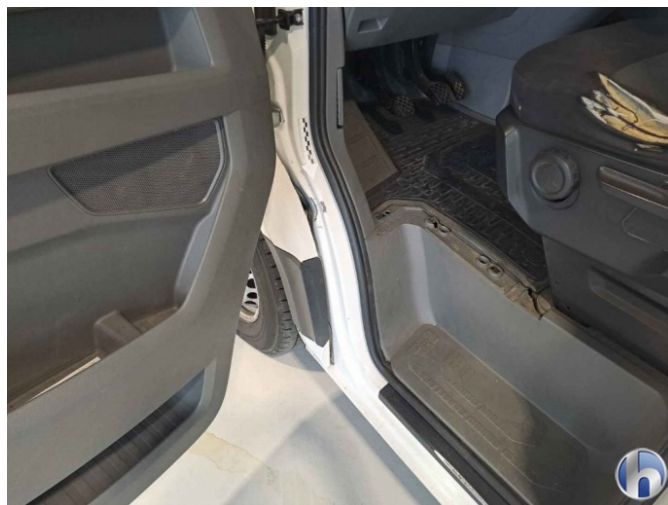
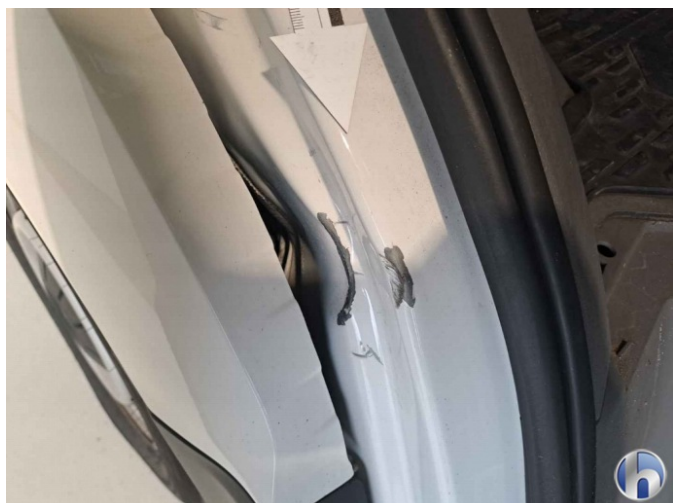
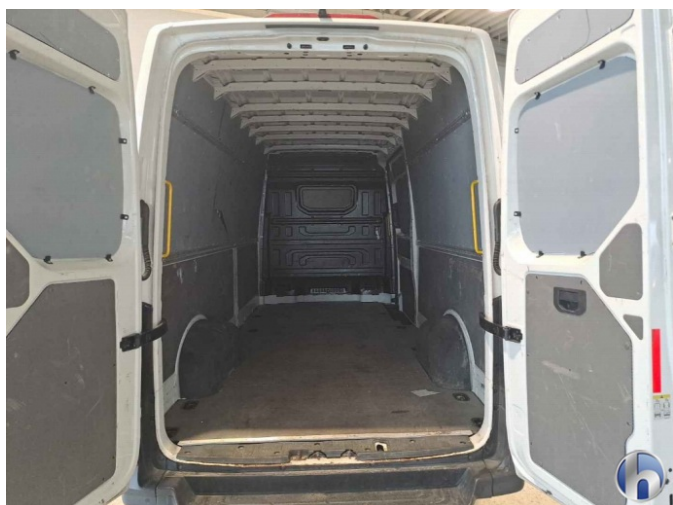
| component | Damage | Rep kind |
|---|---|---|
| 32. Türeinstieg Vorne - Links | Deformed (strongly) | Replace |

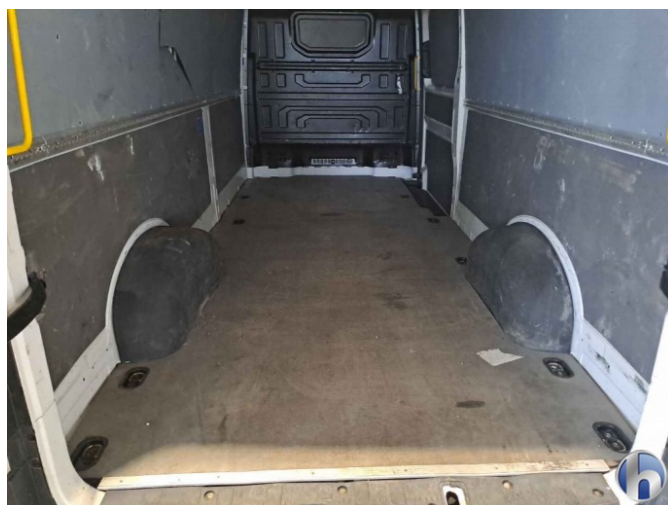
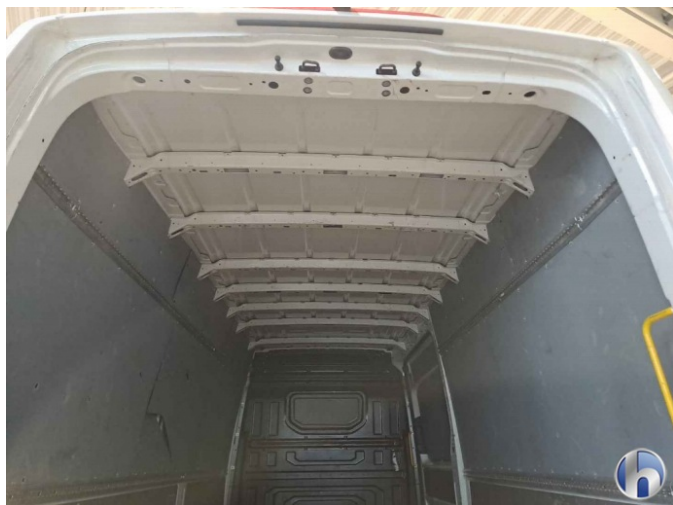
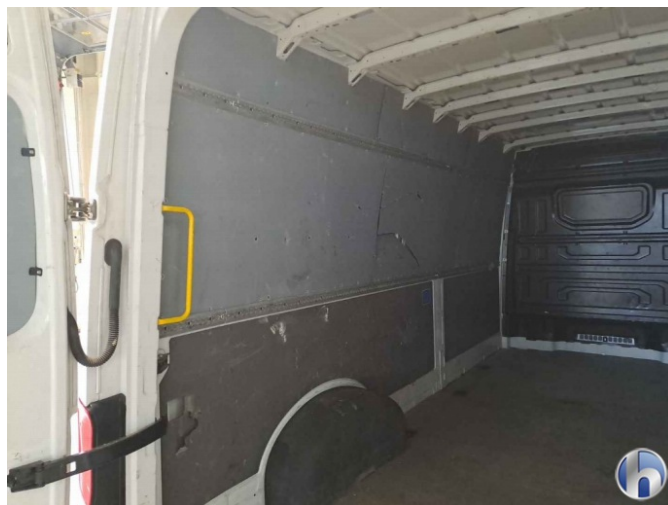
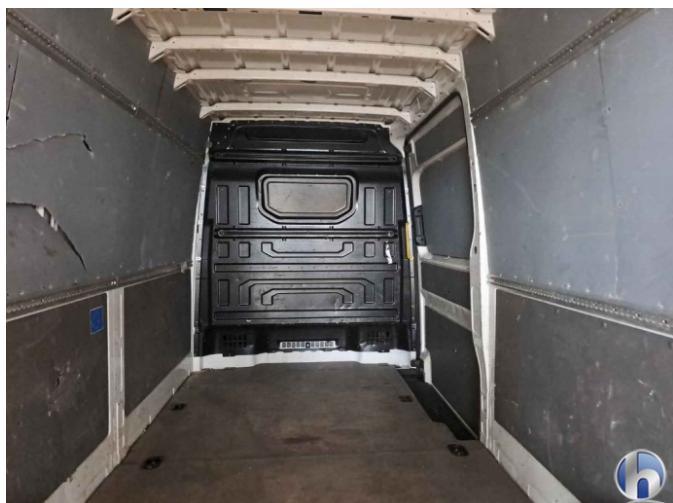
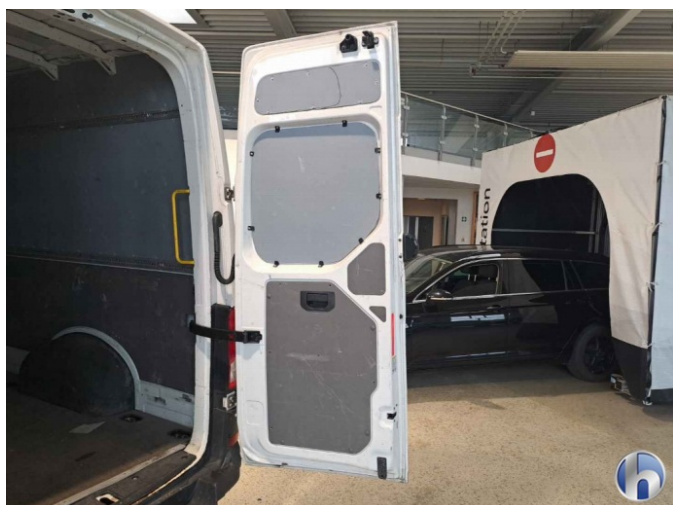
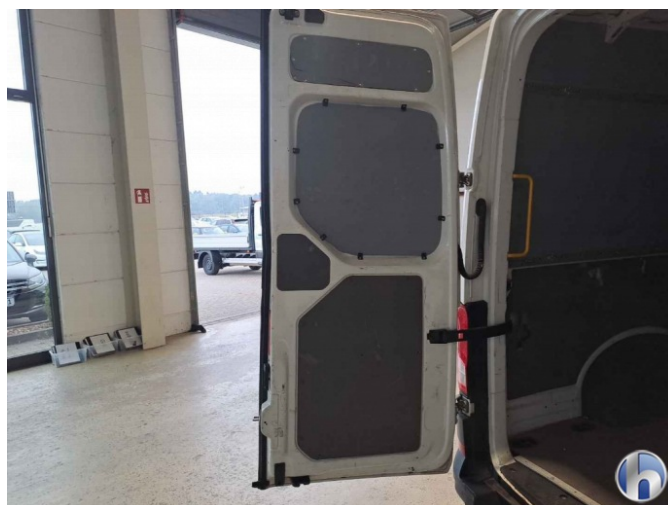
| component | Damage | Rep kind |
|---|---|---|
| 33. | Wear and tear | acceptable |

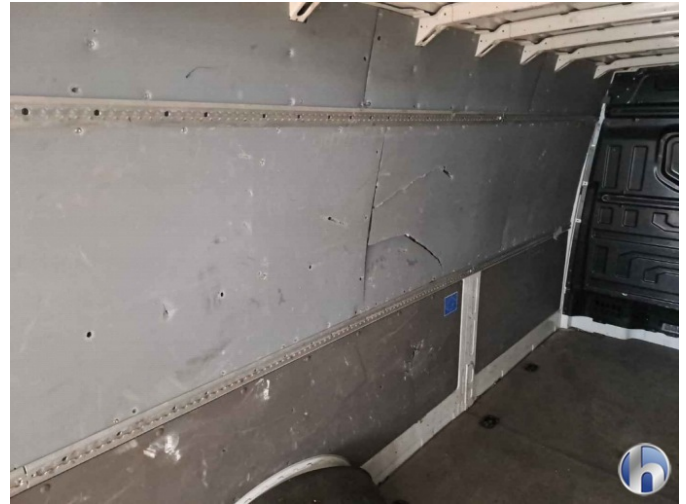
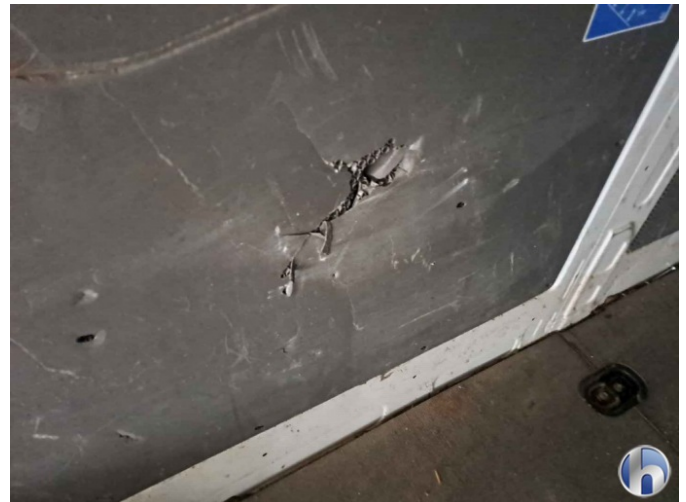
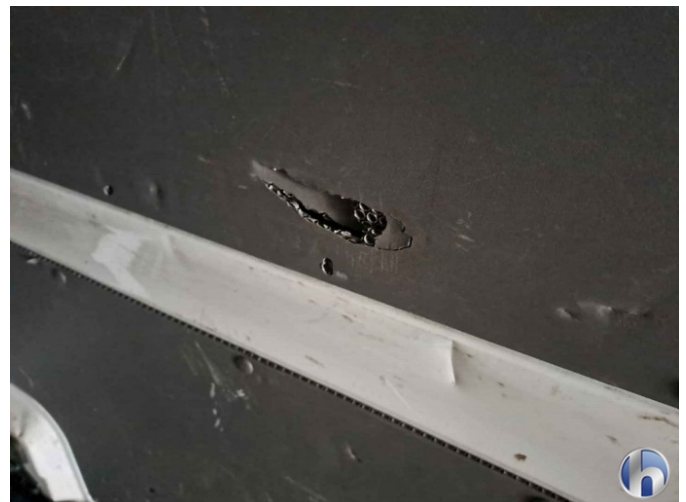
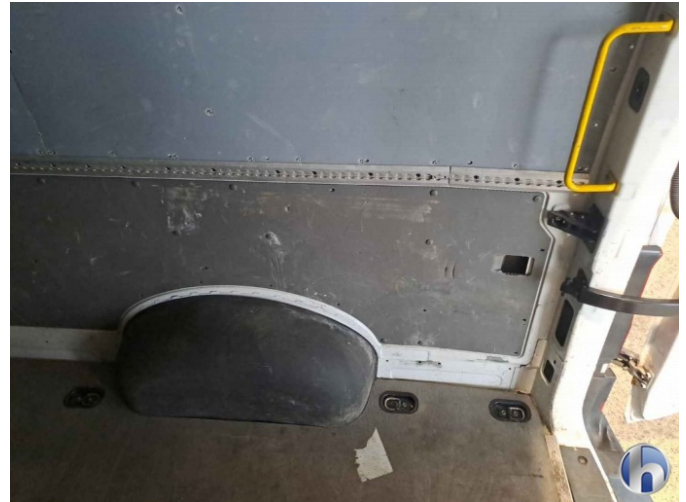
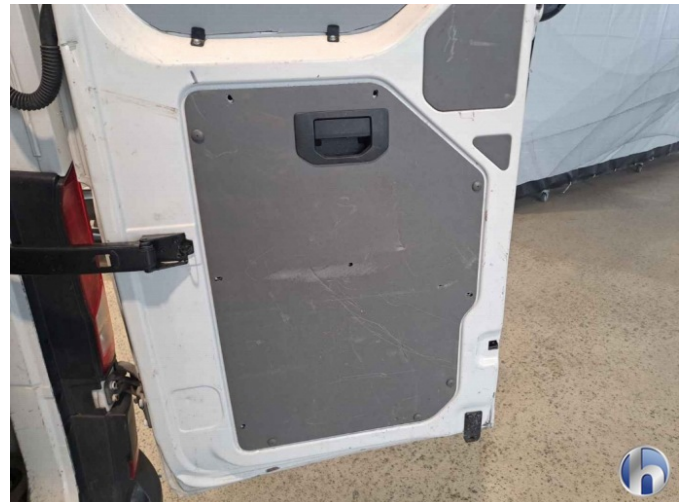
| component | Damage | Rep kind |
|---|---|---|
| 35. Verkleidung Laderaum | Damaged | Replace |

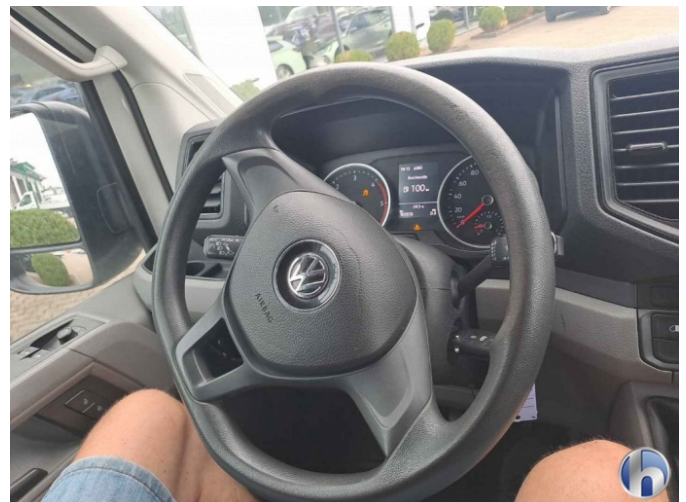
| component | Damage | Rep kind |
|---|---|---|
| 36. steering wheel | Scrape | Replace |
