Expertise

Protocol number: 41636047
Order No. / Reference: 25101293-1
Inspection date: 24 Aug 2025

Manufacturer: Volkswagen	Model: Crafter 35 TDI VA
VIN: WV1ZZZSYZM9030617

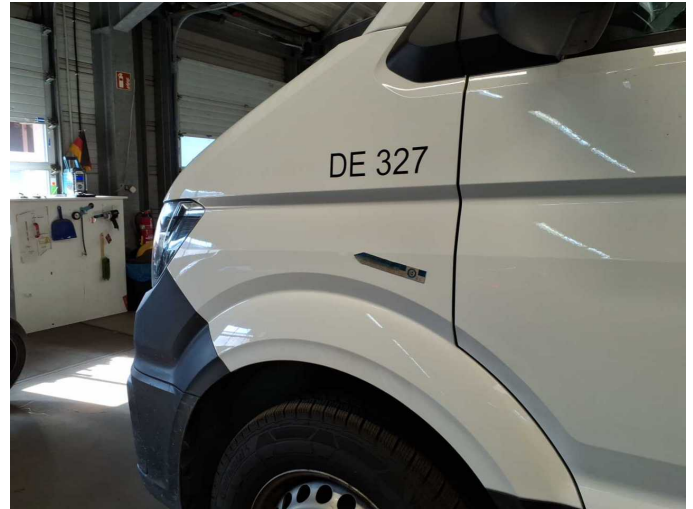
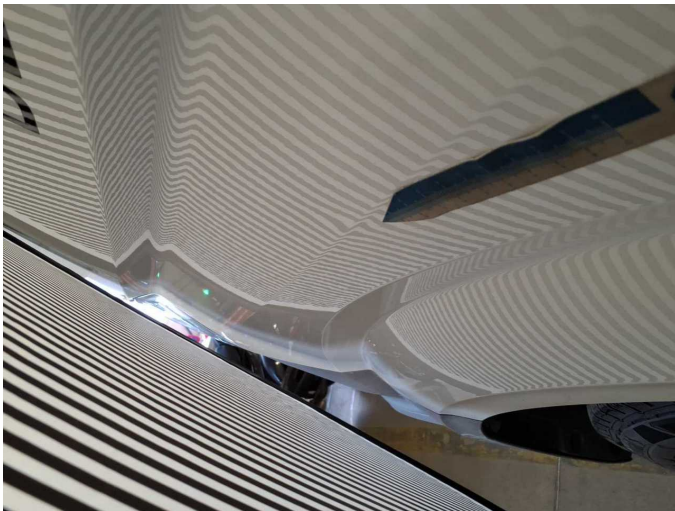
Damage 3: Mudguard - left side: Mudguard - left side - dent(s) - Smooth repair work

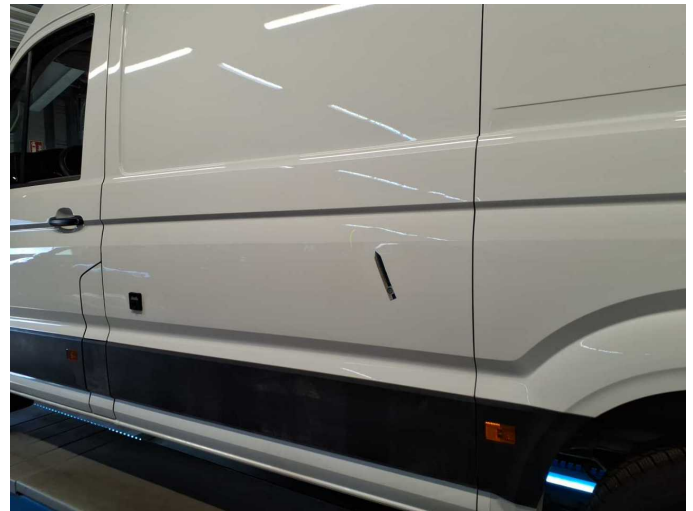
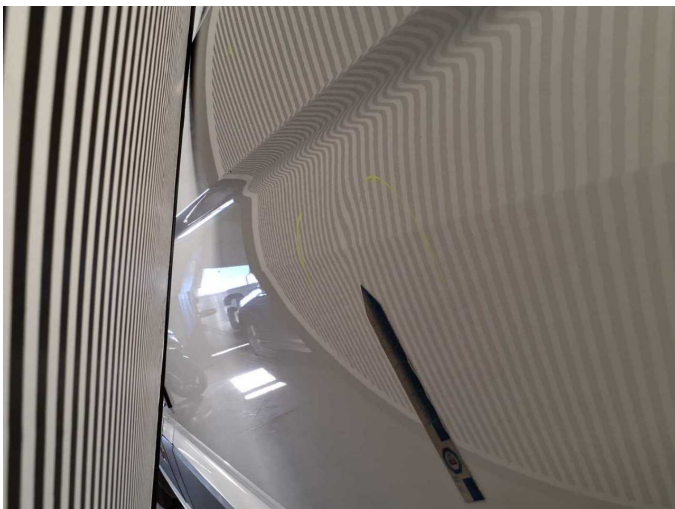
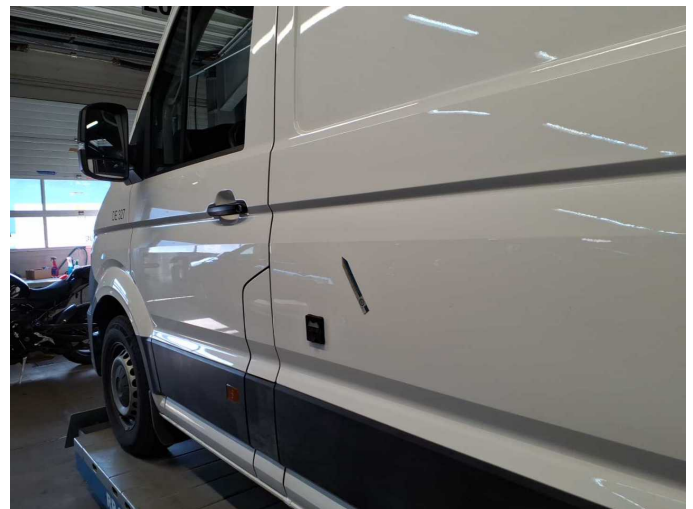
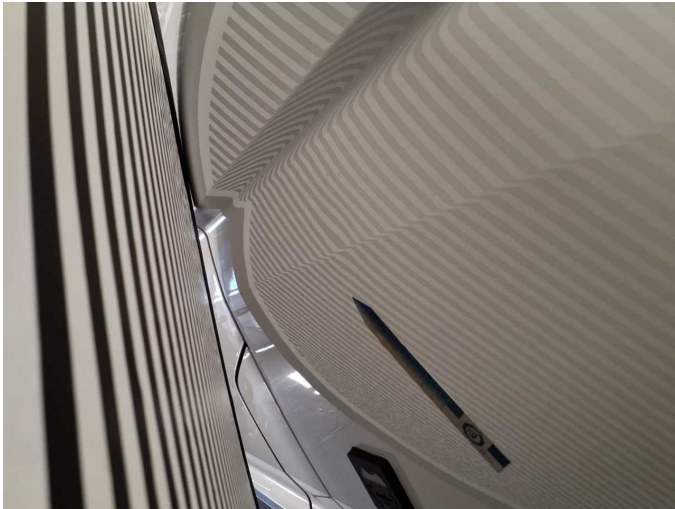
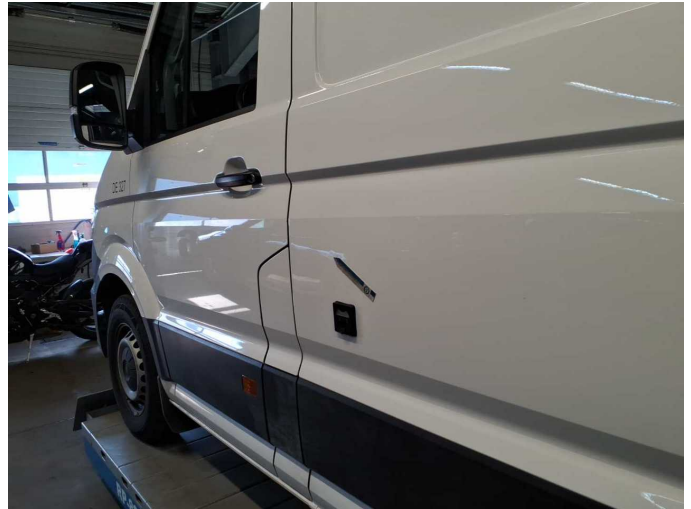
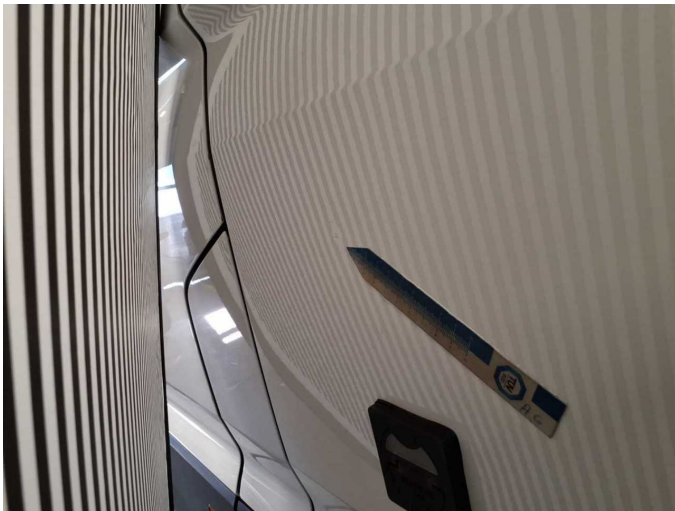
Damage 4: Side panel - rear left side: Side panel - dent(s) - Smooth repair work

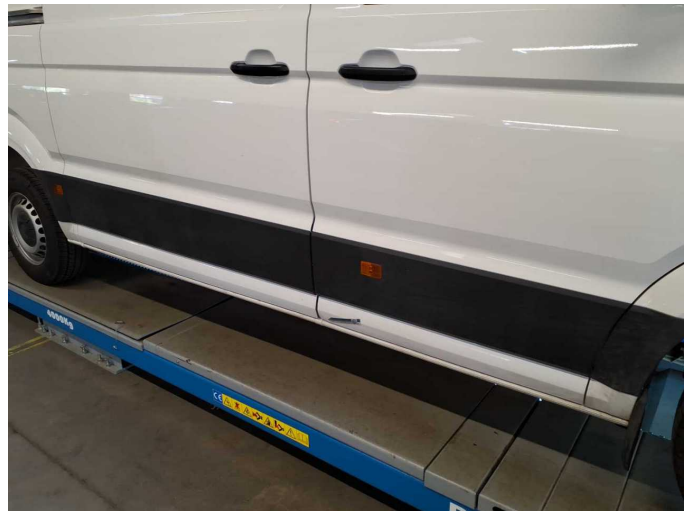
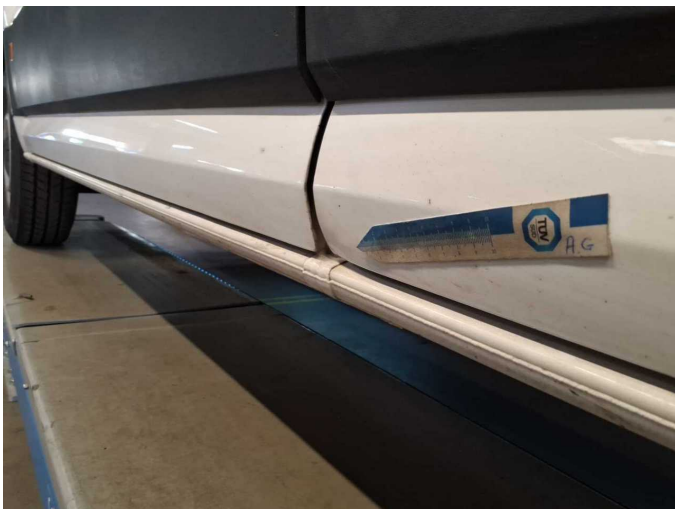
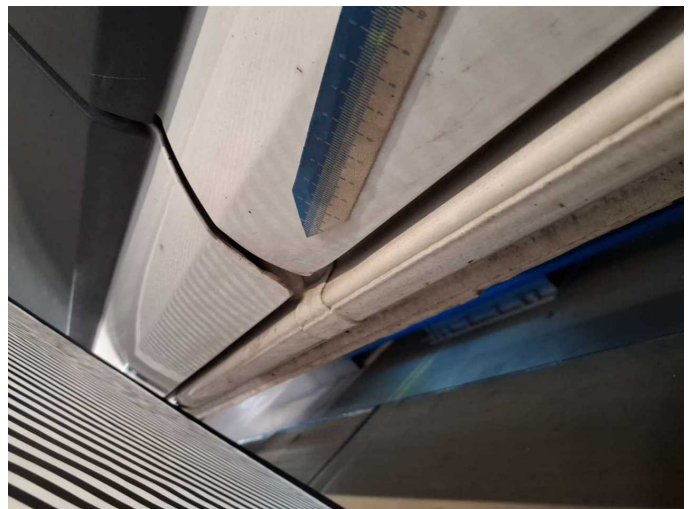
Damage 5: Door - front right side: Door - Deformed - Smart repair

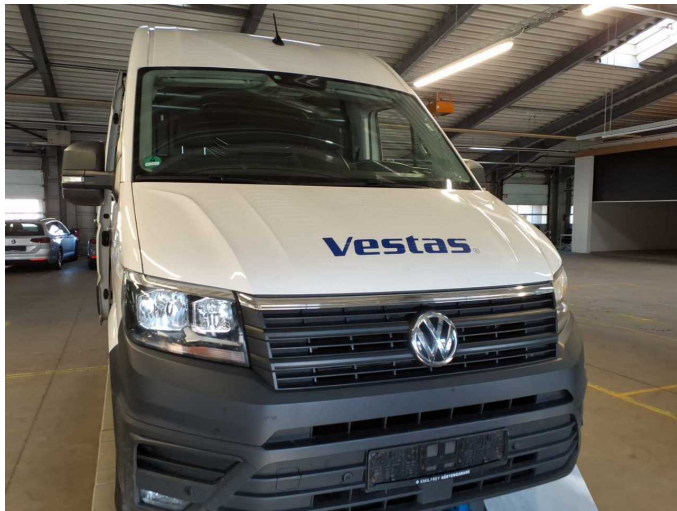
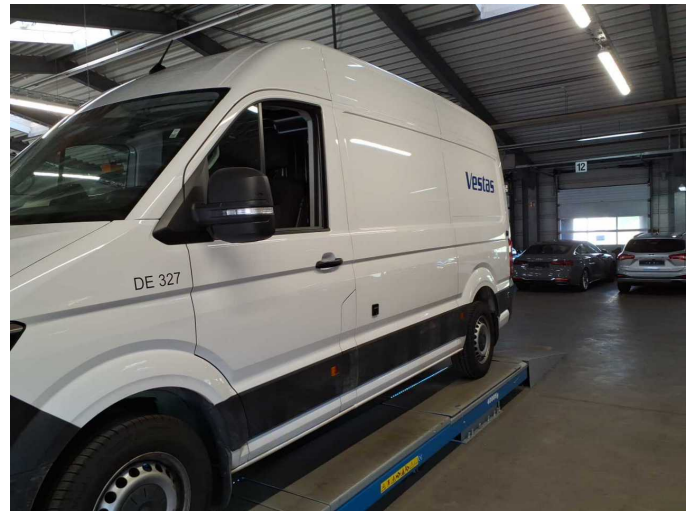
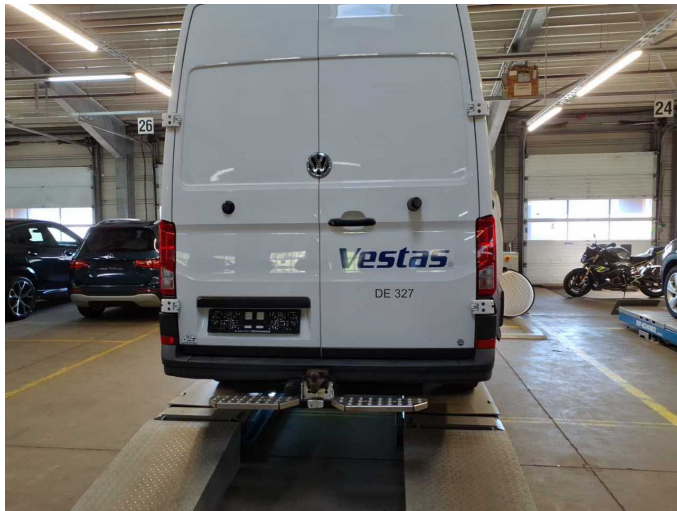
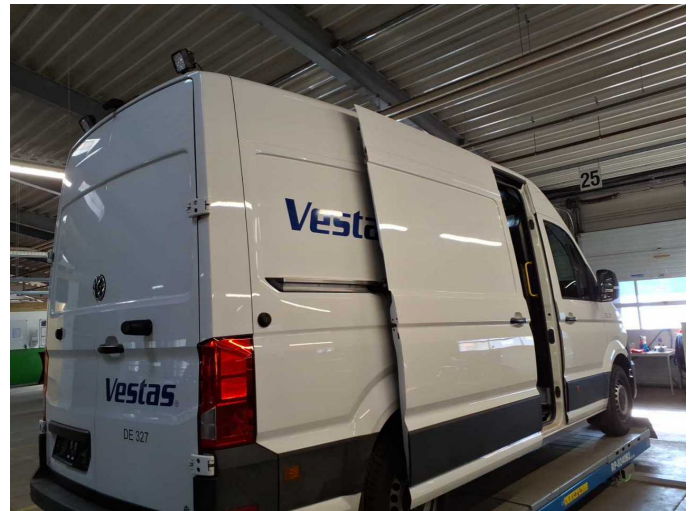
Damage 6: Body: Body - Glued / labelled - De-glue / neutralise

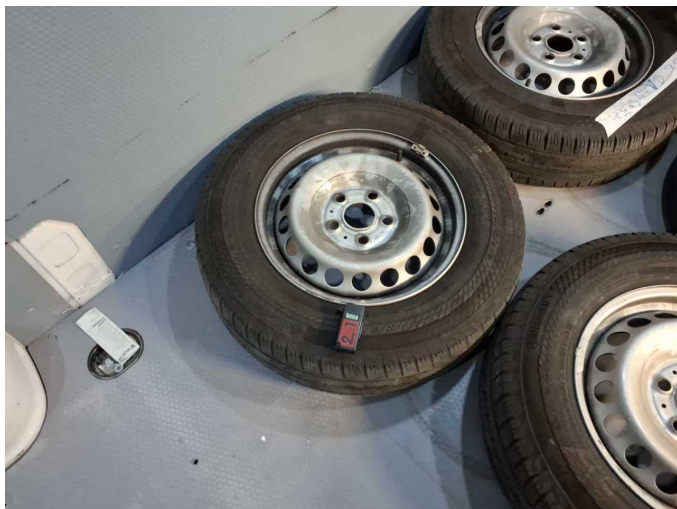
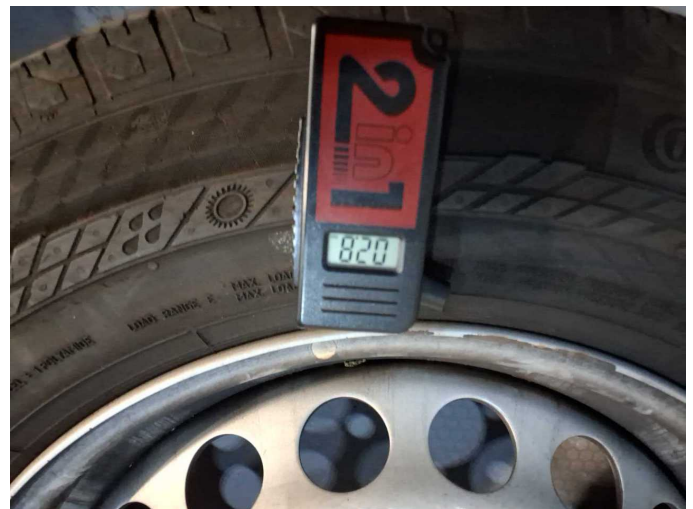
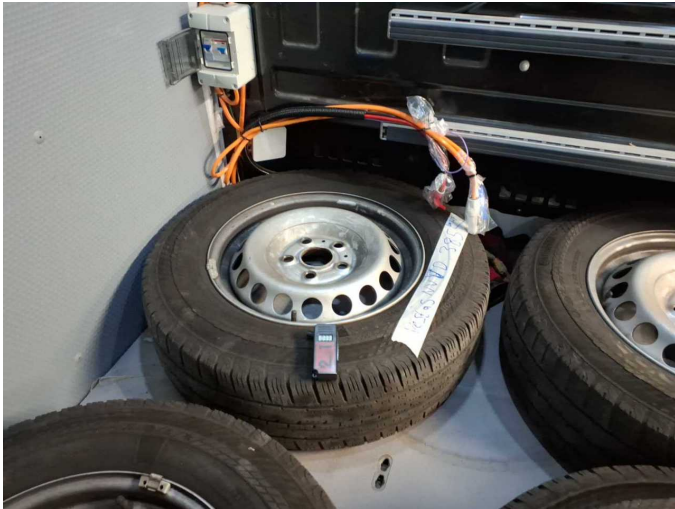
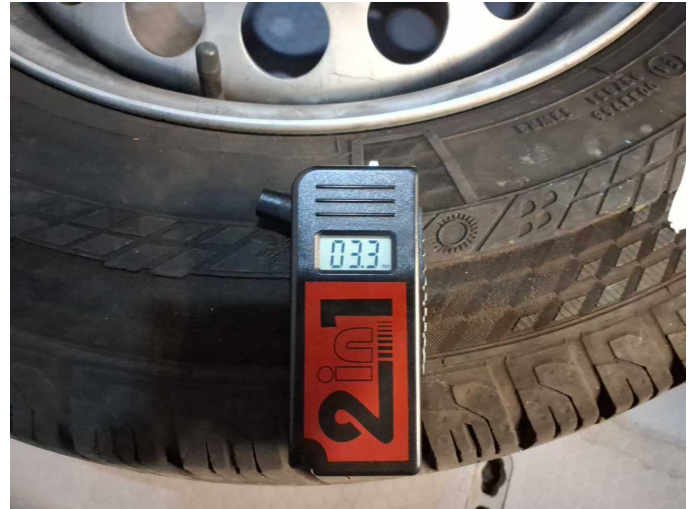
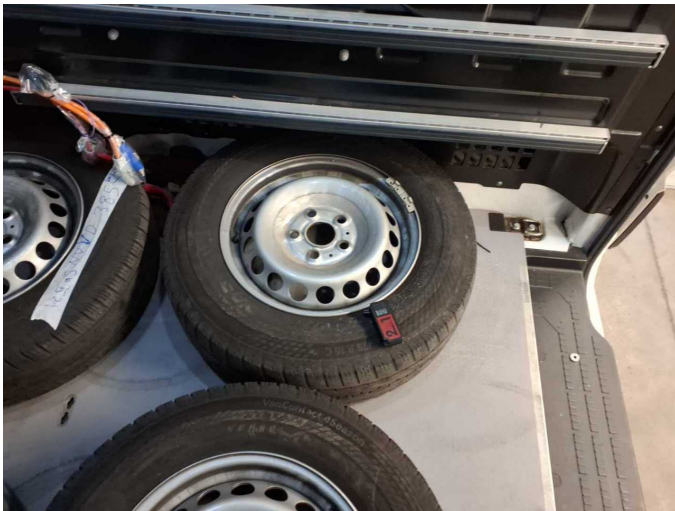
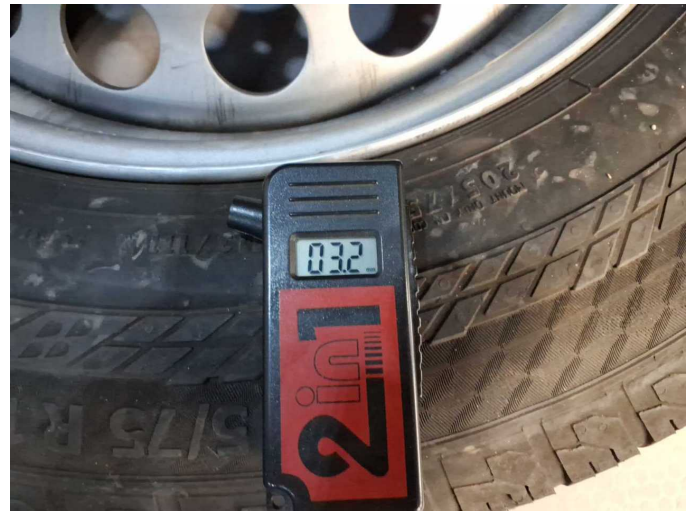
#	Tyre size	Type of tyre	Manufacturer	Tread depth
1)	205/75 R16 113R	All-season tyres on Steel	Continental	2mm / 3mm
2)	205/75 R16 113R	All-season tyres on Steel	Continental	3mm / 4mm

Damage 7: 2nd wheel set: 3 tyres (Profil kleiner 4mm) - Replace

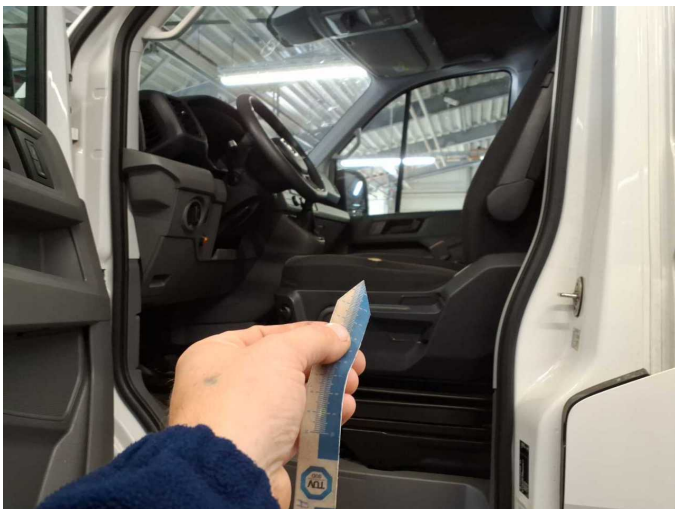
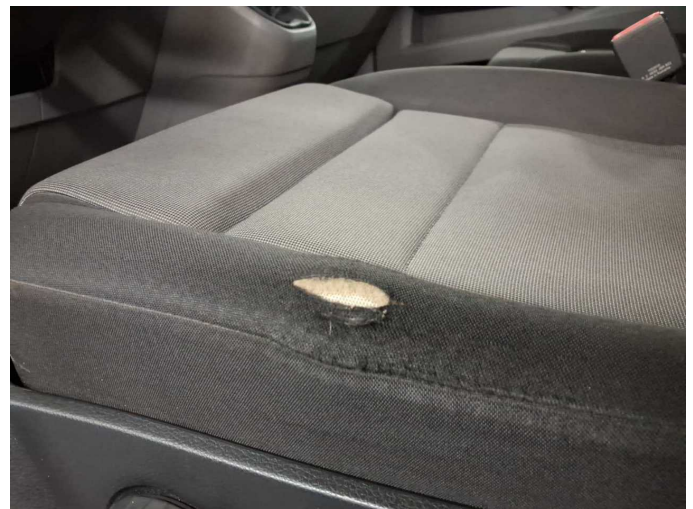
Damage 8: Seat - front: Seat cover - left side - Broken / torn - Replace
