Expertise

Protocol number: 41209143
Order No. / Reference: 25101293
Inspection date: 24 Aug 2025

Manufacturer: Volkswagen Model: Crafter 35 TDI VA

VIN: WV1ZZZSYZM9030617

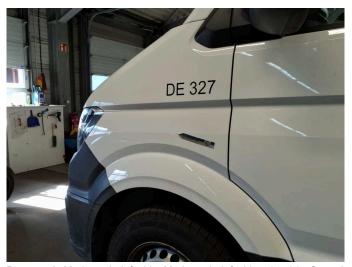
No.	Component group	Description
1	Misc.	Main inspection - No evidence - No deduction
2	Interior	Installations (Einbau Sortimo) - Differs from the original configuration - No deduction
3	Mudguard - left side	Mudguard - left side - dent(s) - Smooth repair work
4	Side panel - rear left side	Side panel - dent(s) - Smooth repair work
5	Door - front right side	Door - Deformed - Smart repair
6	Body	Body - Glued / labelled - De-glue / neutralise
7	2nd wheel set	3 tyres (Profil kleiner 4mm) - Replace
8	Seat - front	Seat cover - left side - Broken / torn - Replace

Damage 3: Mudguard - left side: Mudguard - left side - dent(s) - Smooth repair work

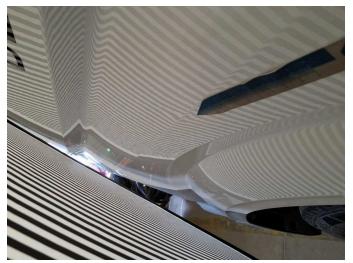
Damage 3: Mudguard - left side: Mudguard - left side - dent(s) - Smooth repair work

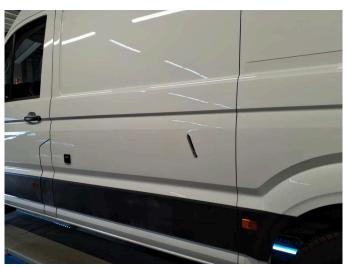
$\label{eq:Damage 4: Side panel - rear left side: Side panel - dent(s) - Smooth \\ repair work$

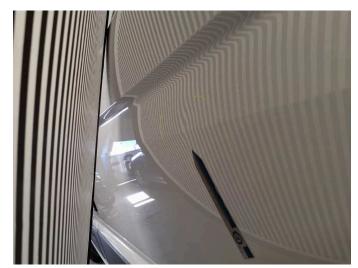
$\label{eq:Damage 4: Side panel - rear left side: Side panel - dent(s) - Smooth \\ repair work$

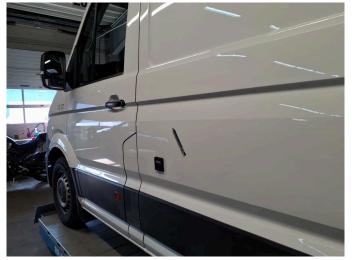
Damage 4: Side panel - rear left side: Side panel - dent(s) - Smooth repair work

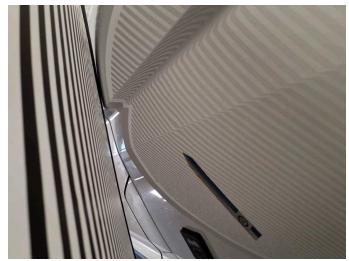
Damage 4: Side panel - rear left side: Side panel - dent(s) - Smooth repair work

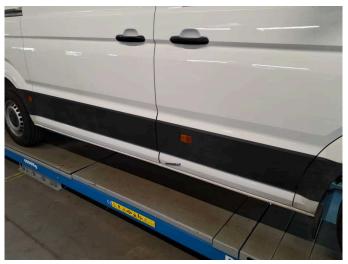
Damage 5: Door - front right side: Door - Deformed - Smart repair

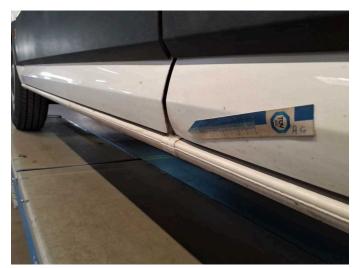
Damage 5: Door - front right side: Door - Deformed - Smart repair

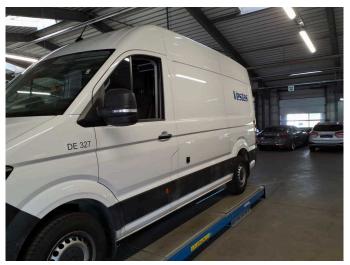
Damage 6: Body: Body - Glued / labelled - De-glue / neutralise

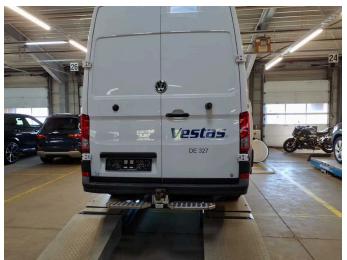
Damage 6: Body: Body - Glued / labelled - De-glue / neutralise

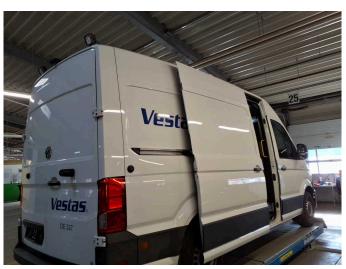
Damage 6: Body: Body - Glued / labelled - De-glue / neutralise

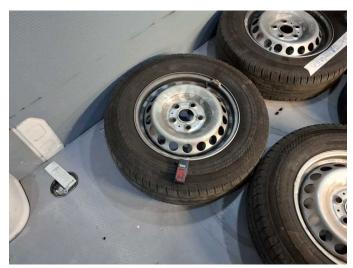
Damage 7: 2nd wheel set: 3 tyres (Profil kleiner 4mm) - Replace

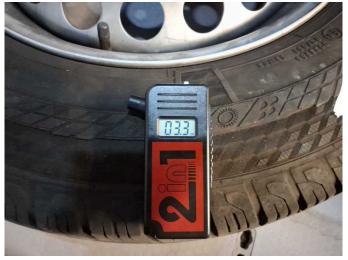
Damage 7: 2nd wheel set: 3 tyres (Profil kleiner 4mm) - Replace

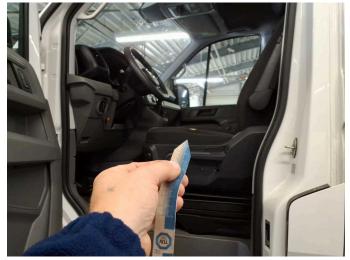
Damage 8: Seat - front: Seat cover - left side - Broken / torn - Replace

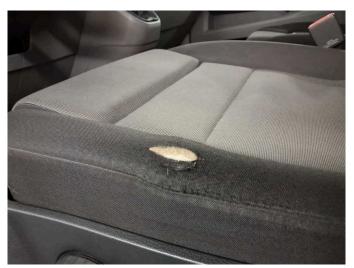
Damage 8: Seat - front: Seat cover - left side - Broken / torn - Replace
