Expertise

Protocol number: 41652818
Order No. / Reference: 25149461
Inspection date: 23 Sept 2025

Manufacturer: Volkswagen

Model: Crafter 35 TDI Autm. VA

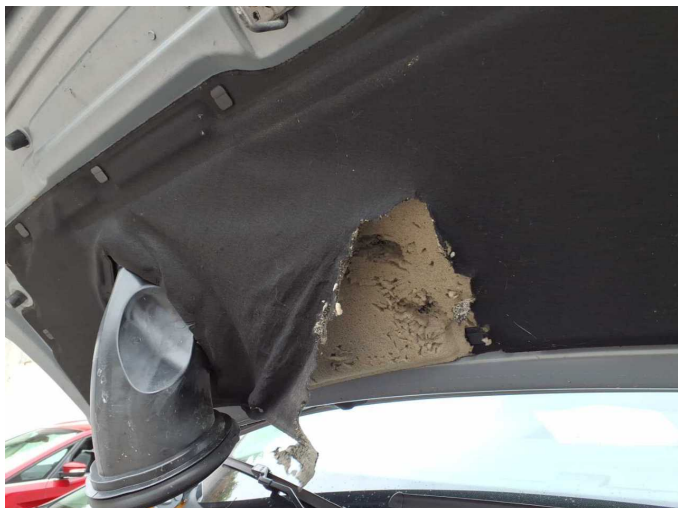
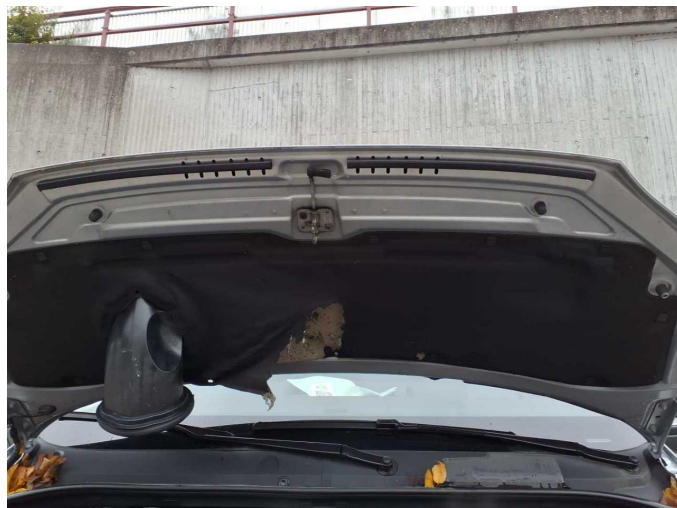
Damage 1: Bonnet: Insulation lining (Mehrkosten möglich) - Damage caused by marten / rodent - Replace

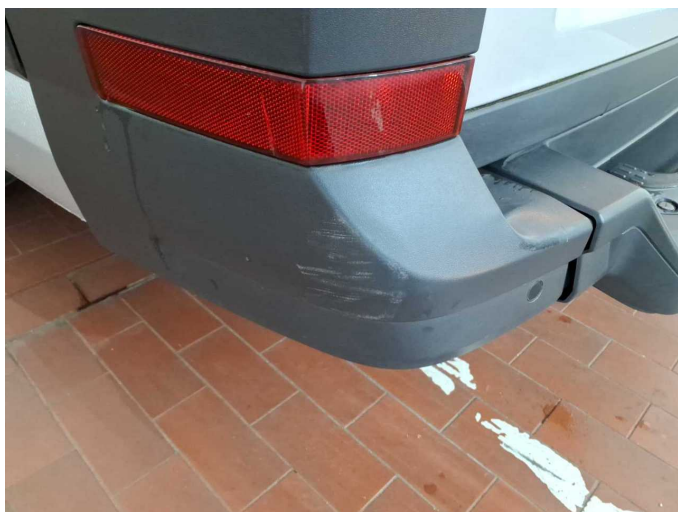
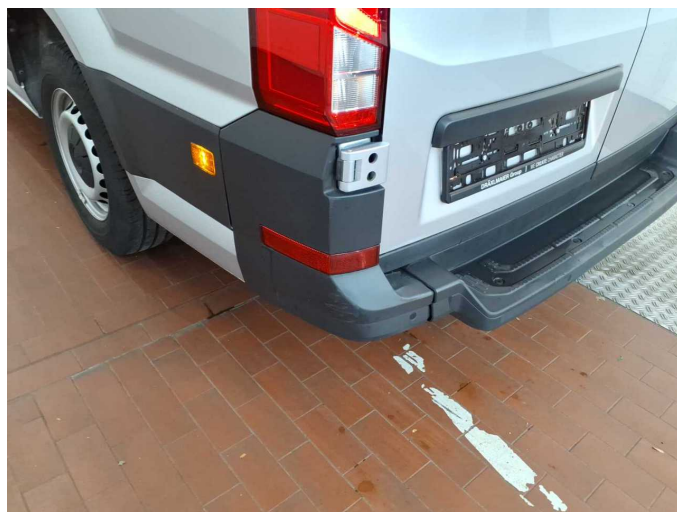
Damage 2: Rear bumper: Rear bumper (unpainted) - Scratched - Loss in value

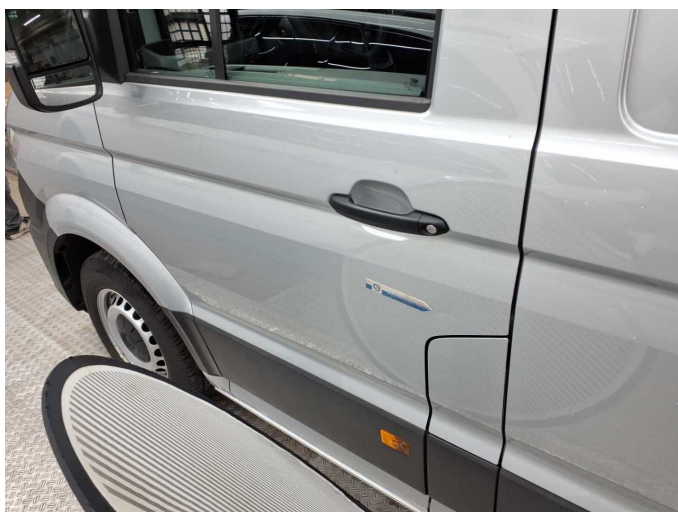
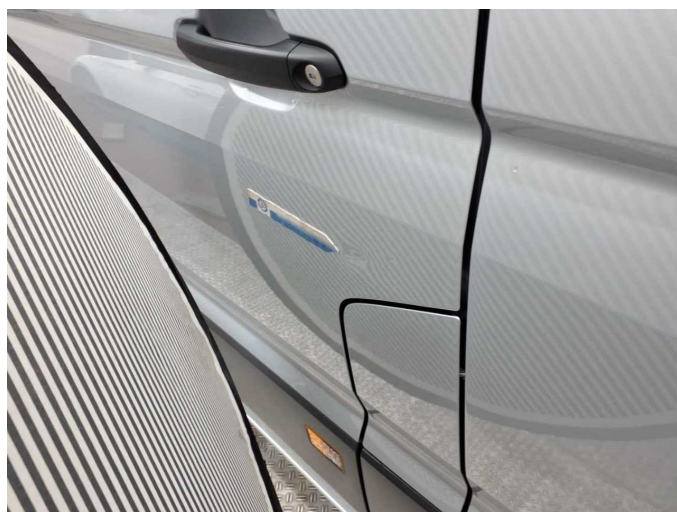
Damage 3: Door - front left side: Door - dent(s) - Smart repair

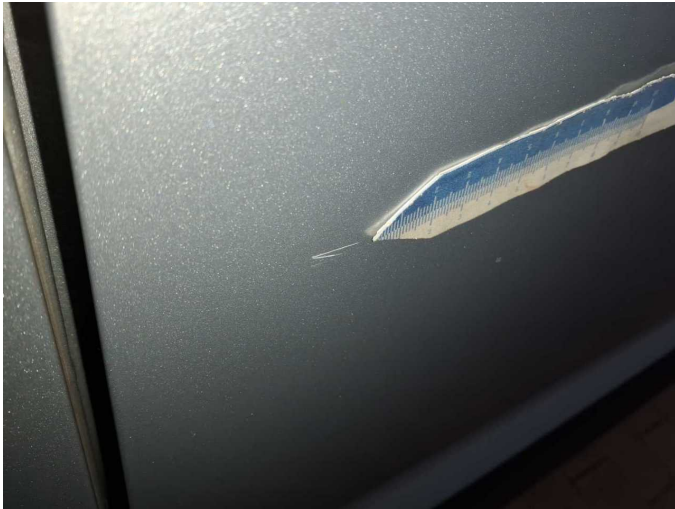
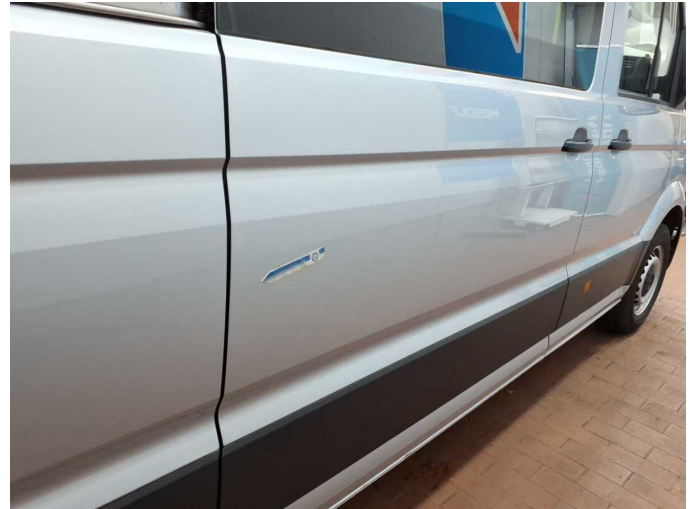
Damage 4: Door - rear right side: Door - Scratch(es) - Smart repair

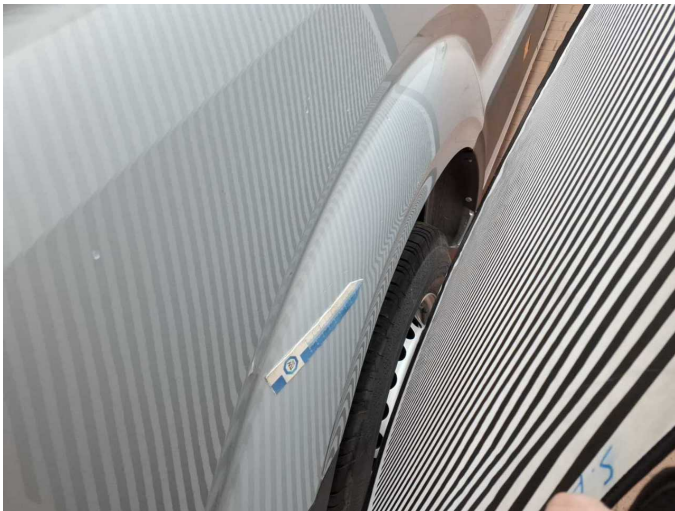
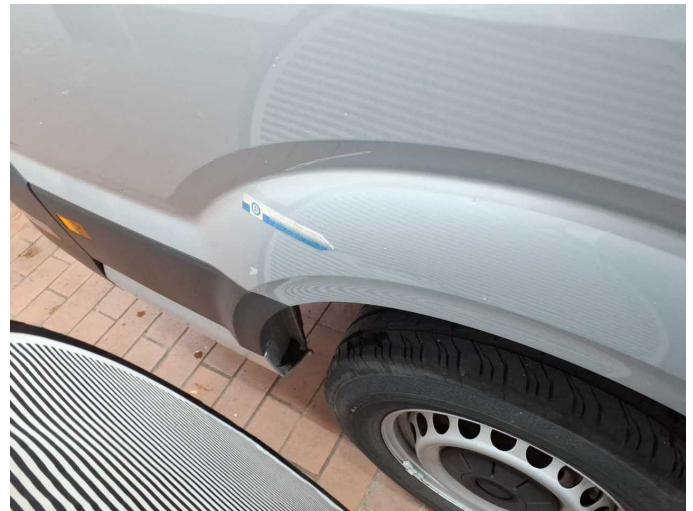
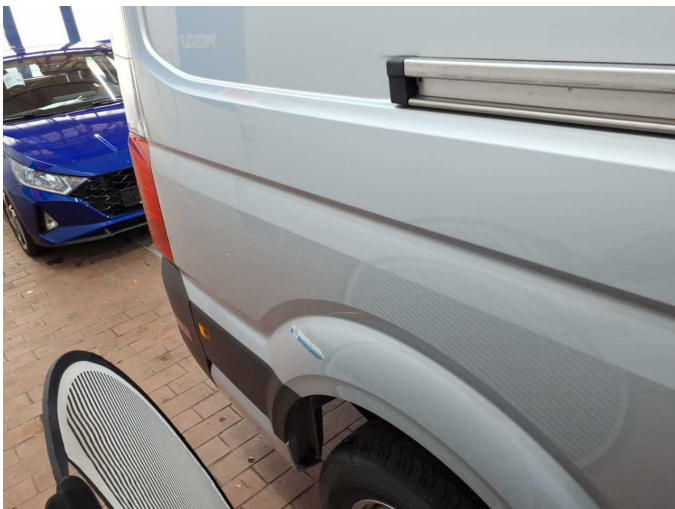
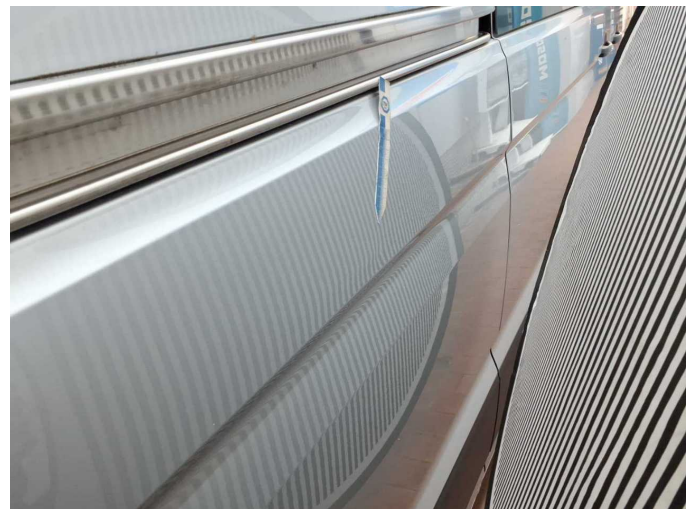
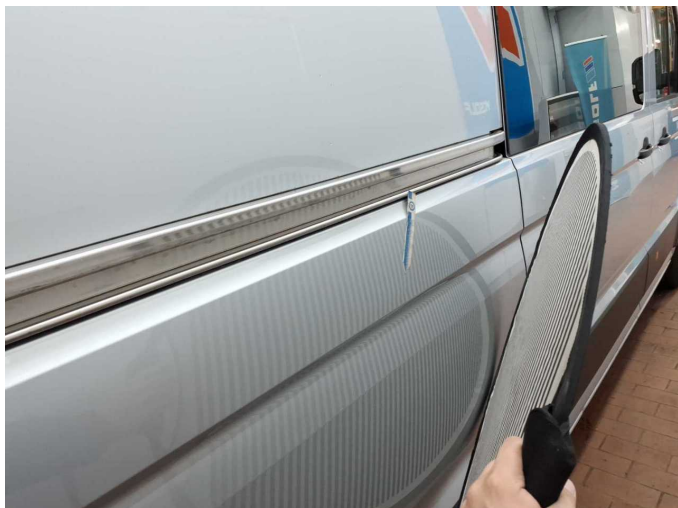
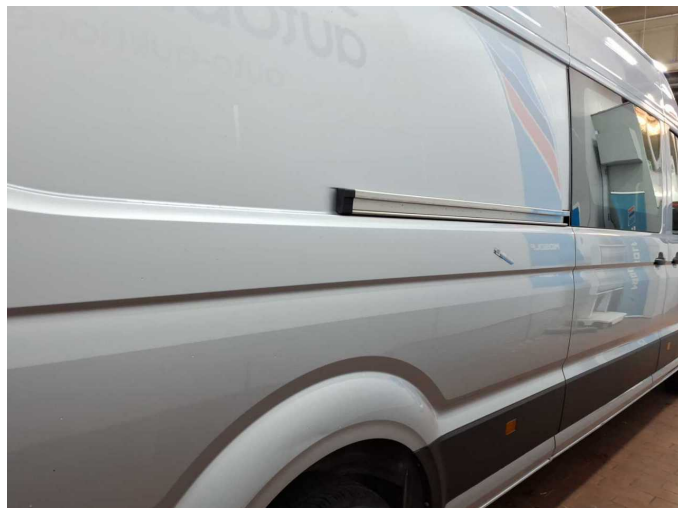
Damage 5: Side panel - rear right side: Side panel - dent(s) - Smart repair
