VOLKSWAGEN T6/MULTIVAN/CARAVELLE Caravelle Kurz

VIN NO WV2ZZZ7HZHH119001 Registration Number HZHH119001

Inspection Report Summary

Customer	BCA Online	Report Number	P20250926103404
Inspection Date / Place	2025-09-26 / Extern	Cosmetic Grade	2

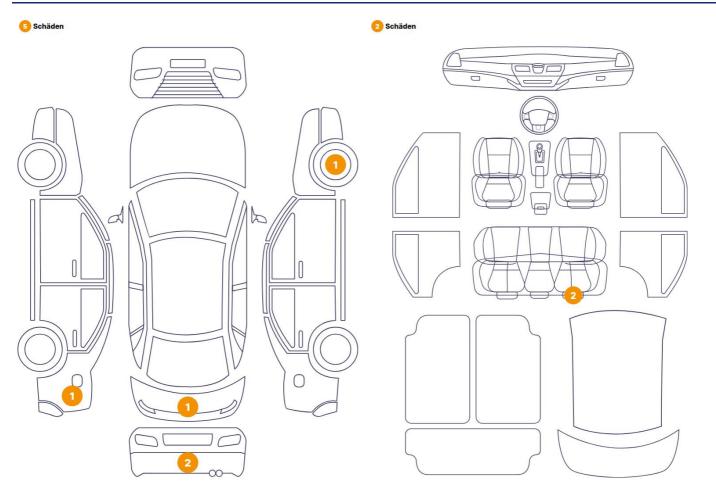
Component	Damage	Comments
1	Side Panel / Back Left	Paint / Poor Previous Repair	
2	Tailgate	Bodywork / Dent / Deformation	
3	Bumper / Back	Paint / Scratch / Scuff	
4	Bumper / Back	Paint / Scratch / Scuff	
5	Rim / Front Right	Out of Bodywork / Scratch	
6	Seat / Back Right	Interior / Worn - out	
7	Seat / Back Right	Interior / Dirty

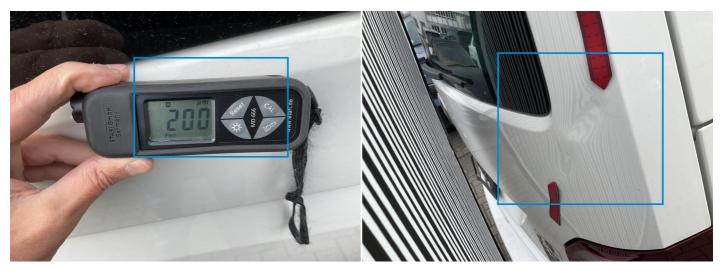
1. Side Panel / Back Left Paint / Poor Previous Repair -

2. Tailgate Bodywork / Dent / Deformation -

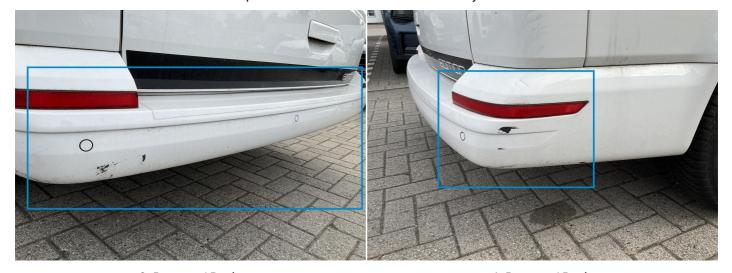
3. Bumper / Back Paint / Scratch / Scuff -

4. Bumper / Back Paint / Scratch / Scuff -

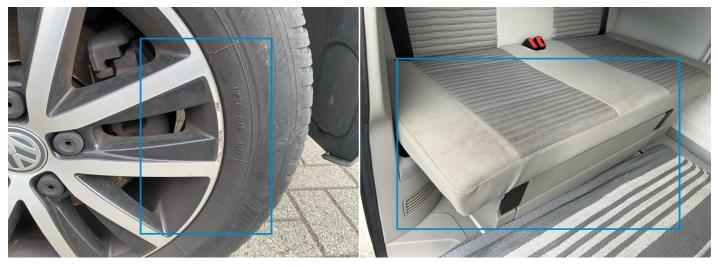
5. Rim / Front Right Out of Bodywork / Scratch -

6. Seat / Back Right Interior / Worn - out -

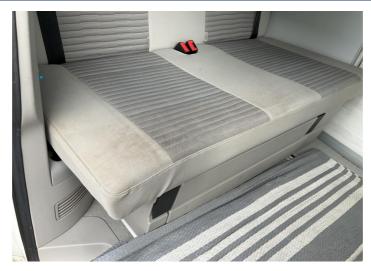
7. Seat / Back Right Interior / Dirty -
