Expertise

Protocol number: 41603379
Order No. / Reference: 25252762
Inspection date: 17 Sept 2025

Manufacturer: Volkswagen

Model: Caravelle T6.1 Kurz Comfortline

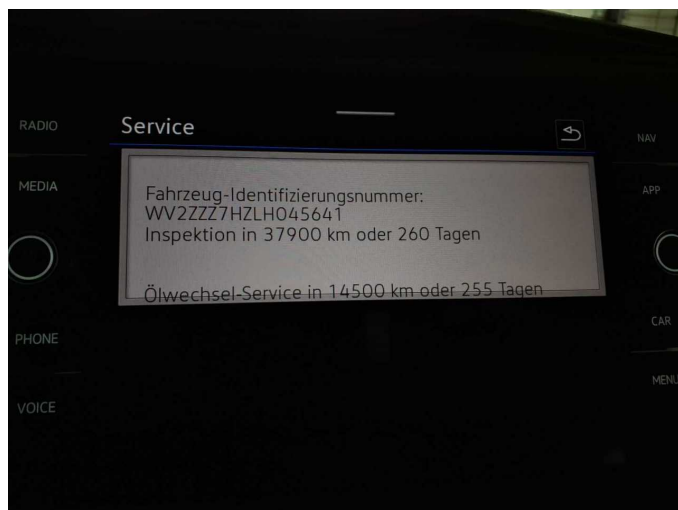
Damage 2: Multimedia system: Screen (halber Bildschirm) - No deduction

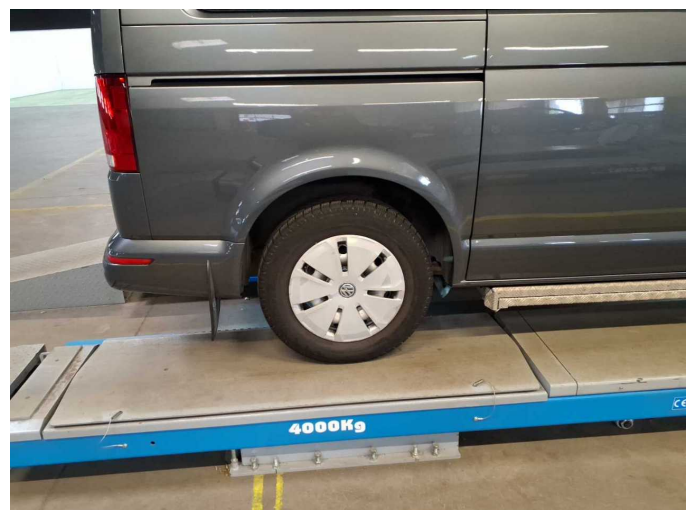
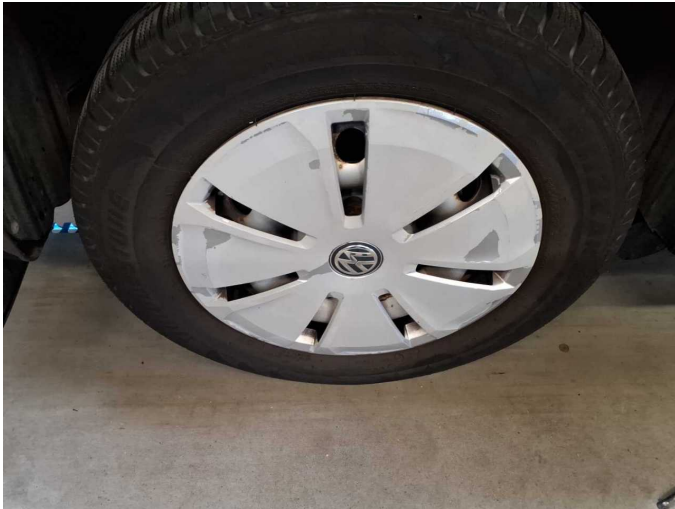
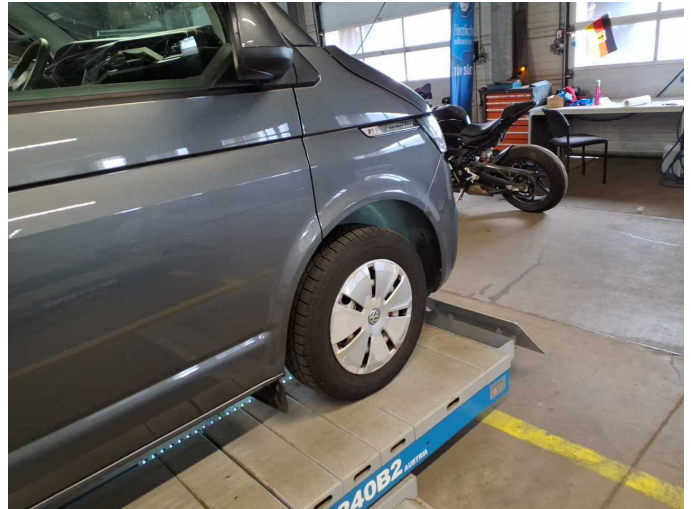
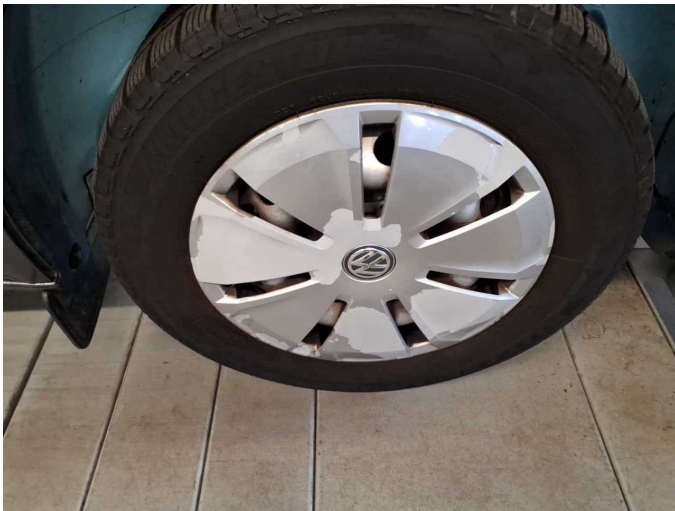
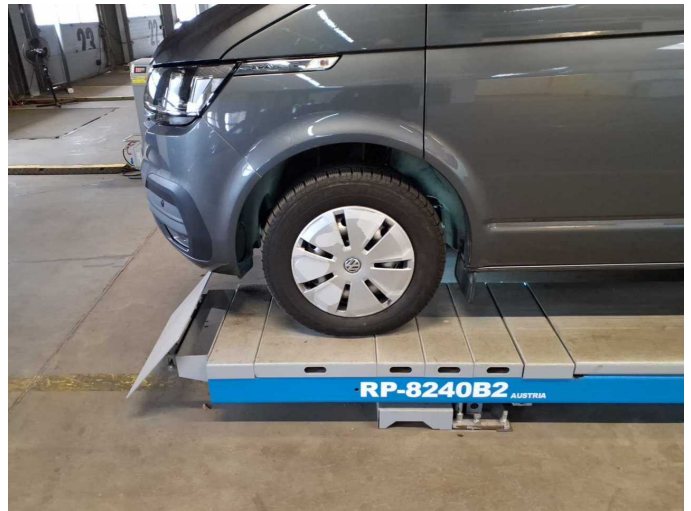
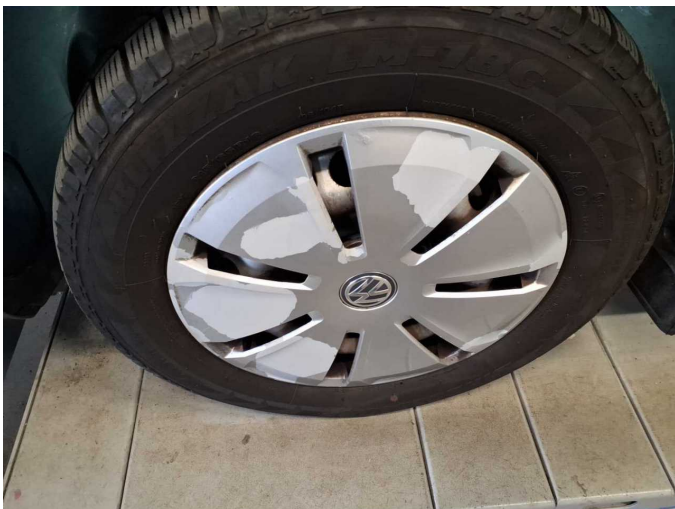
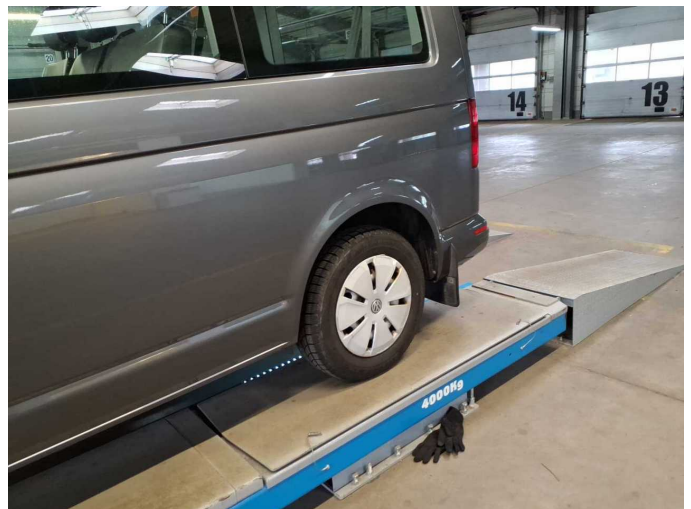
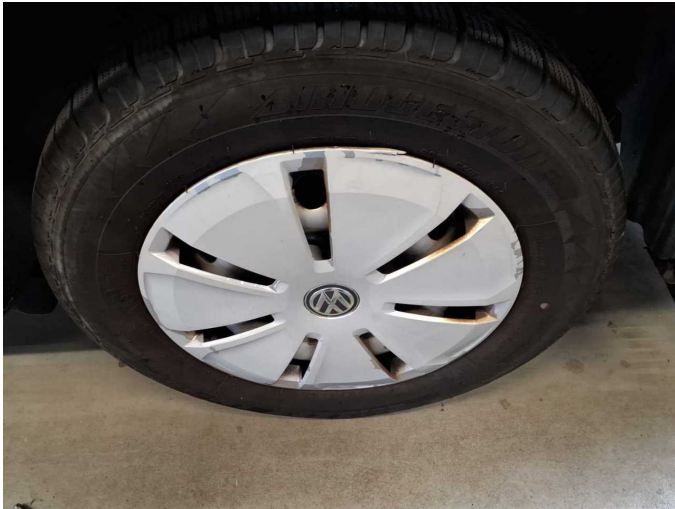
Damage 3: Wheel / tyres: Wheel cover set - complete - Scratched - Replace

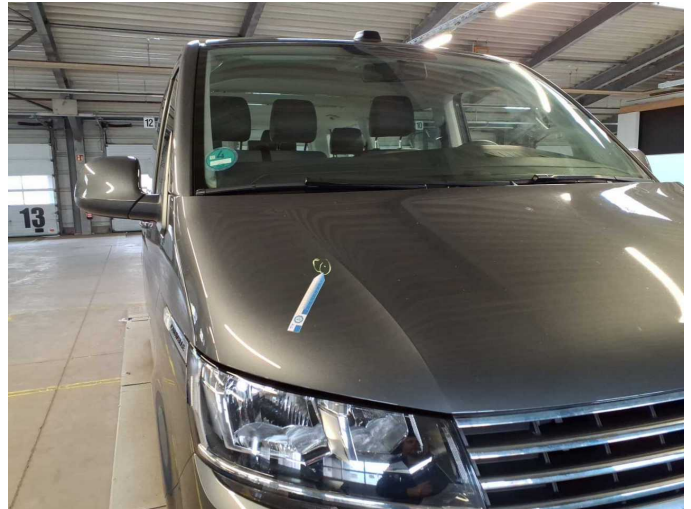
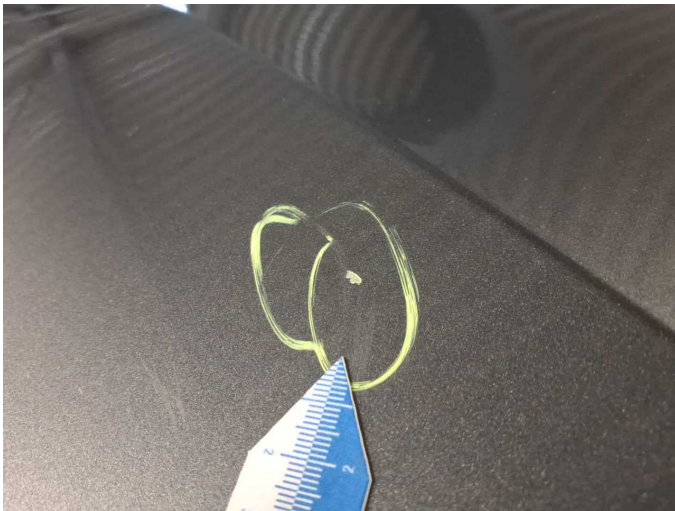
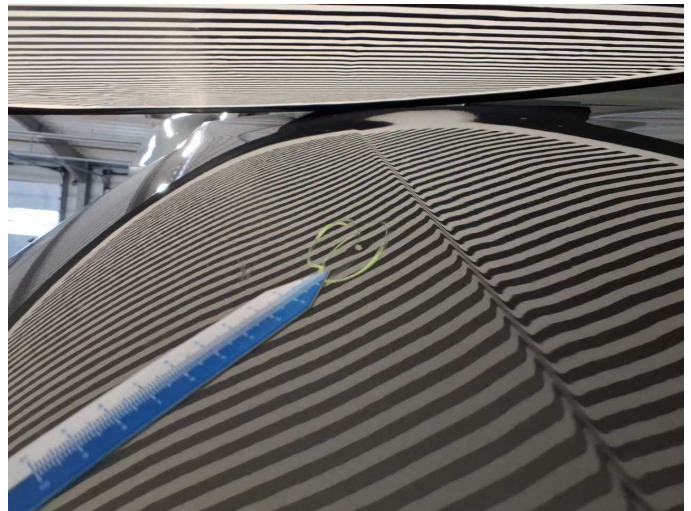
Damage 4: Bonnet: Bonnet - Dent / paintcoat damage - Repair and paint

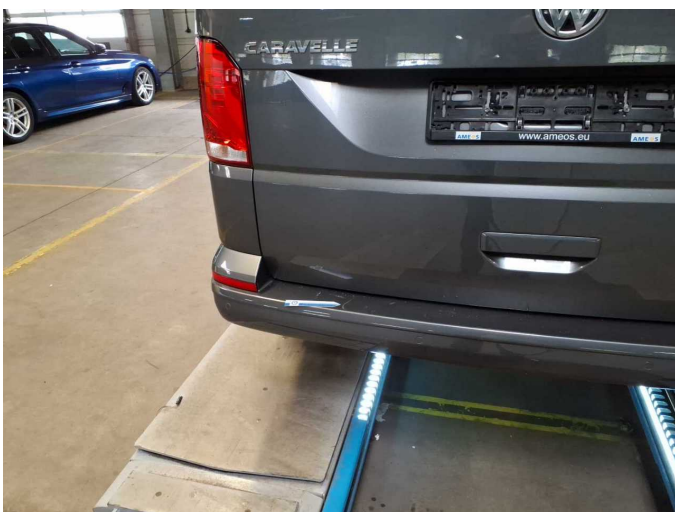
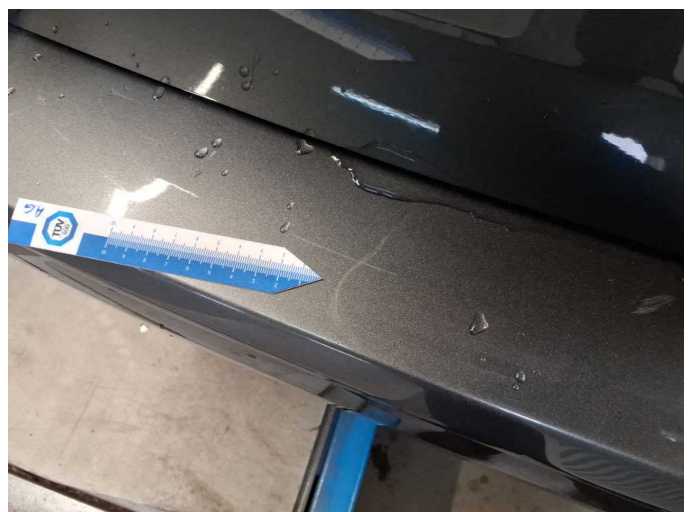
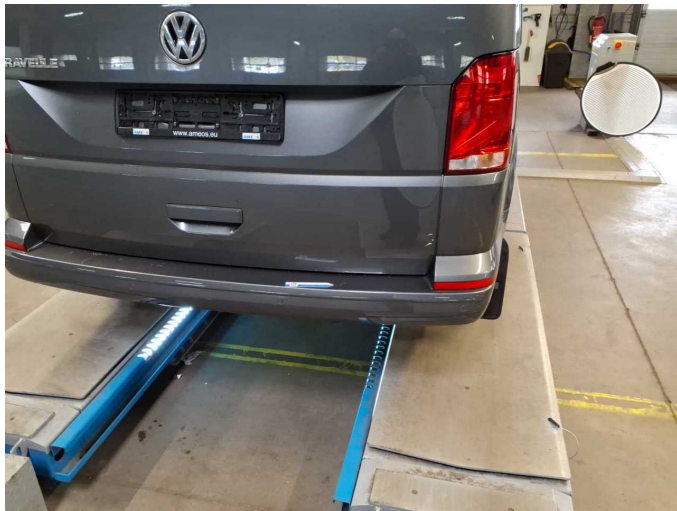
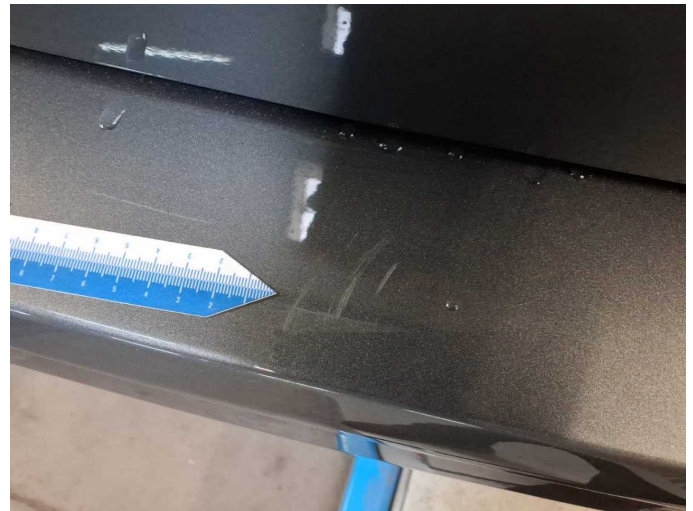
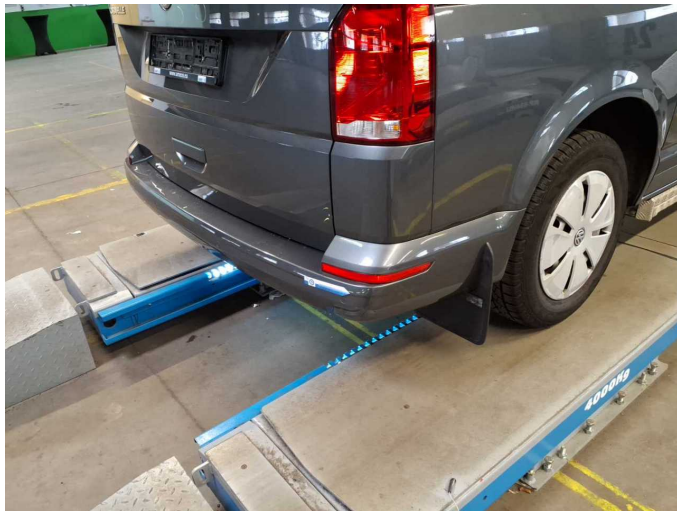
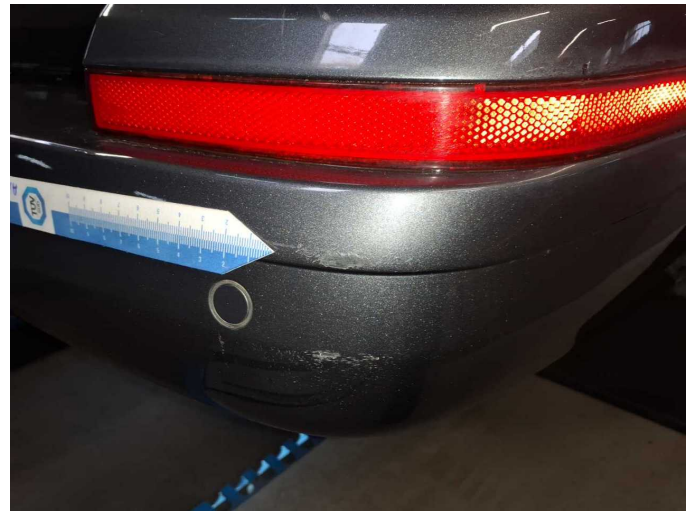
Damage 5: Rear bumper: Rear bumper - Scratch(es) - Paint

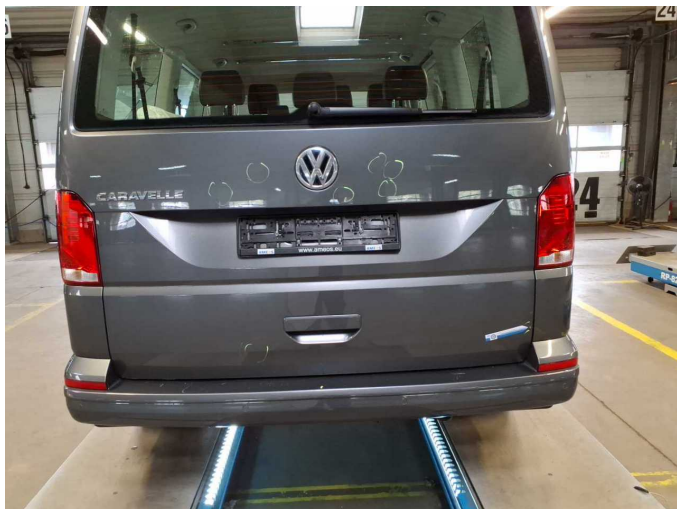
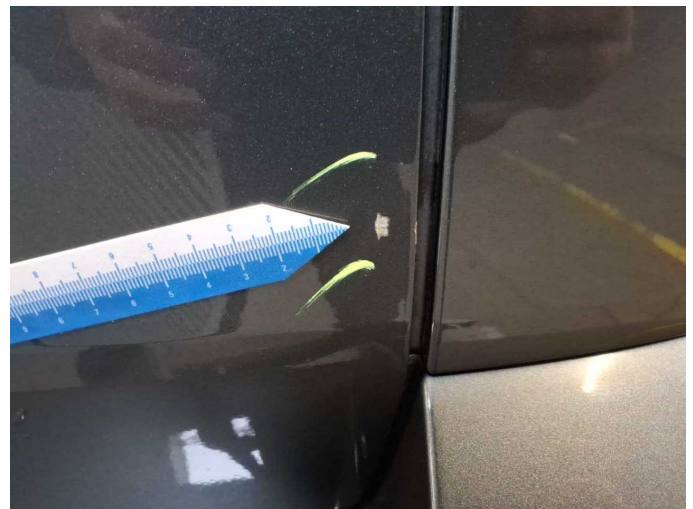
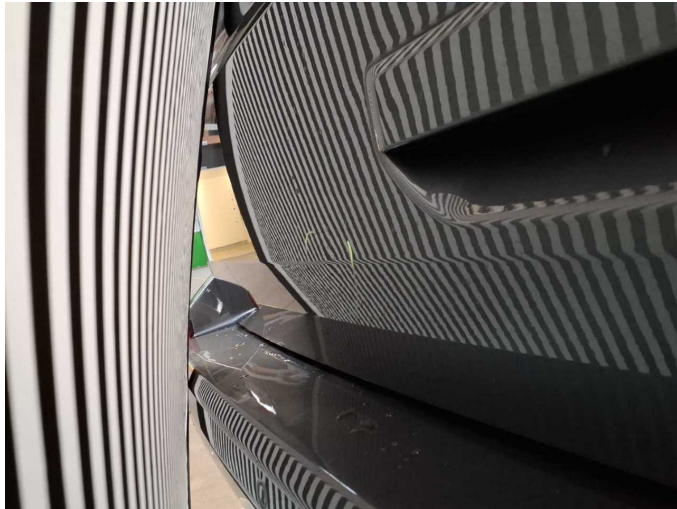
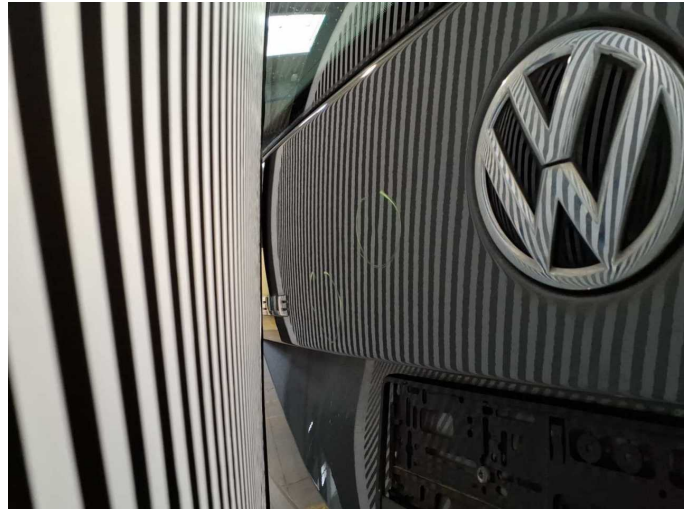
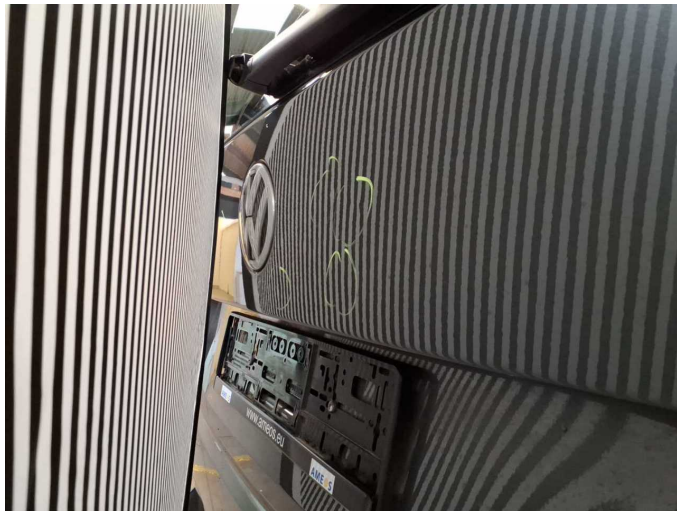
Damage 6: Boot lid / rear door: Boot lid - Dent / paintcoat damage - Repair and paint

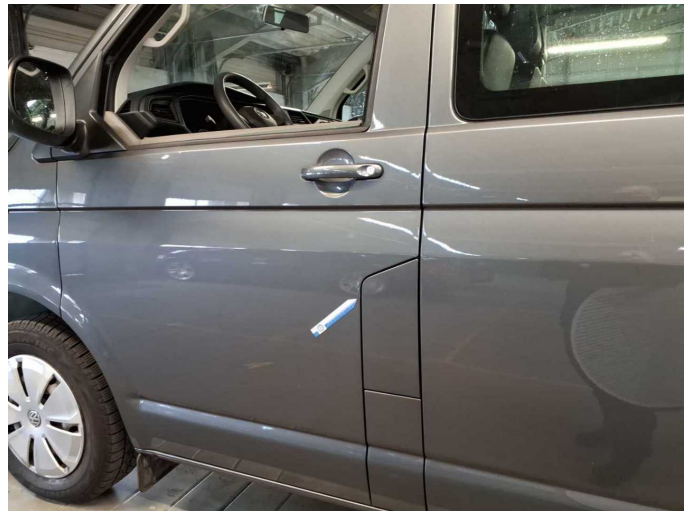
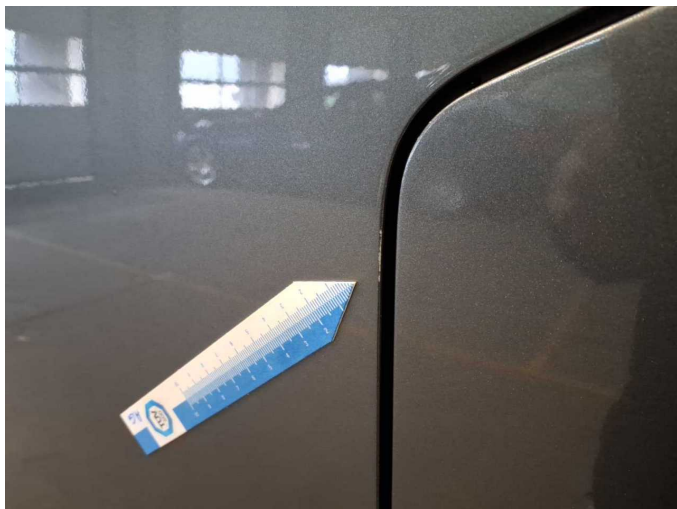
Wear and tear 1: Door - front left side: Door edge - Scratch(es) - Smart repair

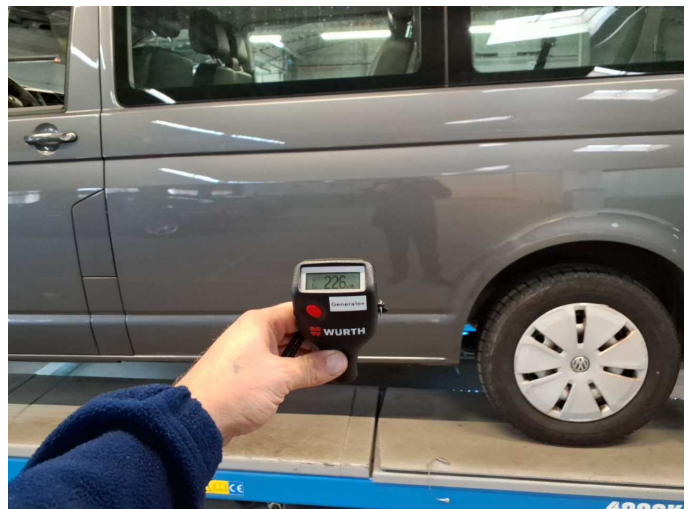
Side panel - rear left side	226 µm	Door - front left side	152 µm
Door - front right side	143 µm

Repainting 1: Side panel - rear left side

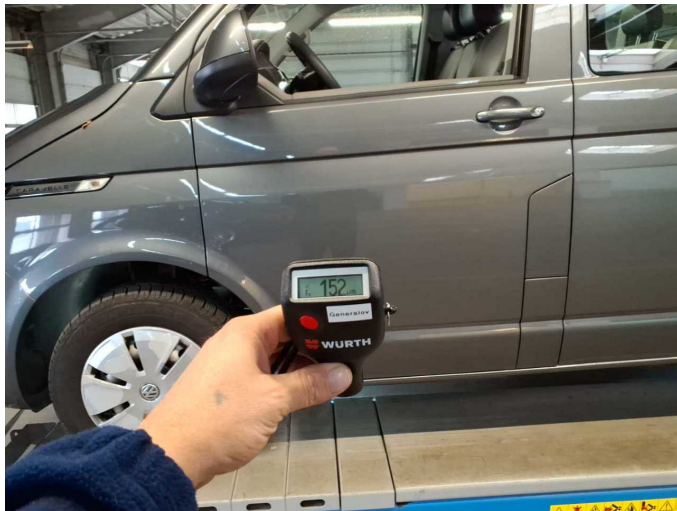
Repainting 2: Door - front left side

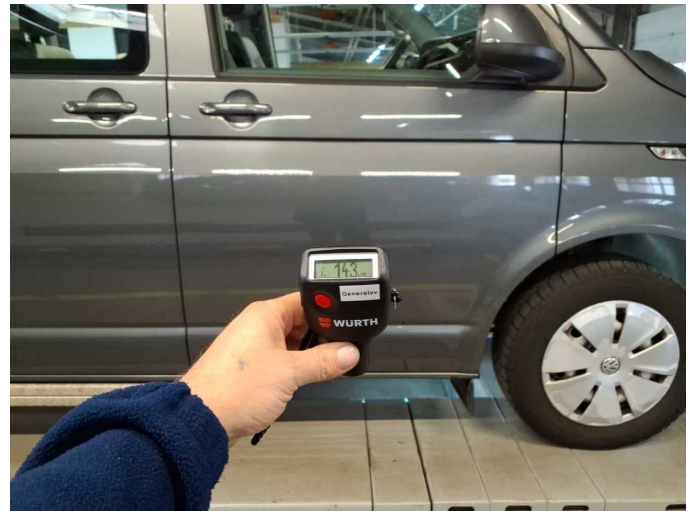
Repainting 3: Door - front right side
