# VOLKSWAGEN T6/MULTIVAN/CARAVELLE

## Transporter T6.1 DSG Kurz

VIN NO WV2ZZZ7HZN008039  
Registration Number HZN008039

### Inspection Report Summary

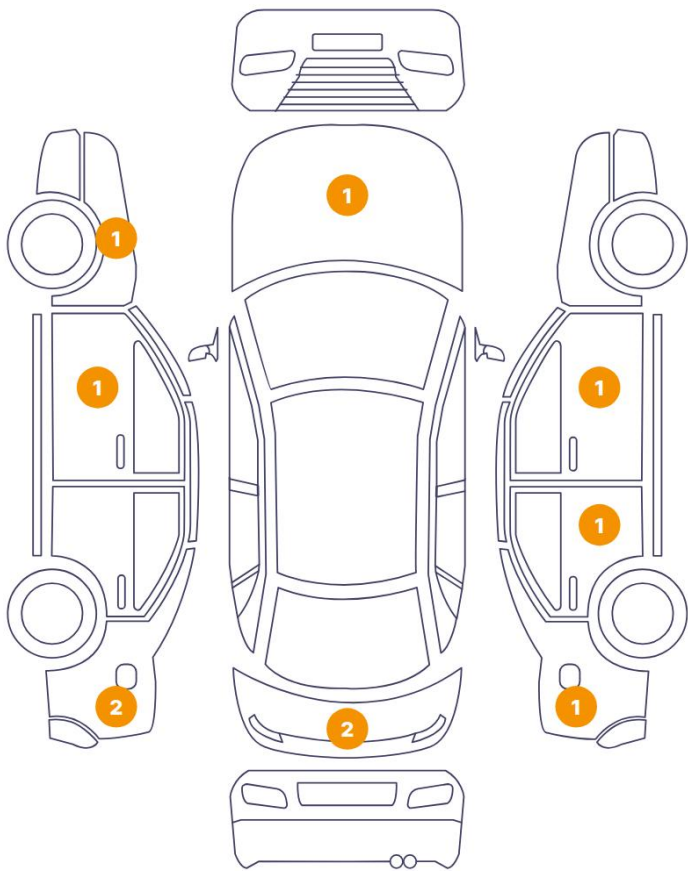
10 Schäden

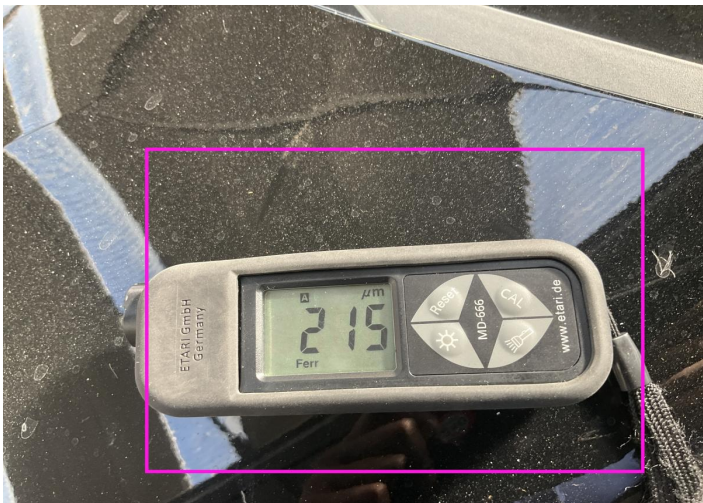
| Component | | Damage | Comments |
|---|---|---|---|
| 1 | Fender / Front Left | Paint / Poor Previous Repair | |

1. Fender / Front Left  
Paint / Poor Previous Repair -

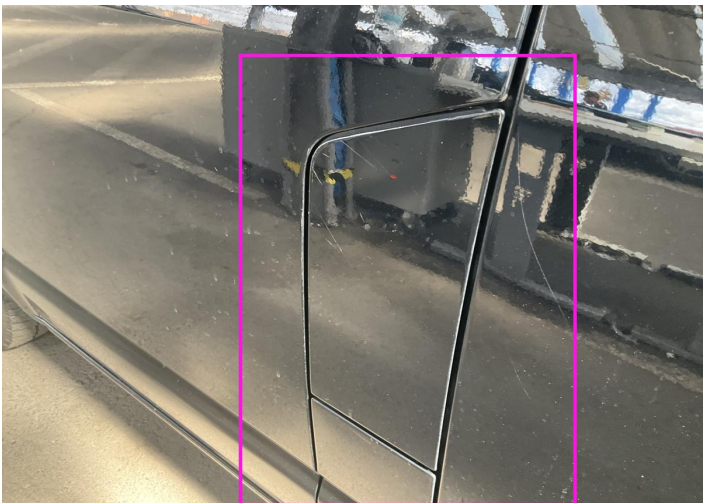
| Component | | Damage | Comments |
|---|---|---|---|
| 2 | Door / Front Left | Paint / Scratch / Scuff | |

2. Door / Front Left  
Paint / Scratch / Scuff -

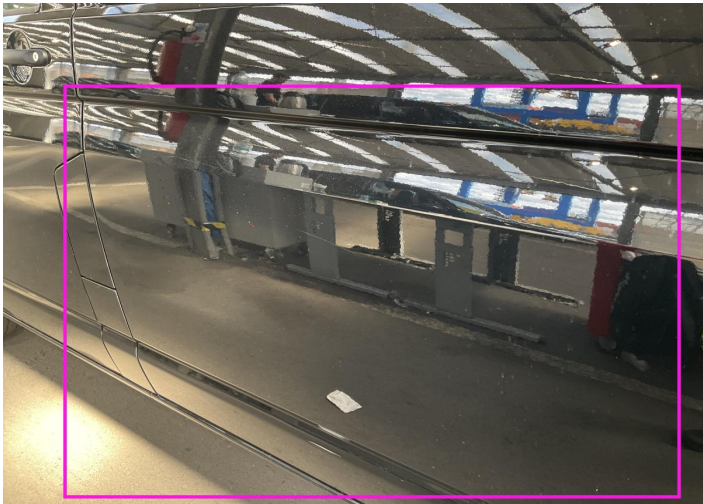
| Component | | Damage | Comments |
|---|---|---|---|
| 3 | Side Panel / Back Left | Paint / Scratch / Scuff | |

3. Side Panel / Back Left  
Paint / Scratch / Scuff -

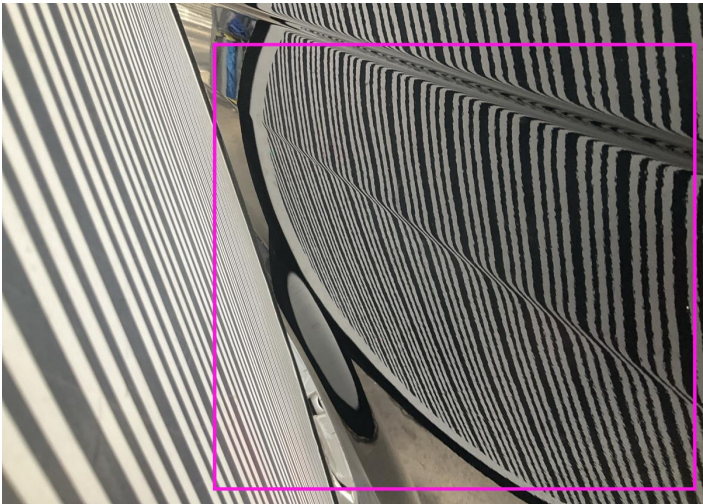
| Component | | Damage | Comments |
|---|---|---|---|
| 4 | Side Panel / Back Left | Bodywork / Dent / Dent | |

4. Side Panel / Back Left  
Bodywork / Dent / Dent -

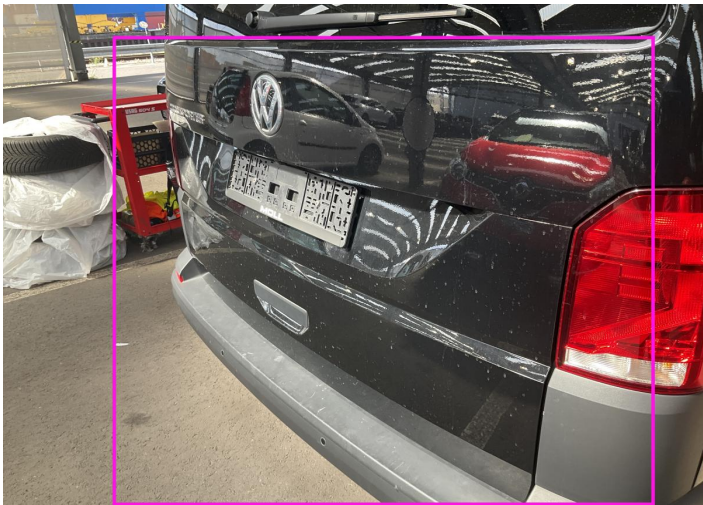
| Component | | Damage | Comments |
|---|---|---|---|
| 6 | Tailgate | Paint / Scratch / Scuff | |

6. Tailgate  
Paint / Scratch / Scuff -

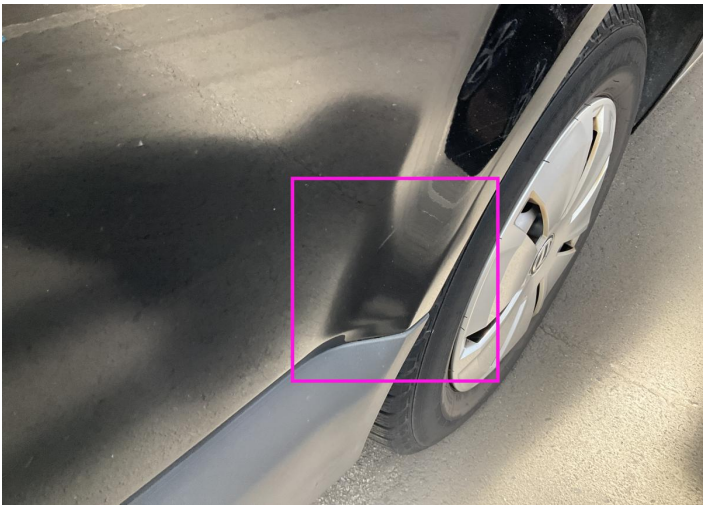
| Component | | Damage | Comments |
|---|---|---|---|
| 7 | Side Panel / Back Right | Paint / Scratch / Scuff | |

7. Side Panel / Back Right  
Paint / Scratch / Scuff -
