# VOLKSWAGEN T6/MULTIVAN/CARAVELLE

## Transporter T6.1 DSG Kurz

VIN NO WV2ZZZ7HZN008039  
Registration Number HZN008039

### Inspection Report Summary

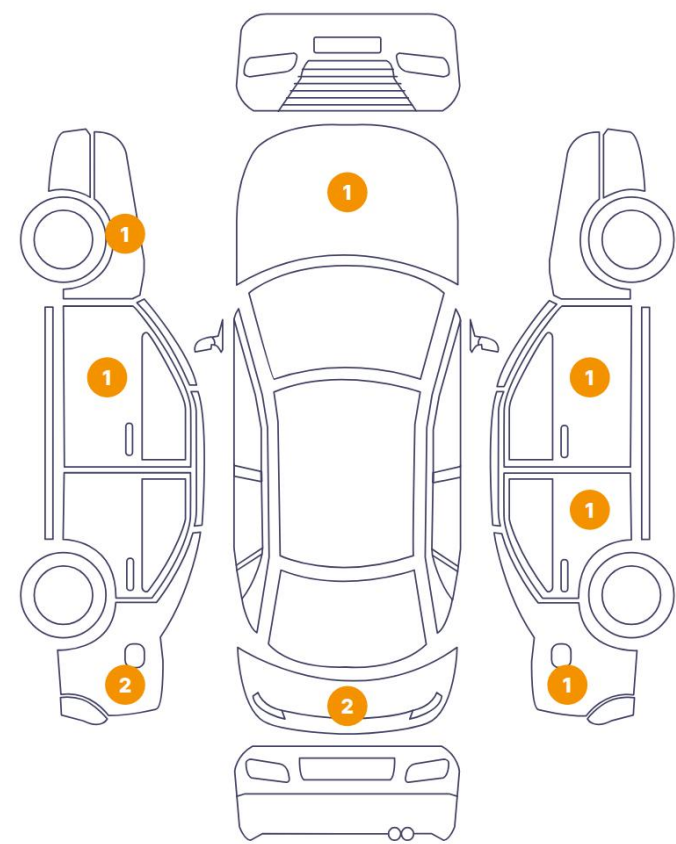
10 Schäden

Component		Damage	Comments
1	Fender / Front Left	Paint / Poor Previous Repair	
2	Door / Front Left	Paint / Scratch / Scuff	
3	Side Panel / Back Left	Paint / Scratch / Scuff	
4	Side Panel / Back Left	Bodywork / Dent / Dent	
5	Tailgate	Paint / Scratch / Scuff	
6	Tailgate	Paint / Scratch / Scuff	
7	Side Panel / Back Right	Paint / Scratch / Scuff	
8	Door / Back Right	Paint / Scratch / Scuff	
9	Mirror / Front Right	Bodywork / Breakage / Crack	
10	Hood	Bodywork / Dent / Dent

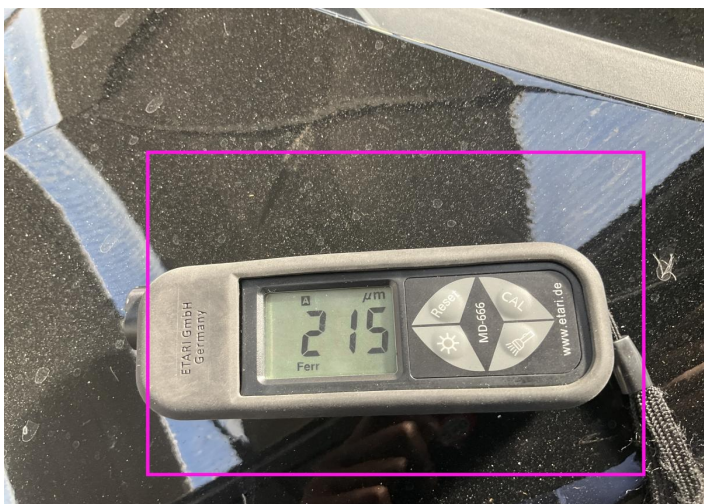
1. Fender / Front Left  
Paint / Poor Previous Repair -

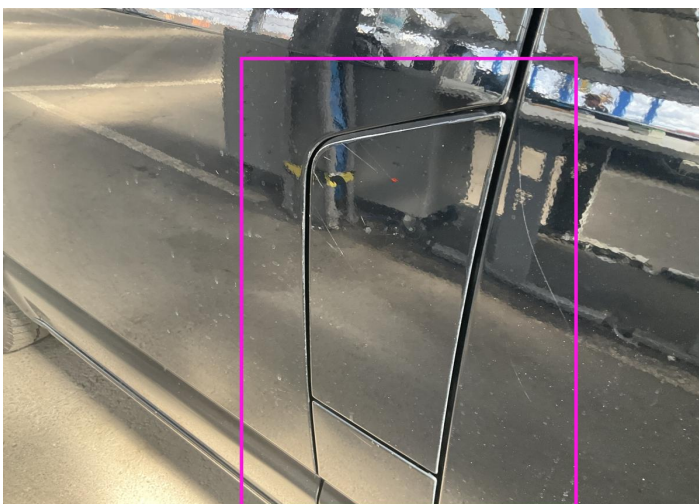
2. Door / Front Left  
Paint / Scratch / Scuff -

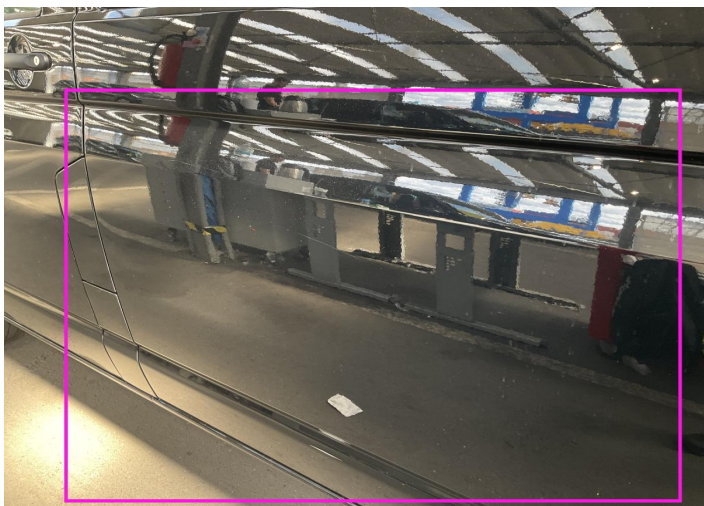
3. Side Panel / Back Left  
Paint / Scratch / Scuff -

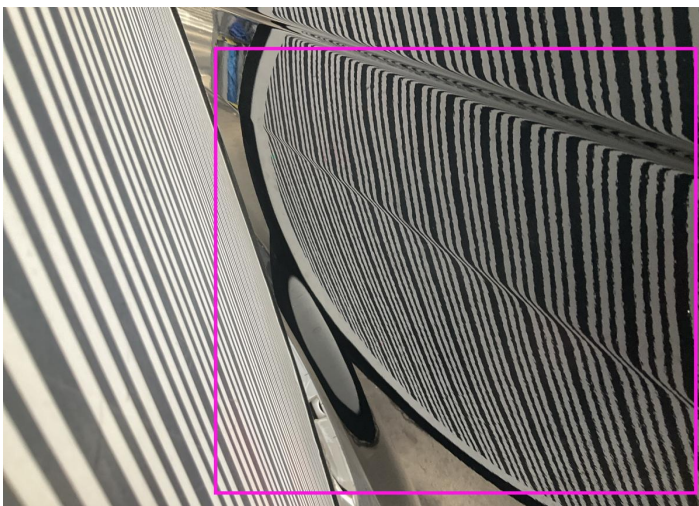
4. Side Panel / Back Left  
Bodywork / Dent / Dent -

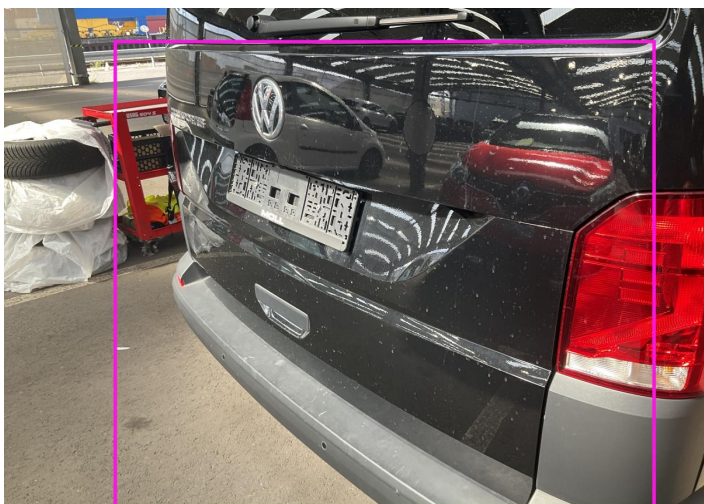
6. Tailgate  
Paint / Scratch / Scuff -

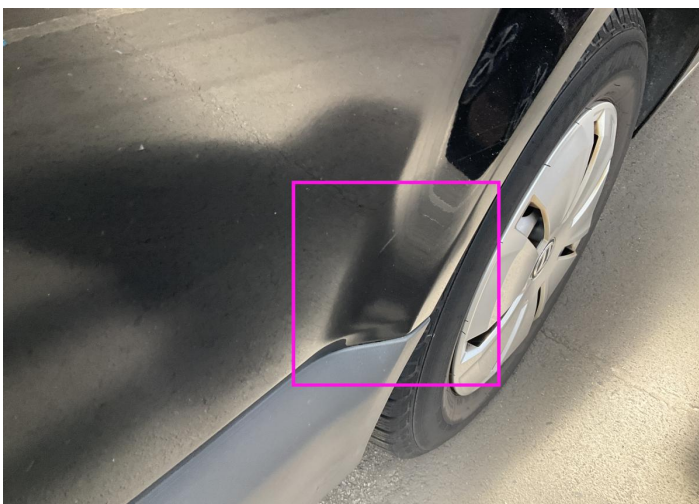
7. Side Panel / Back Right  
Paint / Scratch / Scuff -

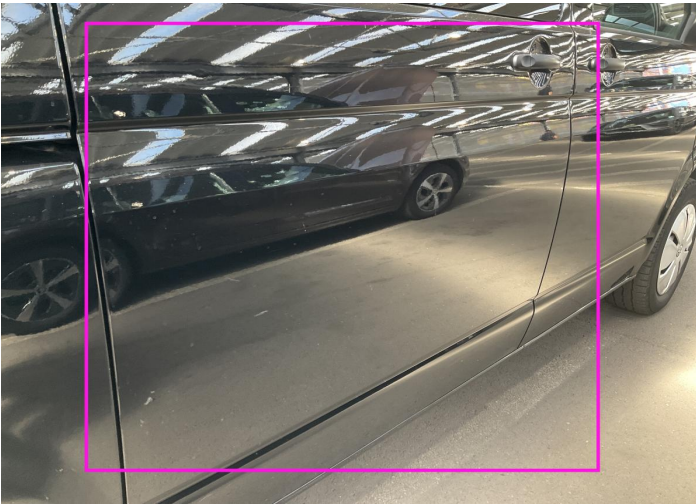
8. Door / Back Right  
Paint / Scratch / Scuff -

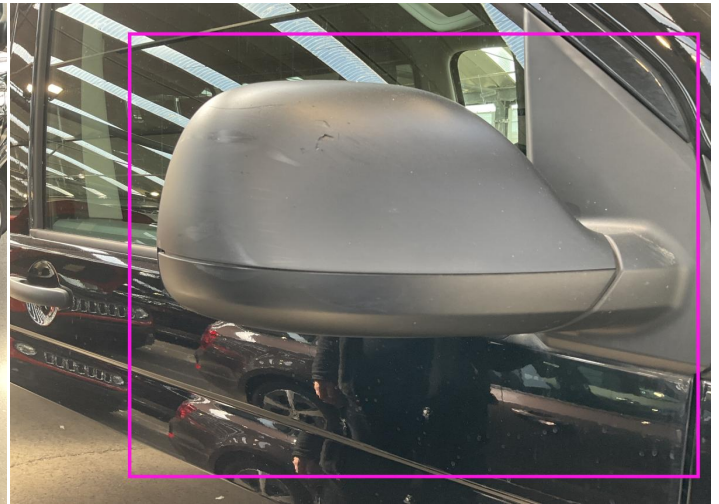
9. Mirror / Front Right  
Bodywork / Breakage / Crack -

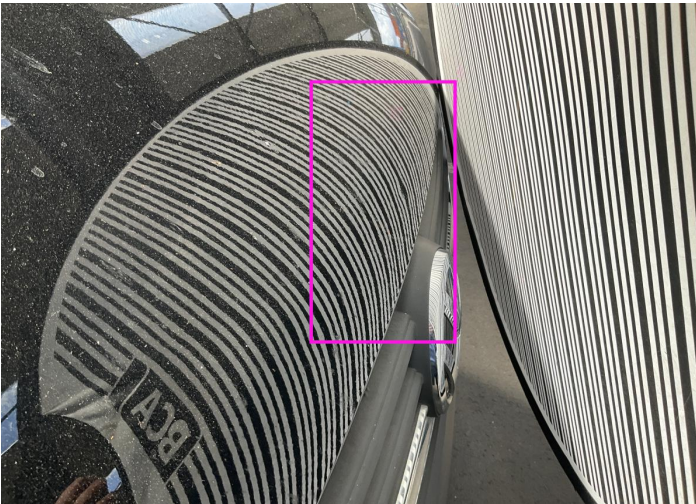
10. Hood  
Bodywork / Dent / Dent -
