Expertise

Protocol number: 41411177  
Order No. / Reference: 25184164  
Inspection date: 8 Sept 2025

Manufacturer: Volkswagen

Model: Touran 2.0 TDI SCR DSG Comfortline

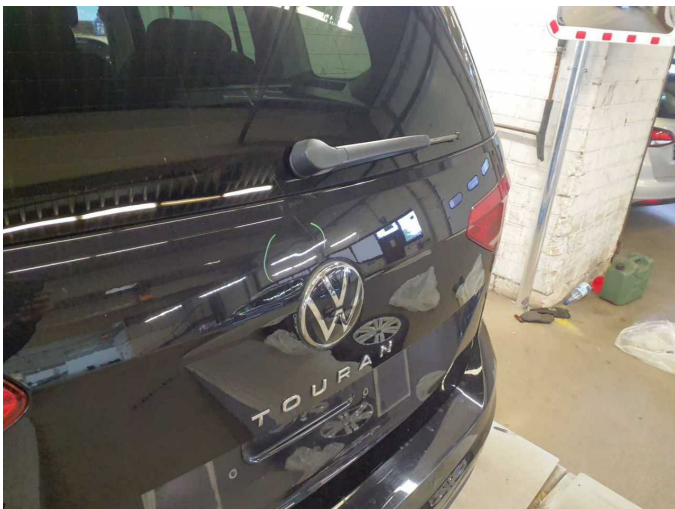
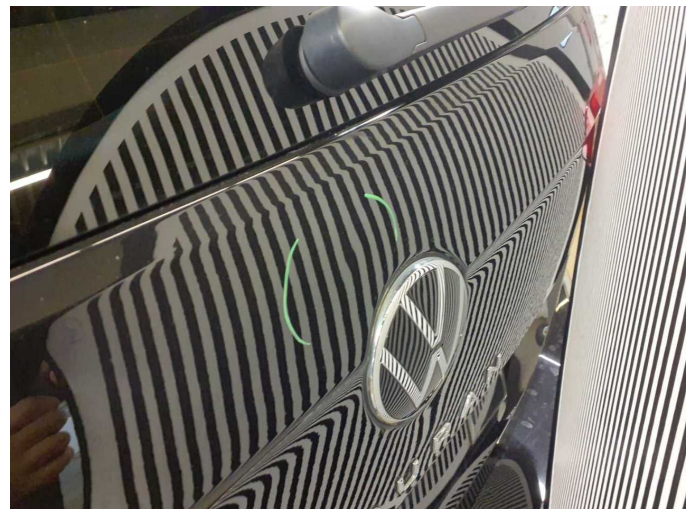
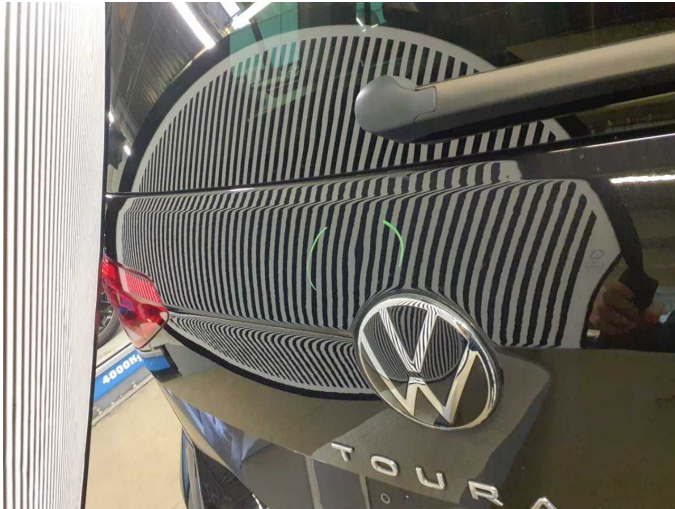
Damage 1: Boot lid / rear door: Boot lid (1) - dent(s) - Smart repair

**Damage 1:** Boot lid / rear door: Boot lid (1) - dent(s) - Smart repair

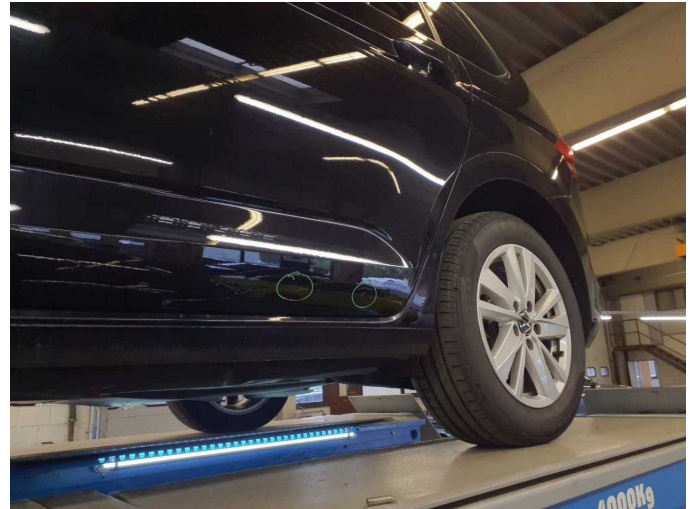
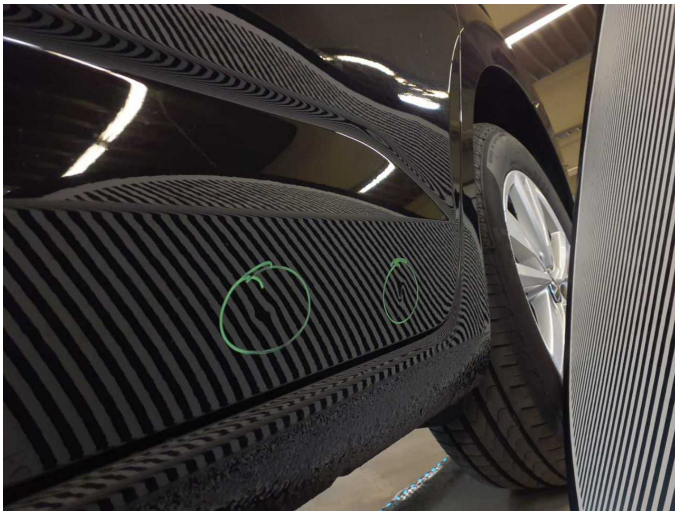
**Damage 2:** Door - rear left side: Door (2) - dent(s) - Smart repair

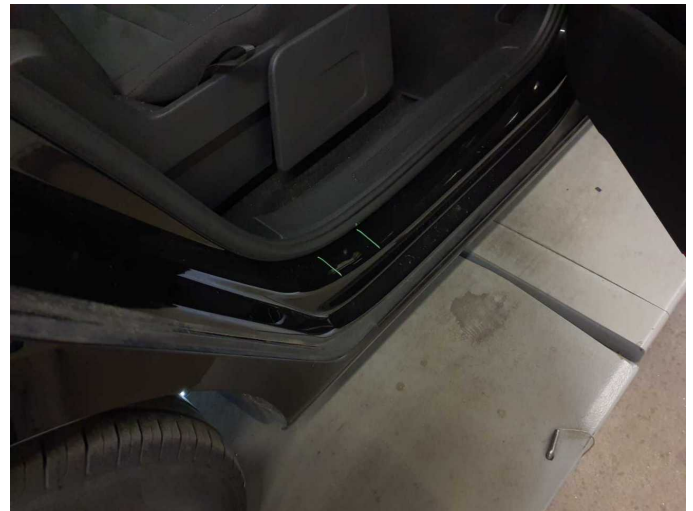
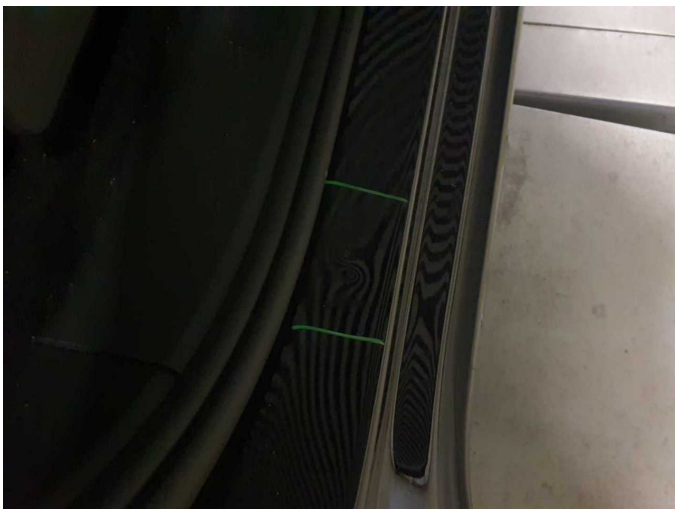
**Damage 3:** Side panel - rear right side: Sill - dent(s) - Smart repair

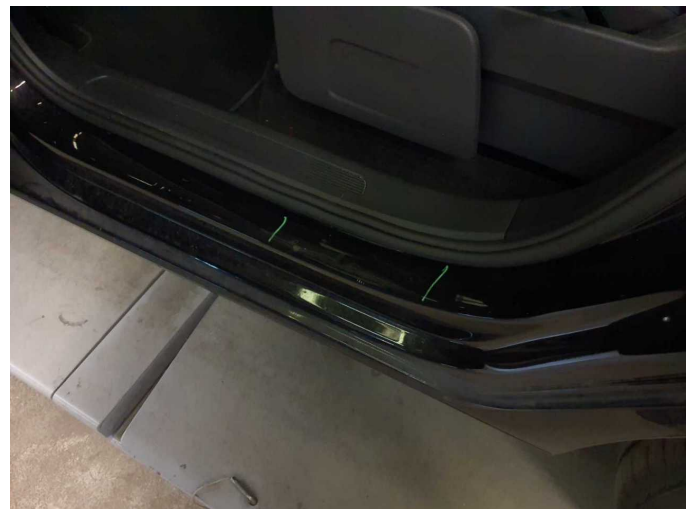
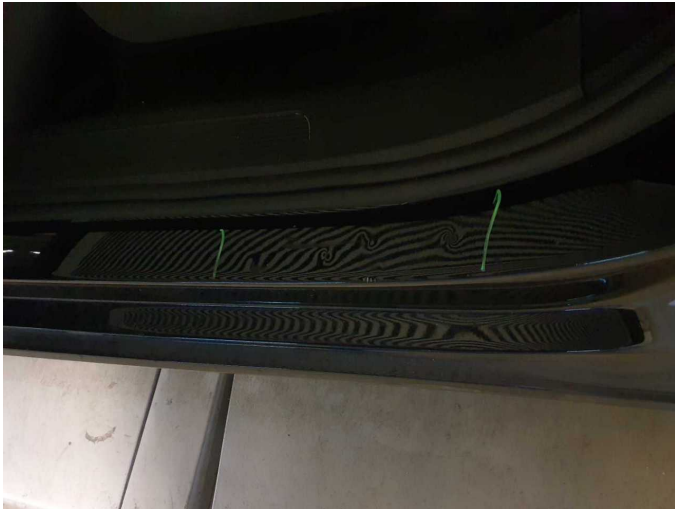
**Damage 4:** Side panel - rear left side: Sill - dent(s) - Smart repair

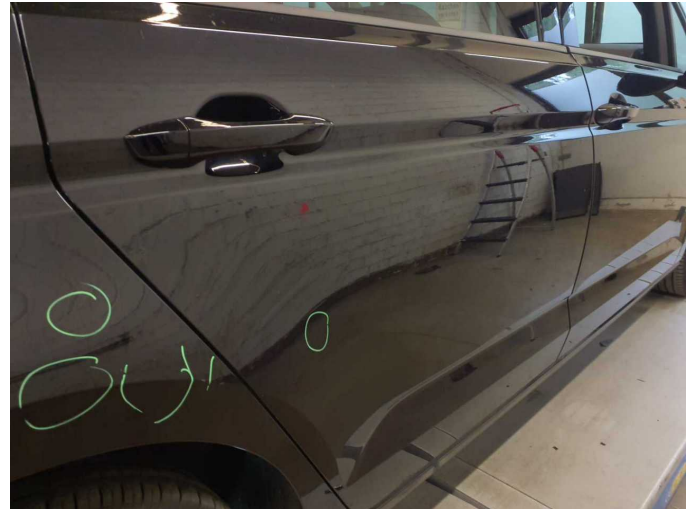
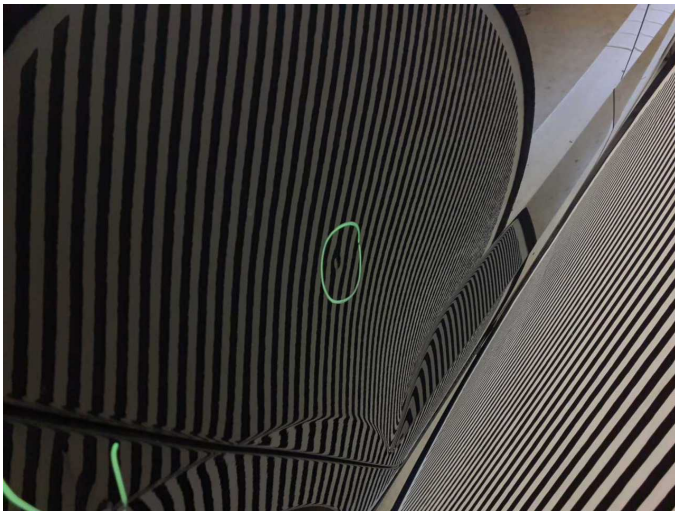
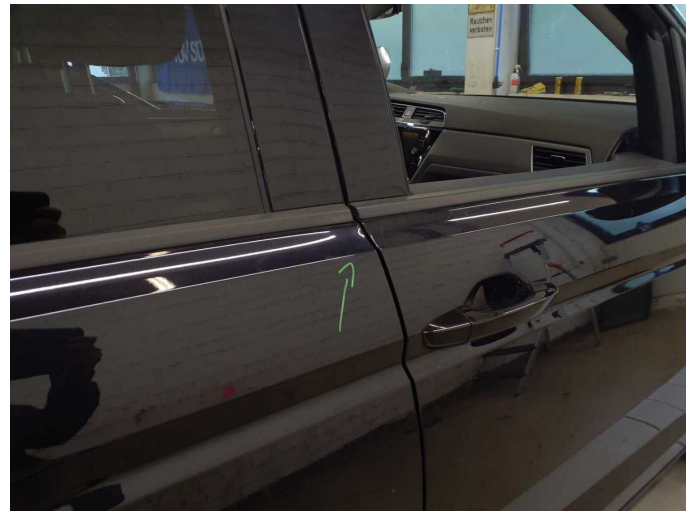
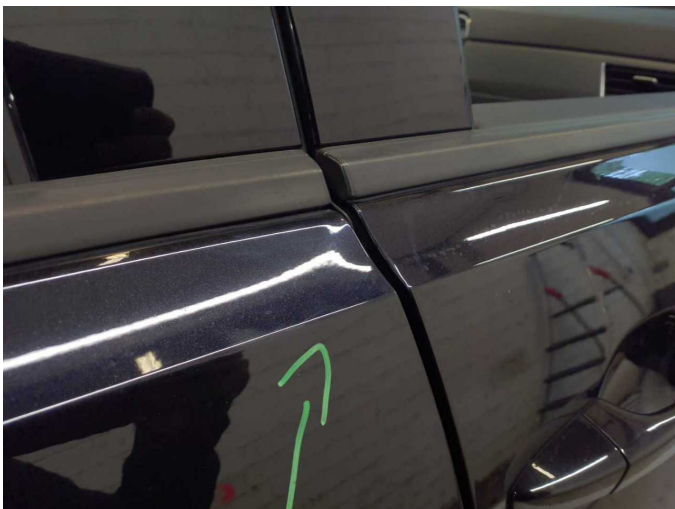
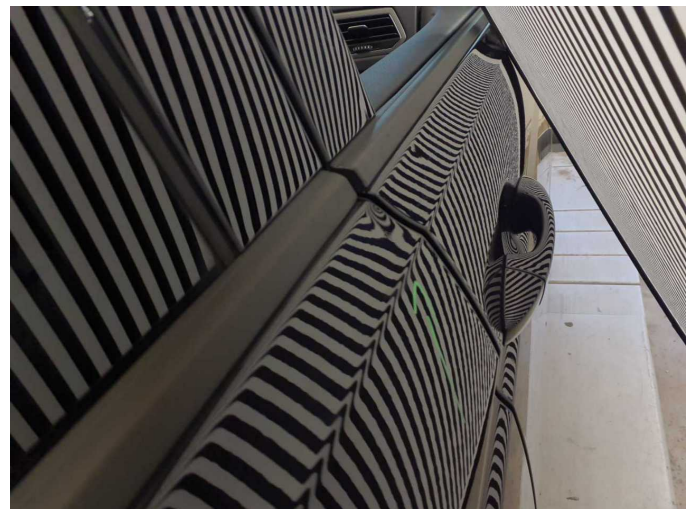
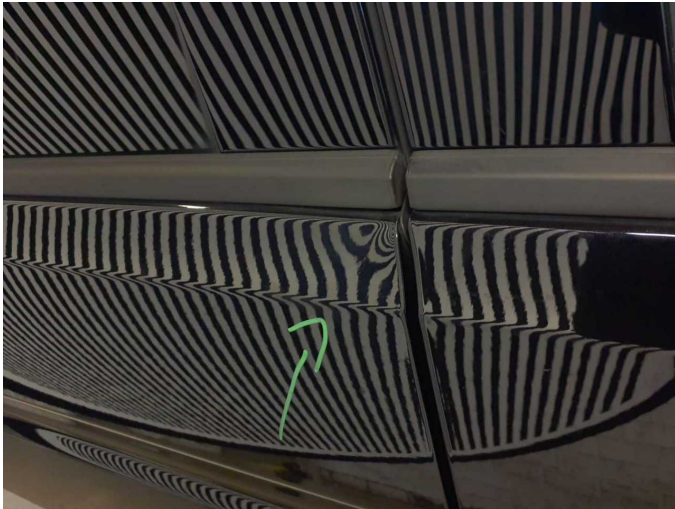
**Damage 5:** Door - rear right side: Door (1 Delle+Knick) - dent(s) - Smart repair

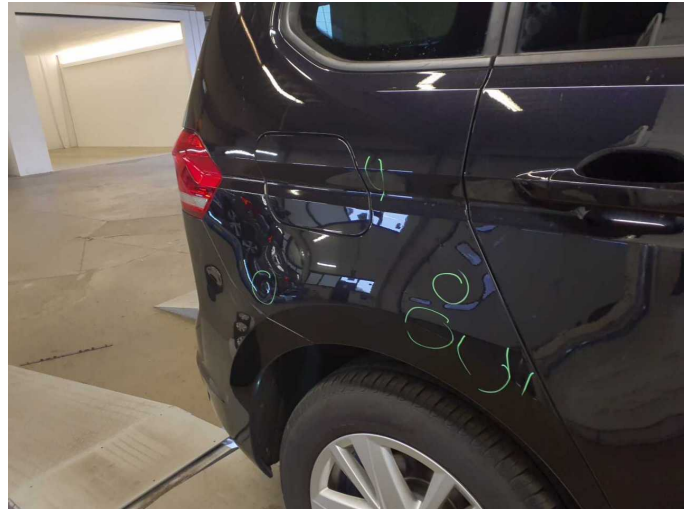
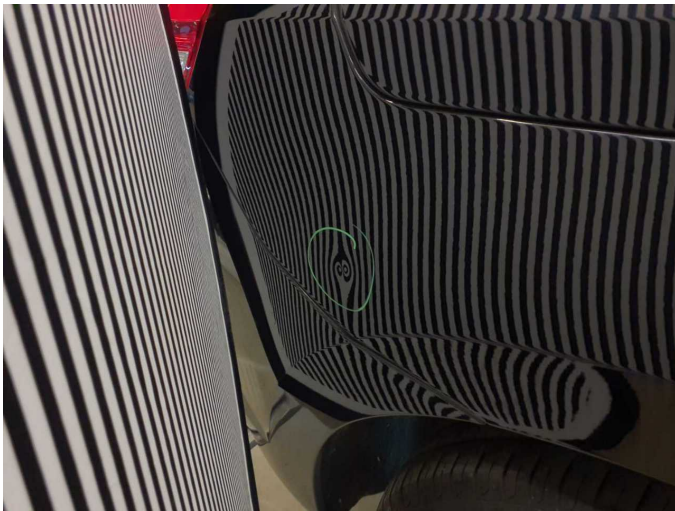
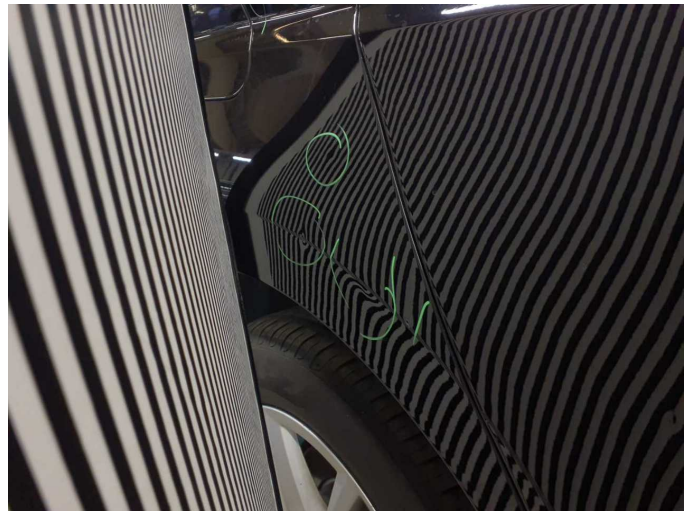
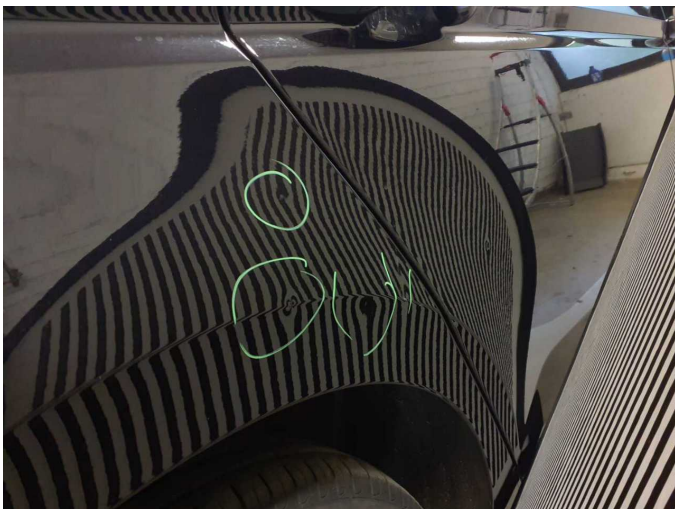
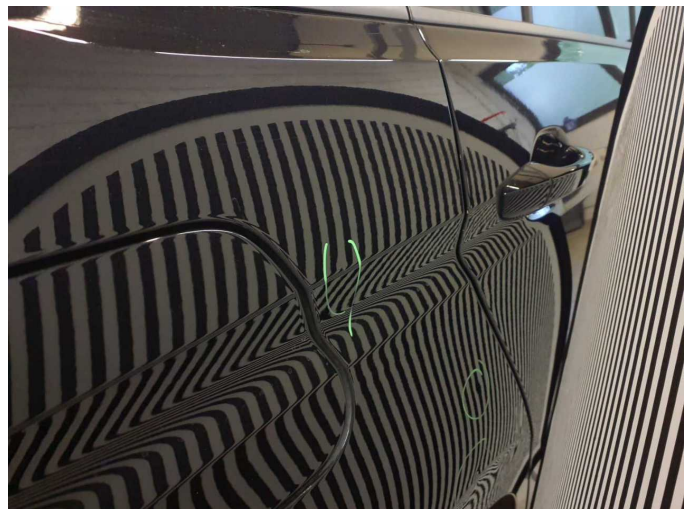
**Damage 6:** Side panel - rear right side: Side panel (6) - dent(s) - Smart repair

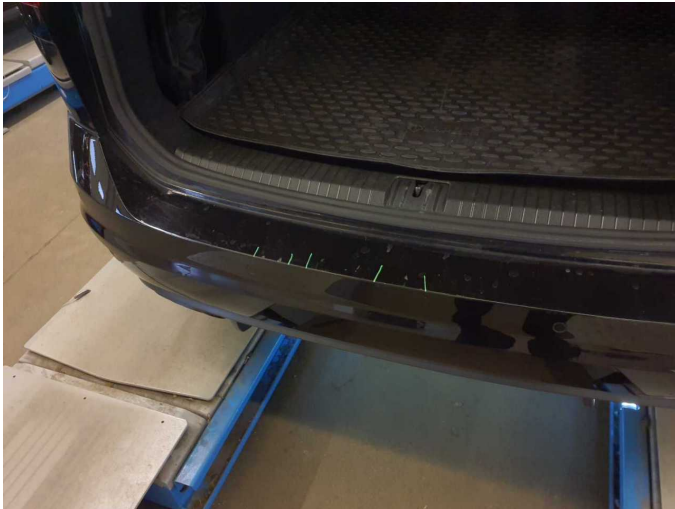
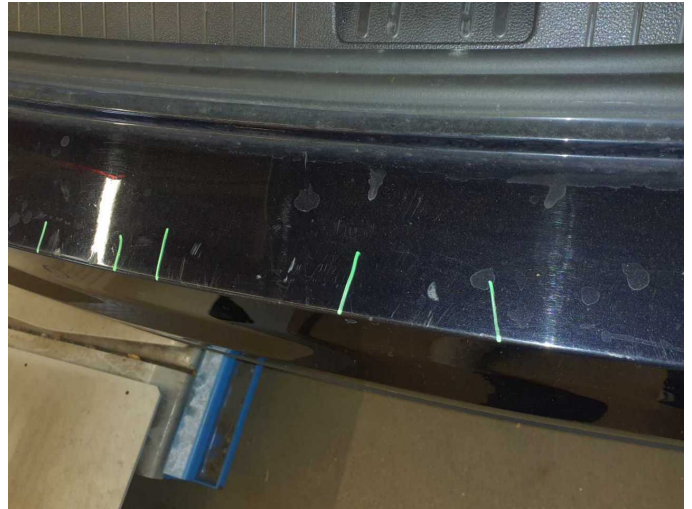
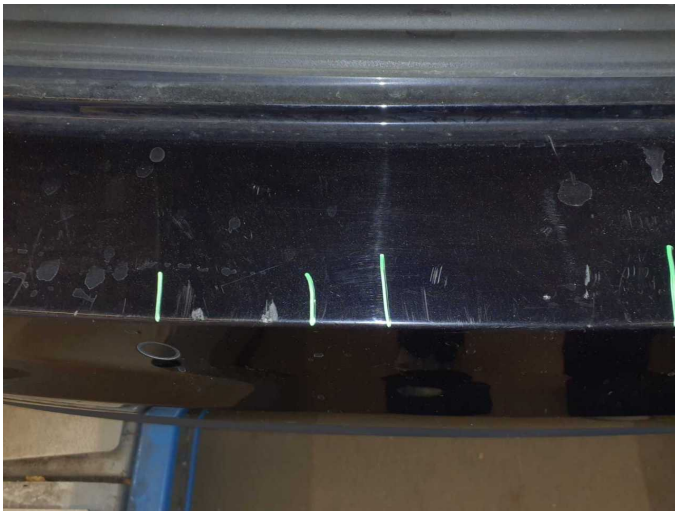
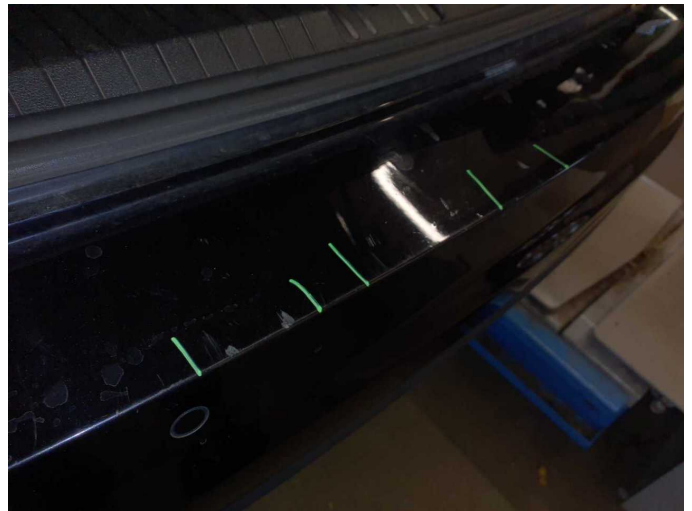
**Damage 8:** Rear bumper: Rear bumper - Scratch(es) - Paint

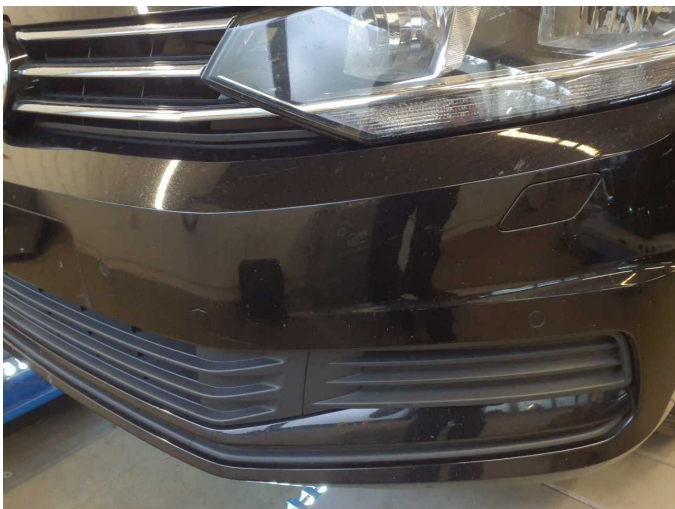
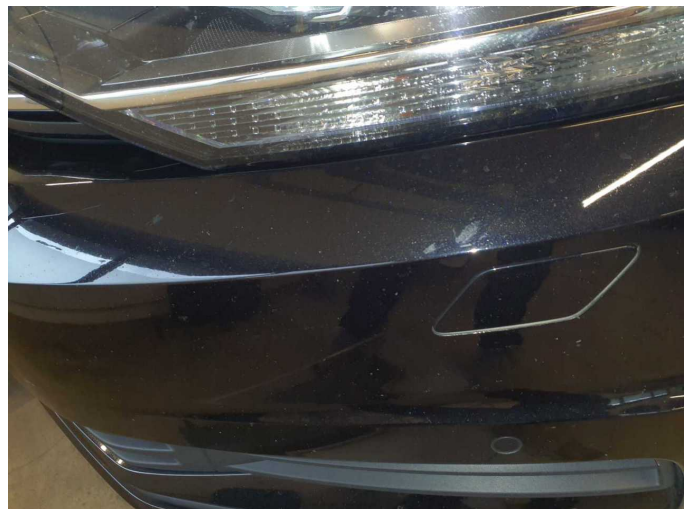
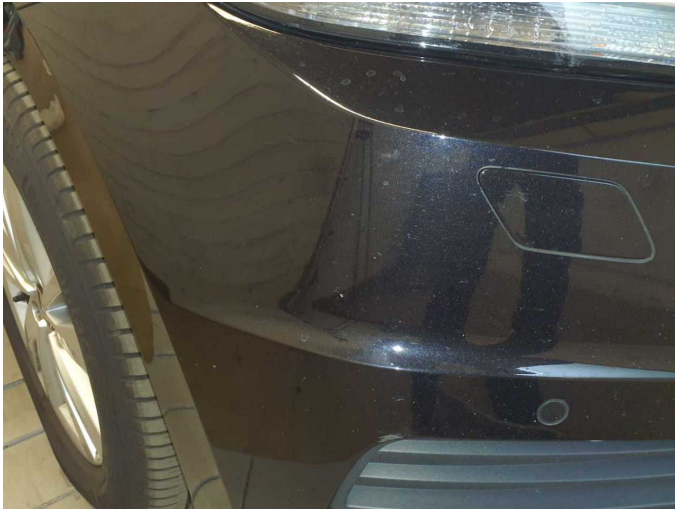
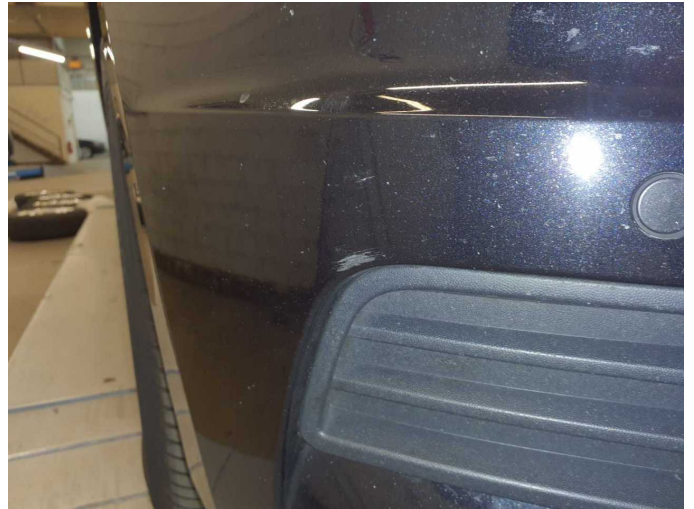
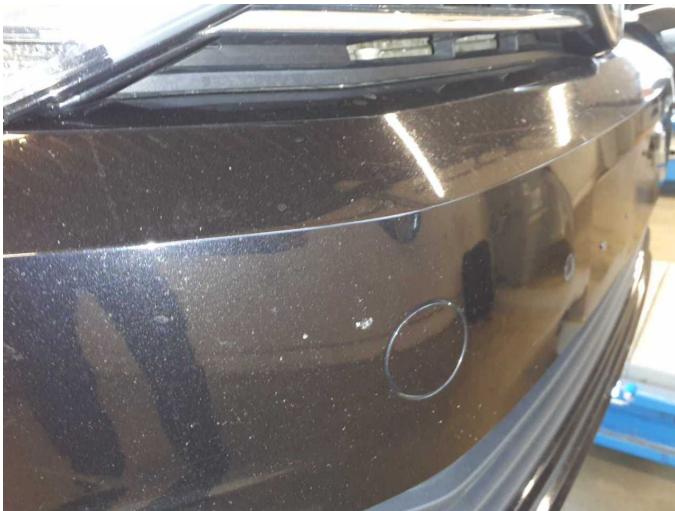
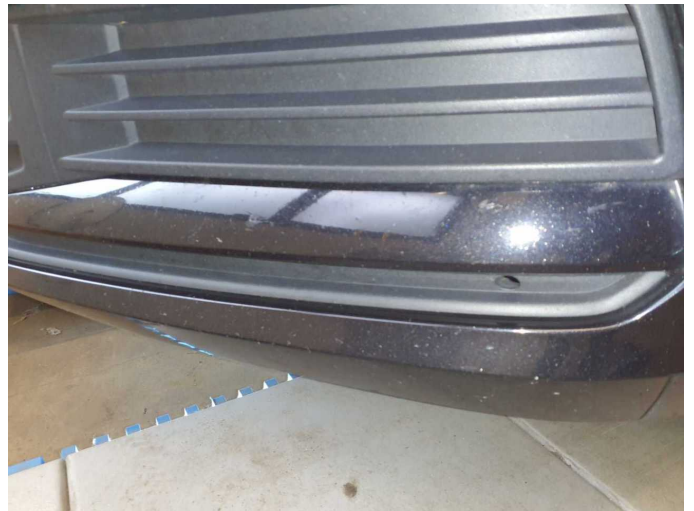
**Damage 9:** Front bumper: Front bumper (Sandstrahleffekt) - Scratch(es) - Paint

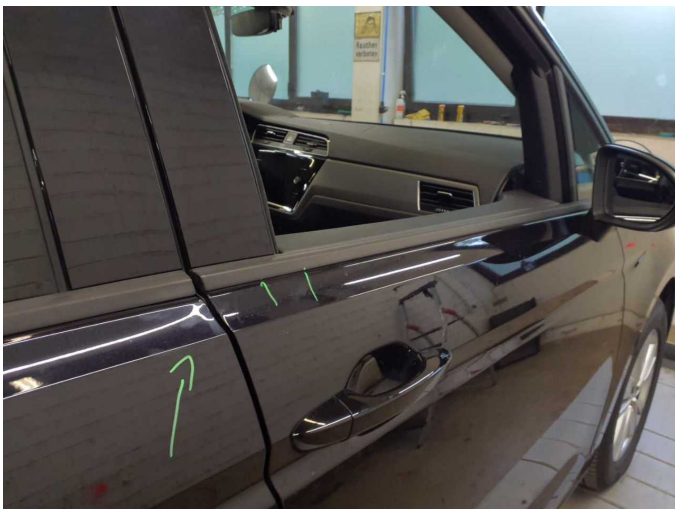
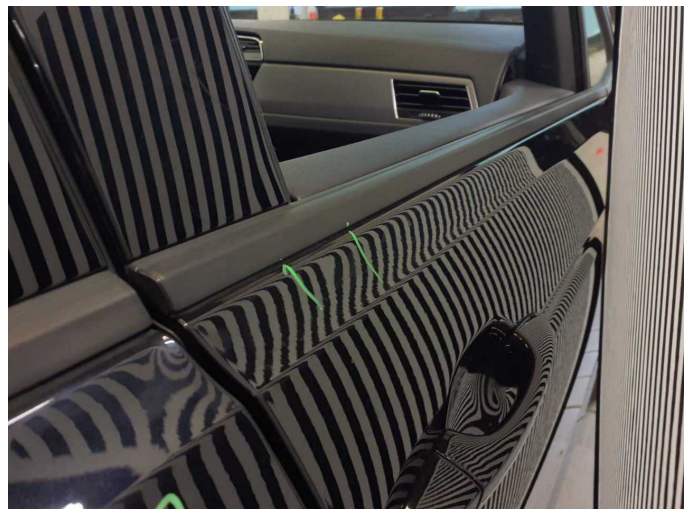
**Wear and tear 2:** Door - front right side: Door - dent(s) - Smart repair
