Expertise

Protocol number: 41173046  
Order No. / Reference: 25050005  
Inspection date: 21 Aug 2025

Manufacturer: Volkswagen

Model: Touran 2.0 TDI SCR DSG Comfortline

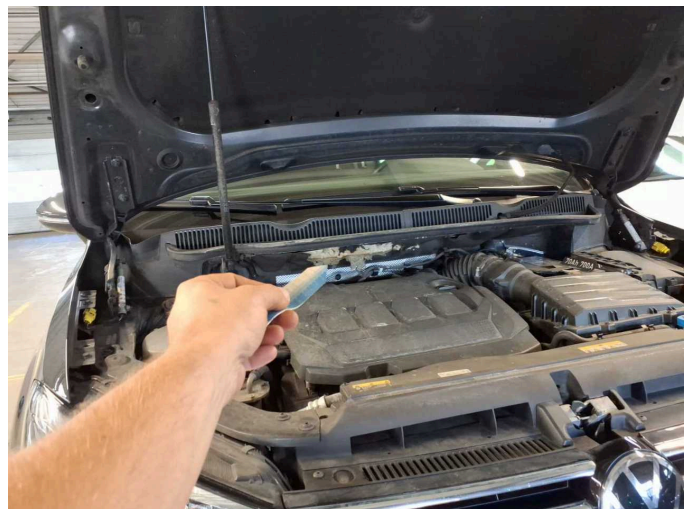
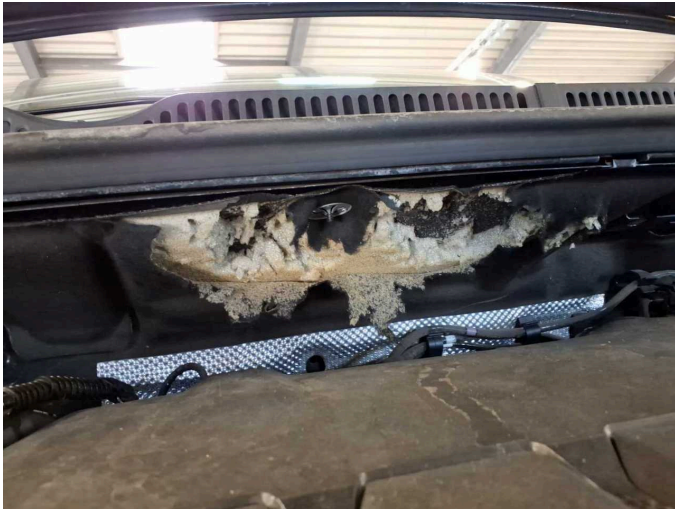
No.	Component group	Description
1	Misc.	Main inspection - No evidence - No deduction
2	Bonnet	Insulation lining (Stirnwand matte) - Broken / torn - Replace
3	Rear bumper	Rear bumper - Scratch(es) - Paint

**Damage 2:** Bonnet: Insulation lining (Stirnwand matte) - Broken / torn - Replace

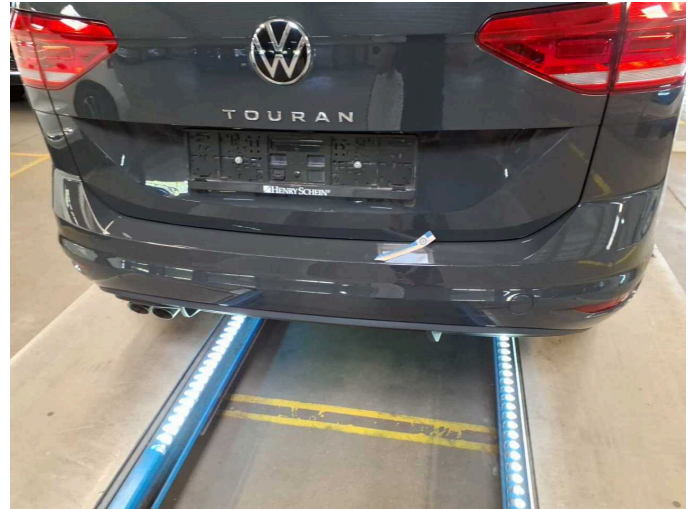
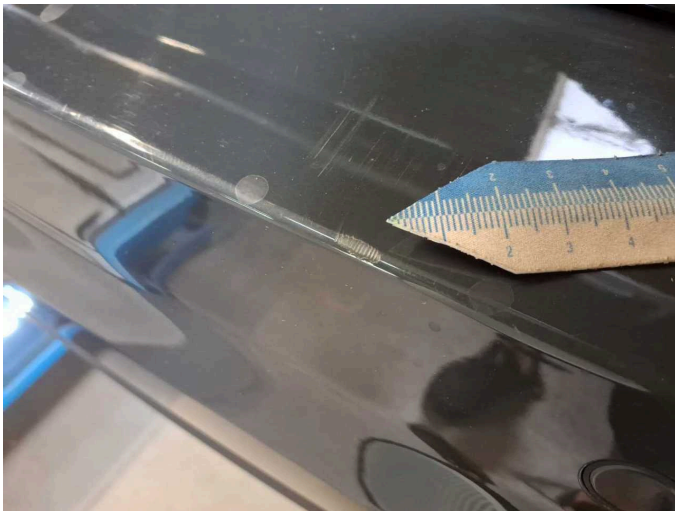
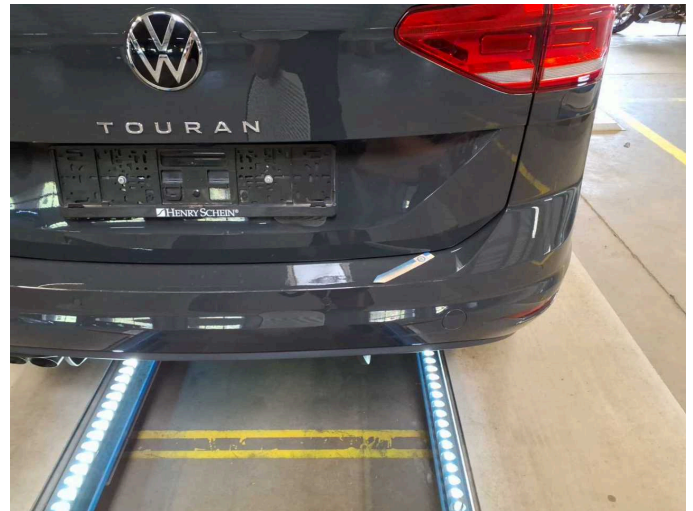
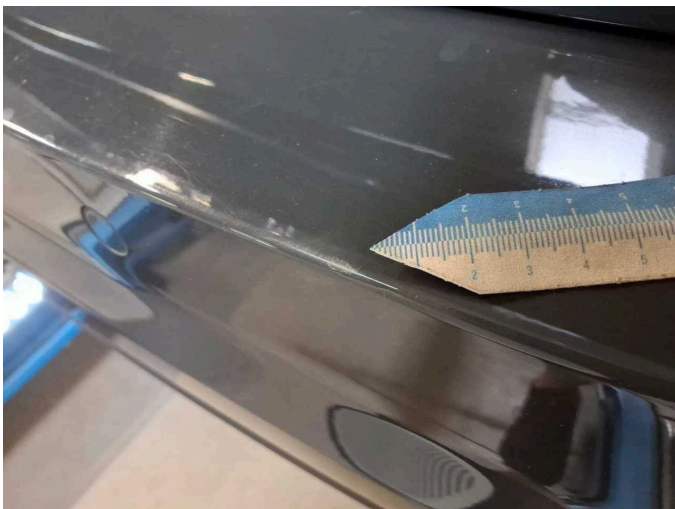
**Damage 3:** Rear bumper: Rear bumper - Scratch(es) - Paint

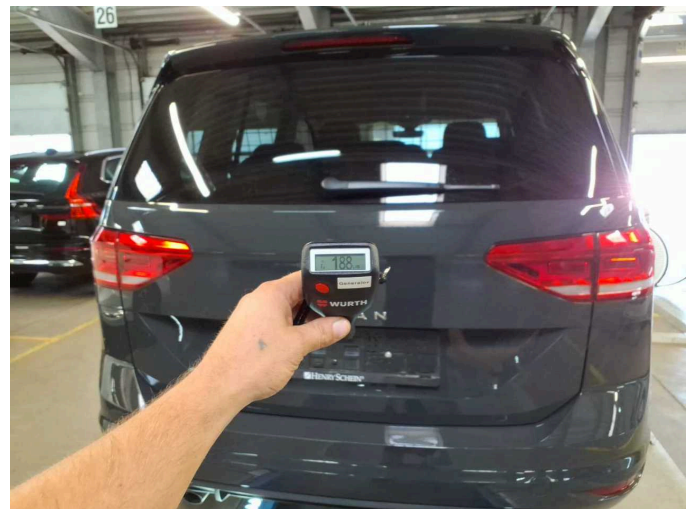
- 1 Boot lid / rear door, Professionally carried out, Invoice of repair done Non-existent
- 2 Mudguard - left side, Professionally carried out, Invoice of repair done Non-existent

Boot lid / rear door	188 µm	Mudguard - left side	161 µm
Mudguard - right side	187 µm	Bonnet	190 µm
Side panel - rear left side	246 µm	Side panel - rear right side	236 µm
Door - rear left side	142 µm	Door - rear right side	253 µm
Door - front left side	283 µm	Door - front right side	199 µm

**Repainting 1:** Boot lid / rear door

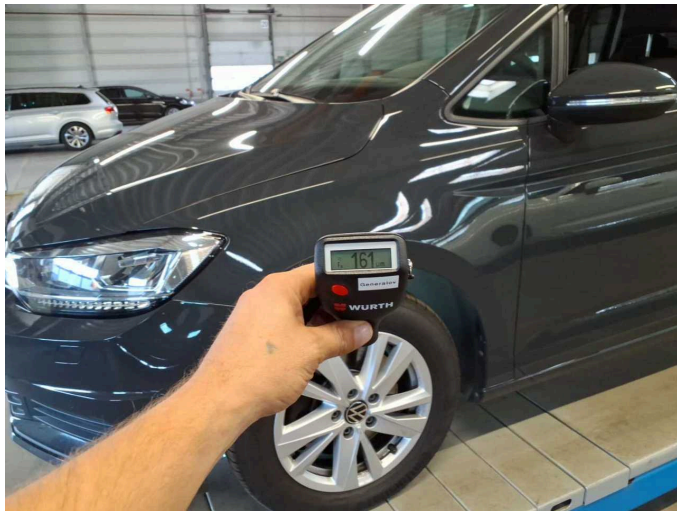
**Repainting 2:** Mudguard - left side

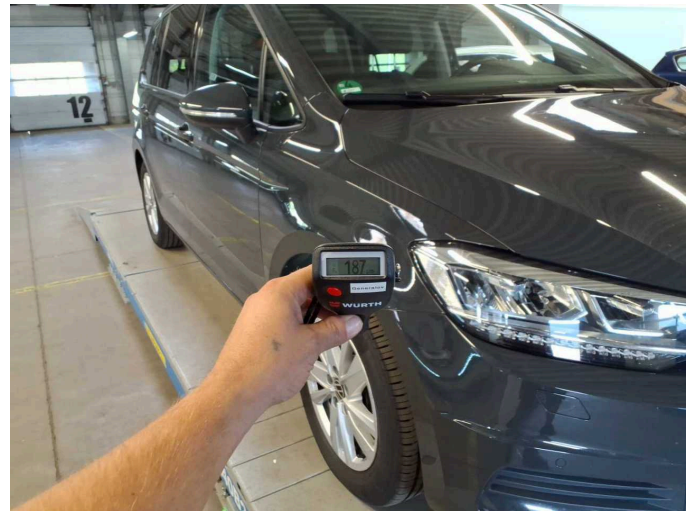
**Repainting 3:** Mudguard - right side

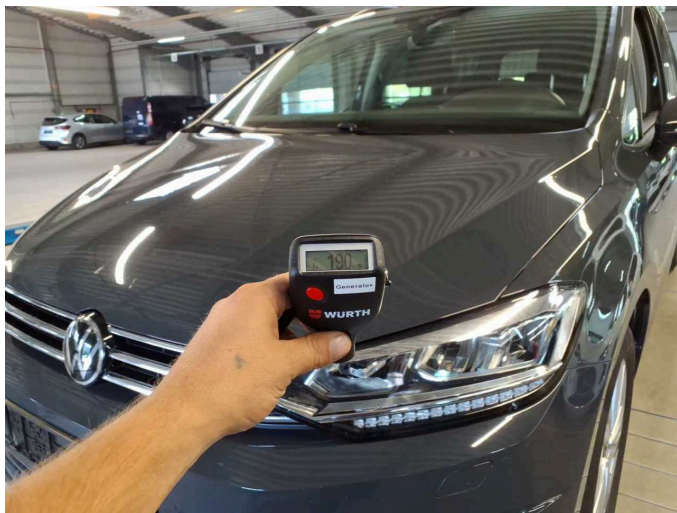
**Repainting 4:** Bonnet

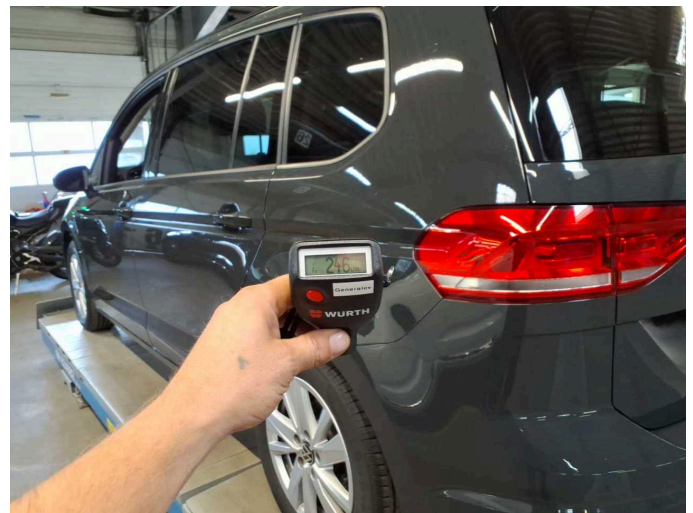
**Repainting 5:** Side panel - rear left side

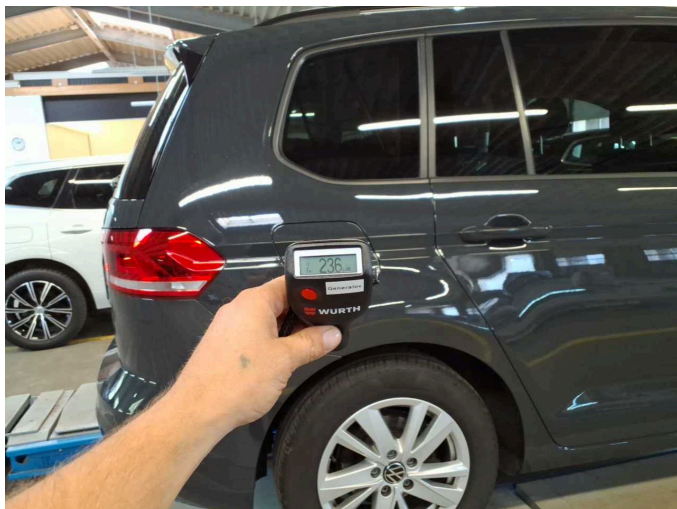
**Repainting 6:** Side panel - rear right side

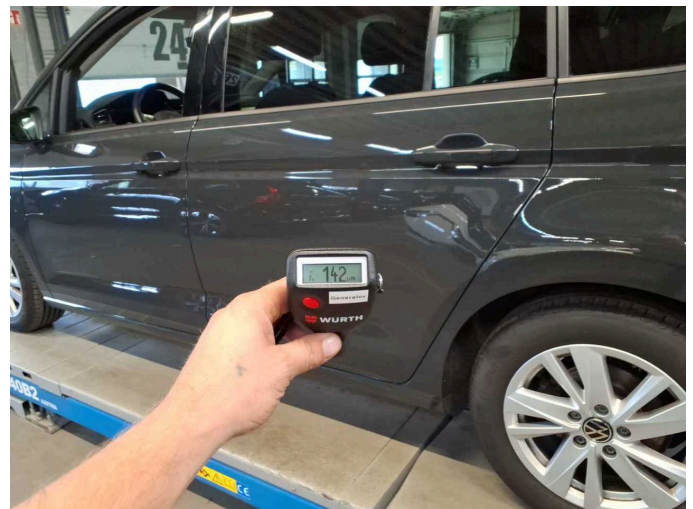
**Repainting 7:** Door - rear left side

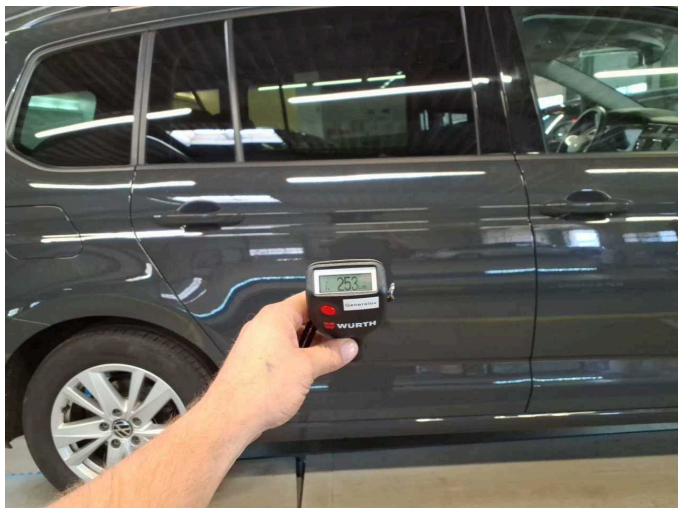
**Repainting 8:** Door - rear right side

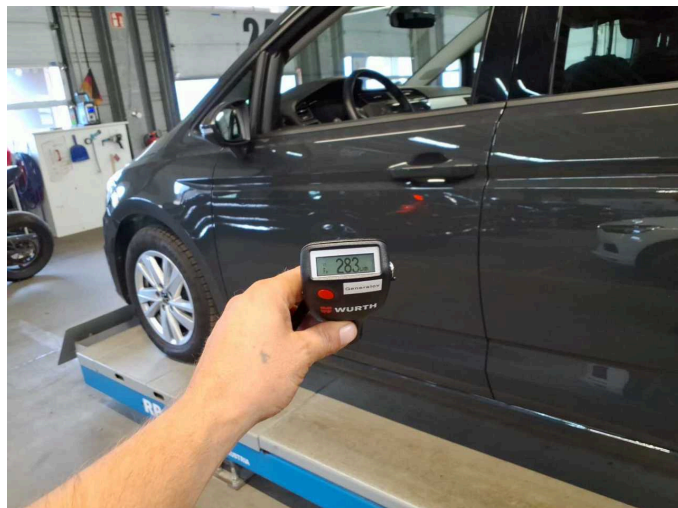
**Repainting 9:** Door - front left side

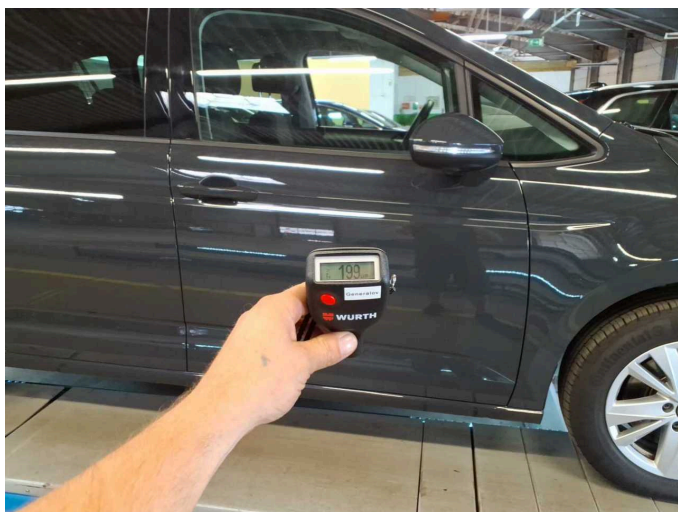
**Repainting 10:** Door - front right side
