## status report

**customer:** Bank 11, Neuss  
**contract number:** 1089861130  
**reference:**

#### Volkswagen Touran Highline

| Vehicle identification number | <b>WVGZZZ1TZW063845</b> | mileage read: | <b>222268 km</b> |

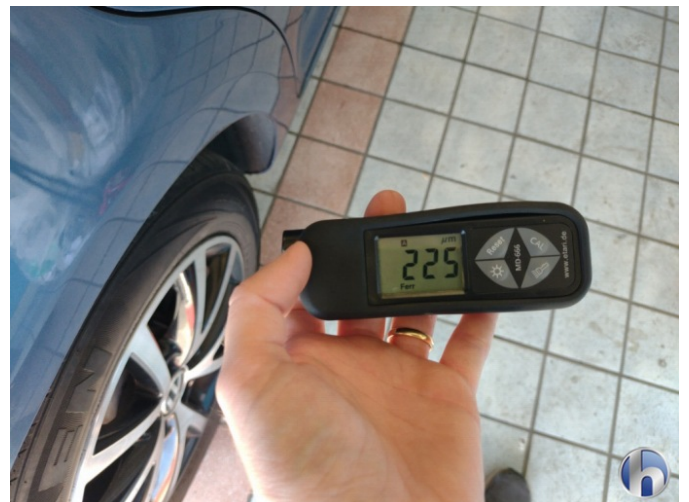
| component | Damage | Rep kind |
|---|---|---|
| 1. Sidewall - Rear - right | Subsequently painted | acceptable |

1. Sidewall - Rear - right

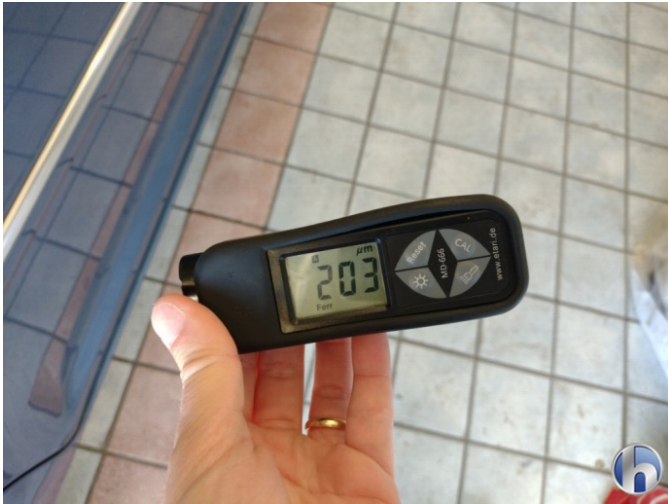
| component | Damage | Rep kind |
|---|---|---|
| 2. Door Rear - right | Subsequently painted | acceptable |

2. Door Rear - right

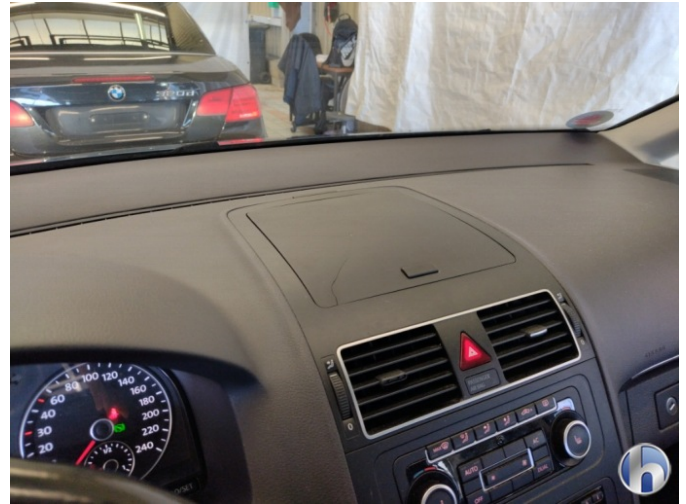
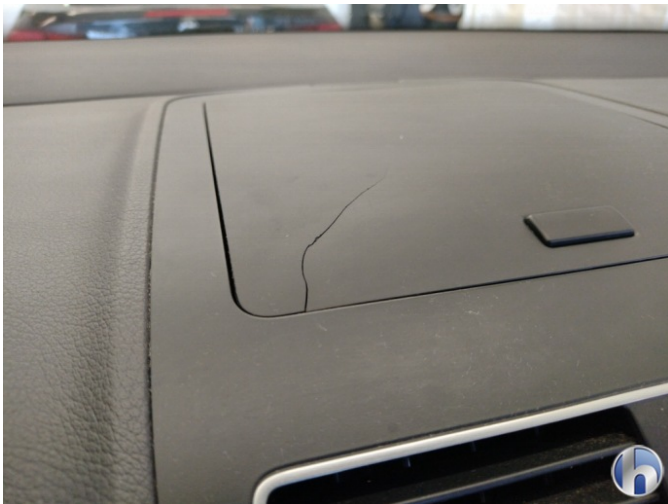
| component | Damage | Rep kind |
|---|---|---|
| 3. Armaturen Brett Klappe | Breakage | Replace |

3. Armaturenbrett Klappe

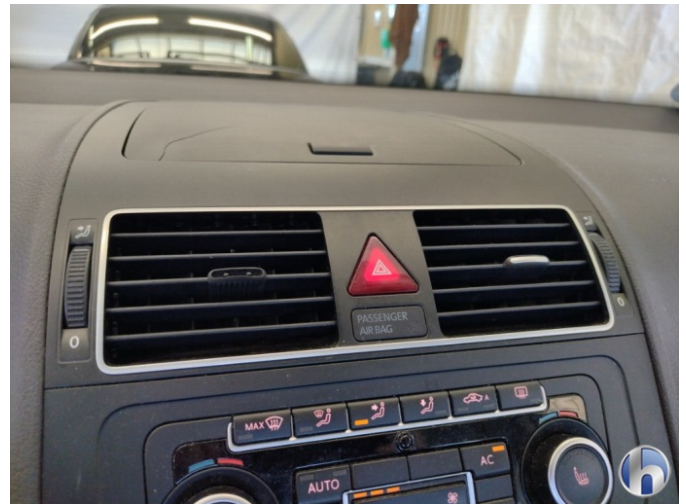
| component | Damage | Rep kind |
|---|---|---|
| 5. Lüftungsgitter Vorne Mitte Versteller | Damaged | Replace |

5. Lüftungsgitter Vorne Mitte Versteller

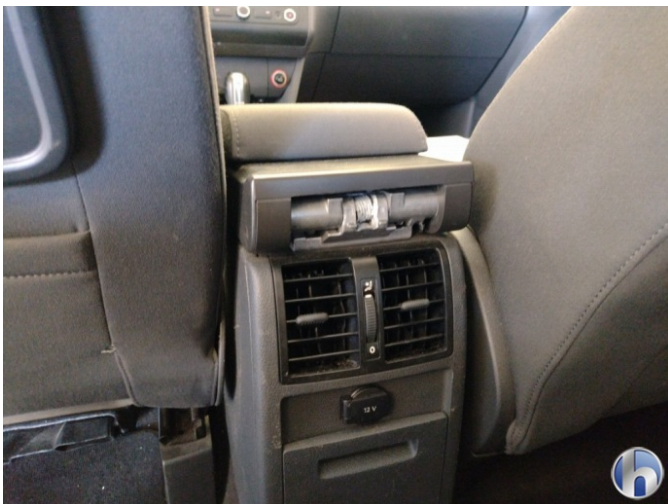
| component | Damage | Rep kind |
|---|---|---|
| 6. Mittelkonsole Hinten Verkleidung | Missing | Replace |

6. Mittelkonsole Hinten Verkleidung

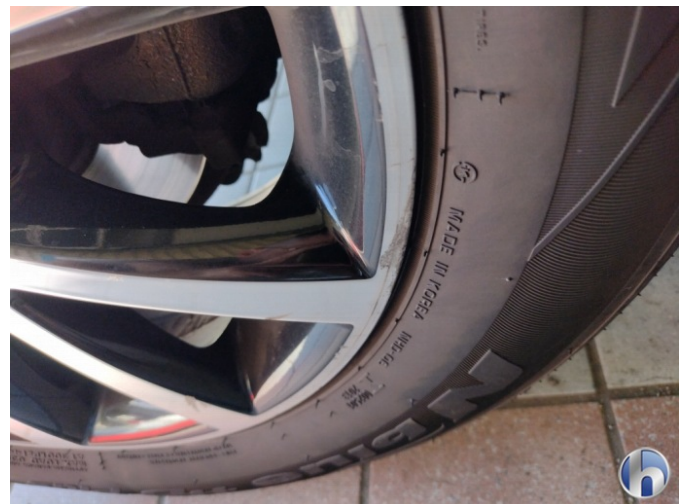
| component | Damage | Rep kind |
|---|---|---|
| 8. Rim rear - right | Scratch(es) | Paint |

8. Rim rear - right

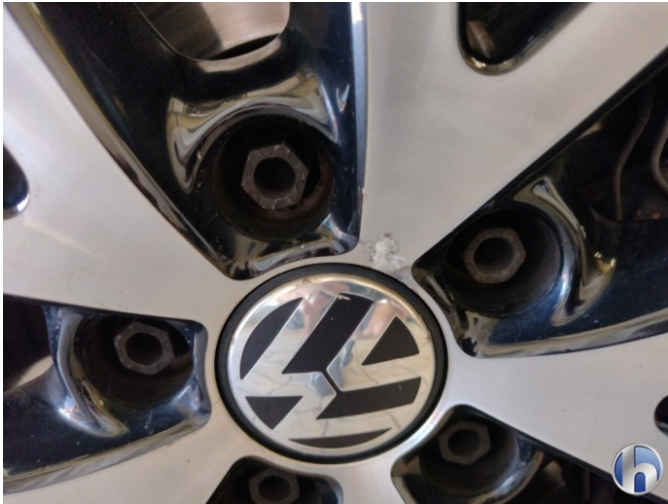
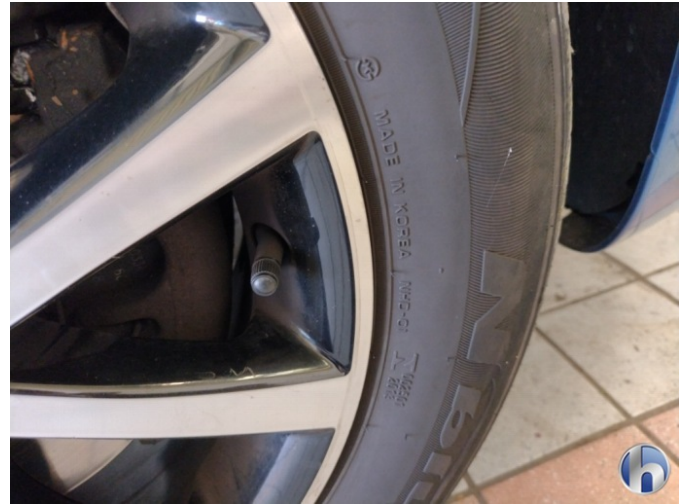
| component | Damage | Rep kind |
|---|---|---|
| 9. Rim front - right | Damaged | Replace |

9. Rim front - right

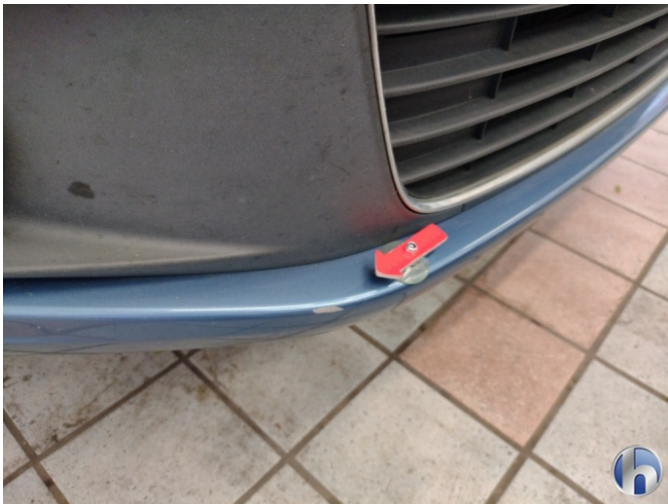
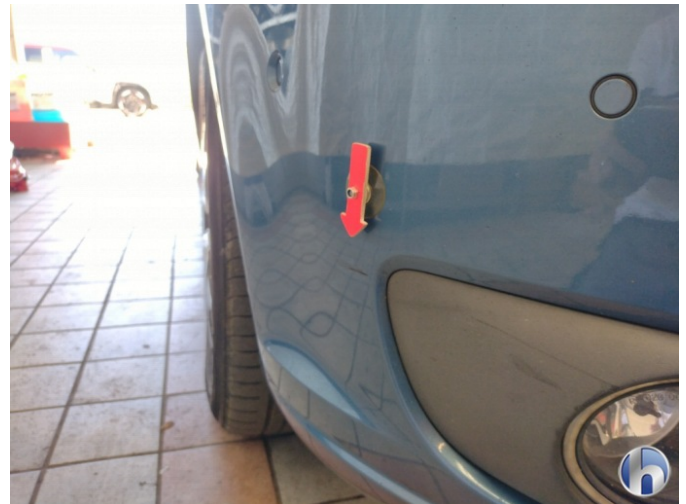
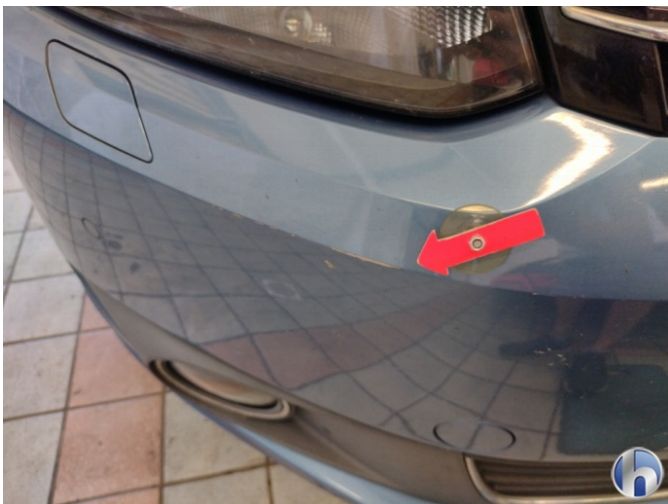
| component | Damage | Rep kind |
|---|---|---|
| 10. Front bumper | Scrape | Paint |

10. Front bumper

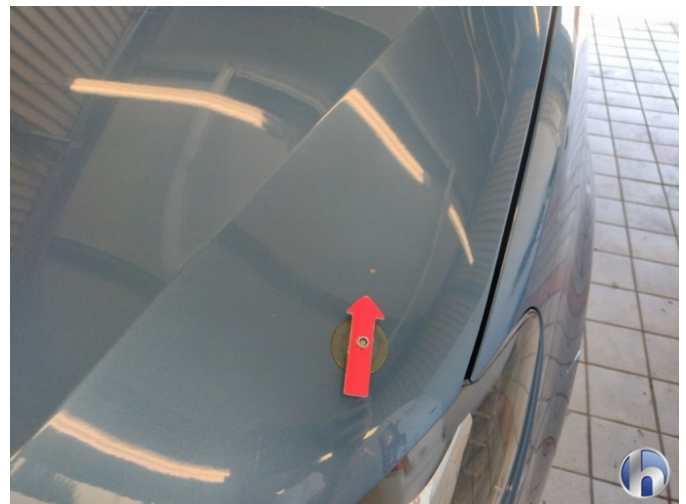
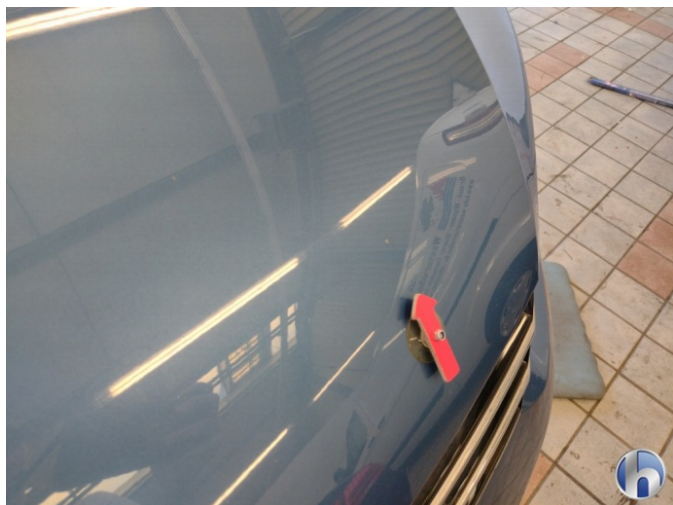
| component | Damage | Rep kind |
|---|---|---|
| 11. hood | Wear and tear | acceptable |

11. hood

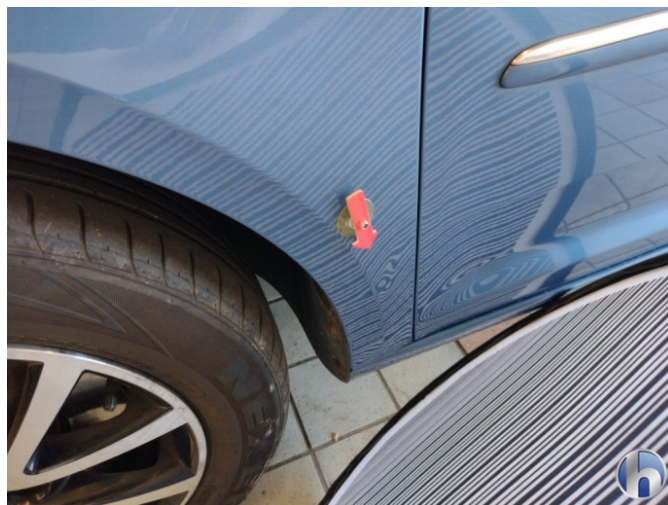
| component | Damage | Rep kind |
|---|---|---|
| 12. Front fender - left | Deformed | Refurbish and paint |

12. Front fender - left

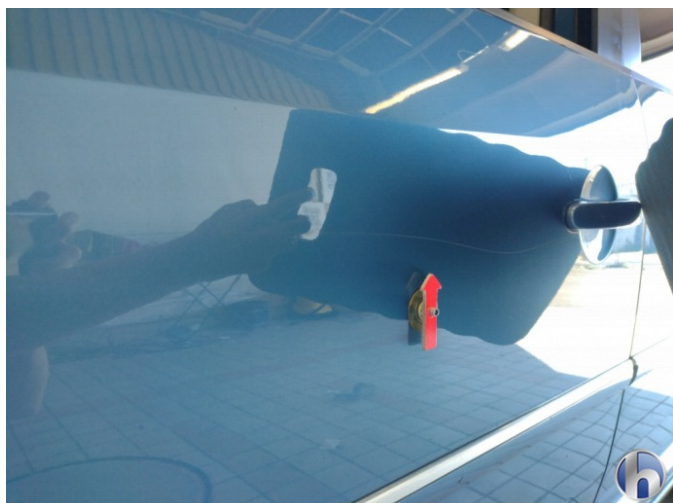
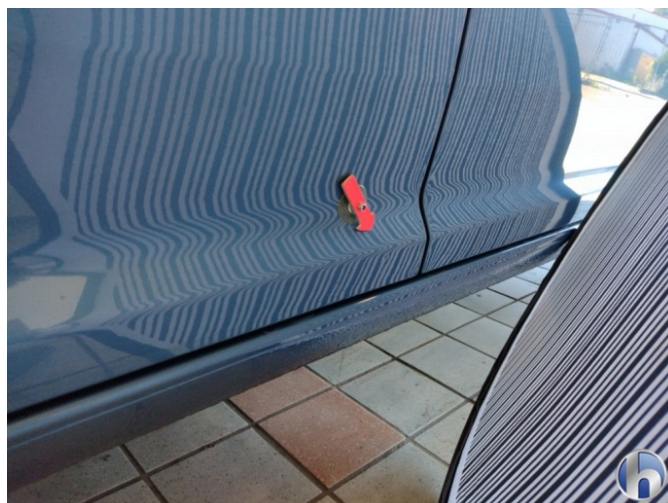
| component | Damage | Rep kind |
|---|---|---|
| 13. Front door - left | Scratch(es) | Paint |

13. Front door - left

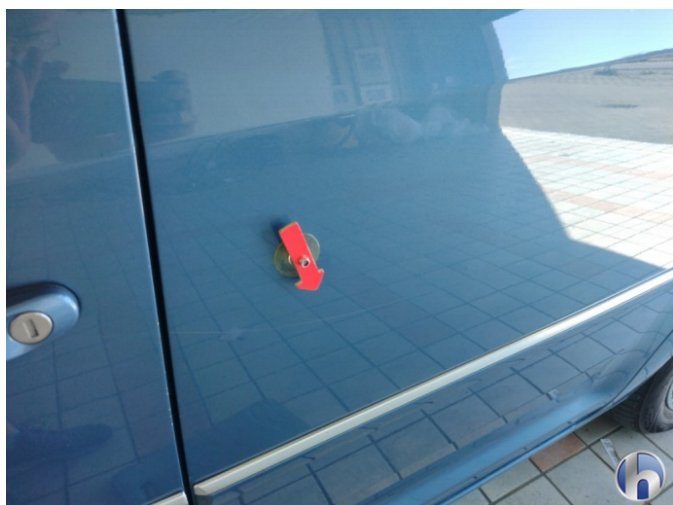
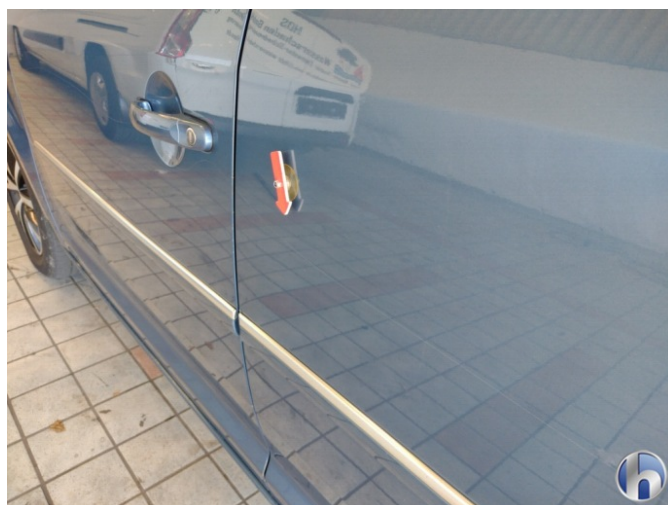
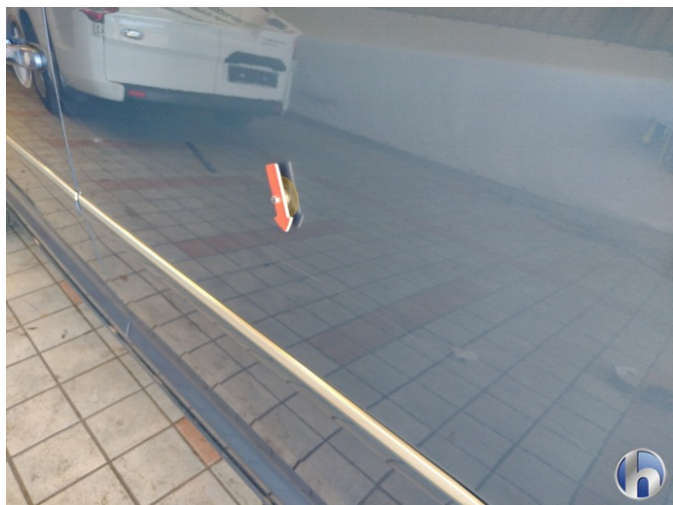
| component | Damage | Rep kind |
|---|---|---|
| 14. Rear door - left | Scratch(es) | Paint |

14. Rear door - left

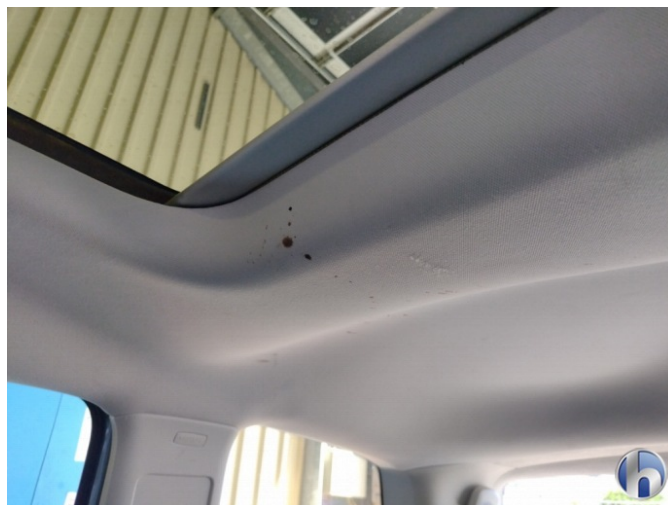
| component | Damage | Rep kind |
|---|---|---|
| 15. Dachhimmel | Dirty | |

15. Dachhimmel

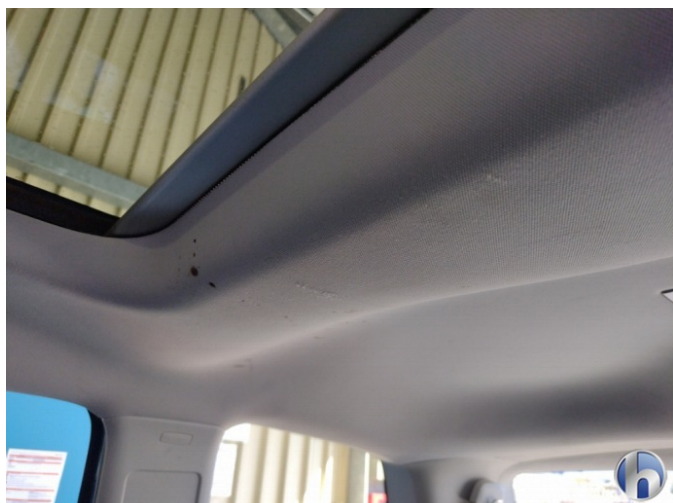
| component | Damage | Rep kind |
|---|---|---|
| 16. headlining | Damaged | Smart repair |

16. headlining

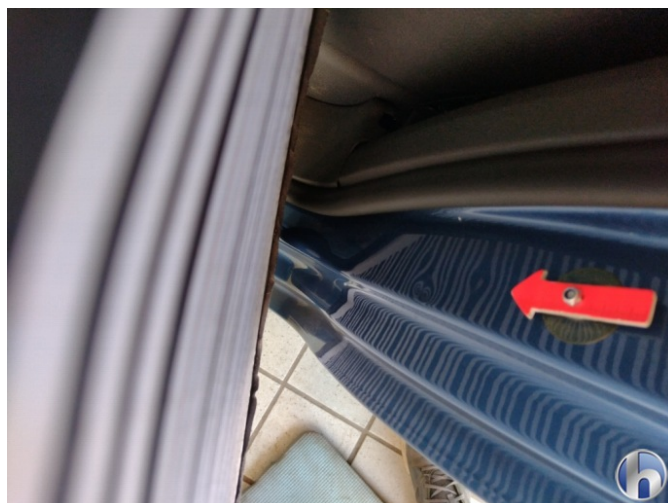
| component | Damage | Rep kind |
|---|---|---|
| 17. Türeinstieg Hinten - Links | Damaged | Refurbish and paint |

17. Türeinstieg Hinten - Links

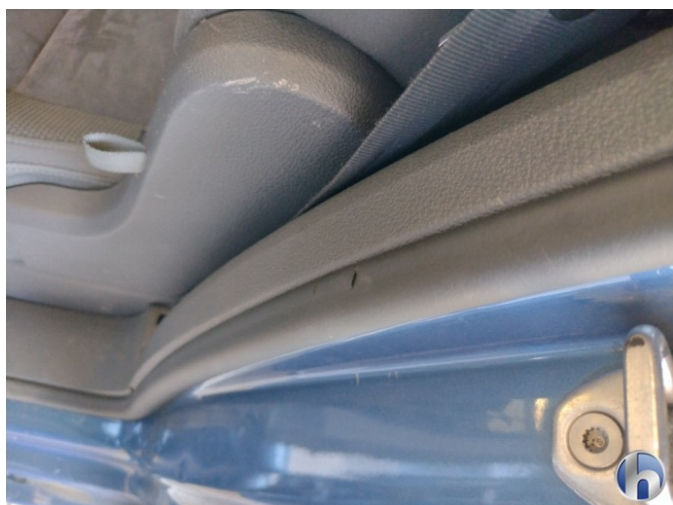
| component | Damage | Rep kind |
|---|---|---|
| 18. Rear door seal - left | Damaged | Replace |

18. Rear door seal - left

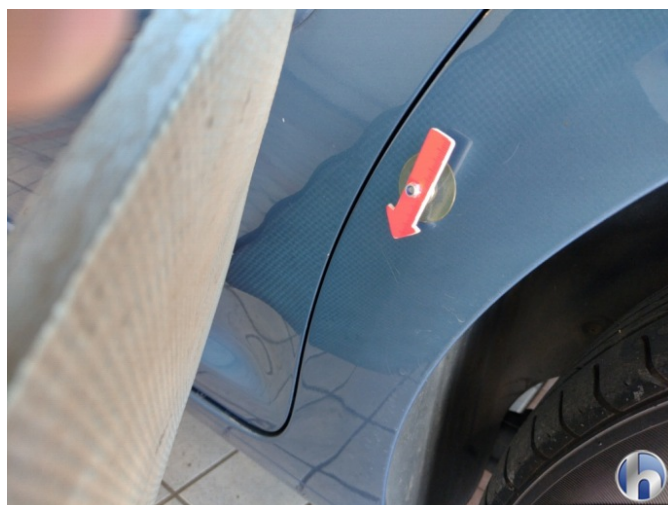
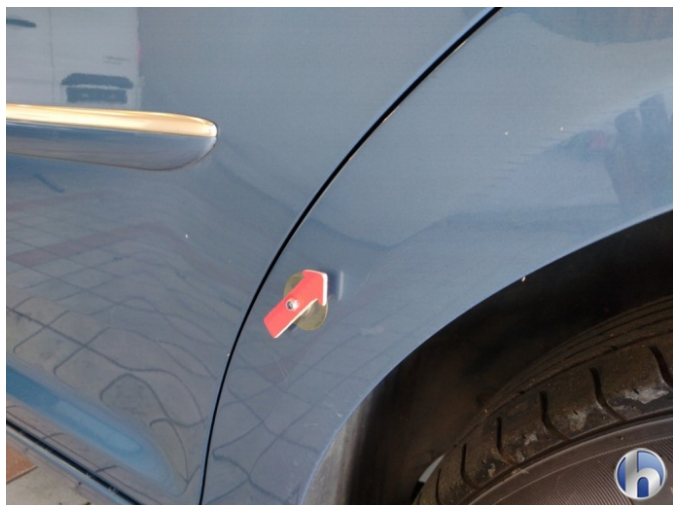
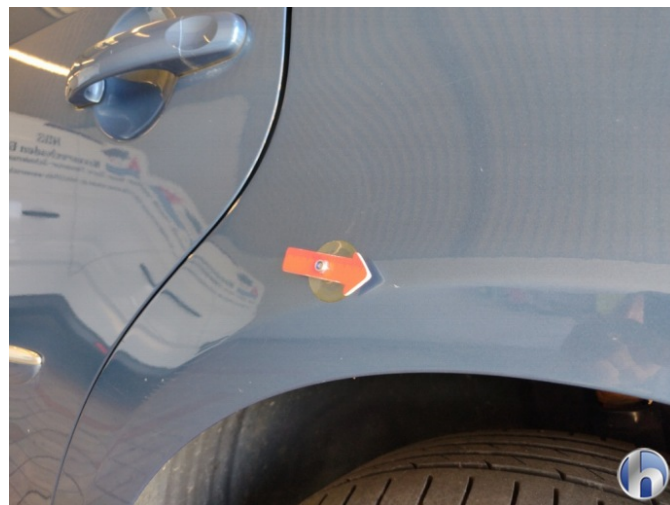
| component | Damage | Rep kind |
|---|---|---|
| 19. Sidewall - Rear - Left | Scratch(es) | Paint |

19. Sidewall - Rear - Left

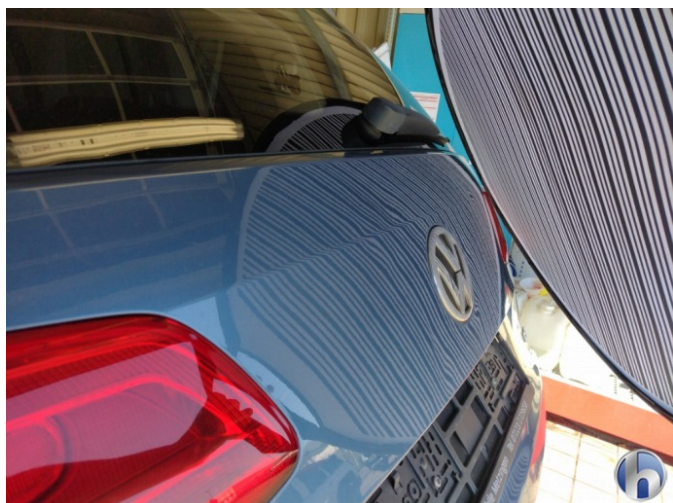
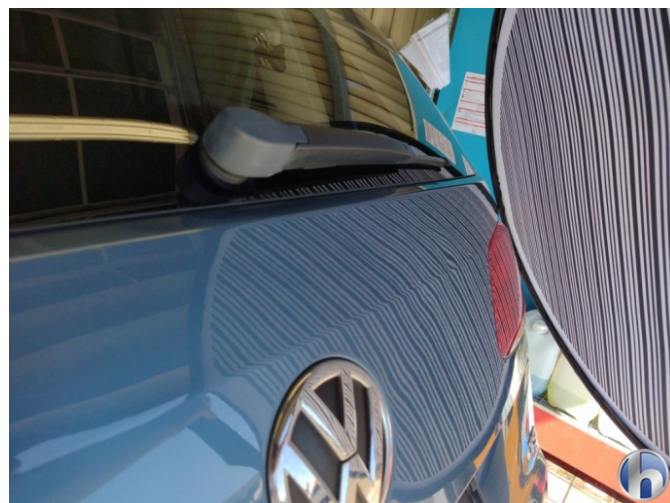
| component | Damage | Rep kind |
|---|---|---|
| 20. tailgate | Deformed | Refurbish and paint |

20. tailgate

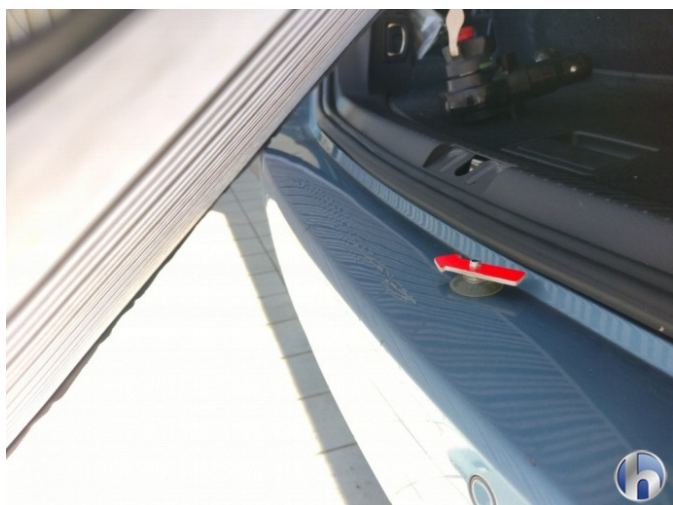
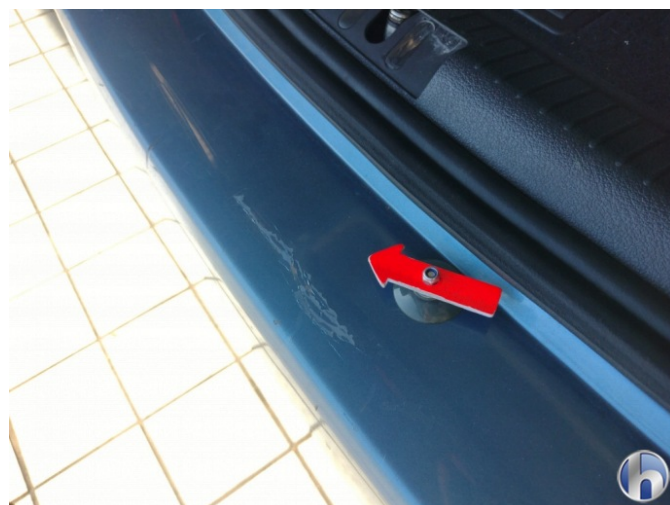
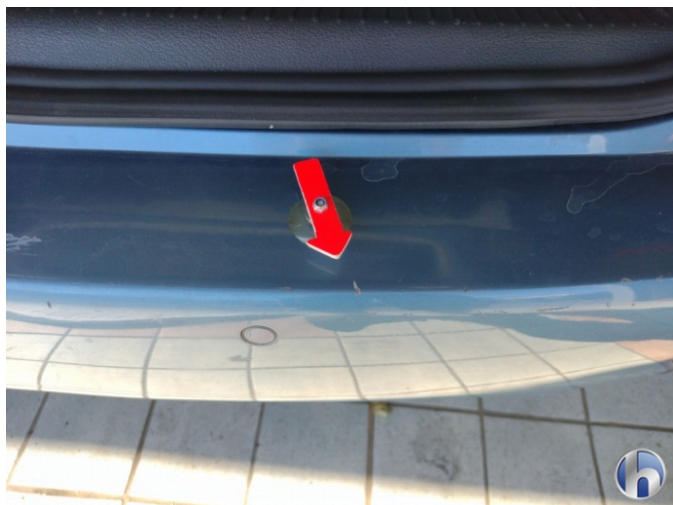
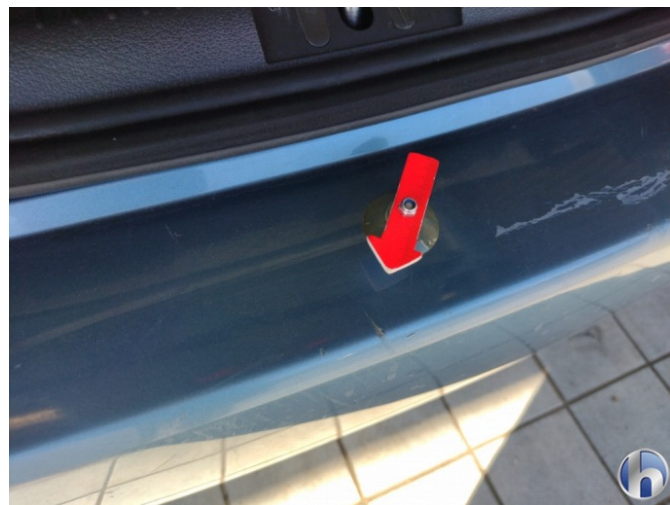
| component | Damage | Rep kind |
|---|---|---|
| 21. Rear bumper | Damaged | Refurbish and paint |

21. Rear bumper

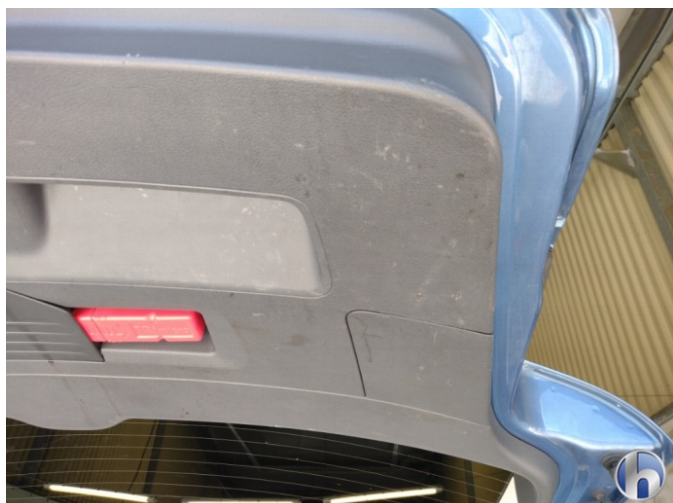
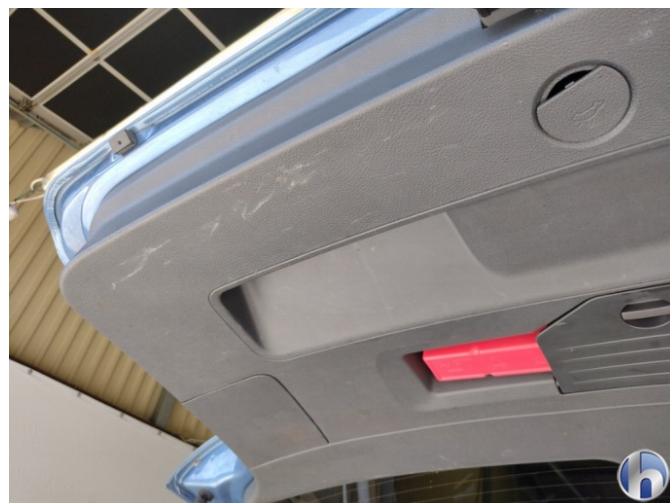
| component | Damage | Rep kind |
|---|---|---|
| 22. tailgate trim | Damaged | Smart repair |

22. tailgate trim

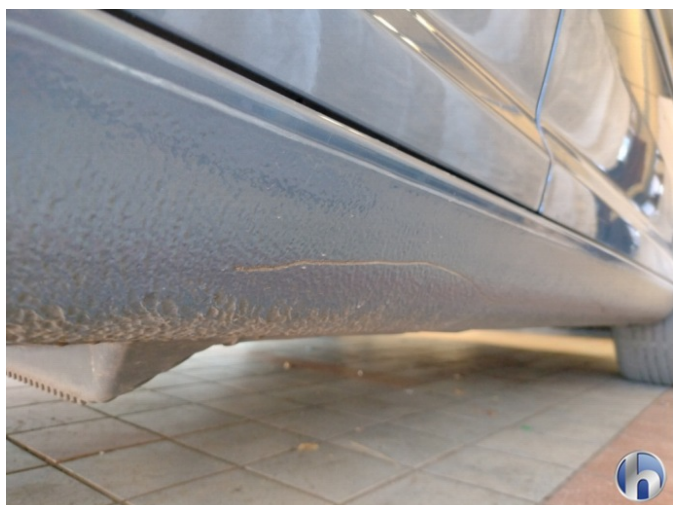
| component | Damage | Rep kind |
|---|---|---|
| 23. side skirt - right | Scratch(es) | Paint |

23. side skirt - right

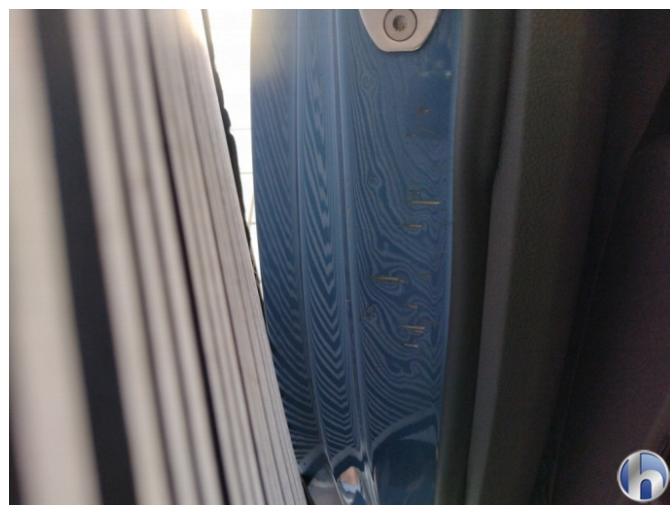
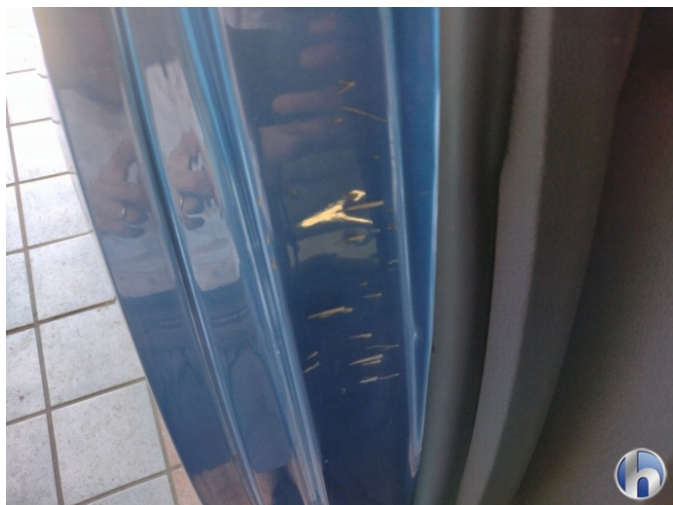
| component | Damage | Rep kind |
|---|---|---|
| 24. Türeinstieg Hinten - Rechts | Damaged | Refurbish and paint |

24. Türeinstieg Hinten - Rechts

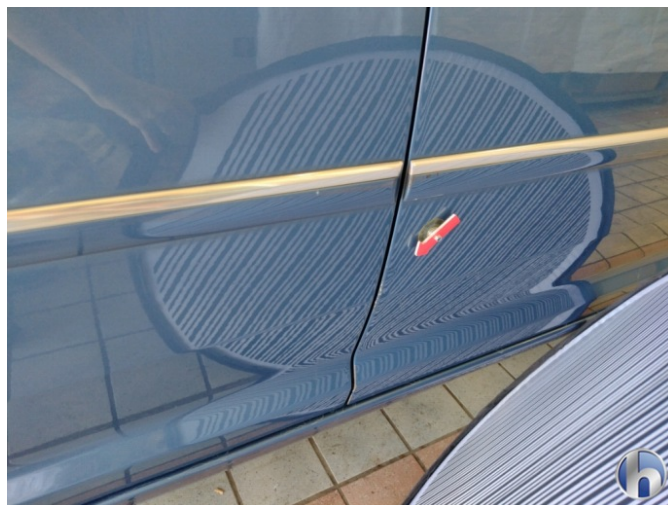
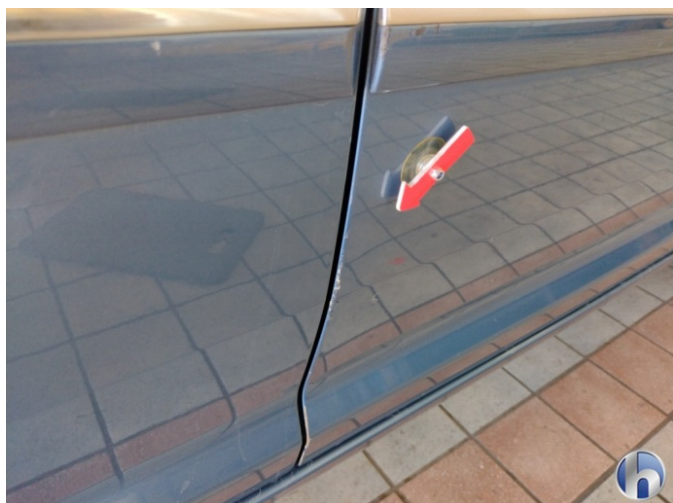
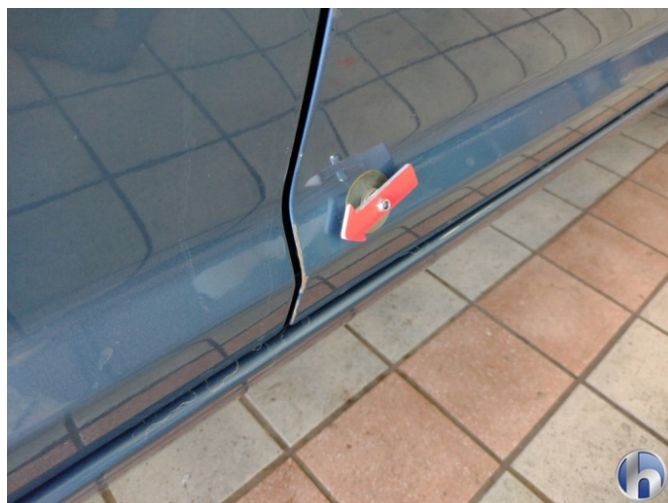
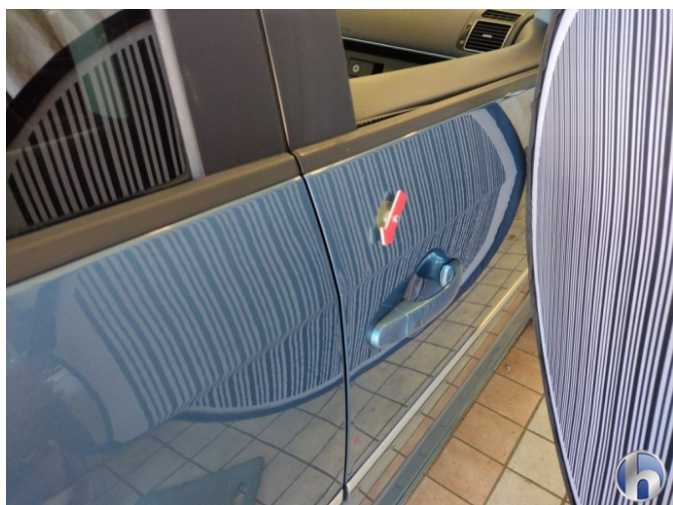
| component | Damage | Rep kind |
|---|---|---|
| 25. Front door - right | Deformed | Refurbish and paint |

25. Front door - right

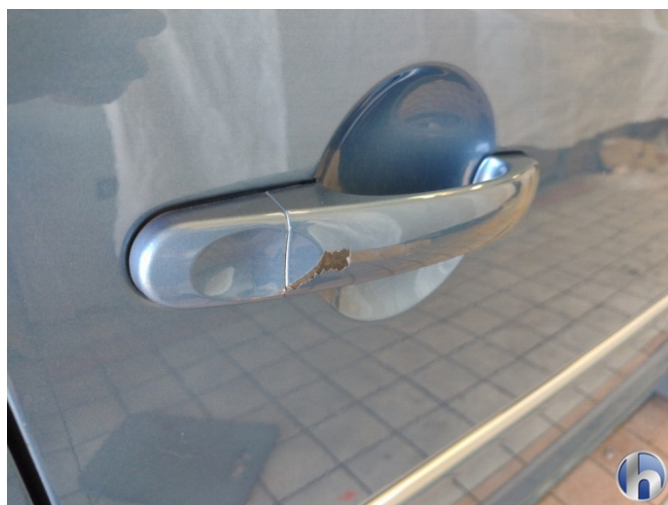
| component | Damage | Rep kind |
|---|---|---|
| 26. Outside Door Handle Front - right | Scrape | Paint |

26. Outside Door Handle Front - right

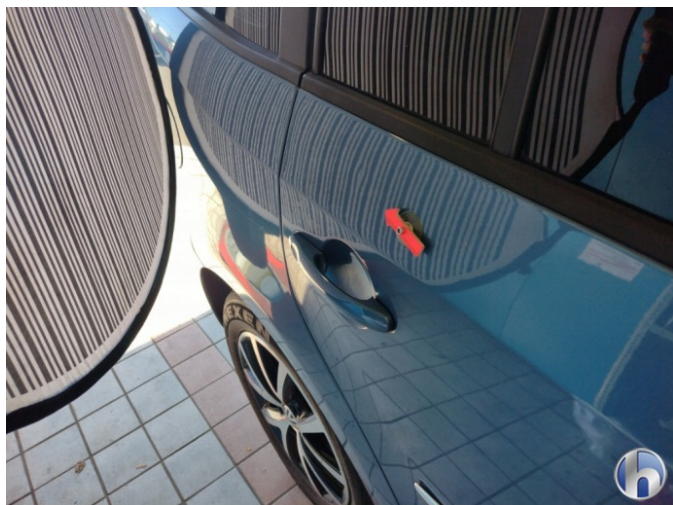
| component | Damage | Rep kind |
|---|---|---|
| 27. Door Rear - right | Delle | Smart repair |

27. Door Rear - right

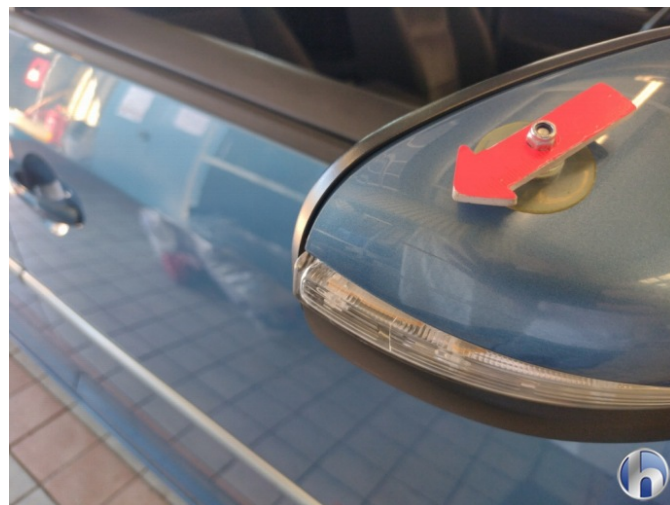
| component | Damage | Rep kind |
|---|---|---|
| 28. | Scratch(es) | Paint |

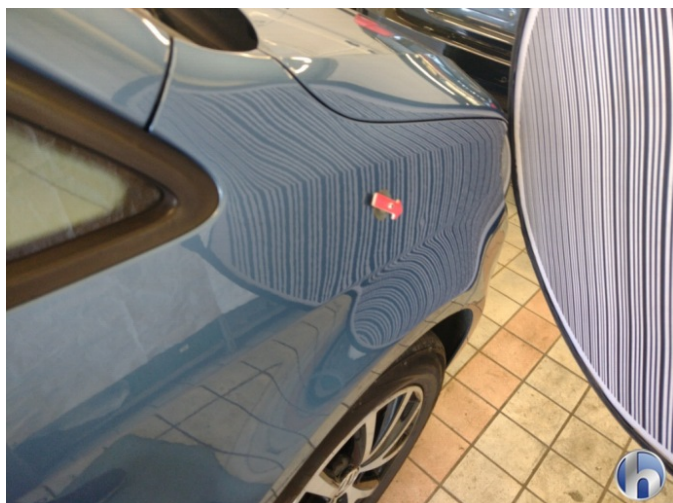
| component | Damage | Rep kind |
|---|---|---|
| 29. Front fender - right | Delle | Smart repair |

29. Front fender - right

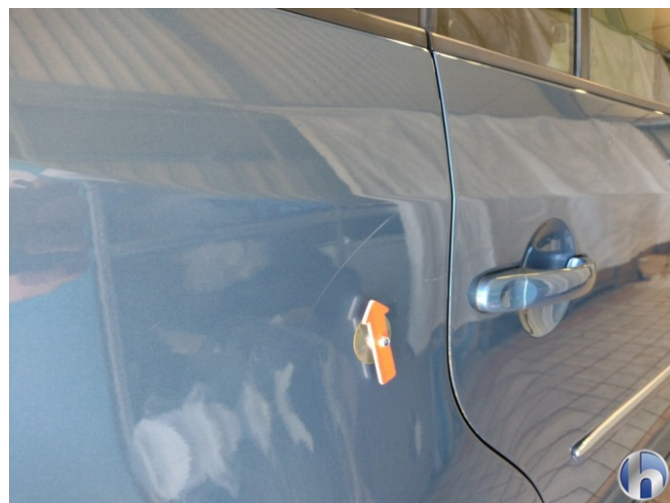
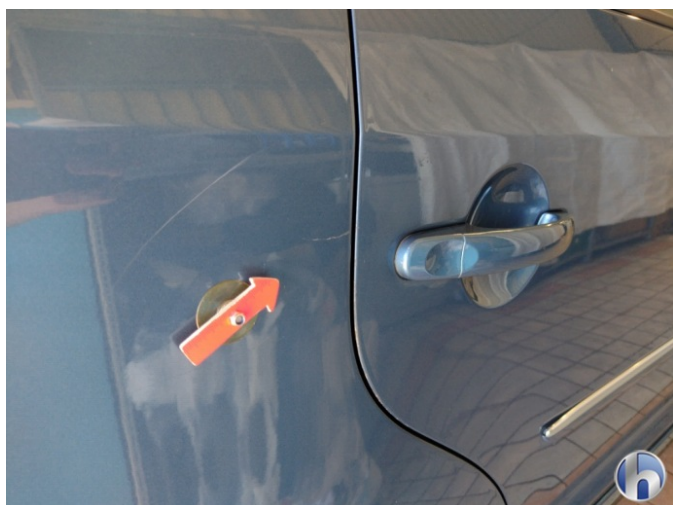
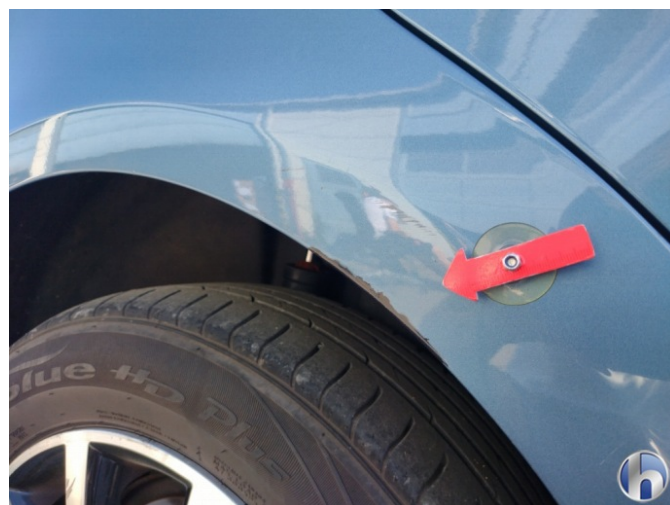
| component | Damage | Rep kind |
|---|---|---|
| 30. Sidewall - Rear - right | Damaged | Paint |

30. Sidewall - Rear - right
