VOLKSWAGEN Touran

Touran 1.6 TDI DPF

VIN NO WVGZZZ1TZDW061354
Registration Number TZDW061354

Inspection Report Summary

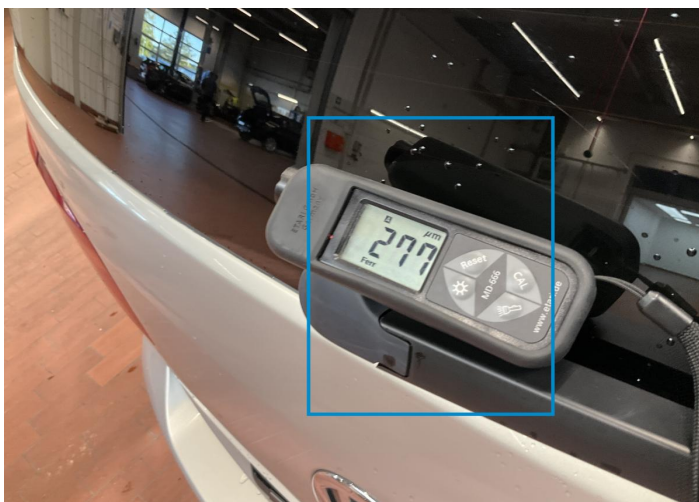
1. Tailgate
Paint / Poor Previous Repair -

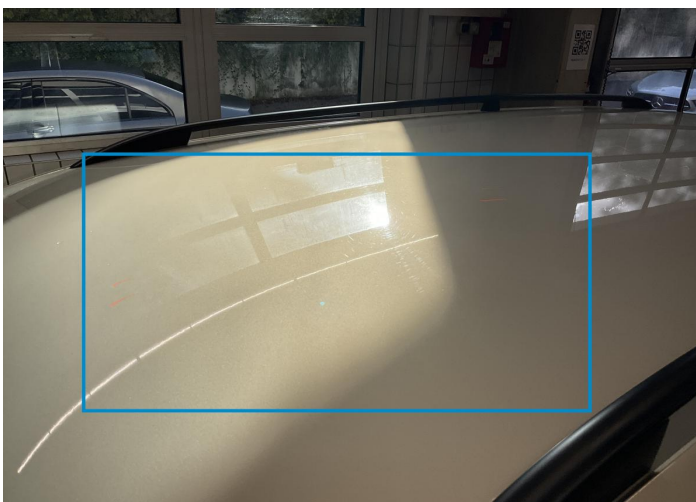
2. Roof
Bodywork / Dent / Dent -

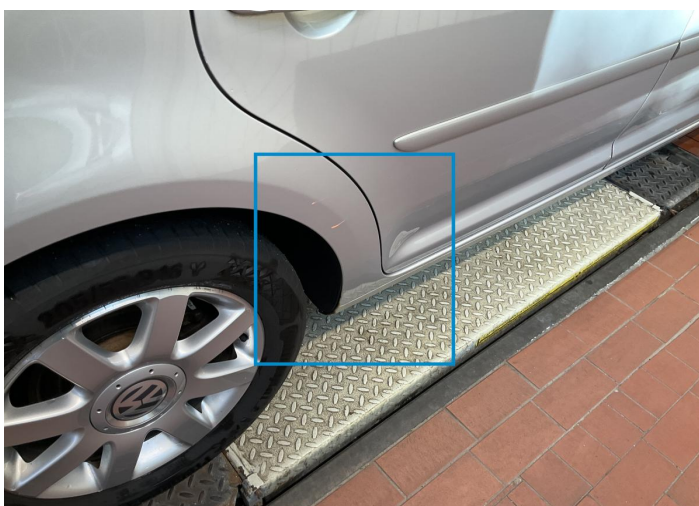
3. Side Panel / Back Right
Bodywork / Dent / Dent -

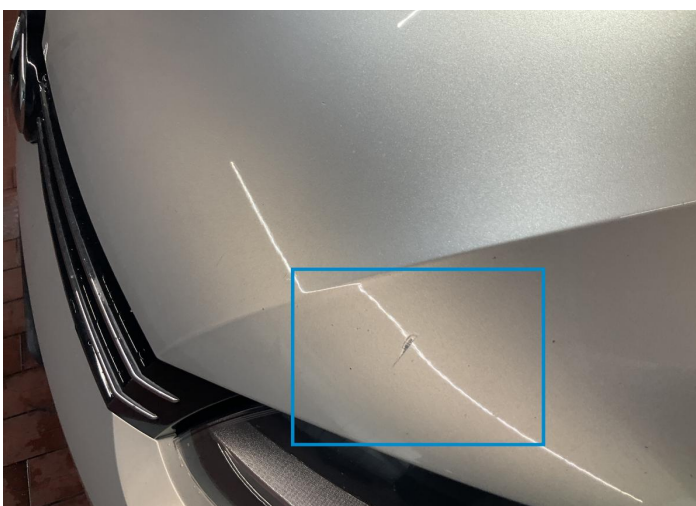
4. Hood
Paint / Scratch / Scuff -

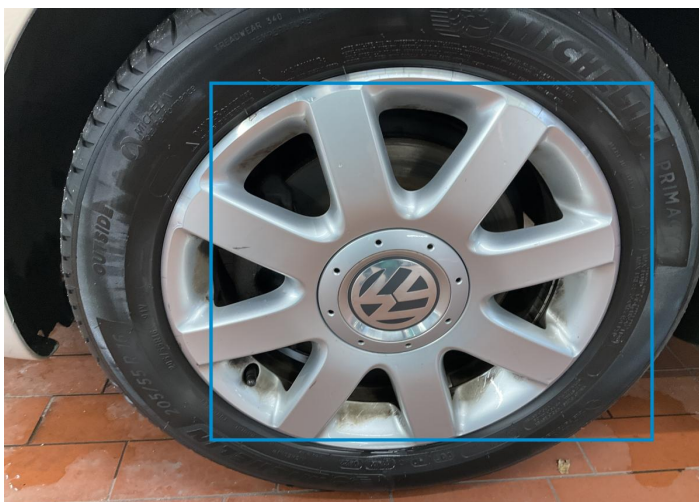
5. Rim / Front Left
Out of Bodywork / Scratch -

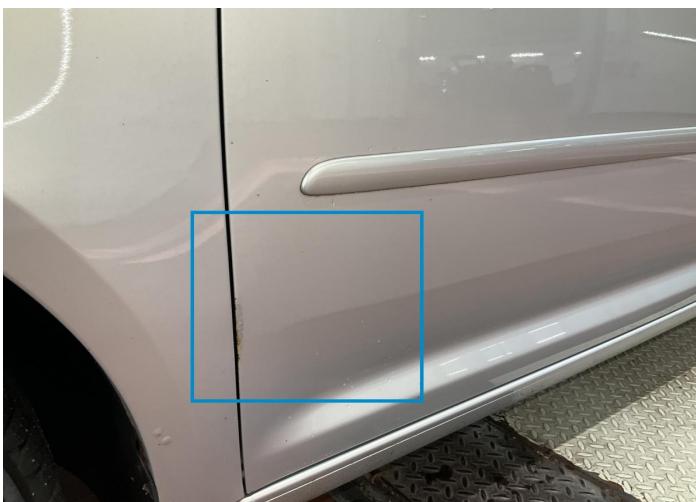
6. Door / Front Left
Paint / Corrosion -

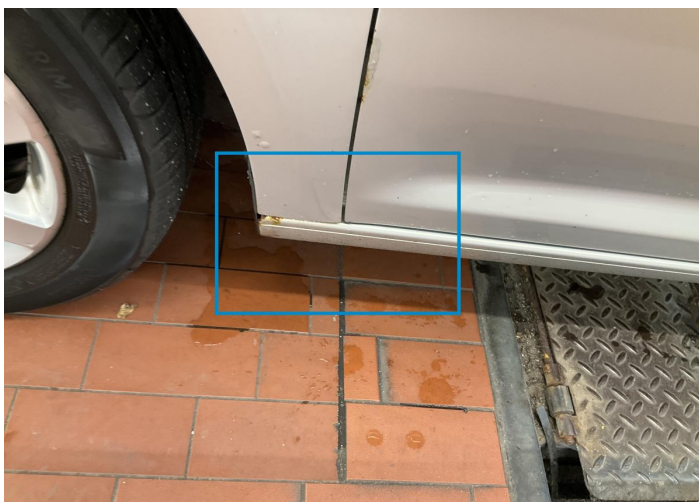
7. Rocker Panel / Center Left
Paint / Corrosion -

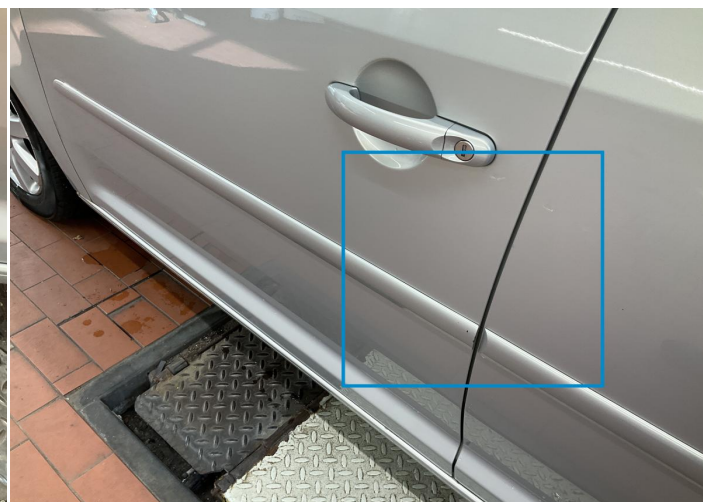
8. Door / Front Left
Paint / Scratch / Scuff -

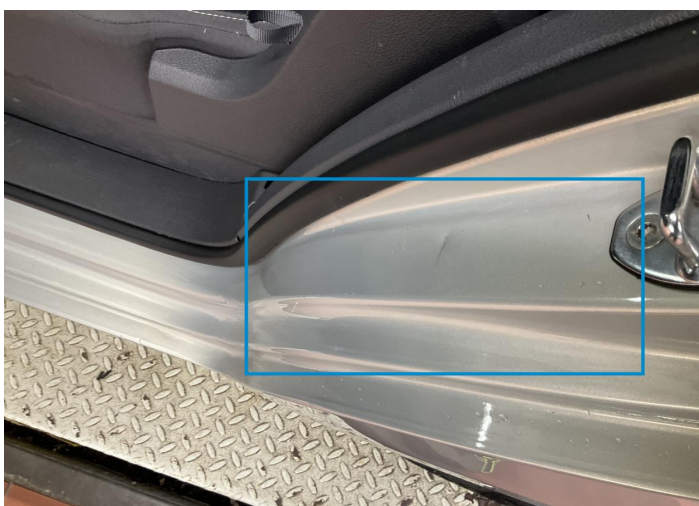
9. Pillar / Back Left
Bodywork / Dent / Dent -

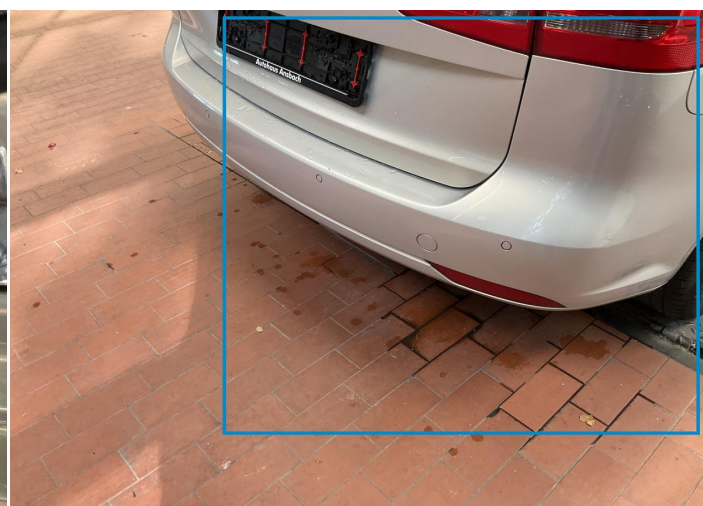
10. Bumper / Back
Paint / Scratch / Scuff -

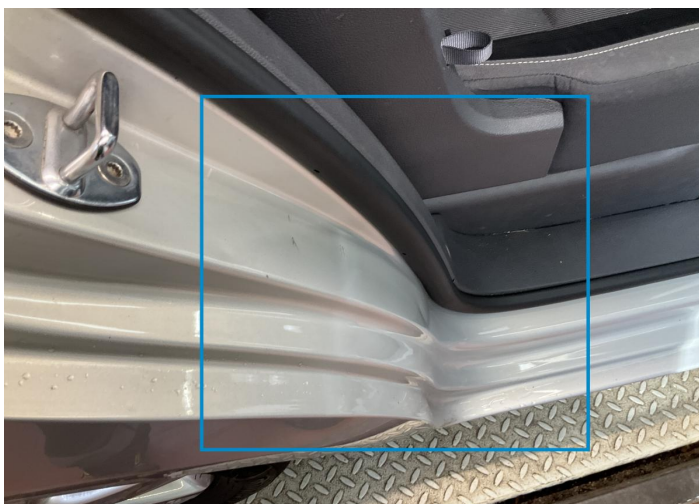
11. Pillar / Back Right
Bodywork / Dent / Dent -

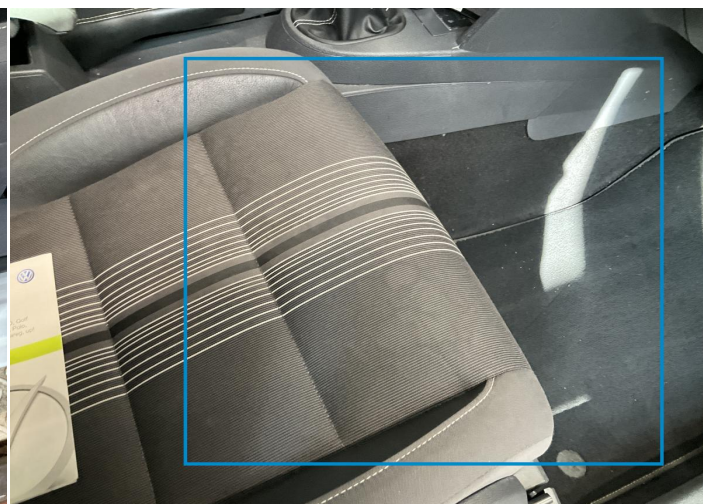
12. Seat / Front Right
Interior / Dirty -

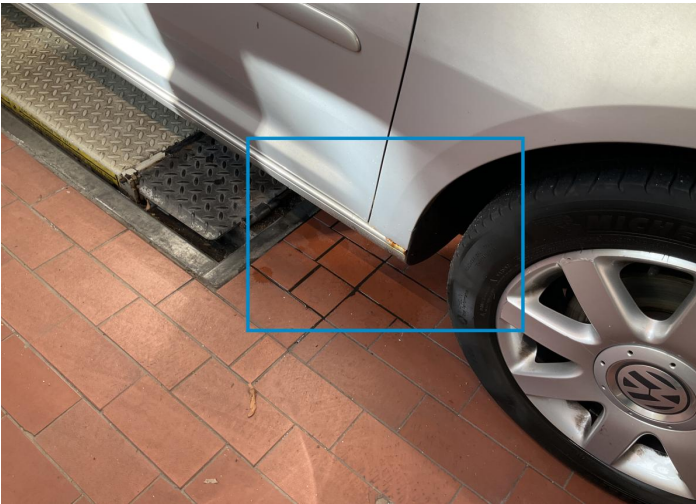
13. Rocker Panel / Center Right
Paint / Corrosion -

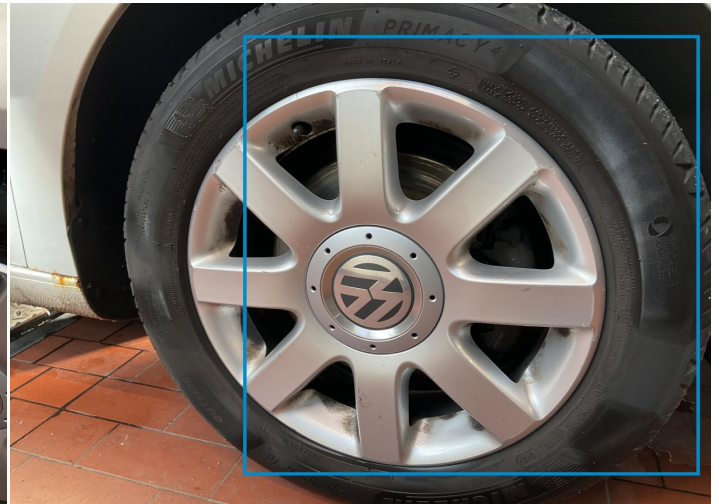
14. Rim / Front Right
Out of Bodywork / Scratch -

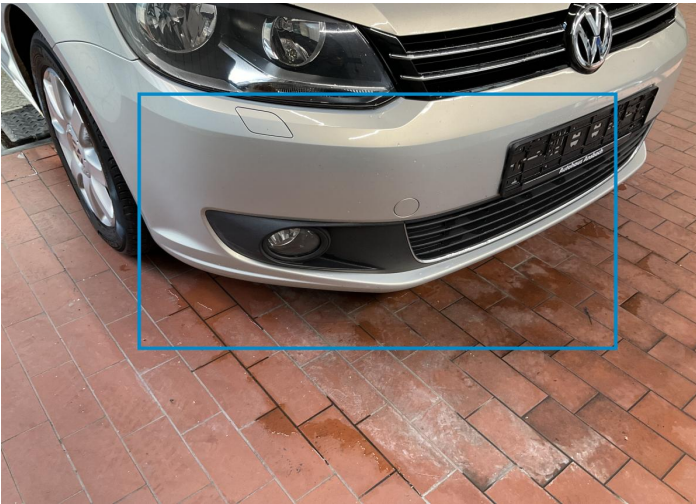
15. Bumper / Front
Paint / Stone Chip -
