## status report

#### Volkswagen Touran Cup

| Vehicle identification number | <b>WVGZZZ1TZFW021814</b> | mileage read: | <b>180687 km</b> |

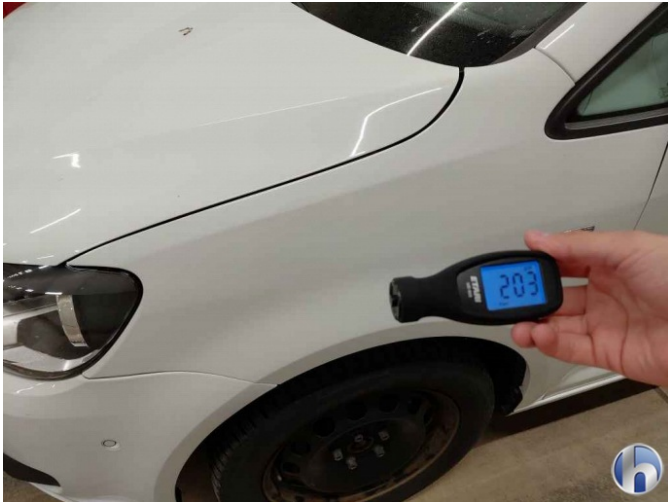
| component | Damage | Rep kind |
|---|---|---|
| 1. Front fender - left | Subsequently painted | acceptable |

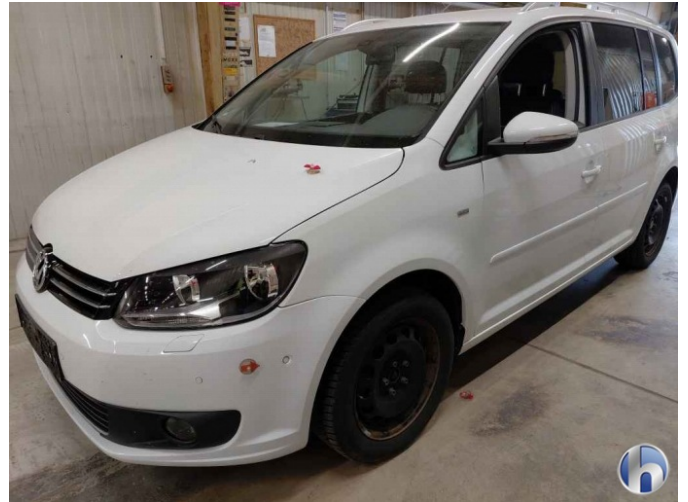
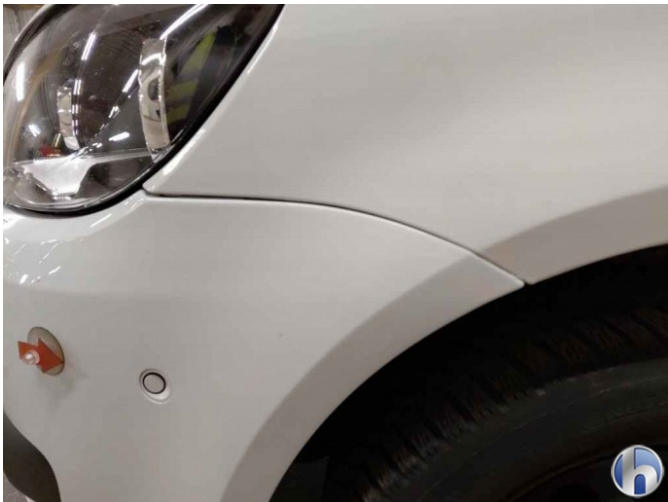
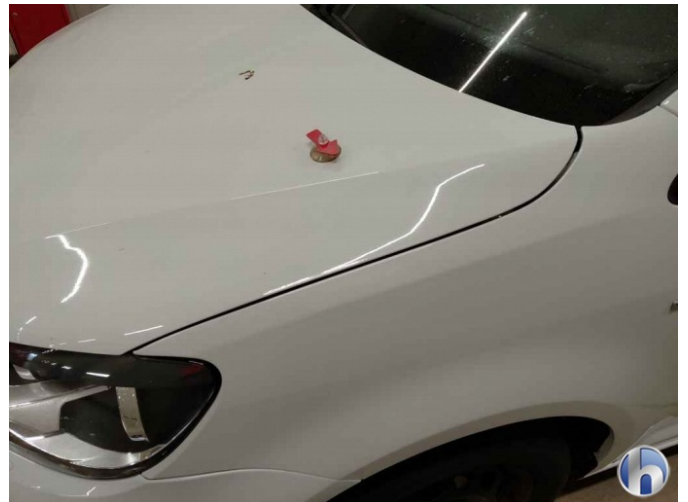
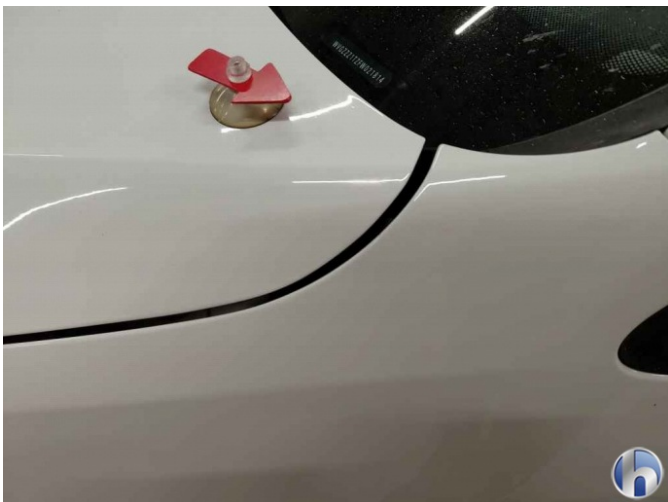
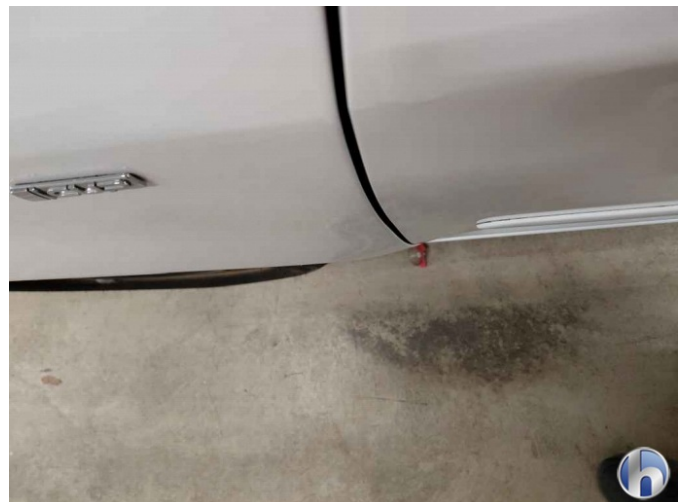
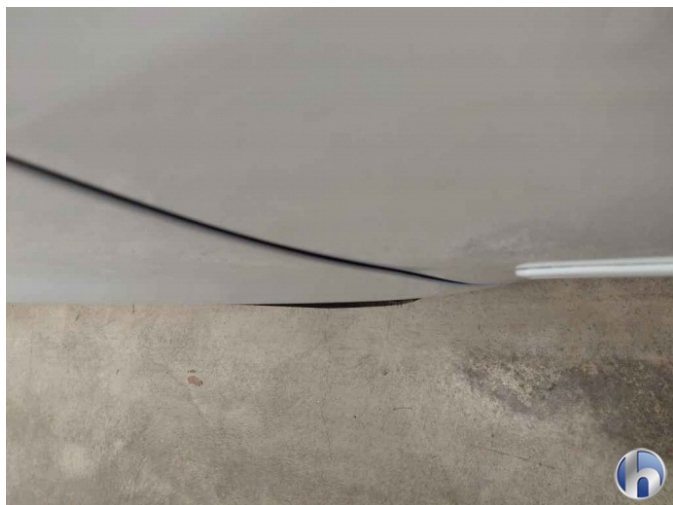
Farbabweichung Plastikteile

| component | Damage | Rep kind |
|---|---|---|
| 2. Fahrzeug (Farbtonunterschied, Spaltmaße ungenau ) | Execution defect | Paint |

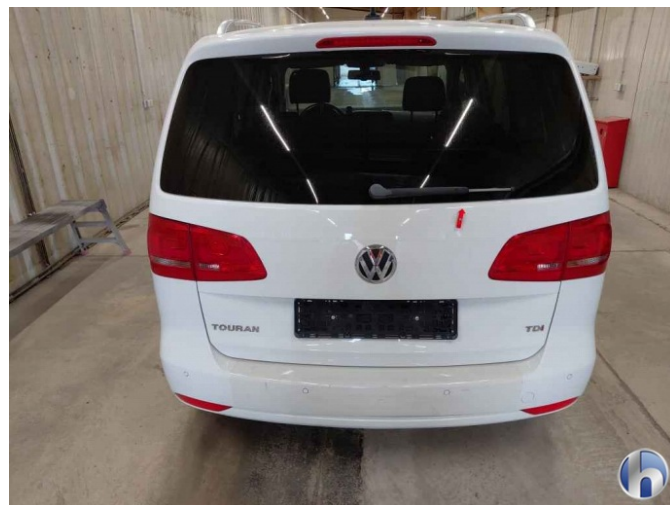
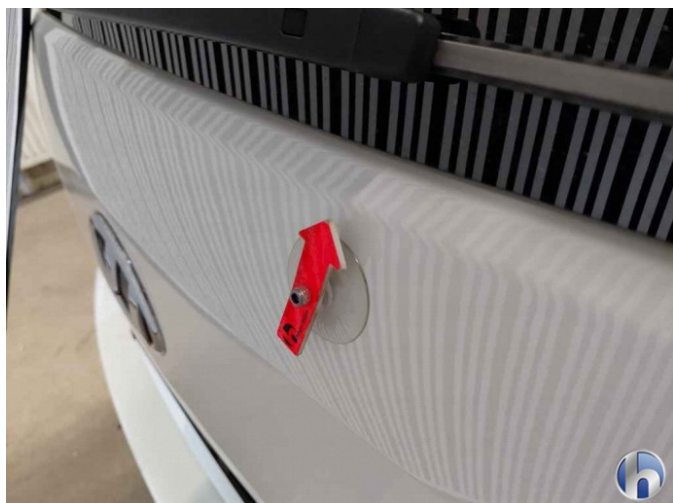
| component | Damage | Rep kind |
|---|---|---|
| 3. tailgate | Delle | Refurbish and paint |

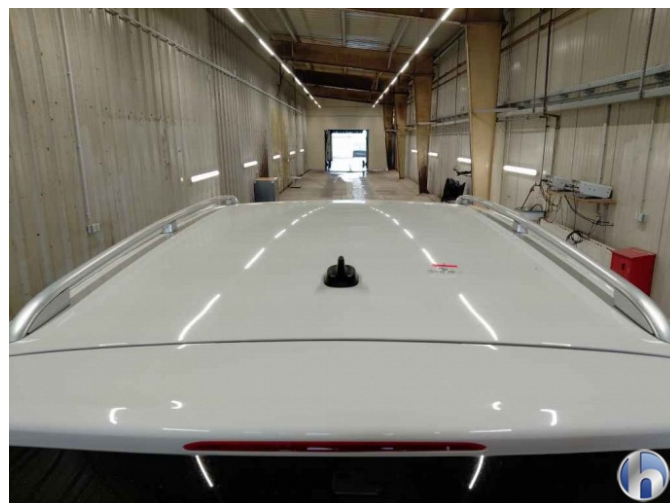
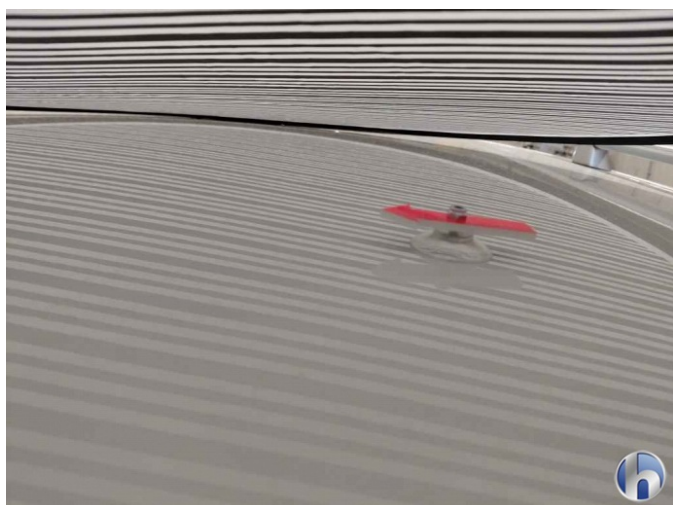
| component | Damage | Rep kind |
|---|---|---|
| 4. roof | Delle | Refurbish and paint |

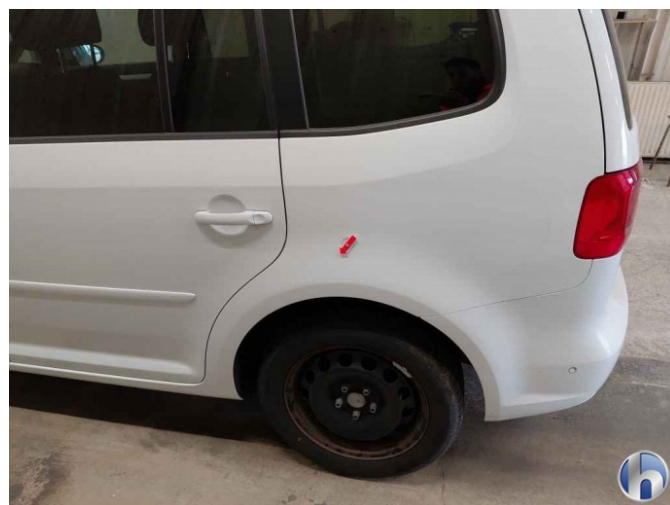
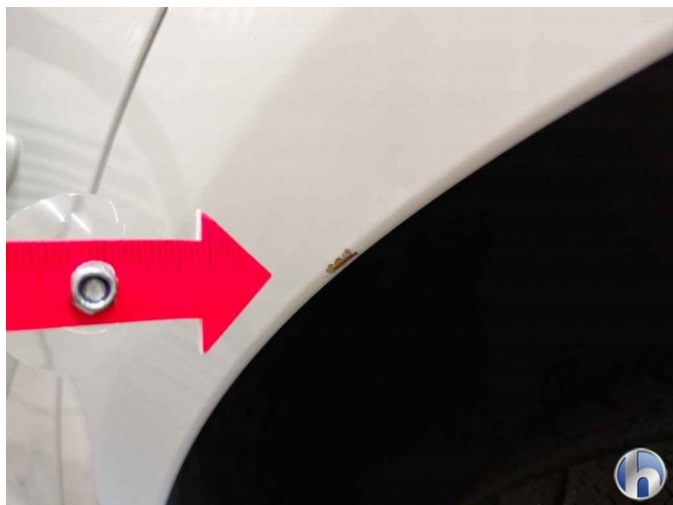
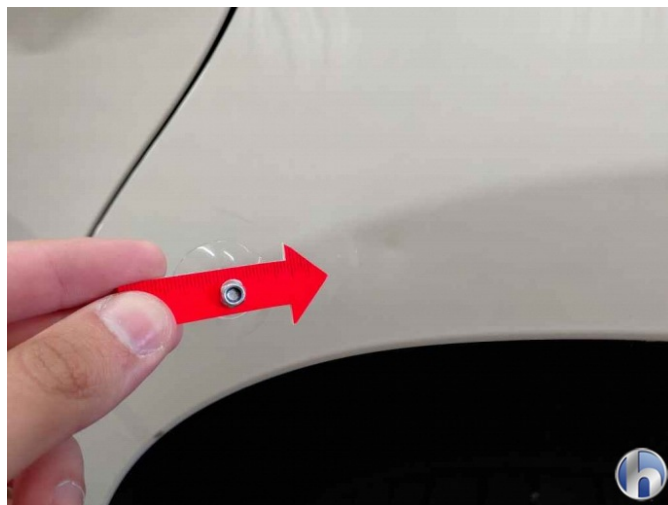
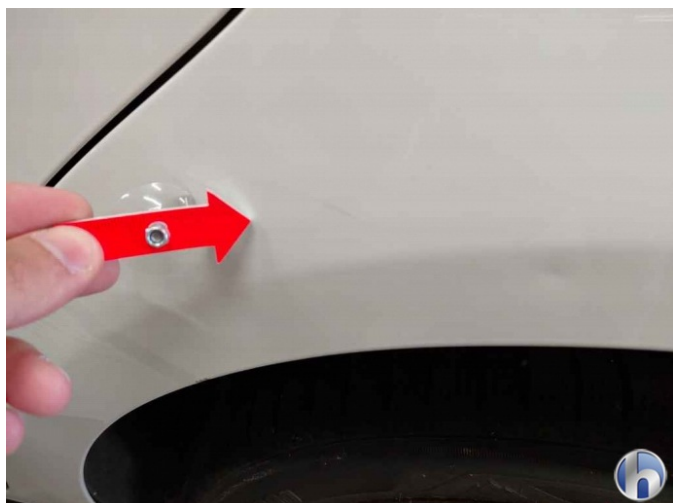
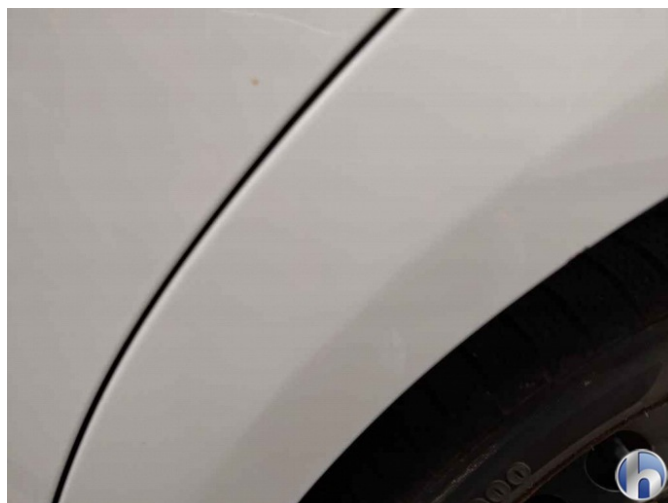
| component | Damage | Rep kind |
|---|---|---|
| 5. Seitenwand hinten links | | Refurbish and paint |

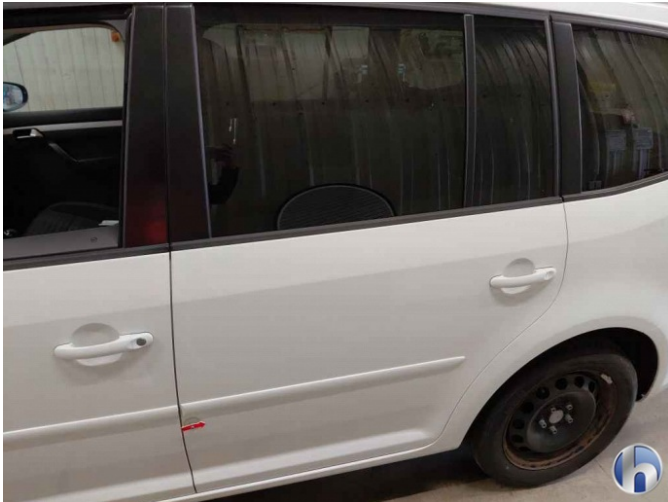
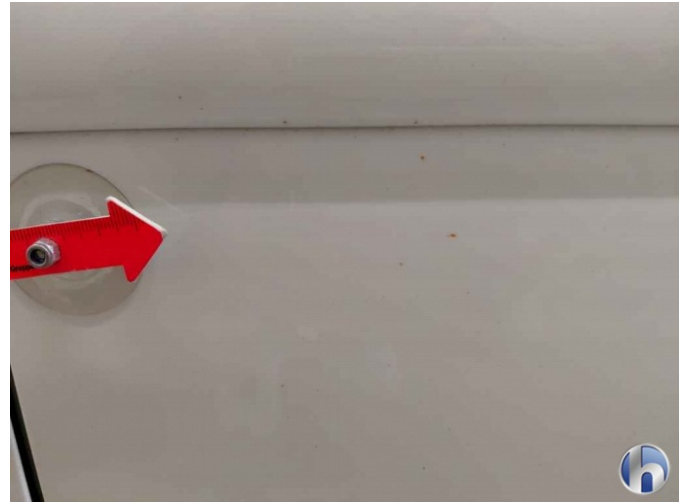
| component | Damage | Rep kind |
|---|---|---|
| 7. Rear door - left | Rust | Refurbish and paint |

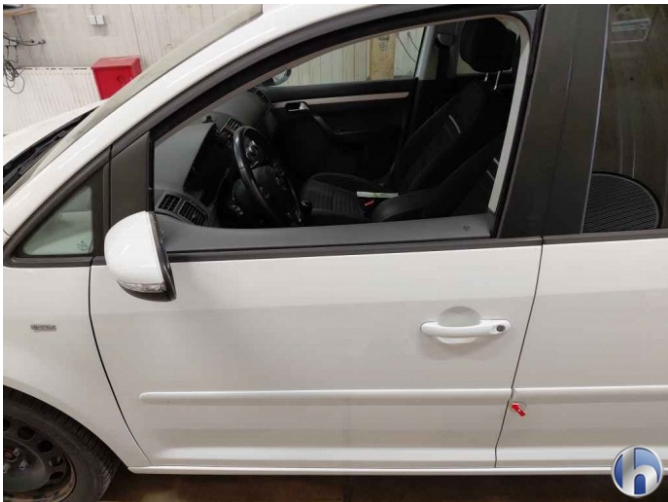
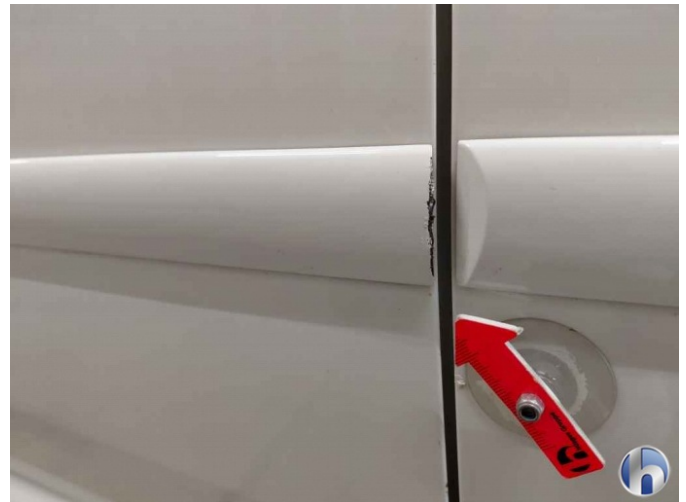
| component | Damage | Rep kind |
|---|---|---|
| 8. Türleiste vorne links | Scratch(es) | Refurbish and paint |

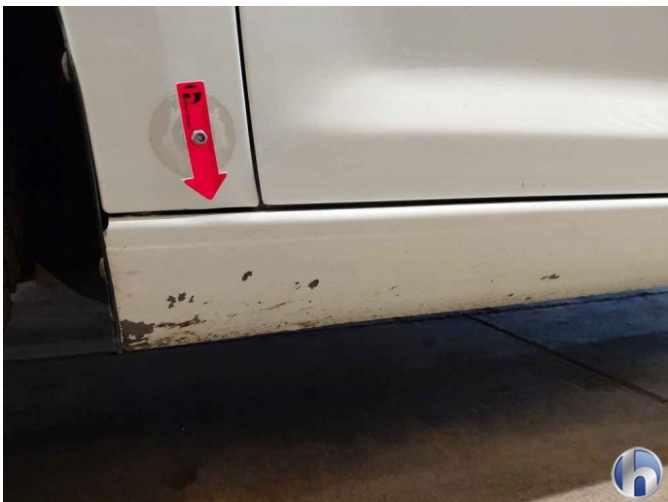
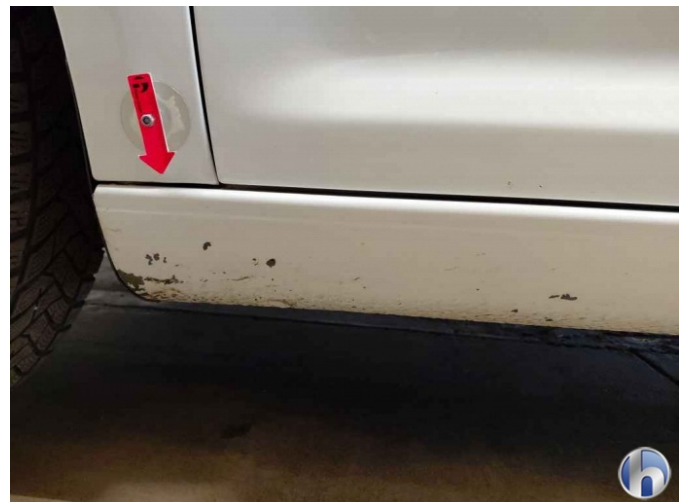
| component | Damage | Rep kind |
|---|---|---|
| 9. side skirt - left | Material wear | Paint |

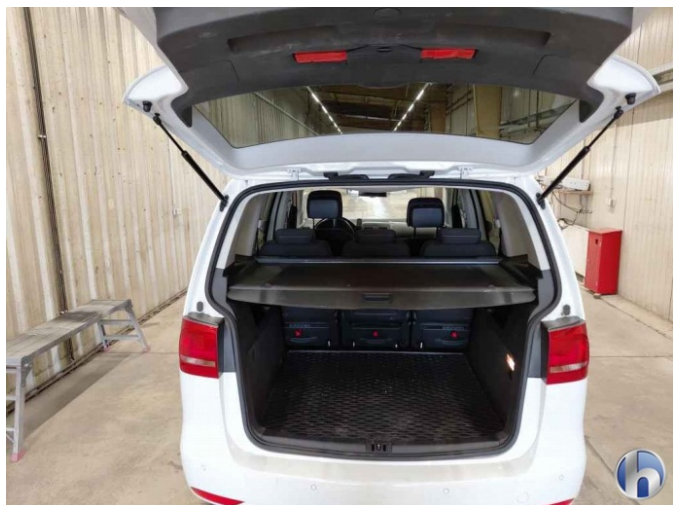
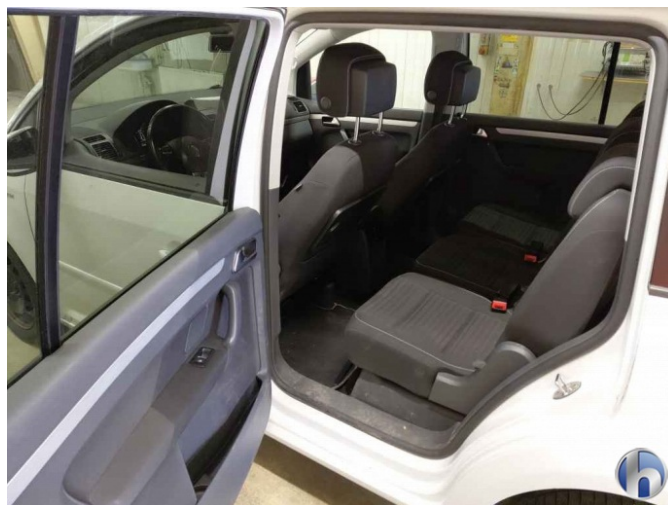
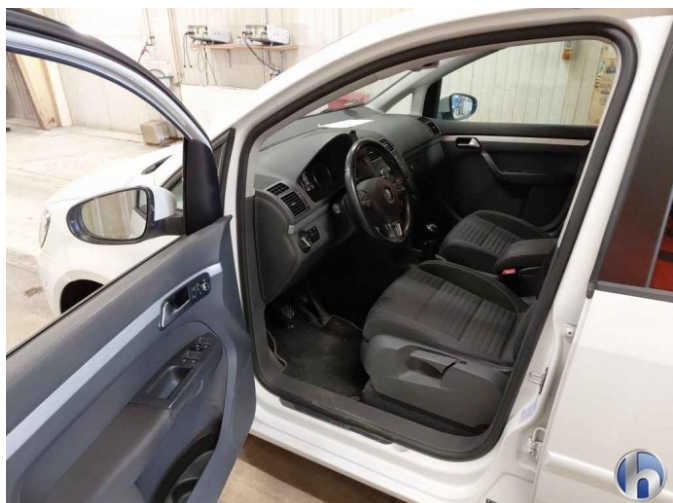
| component | Damage | Rep kind |
|---|---|---|
| 10. Kofferraum Innenraum | Wear and tear | acceptable |

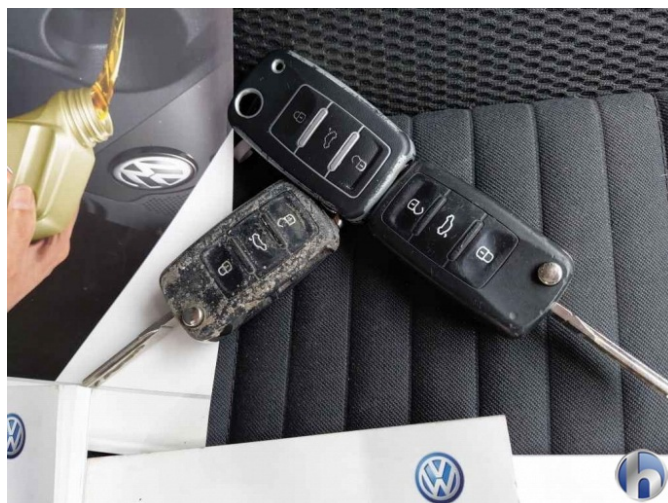
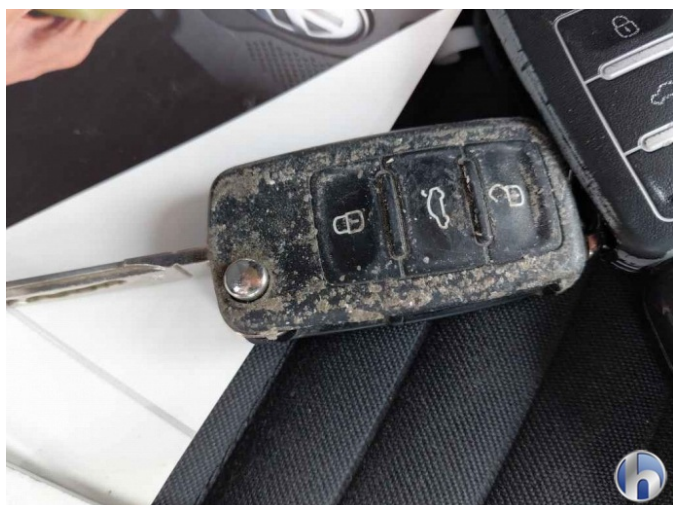
| component | Damage | Rep kind |
|---|---|---|
| 11. key | Not okay | Replace |
