## status report

#### Volkswagen Touran Comfortline BMT/Start-Stopp

| Vehicle identification number | <b>WVGZZZ1TZLW021842</b> | mileage read: | <b>216114 km</b> |

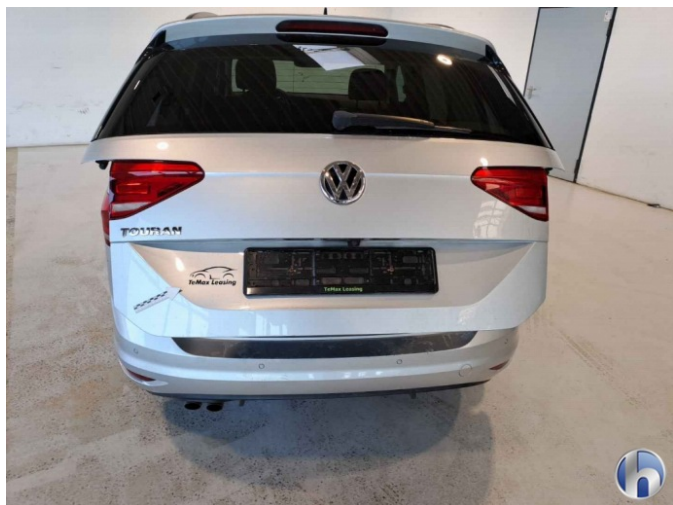
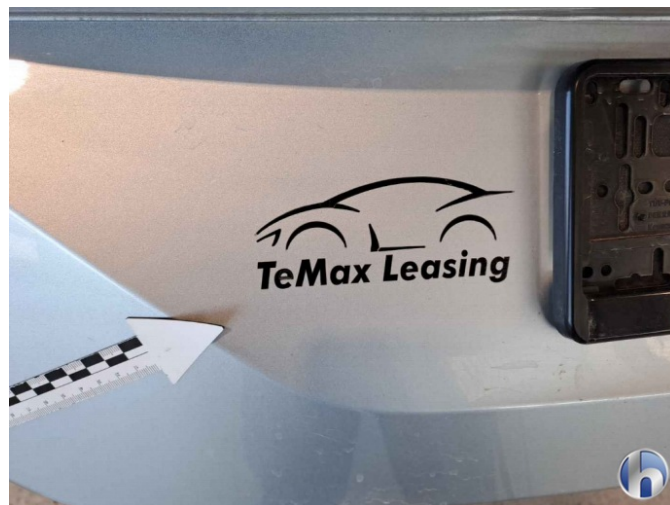
3. tailgate

| | component | Damage | Rep kind |
|---|---|---|---|
| 3. | tailgate | Sticker | |

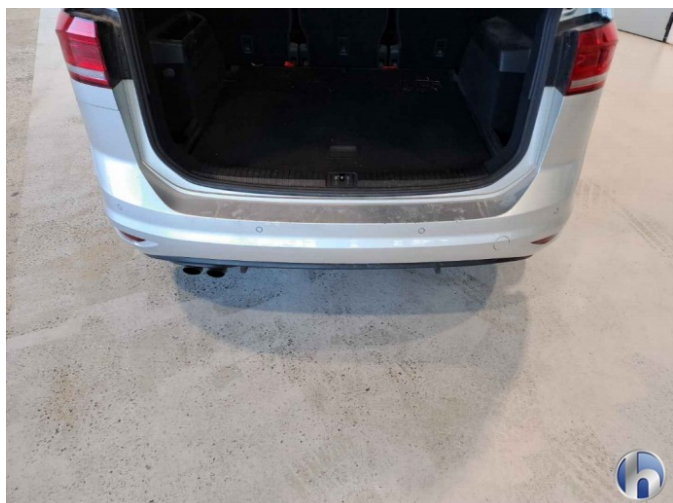
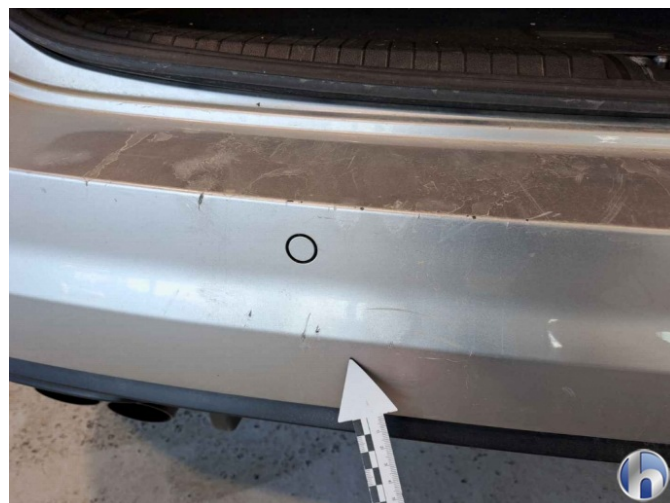
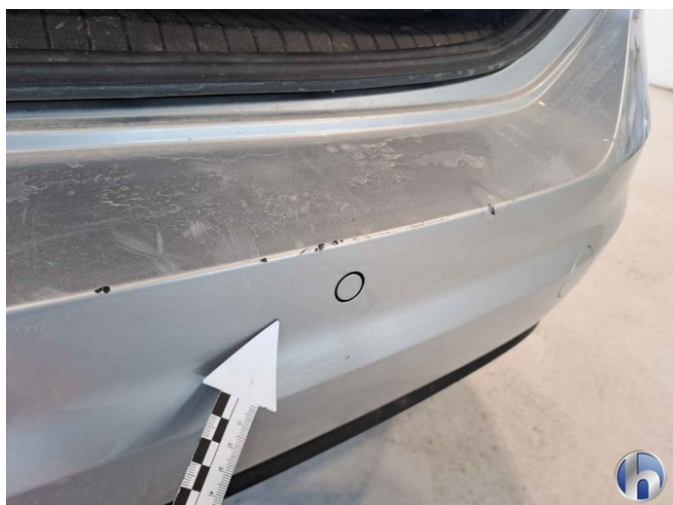
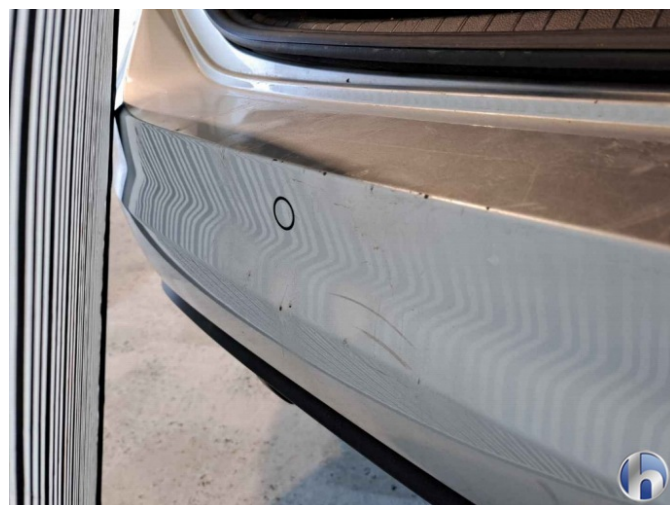
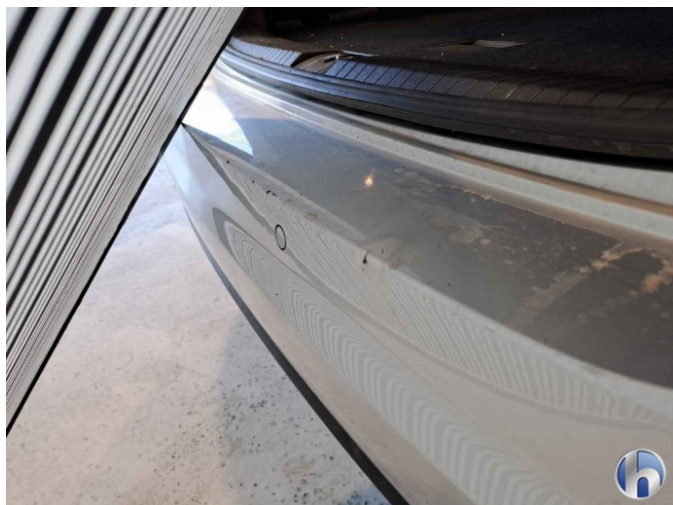
4. Rear bumper

| | component | Damage | Rep kind |
|---|---|---|---|
| 4. | Rear bumper | Damaged | Replace |

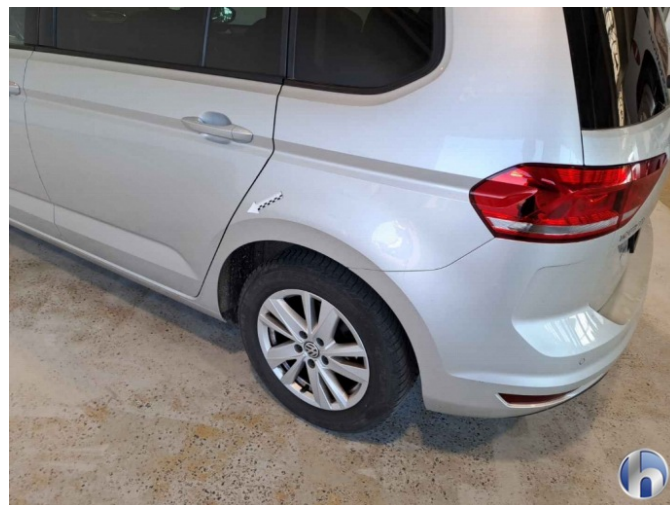
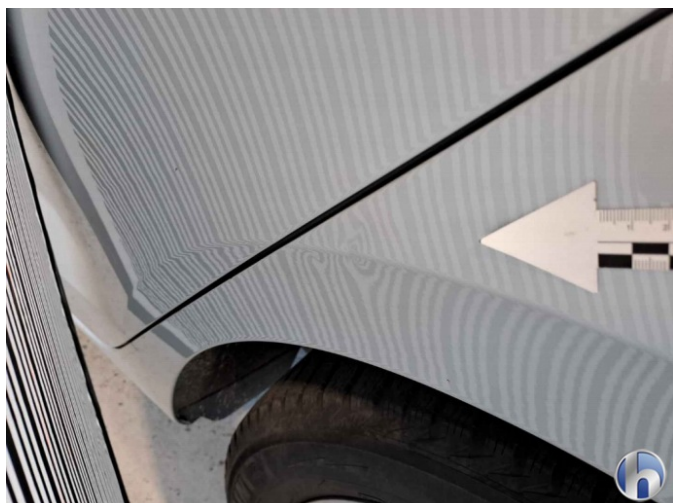
5. Sidewall - Rear - Left

| | component | Damage | Rep kind |
|---|---|---|---|
| 5. | Sidewall - Rear - Left | Deformed (slightly) | Refurbish and paint |

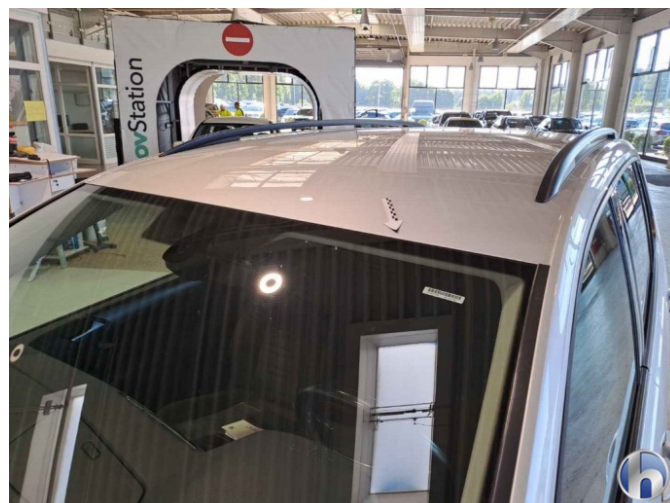
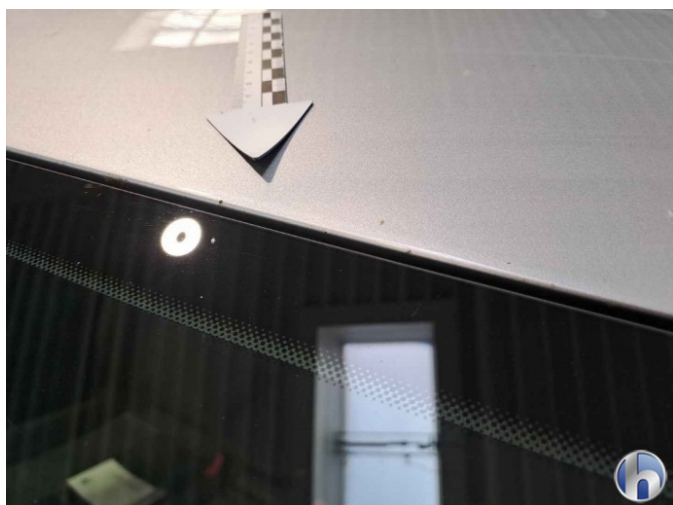
6. roof

| | component | Damage | Rep kind |
|---|---|---|---|
| 6. | roof | chipped paint | Smart repair |

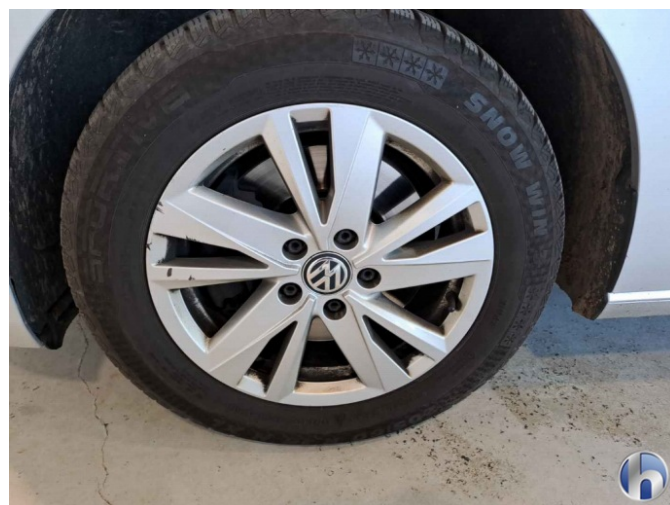
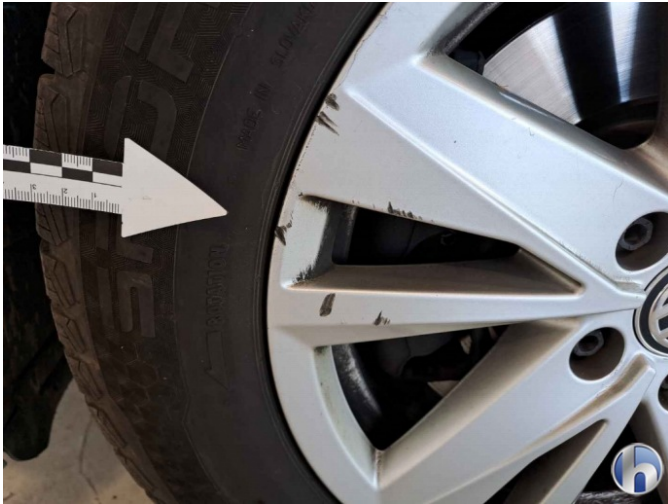
7. Rim front - left

| | component | Damage | Rep kind |
|---|---|---|---|
| 7. | Rim front - left | Scratch(es) | Paint |

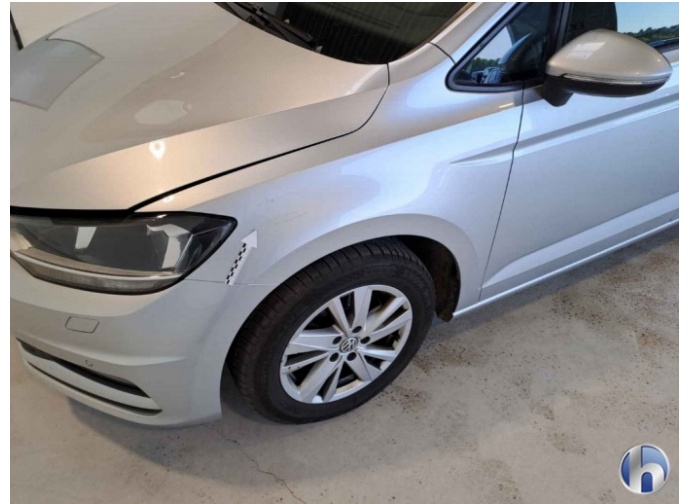
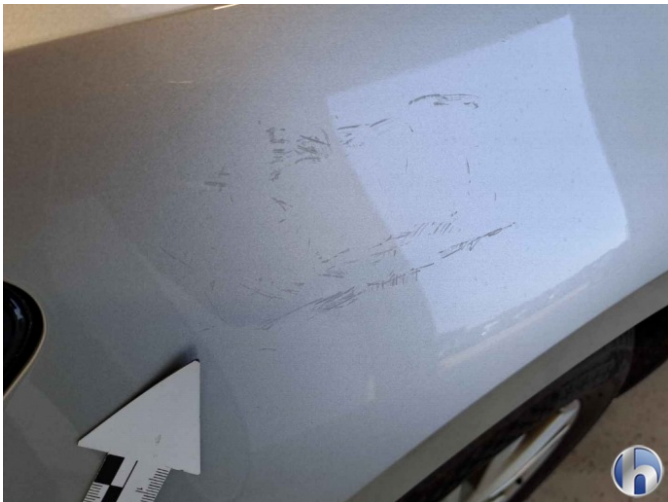
8. Front fender - left

| | component | Damage | Rep kind |
|---|---|---|---|
| 8. | Front fender - left | Damaged | Paint |

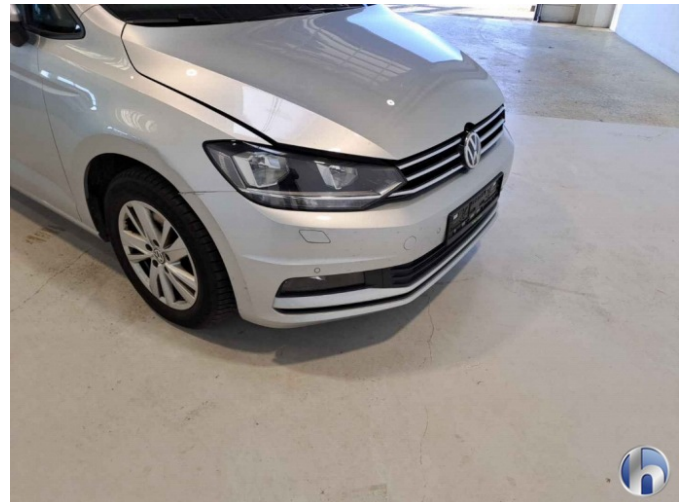
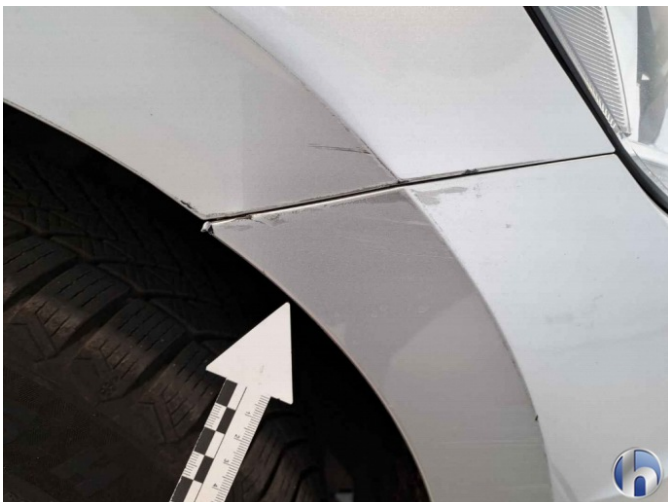
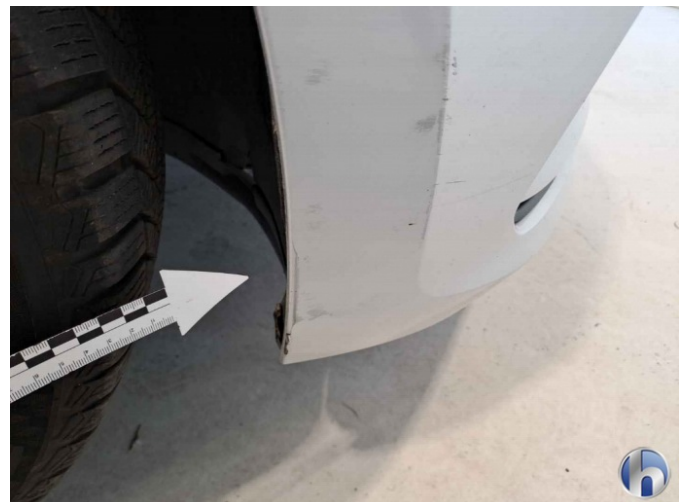
9. Front bumper

| Performed testing technology | |
|---|---|
| <b>reference:</b> | *Fahrzeug hat Alter und Laufleistungs bedingte Gebrauchsspuren innen und außen Unfallschaden Stoßfänger vorne rechts, Kotflügel VR Schaden und Kosten Erweiterung möglich |

| | component | Damage | Rep kind |
|---|---|---|---|
| 9. | Front bumper | Accident damage | Replace |

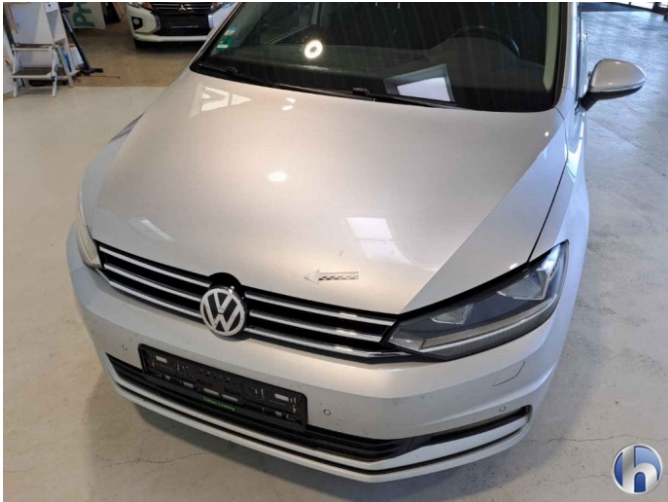
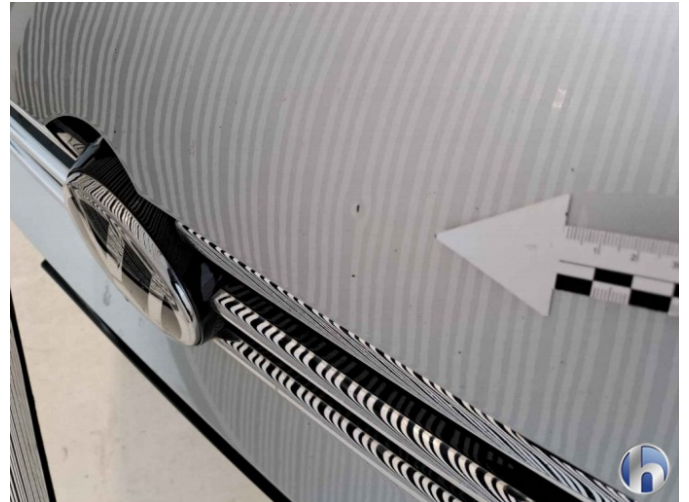
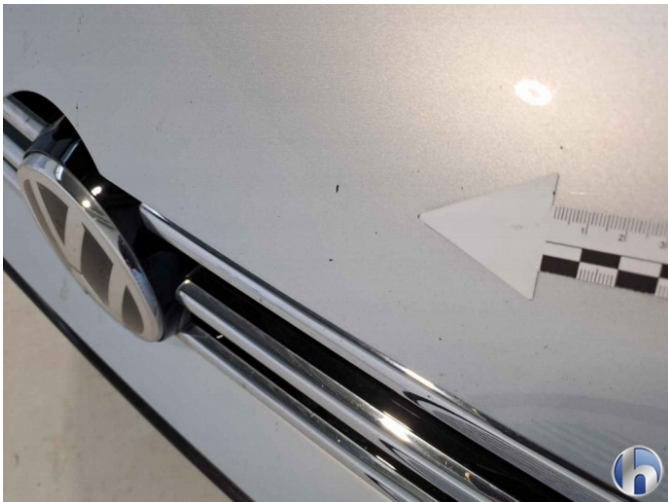
10. hood

| | component | Damage | Rep kind |
|---|---|---|---|
| 10. | hood | | Refurbish and paint |

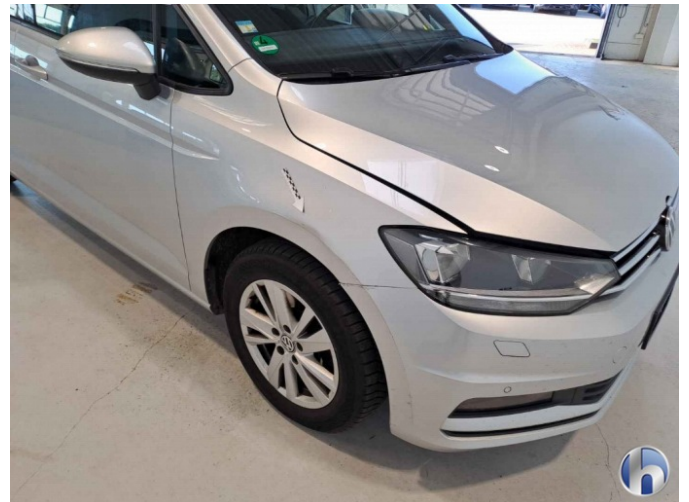
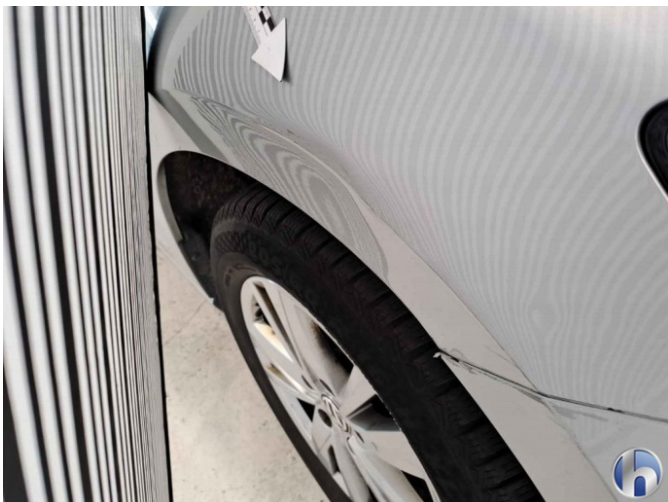
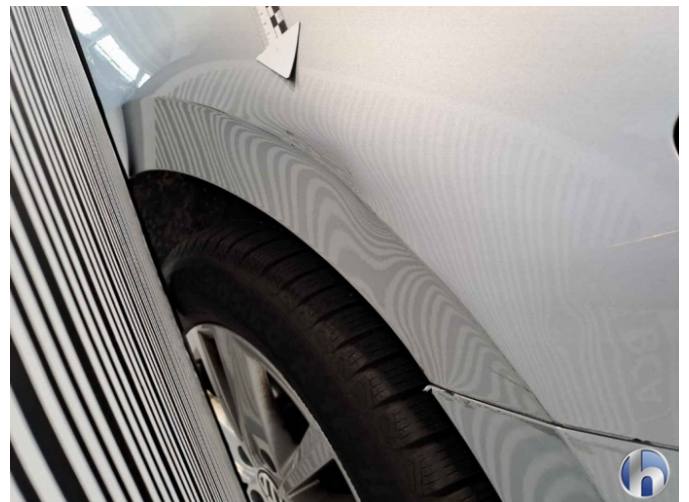
11. Front fender - right

| | component | Damage | Rep kind |
|---|---|---|---|
| 11. | Front fender - right | Accident damage | Refurbish and paint |

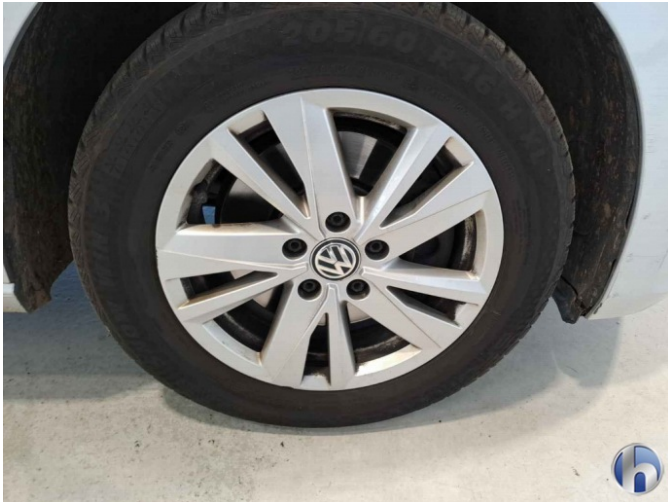
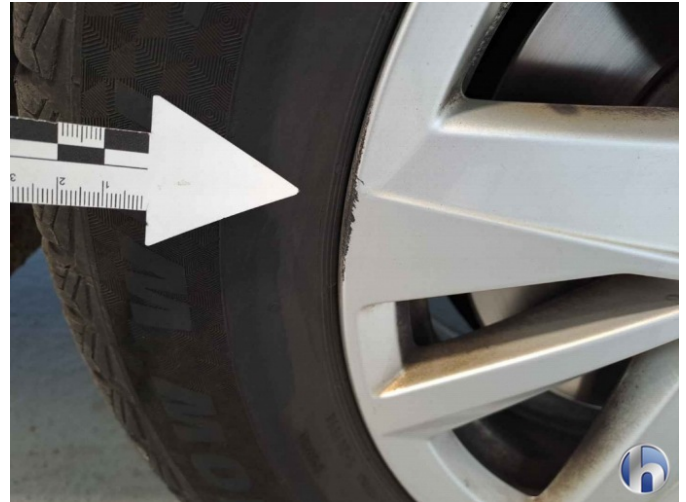
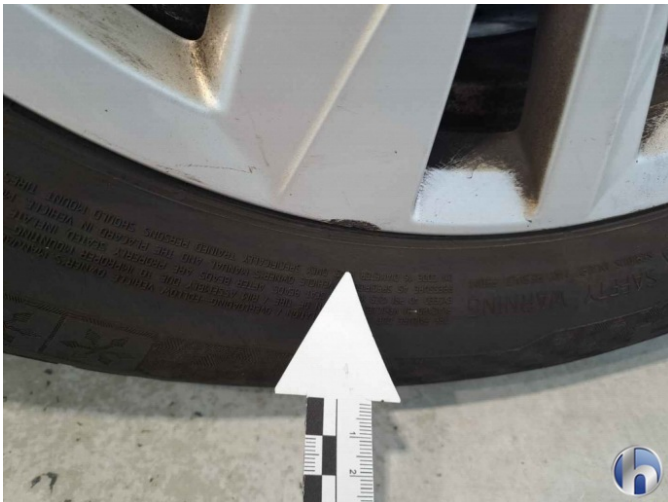
12. Rim front - right

| | component | Damage | Rep kind |
|---|---|---|---|
| 12. | Rim front - right | Scratch(es) | Paint |

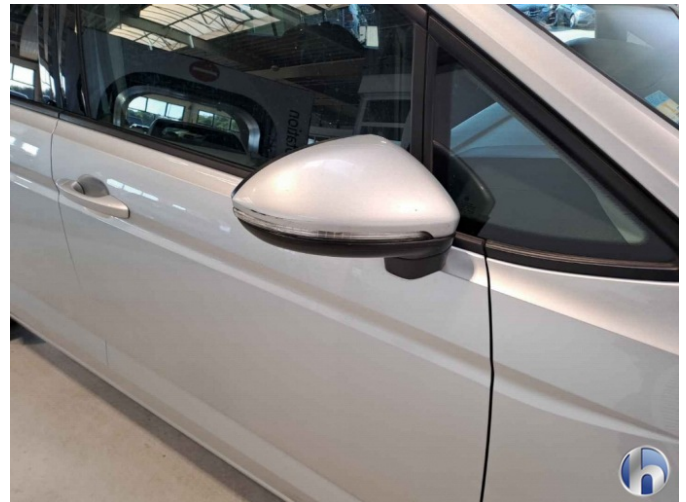
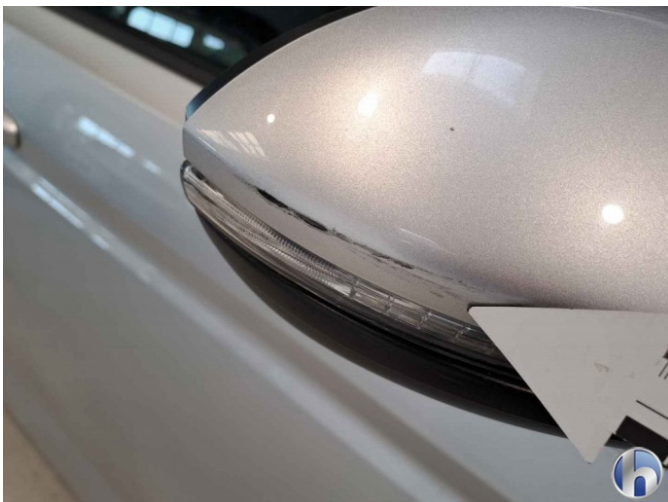
| | component | Damage | Rep kind |
|---|---|---|---|
| 13. | | Scrape | Smart repair |

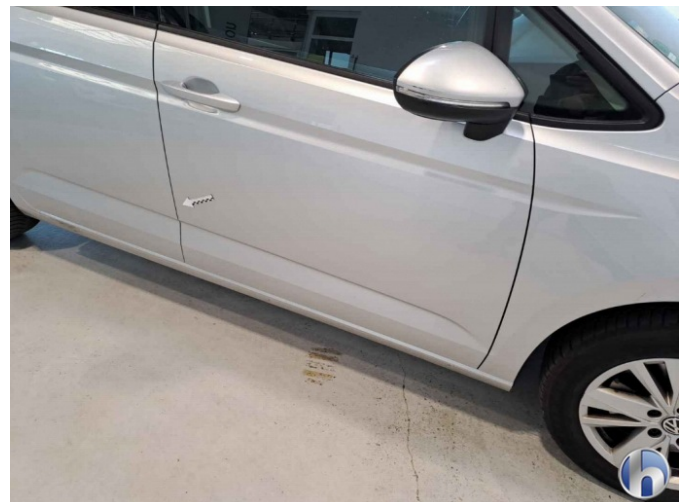
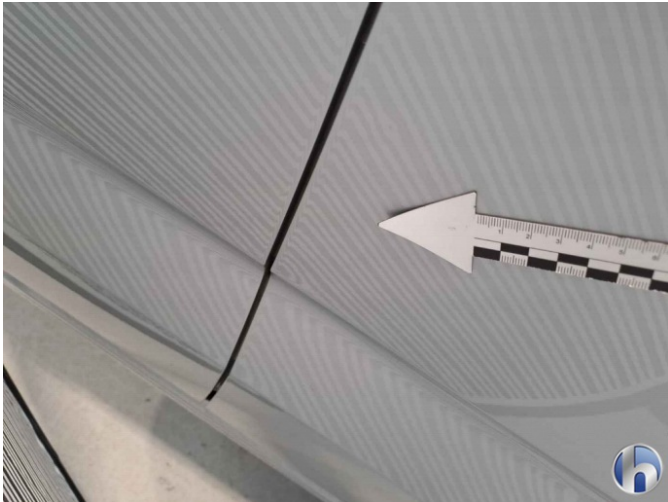
14. Front door - right

| | component | Damage | Rep kind |
|---|---|---|---|
| 14. | Front door - right | Deformed (slightly) | Refurbish and paint |

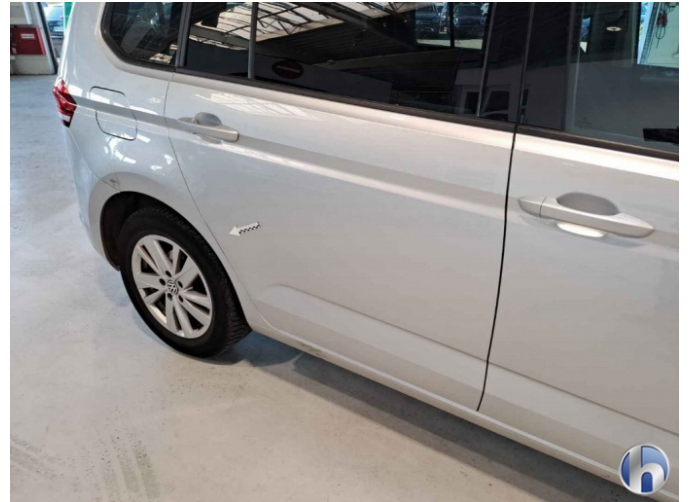
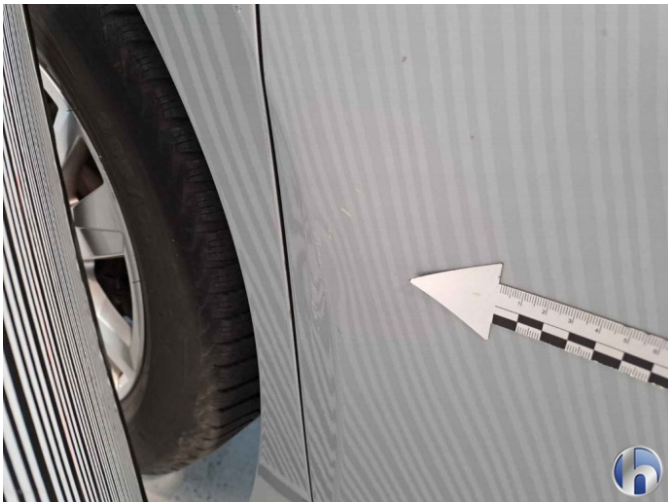
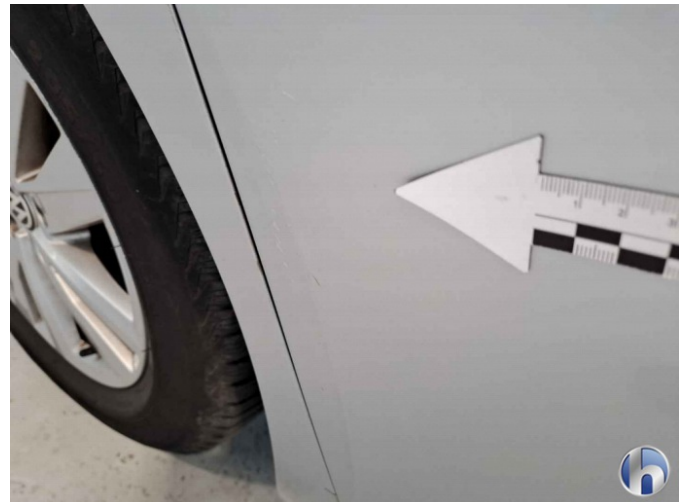
15. Door Rear - right

| | component | Damage | Rep kind |
|---|---|---|---|
| 15. | Door Rear - right | Damaged | Refurbish and paint |

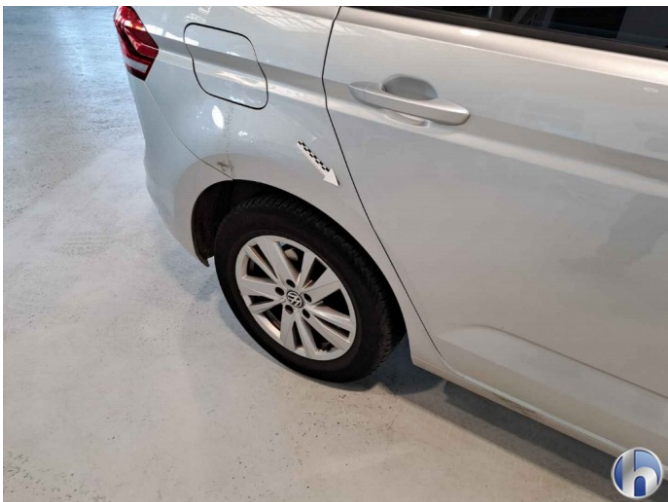
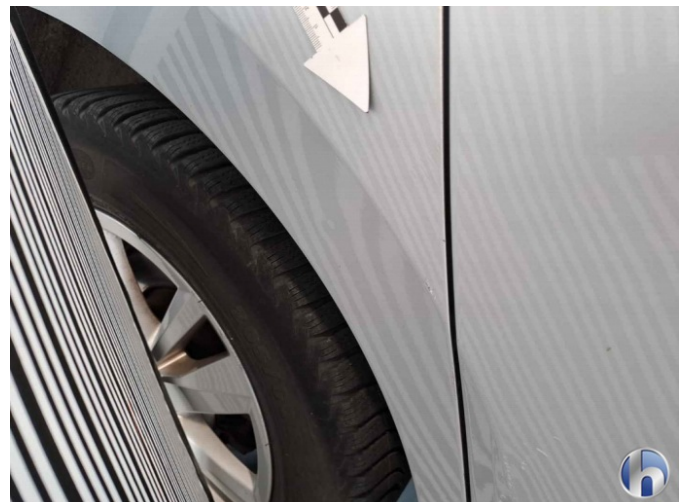
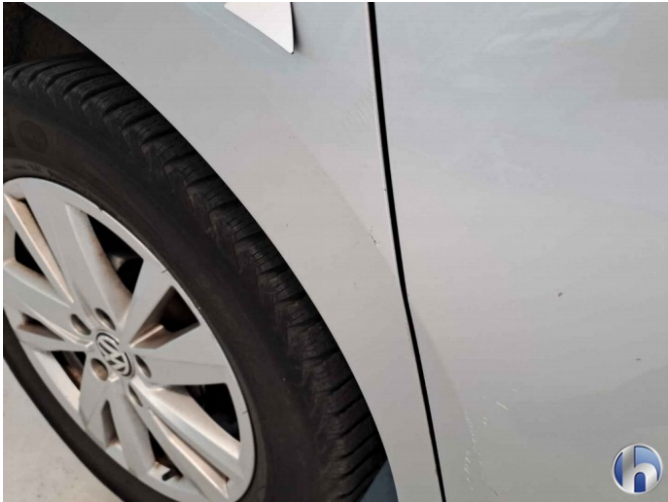
16. Sidewall - Rear - right

| | component | Damage | Rep kind |
|---|---|---|---|
| 16. | Sidewall - Rear - right | Damaged | Refurbish and paint |

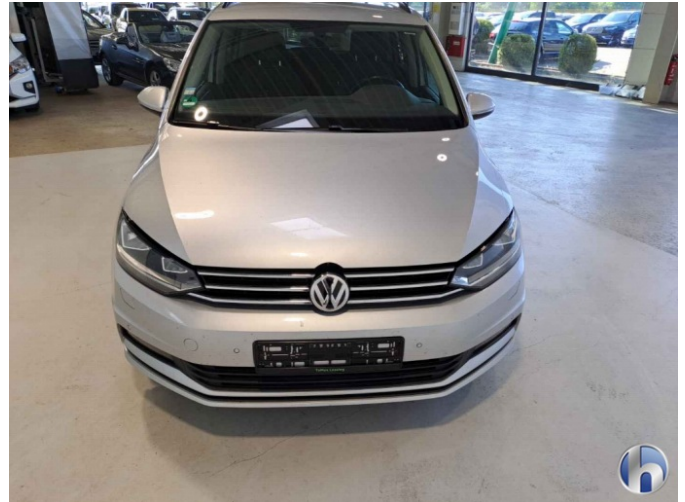
17. exterior body

| | component | Damage | Rep kind |
|---|---|---|---|
| 17. | exterior body | Surface scratch(es) | |

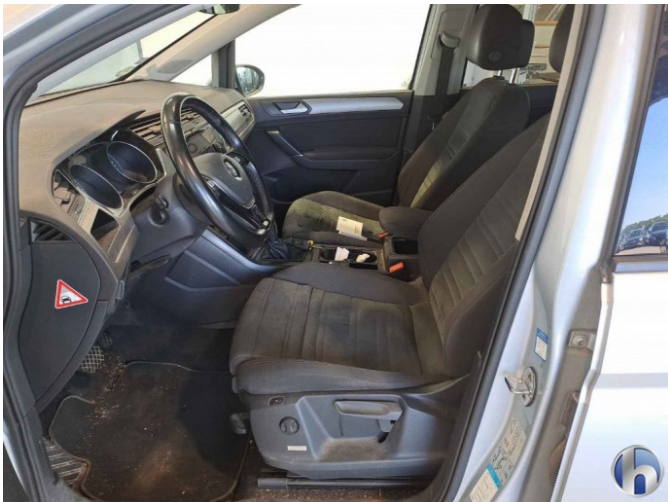
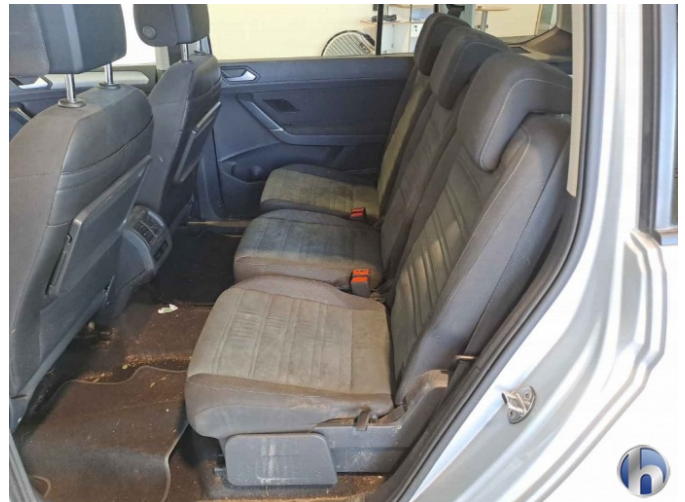
| | component | Damage | Rep kind |
|---|---|---|---|
| 18. | | Wear and tear | acceptable |

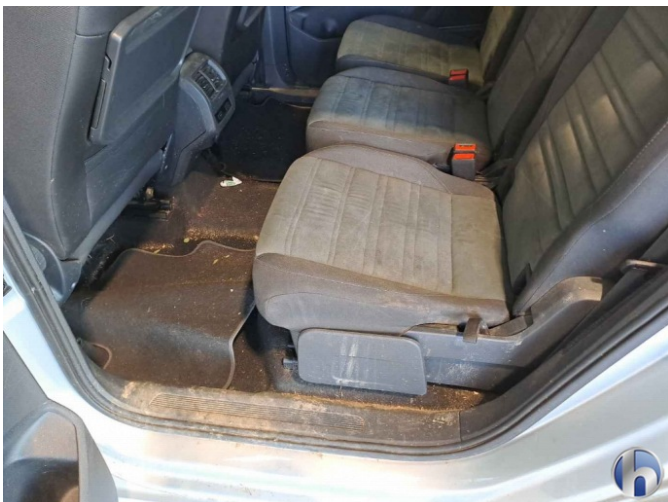
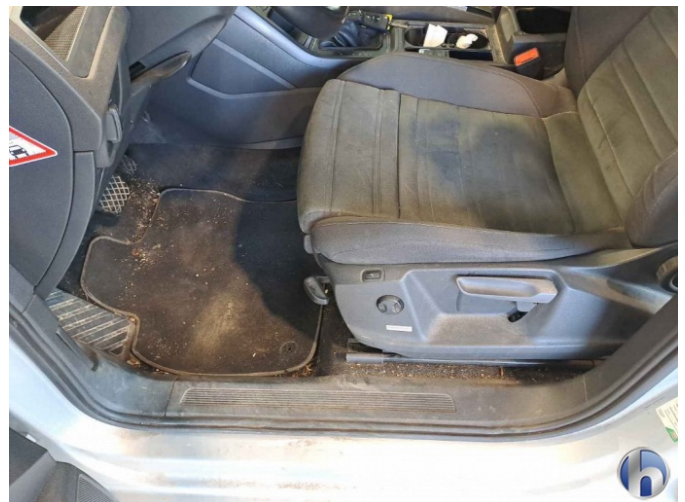
| | component | Damage | Rep kind |
|---|---|---|---|
| 19. | | Dirty (strong) | |

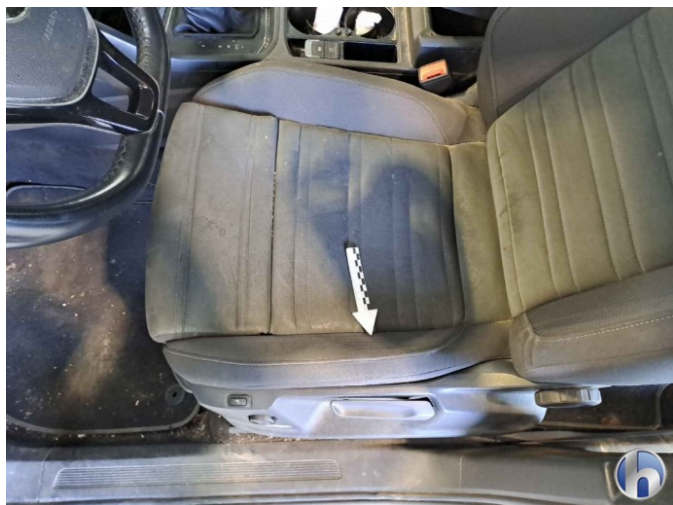
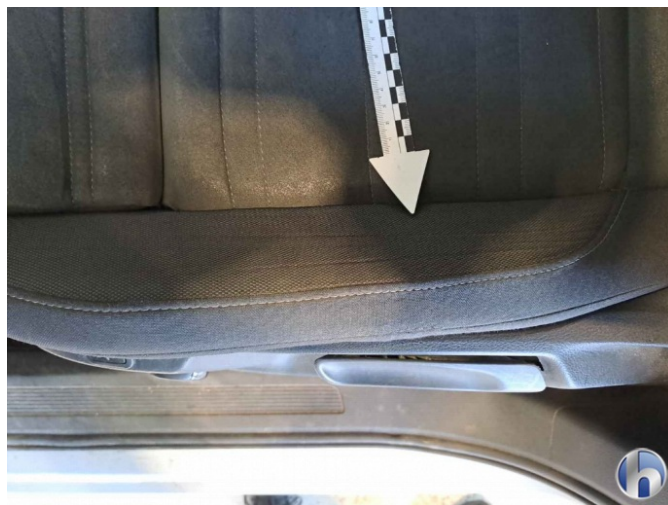
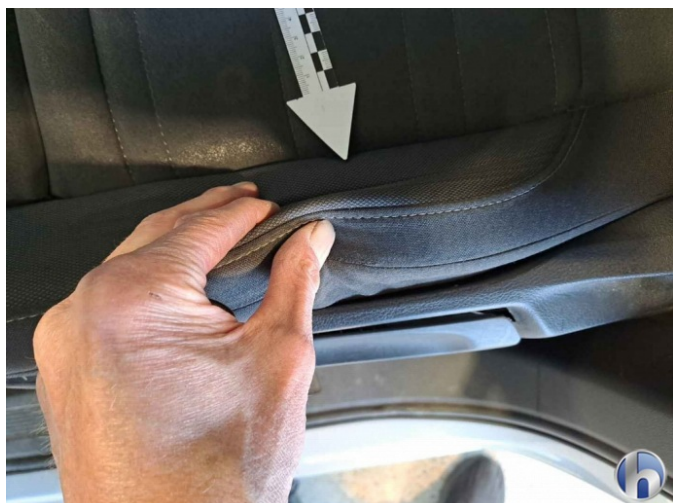
| | component | Damage | Rep kind |
|---|---|---|---|
| 21. | | Damaged | Replace |

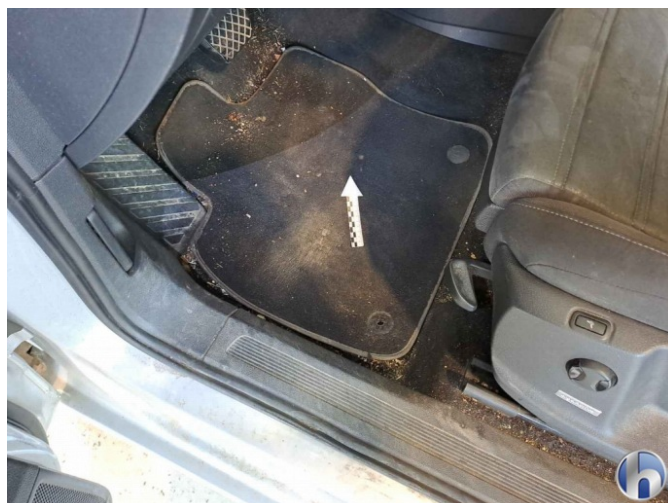
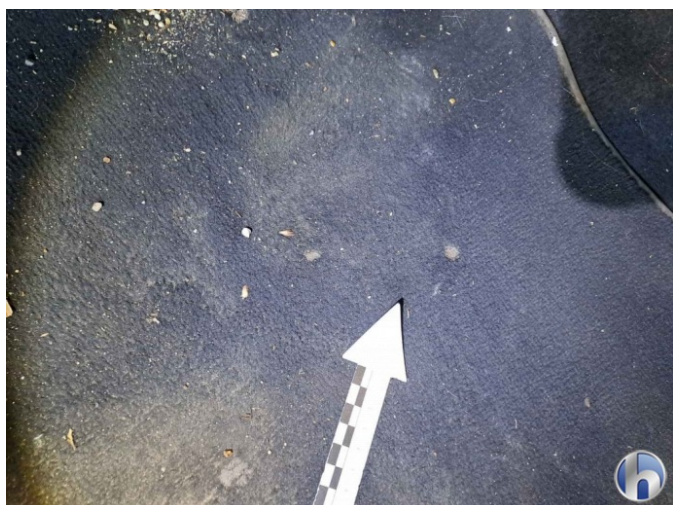
| | component | Damage | Rep kind |
|---|---|---|---|
| 22. | | Burn hole | Replace |

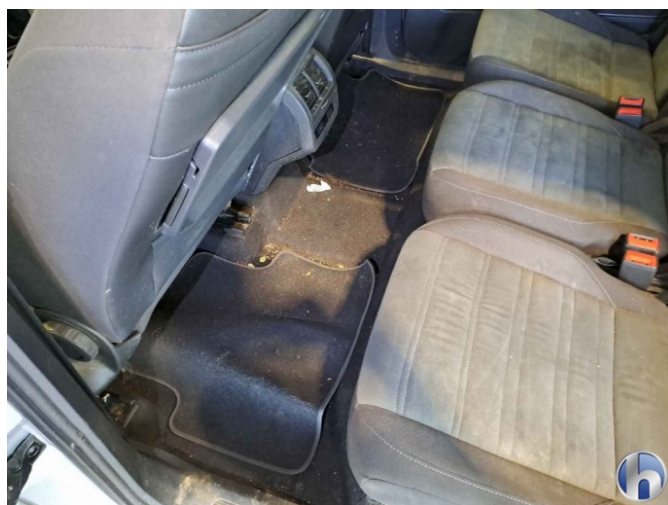
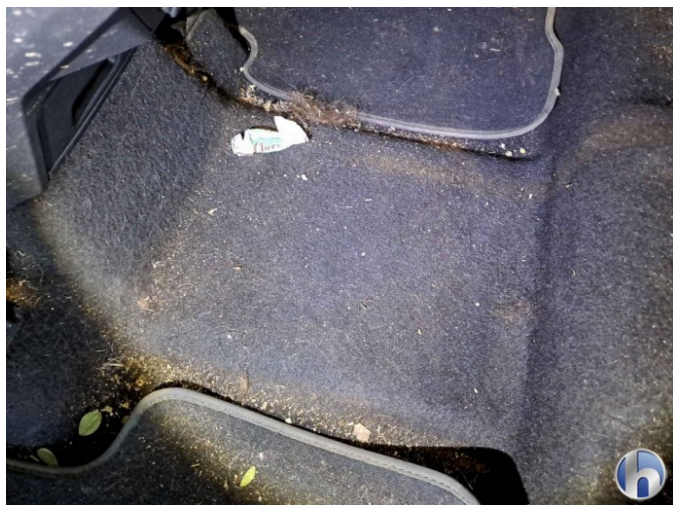
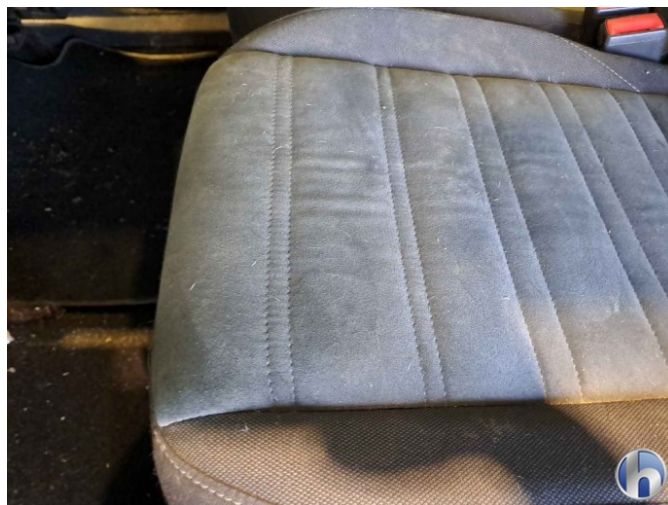
| | component | Damage | Rep kind |
|---|---|---|---|
| 23. | | Dirty (animal hair) | |

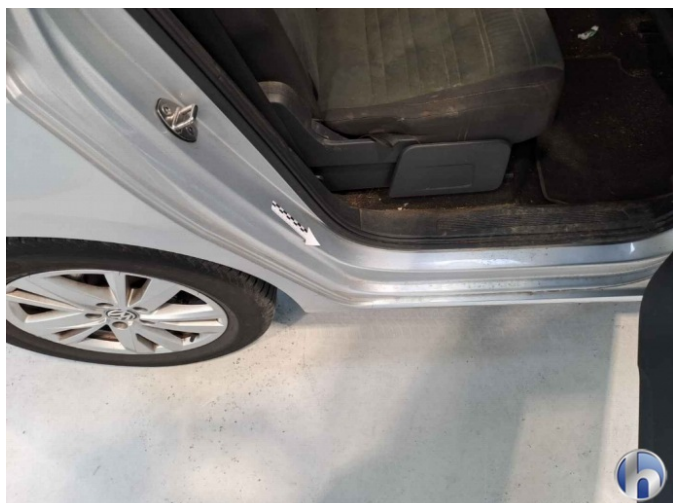
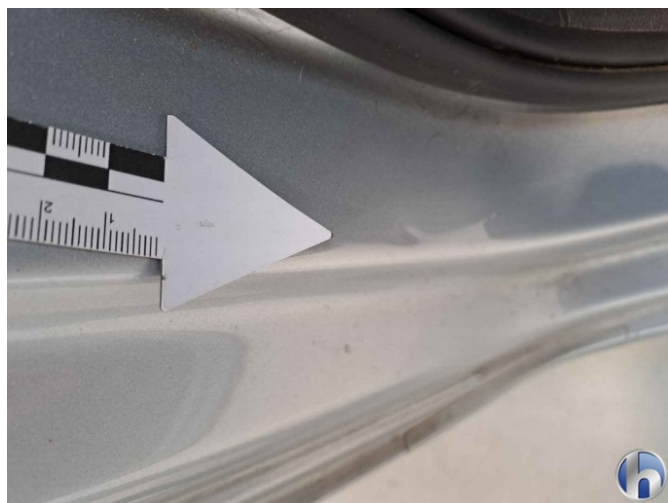
24. Türeinstieg Hinten - Rechts

| | component | Damage | Rep kind |
|---|---|---|---|
| 24. | Türeinstieg Hinten - Rechts | Delle | Smart repair |
