Expertise

Protocol number: 41790553
Order number / reference: 25283029
Inspection date: 1 Oct 2025

Manufacturer: Volkswagen

Model: Touran 1.5 TSI ACT OPF DSG Highline

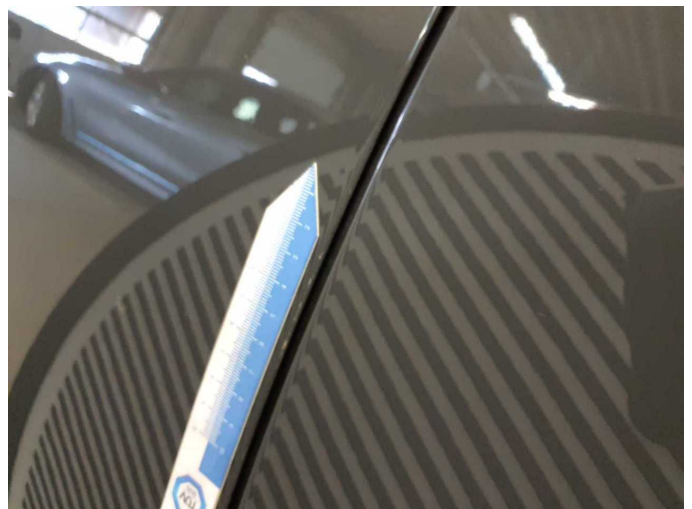
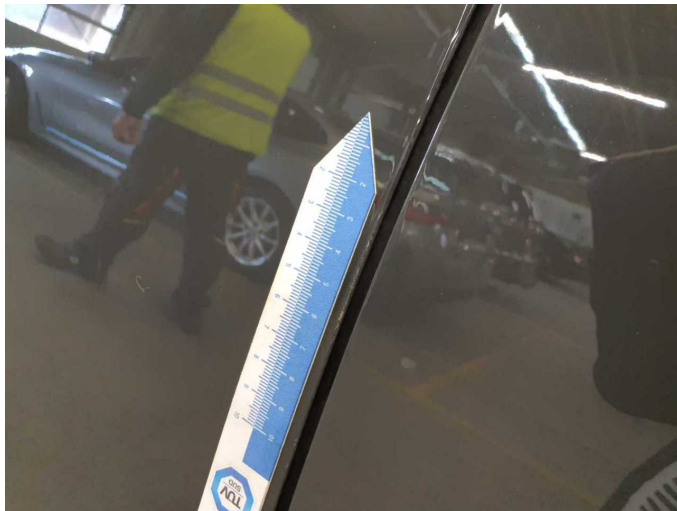
Damage 1: Door - front left side: Door edge - Scratched - Smart repair

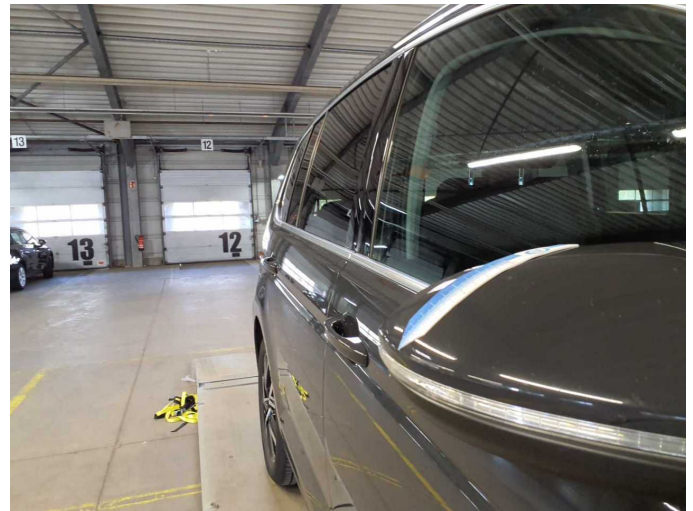
Damage 1: Door - front left side: Door edge - Scratched - Smart repair

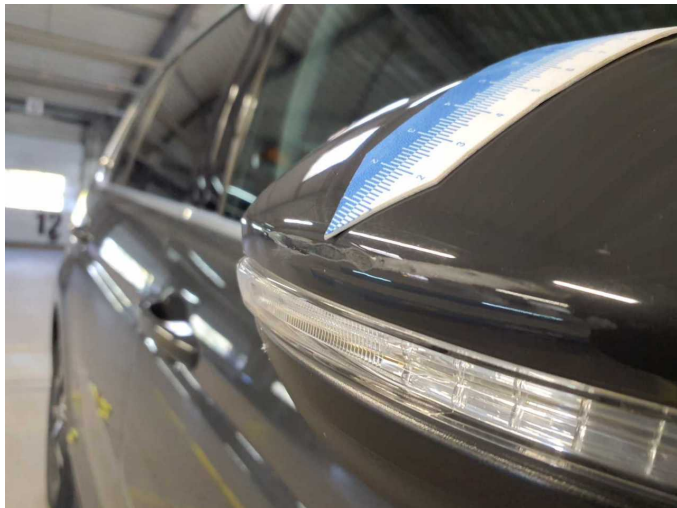
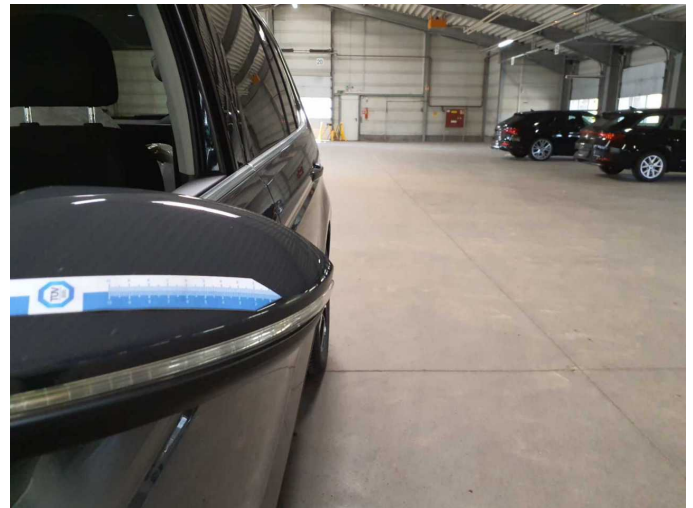
Damage 2: Wing mirror - right side: Cap - Scratched - Paint

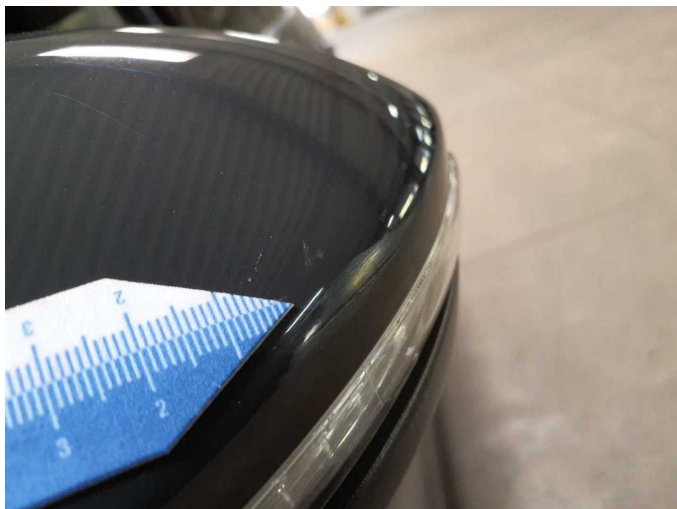
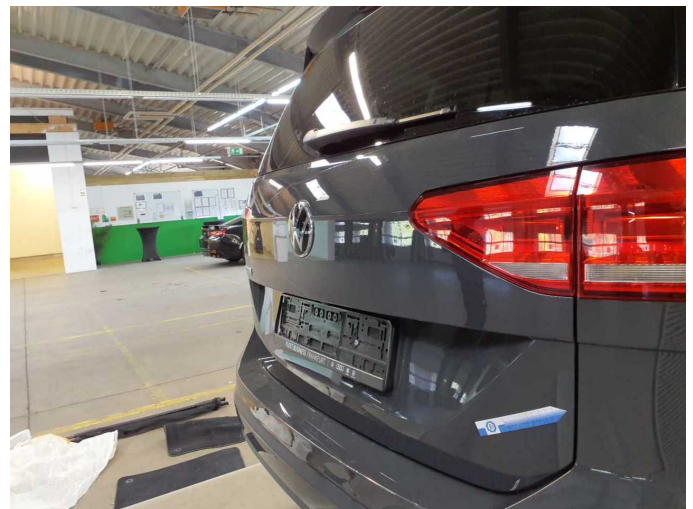
Damage 3: Wing mirror - left side: Cap - Scratched - Paint

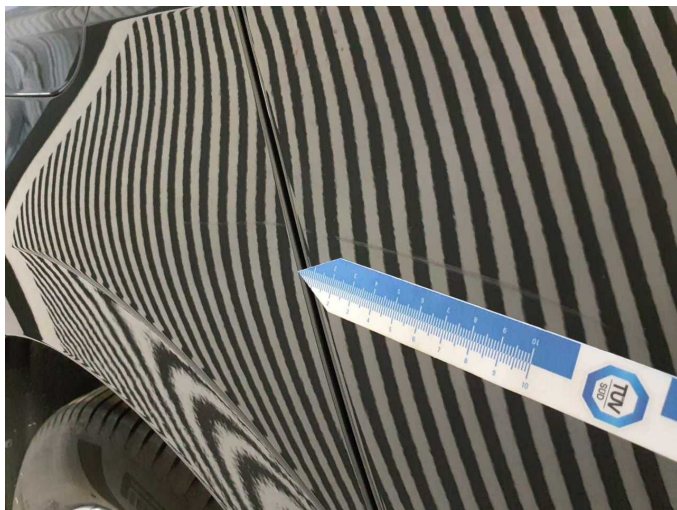
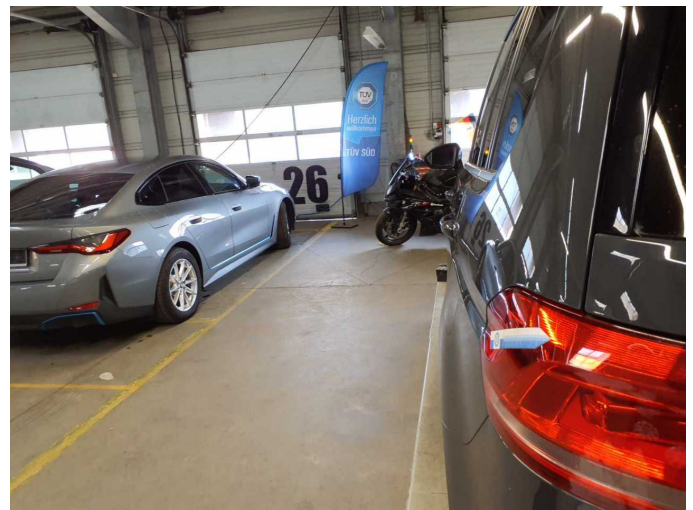
Damage 5: Door - rear right side: Door - Scratched - Smart repair

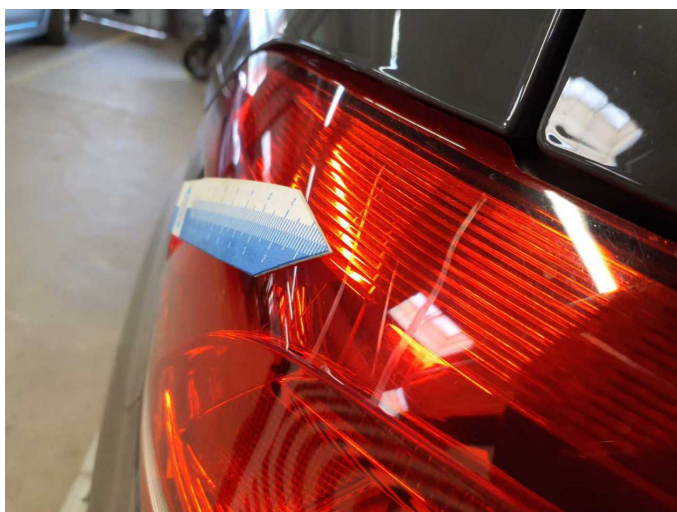
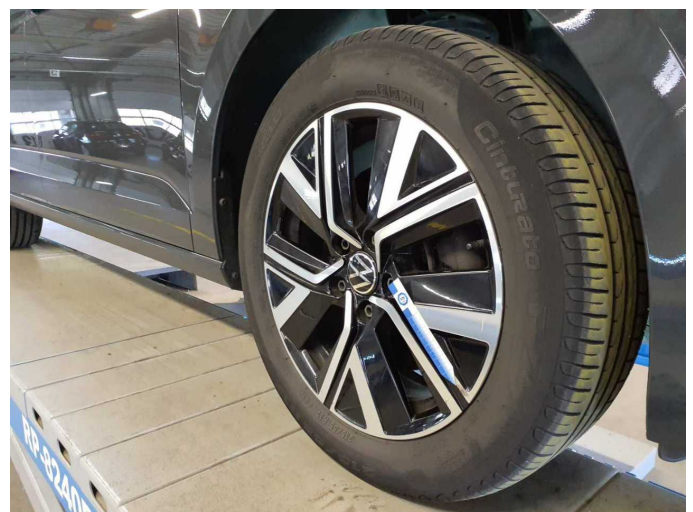
Damage 6: Tail light: Tail lamp - left side - Scratched - Replace

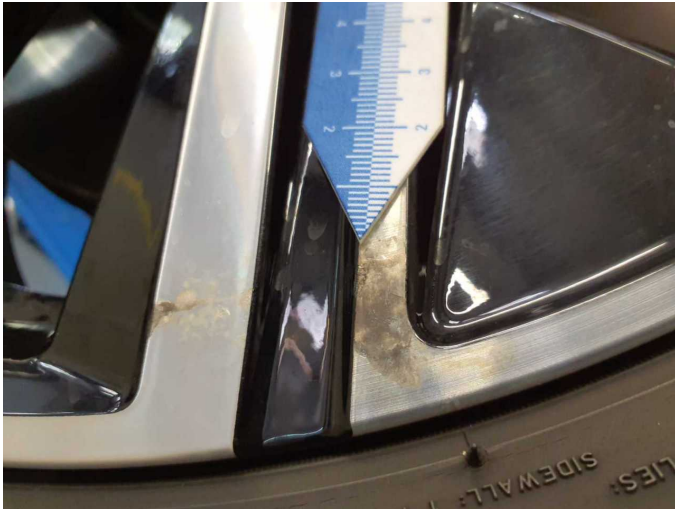
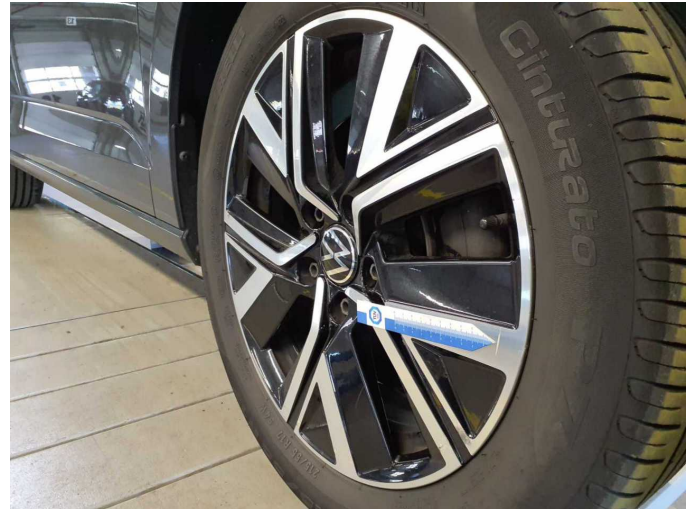
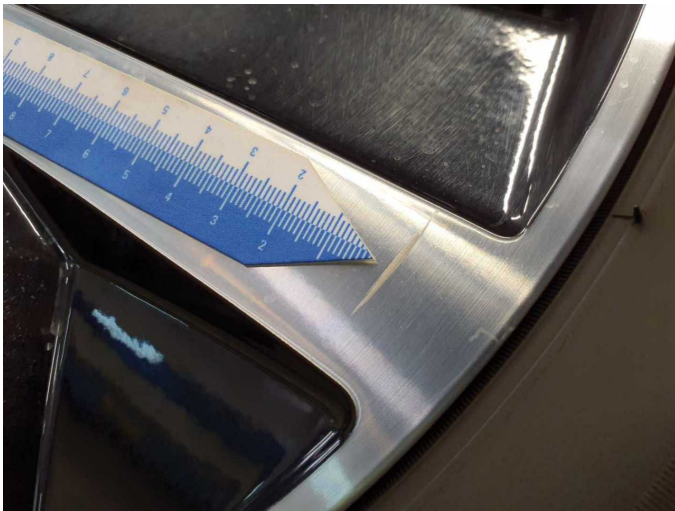
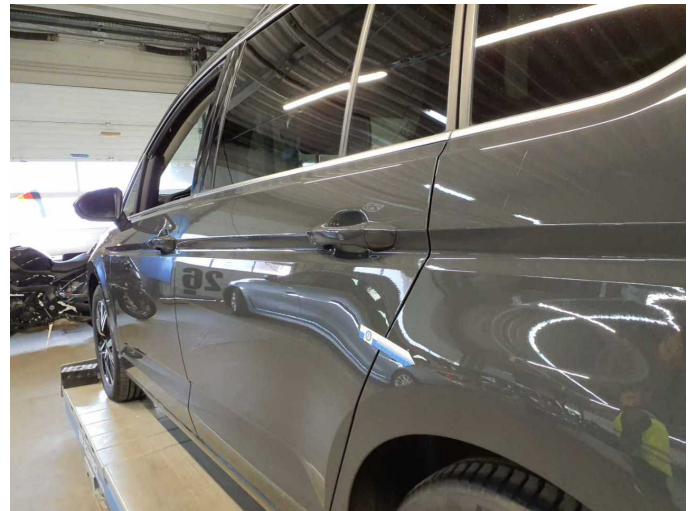
Damage 7: Wheel / tyres: Alloy rim - front right side (Kratzer) - Corrosion - Loss in value

Damage 7: Wheel / tyres: Alloy rim - front right side (Kratzer) - Corrosion
- Loss in value

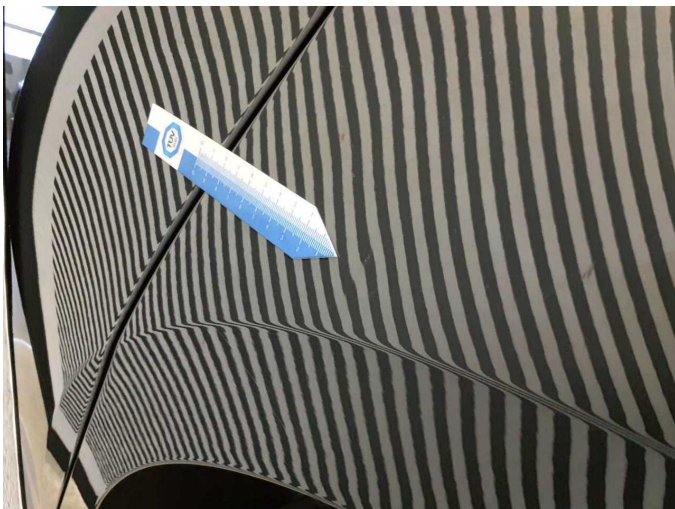
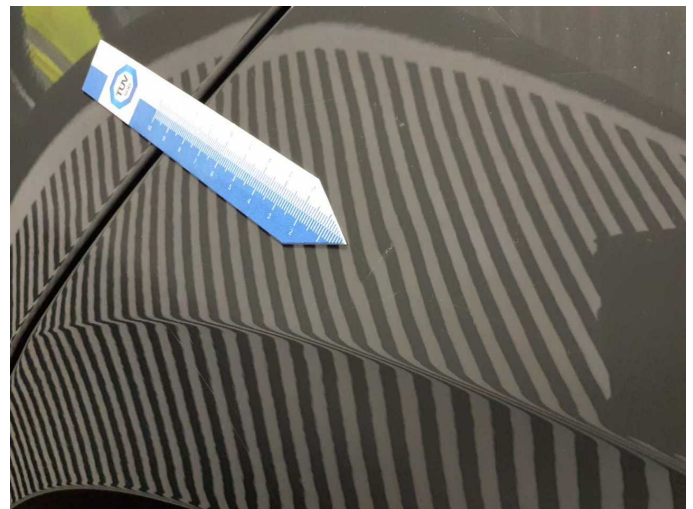
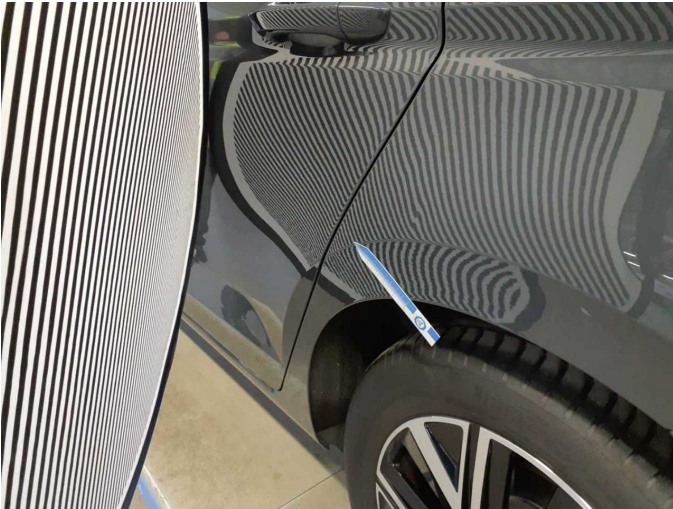
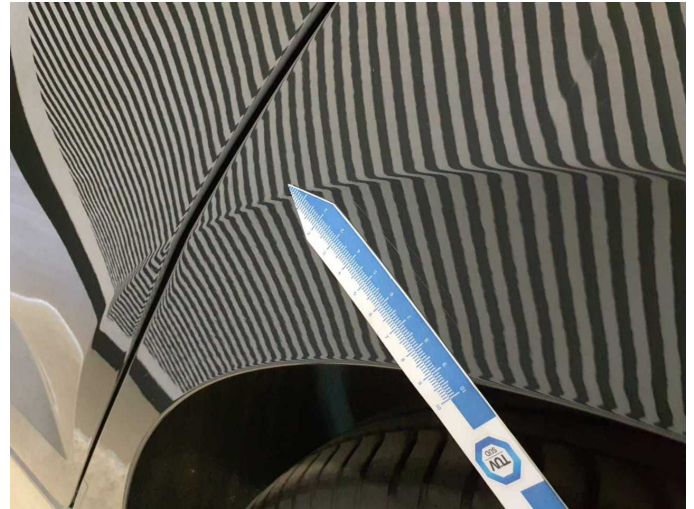
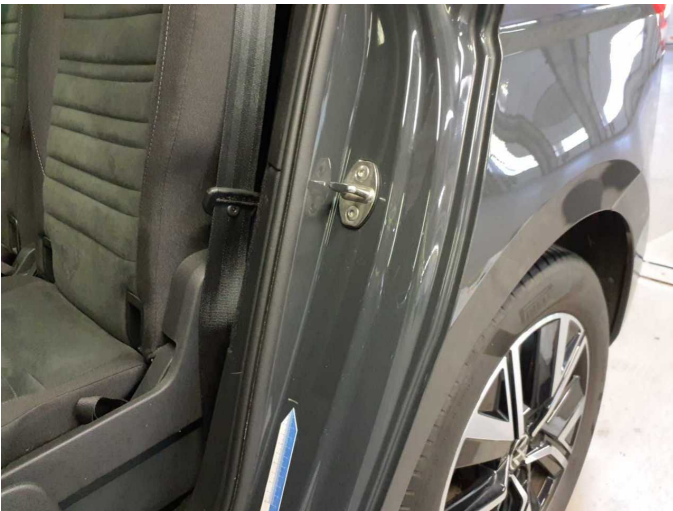
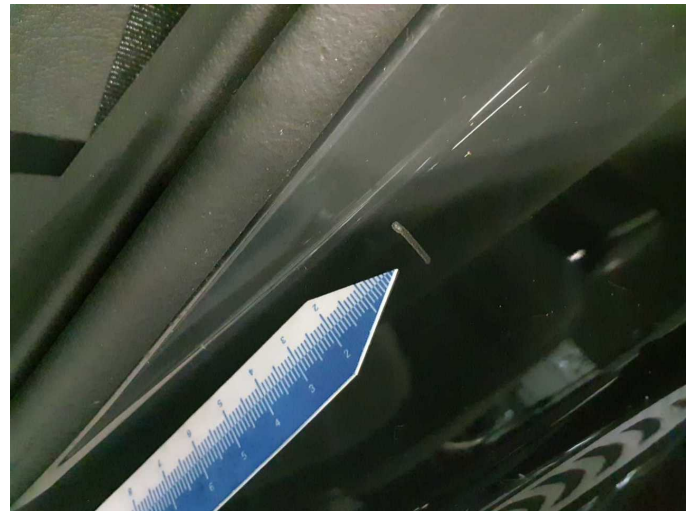
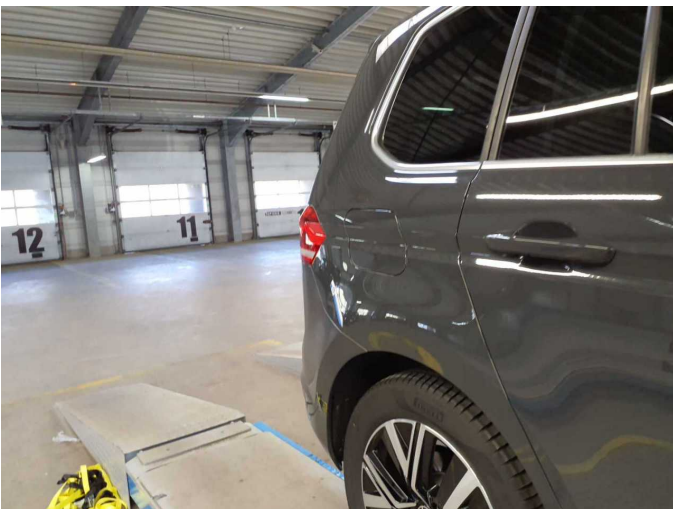
Damage 8: Side panel - rear left side: Side panel (Kratzer) - Dent /
paintcoat damage - Repair and paint

Damage 8: Side panel - rear left side: Side panel (Kratzer) - Dent / paintcoat damage - Repair and paint

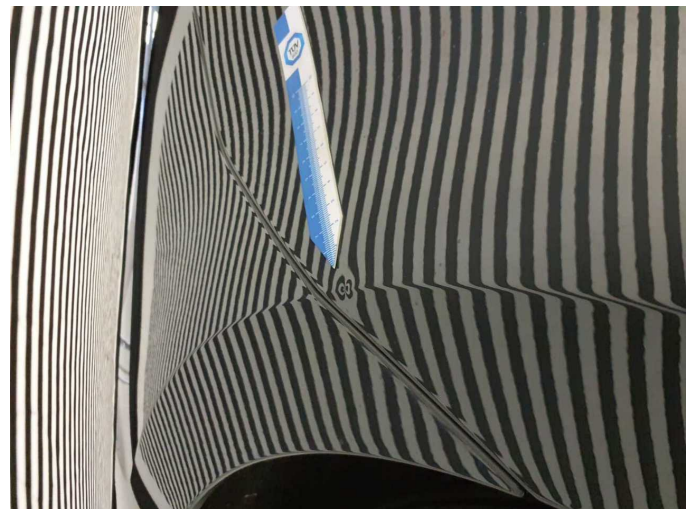
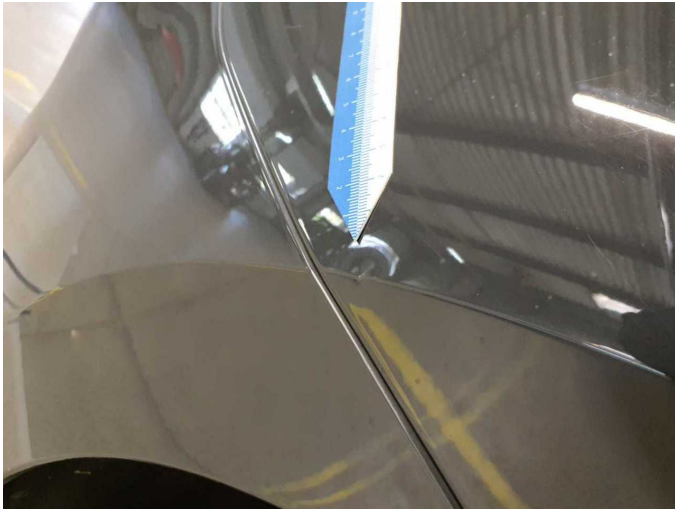
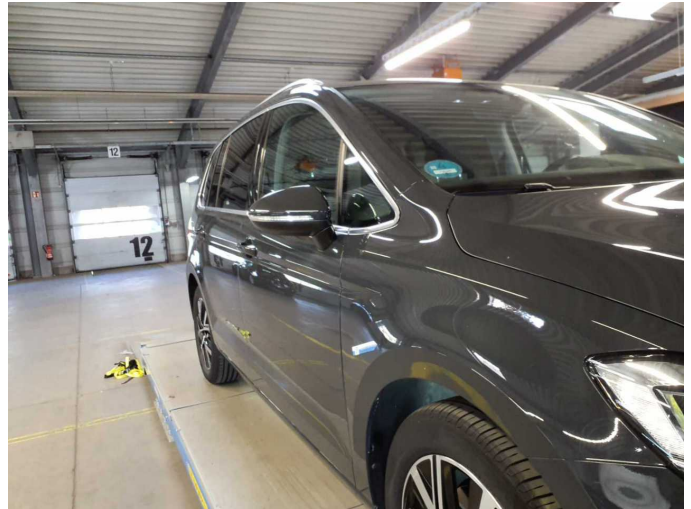
Damage 9: Side panel - rear right side: Side panel - Dent / paintcoat damage - Repair and paint

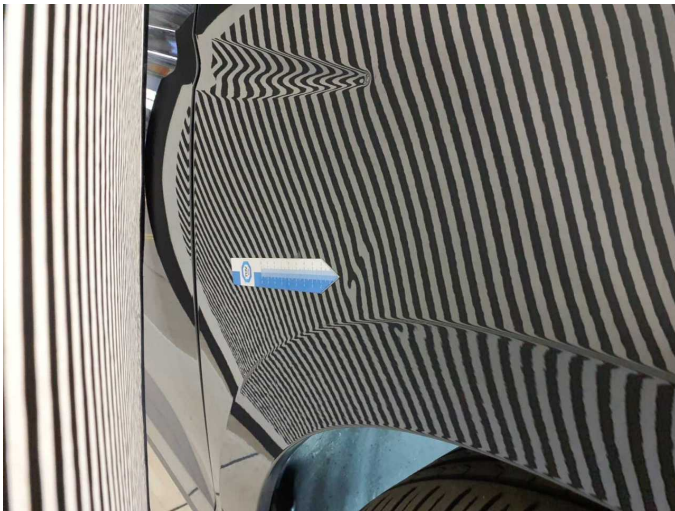
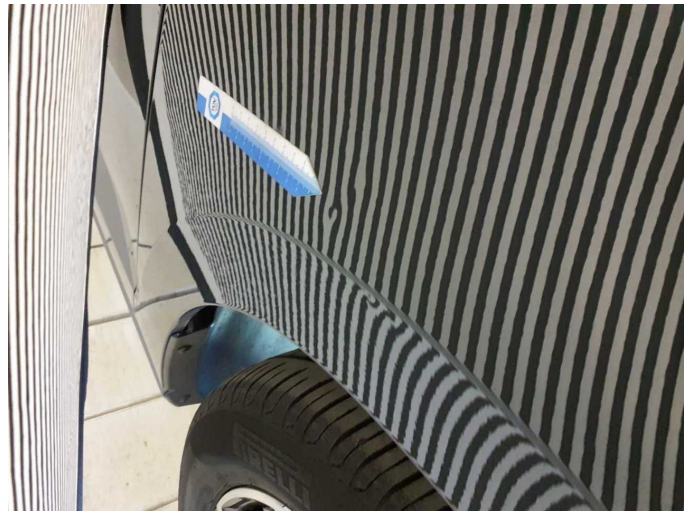
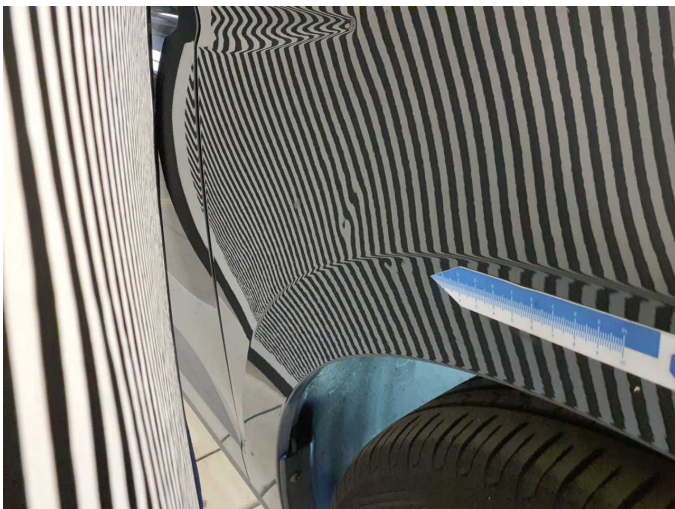
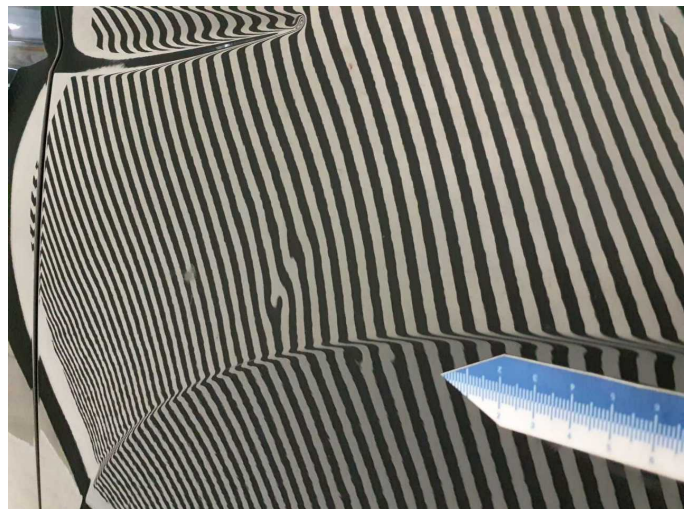
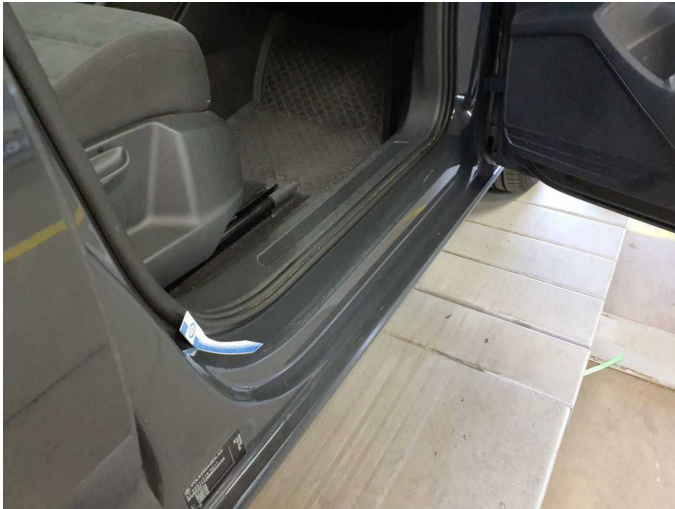
Damage 10: Mudguard - right side: Mudguard - right side - Deformed - Repair and paint

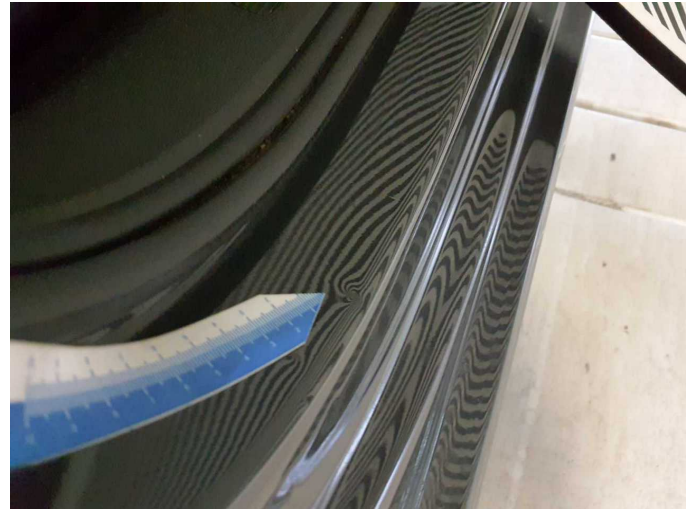
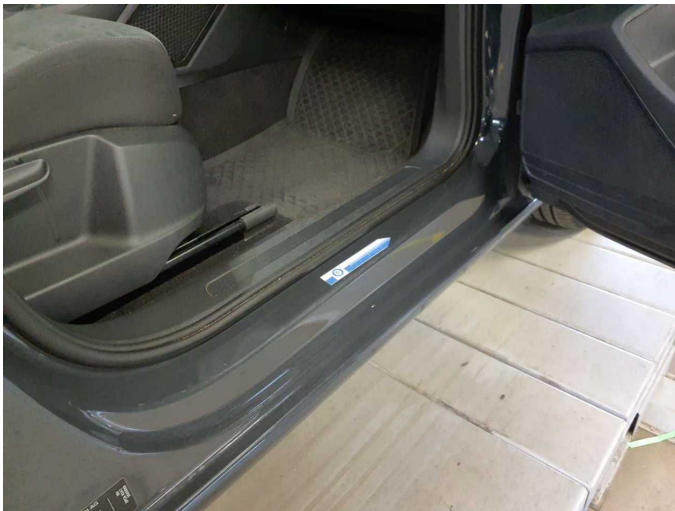
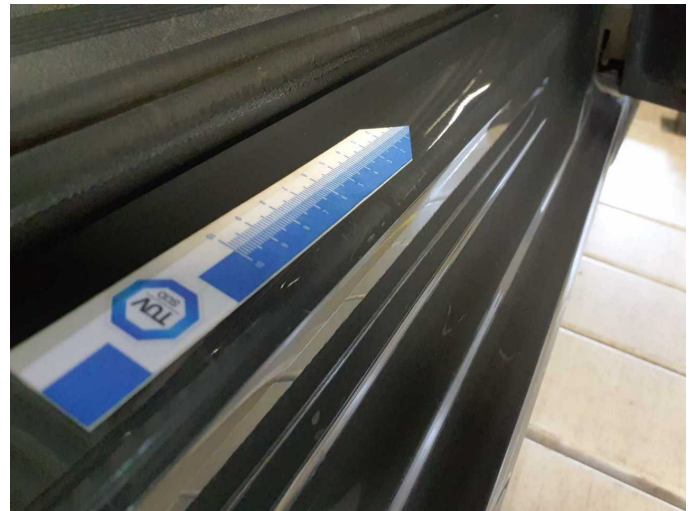
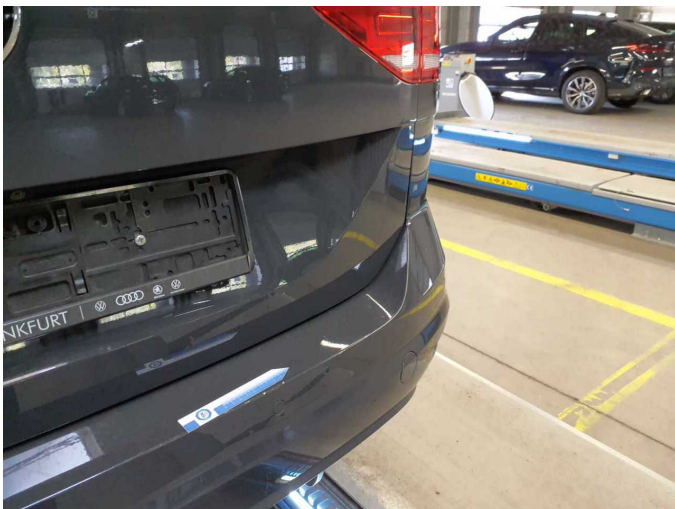
Damage 11: Sill - right side: Sill (Kratzer) - dent(s) - Repair and paint

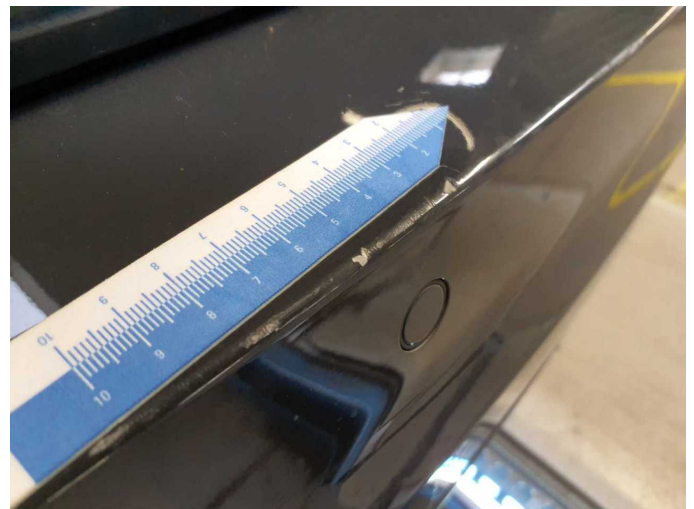
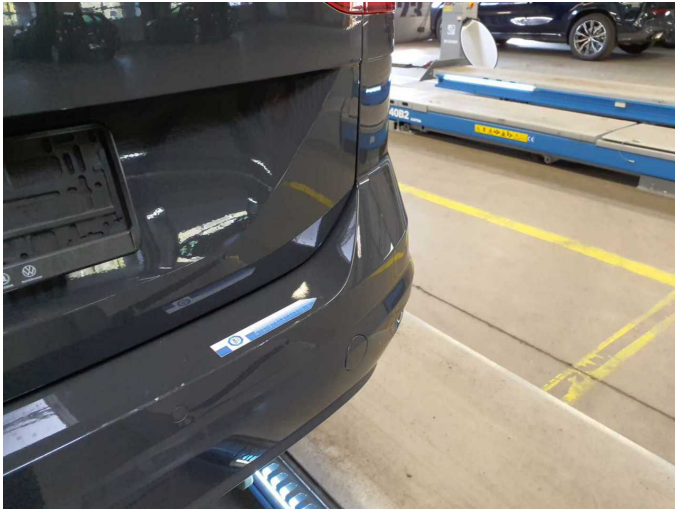
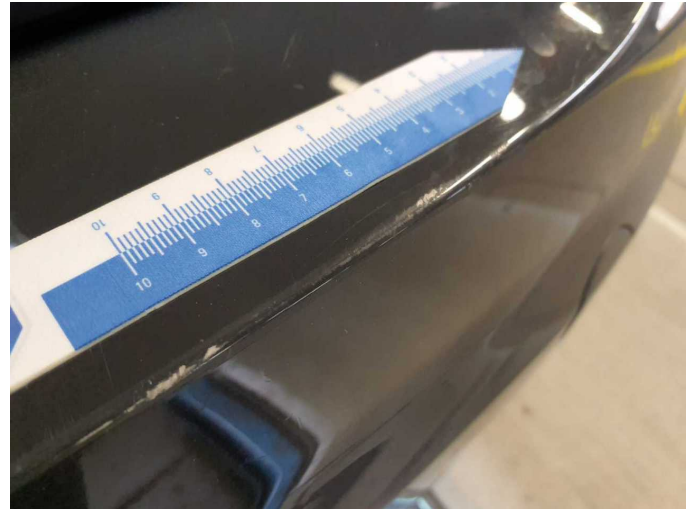
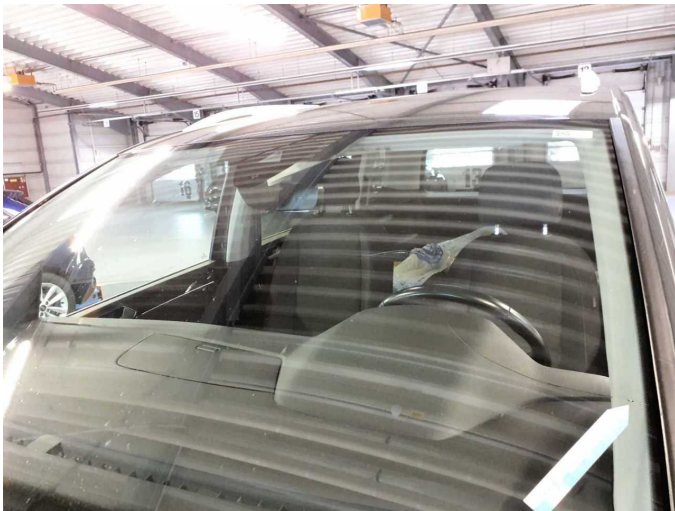
Damage 12: Rear bumper: Rear bumper - Scratched - Paint

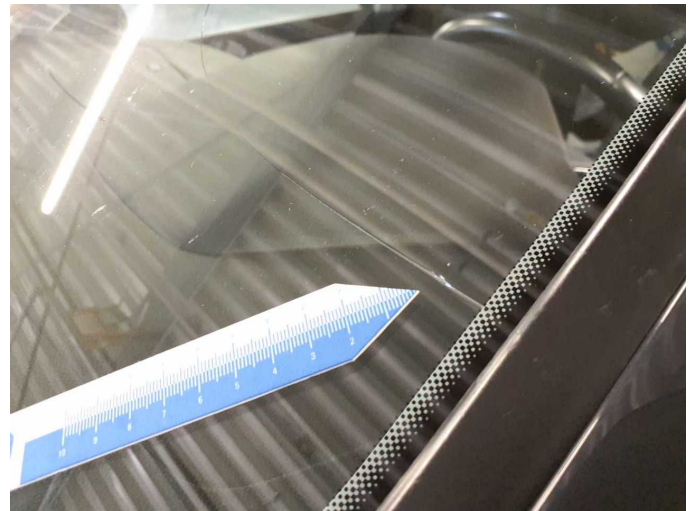
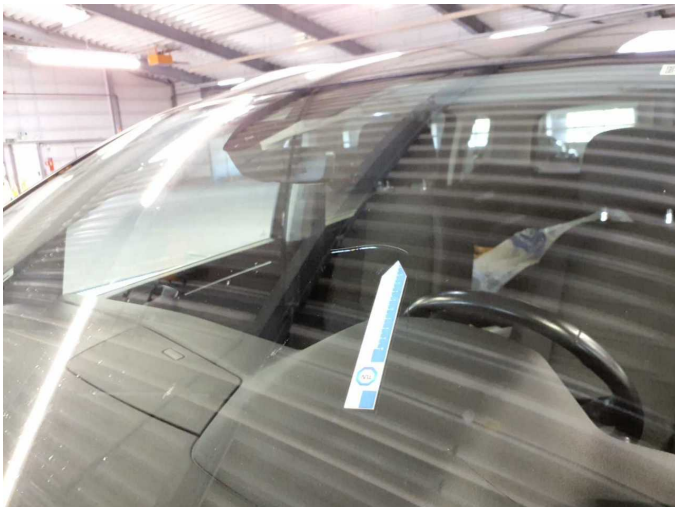
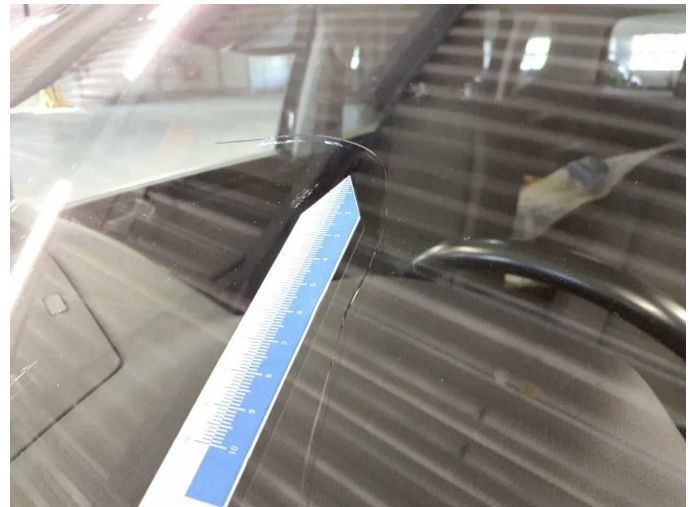
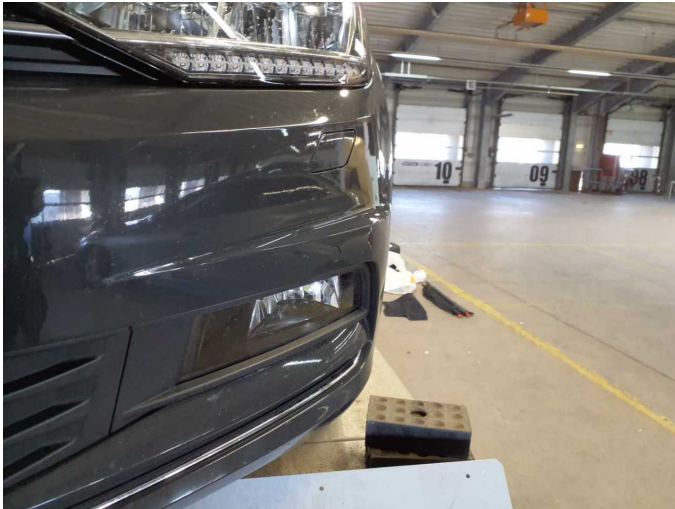
Damage 13: Vehicle glazing: Windscreen - Broken / torn - repair according to calculation

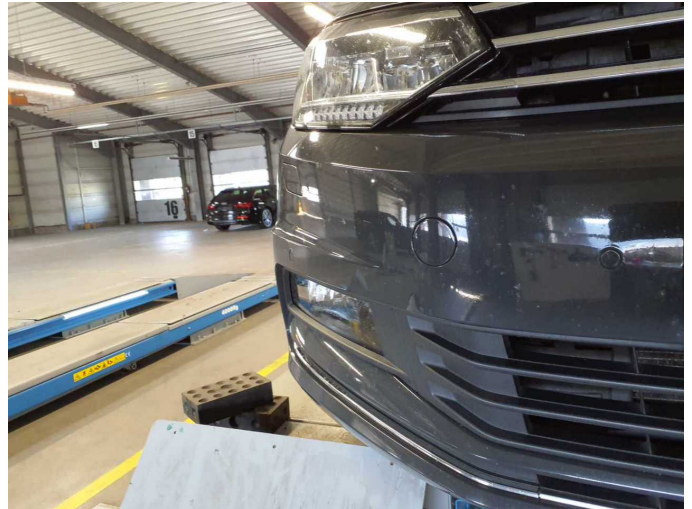
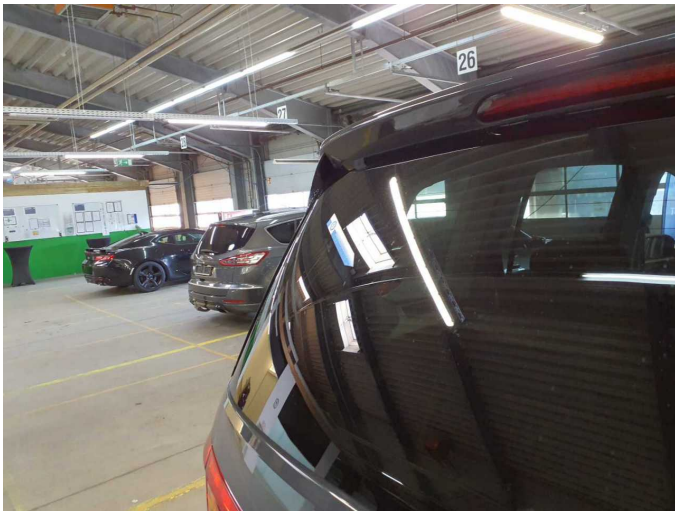
Wear and tear 1: Front bumper: Front bumper (Kratzer) - Stone chips - No deduction

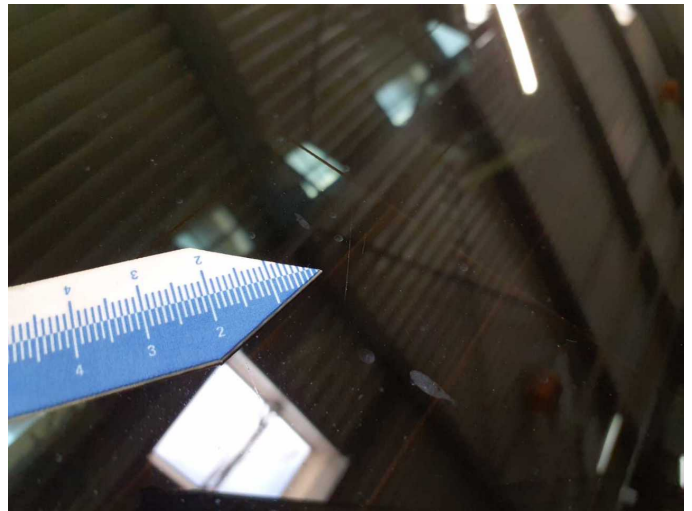
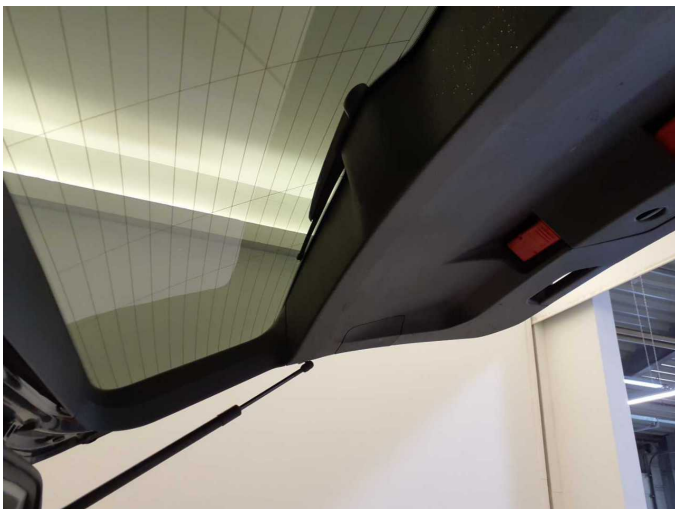
Wear and tear 5: Vehicle glazing: Rear window - Scratch(es) - No deduction

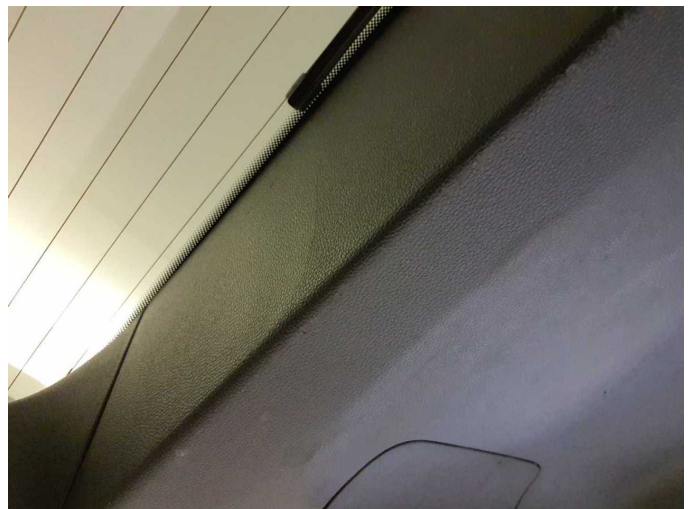
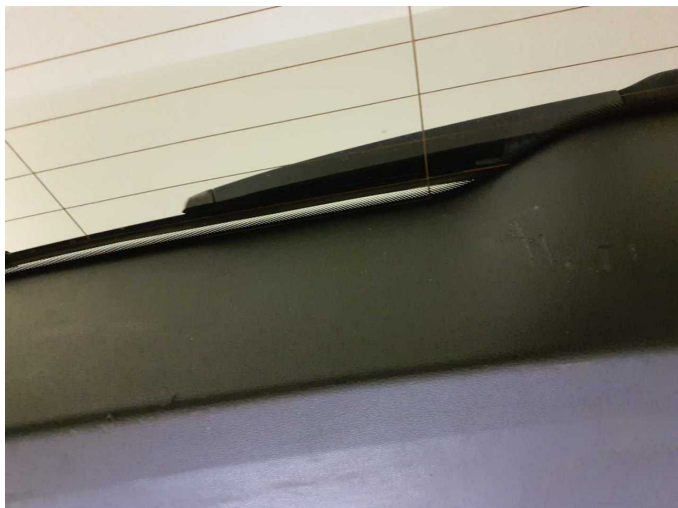
Wear and tear 7: Trim / covers: Boot lid - interior trim - Scratched - No deduction
