Expertise

Protocol number: 41081683  
Order No. / Reference: 25013382  
Inspection date: 11 Aug 2025

Manufacturer: Volkswagen

Model: Touran 2.0 TDI SCR Comfortline

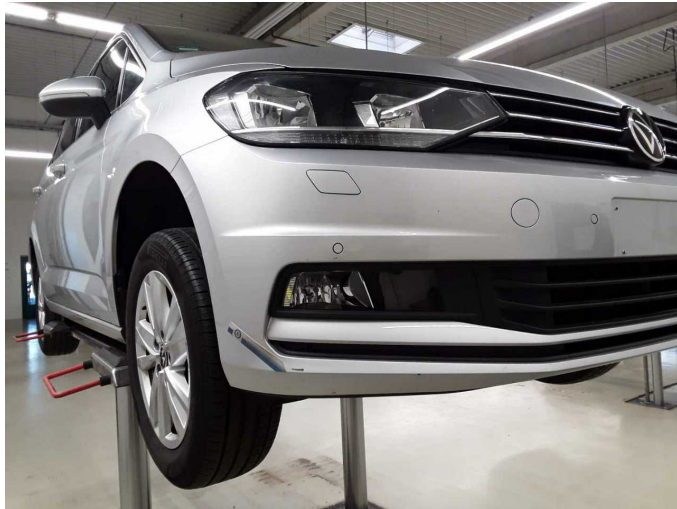
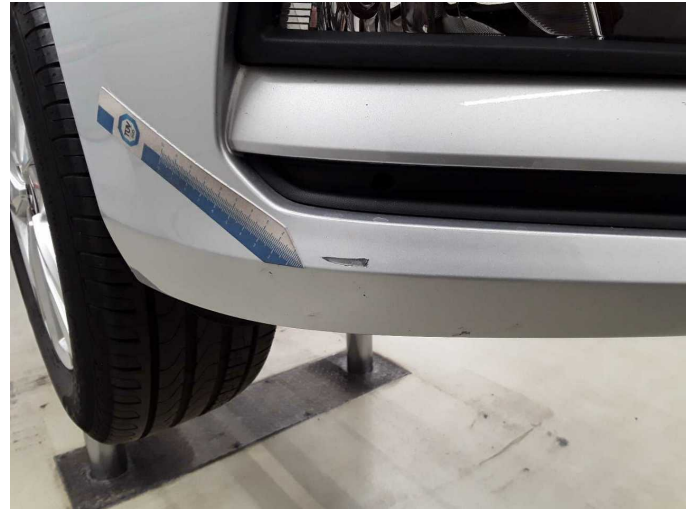
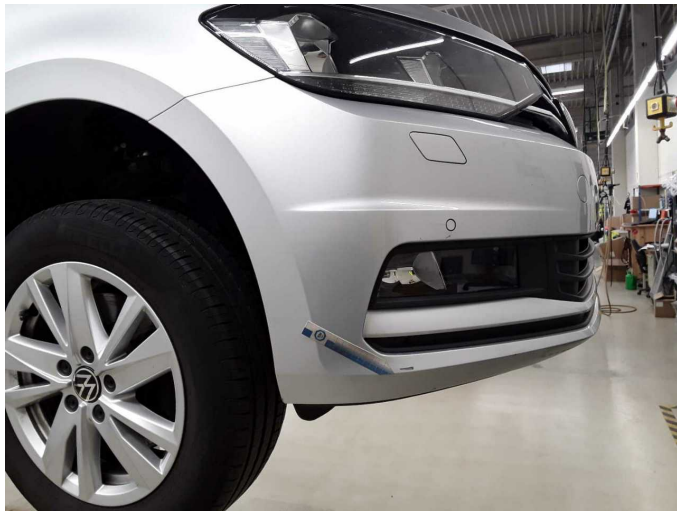
No.	Component group	Description
1	Front bumper	Front bumper - Scratched - Smart repair

**Damage 1:** Front bumper: Front bumper - Scratched - Smart repair

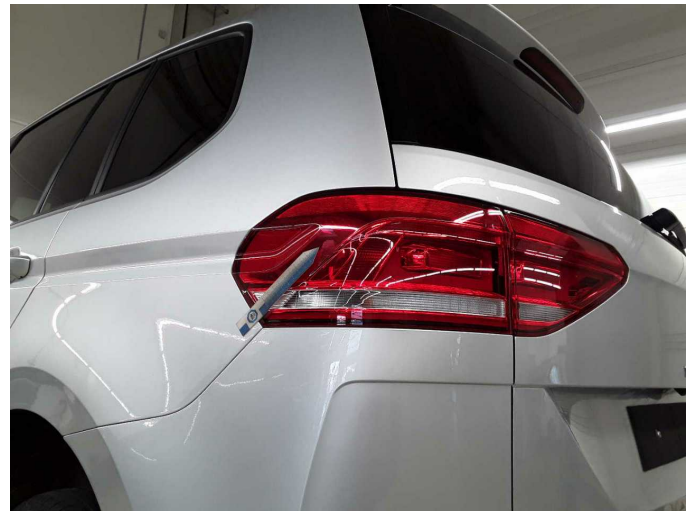
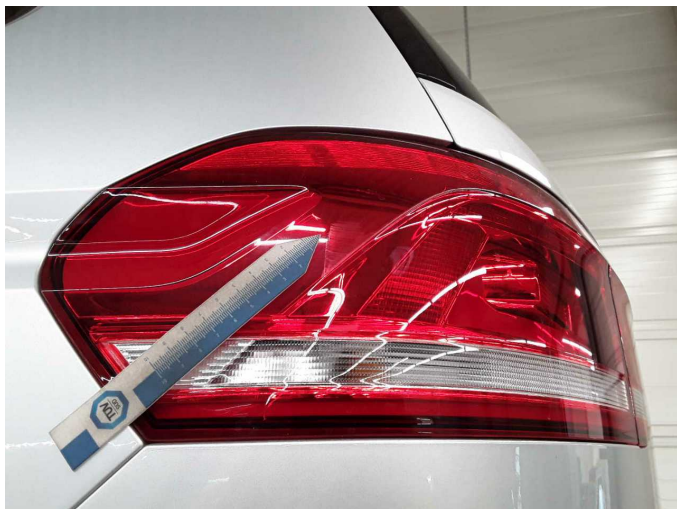
**Wear and tear 1:** Tail light: Tail lamp - left side - Scratch(es) - No deduction

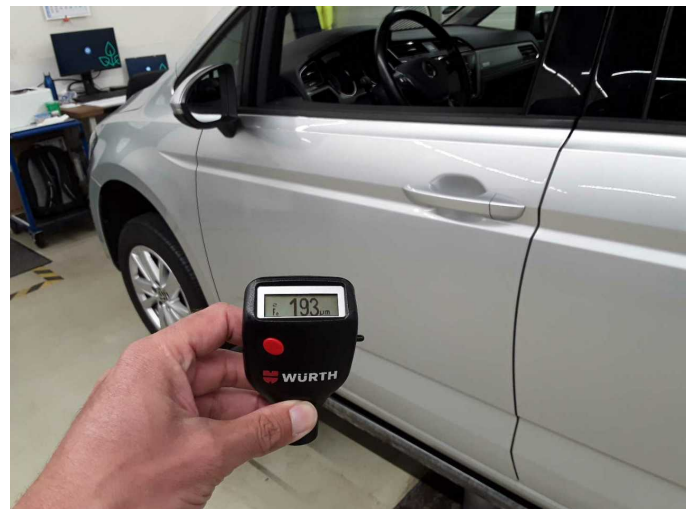
No.	Repainting
1	Door - front left side, Professionally carried out

**Repainting 1:** Door - front left side

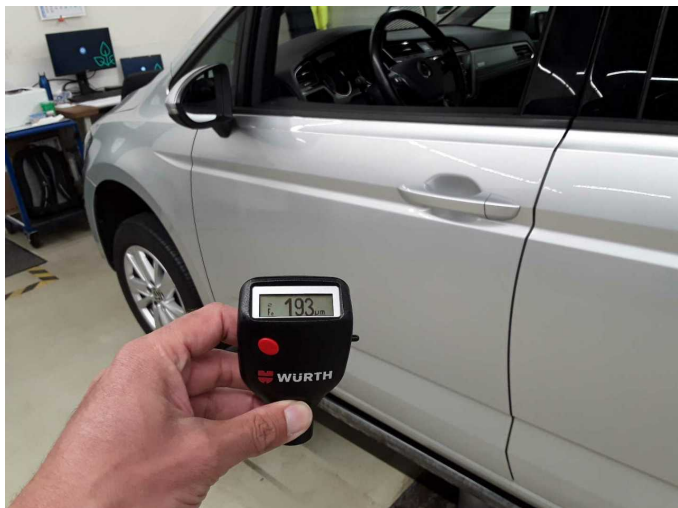
Door - front left side	193 µm
------------------------	--------

**Door - front left side:** 193 µm
