Expertise

Protocol number: 41249974
Order No. / Reference: 25101121
Inspection date: 26 Aug 2025

Model: Touran 2.0 TDI SCR DSG Comfortline

VIN: WVGZZZ1TZNW013719

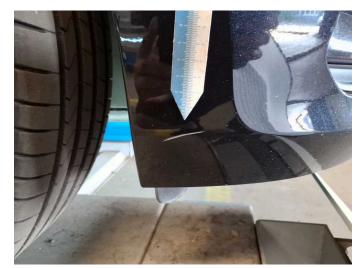
Damage 2: Front bumper: Front bumper - Scratch(es) - Smart repair

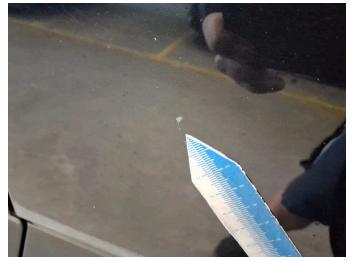
Damage 3: Door - rear left side: Door - Dent / paintcoat damage - Repair and paint

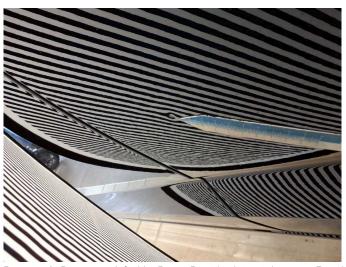
Damage 3: Door - rear left side: Door - Dent / paintcoat damage - Repair and paint

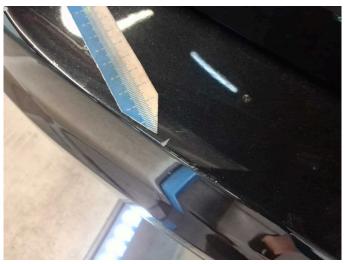
Damage 4: Rear bumper: Rear bumper - Scratch(es) - Paint

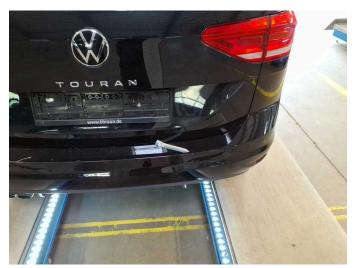
Damage 4: Rear bumper: Rear bumper - Scratch(es) - Paint
