VOLKSWAGEN Tiguan

Tiguan 1.4 TSI BlueMotion Technology

Inspection Report Summary

Customer	BCA Online	Report Number	P20250604081442
Inspection Date / Place	2025-06-04 / BCA Oberndorf	Cosmetic Grade	5

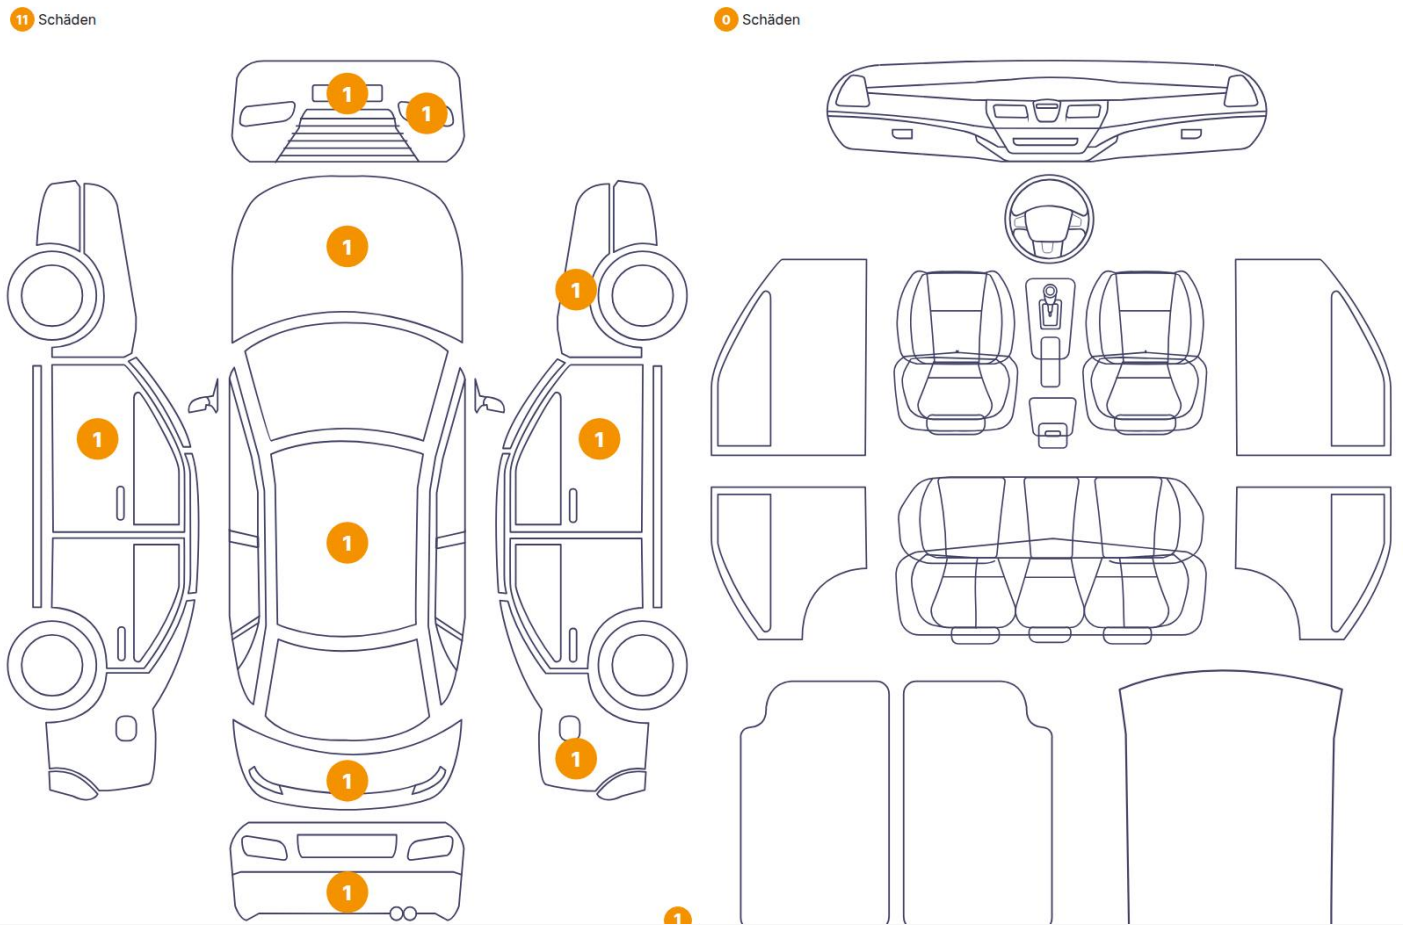
Component		Damage	Comments
1	Fender / Front Right	Bodywork / Dent / Dent	
2	Bumper / Front	Bodywork / Breakage / Crack	
3	Halogen Headlight / Front - Right	Bodywork / Breakage / Crack	
4	Other	Anomalyon Element	
5	Hood	Paint / Scratch / Scuff	
6	Roof	Paint / Scratch / Scuff	
7	Mirror / Front Left	Paint / Scratch / Scuff	
8	Bumper / Back	Bodywork / Breakage / Crack	
9	Rear Trunk	Bodywork / Dent / Dent	
10	Side Panel / Back Right	Paint / Scratch / Line	
11	Door / Front Right	Bodywork / Dent / Dent

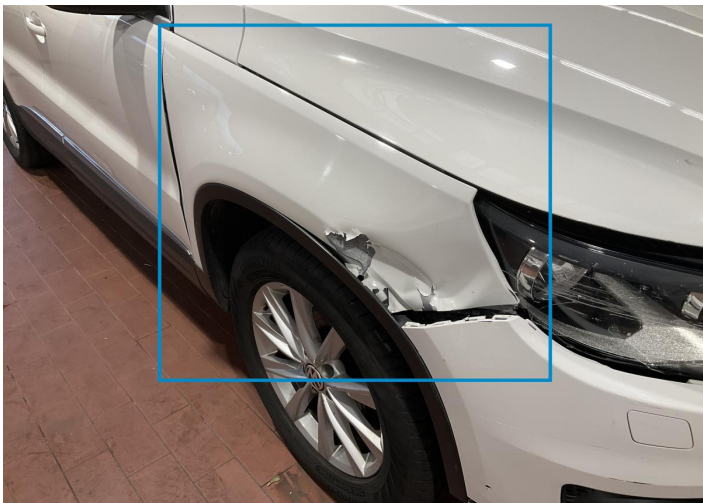
1. Fender / Front Right
Bodywork / Dent / Dent -

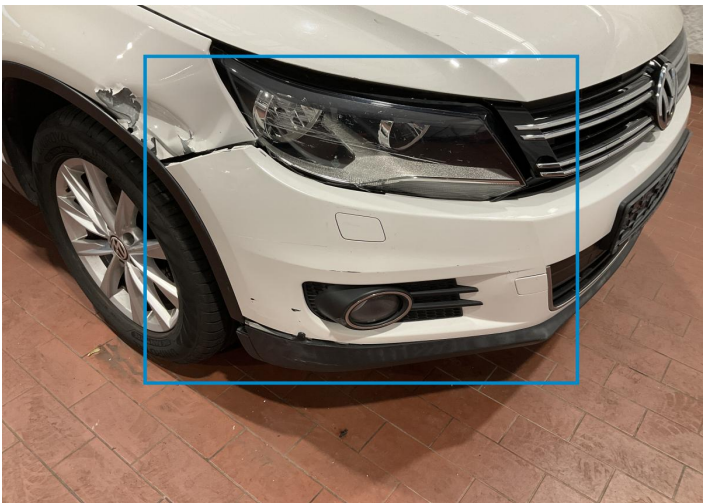
2. Bumper / Front
Bodywork / Breakage / Crack -

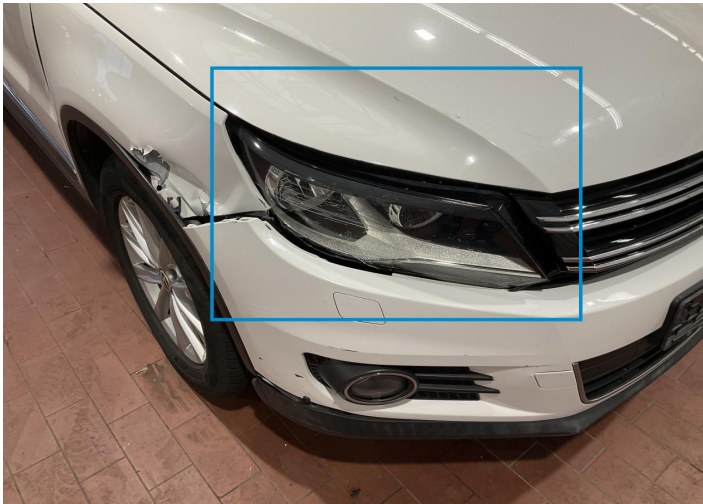
3. Halogen Headlight / Front - Right
Bodywork / Breakage / Crack -

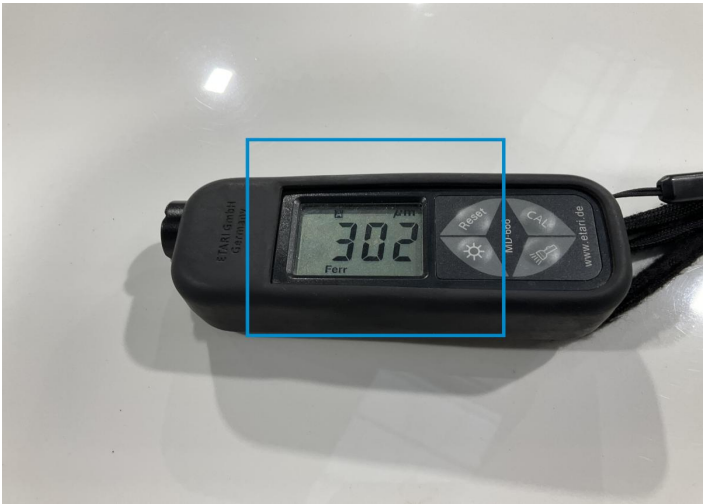
4.
Anomaly Element -

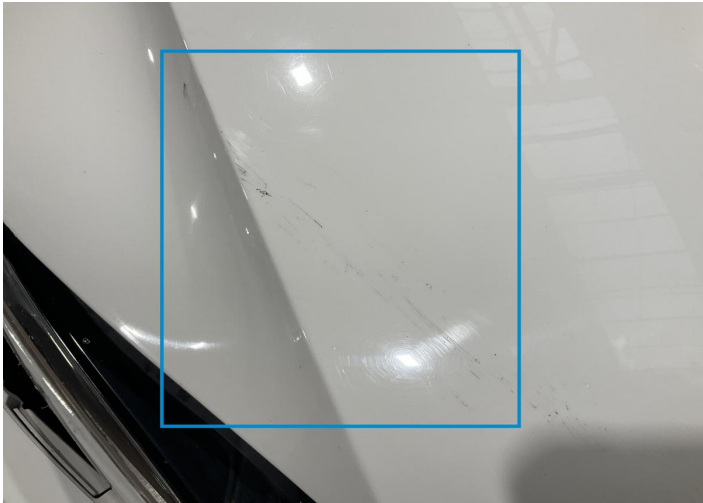
5. Hood
Paint / Scratch / Scuff -

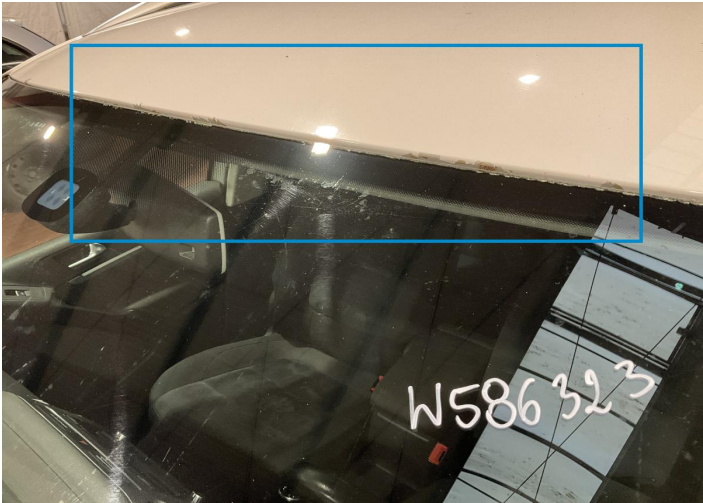
6. Roof
Paint / Scratch / Scuff -

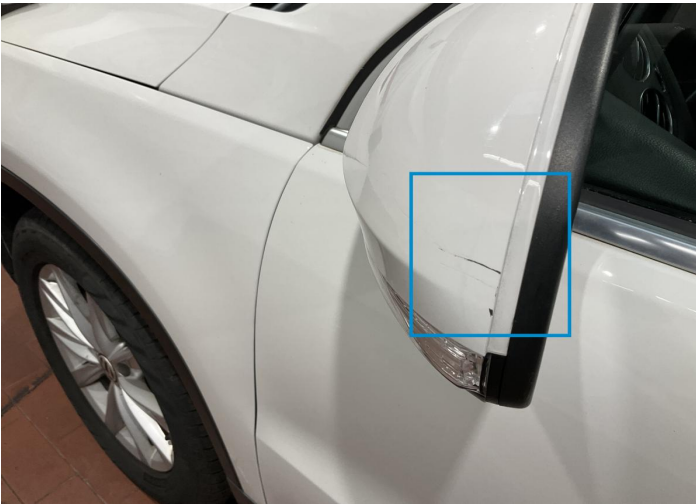
7. Mirror / Front Left
Paint / Scratch / Scuff -

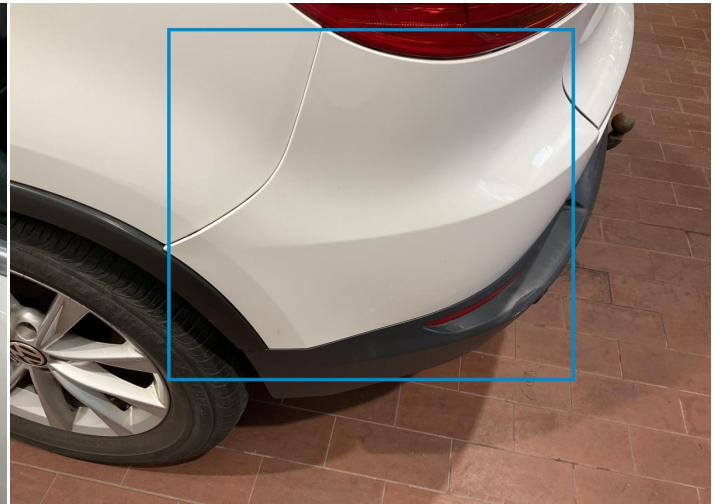
8. Bumper / Back
Bodywork / Breakage / Crack -

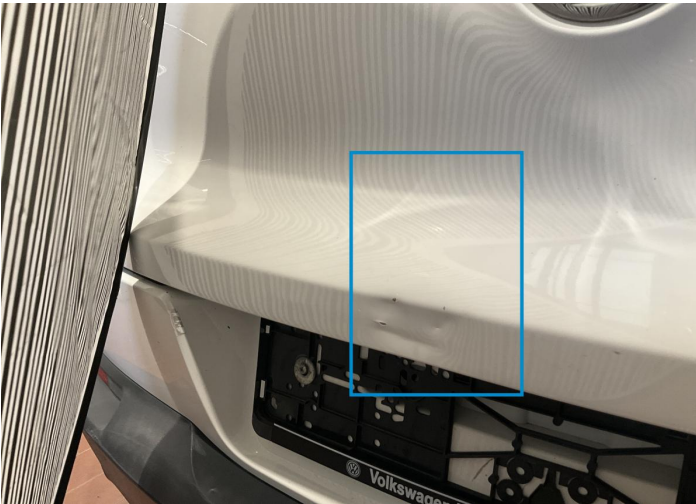
9. Rear Trunk
Bodywork / Dent / Dent -

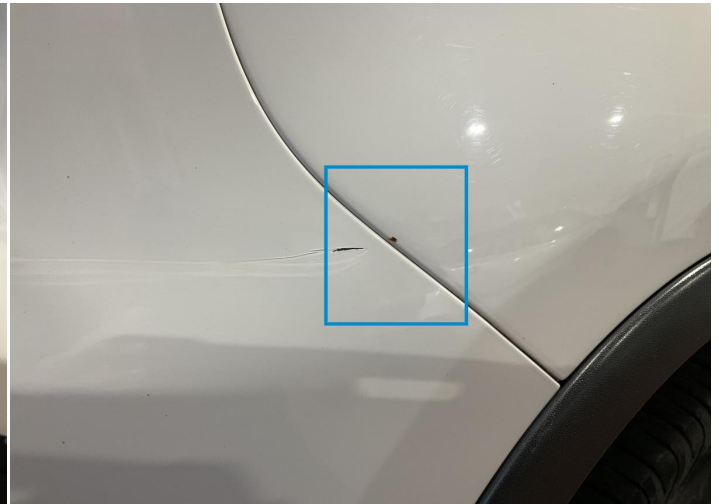
10. Side Panel / Back Right
Paint / Scratch / Line -

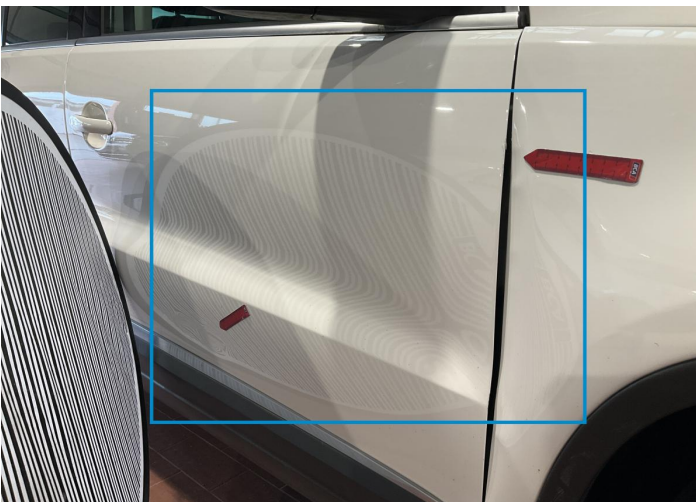
11. Door / Front Right
Bodywork / Dent / Dent -
