Expertise

Protocol number: 39741604  
Order No. / Reference: 24686615  
Inspection date: 15 May 2025

Manufacturer: Volkswagen	Model: Tiguan Allspace 2.0 TDI SCR 4Motion DSG Comfortline
VIN: WVGZZZ5NZMM146255

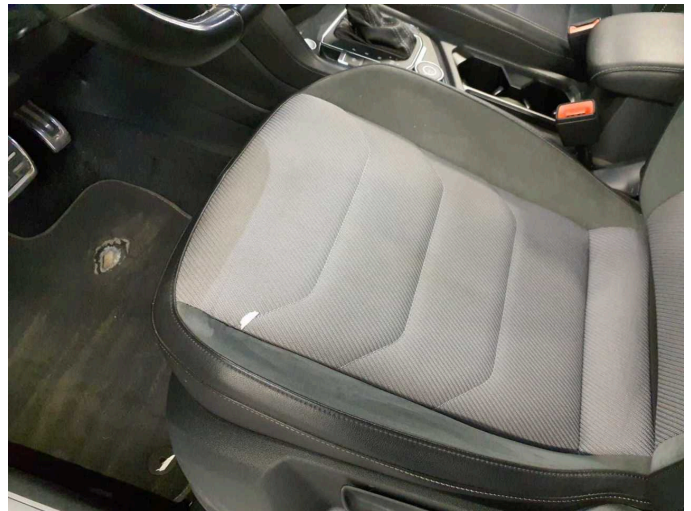
Damage 1: Seat - front: Seat cover - left side - Soiled - Clean

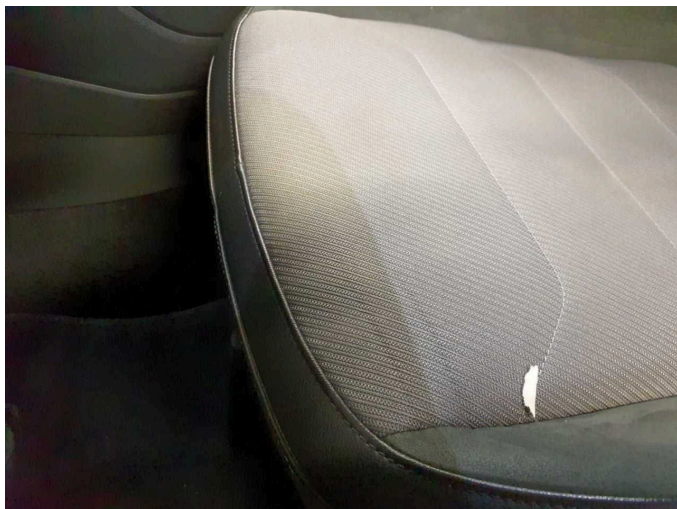
Damage 1: Seat - front: Seat cover - left side - Soiled - Clean

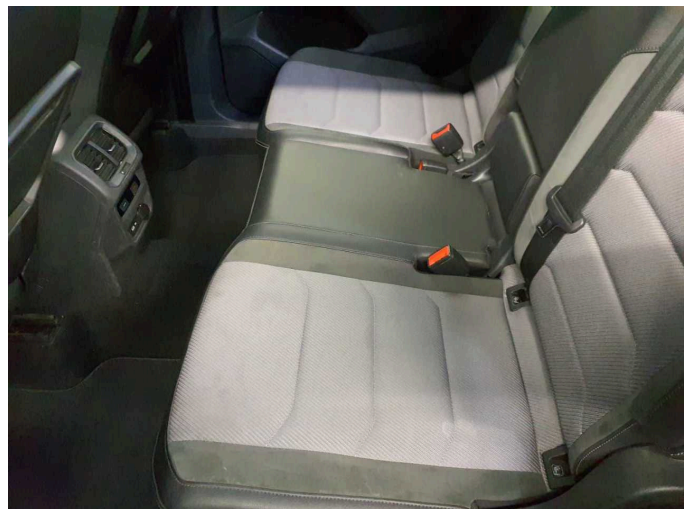
Damage 2: Seat - rear: Back seat - Soiled - Clean

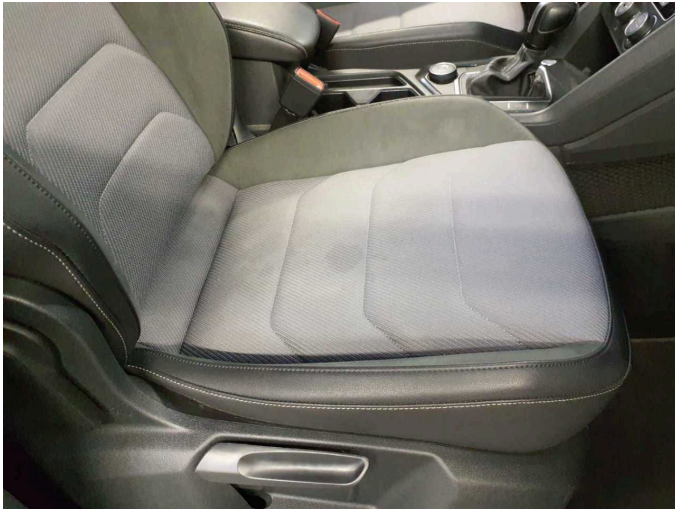
**Damage 3:** Seat - front: Seat cover - right side - Soiled - Clean

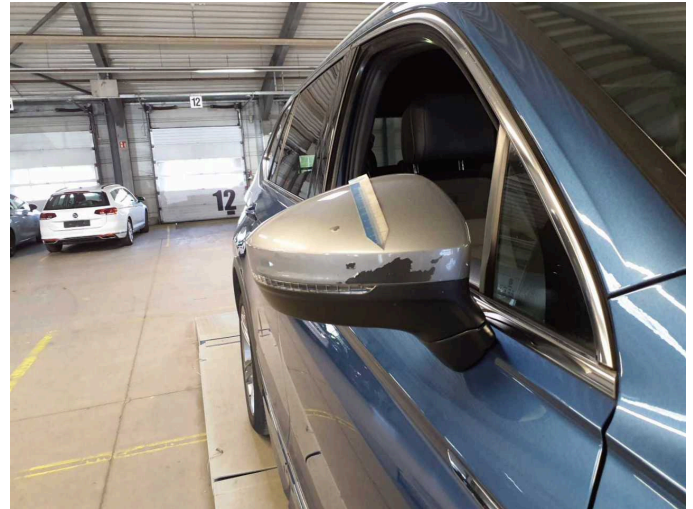
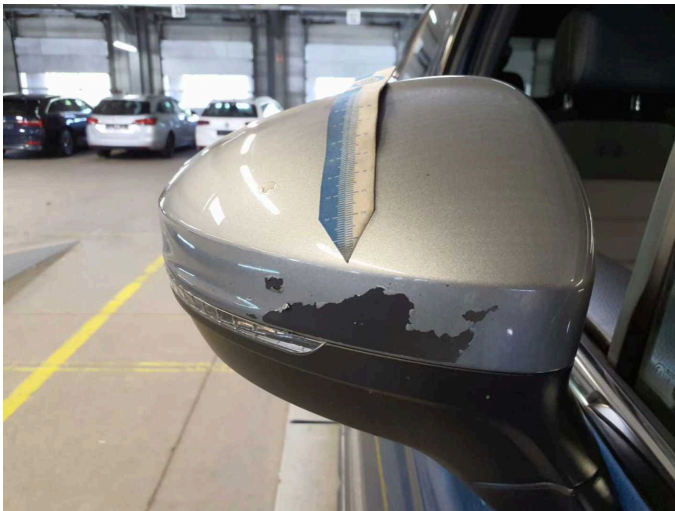
**Damage 4:** Wing mirror - right side: Cap - Scratched - Paint

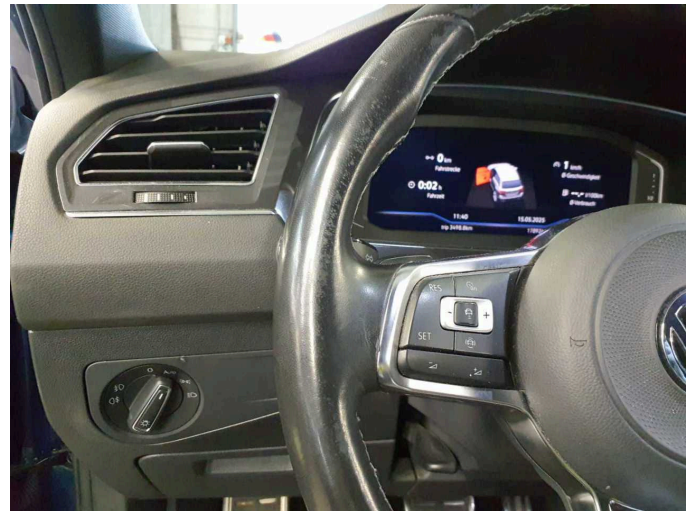
**Damage 5:** Steering system: Steering wheel - Scratched - Smart repair

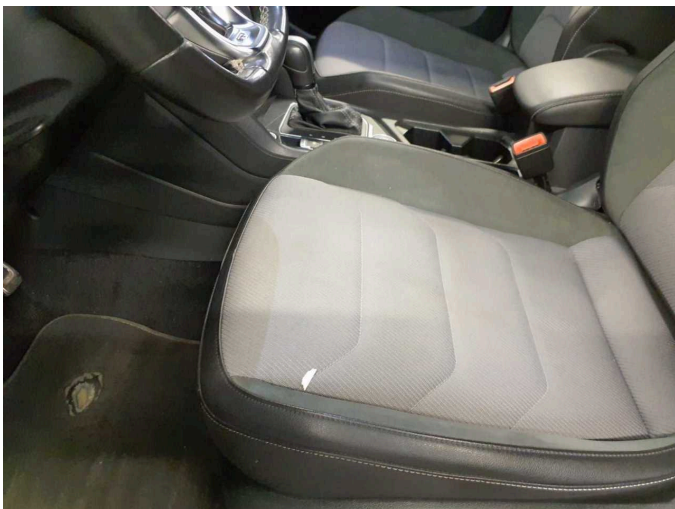
**Damage 6:** Interior: Interior - Odour - Ozone treatment

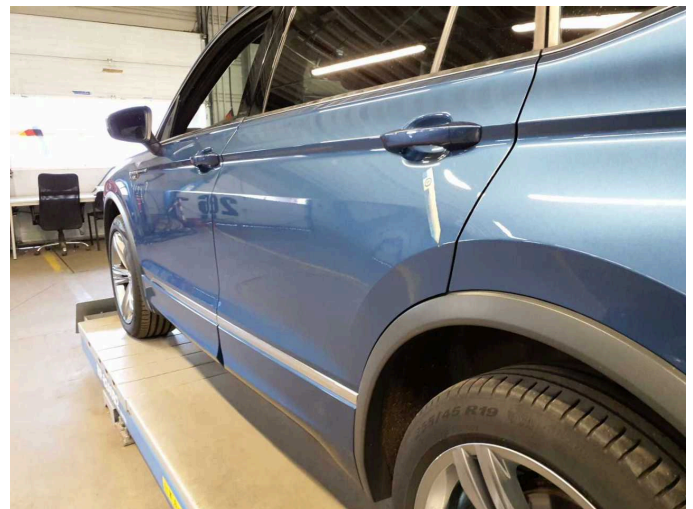
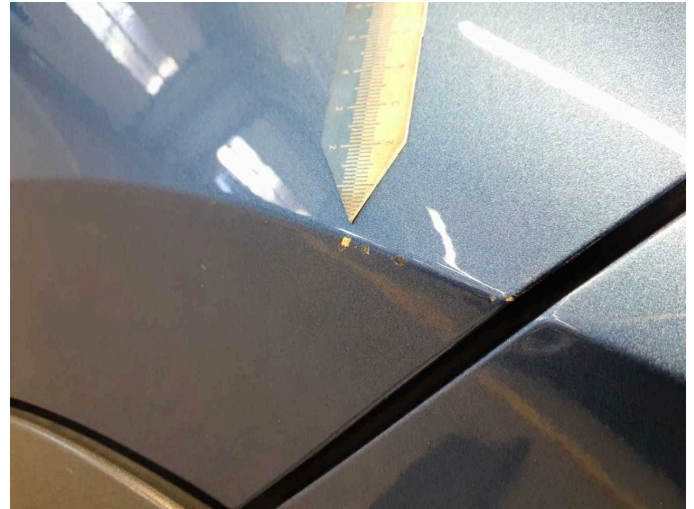
**Damage 7:** Door - rear left side: Door (Steinschlag) - Scratched - Smart repair

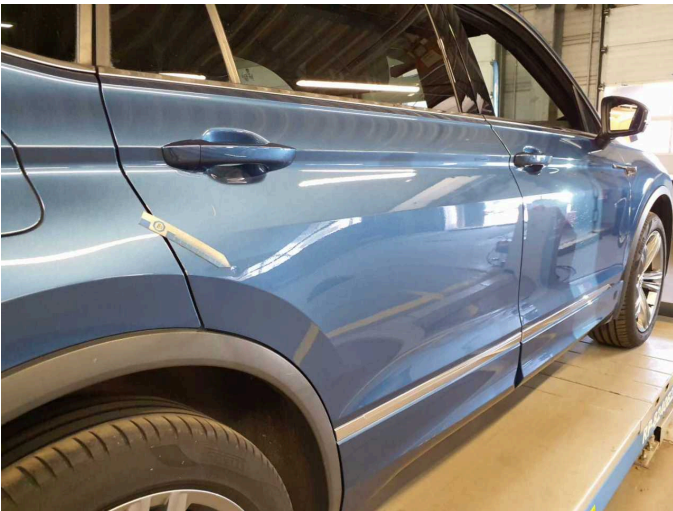
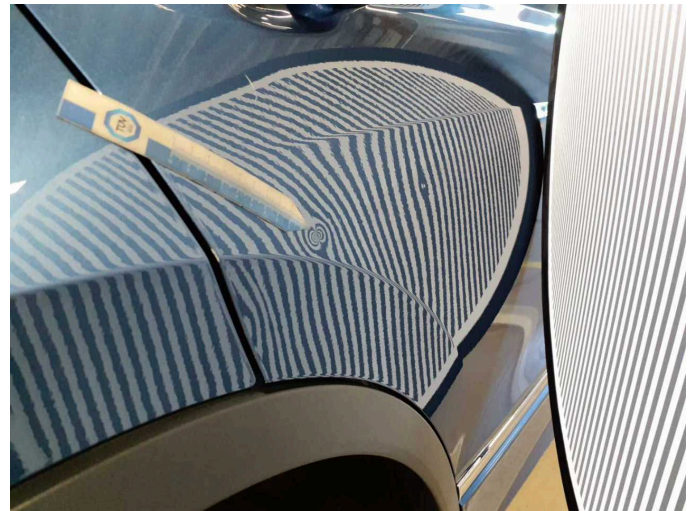
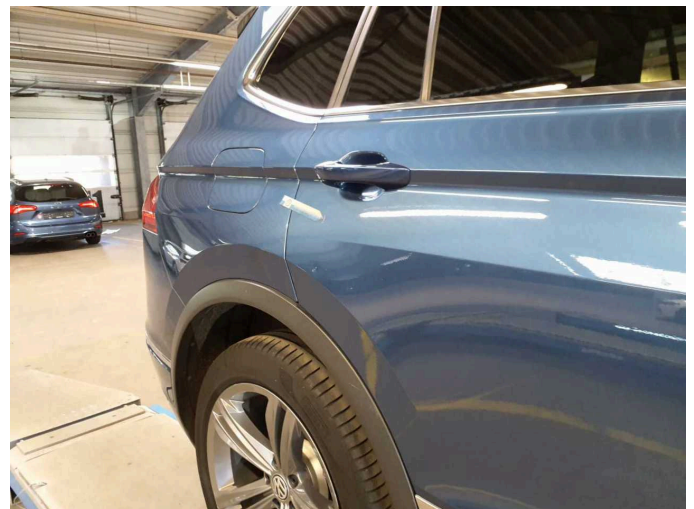
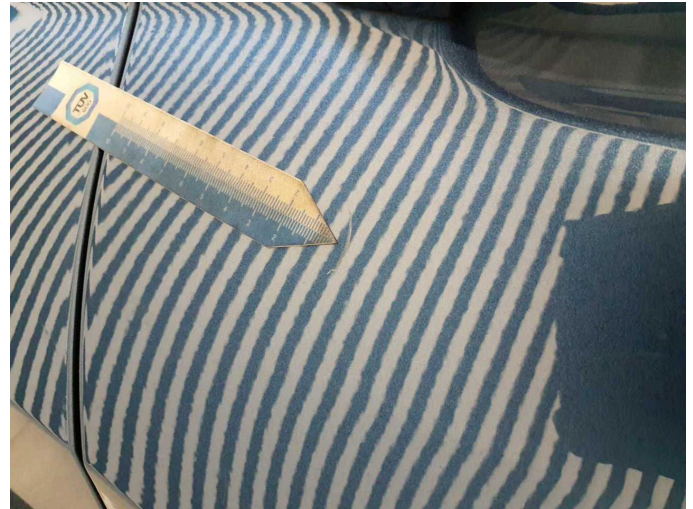
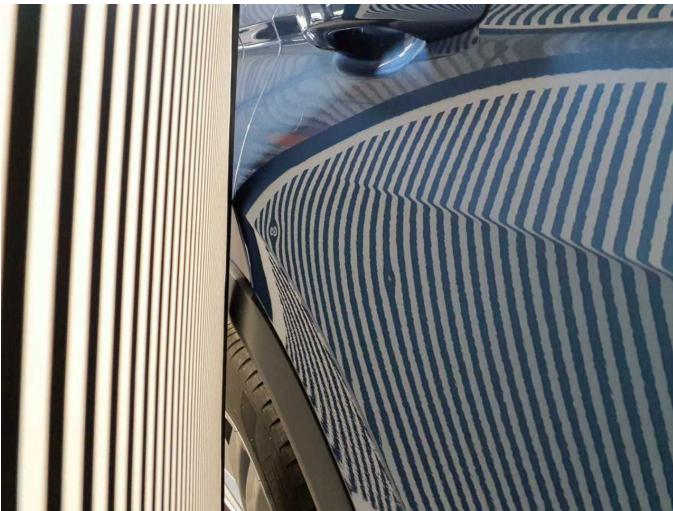
**Damage 8:** Door - rear right side: Door - Dent / paintcoat damage - Smart repair

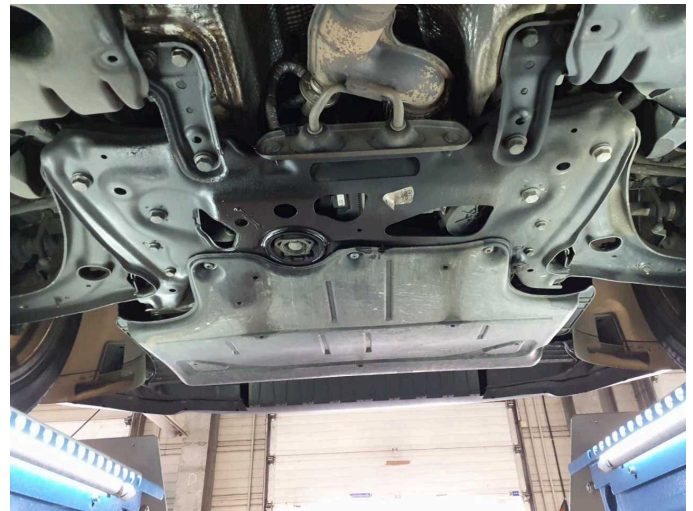
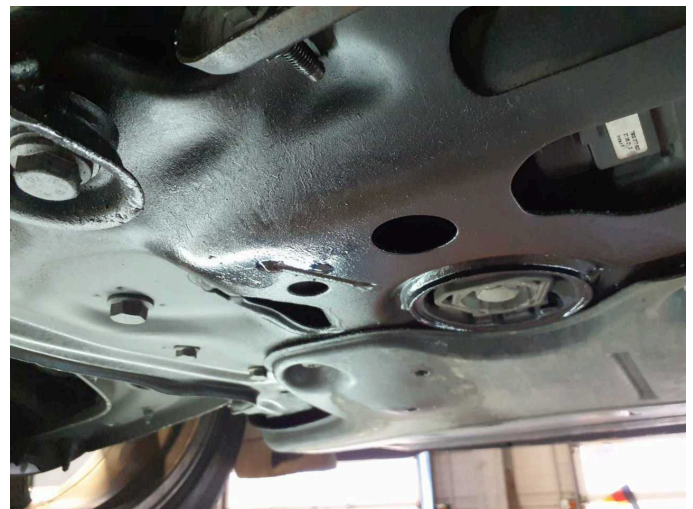
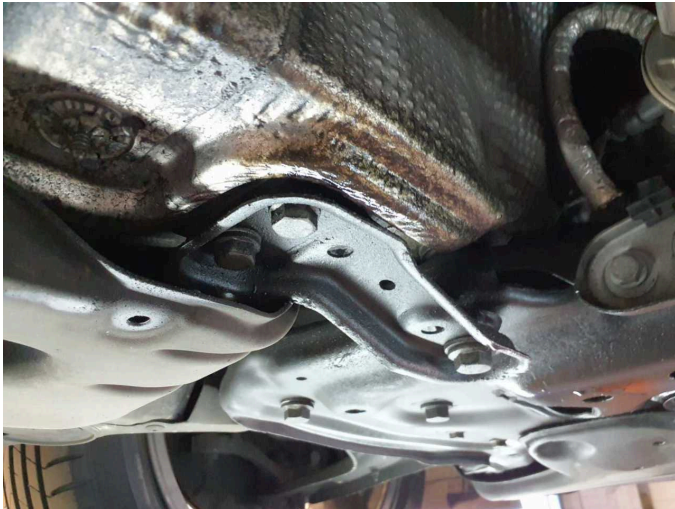
**Damage 9:** Engine: Engine (Ölundichtigkeiten Motor) - Leaking - Perform diagnosis

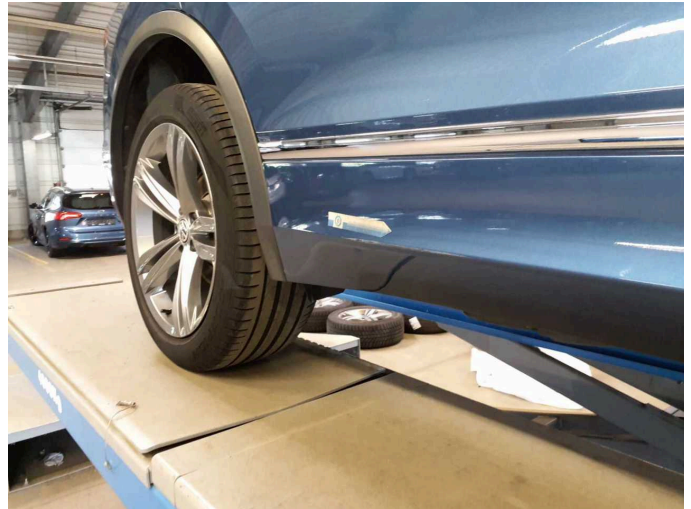
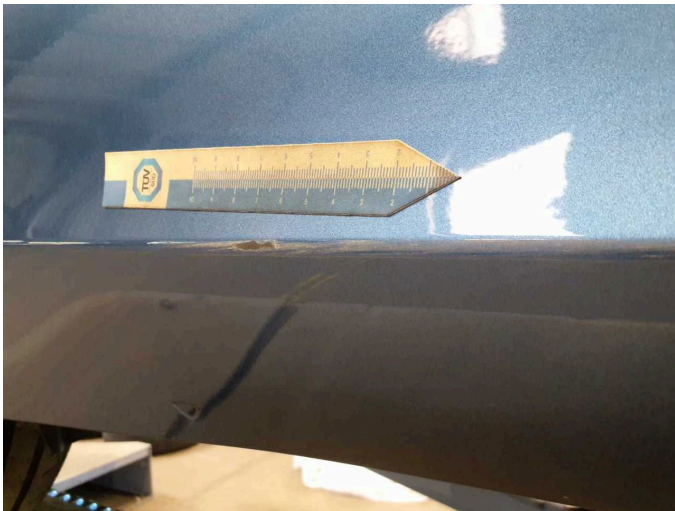
**Damage 10:** Door - rear right side: Brightware - lower - Scratched - Paint

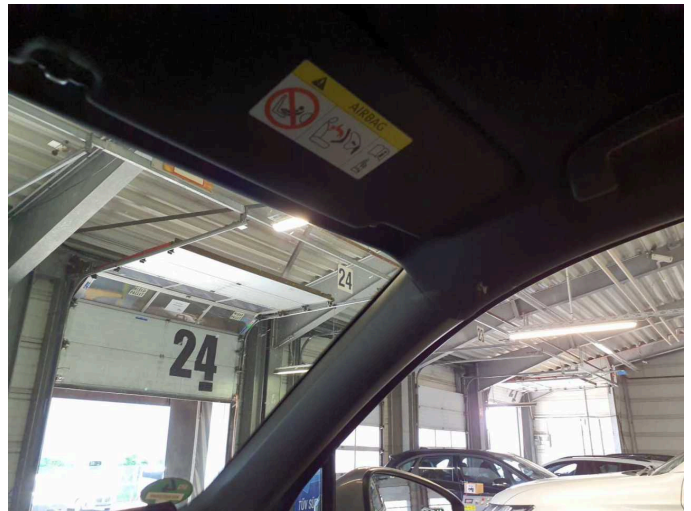
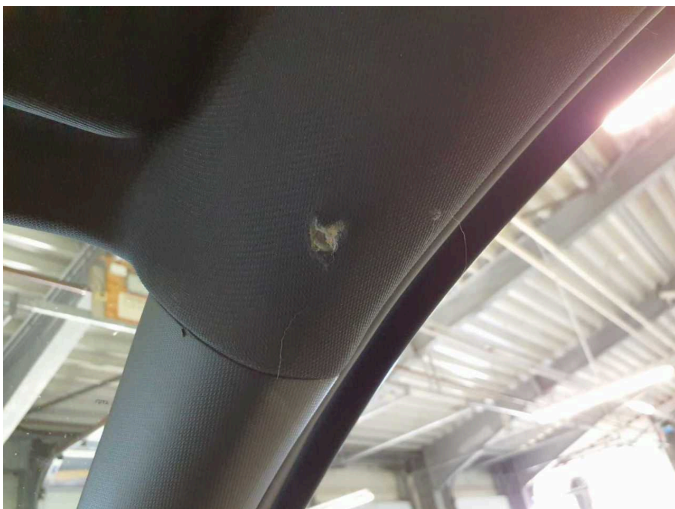
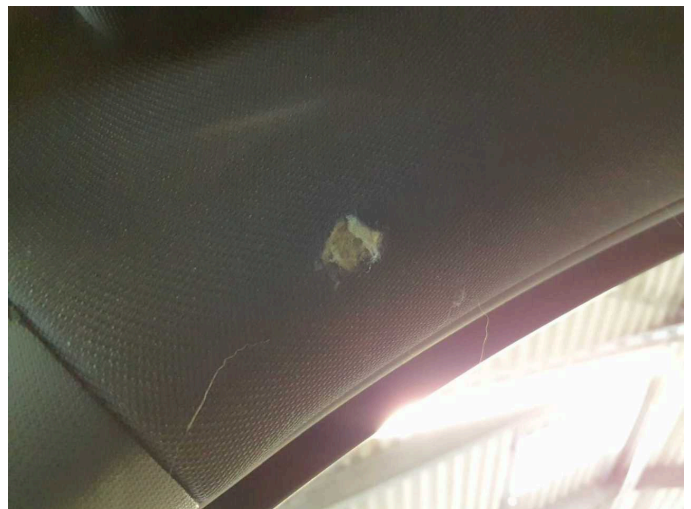
**Damage 11:** Trim / covers: Roof lining - Holes - Smart repair

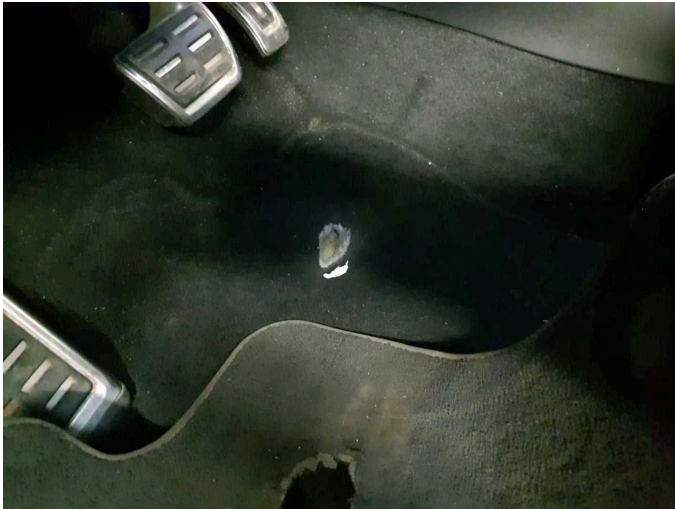
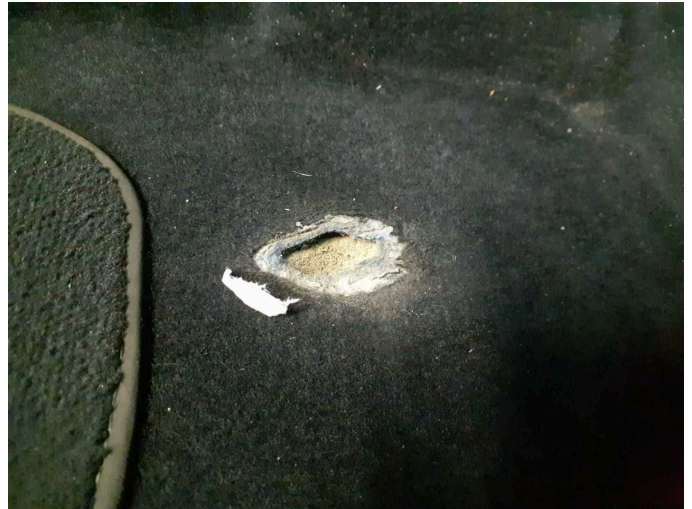
**Damage 12:** Trim / covers: Carpet - front left side - Holes - Smart repair

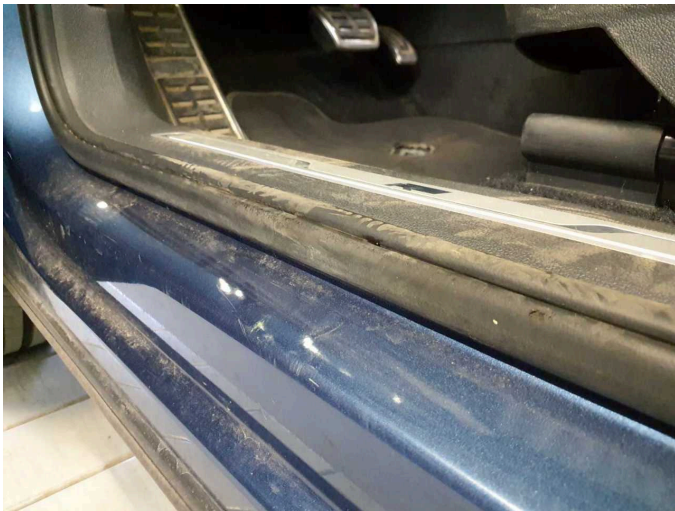
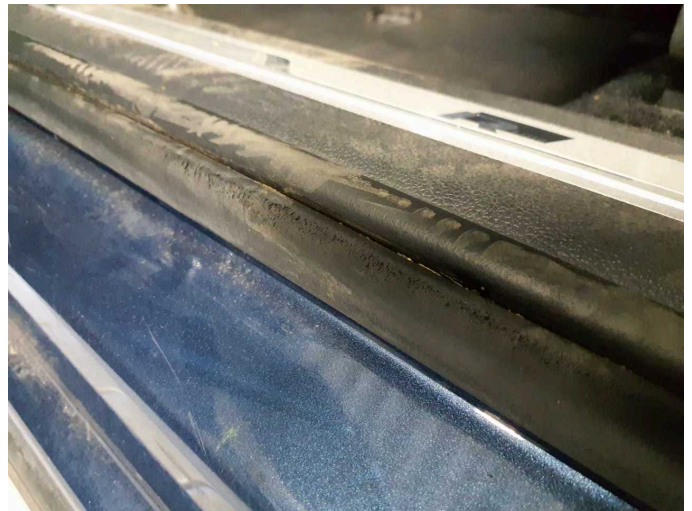
**Damage 13:** Door - front left side: Door seal - Scratched - Replace

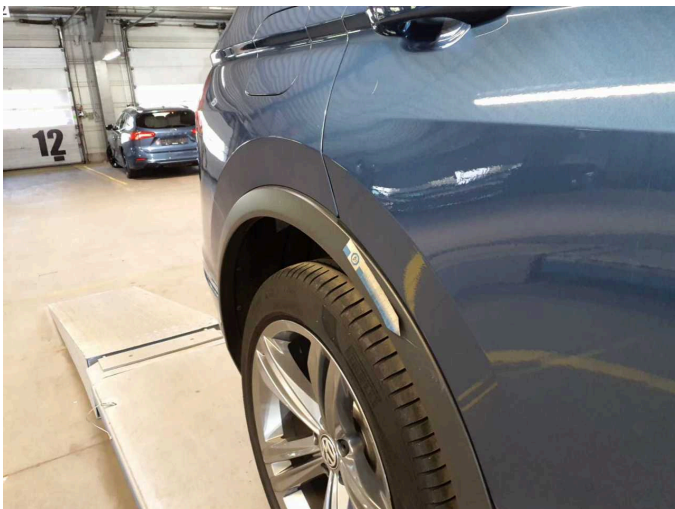
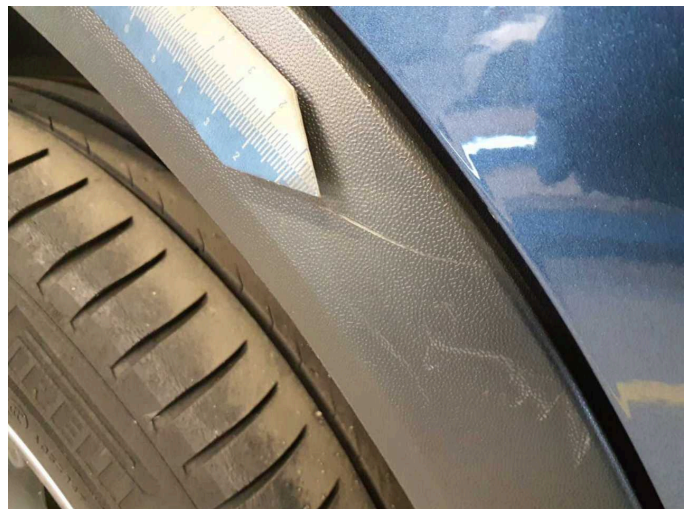
**Damage 14:** Side panel - rear right side: Wheel well extension - Scratched - Replace

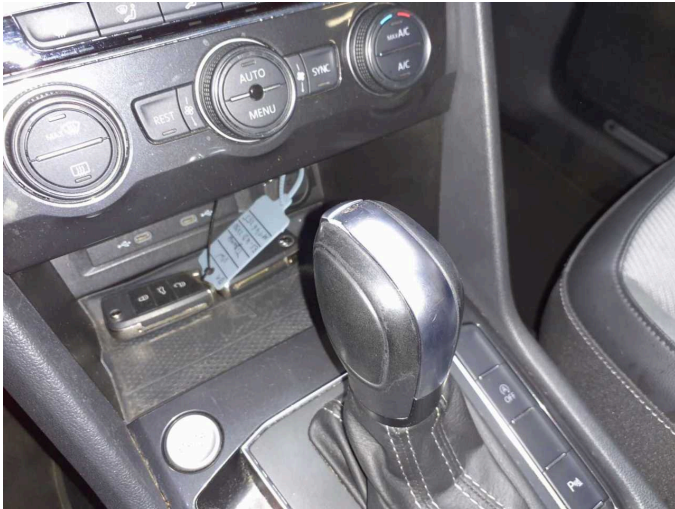
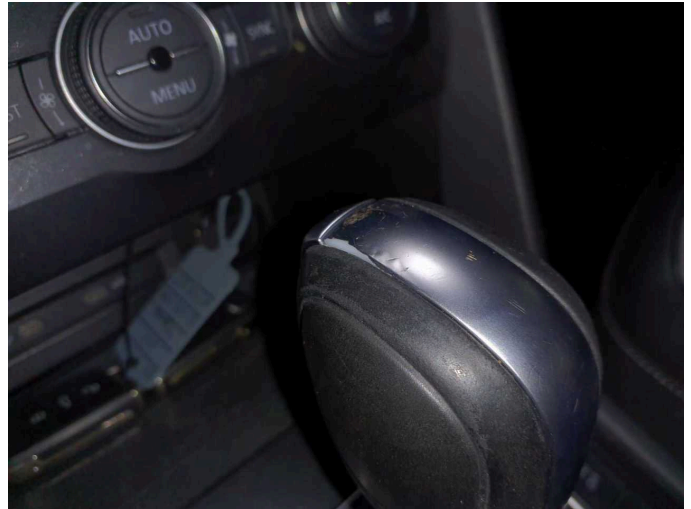
**Damage 15:** Gearbox: Gear knob - Scratched - Replace

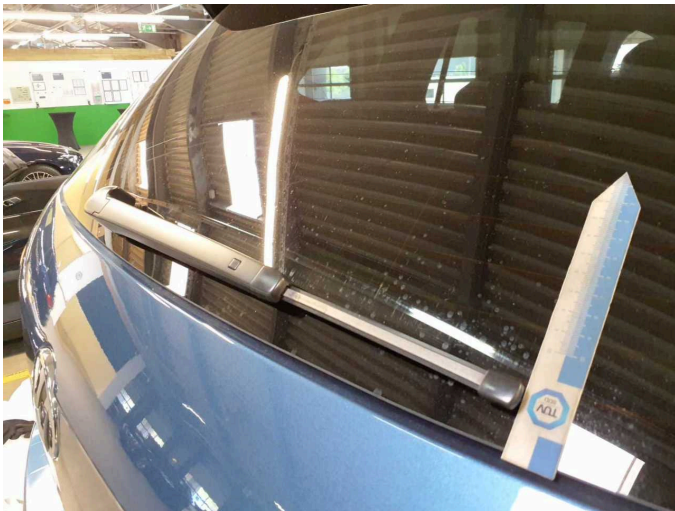
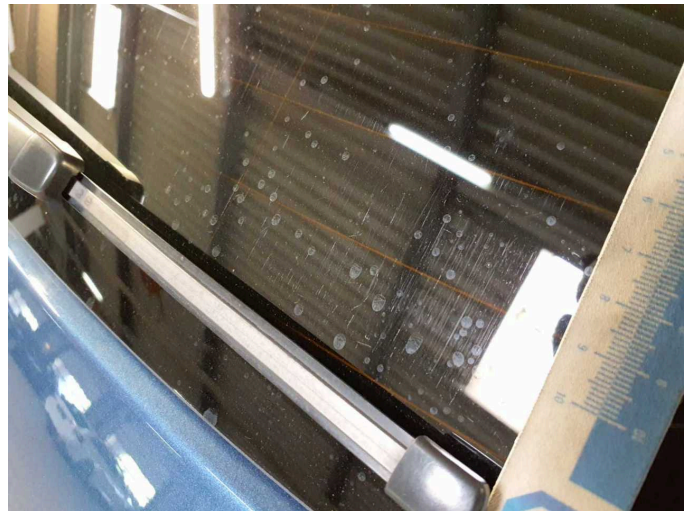
**Damage 16:** Vehicle glazing: Rear window - Scratched - Loss in value

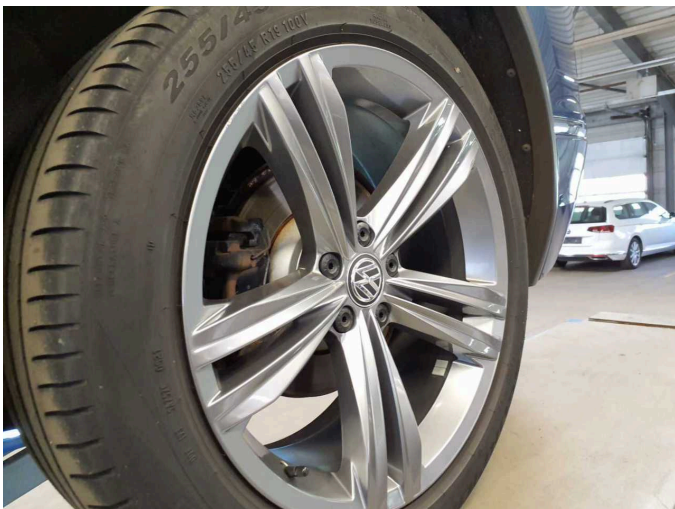
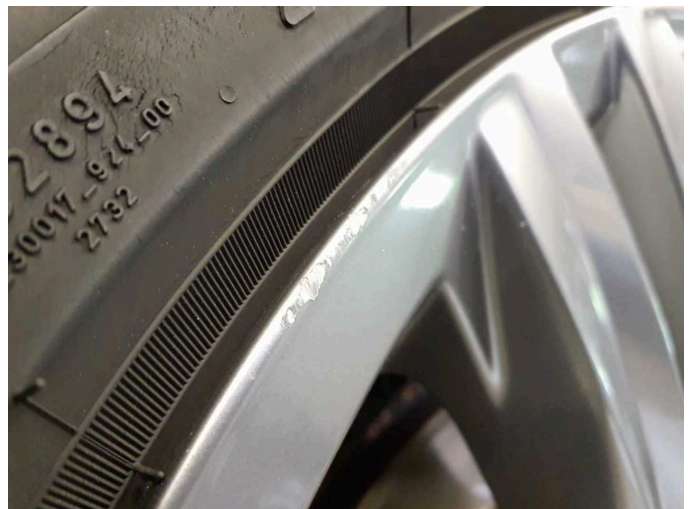
**Damage 17:** Wheel / tyres: Alloy rim - rear left side - Damaged - Loss in value

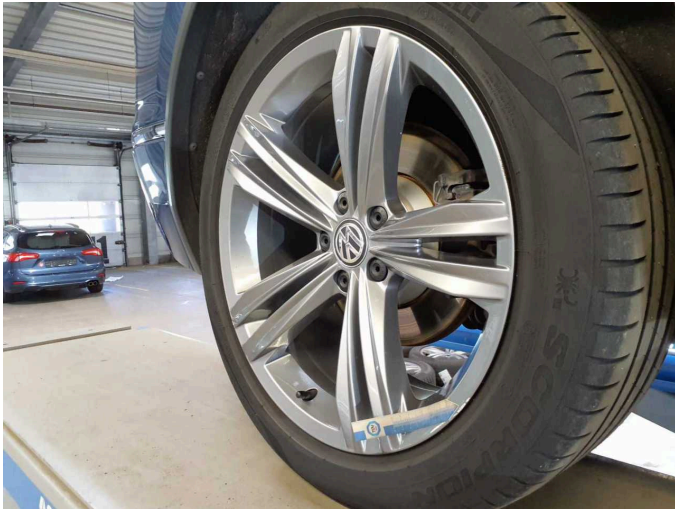
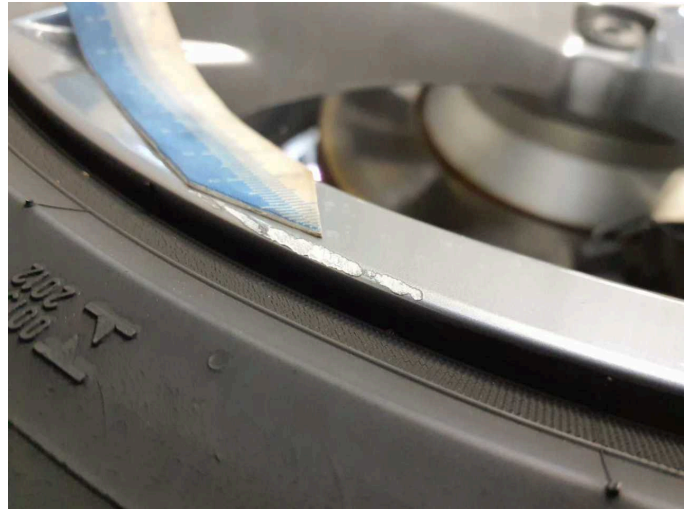
**Damage 18:** Wheel / tyres: Alloy rim - rear right side - Damaged - Loss in value

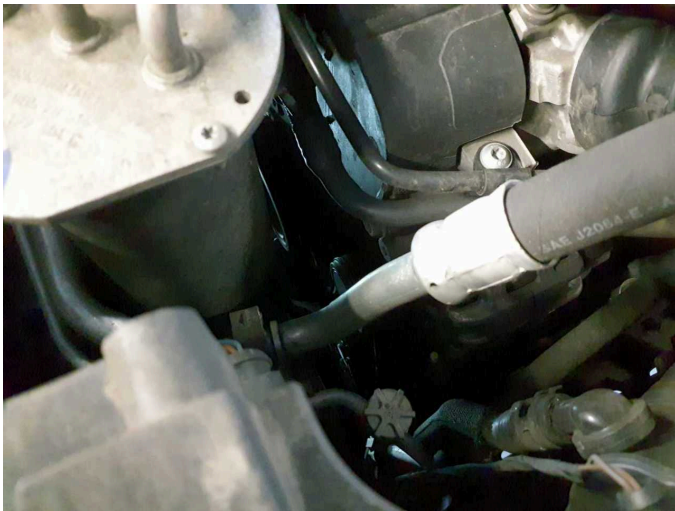
**Damage 19:** Engine: Engine (Riementrieb) - Noise - Perform diagnosis

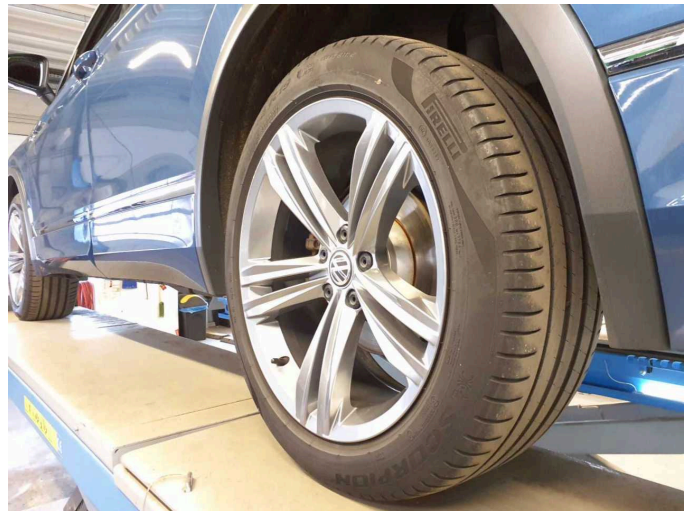
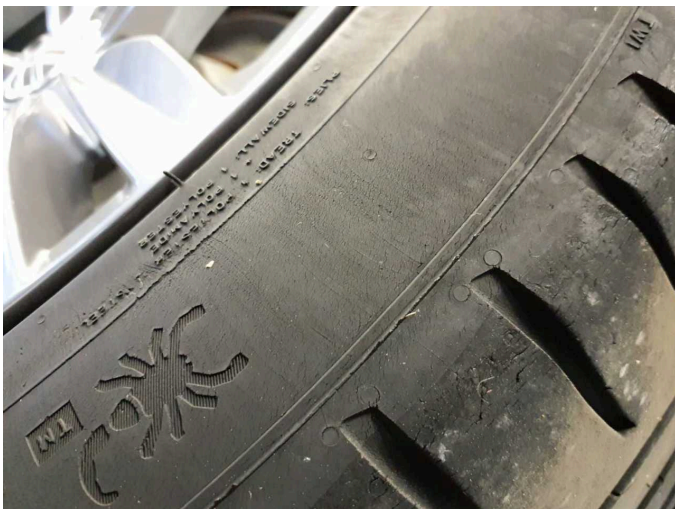
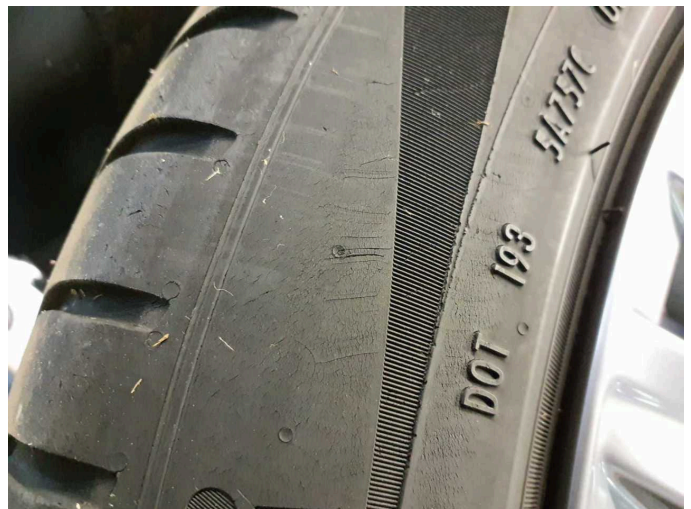
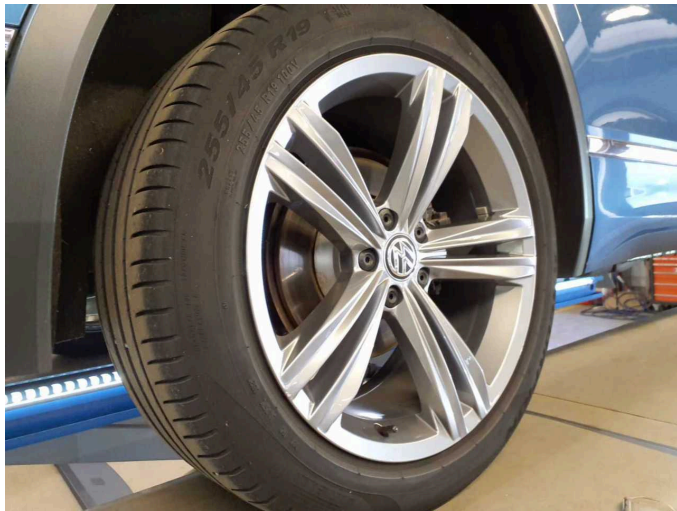
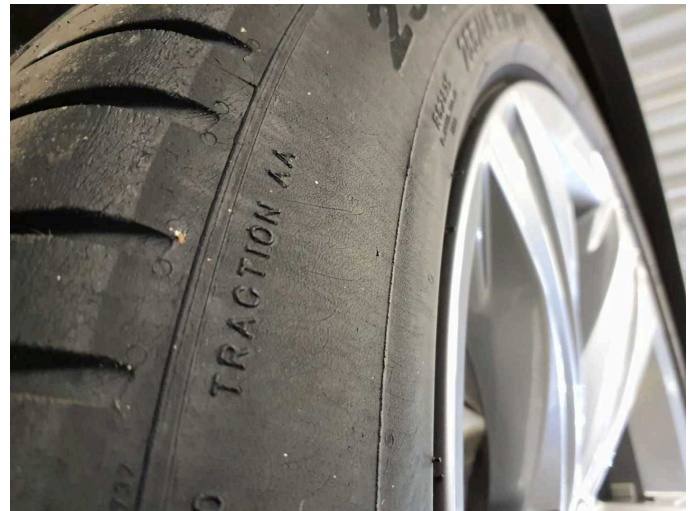
**Damage 20:** Wheel / tyres: Tyre - right - Porous / cracked - Replace

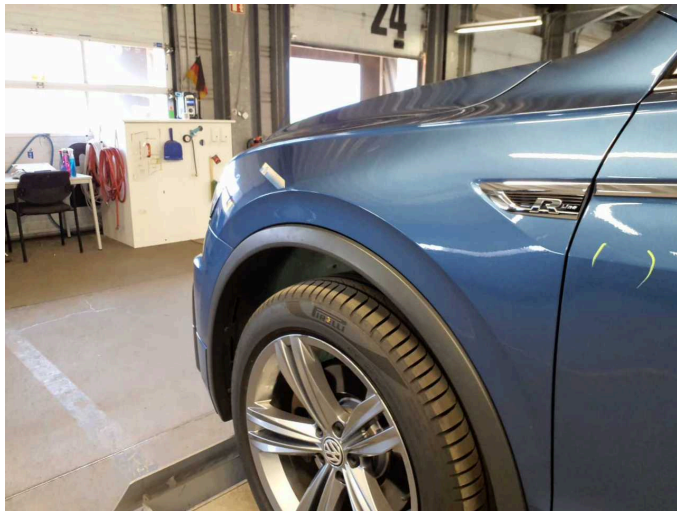
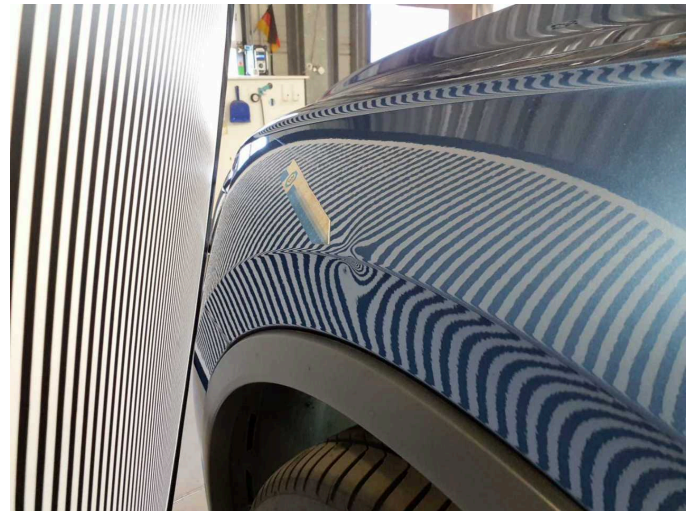
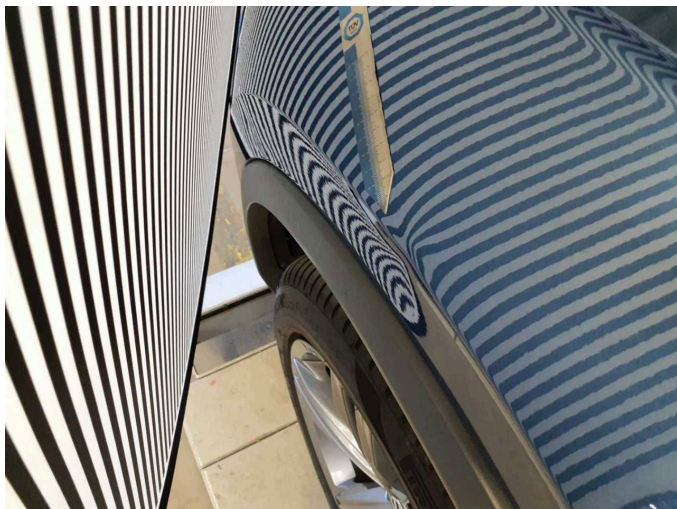
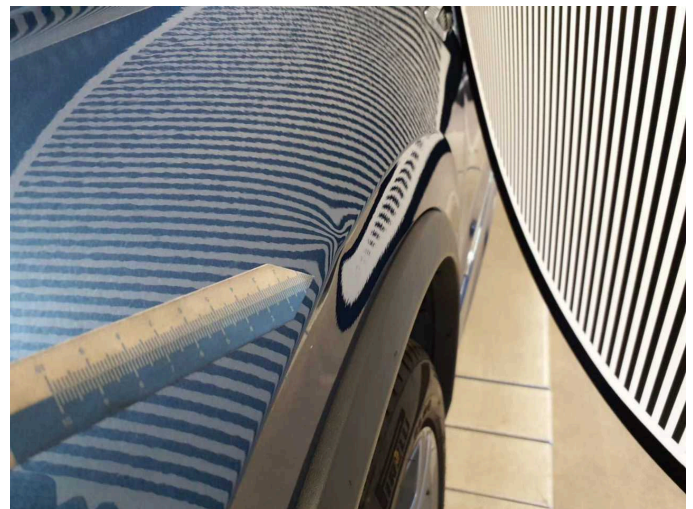
**Damage 21:** Mudguard - left side: Mudguard - left side - Deformed - Repair and paint

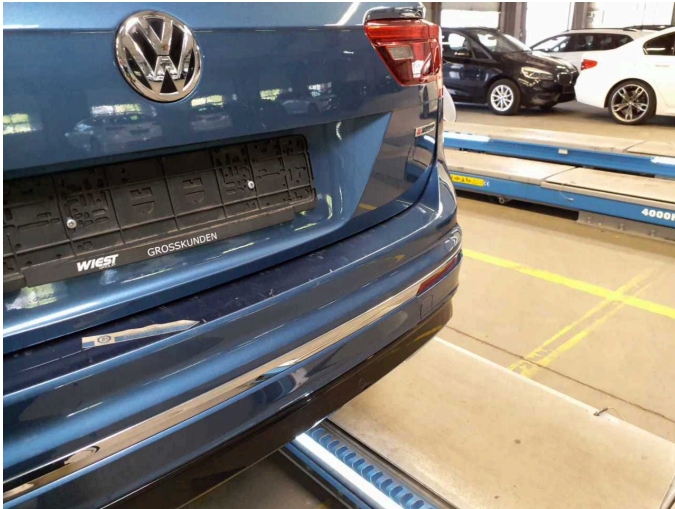
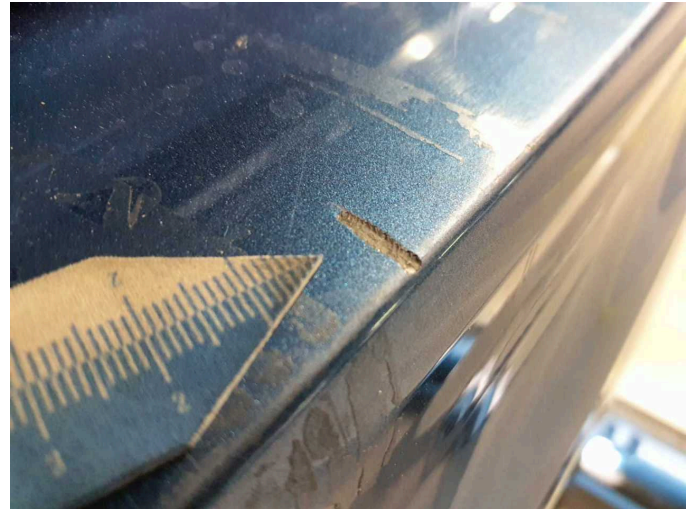
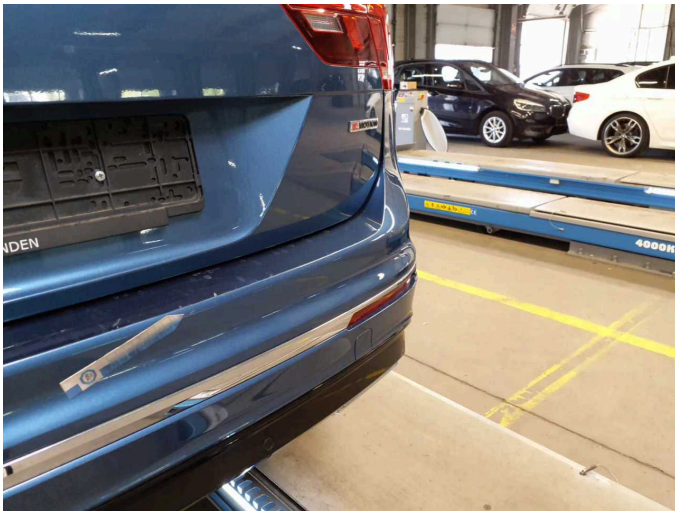
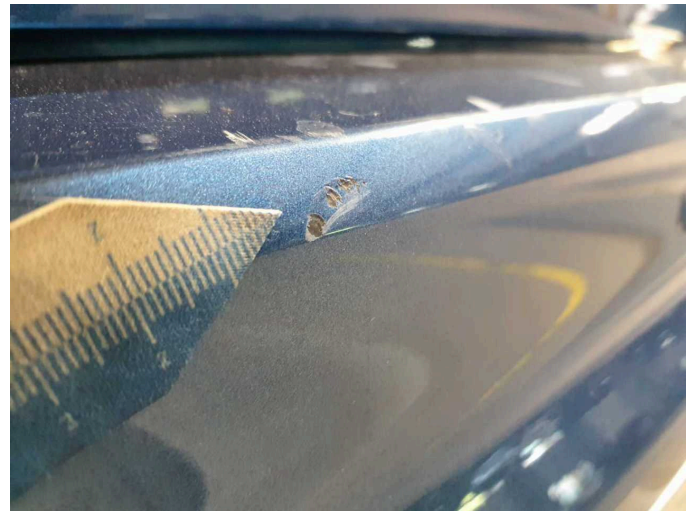
**Damage 22:** Rear bumper: Rear bumper - Scratched - Repair and paint

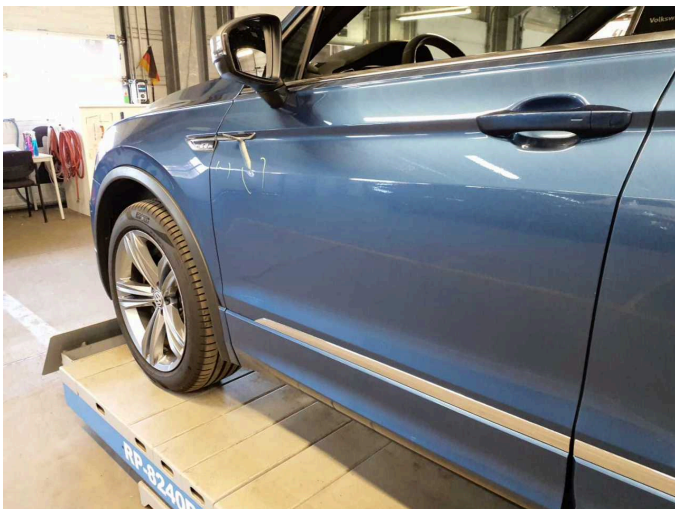
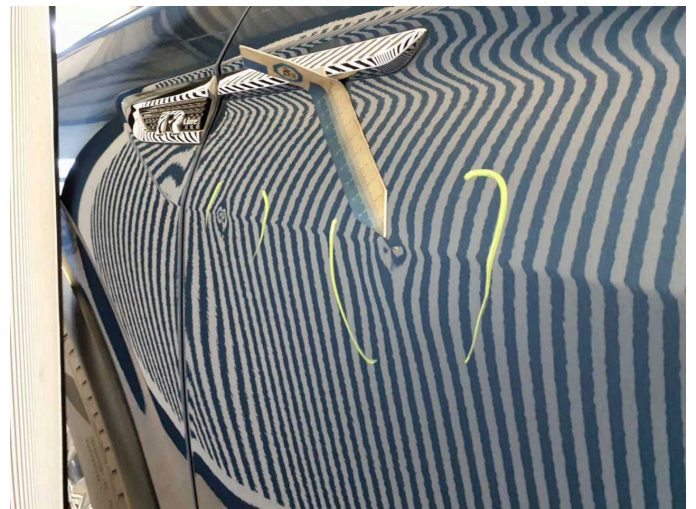
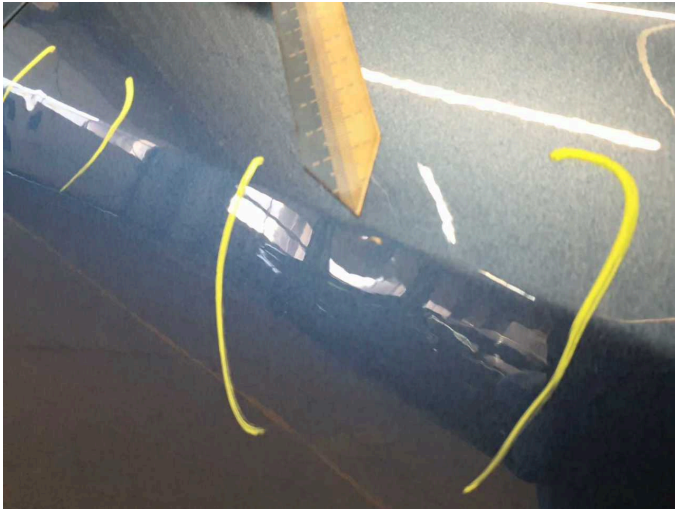
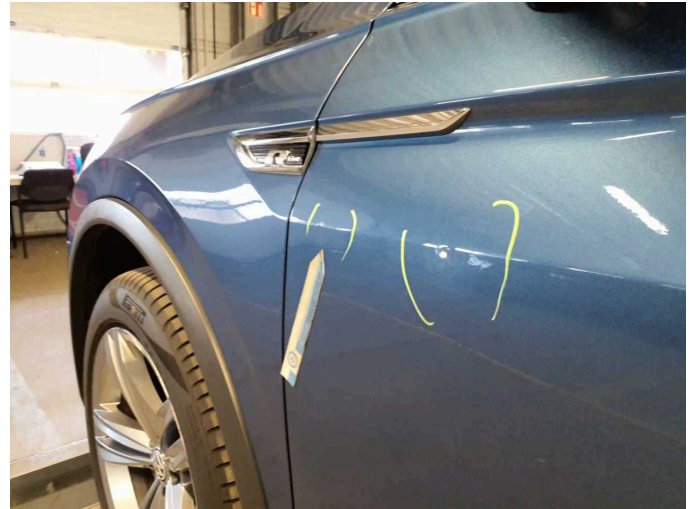
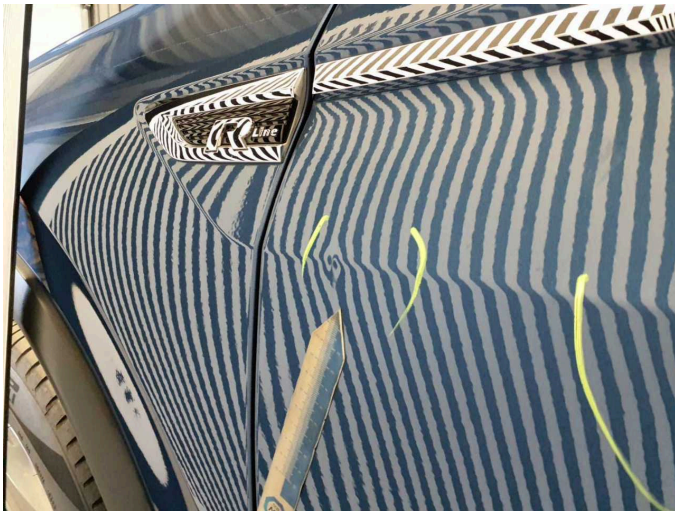
**Damage 23:** Door - front left side: Door - Dent / paintcoat damage - Repair and paint

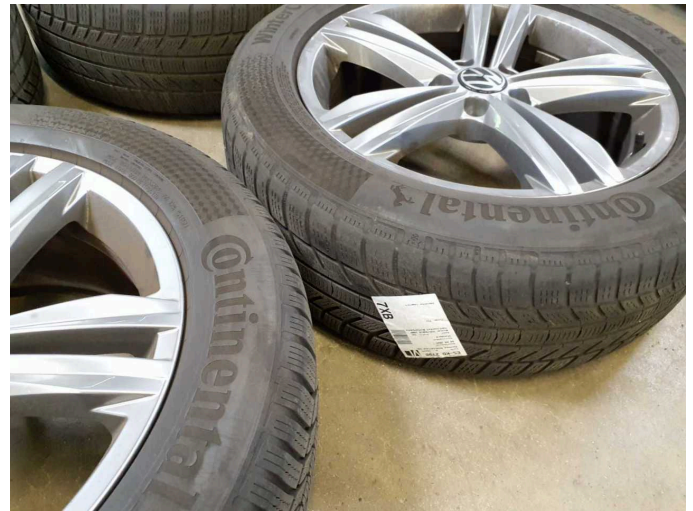
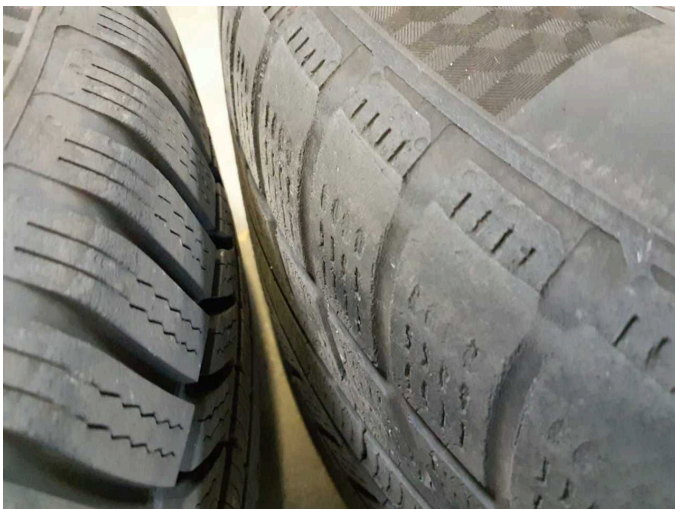
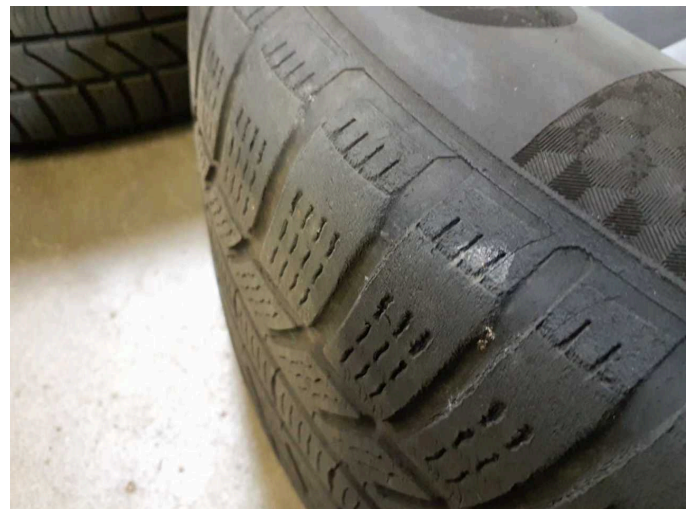
**Wear and tear 1:** 2nd wheel set: 2 tyres (einseitig) - Expired - No deduction

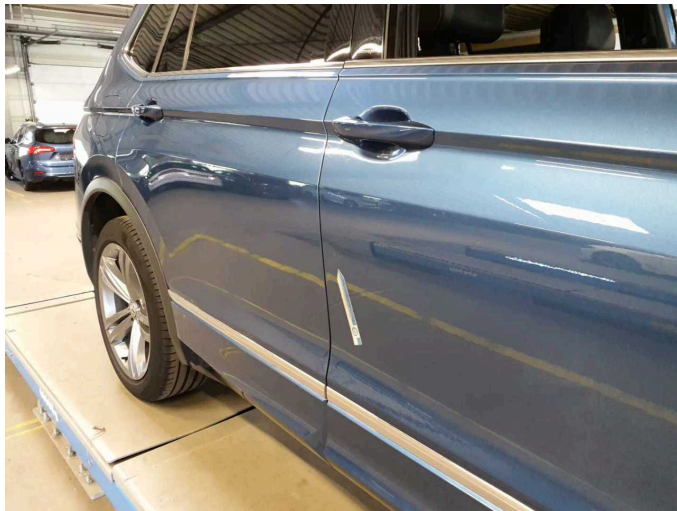
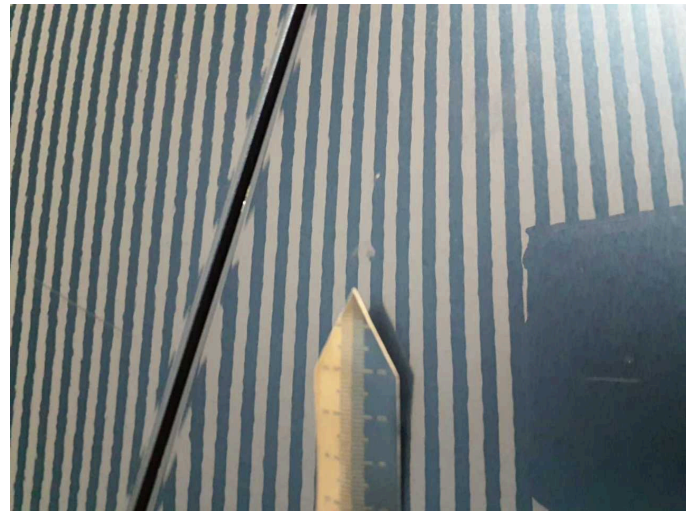
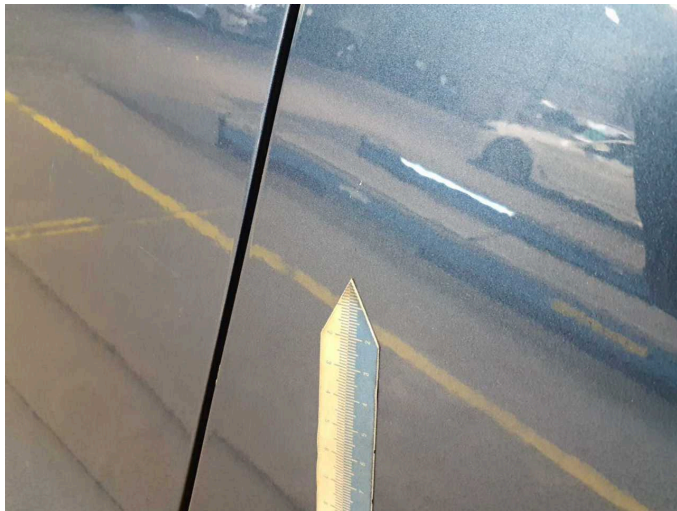
**Wear and tear 7:** Door - front right side: Door - Paint defect - No deduction

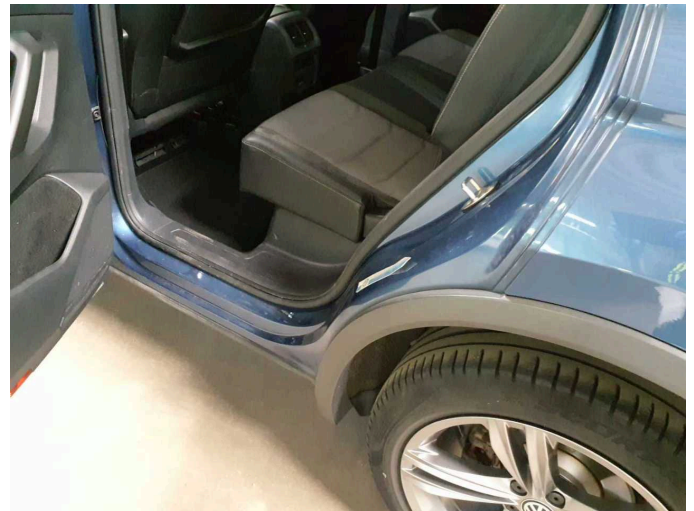
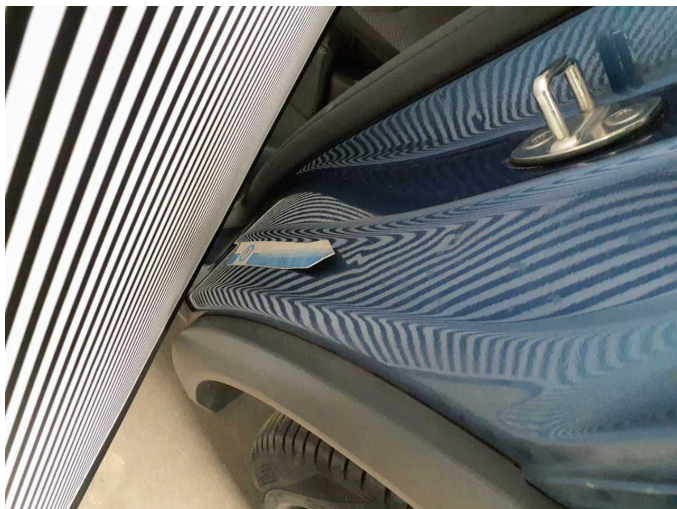
**Wear and tear 16:** Side panel - rear left side: Sill - dent(s) - Smooth repair work
