Expertise

Protocol number: 39741604  
Order No. / Reference: 24686615  
Inspection date: 15 May 2025

Manufacturer: Volkswagen	Model: Tiguan Allspace 2.0 TDI SCR 4Motion DSG Comfortline
VIN: WVGZZZ5NZMM146255

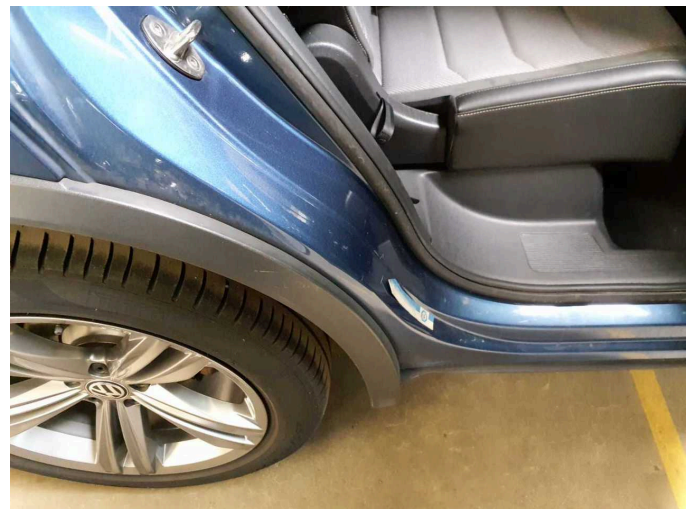
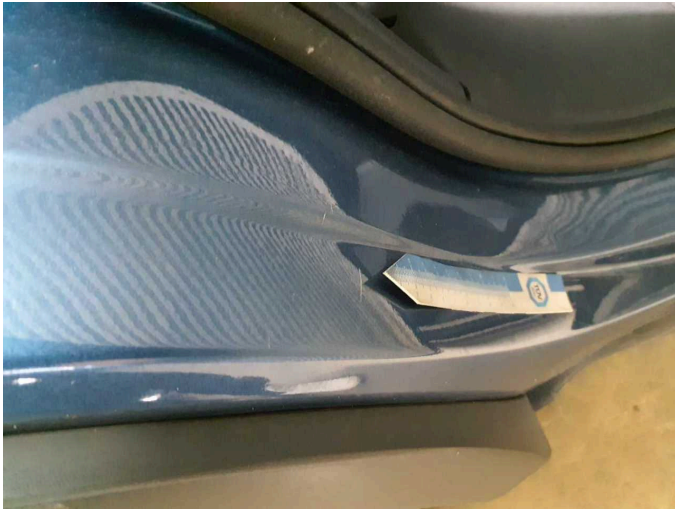
**Wear and tear 17:** Side panel - rear right side: Sill - Scratch(es) - Cover / polish

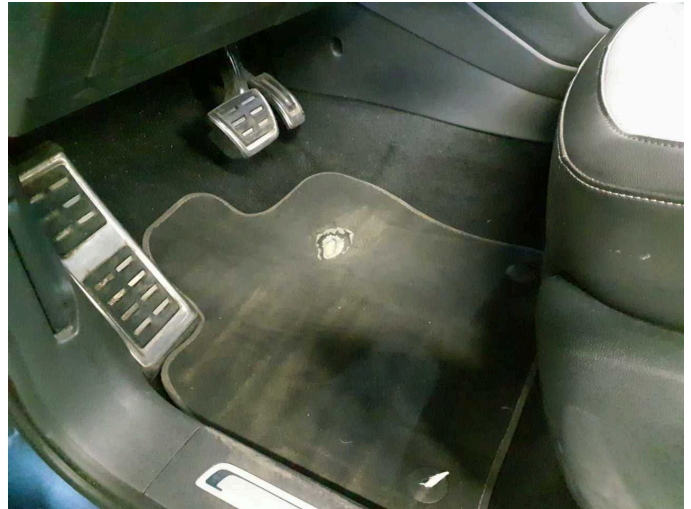
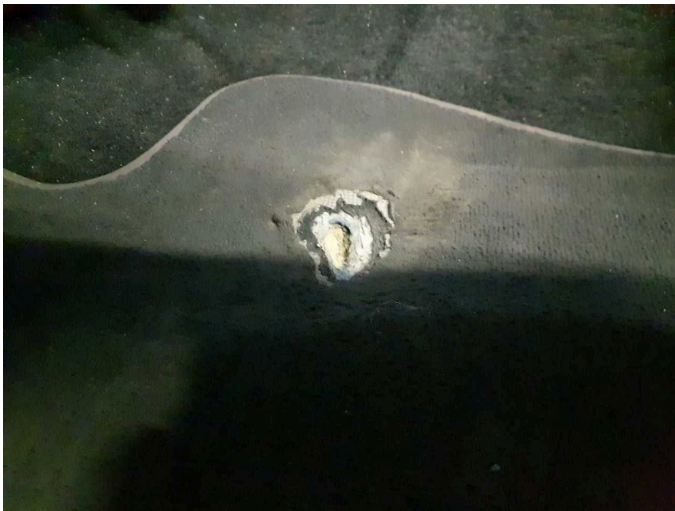
**Wear and tear 18:** Trim / covers: Floor mats - Holes - No deduction

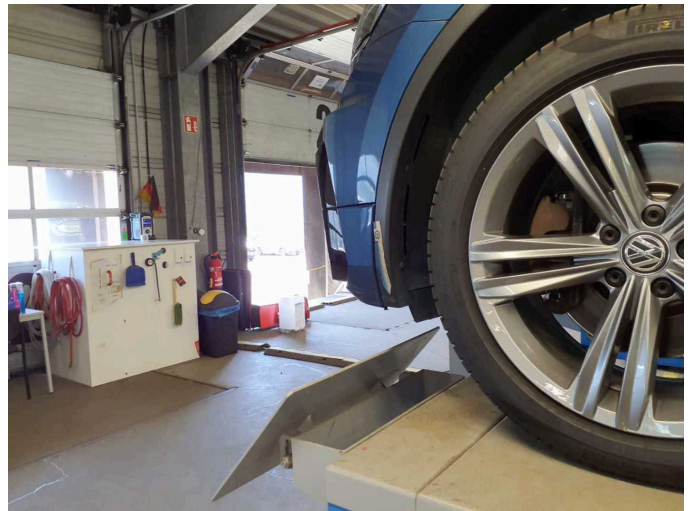
**Accident 1:** Front, Side - left, Side right
