Expertise

Protocol number: 41179667
Order No. / Reference: 25120216
Inspection date: 22 Aug 2025

Manufacturer: Volkswagen
VIN: WVGZZZ5NZMW405827

Model: Tiguan 1.4 eHybrid OPF DSG Life

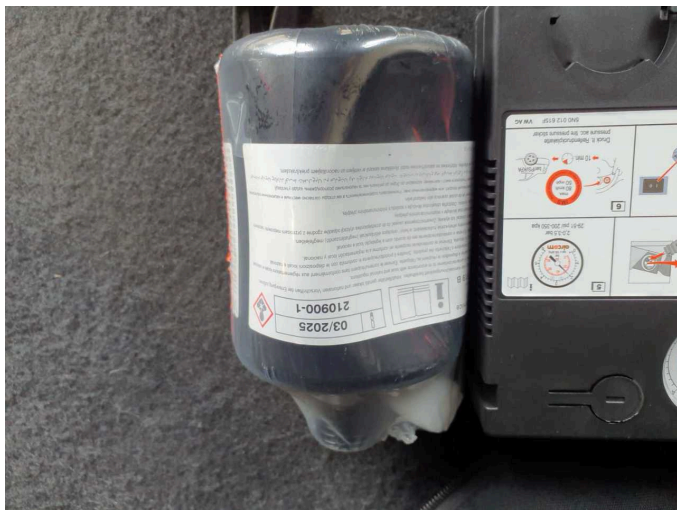
Damage 1: Equipment: Tirefit filler - Expired - Replace

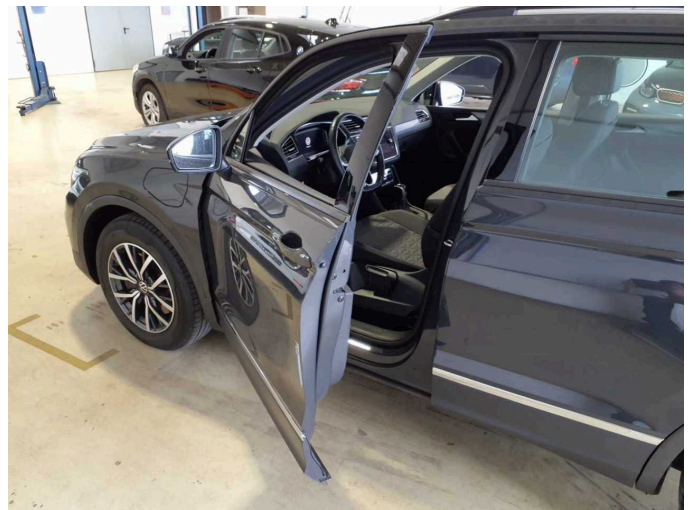
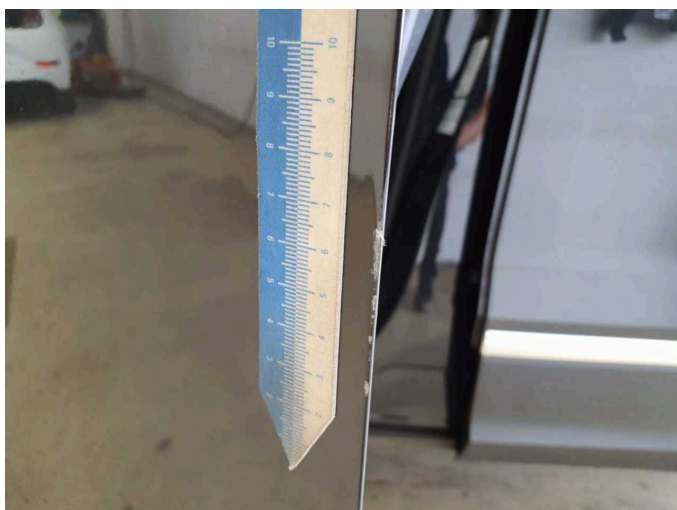
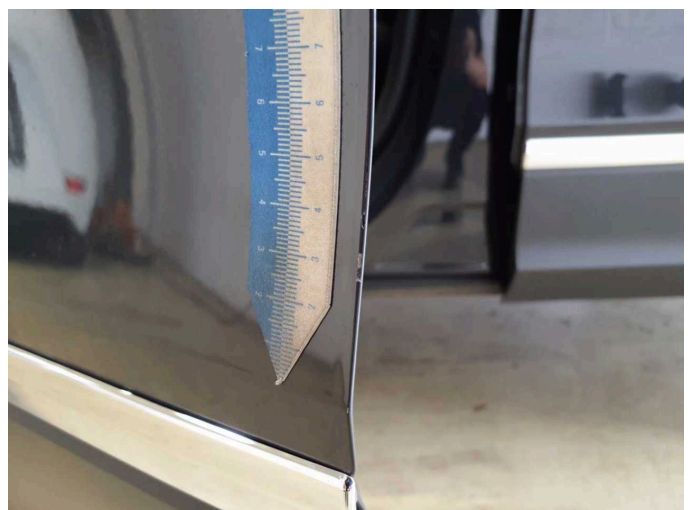
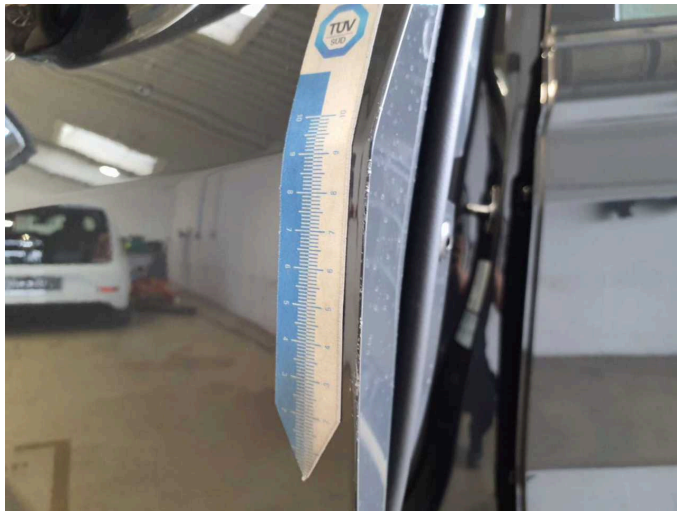
Damage 2: Door - front left side: Door edge - Scratch(es) - Smart repair

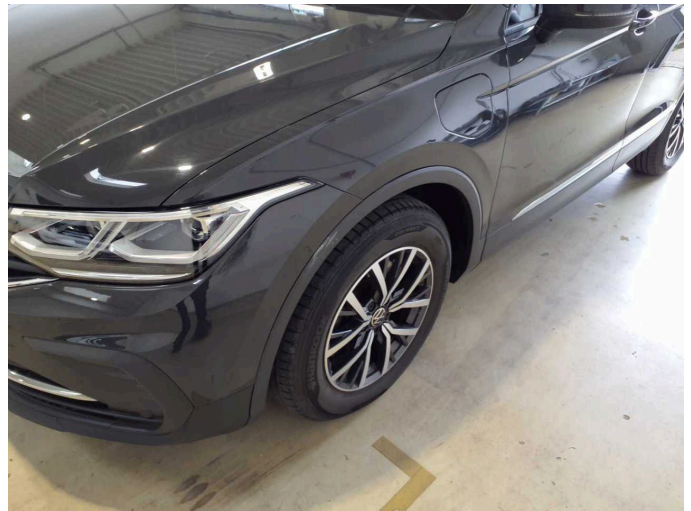
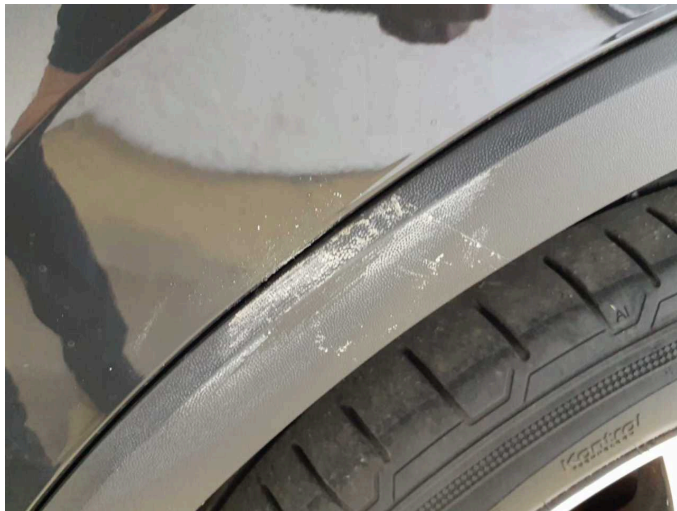
Damage 3: Mudguard - left side: Wheel well extension - Soiled - Clean

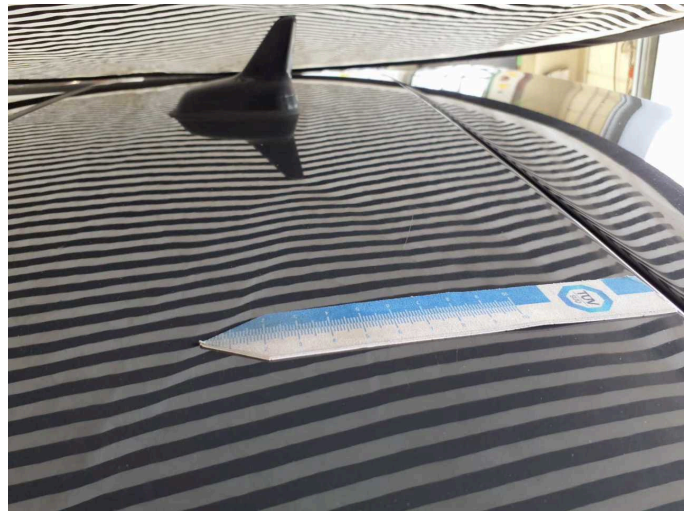
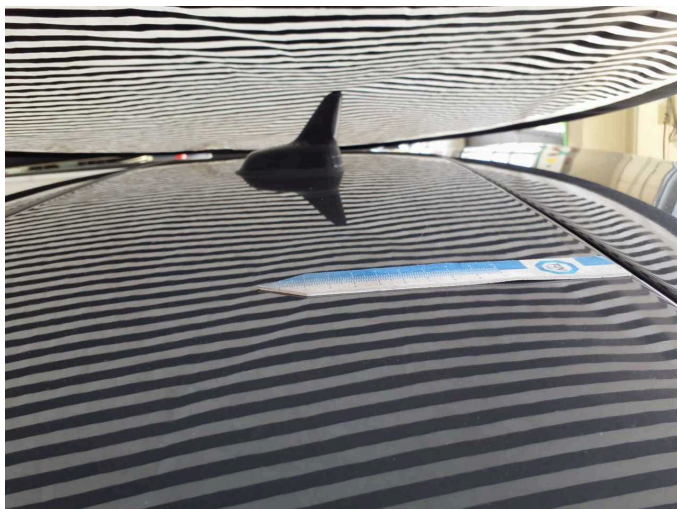
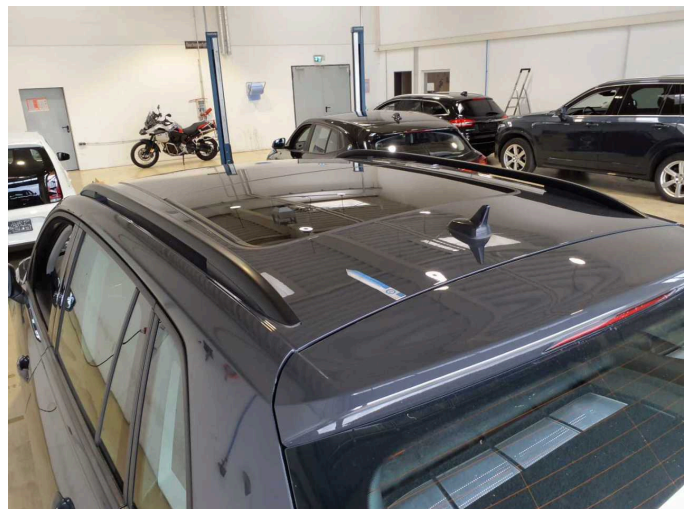
Damage 4: Roof: Roof - dent(s) - Smooth repair work

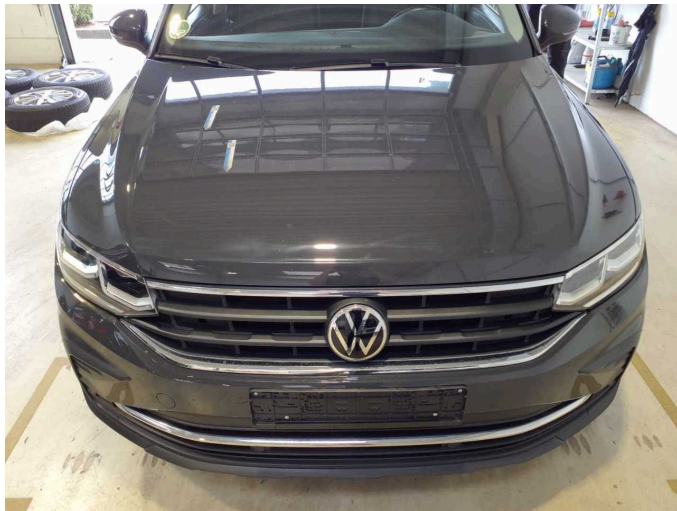
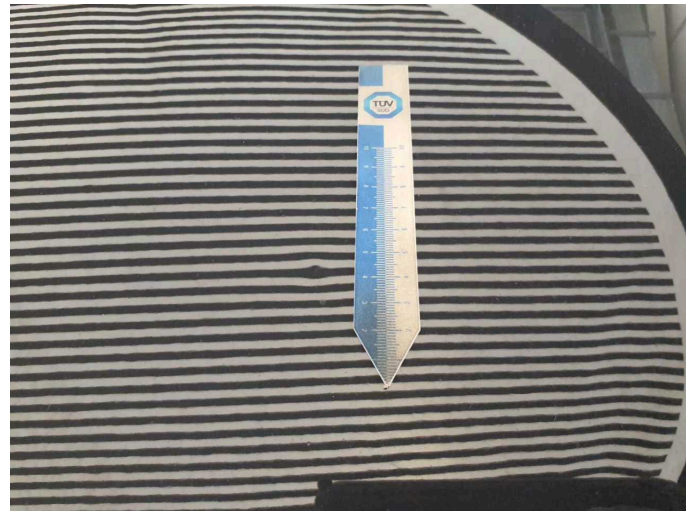
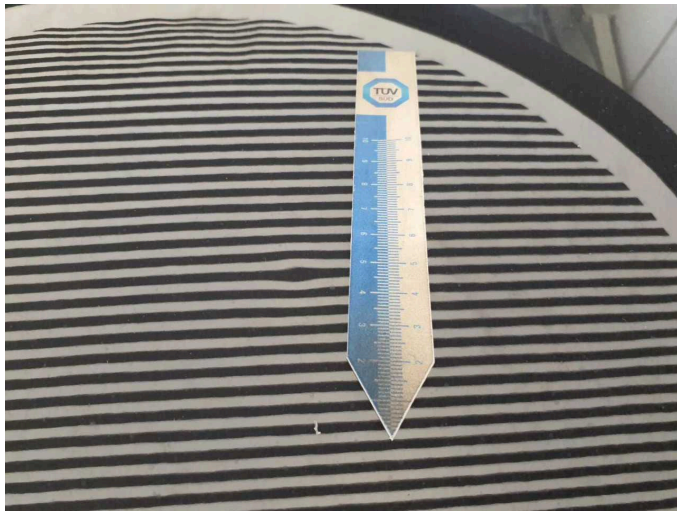
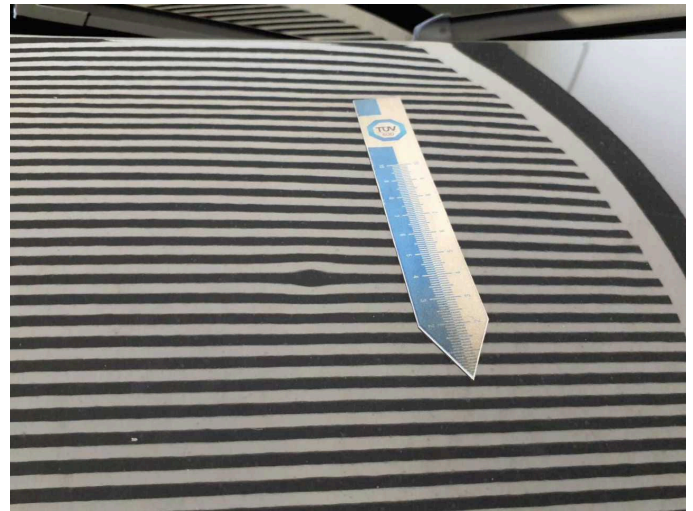
Damage 5: Bonnet: Bonnet - dent(s) - Smooth repair work

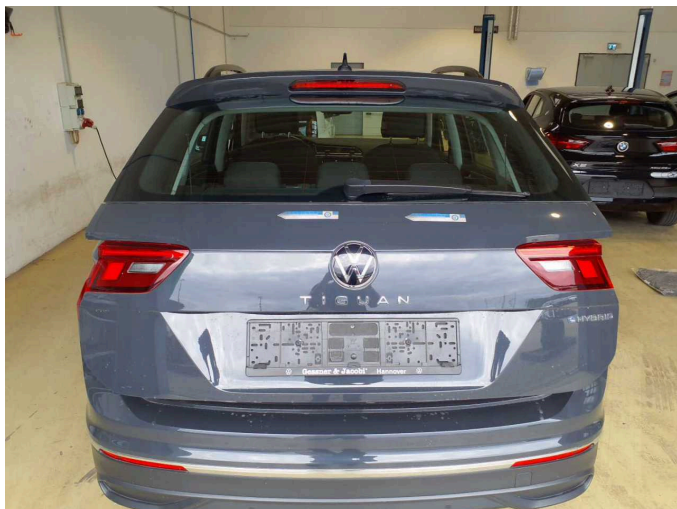
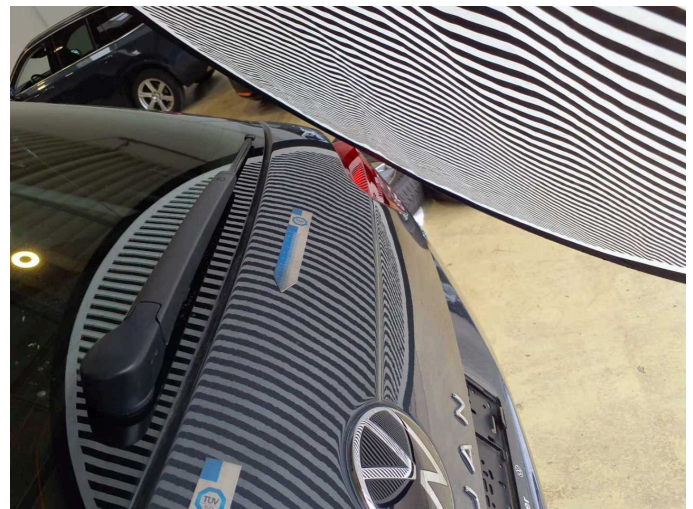
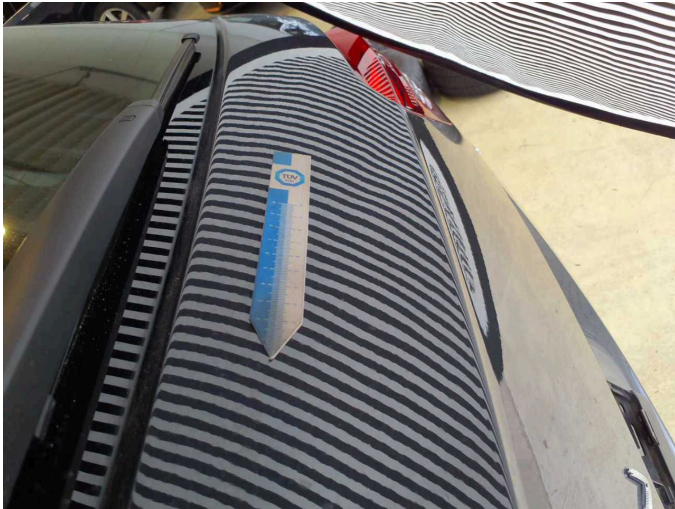
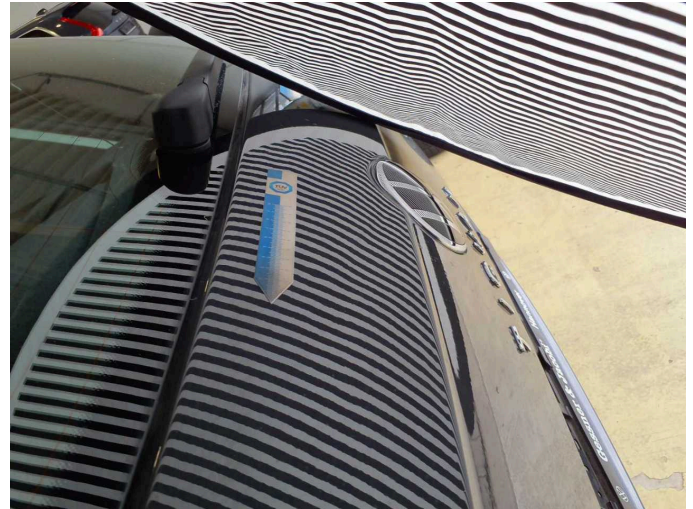
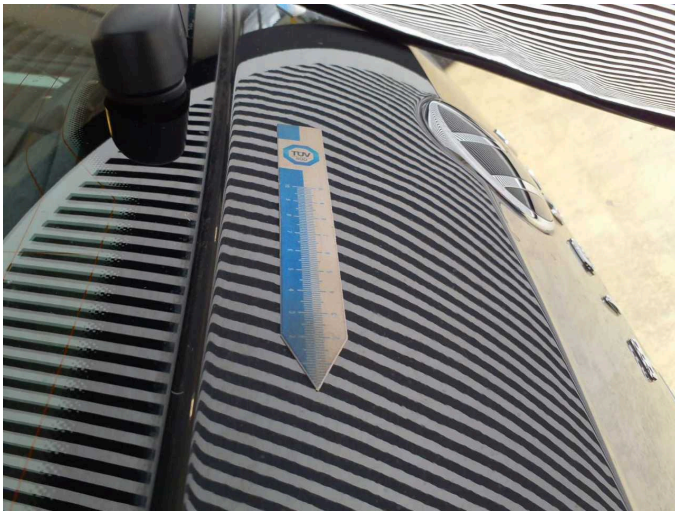
Damage 6: Boot lid / rear door: Boot lid - dent(s) - Smooth repair work

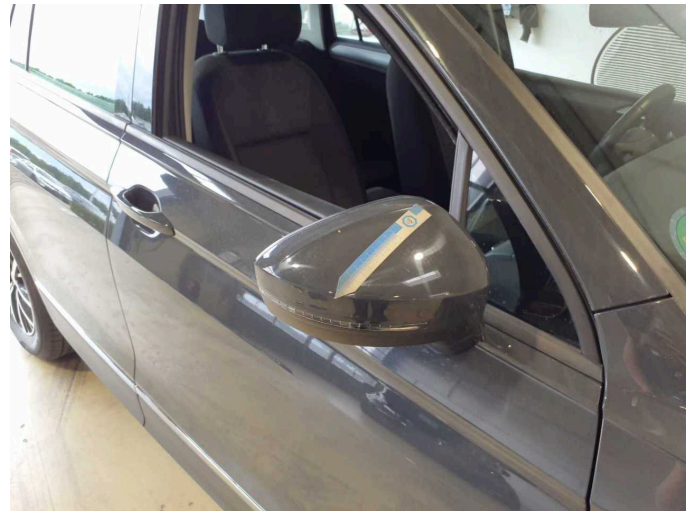
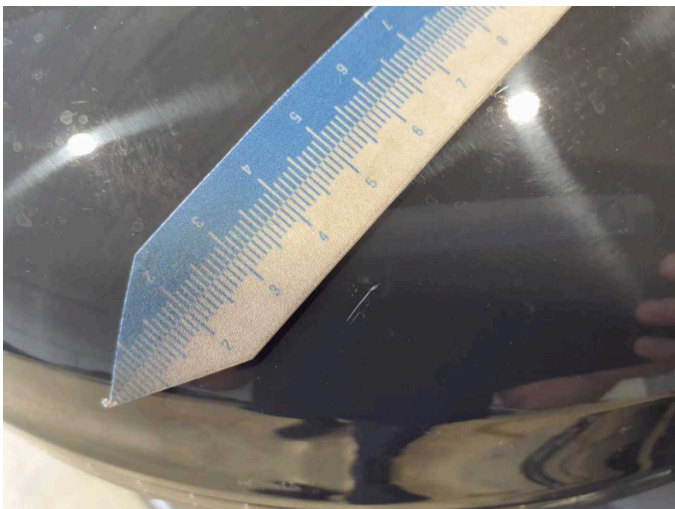
Damage 7: Wing mirror - right side: Cap - Scratch(es) - Paint

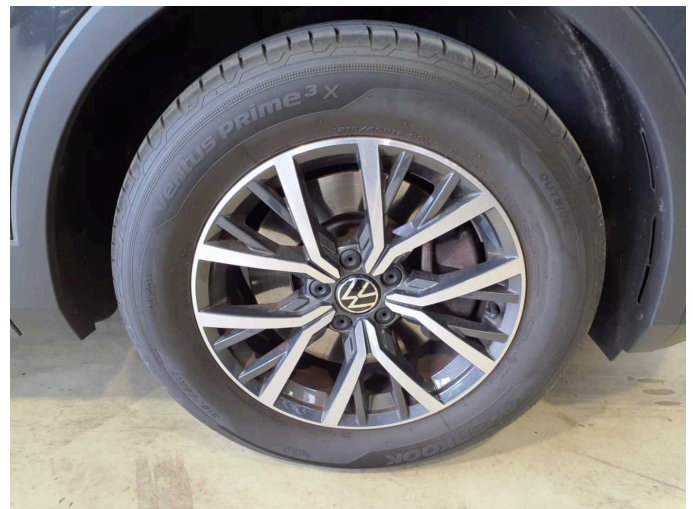
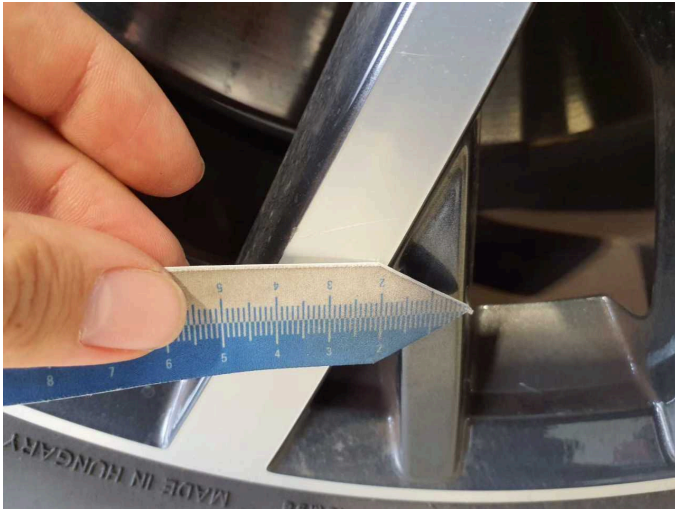
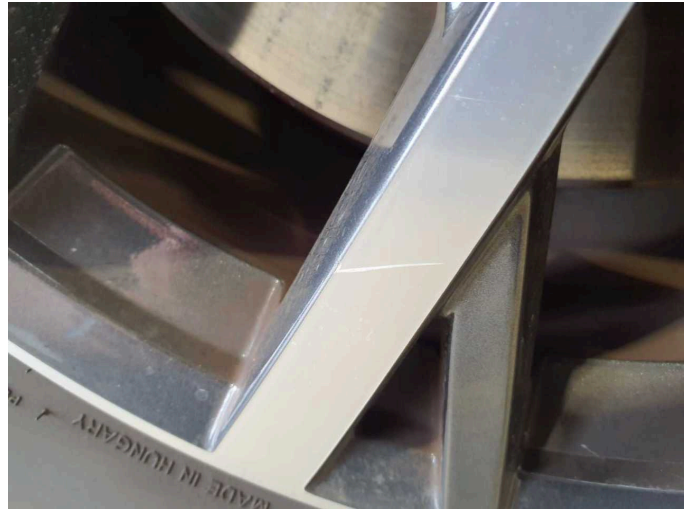
Damage 8: Wheel / tyres: Alloy rim - front right side - Scratch(es) - Loss in value

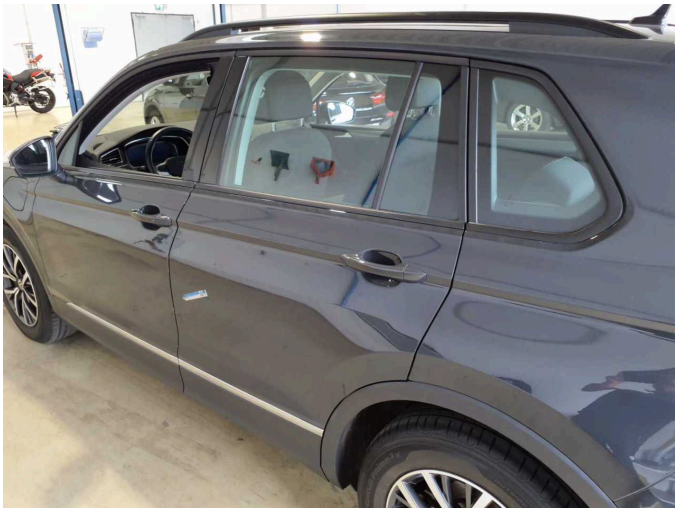
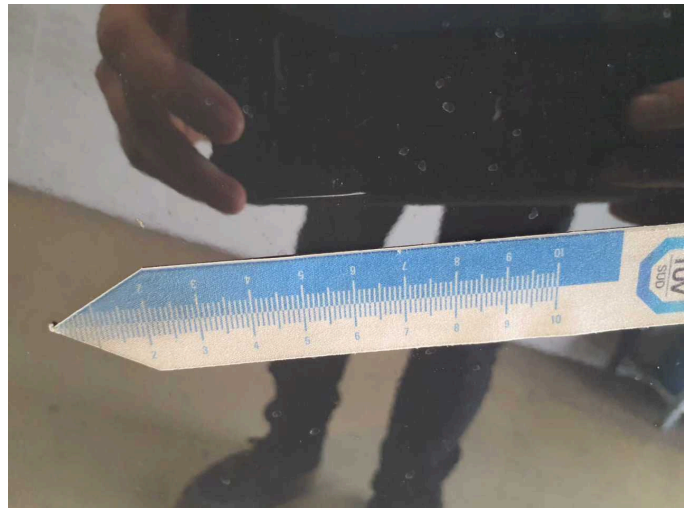
Damage 9: Door - rear left side: Door - Scratch(es) - Smart repair

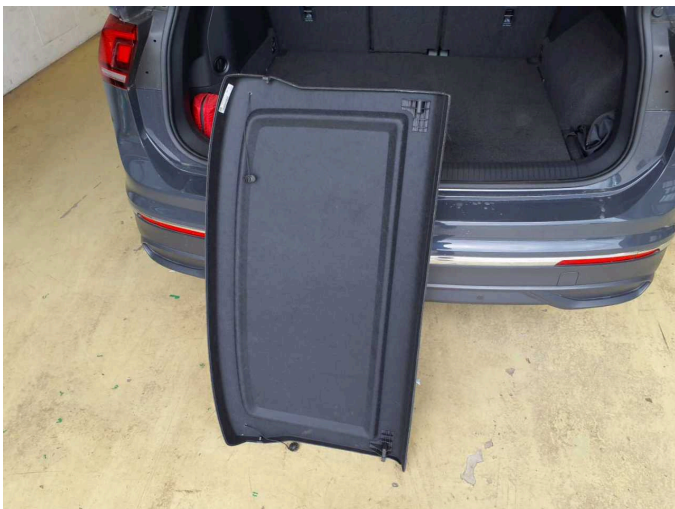
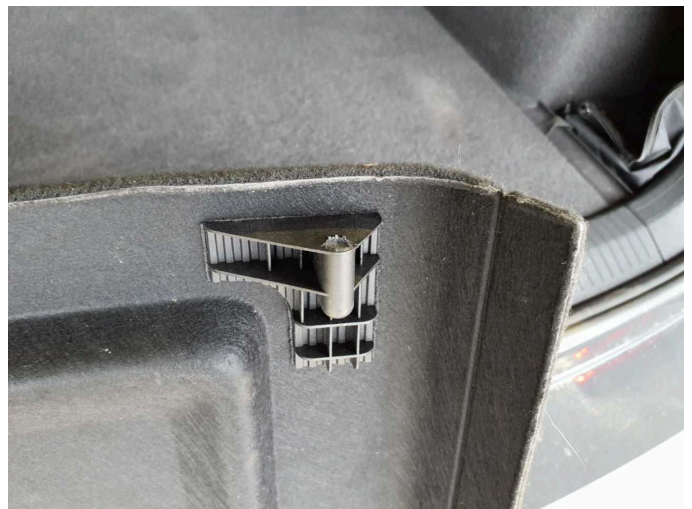
Damage 10: Interior: Boot cover / roller cover - Damaged - Replace

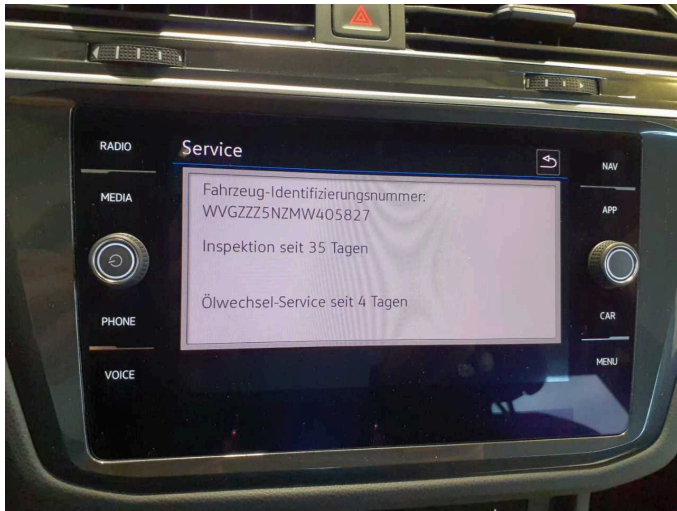
Damage 11: Misc.: Inspection / maintenance - Due - Perform

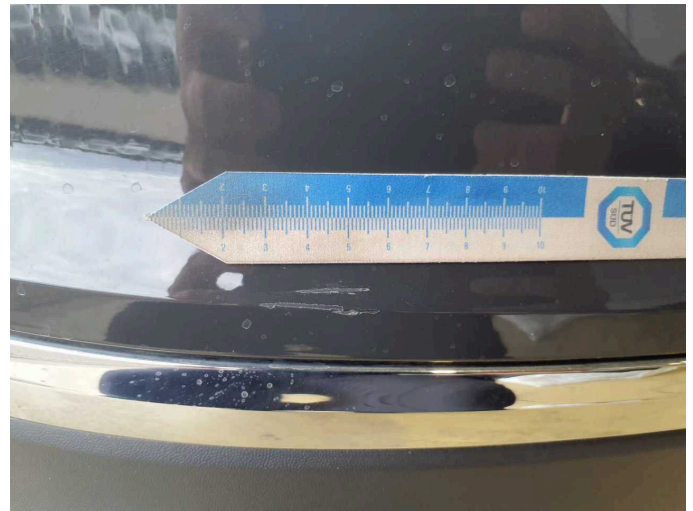
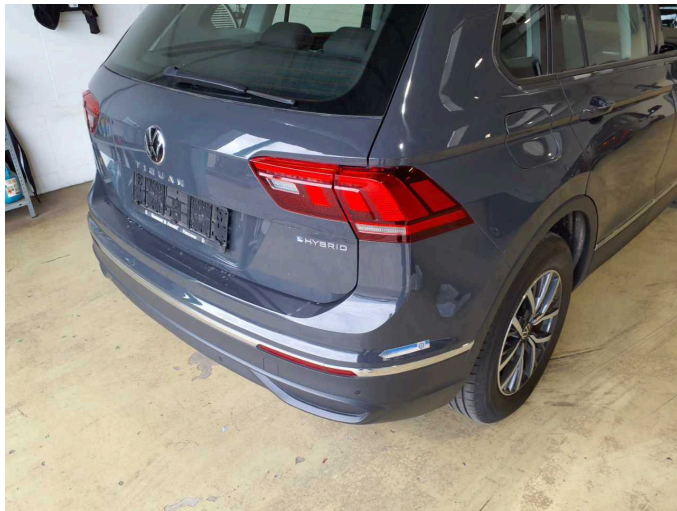
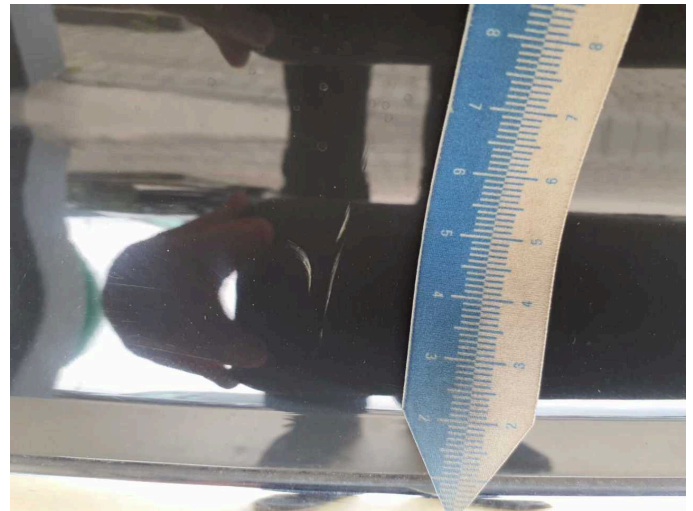
Damage 12: Rear bumper: Rear bumper - Scratch(es) - Paint

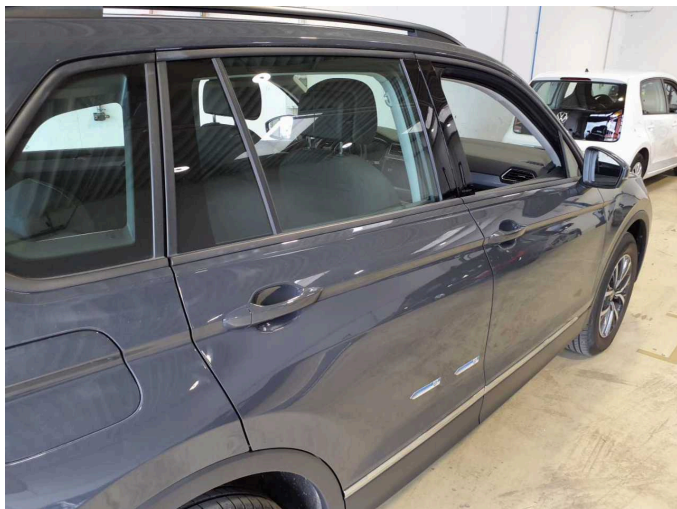
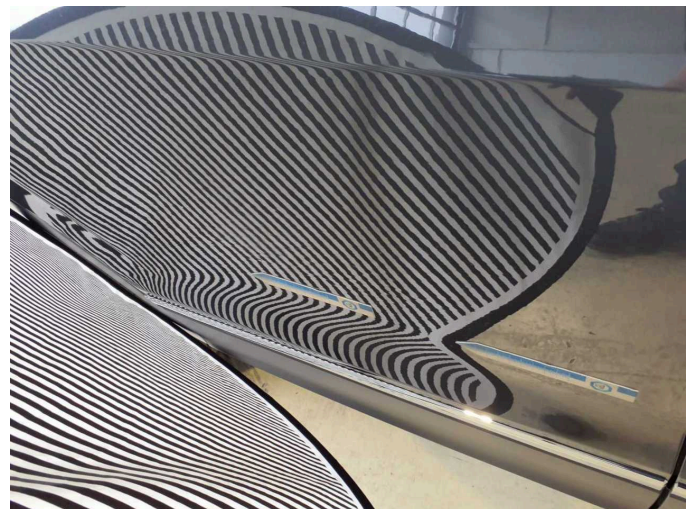
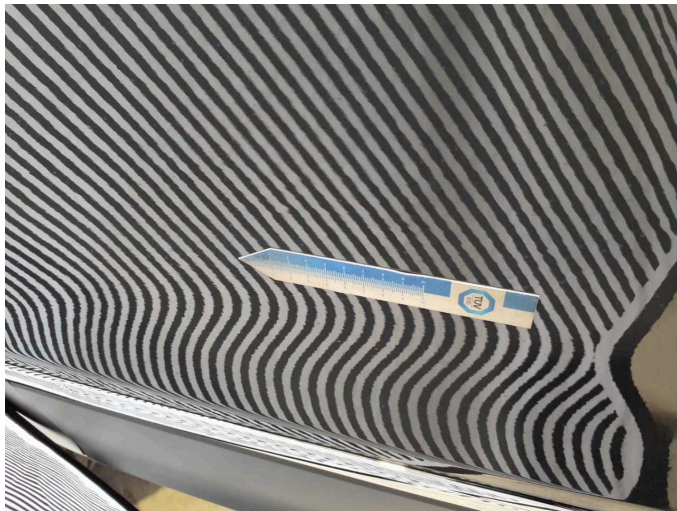
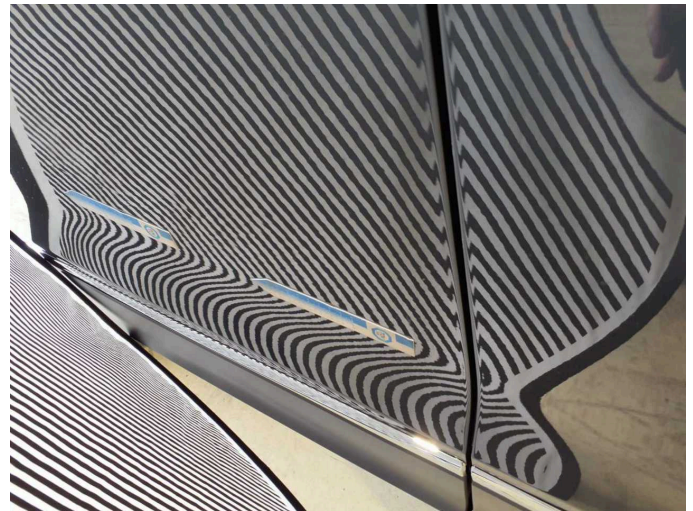
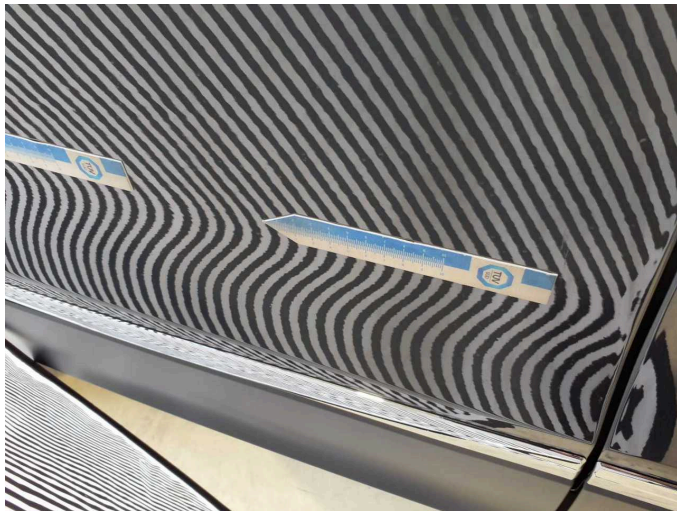
An unprofessionally repaired previous damage was found at the vehicle.

Damage 13: Door - rear right side: Door (Wellig) - Unprofessionally repaired - Repair and paint

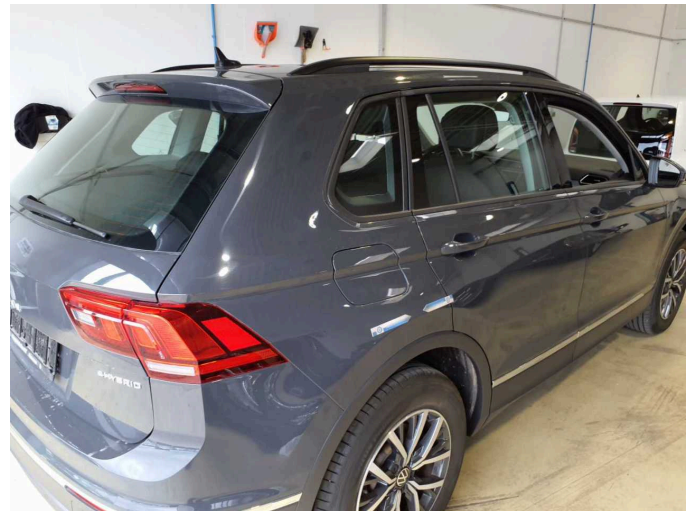
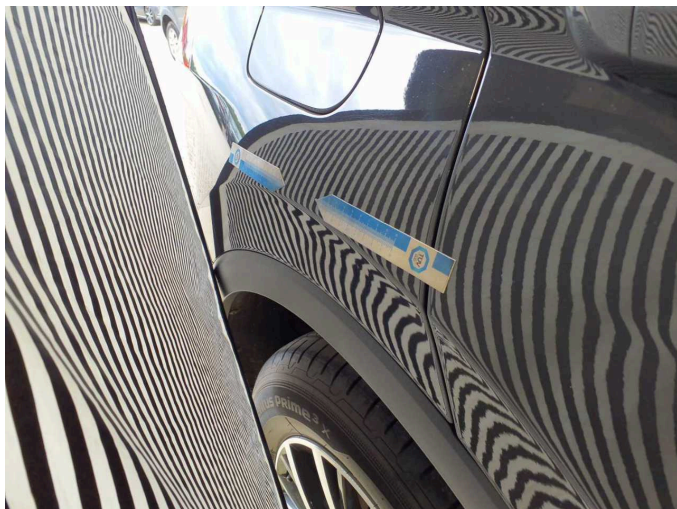
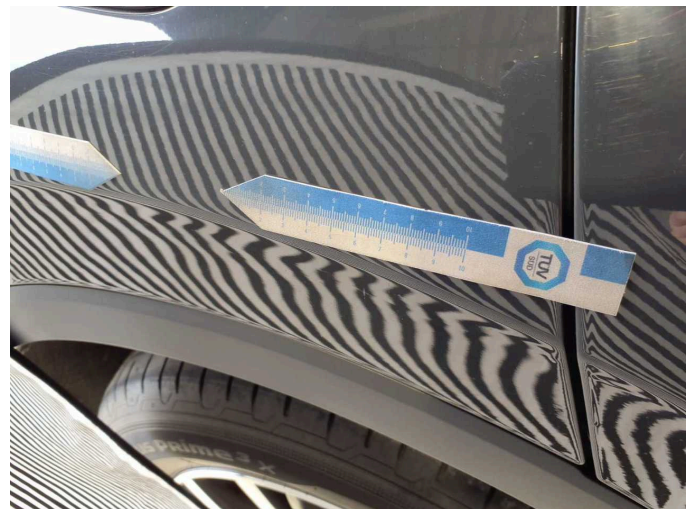
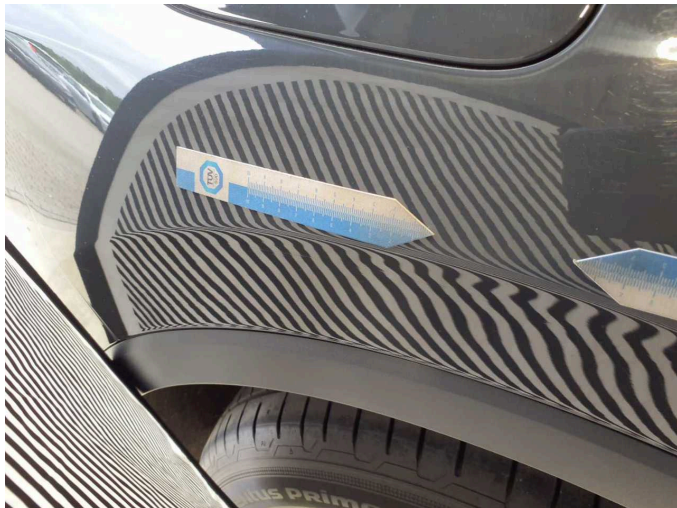
Damage 14: Side panel - rear right side: Side panel (Wellig) - Unprofessionally repaired - Repair and paint

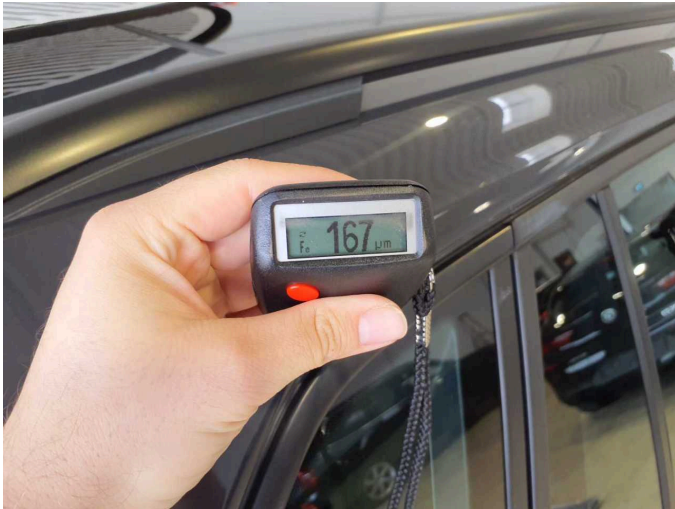
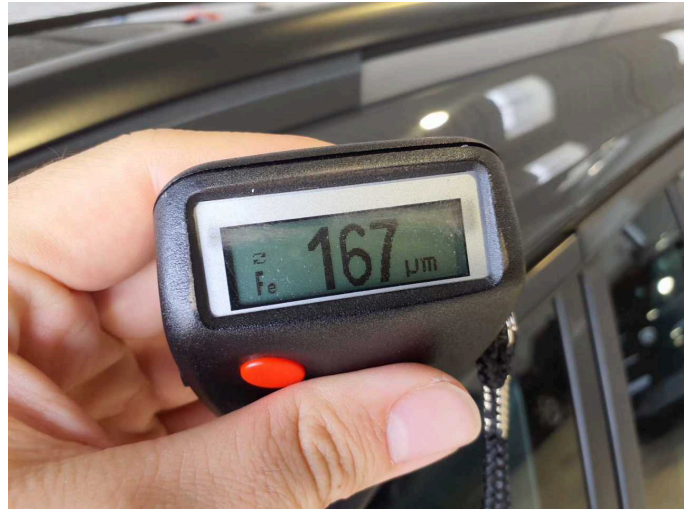
Roof rail - right side	167 µm	Side panel - rear right side	272 µm
Door - rear right side	252 µm

Repainting 1: Roof rail - right side

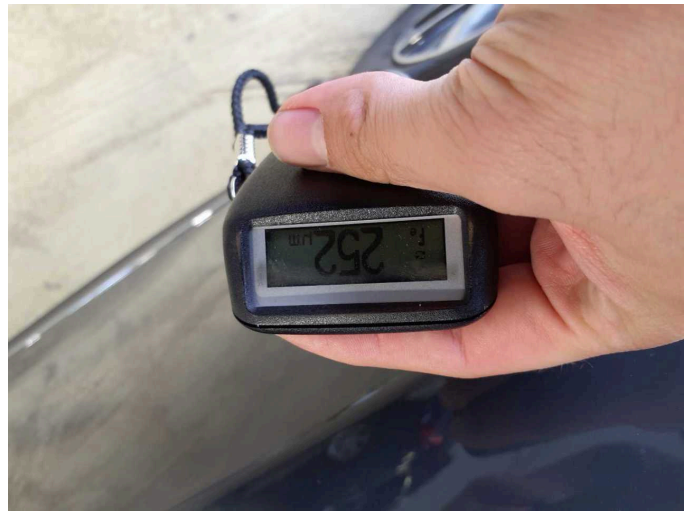
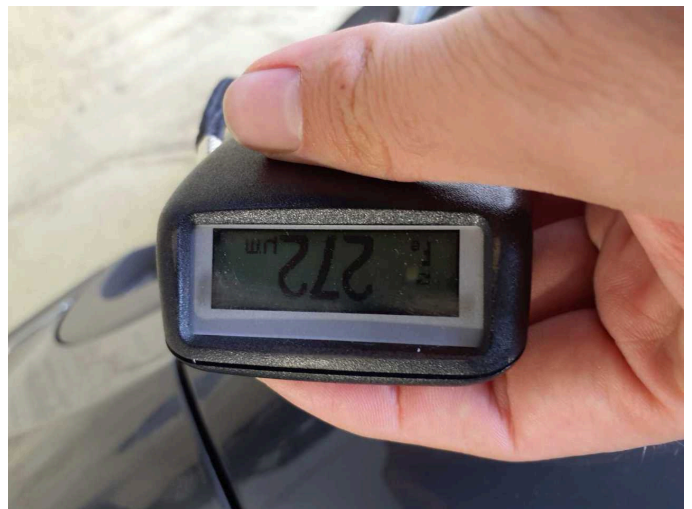
No.	Repainting
1	Roof rail - right side
2	Side panel - rear right side, Door - rear right side, Unprofessionally carried out

Repainting 2: Side panel - rear right side, Door - rear right side
