## status report

**customer:** BCA Autoauktionen GmbH

#### Volkswagen Tiguan R-Line

| Vehicle identification number | <b>WVGZZZ5NZMW560299</b> | mileage read: | <b>32818 km</b> |

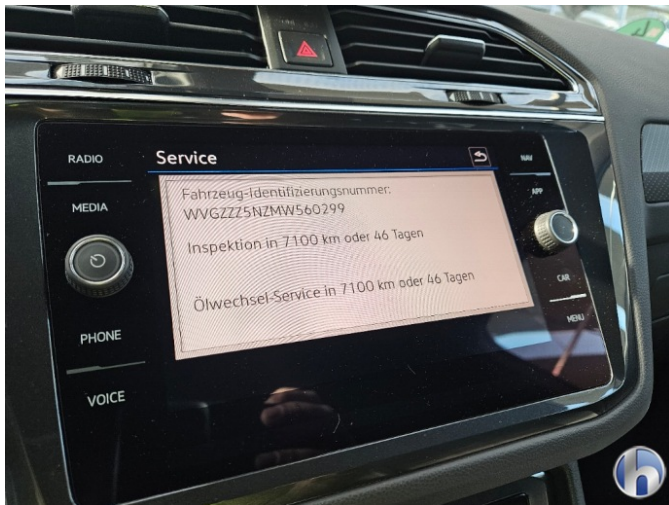
1. Wartung

| | component | Damage | Rep kind |
|---|---|---|---|
| 1. | Wartung | | Replace |

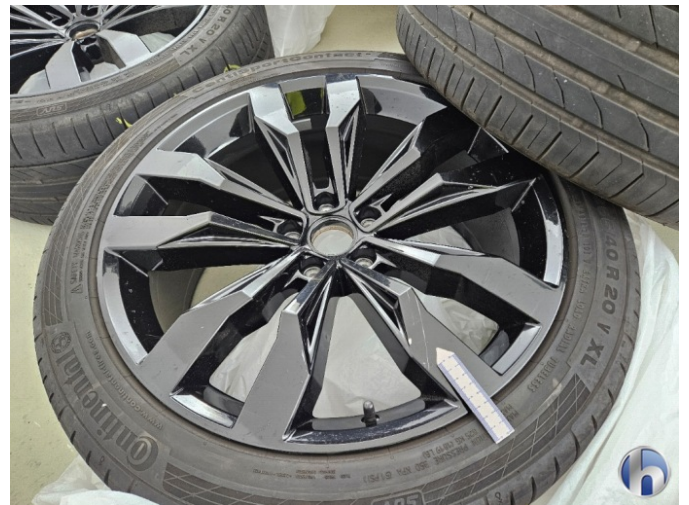
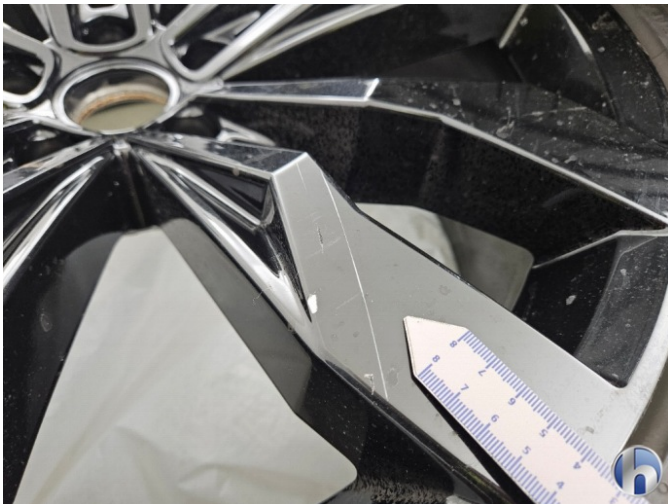
2. Felge

| | component | Damage | Rep kind |
|---|---|---|---|
| 2. | Felge | Scratch(es) | Paint |

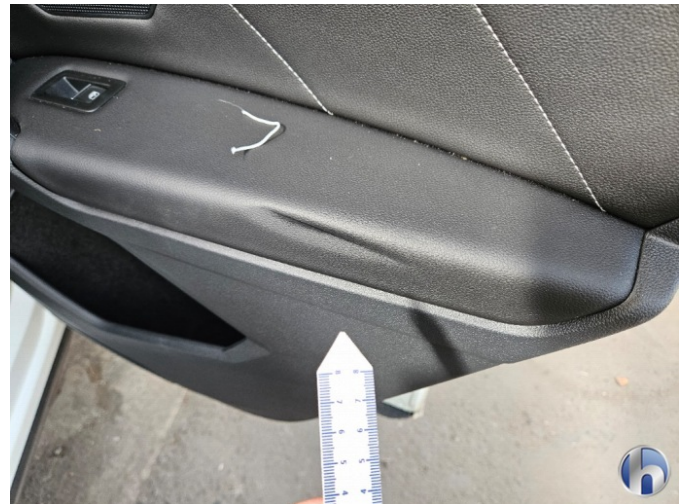
3. Türverkleidung h.r.

| | component | Damage | Rep kind |
|---|---|---|---|
| 3. | Türverkleidung h.r. | Wear and tear | acceptable |

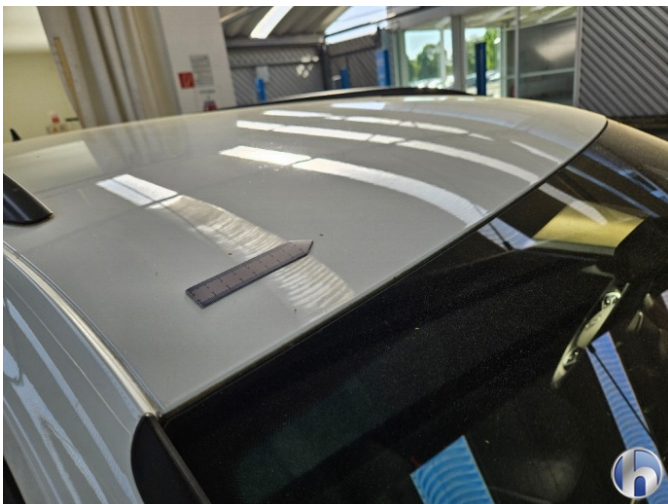
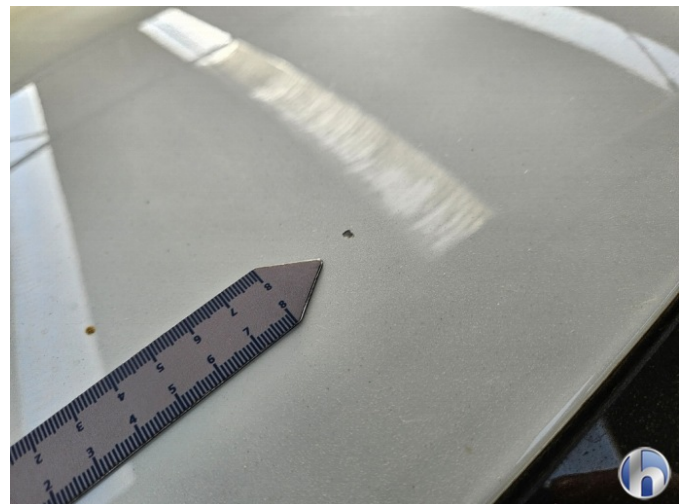
4. roof

| | component | Damage | Rep kind |
|---|---|---|---|
| 4. | roof | Wear and tear | acceptable |

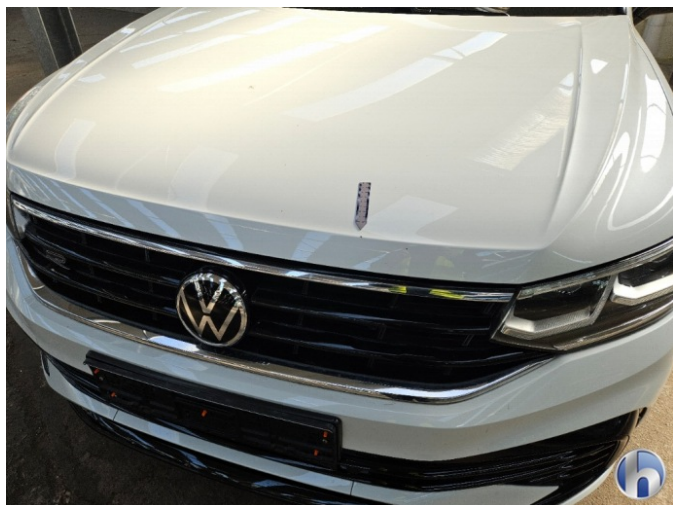
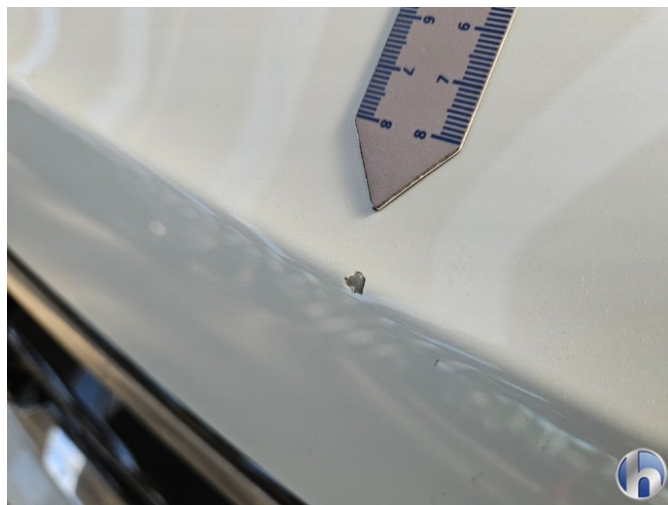
5. hood

| | component | Damage | Rep kind |
|---|---|---|---|
| 5. | hood | Wear and tear | acceptable |

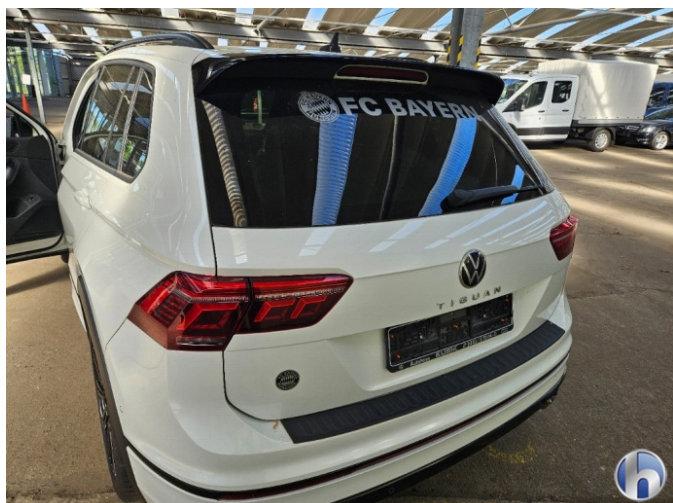
6. tailgate

| | component | Damage | Rep kind |
|---|---|---|---|
| 6. | tailgate | Sticker | |
