Expertise

Protocol number: 41459294
Order No. / Reference: 25170810
Inspection date: 8 Sept 2025

Manufacturer: Volkswagen

Model: Tiguan 2.0 TDI SCR 4MOTION DSG Elegance

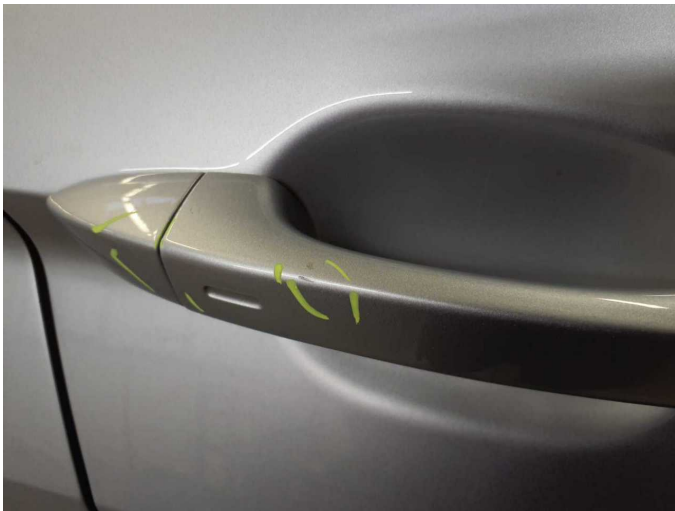
Damage 3: Door - front right side: Door handle - outside - Scratch(es) - Smart repair

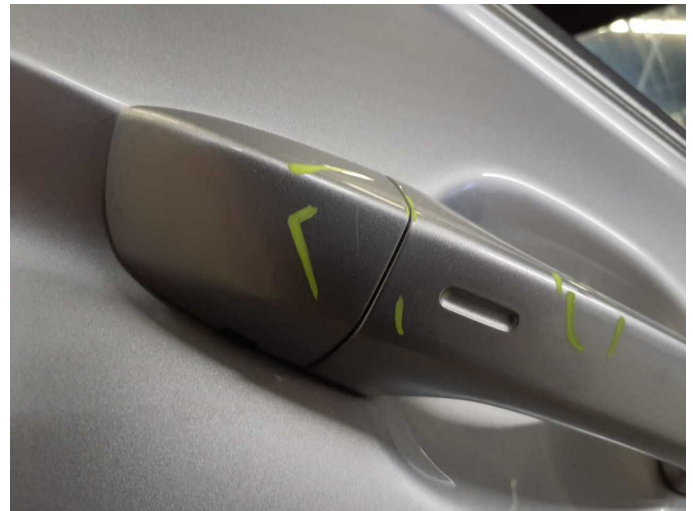
Damage 3: Door - front right side: Door handle - outside - Scratch(es) - Smart repair

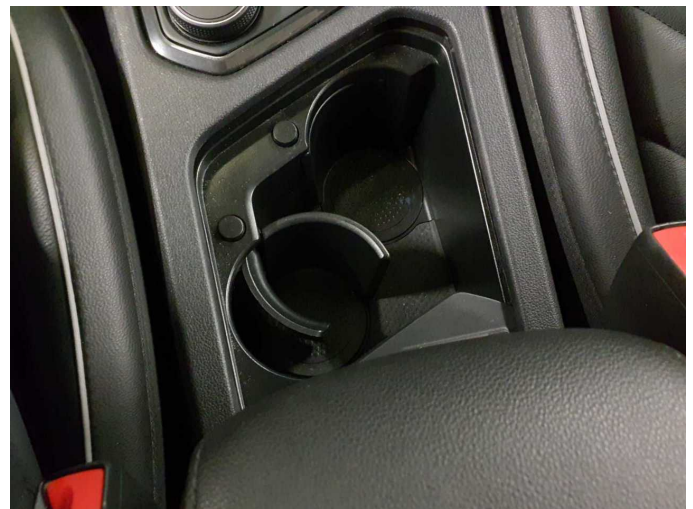
Damage 4: Interior: Cup holder - centre - Broken / torn - Replace

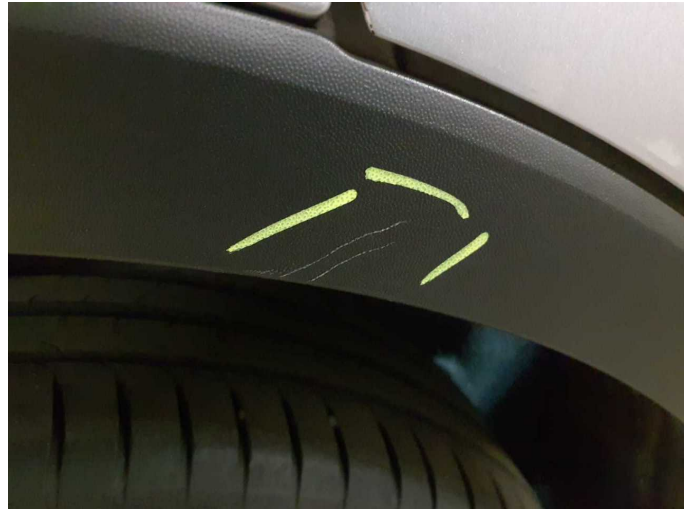
Damage 5: Side panel - rear right side: Wheel well extension - Scratch(es) - Loss in value

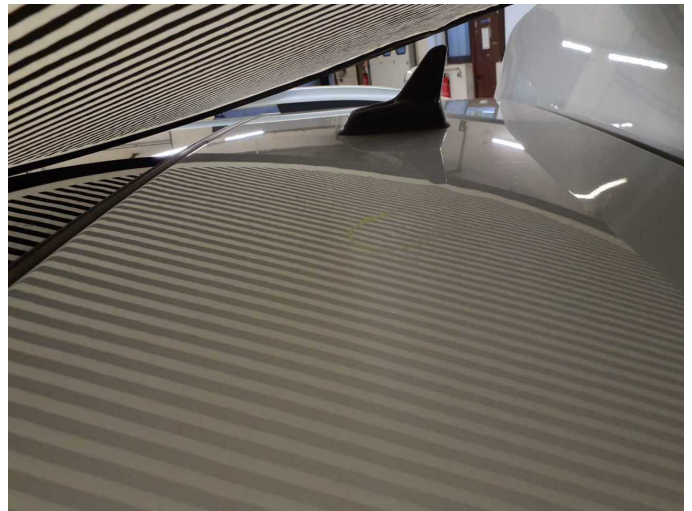
Damage 6: Roof: Roof - dent(s) - Smooth repair work

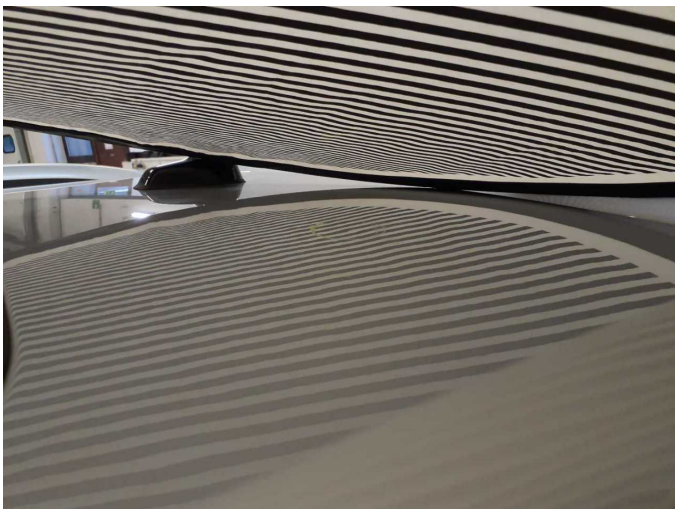
Damage 6: Roof: Roof - dent(s) - Smooth repair work

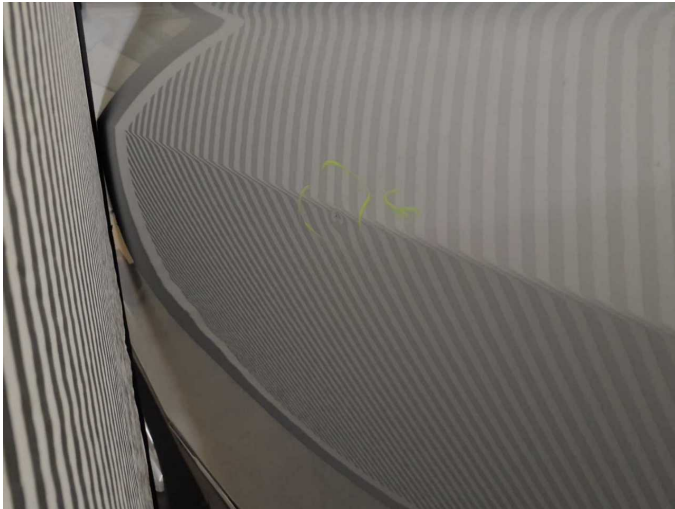
Damage 7: Door - rear right side: Door - dent(s) - Smooth repair work

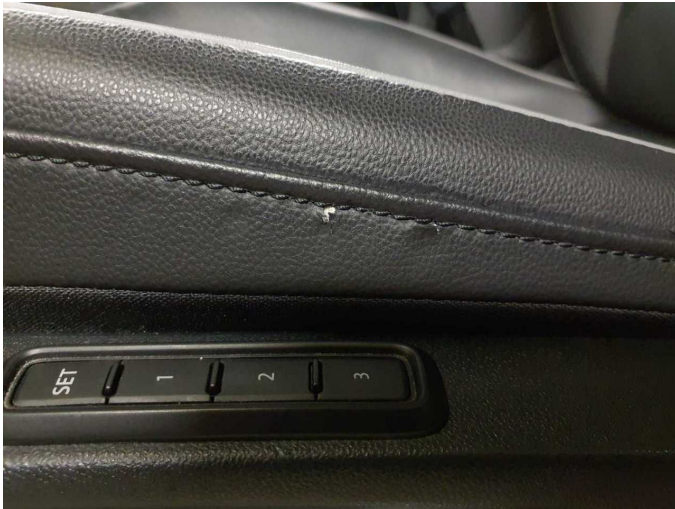
Damage 8: Seat - front: Seat cover - left side - Scratched - Smart repair

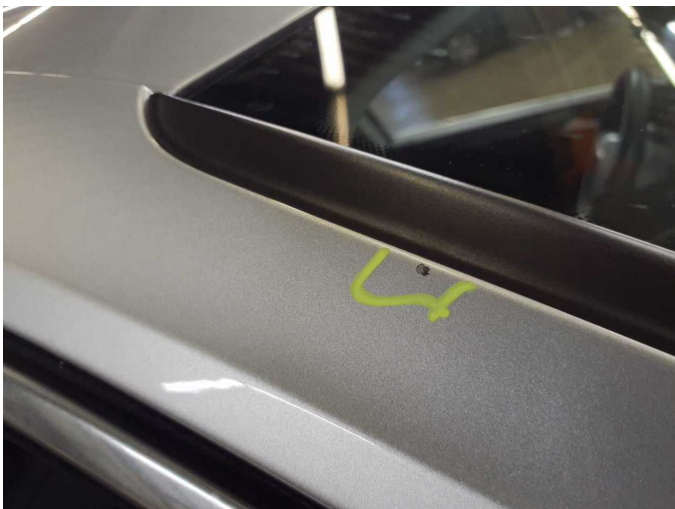
Damage 9: Roof: Roof rail - right side - Stone chips - Smart repair

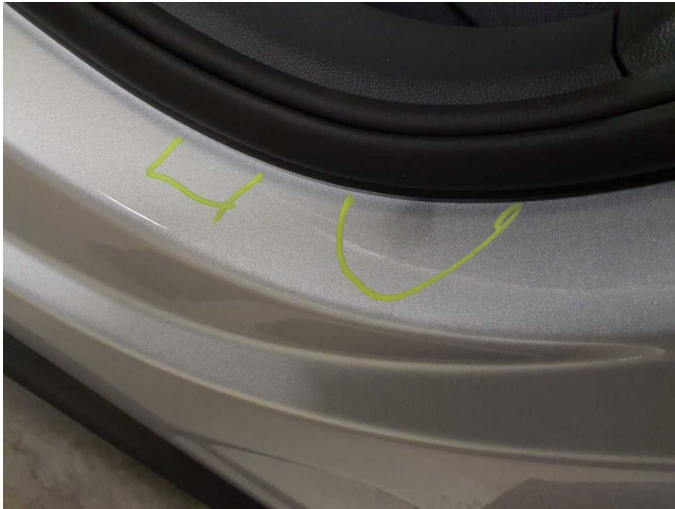
Damage 10: Sill - left side: Sill (Lackfehler / Lackpickel / Kratzer) - Scratched - Smart repair

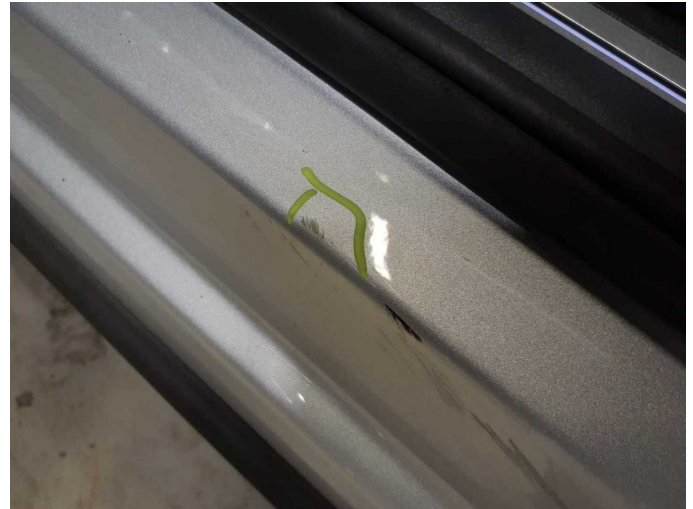
Damage 10: Sill - left side: Sill (Lackfehler / Lackpickel / Kratzer) - Scratched - Smart repair

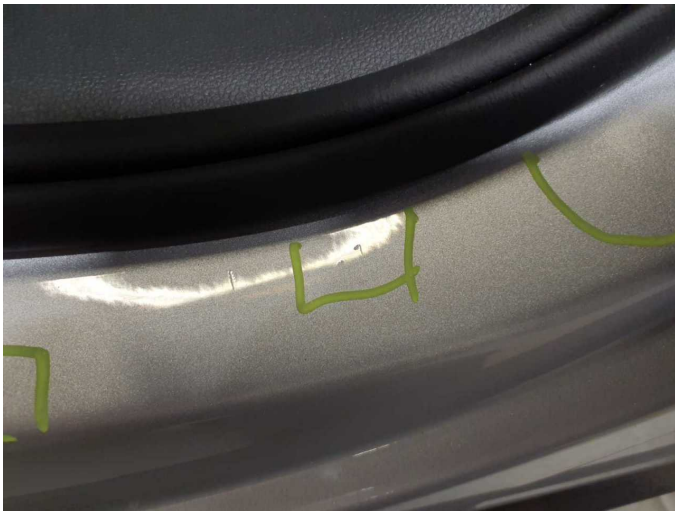
Damage 10: Sill - left side: Sill (Lackfehler / Lackpickel / Kratzer) - Scratched - Smart repair

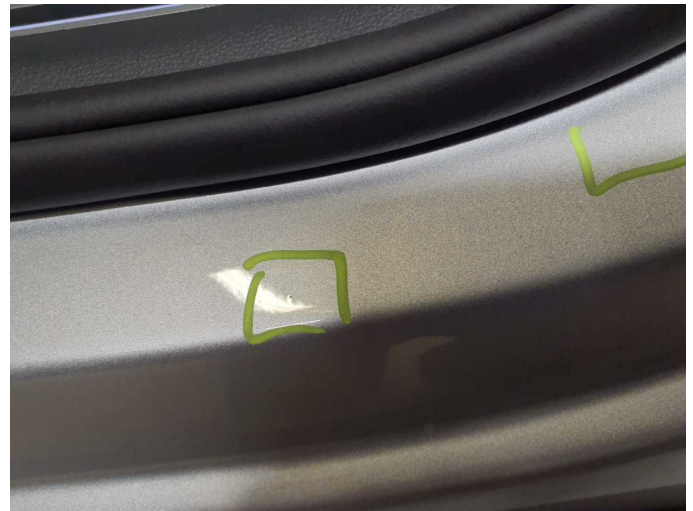
Damage 10: Sill - left side: Sill (Lackfehler / Lackpickel / Kratzer) - Scratched - Smart repair

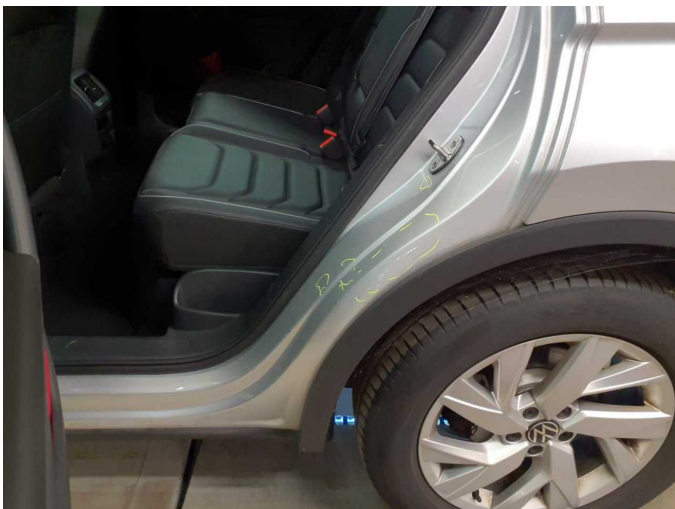
Damage 10: Sill - left side: Sill (Lackfehler / Lackpickel / Kratzer) - Scratched - Smart repair

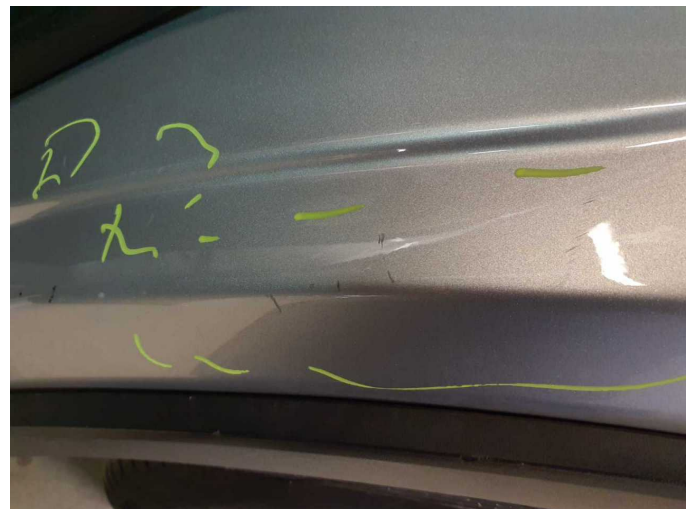
Damage 11: Side panel - rear left side: Sill - Scratched - Smart repair

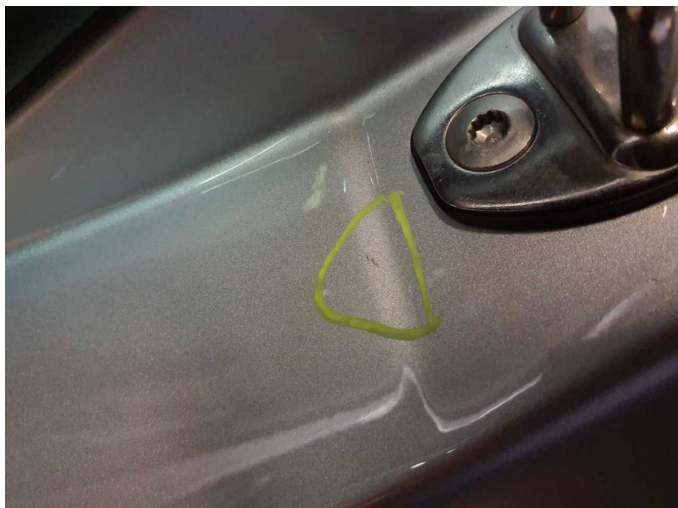
Damage 11: Side panel - rear left side: Sill - Scratched - Smart repair

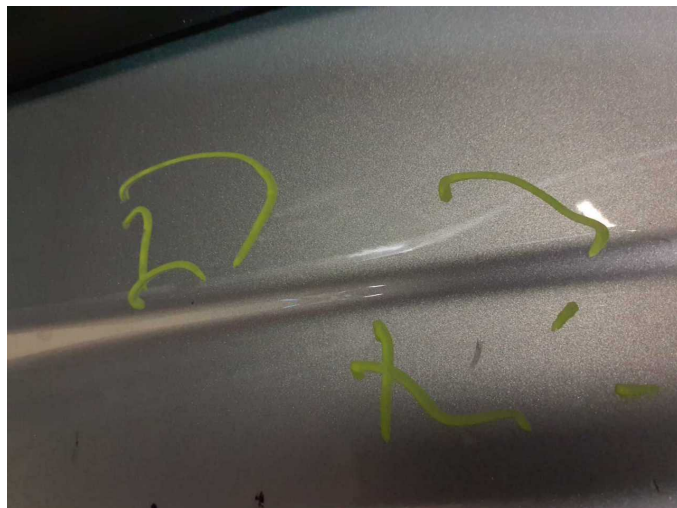
Damage 11: Side panel - rear left side: Sill - Scratched - Smart repair

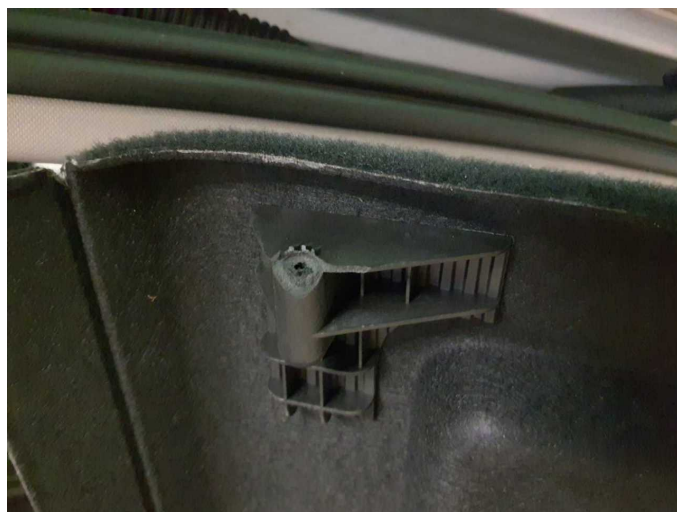
Damage 12: Interior: Rear shelf - Broken / torn - Replace

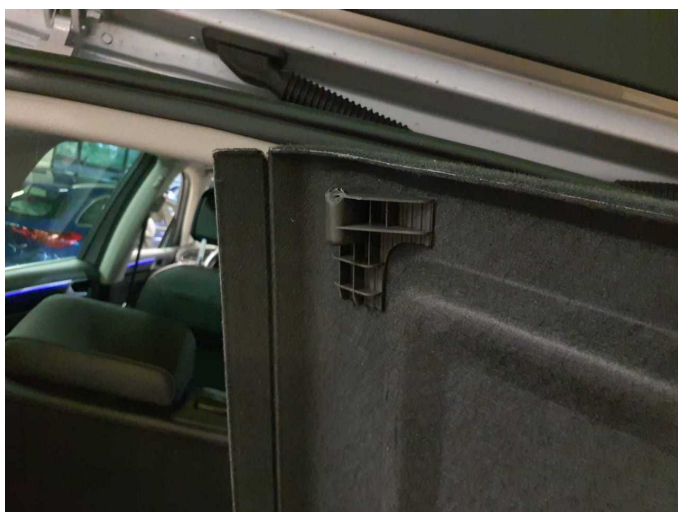
Damage 12: Interior: Rear shelf - Broken / torn - Replace

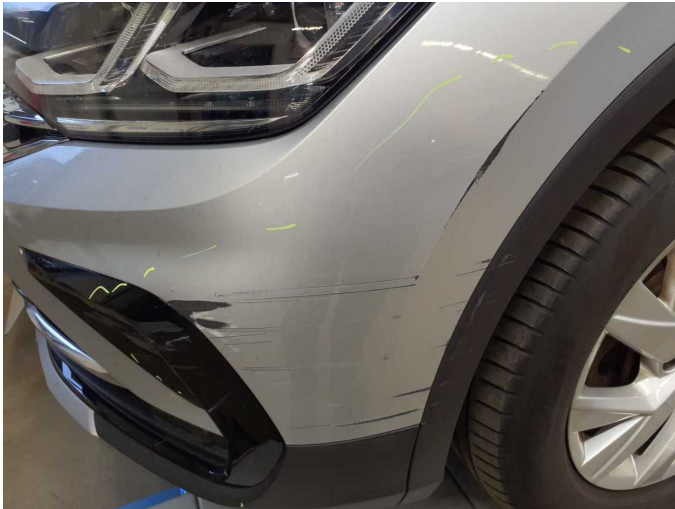
Damage 13: Front bumper: Front bumper - Scratched - Paint

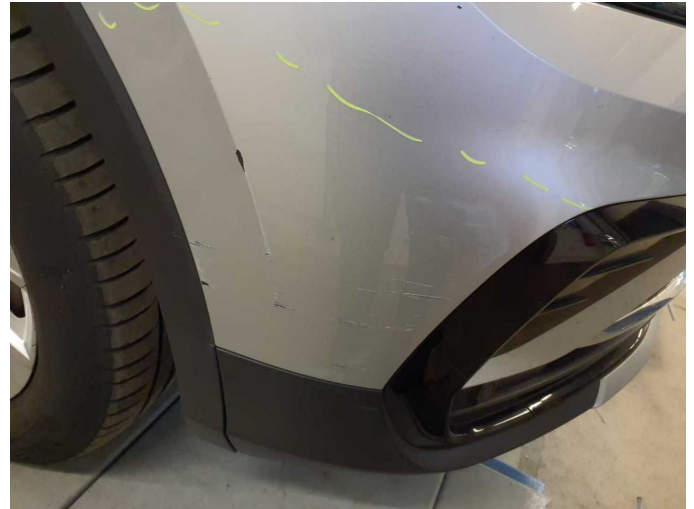
Damage 13: Front bumper: Front bumper - Scratched - Paint

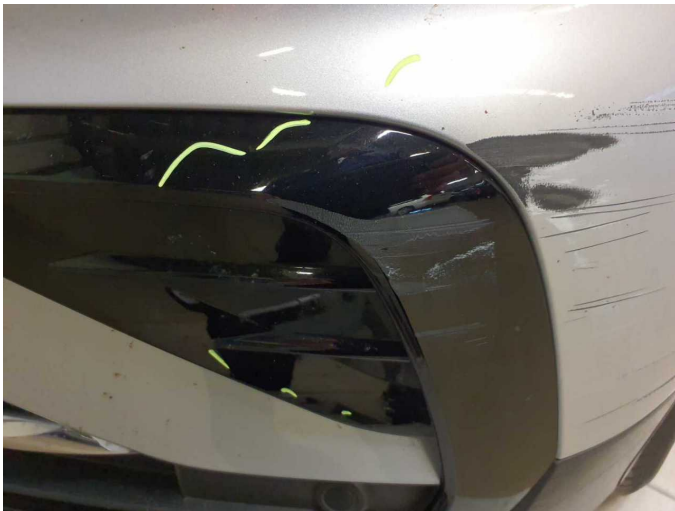
Damage 13: Front bumper: Front bumper - Scratched - Paint

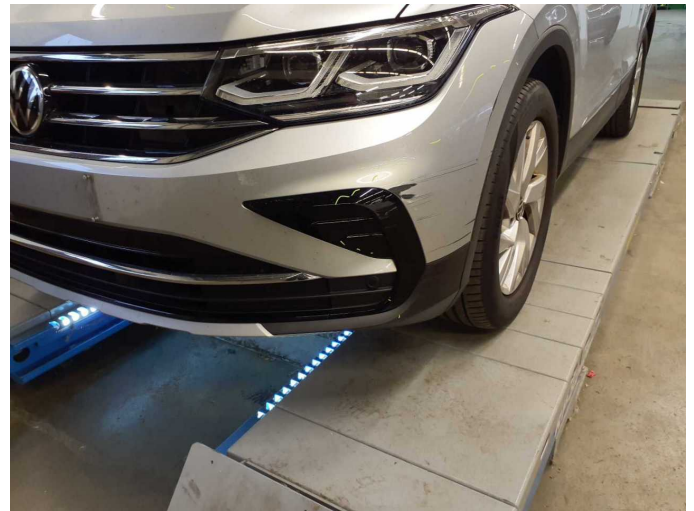
Damage 13: Front bumper: Front bumper - Scratched - Paint

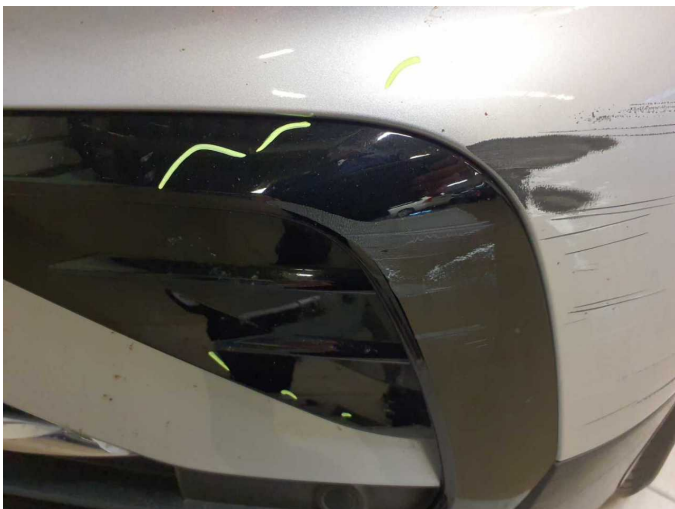
Damage 14: Front bumper: Cover bumper - front (Materialabtrag) - Scratched - Replace

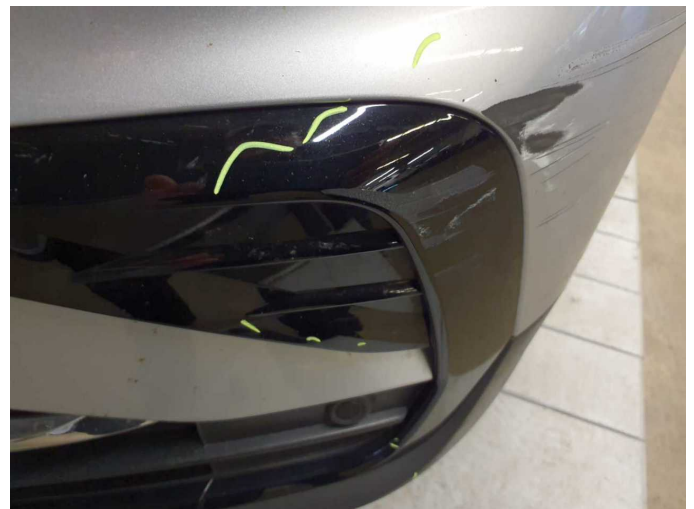
Damage 14: Front bumper: Cover bumper - front (Materialabtrag) - Scratched - Replace

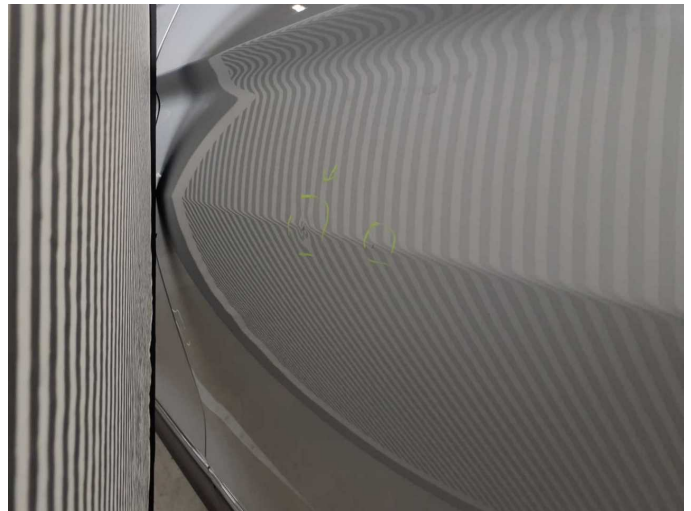
Damage 15: Door - rear left side: Door - Dent / paintcoat damage - Repair and paint

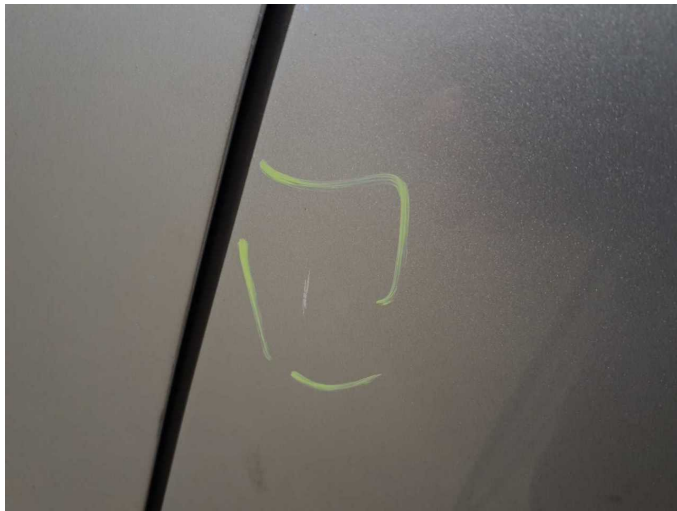
Damage 15: Door - rear left side: Door - Dent / paintcoat damage - Repair and paint

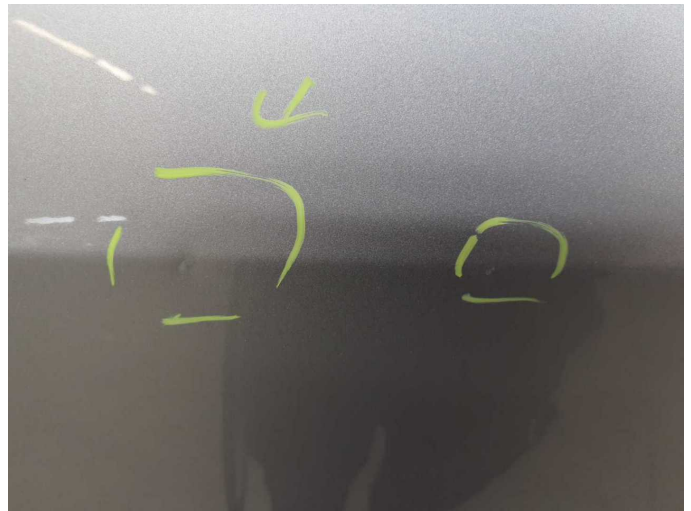
Damage 15: Door - rear left side: Door - Dent / paintcoat damage - Repair and paint

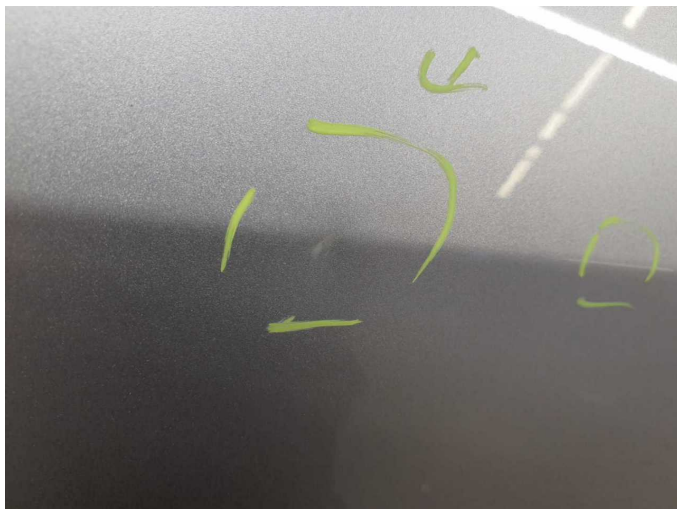
Damage 15: Door - rear left side: Door - Dent / paintcoat damage - Repair and paint

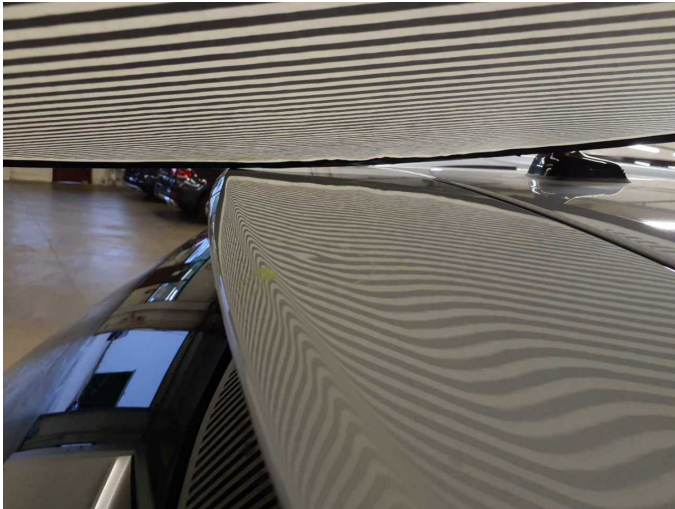
Damage 16: Boot lid / rear door: Boot lid - Dent / paintcoat damage - Repair and paint

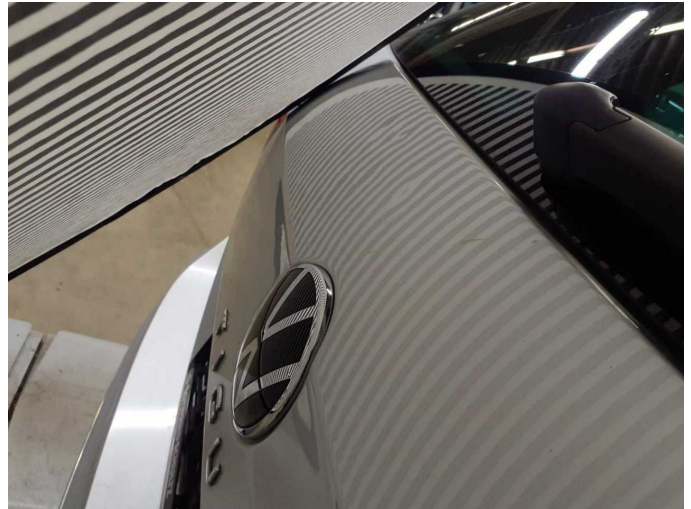
Damage 16: Boot lid / rear door: Boot lid - Dent / paintcoat damage - Repair and paint

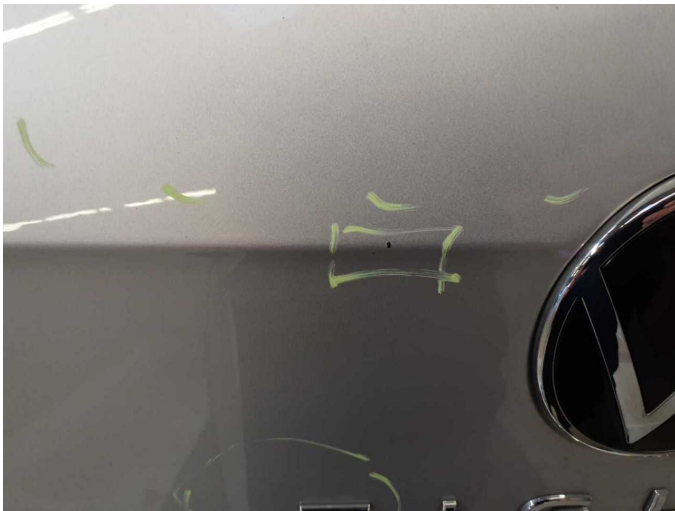
Damage 16: Boot lid / rear door: Boot lid - Dent / paintcoat damage - Repair and paint

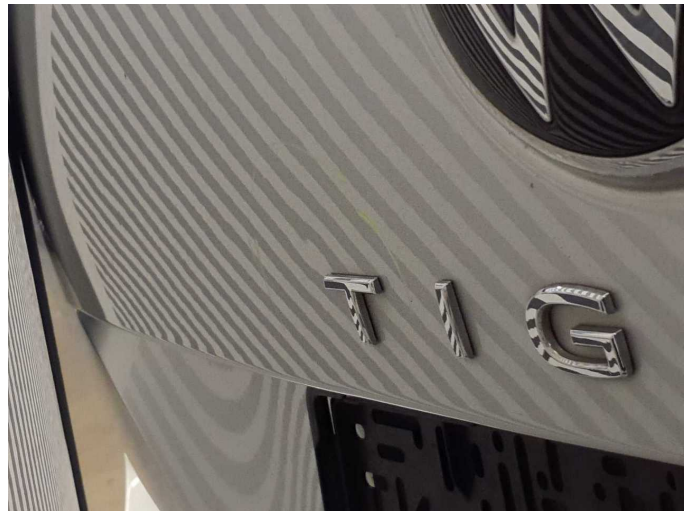
Damage 16: Boot lid / rear door: Boot lid - Dent / paintcoat damage - Repair and paint

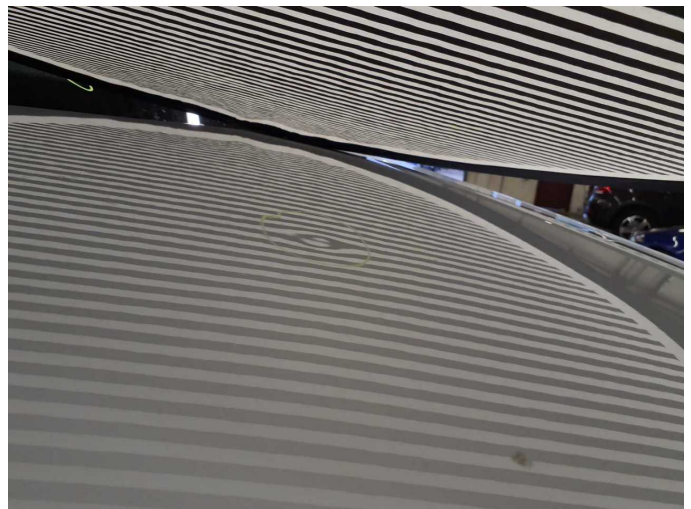
Damage 17: Bonnet: Bonnet - Dent / paintcoat damage - Repair and paint

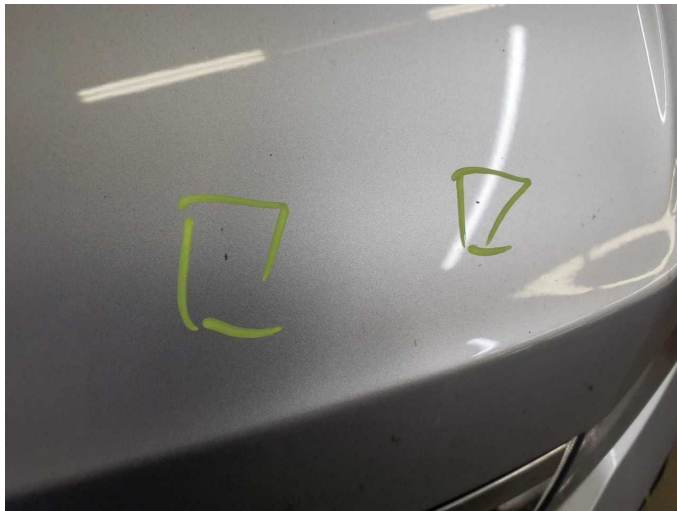
Damage 17: Bonnet: Bonnet - Dent / paintcoat damage - Repair and paint

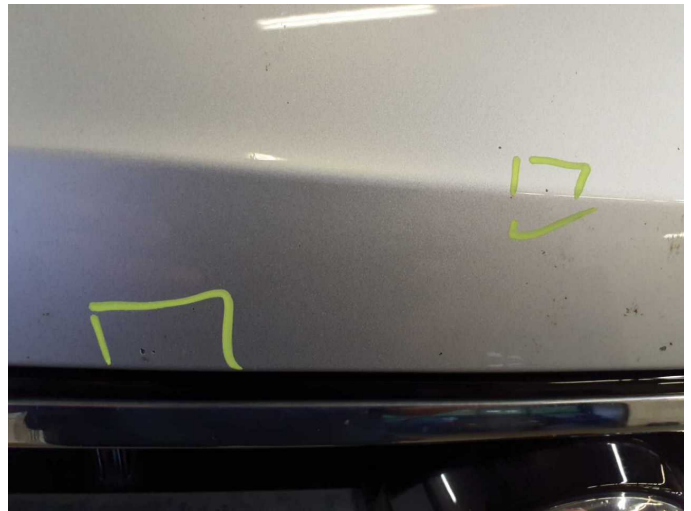
Damage 17: Bonnet: Bonnet - Dent / paintcoat damage - Repair and paint

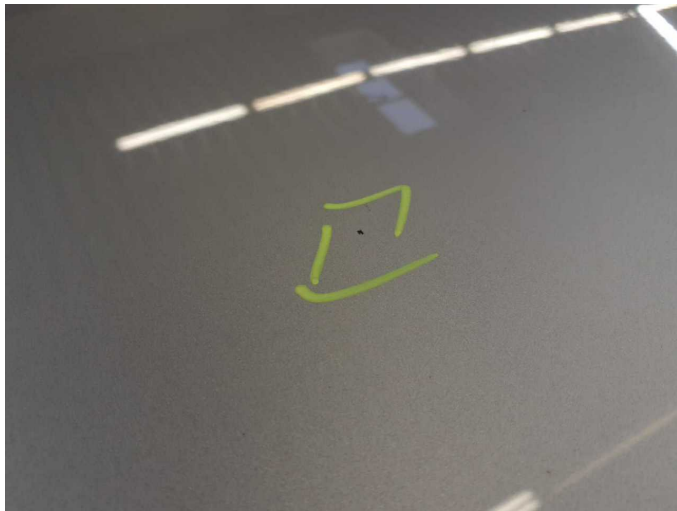
Damage 17: Bonnet: Bonnet - Dent / paintcoat damage - Repair and paint

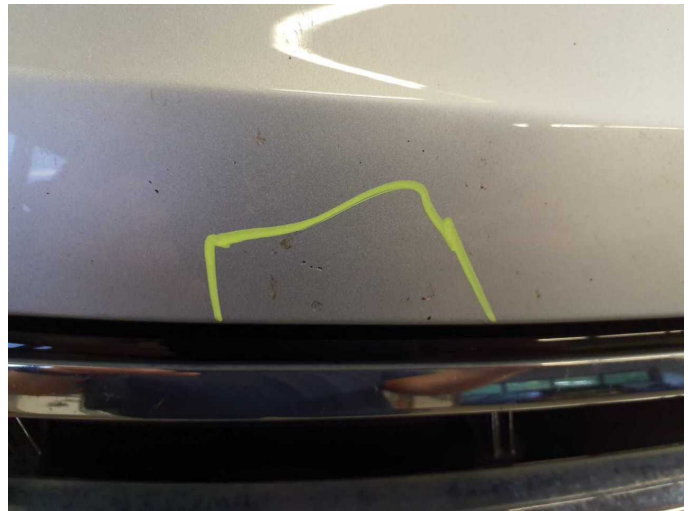
Damage 17: Bonnet: Bonnet - Dent / paintcoat damage - Repair and paint

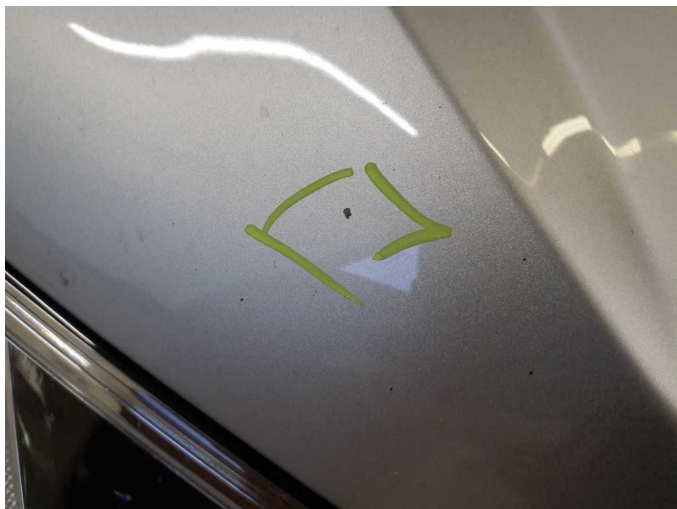
Damage 17: Bonnet: Bonnet - Dent / paintcoat damage - Repair and paint
