## status report

#### Volkswagen T-Roc Style

Vehicle identification number	<b>WVGZZA1ZKV020133</b>	mileage read:	<b>52462 km</b>
..			
First Registration / construction year:	<b>08.11.2018 / 2018</b>	Visit Date / place of birth:	<b>21.11.2024 Riedstadt-Goddelau</b>
Bodywork:	<b>SUV</b>	Re - import:	<b>unknown</b>
Body type:	<b>Road /</b>	KBA no. :	<b>0603//CFO</b>
Fuel / emission class:	<b>diesel / -</b>	transmission type:	<b>manual transmission</b>
Displacement / power:	<b>1598 ccm / 85 kW (116 PS)</b>	Engine:	<b>front-wheel drive</b>
paint:	<b>Pure White</b>	Number of previous owners:	<b>3</b>
Doors / seats:	<b>5 / 5</b>	number keys:	<b>2</b>
Next HU / AU:	<b>- / -</b>	cushion type:	<b>substance</b>
Service book available:	<b>no</b>	Interior Color:	<b>black</b>
smoking vehicle:	<b>no</b>	Last service km / on the:	<b>- / -</b>
Vehicle roadworthy:	<b>yes</b>	Vehicle roadworthy:	<b>yes</b>
Submitted vehicle	<b>-</b>	state outside:	<b>3 - Average</b>

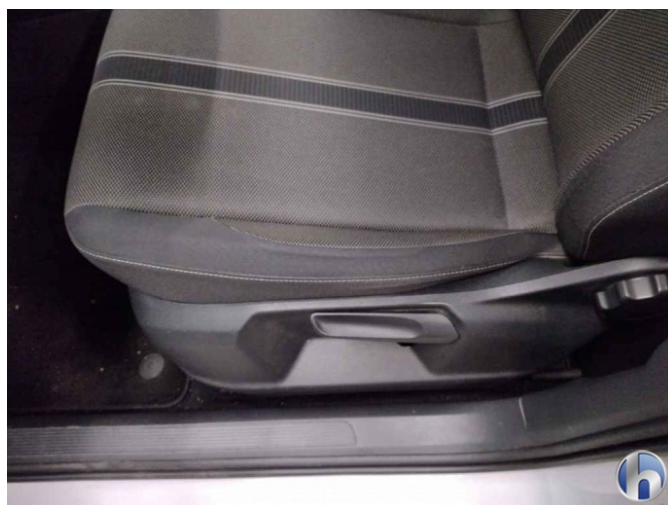
component	Damage	Rep kind
1.	Sitz Vorne Links	Wear and tear	acceptable
2.	proof of maintenance	Missing	Replace
3.	Tire-fit compressor	Missing	Replace
4.	Rim front - right	Damaged	Replace
5.	Rim rear - right	Damaged	Replace
6.	spoiler	Scratch(es)	Replace
7.	Rear door - left		Refurbish and paint
8.	tailgate		Smart repair
9.	Heckklappenverkleidung Halter Hutablage Rechts	Damaged	Replace
10.	maintenance	Due	Replace
